BRIDGE NO HAM-562-0147
PID No. 105476

NORWOOD LATERAL PARKWAY OVER ROSS AVENUE

INSPECTION DETAILS:

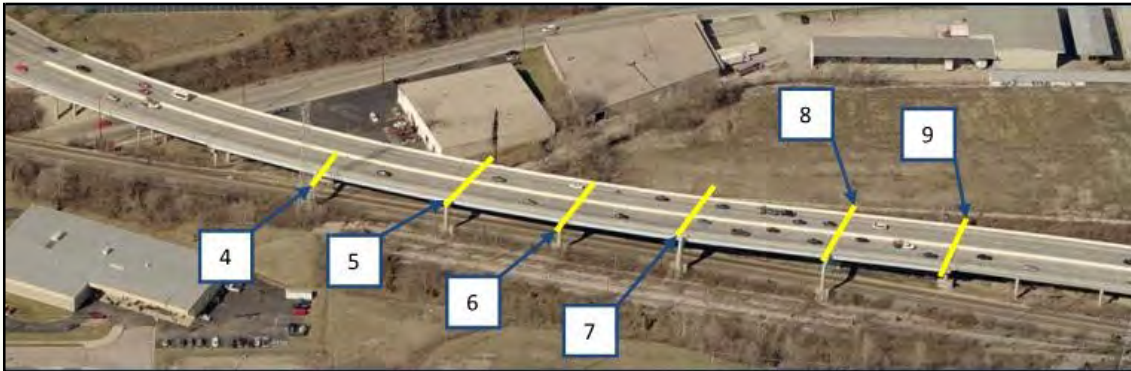
FRACTURE CRITICAL MEMBER LOCATIONS:

The structure has six (6) fracture critical pier caps located at Piers 4, 5, 6, 7, 8, and 9. At Pier 4, only the right superstructure is supported while the remaining caps dually support both superstructures. All the pier caps are welded steel box girders that support a varying number of welded steel plate girders. Pier Caps 4, 5, 6, 7 and 9 are simply supported with cantilevers over the left pier columns. Pier Cap 8 is a two-span continuous unit. The nomenclature and girder descriptions shown on the design plans will be used during the inspection.

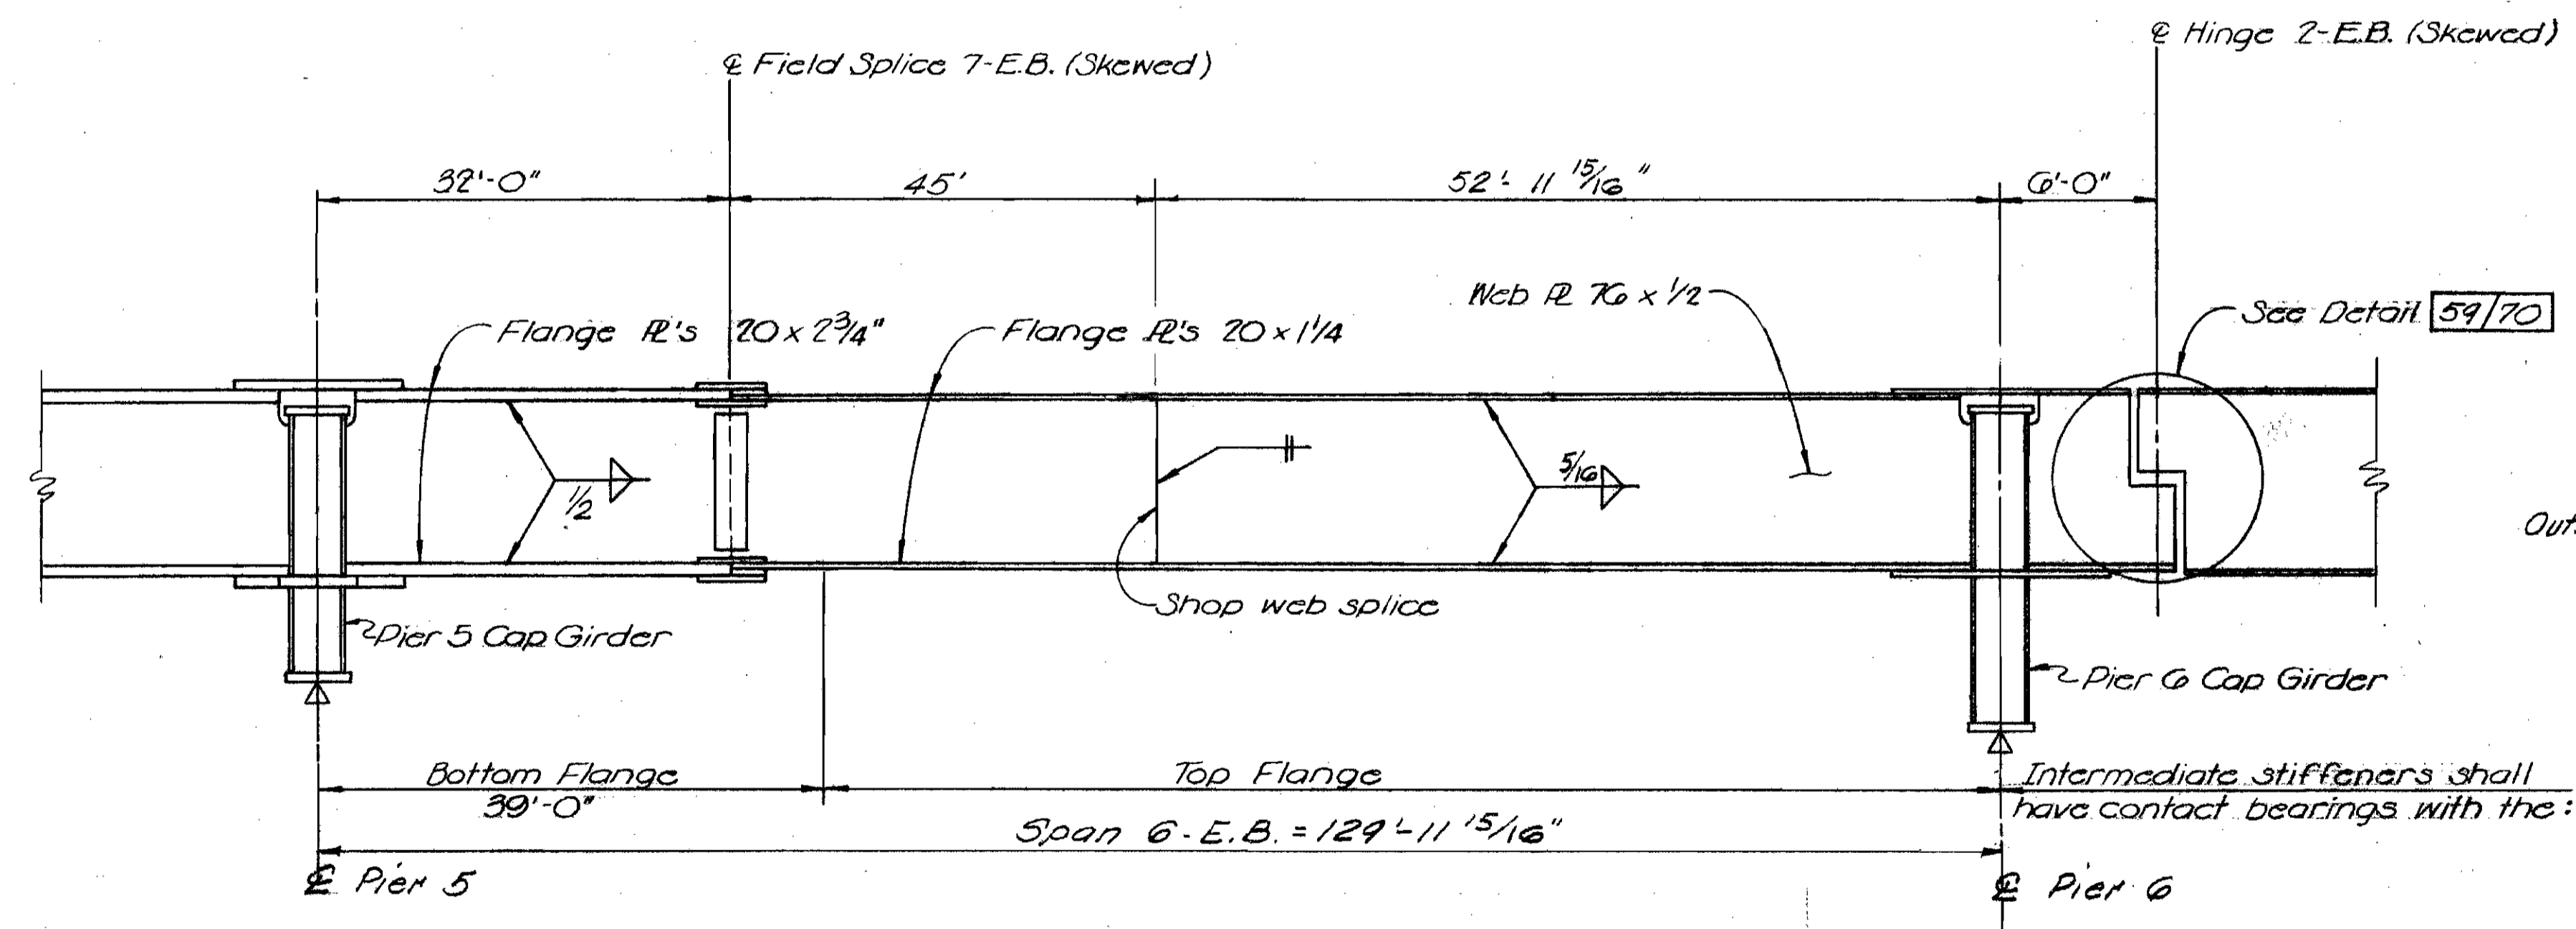
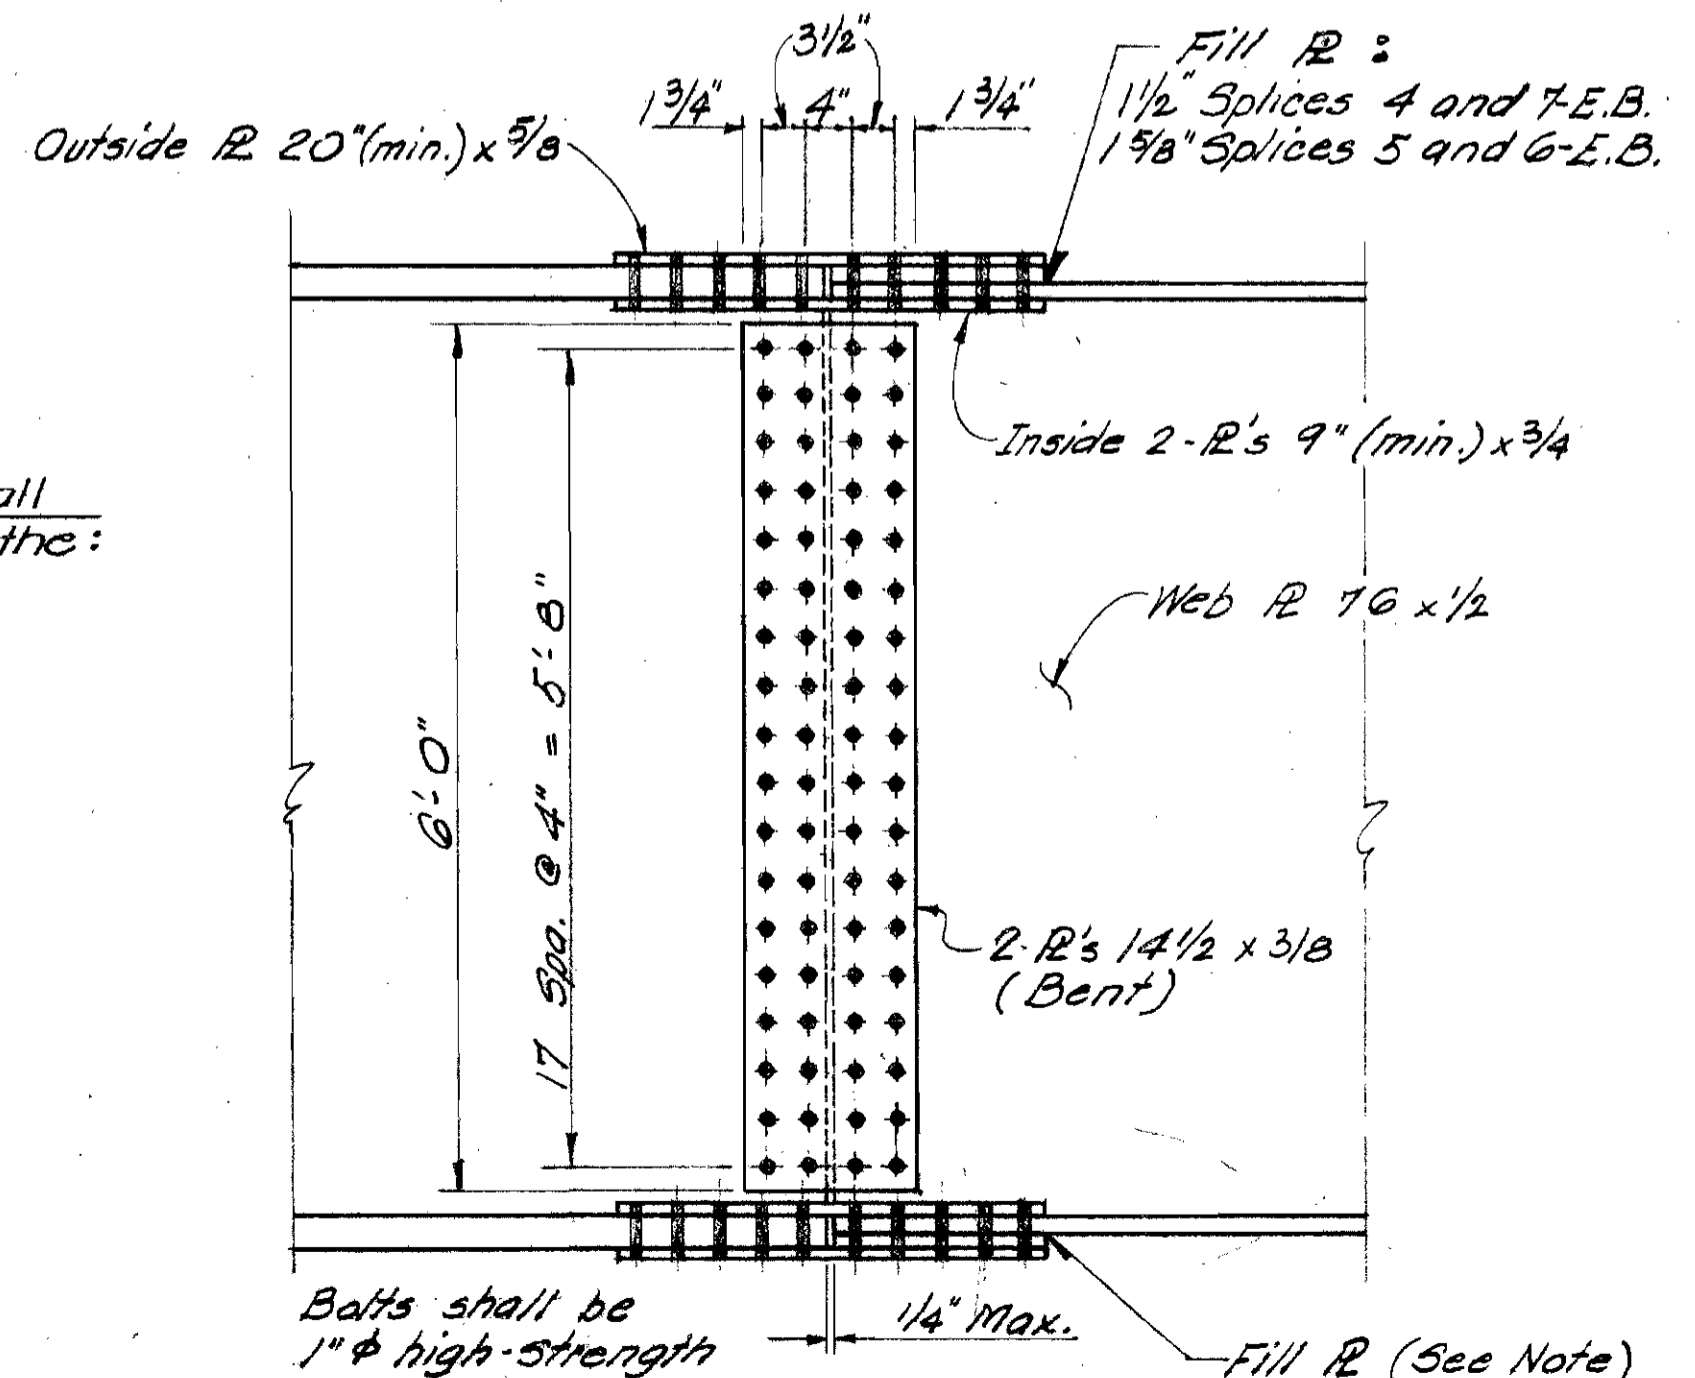
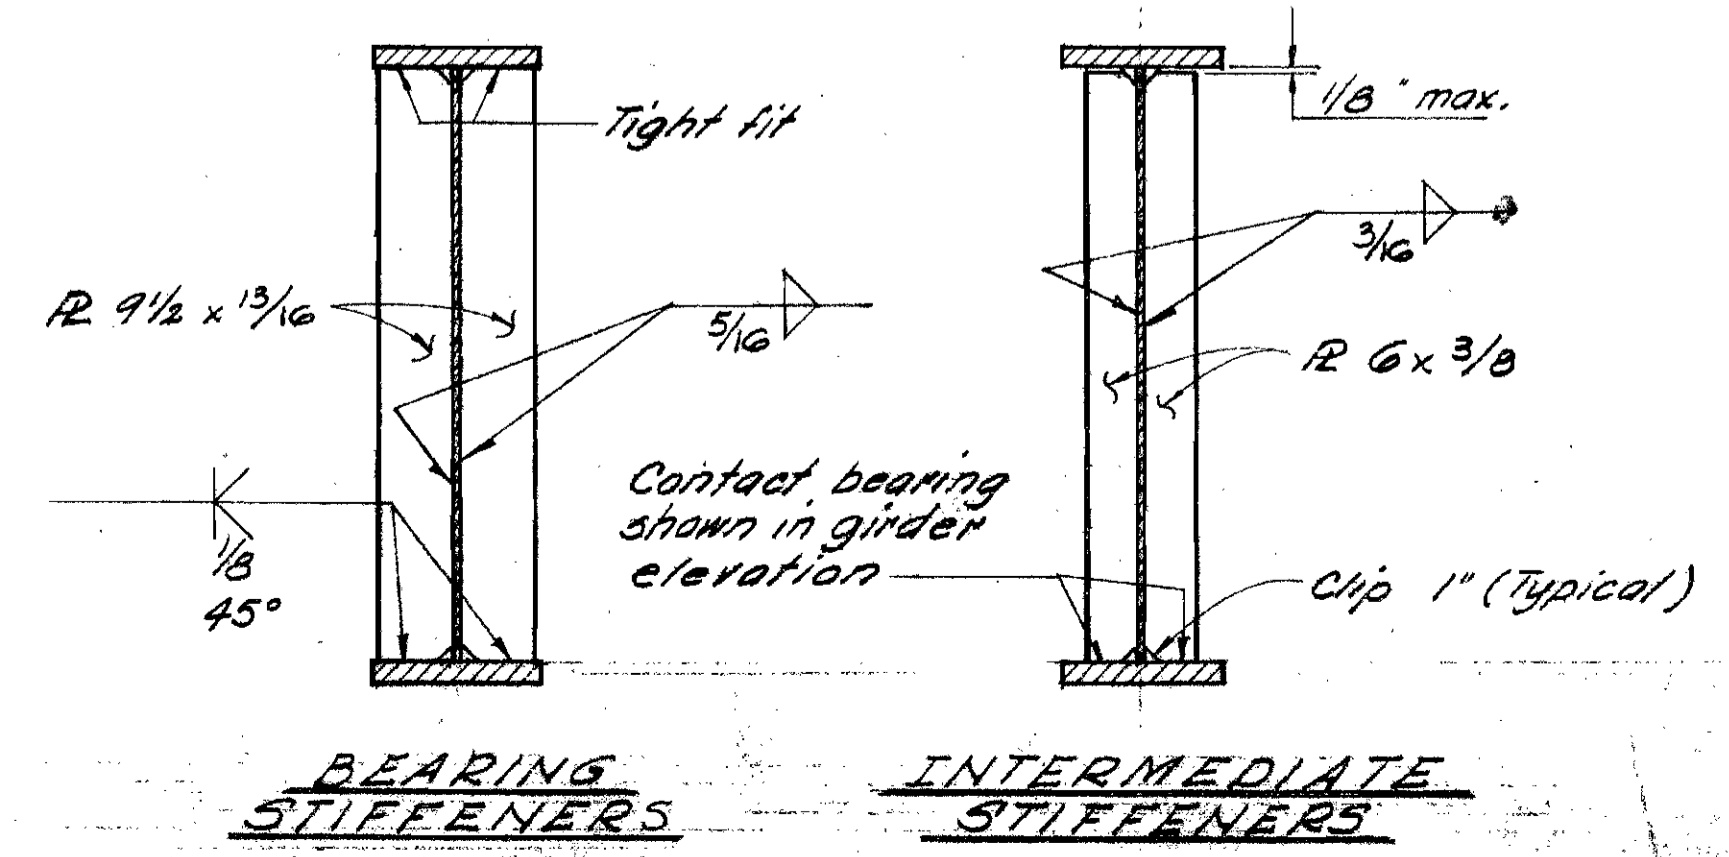
NOTE:
 Splices 5 and 7 - E.B. Shown.
 Splices 4 and 6 - E.B. opposite hand.
 FIELD SPLICES 4, 5, 6 AND 7 - E.B. LANES

For joint preparations see 37/70

Girder Line	DIMENSIONS					
	Span 4	Span 5	a	b	c	d
6	125'-6 3/8"	160'-0 9/16"	93'-6 3/8"	32'-0"	36'-0"	88'-0 9/16"
7	127'-5 3/4"	160'-0 9/16"	95'-5 3/4"	32'-0"	36'-0"	88'-0 9/16"
8	129'-5 1/16"	160'-0 9/16"	97'-5 1/16"	32'-0"	36'-0"	88'-0 9/16"
9	131'-4 1/16"	160'-0 9/16"	99'-4 1/16"	32'-0"	36'-0"	88'-0 9/16"
9-A	132'-6 3/4"	*28'-9 1/8"	100'-7 1/8"	31'-11 1/16"	*28'-9 1/8"	—
10	133'-9 3/8"	159'-10 7/16"	101'-9 1/16"	31'-11 1/16"	35'-11 7/8"	87'-10 1/16"

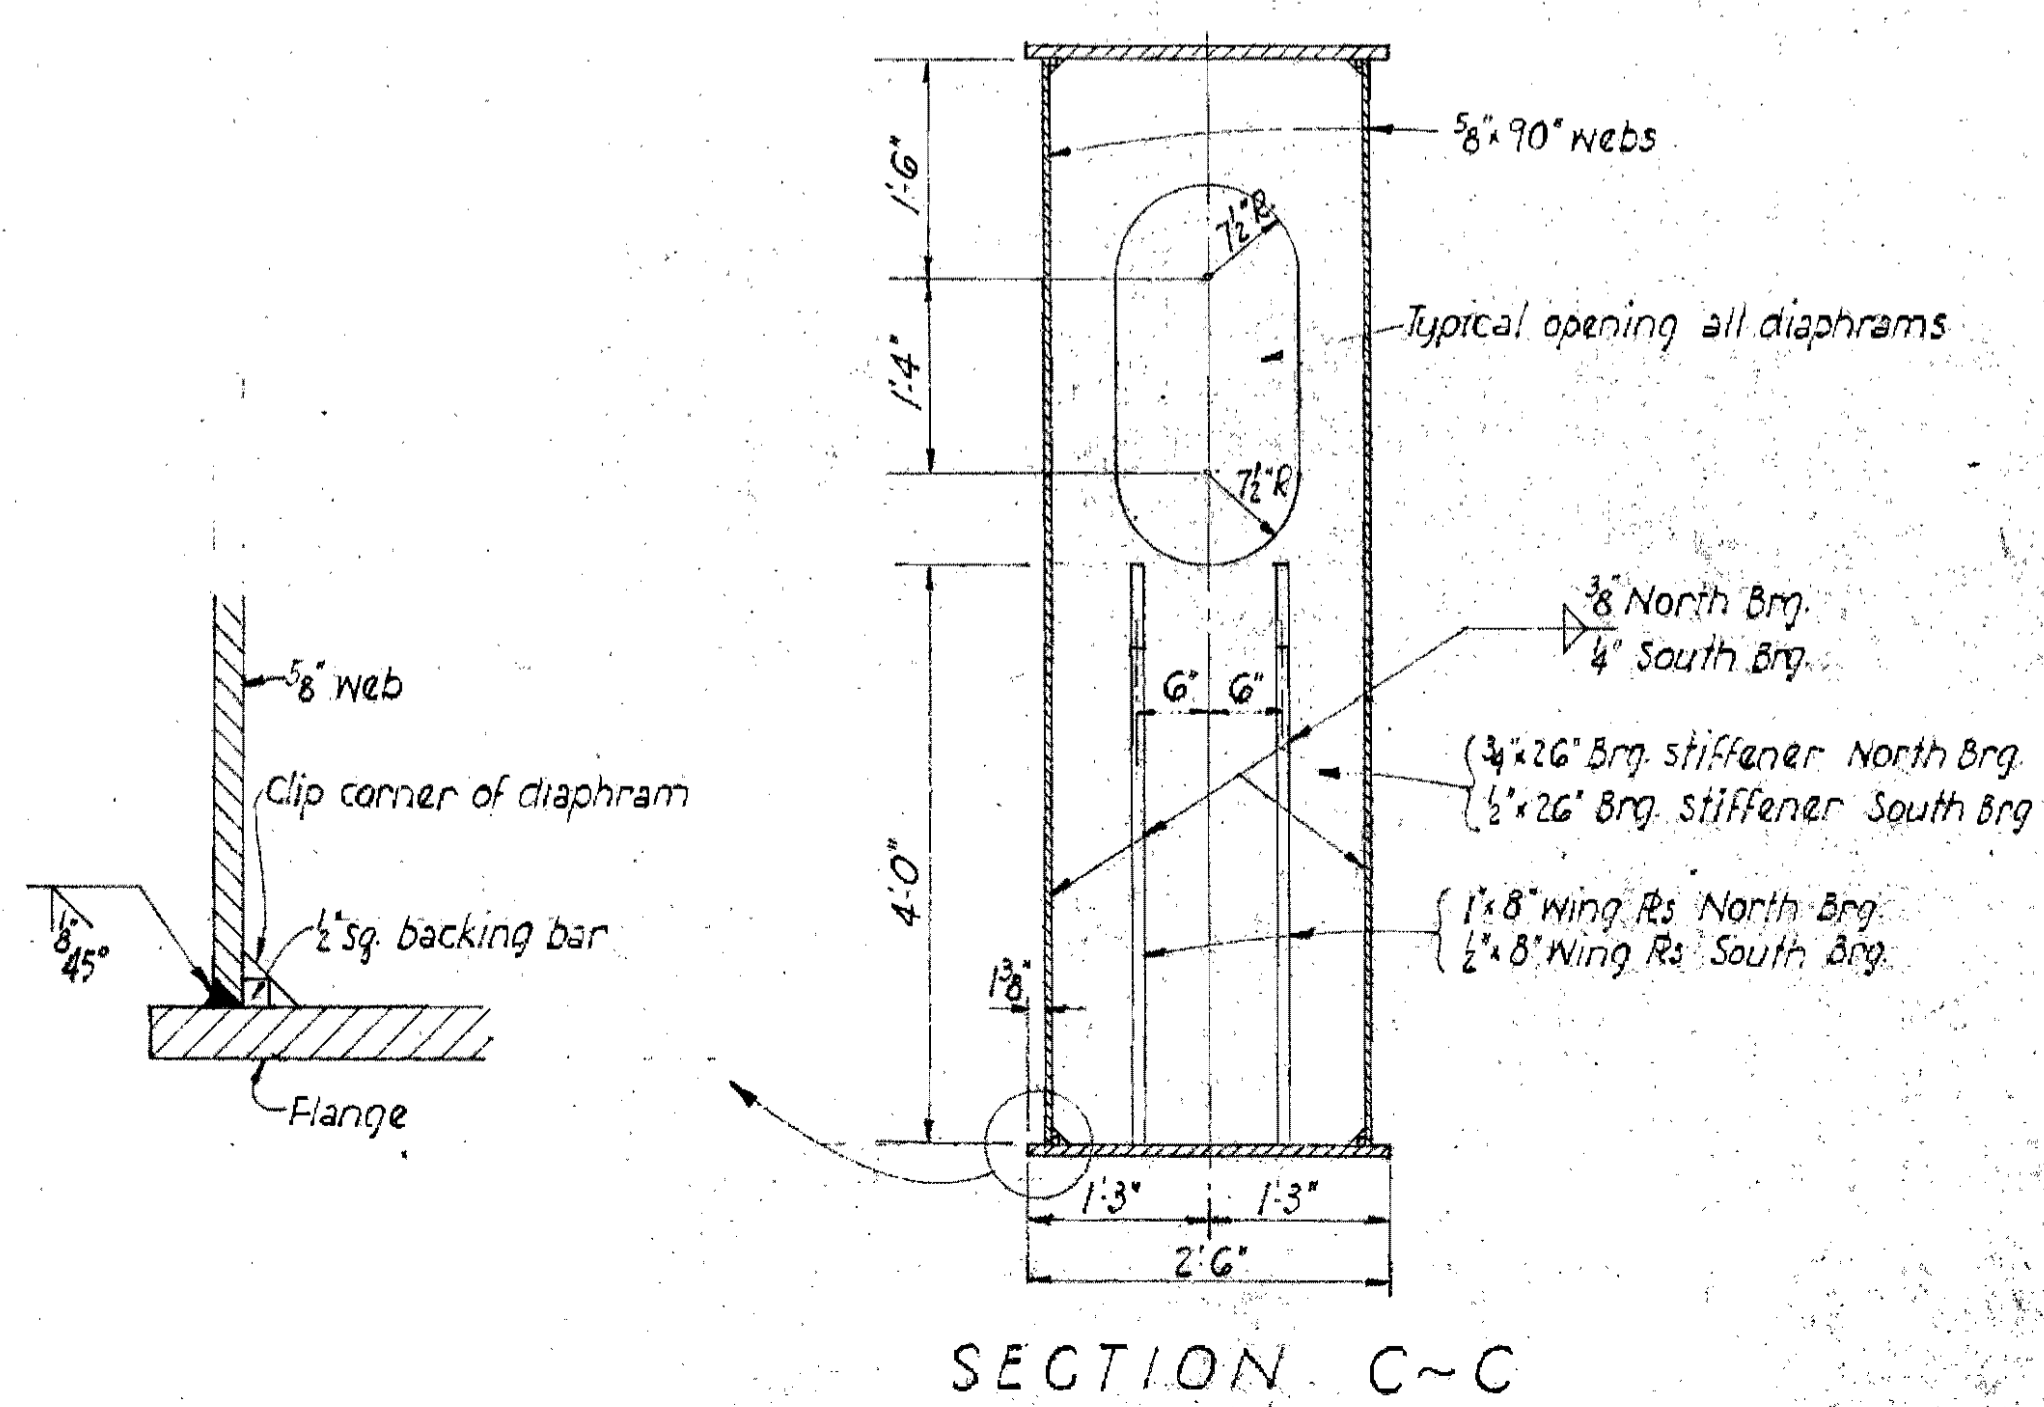
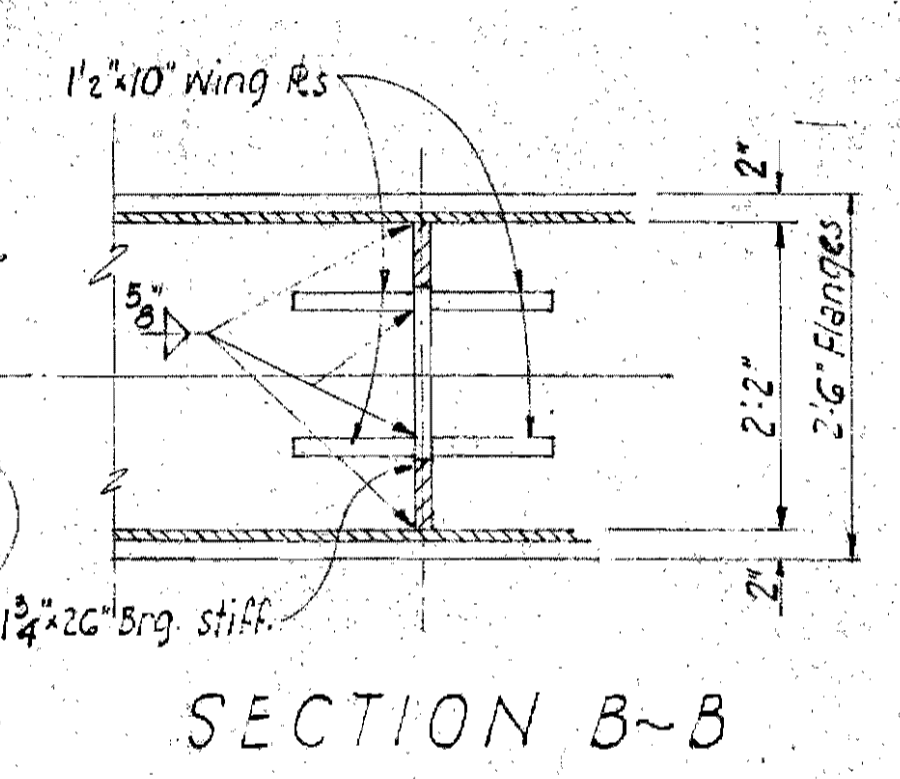
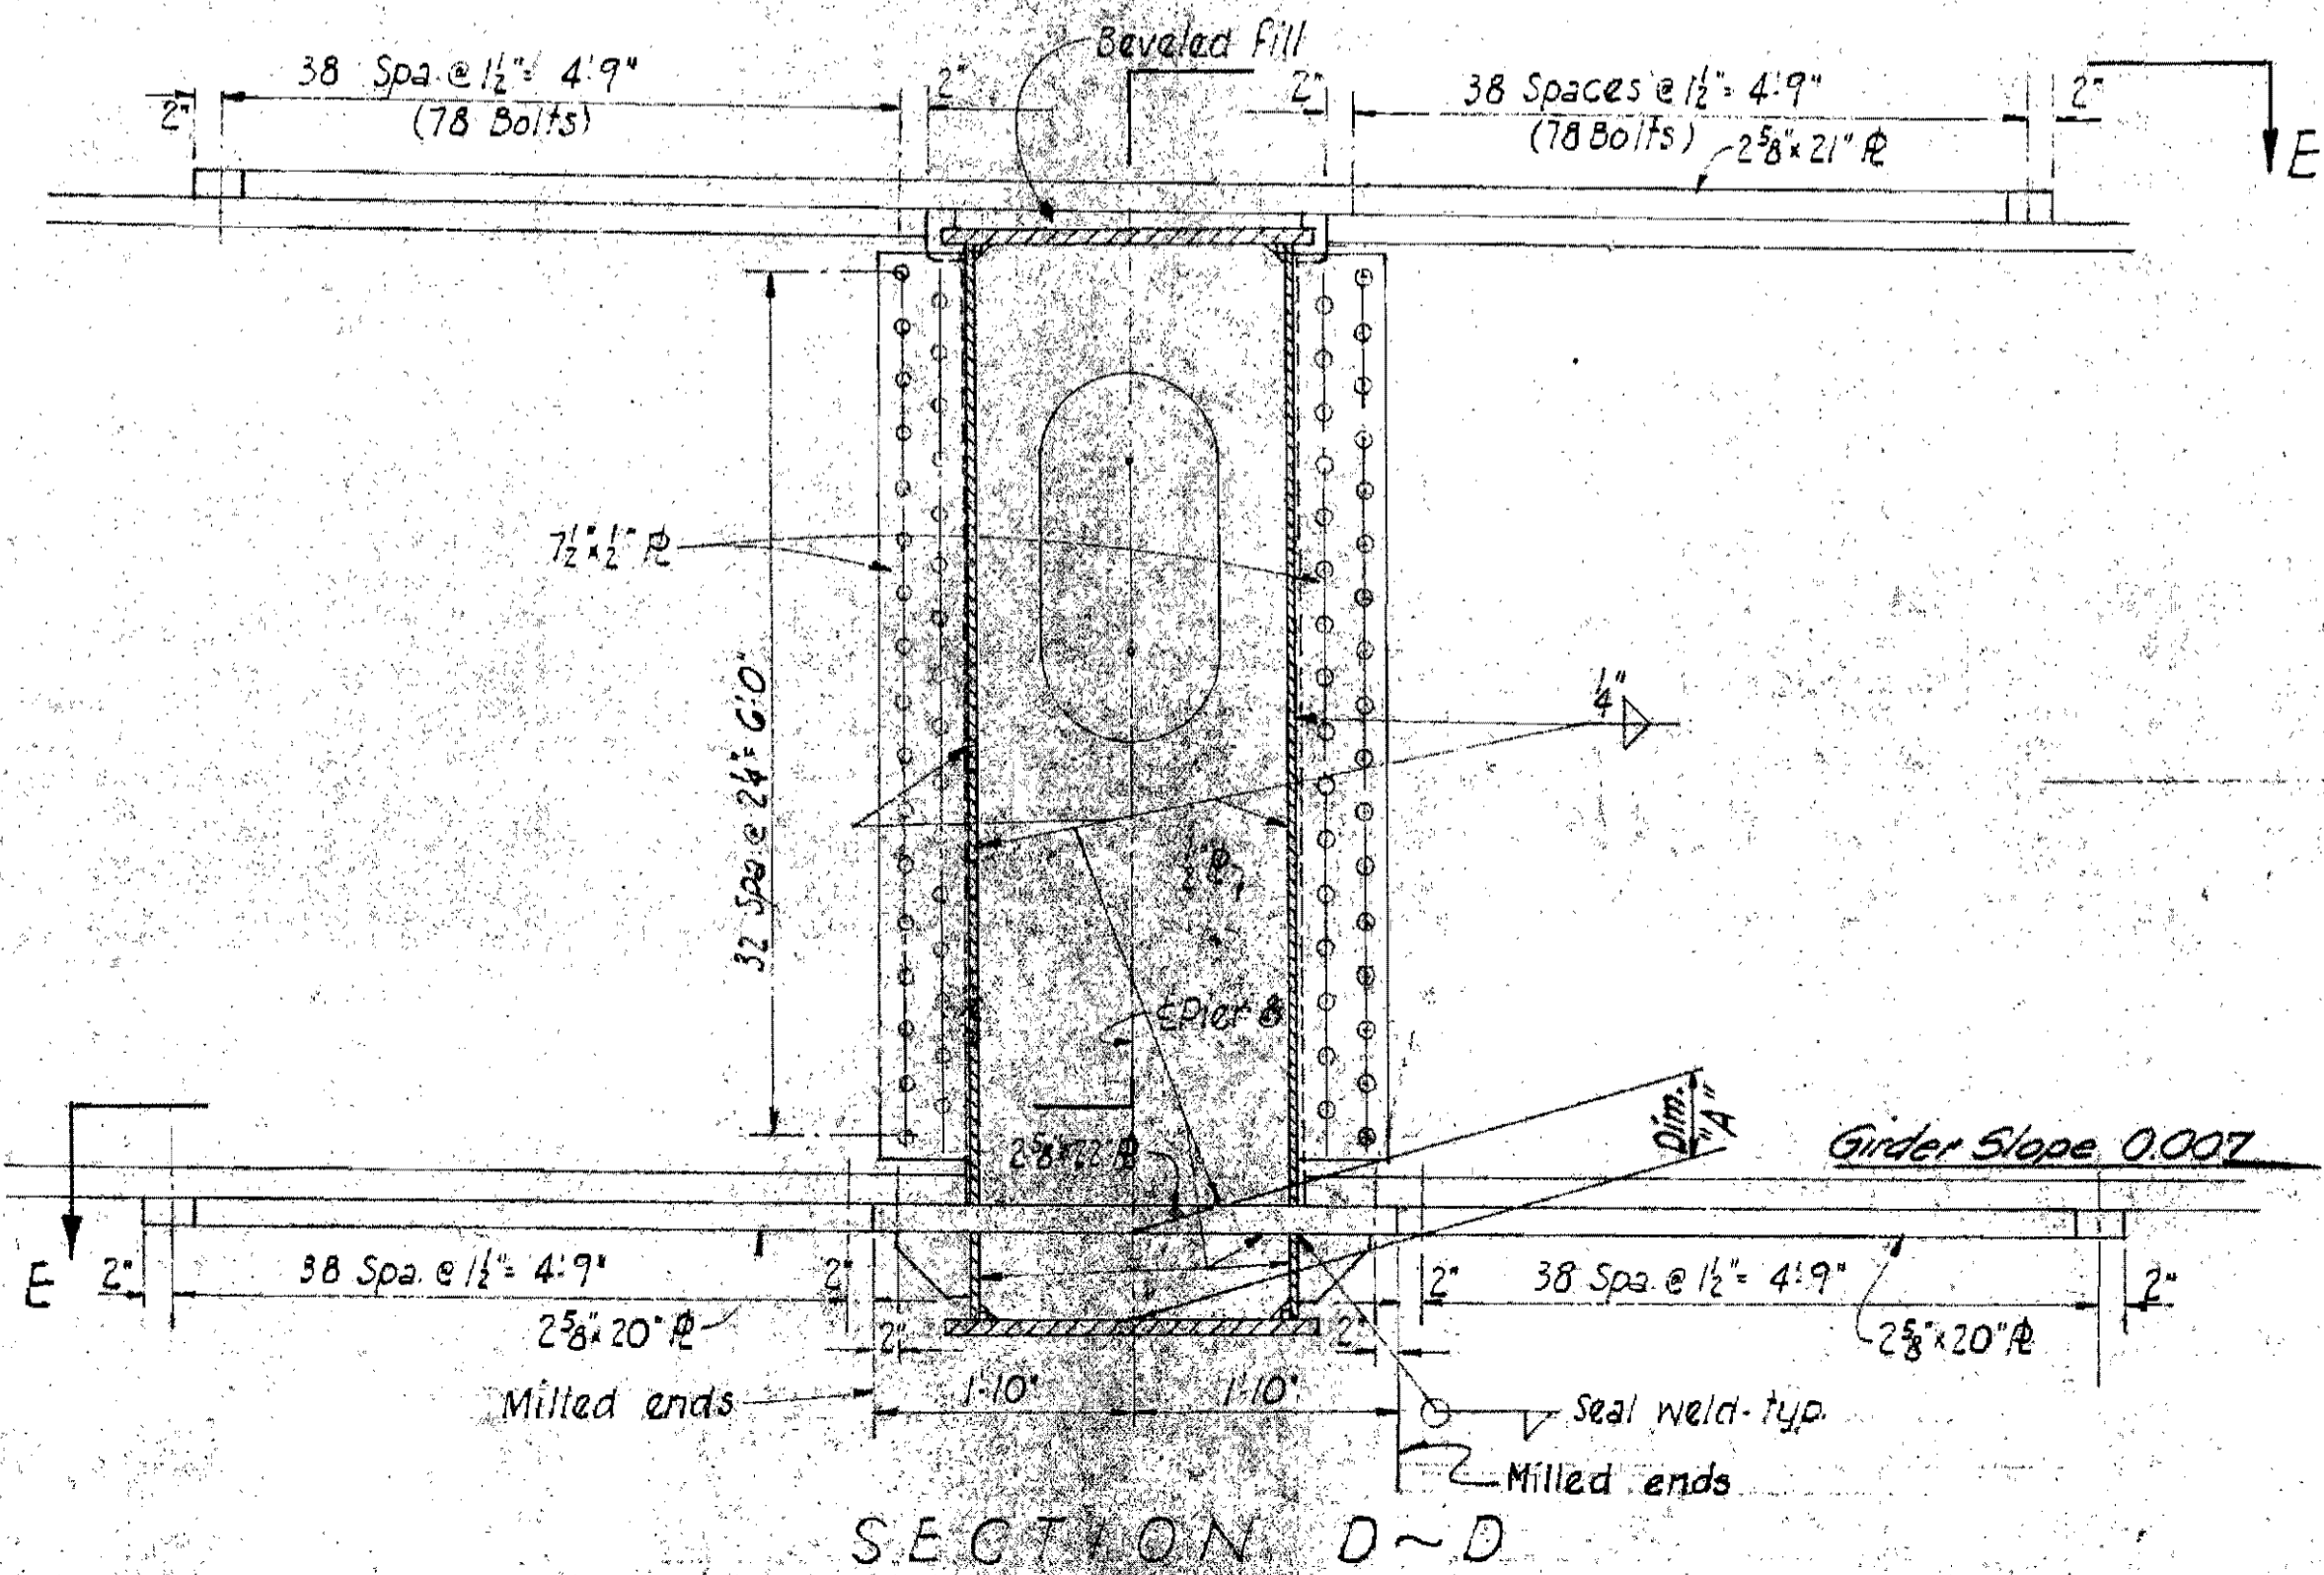
PIER 8 CAP GIRDER
BRIDGE NO. HAM-562-0150
NORWOOD LATERAL OVER
ROSS AVE. AND B.&O.R.R.
HAMILTON COUNTY STA. 79 + 47.35
STA. 93 + 52.25

Note! A bend line exists at the center line for Girders 1-10

GIRDER NO.	Dim. "A"
1	7 3/16"
2	7 1/16"
3	7"
4	6 15/16"
5	6 7/8"

GIRDER NO.	Dim. "A"
6	6 1/16"
7	6 3/4"
8	6 9/16"
9	6 15/16"
10	7 1/16"

For additional notes and end diaphragm cover see 54/70
For joint preparation see 37/70

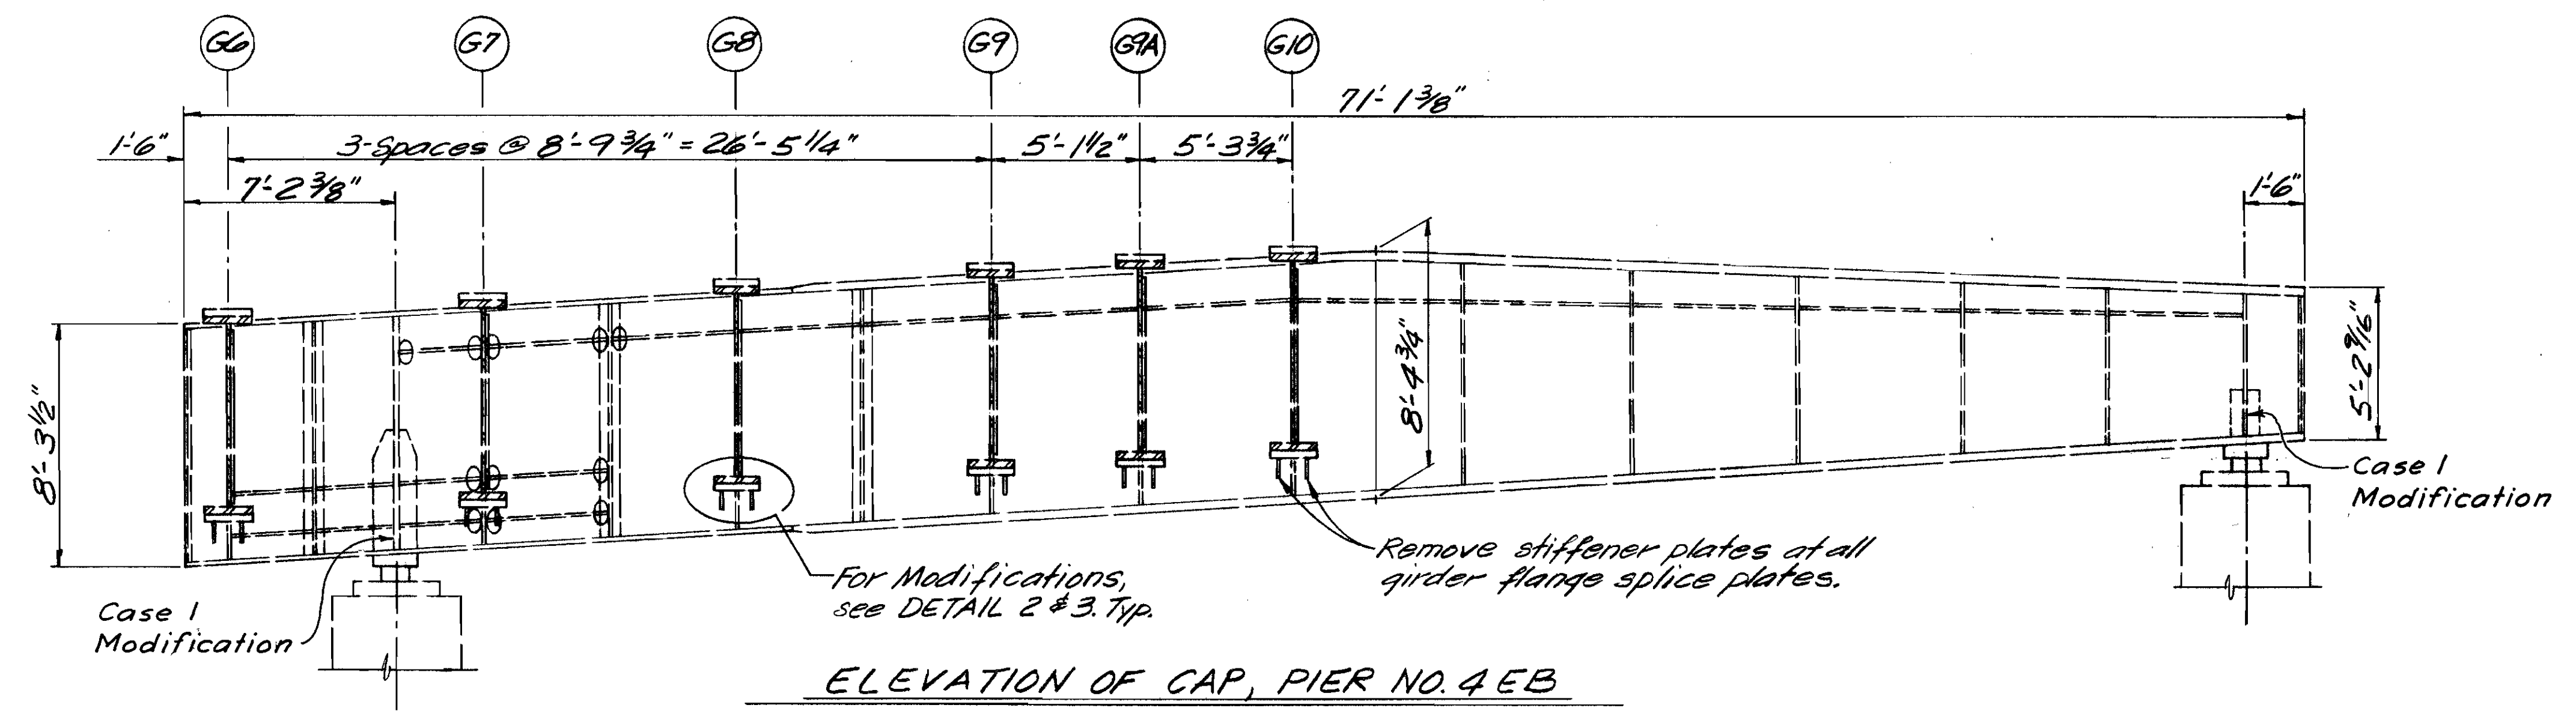
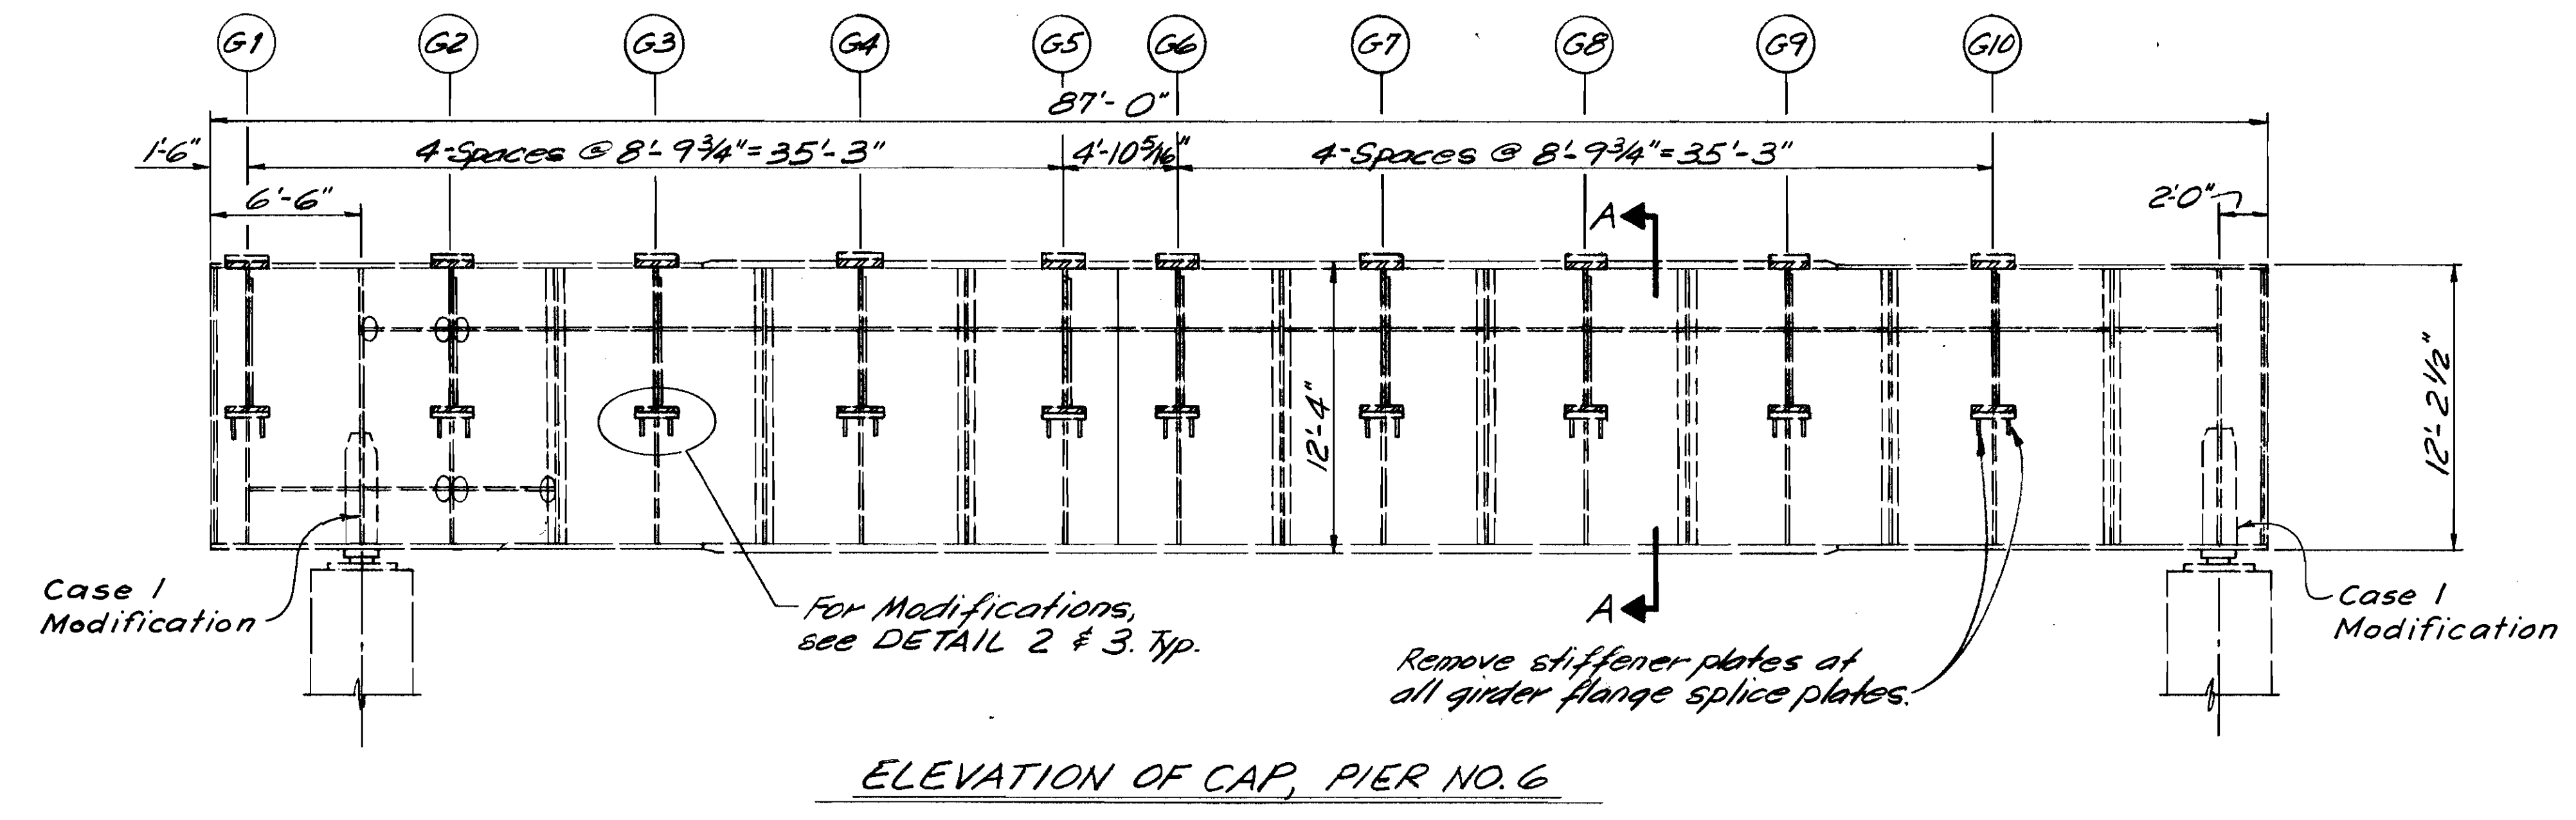
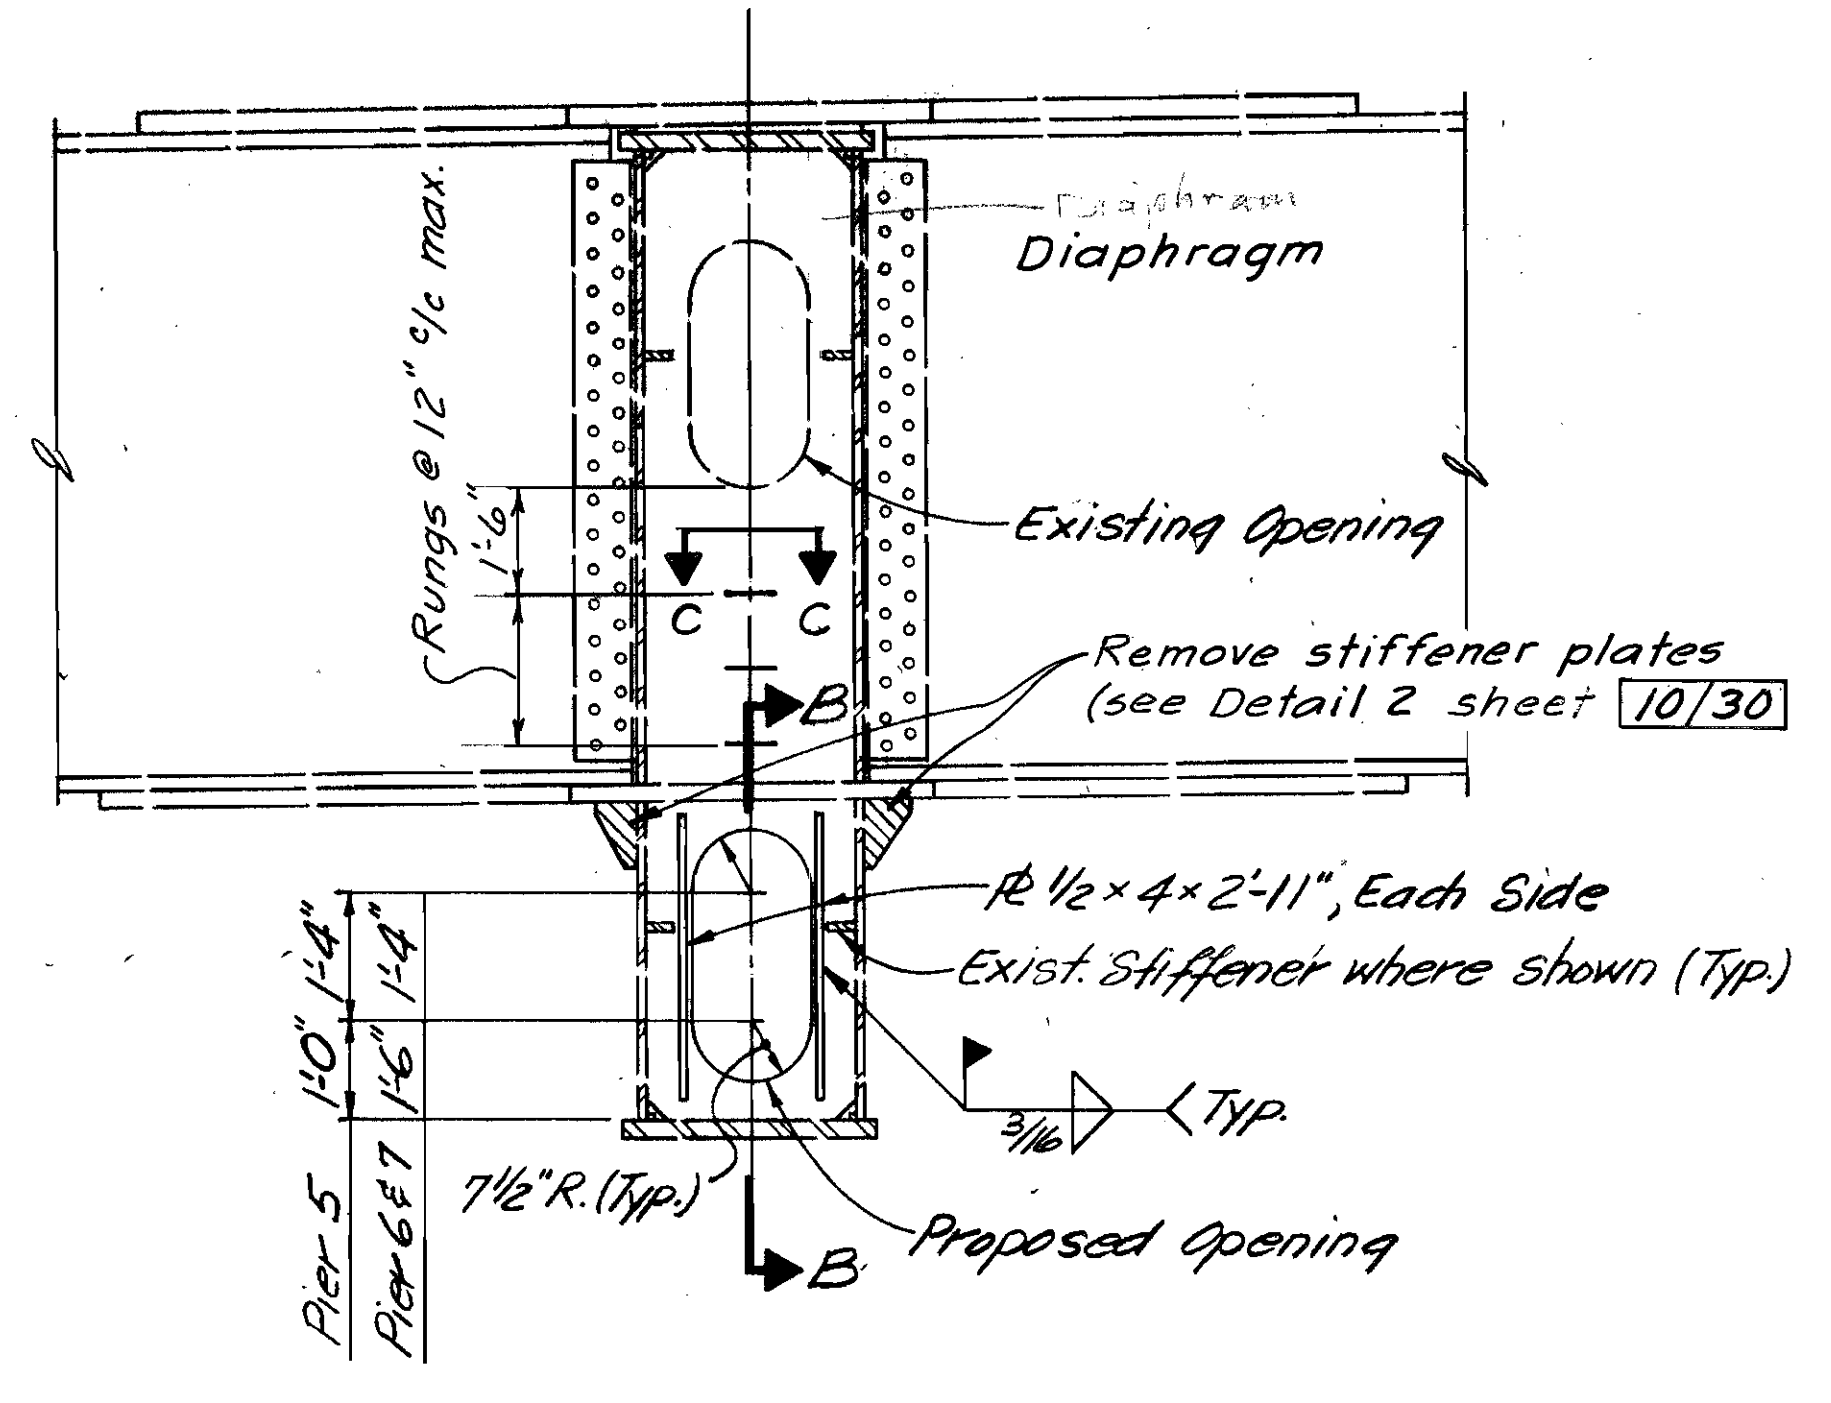
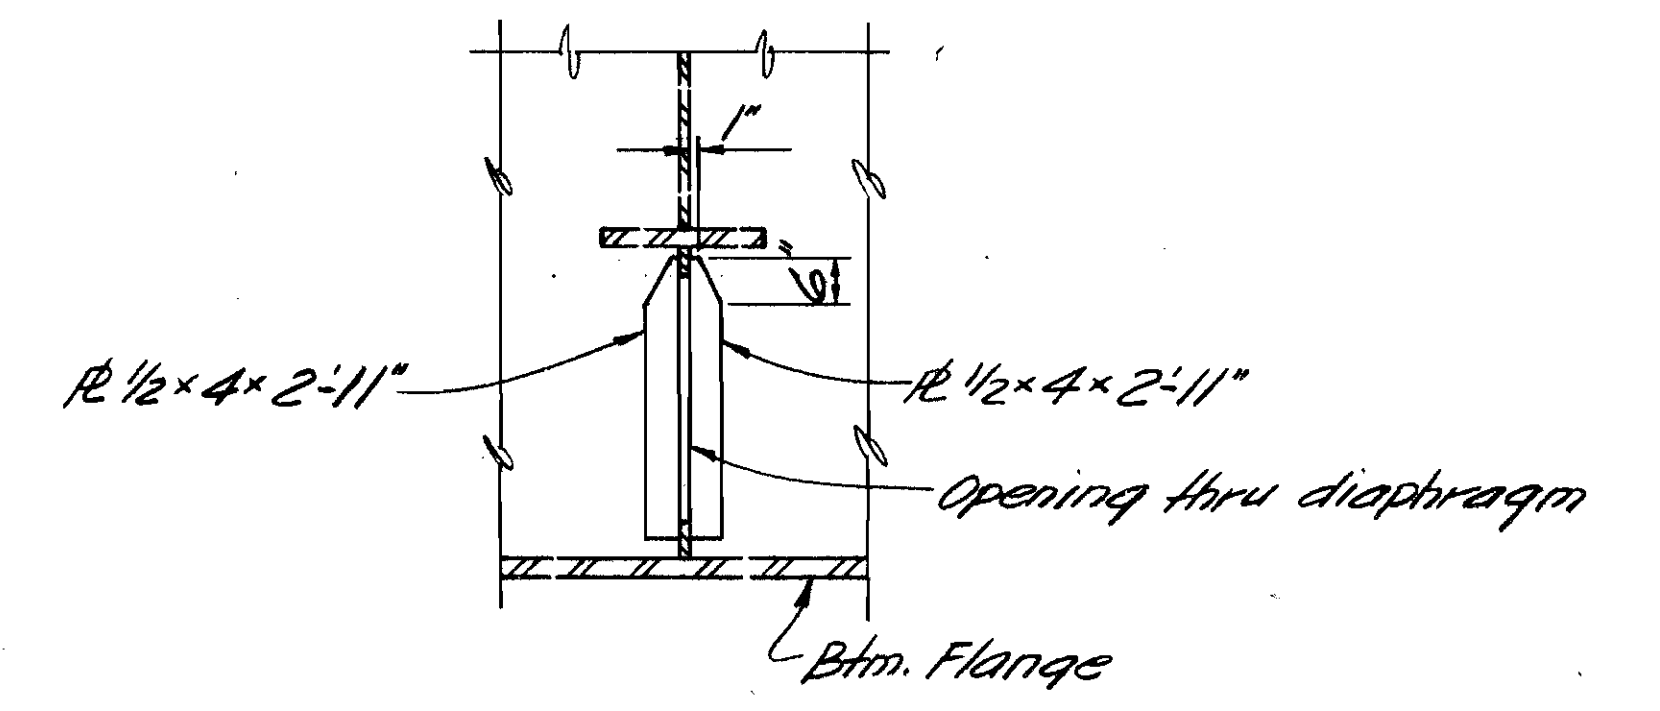
BALKE ENGINEERS 8/30					
1848 SUMMIT RD. CINCINNATI, OHIO 45227					
PIER CAP DETAILS					
BRIDGE NO. HAM-562-0147					
NORWOOD LATERAL OVER					
ROSS AVE. AND B. & O. R.R.					
DESIGNED	DRAWN	TRACED	CHECKED	REVIEWED DATE	REVISED
MRS	WJH	~	VDG	CRS 3/93

Pier No. 5: G2, G3, G5 thru G10
 Pier No. 6: G2 thru G10
 Pier No. 7: G2 thru G10

NOTES:
 Unless noted otherwise, all diaphragm shall be modified per Case 2 detail as shown on sheet 10/30.
 For Case 1 modification see sht. 10/30.
 O denotes location of longitudinal stiffener retrofits. See DETAIL 1 on Sheet 9/30.
 For DETAIL 2 & 3, see sht. 10/30.
 For SECTION C-C see sht. 10/30.
