BRIDGE NO HAM-562-0147
PID No. 105476

NORWOOD LATERAL PARKWAY OVER ROSS AVENUE

INSPECTION DETAILS:

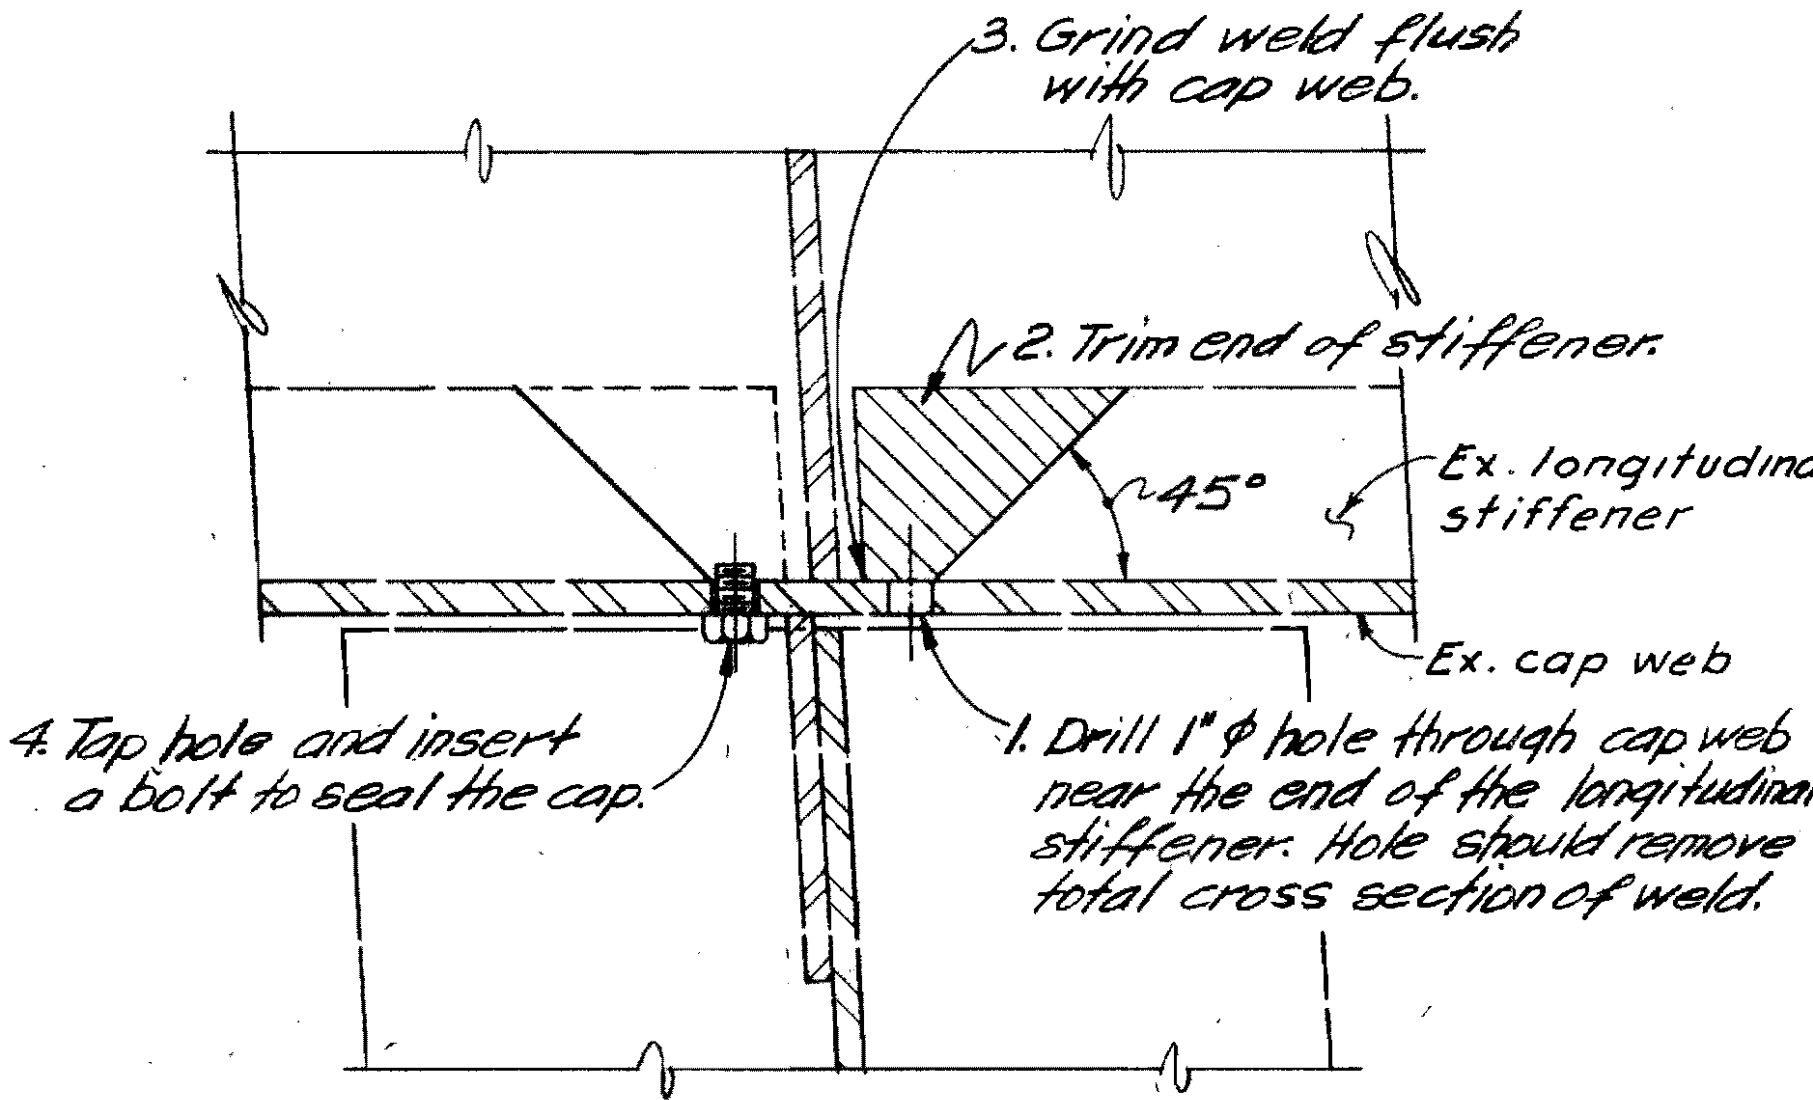
Retrofit detail for termination of longitudinal stiffener in tension zone of cap.

NOTES:
 Unless noted otherwise, all diaphragm shall be modified per Case 2 detail as shown on sheet 10/30.
 For Case 1 modification see sht. 10/30.
 O denotes location of longitudinal stiffener retrofits. See DETAIL 1 on Sheet 9/30.
 For DETAIL 2 & 3, see sht. 10/30.
 For SECTION C-C see sht. 10/30.

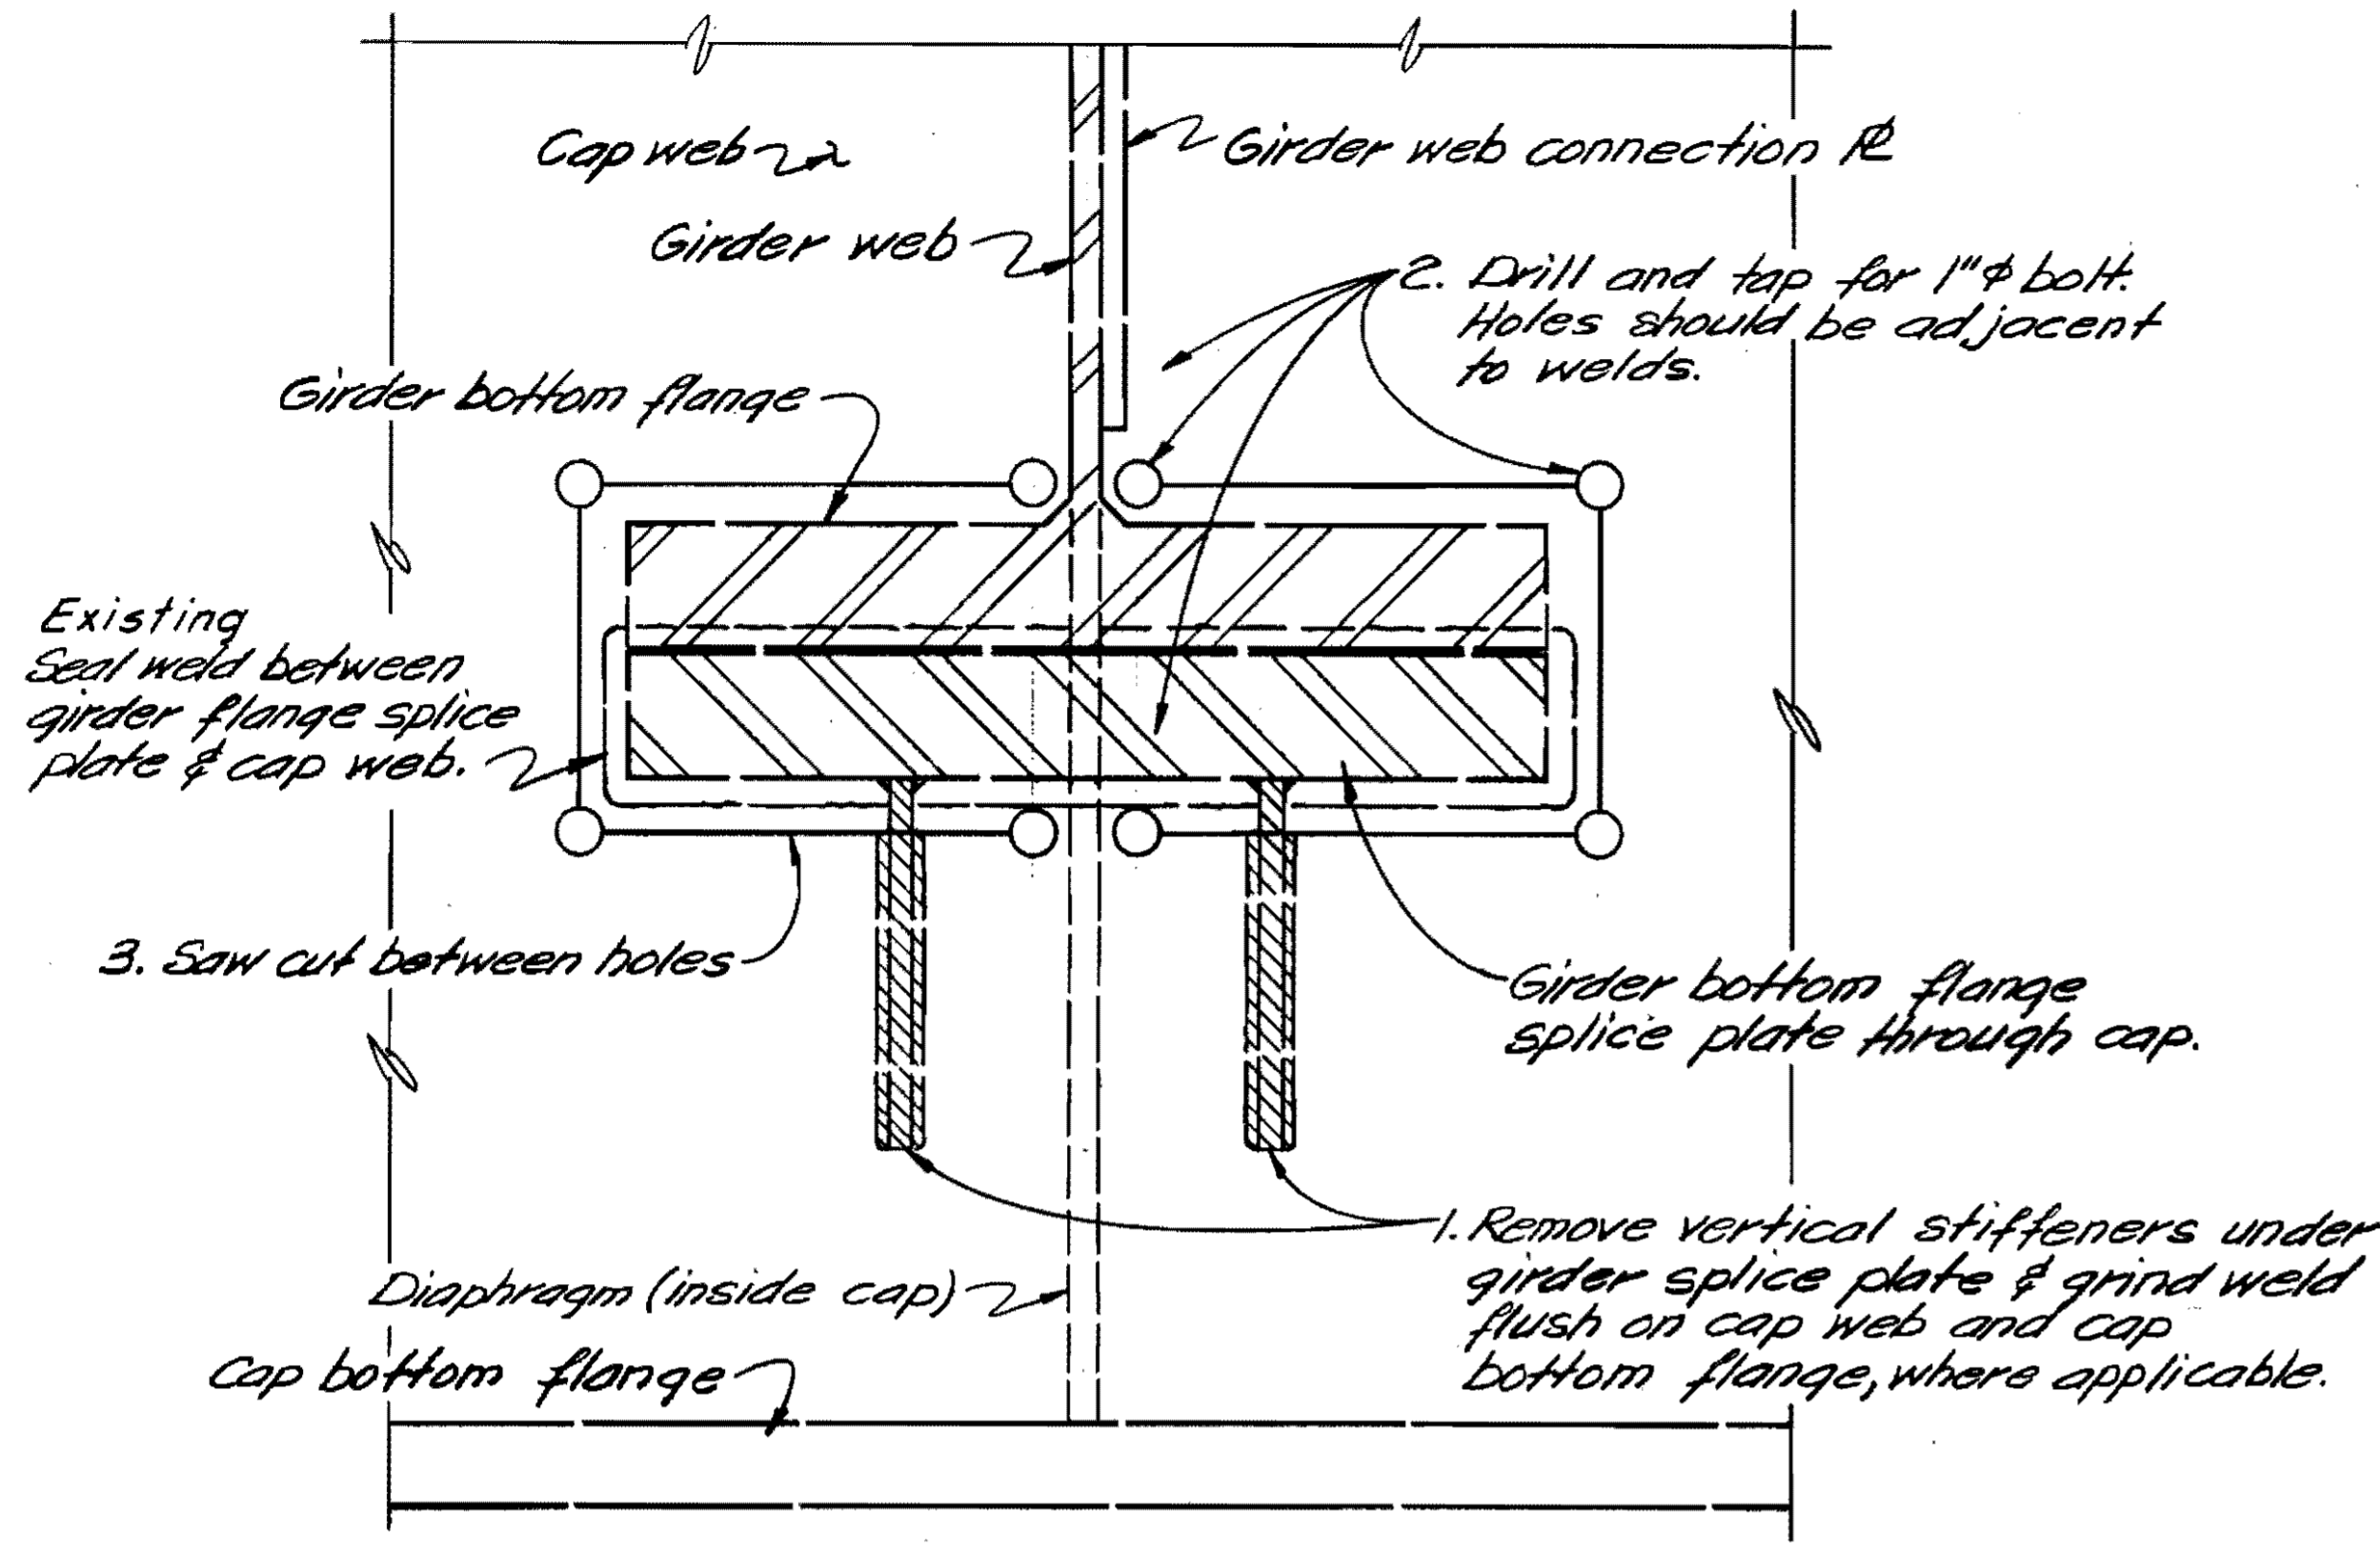
DETAIL 2

4. Place bolts in holes and caulk-in saw cut to seal the cap. Caulk shall be a two compound, 100% solids epoxy mastic. The material shall be Mark 244 from Poly-Carb, Sikador Injection Gel from Sika Chemical Corp., A-188 Splash Zone Compound from Koppers Co., Inc., or approved equal.

- TYPICAL AS NOTED
- Pier 4 E.B. : G8 thru G10
 - Pier 5 : G5 thru G10
 - Pier 6 : G3 thru G10
 - Pier 7 : G1 thru G3
 - Pier 8 : G1 thru G4, G8 thru G10
 - Pier 9 : G5 thru G7

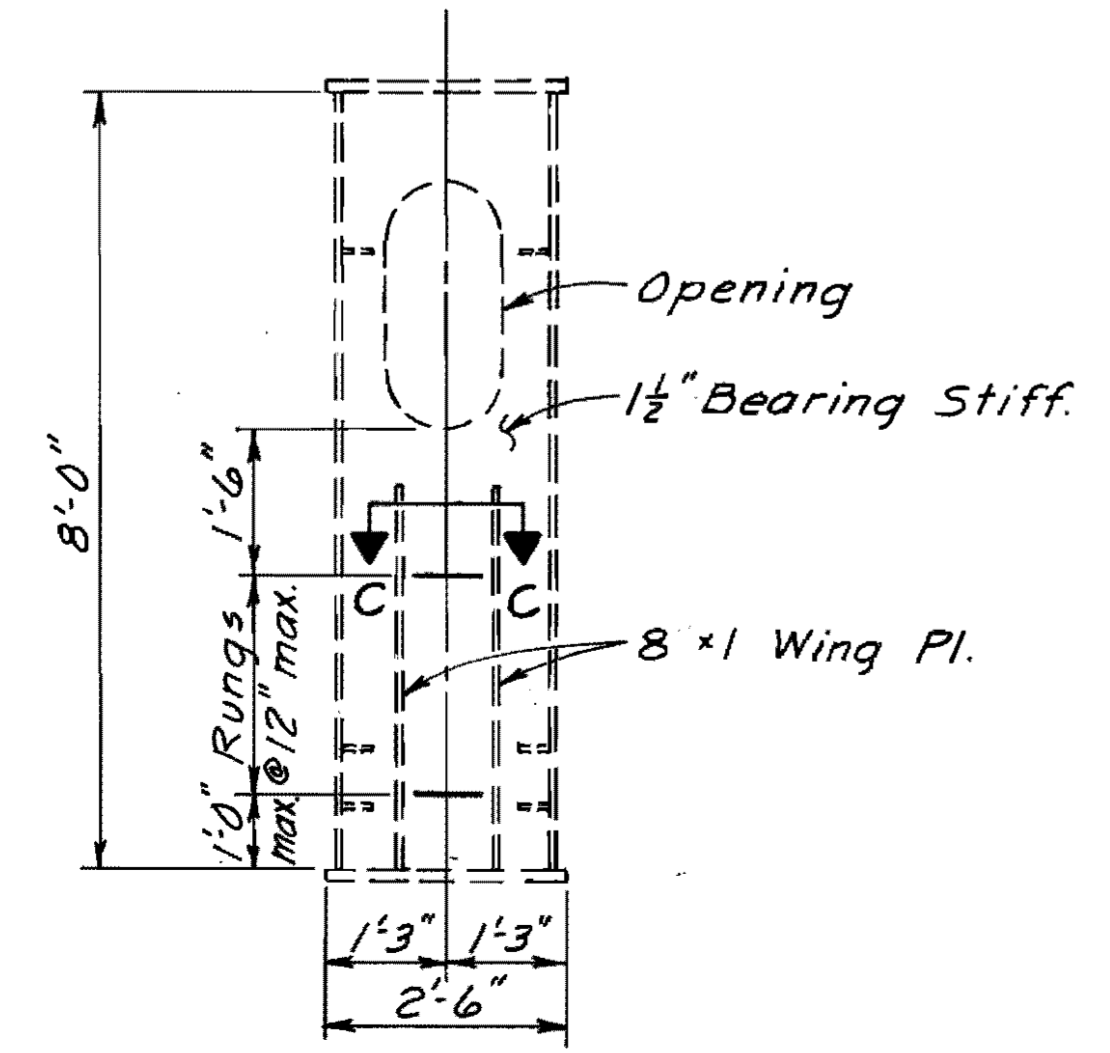
CASE 1
Stiffener Modification

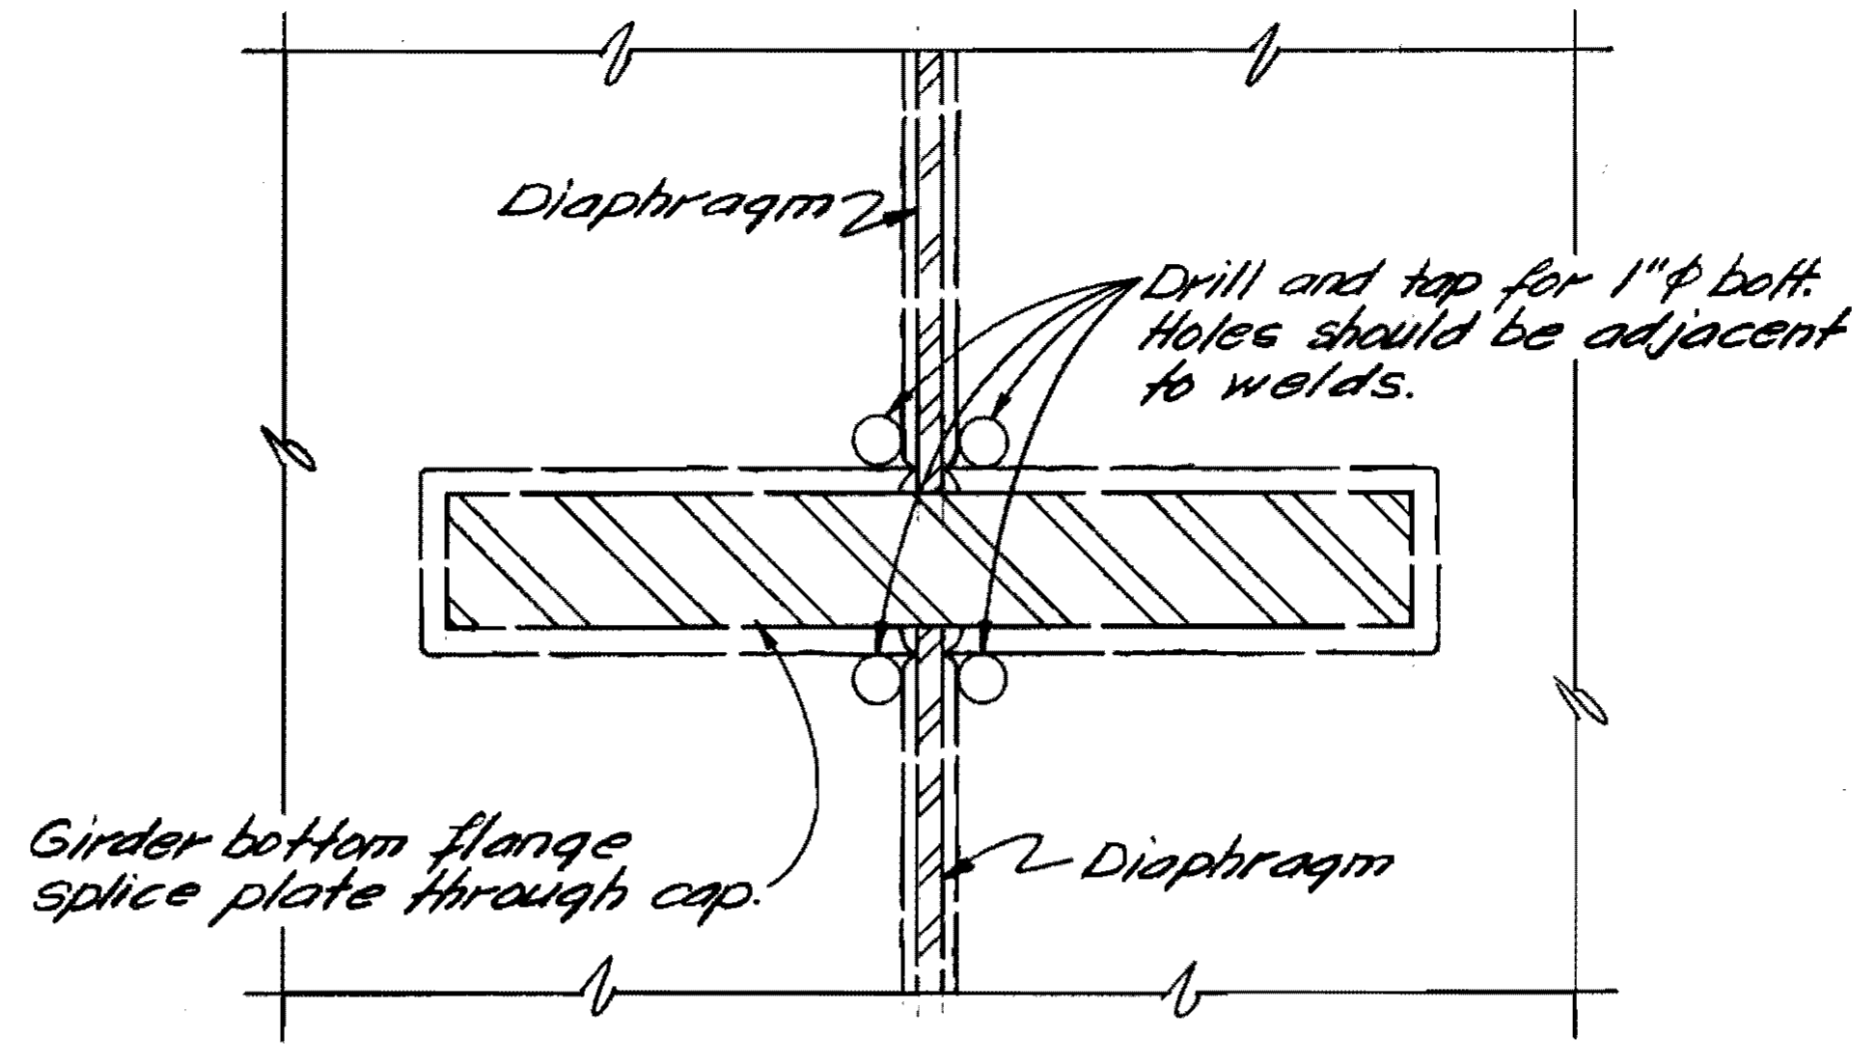
Note: View from inside cap.

NOTES
 Unless noted otherwise, all diaphragms shall be modified per Case 2 detail as shown on sheet 10/30
 For Case 1 modification see sheet 10/30
 For SECTION A-A see sheet 8/30
 For DETAIL 2 & 3 see sheet 10/30

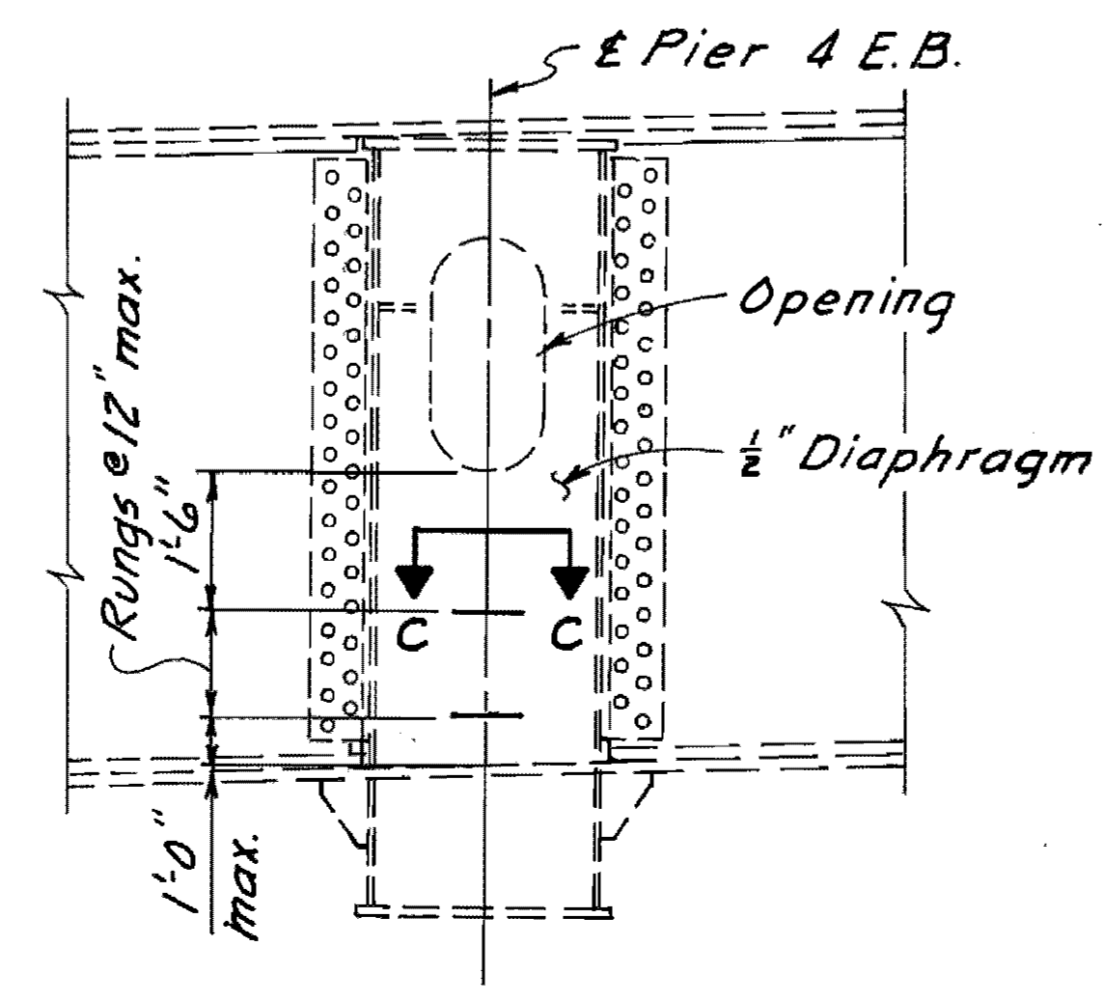
- TYPICAL AS NOTED
- Pier 4 E.B. : G6 & G7
 - Pier 5 : G1 thru G4
 - Pier 6 : G1 & G2
 - Pier 7 : G4 thru G10
 - Pier 8 : G5 thru G7
 - Pier 9 : G1 thru G4, G8 thru G10

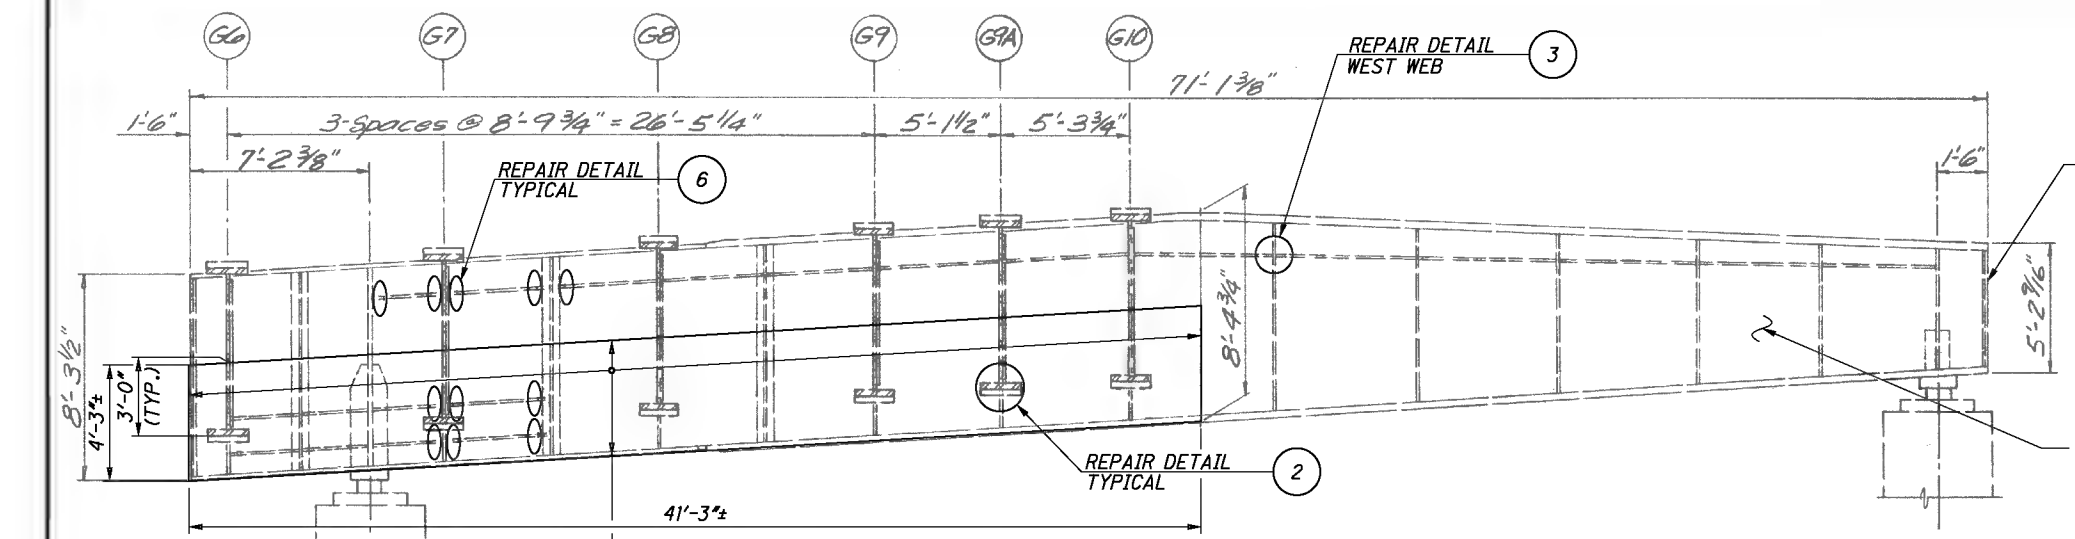
WEST ELEVATION OF CAP, PIER NO. 4 E.B.
(ELEVATION TAKEN FROM 1991 REHAB. DRAWINGS)

THE EXTERIOR SIDES, BOTTOM AND END OF THE PIER 4 E.B. CAP TO BE CLEANED AND PAINTED TO THE LIMITS SHOWN

RESEAL SOUTH ACCESS HATCH WITH NEW NEOPRENE GASKET

THE ENTIRE INTERIOR SURFACE AREA OF PIER 4 E.B. CAP TO BE CLEANED AND PAINTED USING THE EEU PAINT SYSTEM.

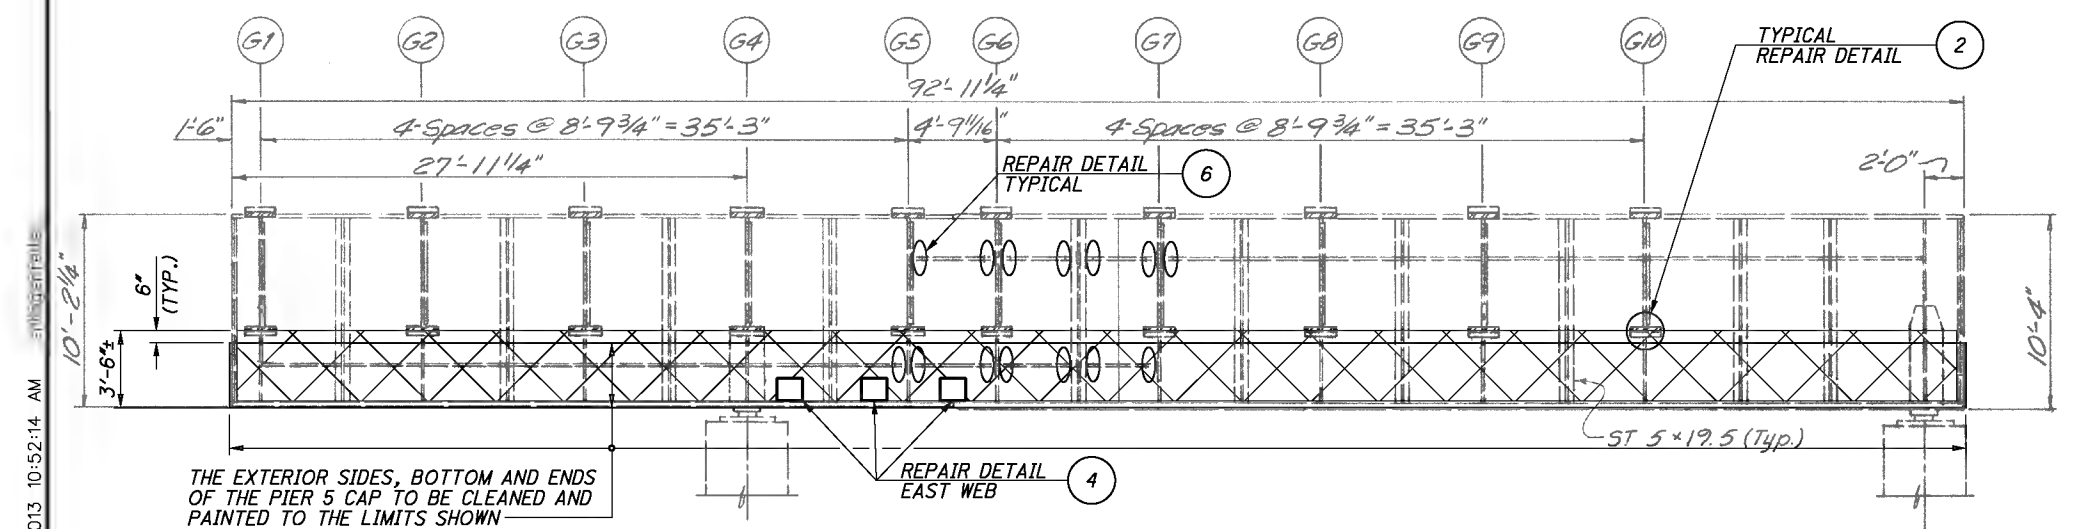
WEST ELEVATION OF CAP, PIER NO. 5
(ELEVATION TAKEN FROM 1991 REHAB. DRAWINGS)

THE EXTERIOR SIDES, BOTTOM AND ENDS OF THE PIER 5 CAP TO BE CLEANED AND PAINTED TO THE LIMITS SHOWN

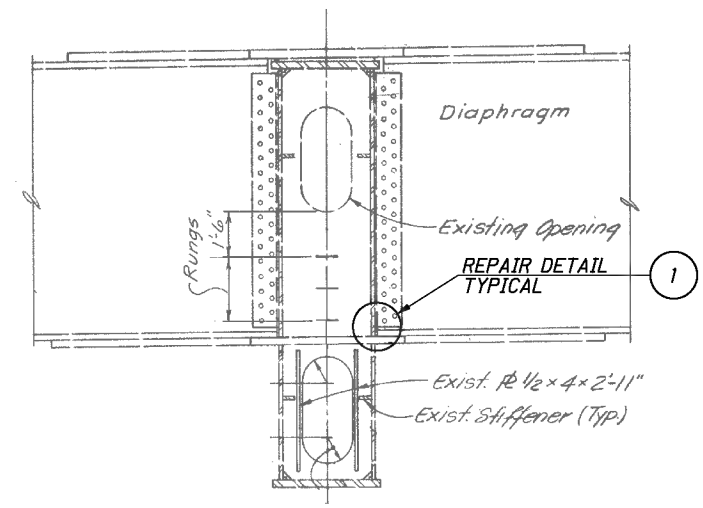
TYPICAL SECTION
PIERS 5, 6 AND 7 SHOWN
PIERS 4 E.B., 8 AND 9 SIMILAR
(SECTION TAKEN FROM 1991 REHAB. DRAWINGS)

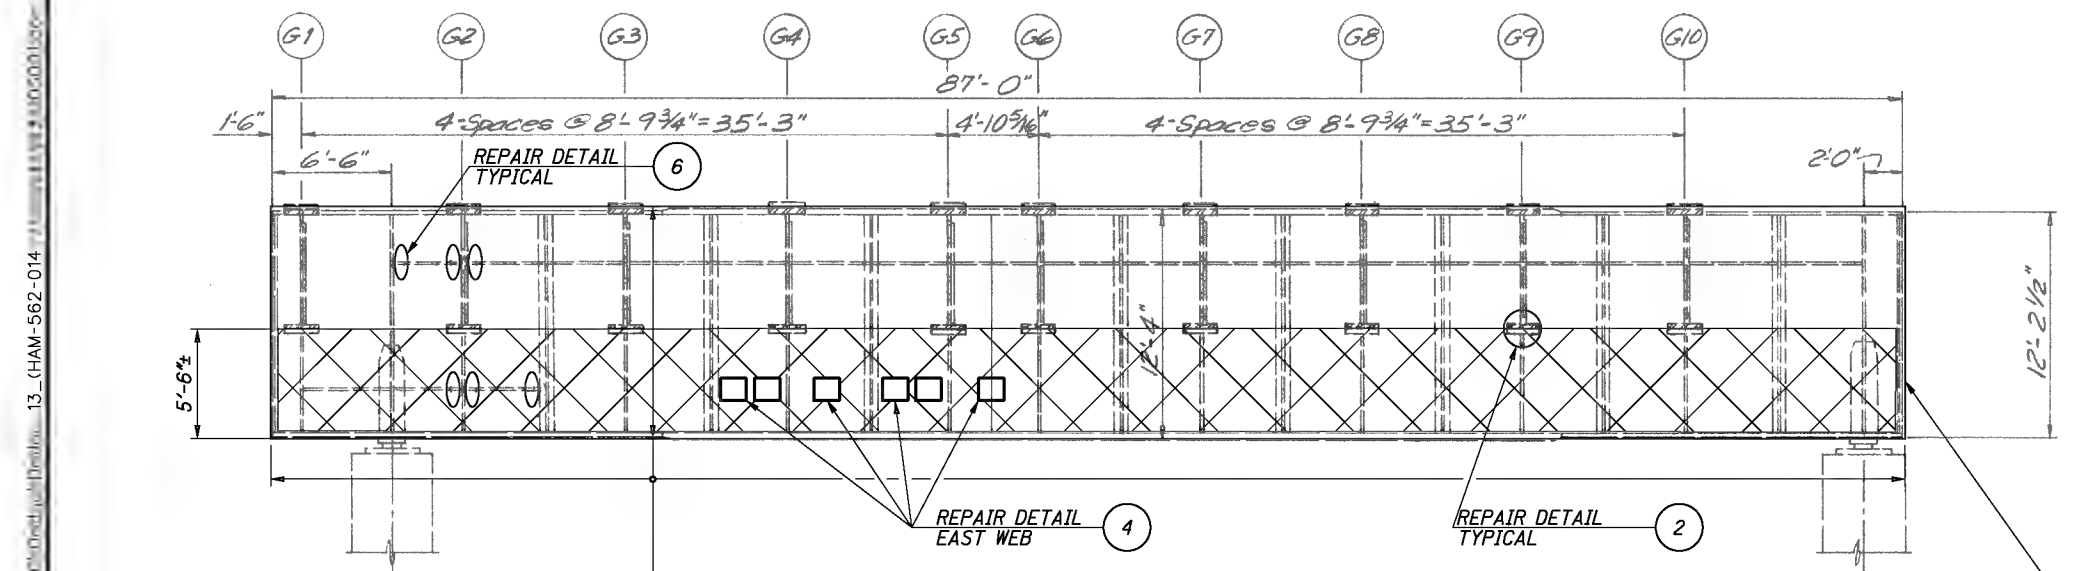
WEST ELEVATION OF CAP, PIER NO. 6
(ELEVATION TAKEN FROM 1991 REHAB. DRAWINGS)

THE EXTERIOR EASTERN SIDE AND BOTTOM OF THE PIER 6 CAP TO BE CLEANED AND PAINTED TO THE LIMITS SHOWN

RESEAL SOUTH ACCESS HATCH WITH NEW NEOPRENE GASKET. REPLACE 7 MISSING BOLTS AT SOUTH WHICH SHALL BE INCIDENTAL TO THE STEEL PIER CAP SEAL, AS PER PLAN.

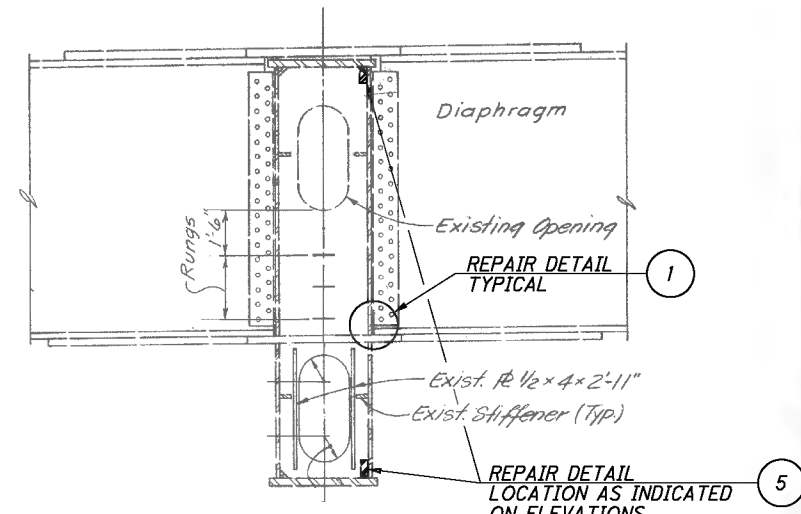
TYPICAL SECTION
PIERS 5, 6 AND 7 SHOWN
PIERS 4 E.B., 8 AND 9 SIMILIAR
(SECTION TAKEN FROM 1991 REHAB. DRAWINGS)

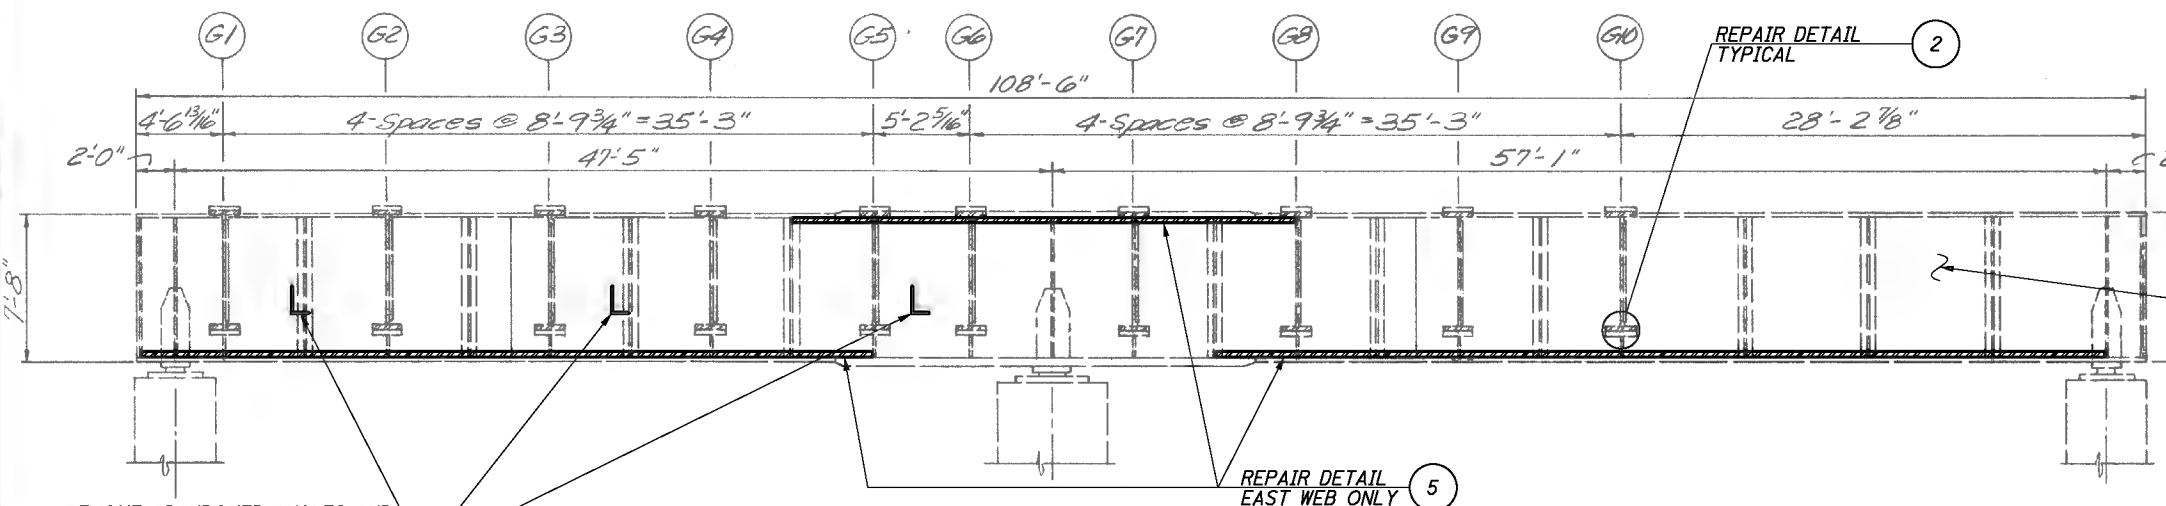
WEST ELEVATION OF CAP, PIER NO. 8
(ELEVATION TAKEN FROM 1991 REHAB. DRAWINGS)

THE ENTIRE INTERIOR SURFACE AREA OF PIER 8 CAP TO BE CLEANED AND PAINTED USING THE EEU PAINT SYSTEM.

REMOVE ABANDONED ANGLES AND GRIND WELDS FLUSH ON THE EAST AND WEST WEB & EXTERIORS (SIX TOTAL)

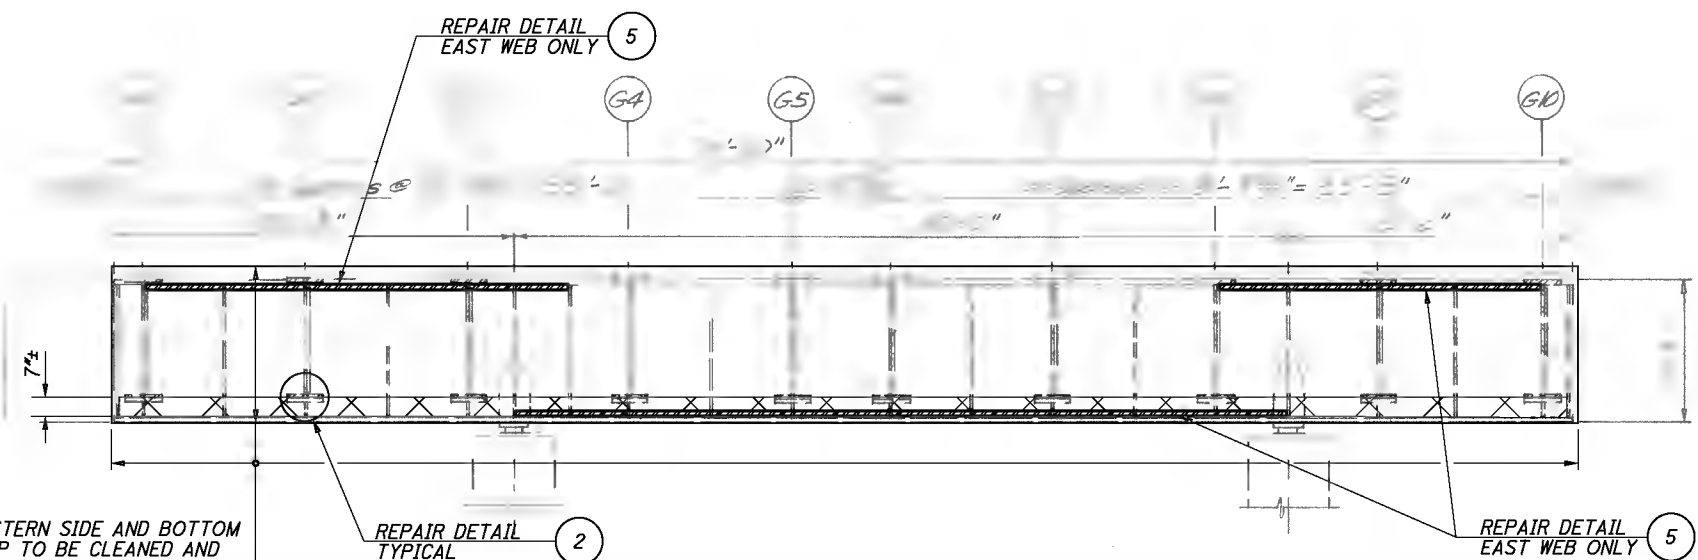
WEST ELEVATION OF CAP, PIER NO. 9
(ELEVATION TAKEN FROM 1991 REHAB. DRAWINGS)

THE EXTERIOR EASTERN SIDE AND BOTTOM OF THE PIER 9 CAP TO BE CLEANED AND PAINTED TO THE LIMITS SHOWN

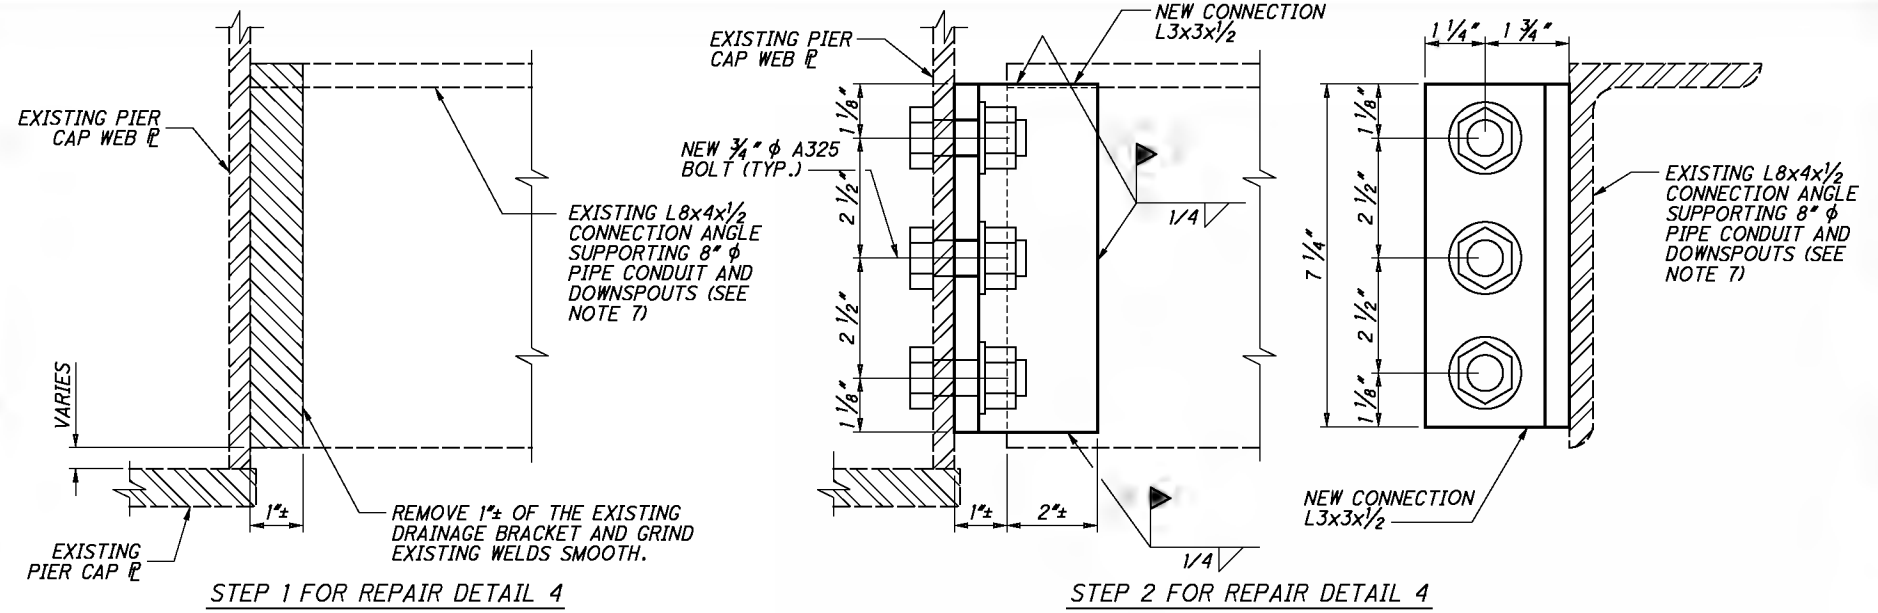
**REPAIR DETAIL
DRAIN BRACKET RETROFIT** 4

- THE NEW DRAINAGE BRACKET CONNECTIONS, INCLUDING GRINDING THE WELDS, NEW CONNECTION ANGLES AND THEIR BOLTED CONNECTIONS, WELDING THE EXISTING BRACKET TO THE NEW ANGLES AND TEMPORARY SUPPORT OF THE EXISTING DOWNSPOUTS AND DRAINAGE CONDUITS ARE INCLUDED IN ITEM 513 - STRUCTURAL STEEL MISC.: STRUCTURAL STEEL REHABILITATION.

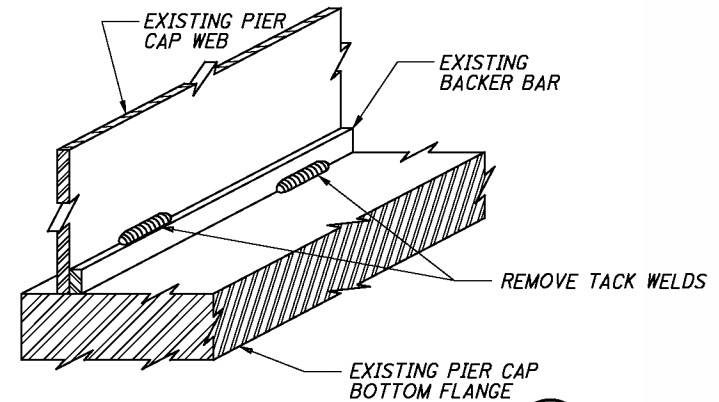
**REPAIR DETAIL
BACKING BAR WELD REMOVAL DETAIL** 5
(BOTTOM FLANGE SHOWN, TOP FLANGE SIMILAR)

- THE GRINDING OF THE BACKER BAR TACK WELDS IS INCLUDED IN ITEM 513 - STRUCTURAL STEEL, MISC.: GRINDING PER FOOT.
- THE CONTRACTOR SHALL ADEQUATELY SUPPORT THE EXISTING 8" phi PIPE CONDUIT AND DOWNSPOUTS DURING THESE REPAIRS TO THE SATISFACTION OF THE ENGINEER.

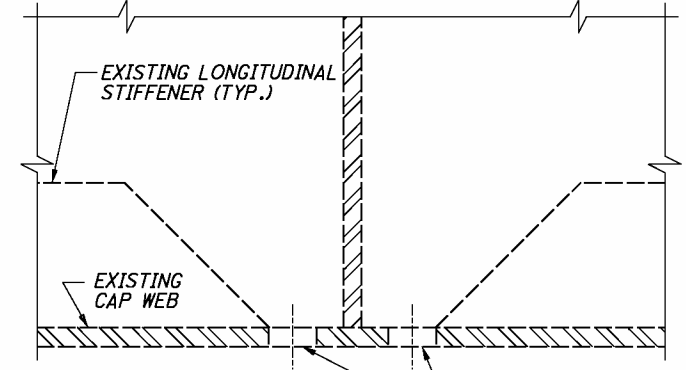
**REPAIR DETAIL
LONGITUDINAL STIFFENERS** 6
REPLUG AND CAULK THE EXISTING STRESS HOLES WITH NEW 1" EXPANSION PLUGS (TYP.)

CLEAN AND RECAULK EX. SAW CUTS AND REPLUG THE STRESS HOLES WITH 1" EXPANSION PLUGS (TYP.)

- ALL WORK ASSOCIATED WITH THE CRACK REPAIR RETROFIT AT THE LONGITUDINAL STIFFENER AT PIER 4 E.B. IS INCLUDED FOR PAYMENT UNDER ITEM 513 - STRUCTURAL STEEL, MISC.: 1/2" STRESS RELIEF HOLE RETROFIT.
