Volume 1 of 2
Maintenance, Inspection,
and Monitoring Manual
I-471 Mt. Adams
Cincinnati, Ohio

Final - April 1988

PREFACE

Construction activities for the I-471 Mt. Adams interchange project included remedial measures for stabilization of the Mt. Adams Hillside and conventional roadway construction of the I-471 interchange complex. The purpose of this Maintenance, Inspection, and Monitoring Manual is to establish guidelines for periodic inspections and monitoring observation of the above structures. These activities are required to ascertain that the structures continue to perform satisfactorily, and that minor maintenance and repair work can readily be accomplished before developing into major improvements.

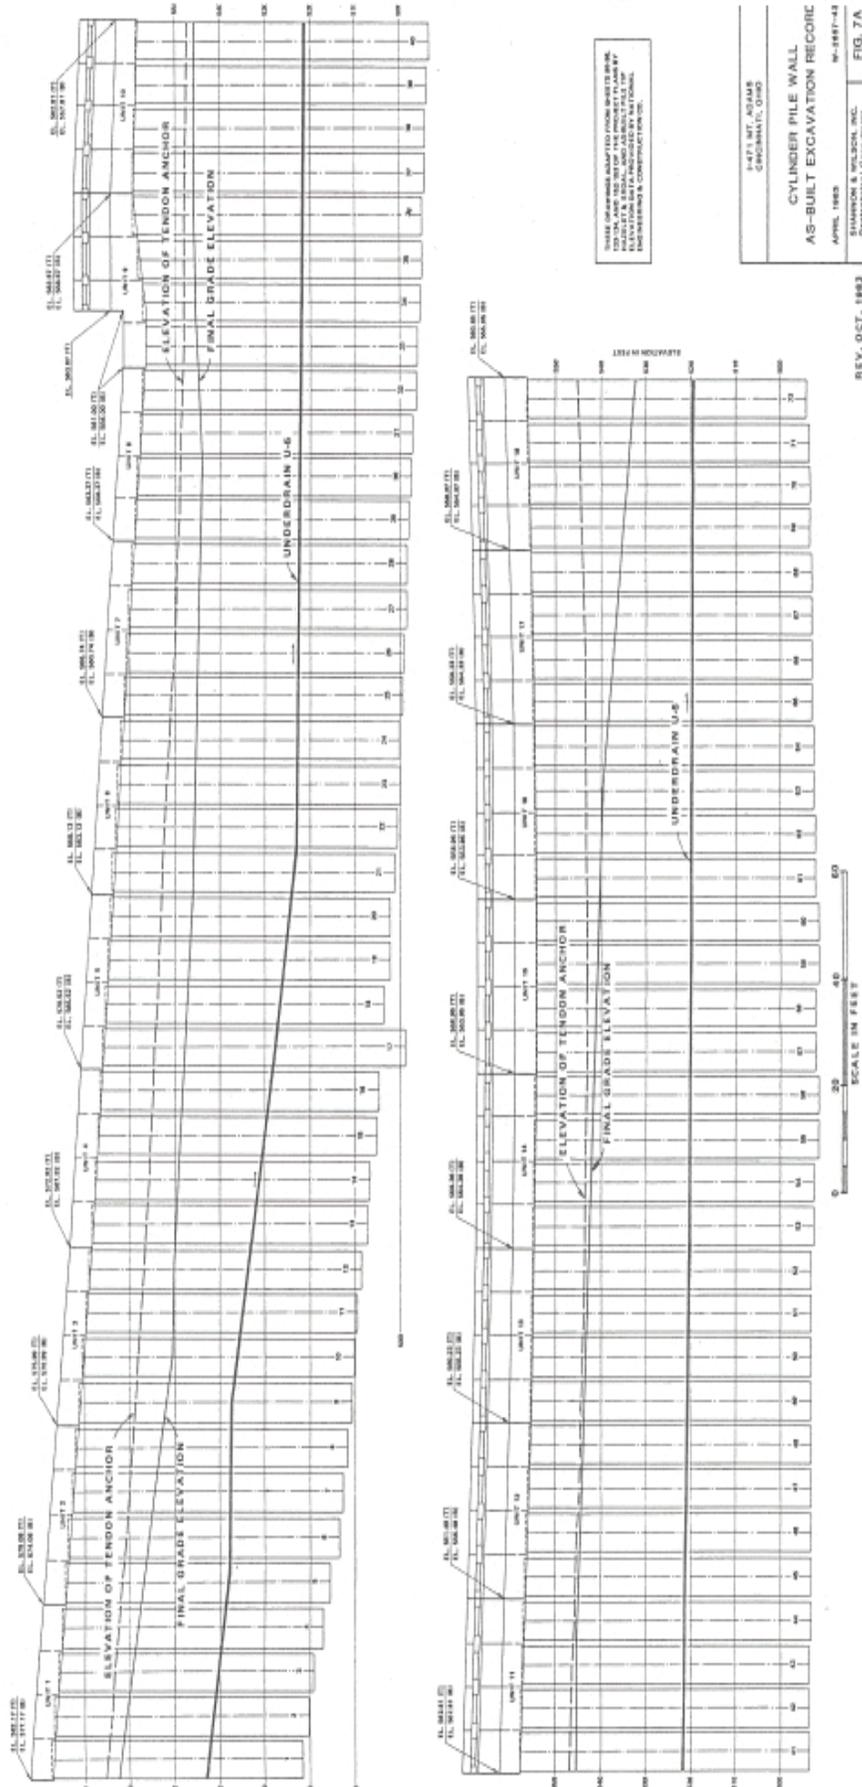
14771 MT. ARMS
CINCINNATI, OHIO
**CYLINDER PILE WALL
AS-BUILT EXCAVATION RECORD**
APRIL 1983
SHAWKOR & FULJOHN, INC.
14771 MT. ARMS
CINCINNATI, OHIO
FIG. 7A

THIS DRAWING ADAPTED FROM SHEET 10-10, 10-11, 10-12 OF THE PROJECT PLAN BY ELEVATION DATA PROVIDED BY NATIONAL INSTRUMENTS CORPORATION, INC.

Typically, a 12-inch-thick shotcrete filler was placed between adjacent piles for the full length of the wall. This filler extends from the underside of the cap beam to approximately 2 feet below the existing ground surface. It provides protection and lateral support of vertical drains located between adjacent piles. An as-built profile of the Cylinder Pile Wall is shown on Figures 7A and 7B. Figure 8 shows the details of the upper-end tendon head assembly.

surrounded by gravel installed between adjacent cylinder piles. These are connected to a horizontal perforated underdrain pipe that is installed along the downslope toe of the wall near the top of rock; see Wall Profile, Figures 7A and 7B. The underdrain system discharges into Manhole No. 19, see Figures 9A, 9B, and 9C for Drainage Location plan. A number of the vertical drain pipes are accessible from the top of the cap beam along Kilgour Street and are identified in Figures 4A and 4B.

The Cylinder Pile Wall was constructed to maintain stability of Mt. Adams above Kilgour Street so excavations consistent with the grade requirements for the I-471 interchange could be accomplished along the toe of the slope. Figures 4A and 4B show the location of the Cylinder Pile Wall and its relation to other features of the project. Figures 9A, 9B, and 9C show the location of the drainage facilities associated with the Cylinder Pile Wall. Figures 7A and 7B present profiles along the front of the wall.

vertical drains. Figures 9A and 9B show the plan location of the horizontal drains and Manhole No. 19. Figure 7A and 7B present the horizontal drains in profile.

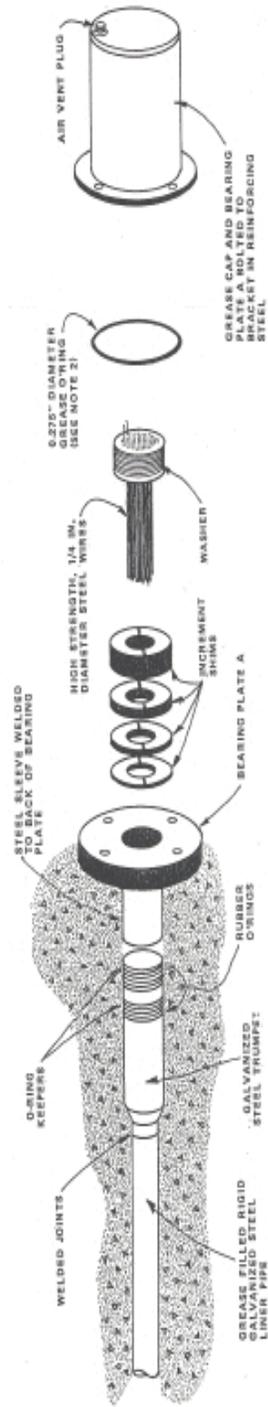
1471
MT. ADAMS, CINCINNATI, OHIO
UPPER END TENDON
HEAD ASSEMBLY
FILES 1 THRU 137
APRIL 1983
SHANNON & WILSON, INC.
CINCINNATI, OHIO
REV. APR. 1988
W-2467-43
FIG. 8

- NOTES**
1. SOME GREASE CAPS HAVE BRASS EXTENSOMETER FITTINGS NEAR AIR VENTS.
 2. REPLACEMENT O-RINGS INSTALLED DURING THE 1978 INSPECTION WERE SUPPLIED BY NETHERLAND RUBBER CO., CINCINNATI, OHIO.

FILES	I.D.
INSIDE	1 - 122	13.075"
DIAMETER	123 - 137	11.438"

O-RING DETAIL
(FROM SHOP DRAWINGS)

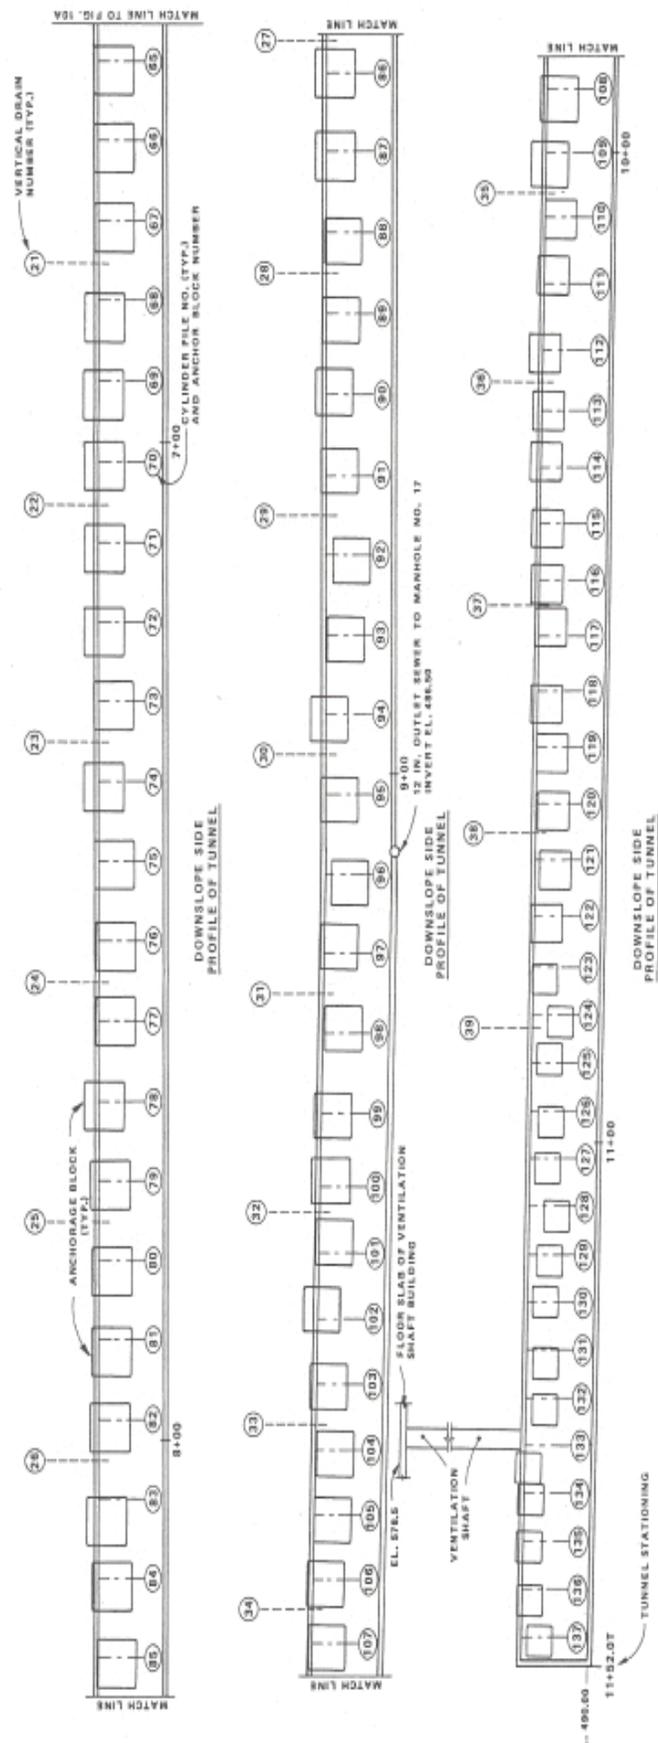
L&T MT. ADAMS, CINCINNATI, OHIO	
PROFILE OF TUNNEL	
APRIL 1983	W-2687-45
SHANNON & WILSON, INC. Geotechnical Consultants	
REV. NOV. 1987	FIG. 10E

POSITIONS AND SIZES OF ANCHOR BLOCKS SHOWN ARE APPROXIMATE.

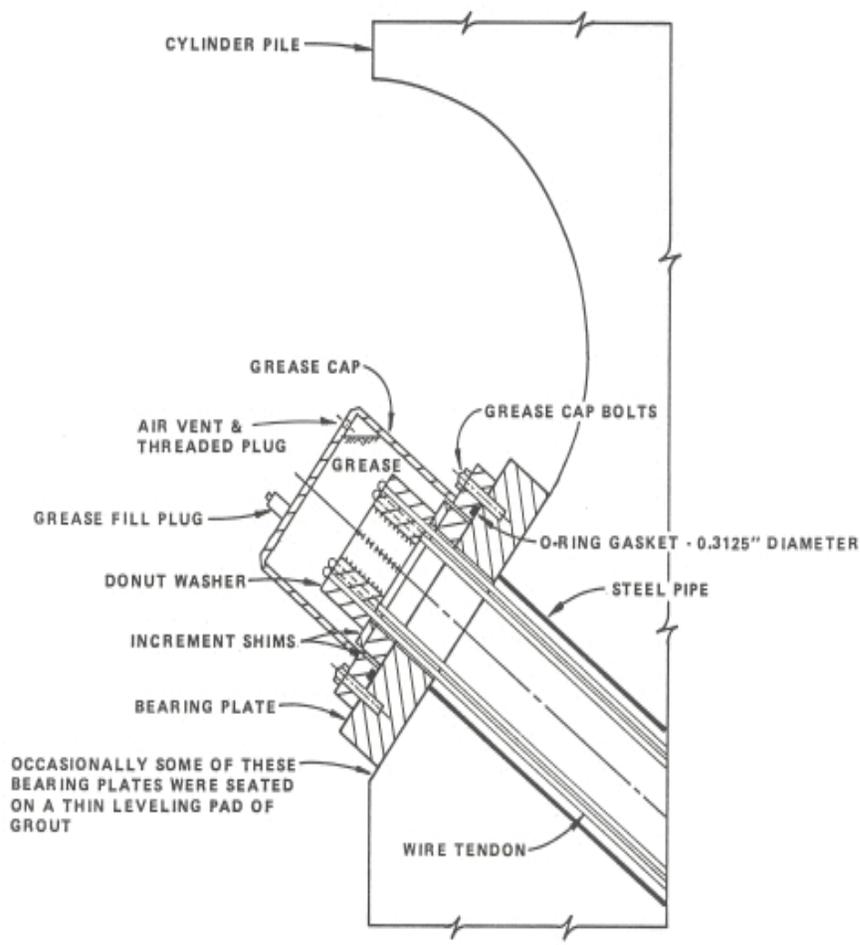
I-471 MT. ADAMS, CINCINNATI, OHIO	
DETAIL OF TENDON CONNECTION TO CYLINDER PILES 138 THRU 161	
APRIL 1983	W-2667-43
SHANNON & WILSON, INC. Geotechnical Consultants	FIG. 15

O-RING DETAIL
(FROM SHOP DRAWINGS)

REPLACEMENT O-RINGS INSTALLED DURING THE 1987-88 INSPECTION WERE SUPPLIED BY NETHERLAND RUBBER CO., CINCINNATI, OHIO.

The tendon bearing assembly at the cylinder pile wall is shown on Figures 5 and 14 for the tunnel anchored tendons, and on Figure 15 for the rock anchored tendons. The two types of bearing assemblies differ in that for the tunnel anchored tendons the upper end steel bearing plates bear directly against the steel reinforcement of the cylinder piles. For the rock anchored tendons the upper end steel bearing plates bear directly against the cylinder pile or cap beam concrete, or on a cement grout pad used to seat the plate against the concrete.

A thorough visual examination of the bearing plate contact conditions at each cylinder pile shall be accomplished. Refer to Figures 5, 14, and 15. Water may collect in any space between the back of the inclined bearing plate and the steel reinforcement, concrete, or grout pad possibly causing deterioration or corrosion. This space, originally filled with grout or caulk, shall be carefully observed for signs of rusting, concrete cracking, spalling, or staining. For cylinder piles 138 to 161, the tendon bearing plates bear directly on concrete. Inspections of these piles shall include careful observation of any cracking or spalling of the concrete or grout pad placed beneath the bearing plate. The grout pad shall be picked or probed to determine its integrity. Any loss of concrete or grout from beneath the bearing plate could cause a reduction of tendon load and necessitate retensioning. Damaged areas shall be brought to the attention of the ODOT Project Manager as soon as feasible.

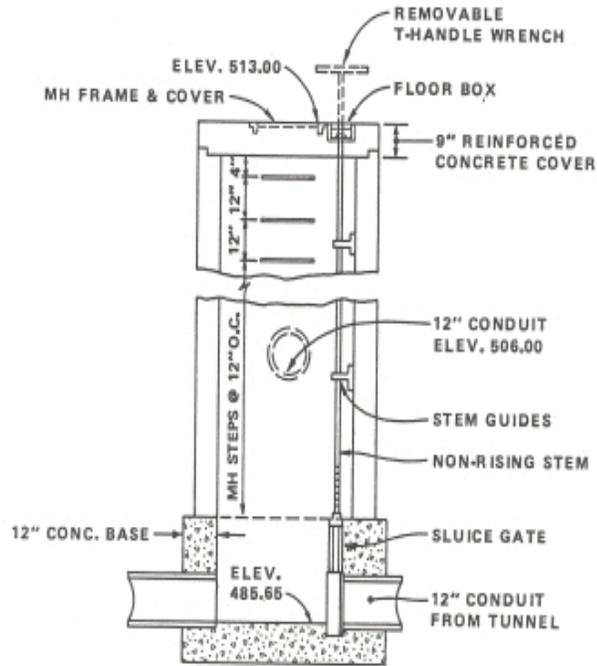
1-471 MT. ADAMS, CINCINNATI, OHIO	
MANHOLE NO. 17	
OCTOBER 1983	W-2667-43
SHANNON & WILSON, INC. Geotechnical Consultants	FIG. 16

MANHOLE NO. 17

on Figure 16.

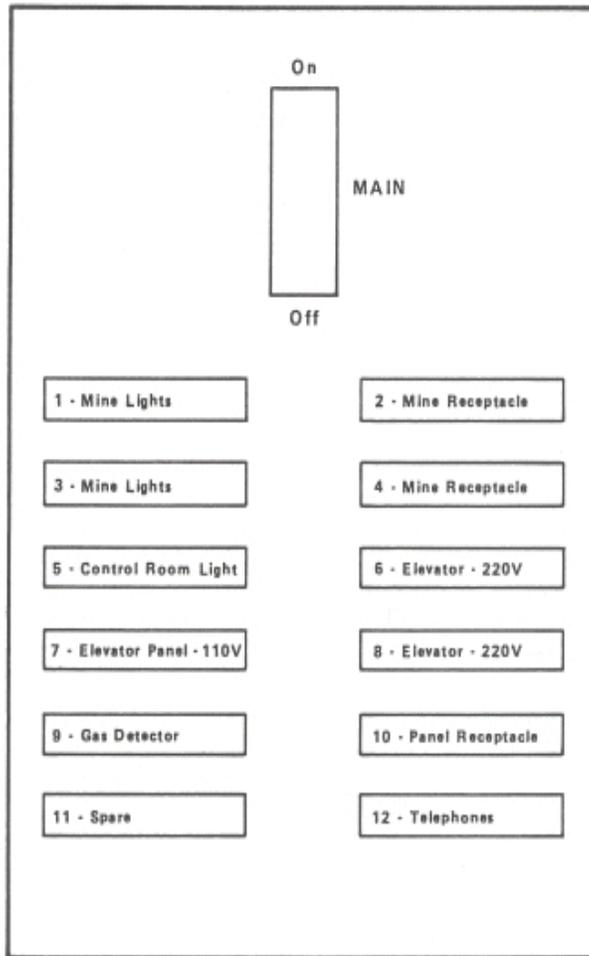
I-471	
MT. ADAMS, CINCINNATI, OHIO	
CIRCUIT BOARD DIAGRAM ACCESS SHAFT BUILDING	
NOVEMBER 1987	W-2667-53
SHANNON & WILSON, INC. Geotechnical Consultants	FIG. 17

CIRCUIT NOS. 5, 9 AND 12 SHOULD ALWAYS BE ON

1. Enter the access shaft building and view the circuit breaker box. Determine if circuits 5, 9, and 12 (room light, gas detector, and telephone) are operating. These circuits should be functioning continuously. Turn on the remainder of the circuits as shown on Figure 17. The gas level within the tunnel, as noted on the gas detection meters, shall be monitored prior to activation of the ventilation fan which will be accomplished at the vent shaft building near the east end of the tunnel.

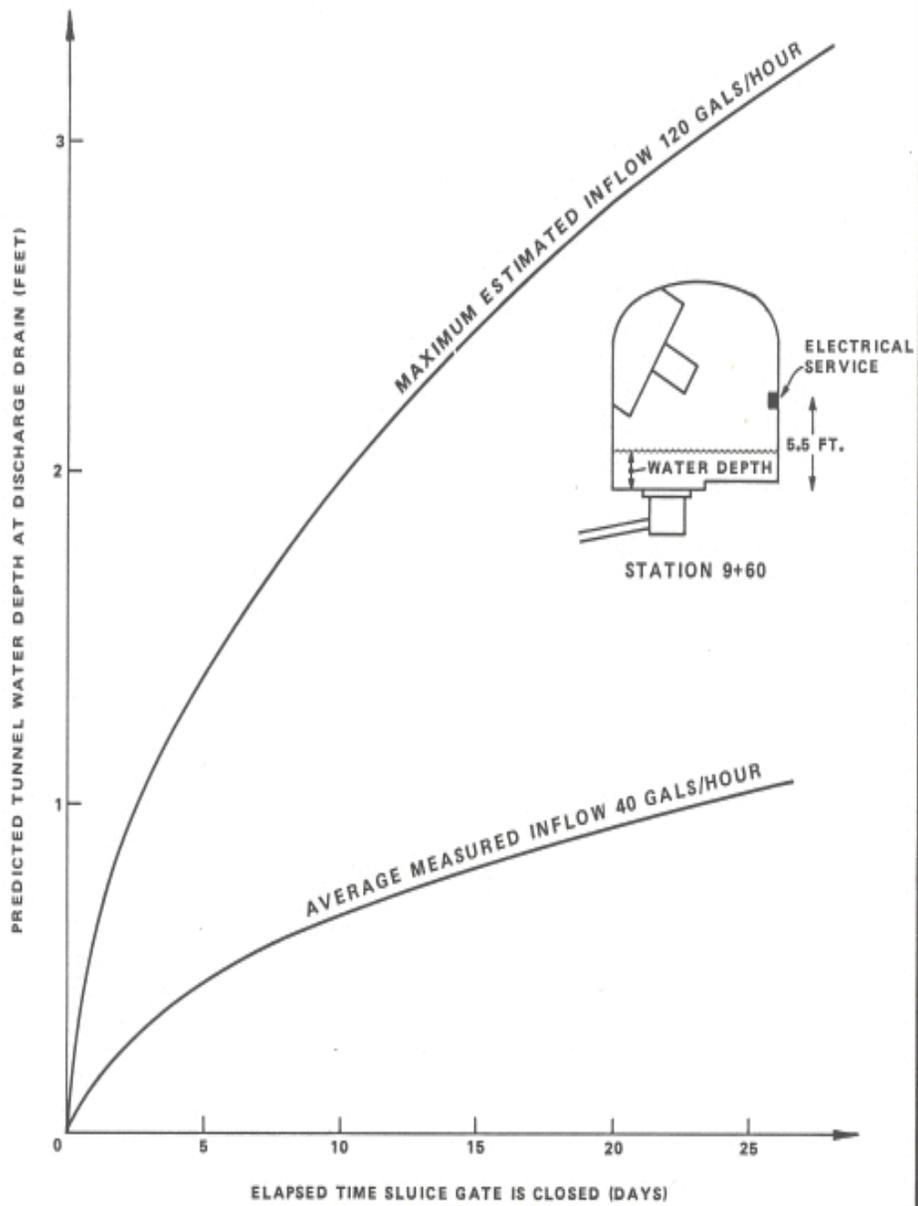
I-471 MT. ADAMS, CINCINNATI, OHIO	
ESTIMATED TUNNEL WATER DEPTH IF SLUICE GATE IS CLOSED	
OCTOBER 1983	W-2667-43
SHANNON & WILSON, INC. Geotechnical Consultants	FIG. 18

1. AVERAGE MEASURED GROUNDWATER INFLOW RATE TO TUNNEL = 40 GAL/HR.
2. AS BUILT TUNNEL PROFILE IS AS DESIGNED.
3. EFFECTIVE TUNNEL WIDTH = 7 FEET.

Estimates based on field data indicate that during normal rainfall periods the groundwater infiltration rate into the tunnel is approximately 40 gallons per hour. If the sluice gate is closed, the depth of water likely to pond in the tunnel was estimated assuming that during flooding the inflow rate is three times the above estimated value. Figure 18 shows the increase in water depth in the tunnel with time. This figure indicates that the sluice gate could be closed for up to four weeks before the water depth reaches approximately 3.3 feet at the low point of the tunnel invert. This is still approximately 2 feet below the nearby electrical receptacles located on the upslope wall of the tunnel.

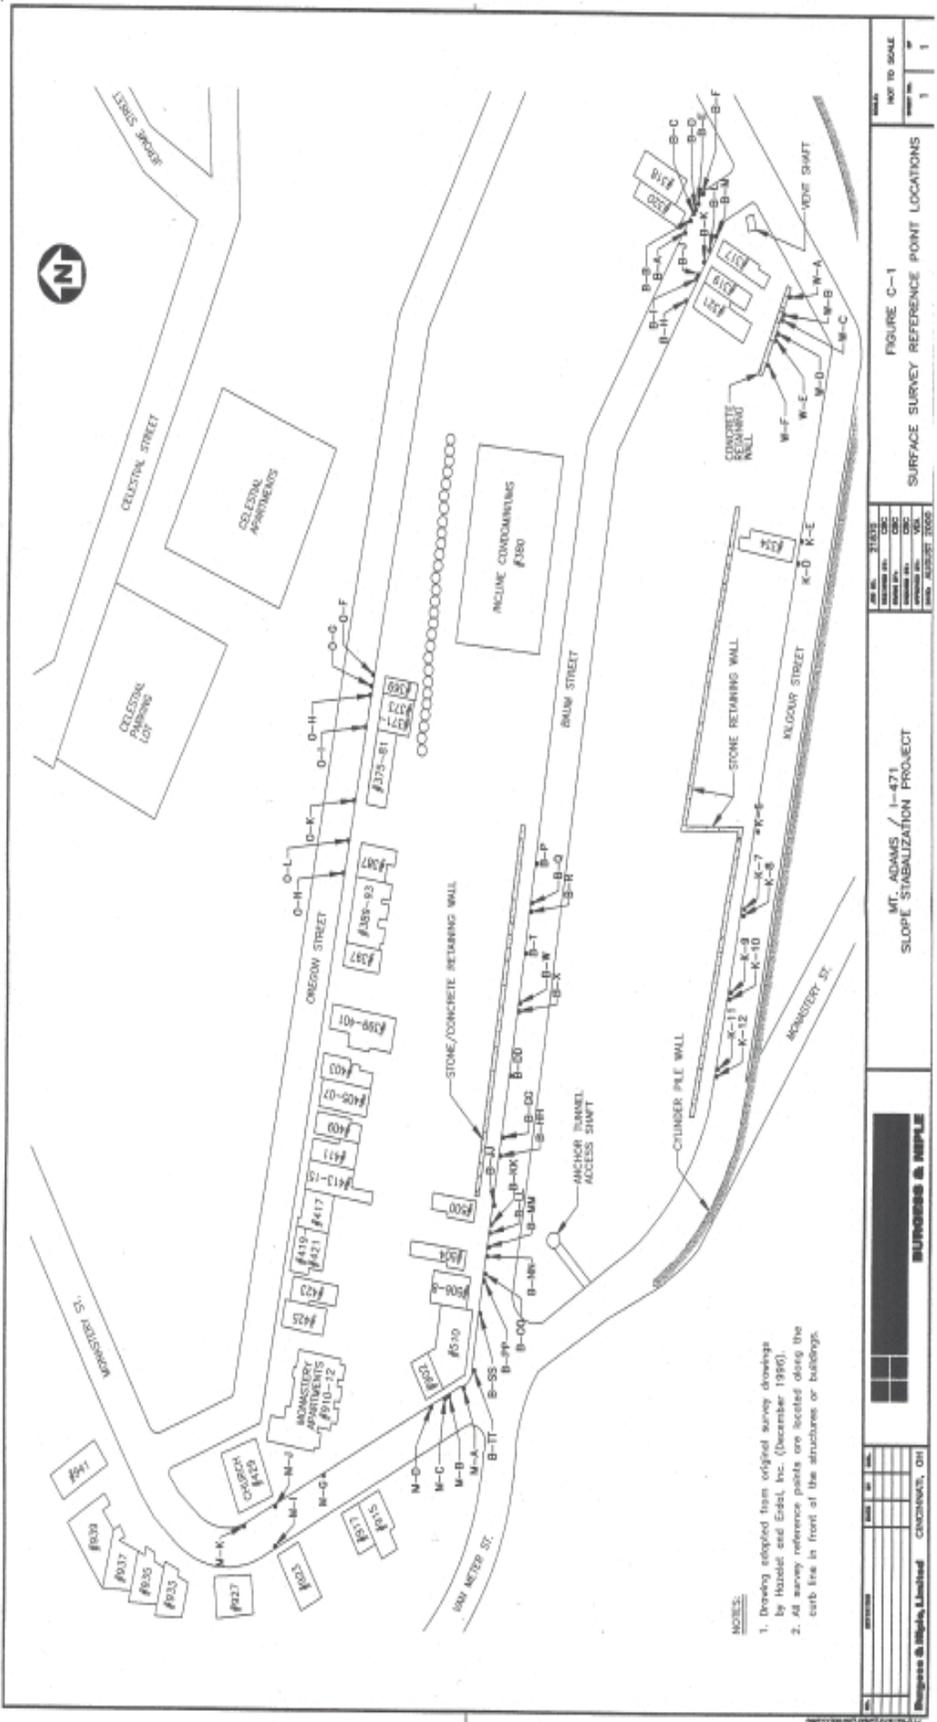
FIGURE C-1
SURFACE SURVEY REFERENCE POINT LOCATIONS

NOTES:
 1. Drawing adopted from original survey drawings by Hazlett and Edsel, Inc. (December 1990).
 2. All survey reference points are located along the curb line in front of the structures or buildings.

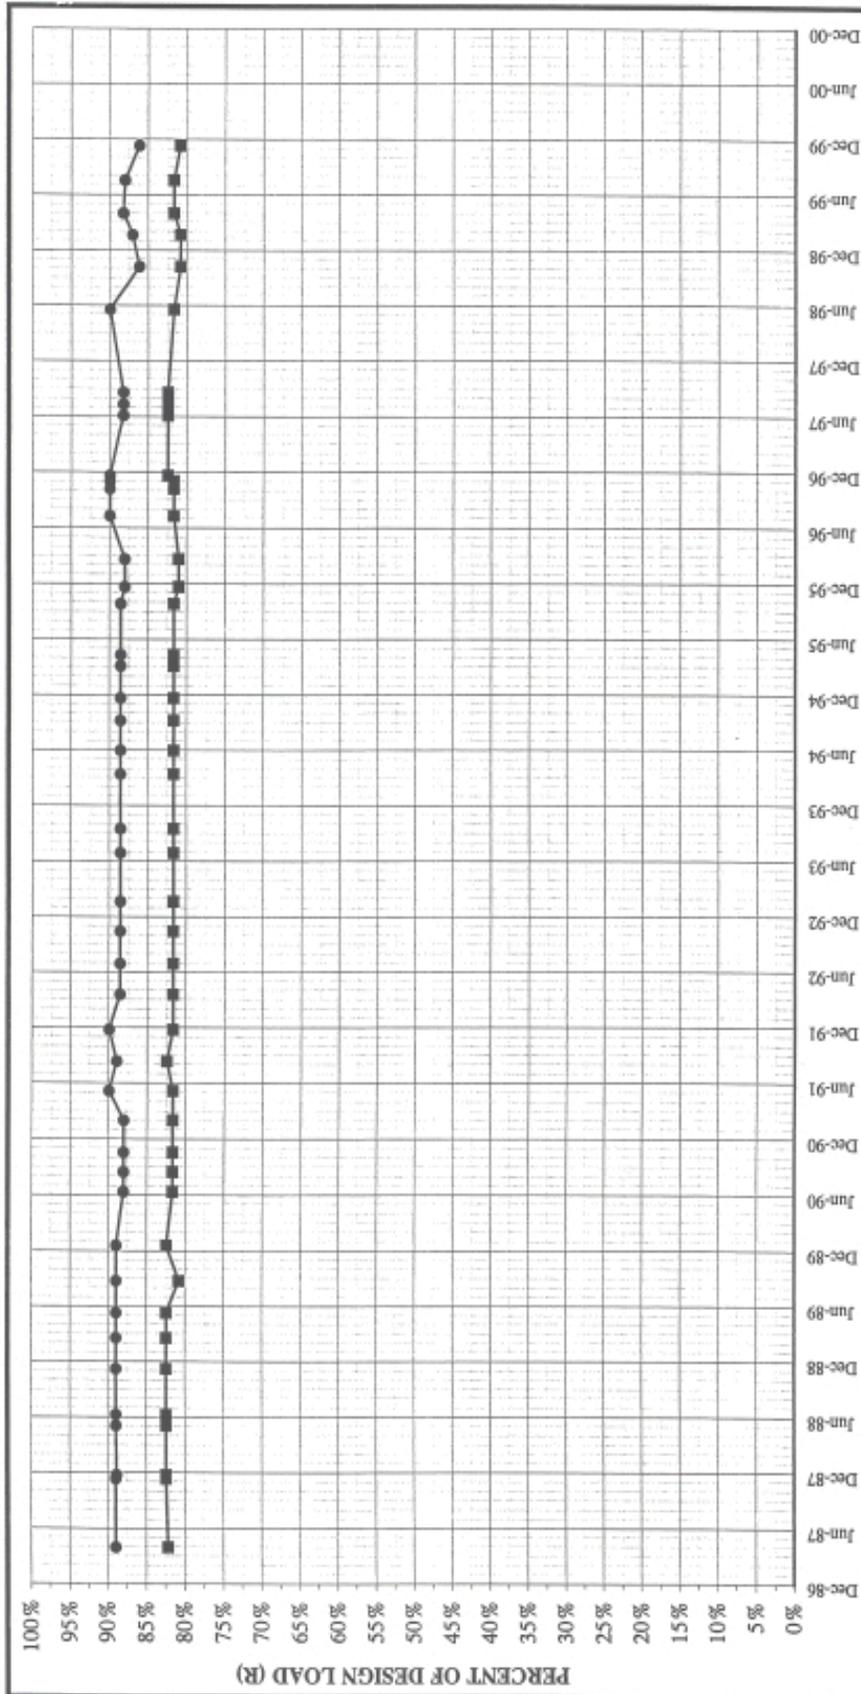
FIGURE
B-1

1. Tendon load data prior to August 1998 obtained from Shannon & Wilson.
2. Tendon load measured in the anchor named with hydraulic load cell.
3. For CP-31, percent of design load (R) = $[21.9(X) + 1.4]/1330$; where X = load cell measurement.
4. For CP-90, percent of design load (R) = $[22.3(X) - 58.8]/1175$; where X = load cell measurement.

CP-31 AND CP-90
TENDON LOAD MEASUREMENTS

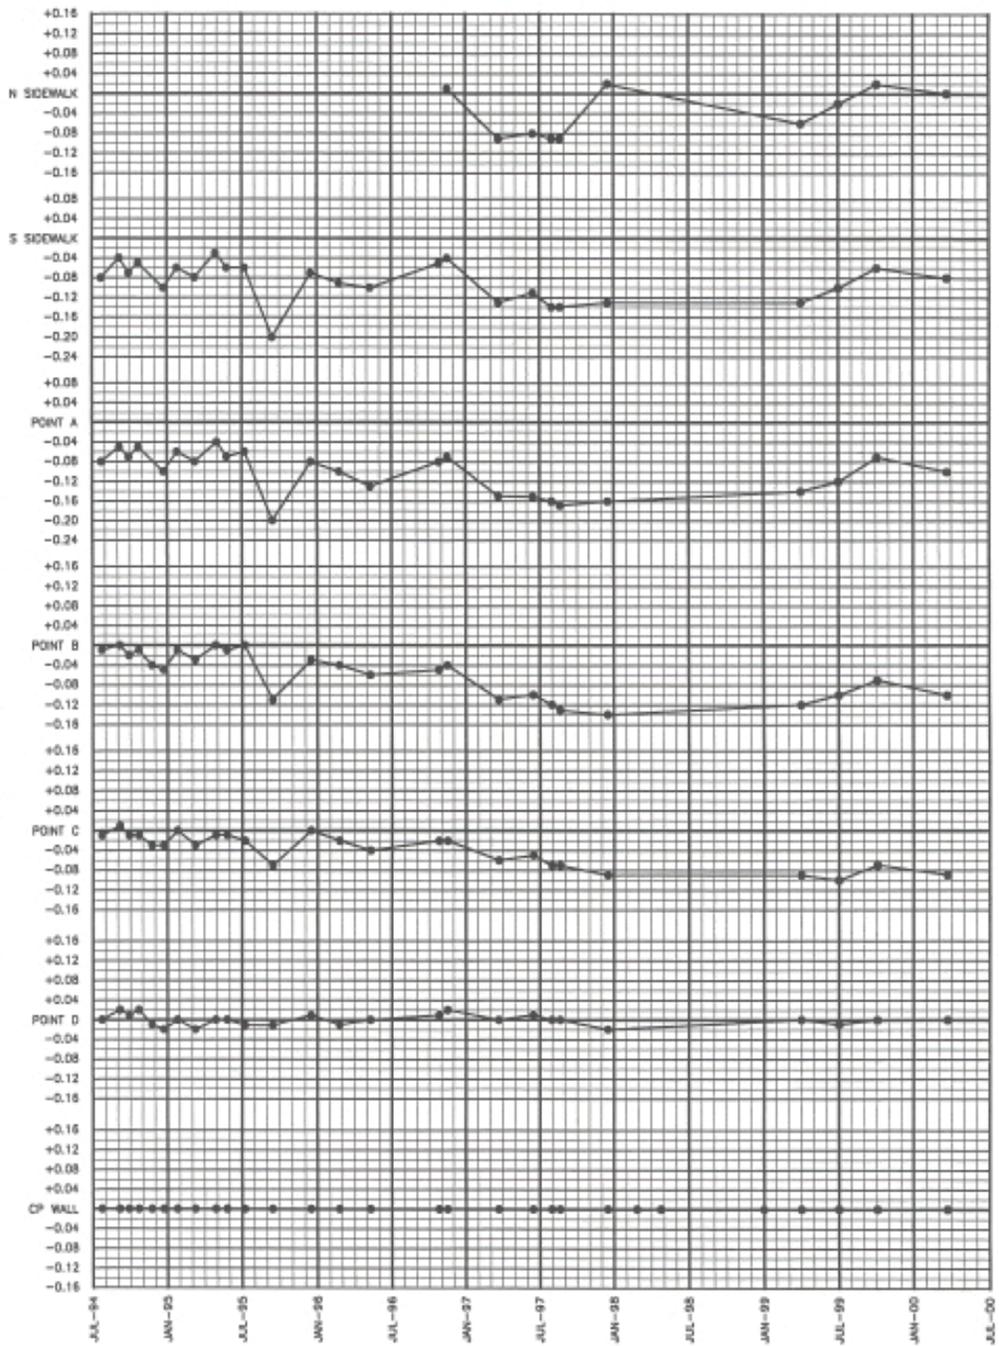
FIGURE
C-4.1

CHANGE IN DISTANCE (FT.) FROM FIXED REFERENCE POINT AT CP WALL
(POSITIVE = UPSLOPE; NEGATIVE = DOWNSLOPE)

1. Displacements referenced to baseline distance of each reference point to an assumed fixed point at the cylinder pile wall.
2. Distances measured sequentially from point to point and parallel to ground surface.
3. Displacement data prior to August 1998 obtained from Shannon & Wilson.

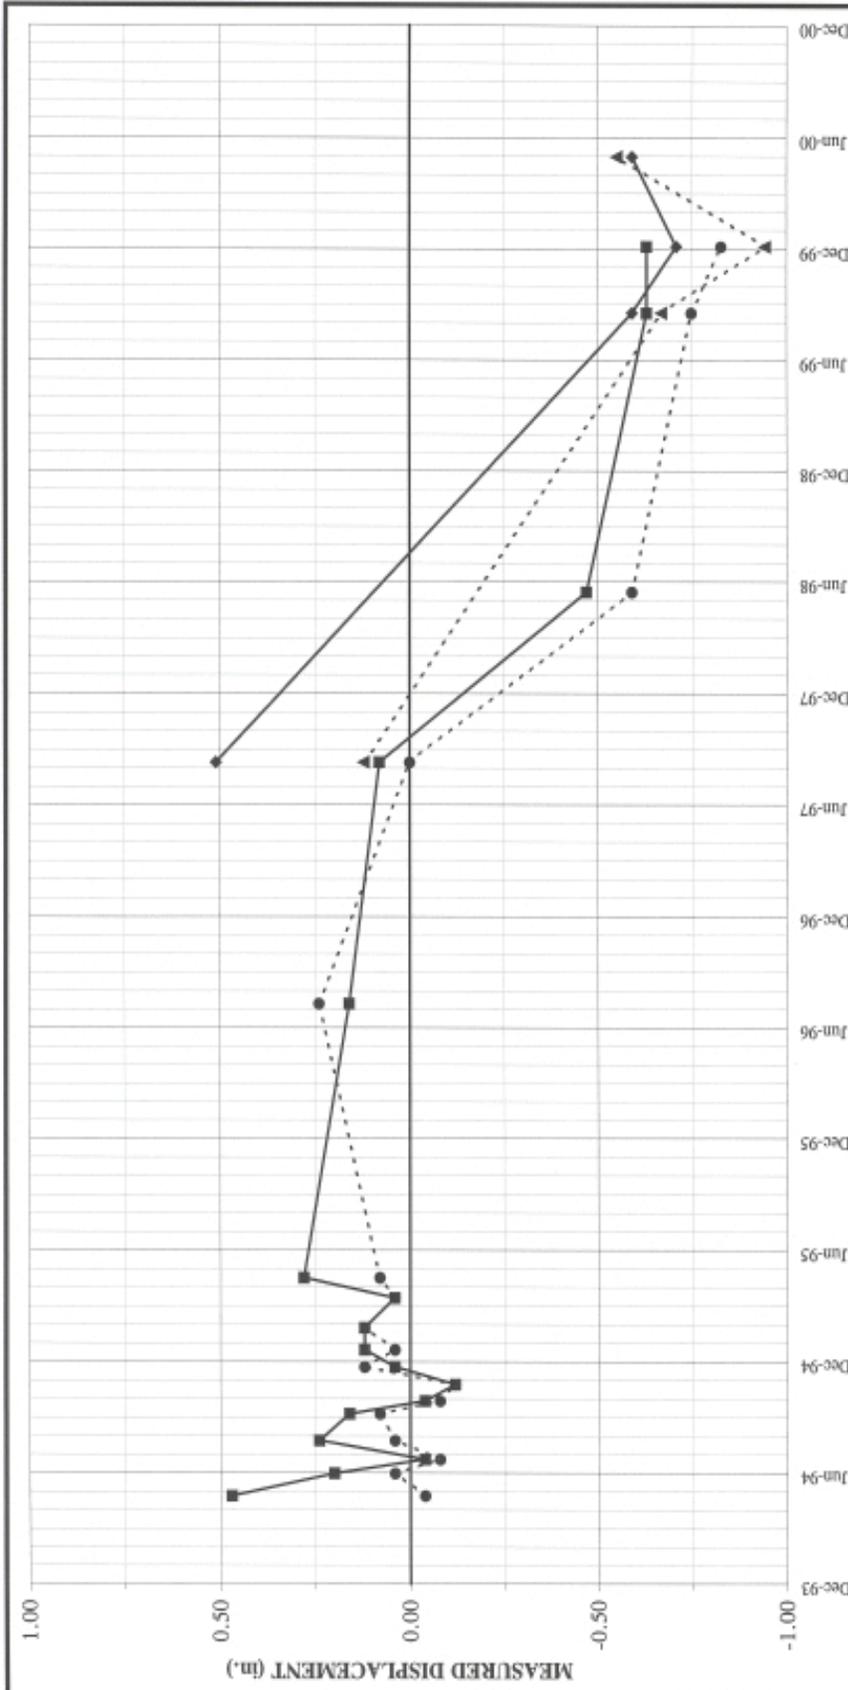
BURGESS & NIPLE	MT. ADAMS / I-471 SLOPE STABILIZATION PROJECT Cincinnati, Ohio August 2000	RAMP P (PIER NUMBER 7) EDM DISPLACEMENTS	FIGURE D-1
---	---	--	----------------------

- CP-3 TO WEST COLUMN
- ▲--- CP-3 TO EAST COLUMN
- CP-4 TO WEST COLUMN
- ◆--- CP-4 TO EAST COLUMN
