RFI/FIELD DESIGN CHANGE/DESIGN DIRECTIVE

RFI Number (from Walsh): 00070 **Date:** 7/20/11

Drawing Package Title: Various Bridges

Description of Change: On bridges 1, 2, 7, 8, 9, due to the end cross frames conflicting with per plan dowel locations on the abutment extensions and seismic pedestals, we cannot drill and install the dowels in the required locations.

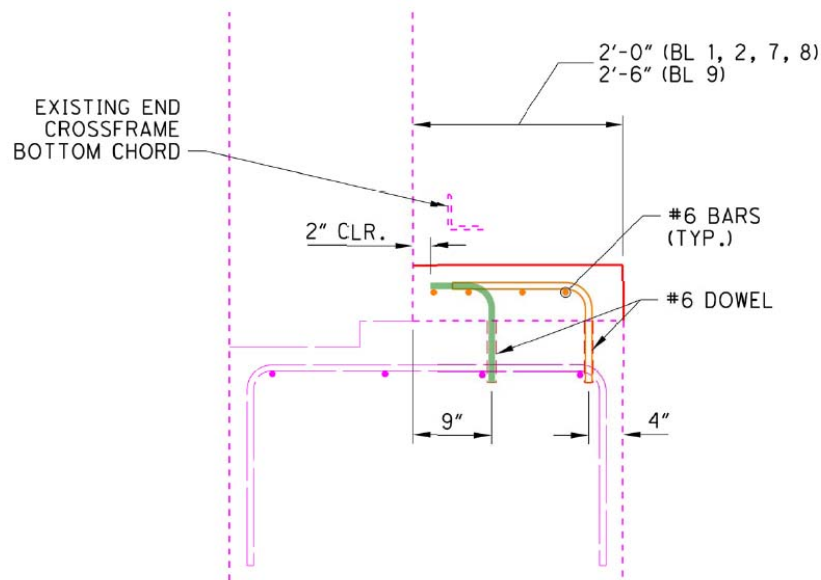
SECTION THRU ABUTMENT SEAT

Response: HNTB recognizes the challenge of installing the dowels beneath the bottom chord of the existing end crossframes remaining and proposes the following alternate details for both the abutment beam seat and seismic pedestal reinforcement.

*Abutment Beam Seat Reinforcement:
(BL 1, 2, 7, 8 & 9)*

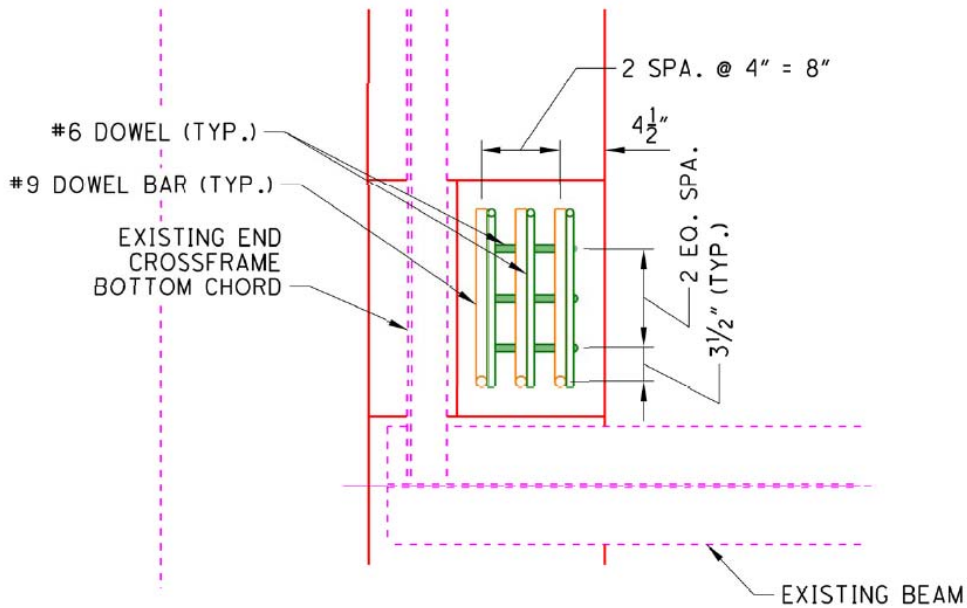
PLAN

Partial Seismic Pedestal Reinforcement: (BL 1, 2, 7 & 8)

*** Due to a proposed reduction in length of the pedestal, a subsequent reduction in load carrying capacity of the pedestal is anticipated. Therefore, additional pedestals will be required to compensate. See attached file for abutment plan locations of the additional pedestals. ***

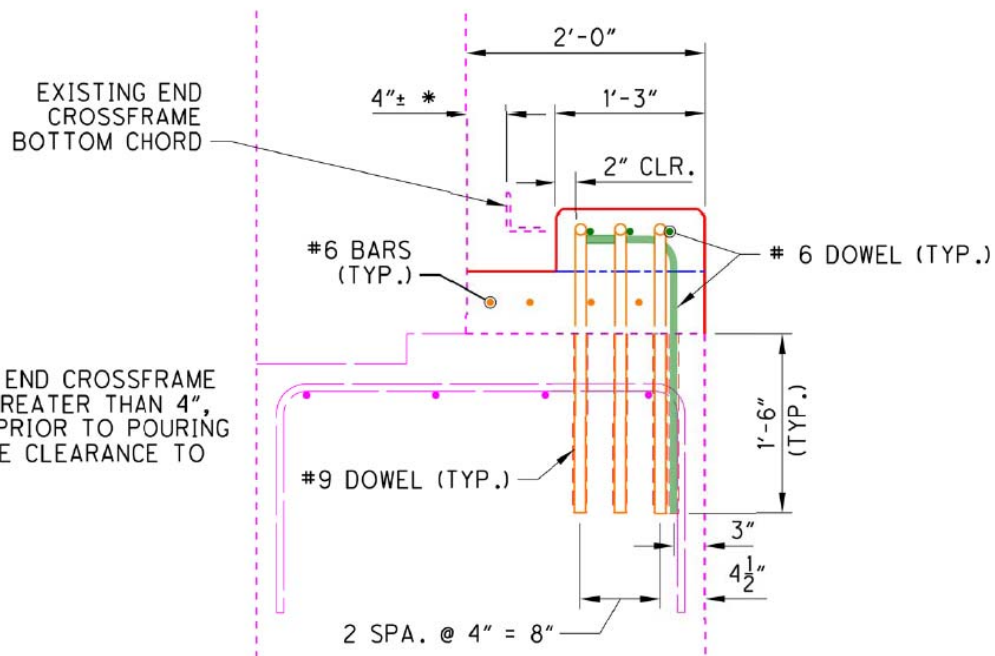
SECTION

* IF CLEARANCE TO END CROSSFRAME BOTTOM CHORD IS GREATER THAN 4", CONTACT ENGINEER PRIOR TO POURING TO VERIFY ADEQUATE CLEARANCE TO SEISMIC PEDESTAL

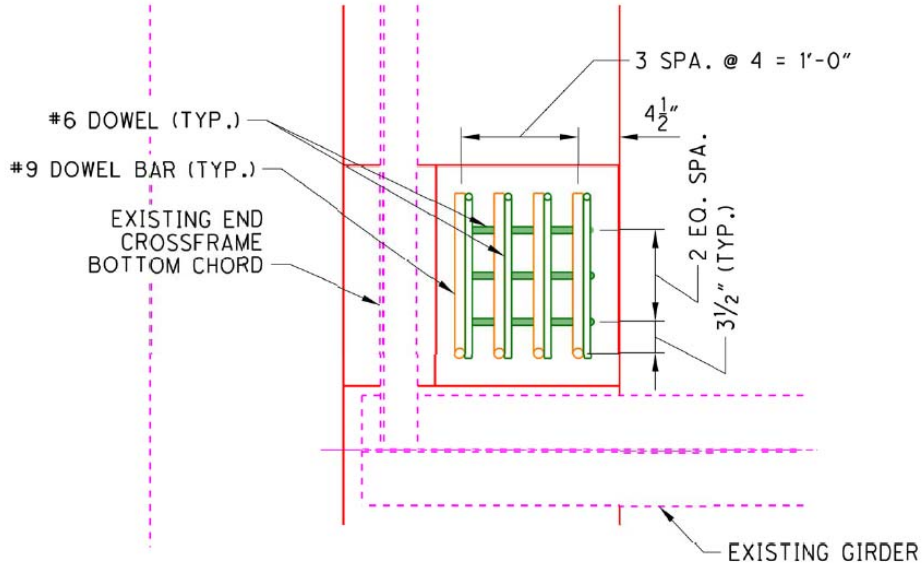
PLAN

Partial Seismic Pedestal Reinforcement: (BL 9)

*** Due to a proposed reduction in length of the pedestal, a subsequent reduction in load carrying capacity of the pedestal is anticipated. Therefore, additional pedestals will be required to compensate. See attached file for abutment plan locations of the additional pedestals. ***

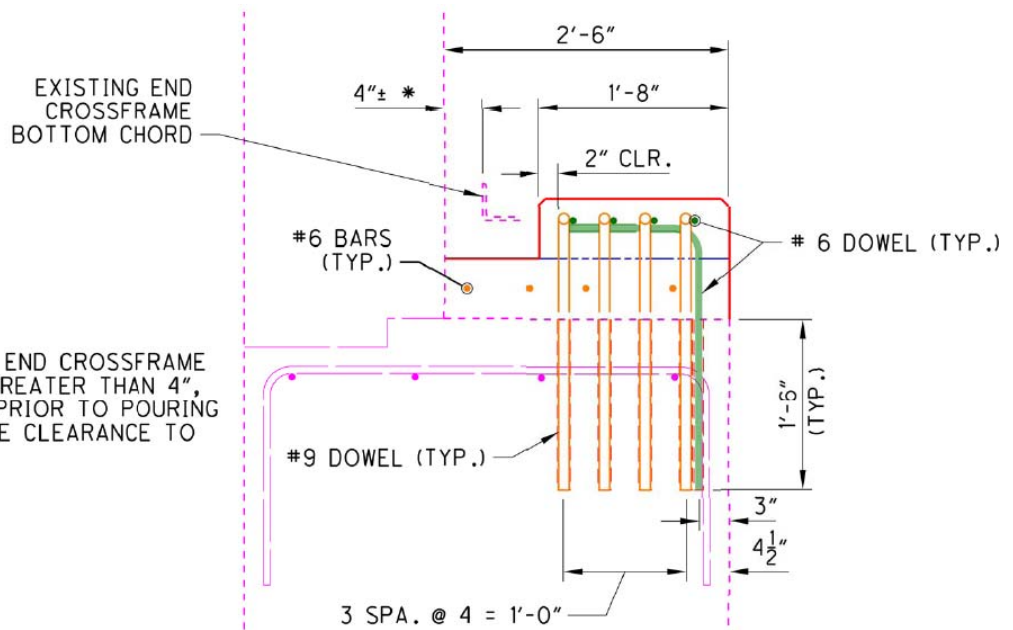
SECTION

* IF CLEARANCE TO END CROSSFRAME BOTTOM CHORD IS GREATER THAN 4", CONTACT ENGINEER PRIOR TO POURING TO VERIFY ADEQUATE CLEARANCE TO SEISMIC PEDESTAL
