# CONSOLIDATION TEST REPORT

<b>Project No.</b> 0121- <b>Project:</b> SCI-823-0.00 <b>Source:</b> C-93	<b>Client:</b> TranSystems, Inc.  <b>Sample No.:</b> P1 <b>Elev./Depth:</b> 10.0	<b>Remarks:</b>
---	--	-----------------

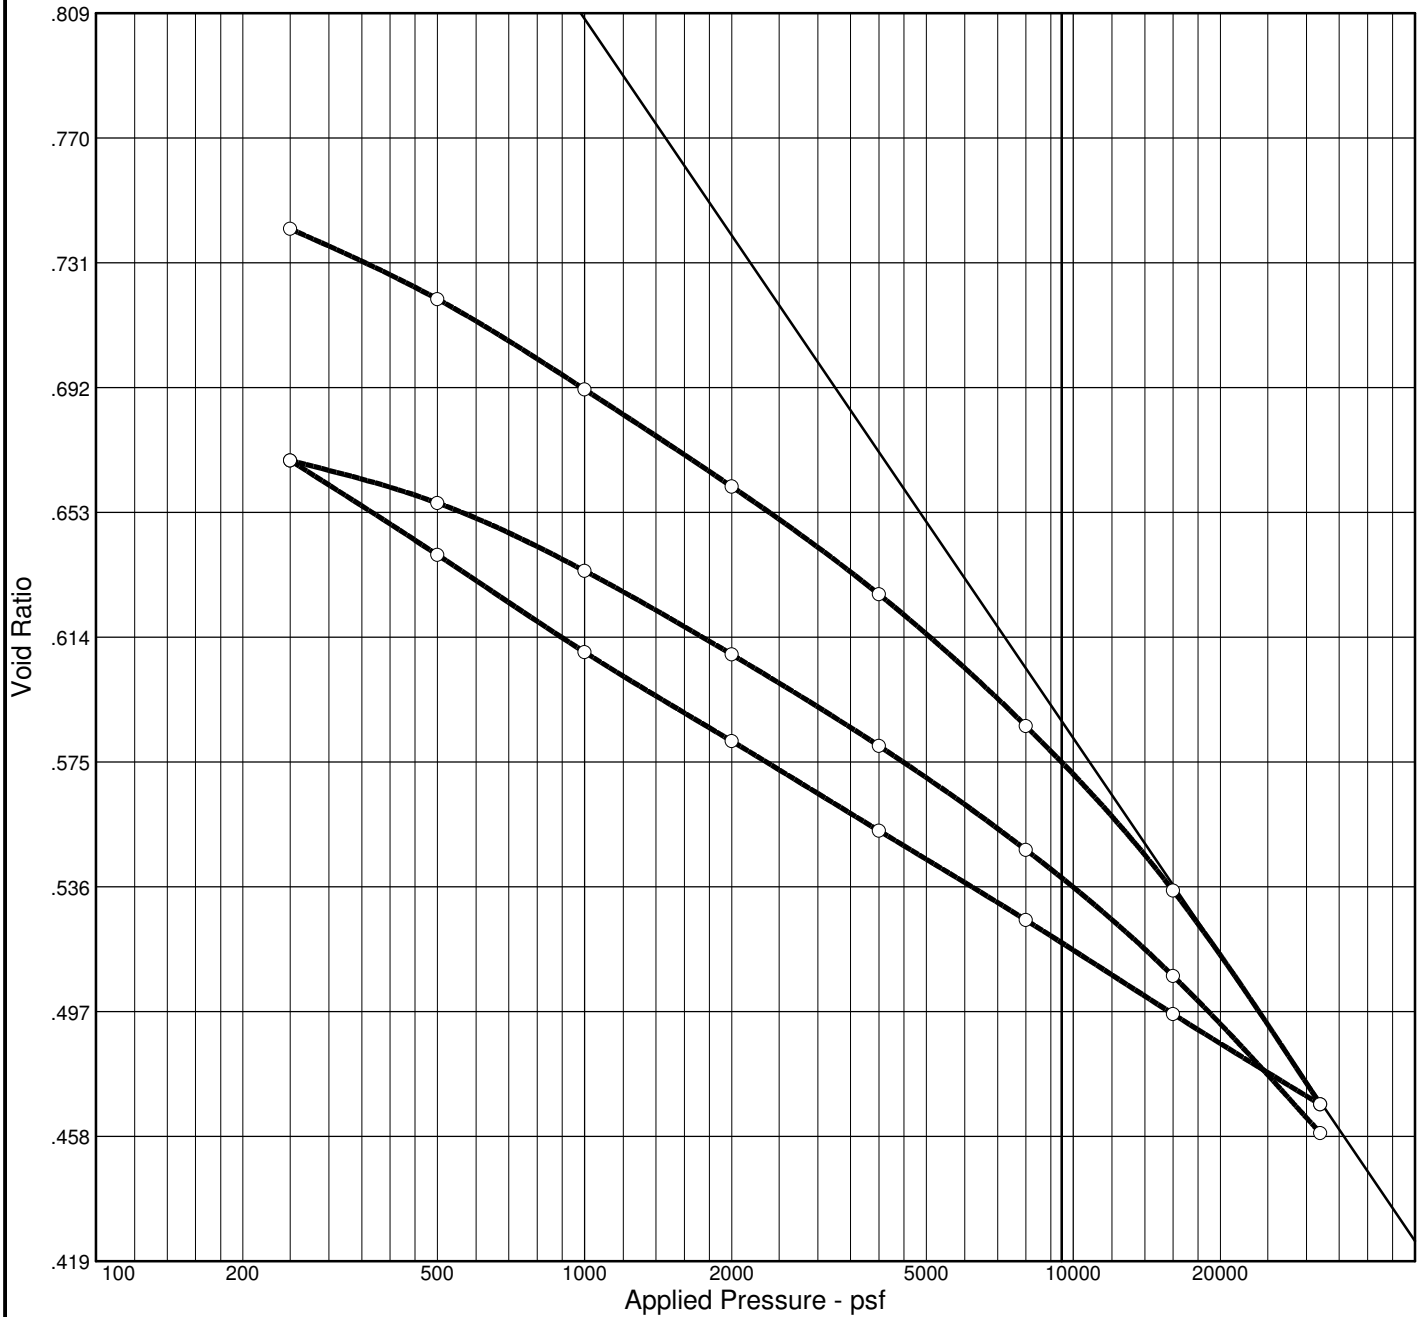
Natural		Dry Dens. (pcf)	LL	PI	Sp. Gr.	USCS	AASHTO	Initial Void Ratio
Saturation	Moisture							
101.5 %	27.9 %	96.8	45	21	2.68	CL	A-7-6(22)	0.738

### MATERIAL DESCRIPTION

Lean clay  
Torvane= 5.25

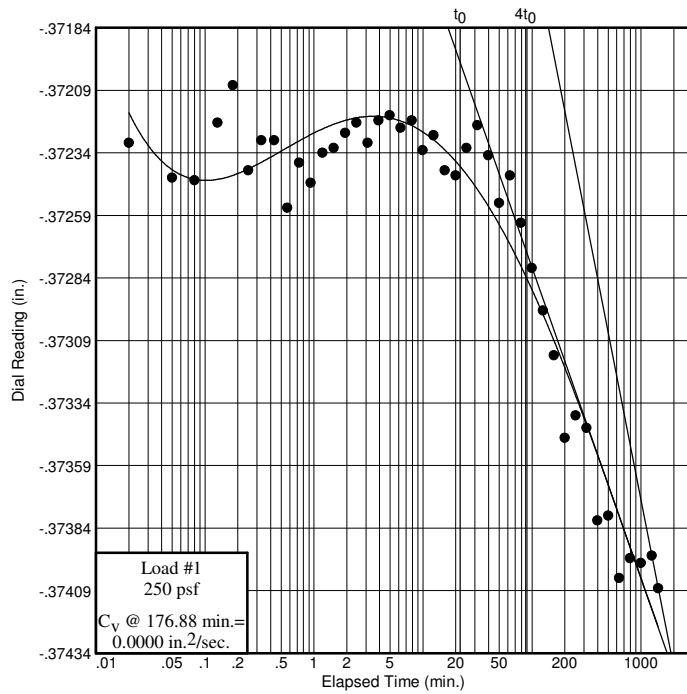
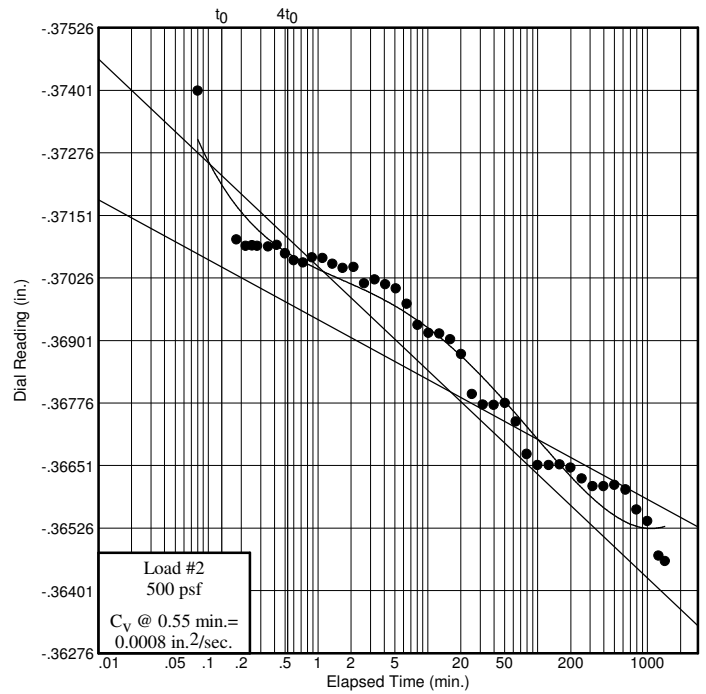
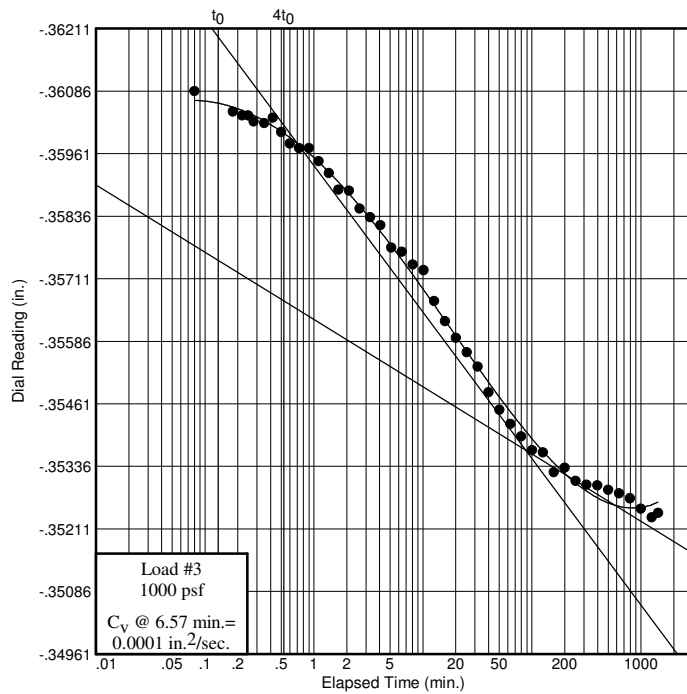
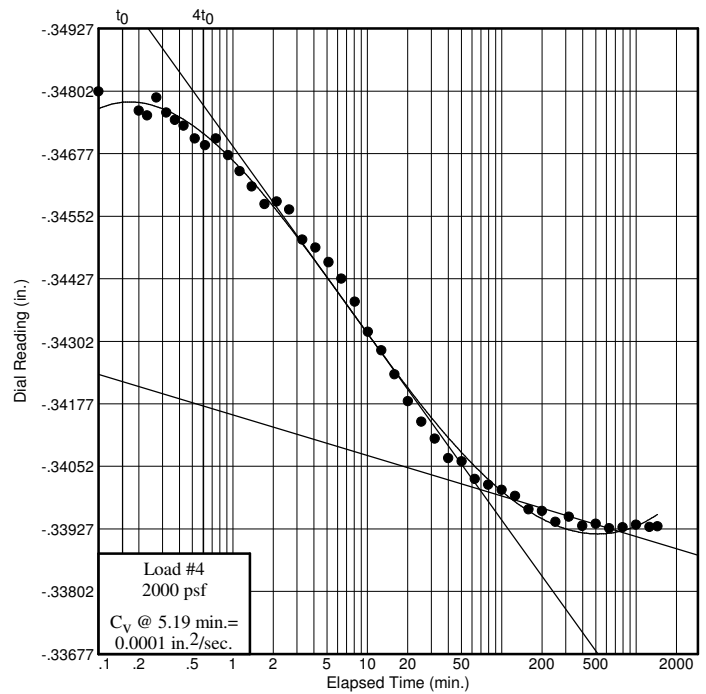
# Dial Reading vs. Time

Project No.: 0121-3070.03

Sample No.: P1

Elev./Depth: 10.0

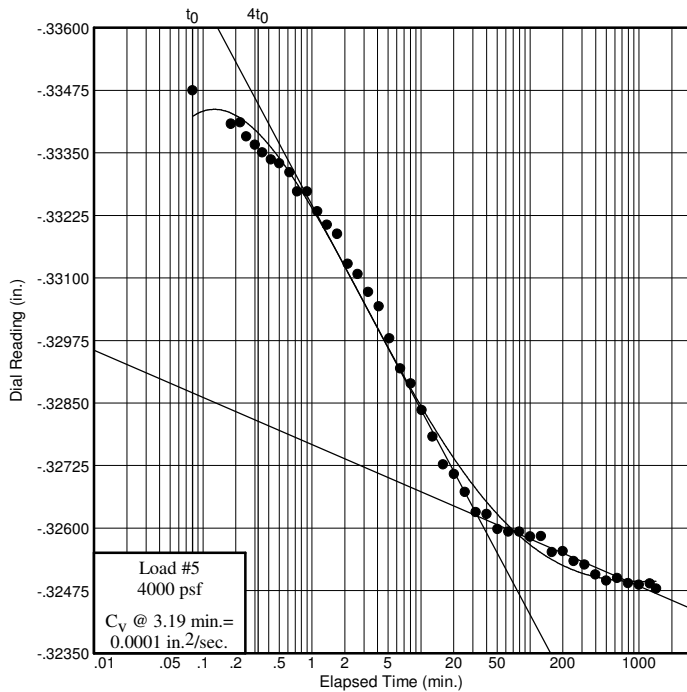
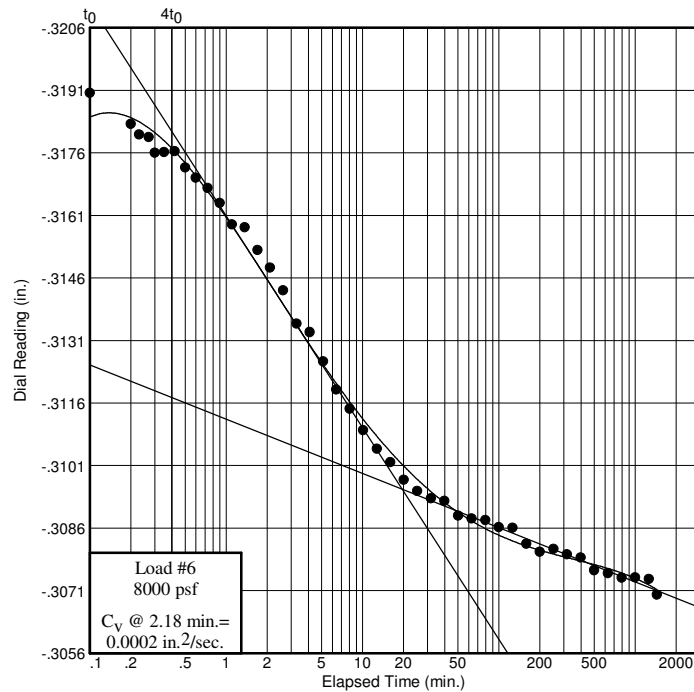
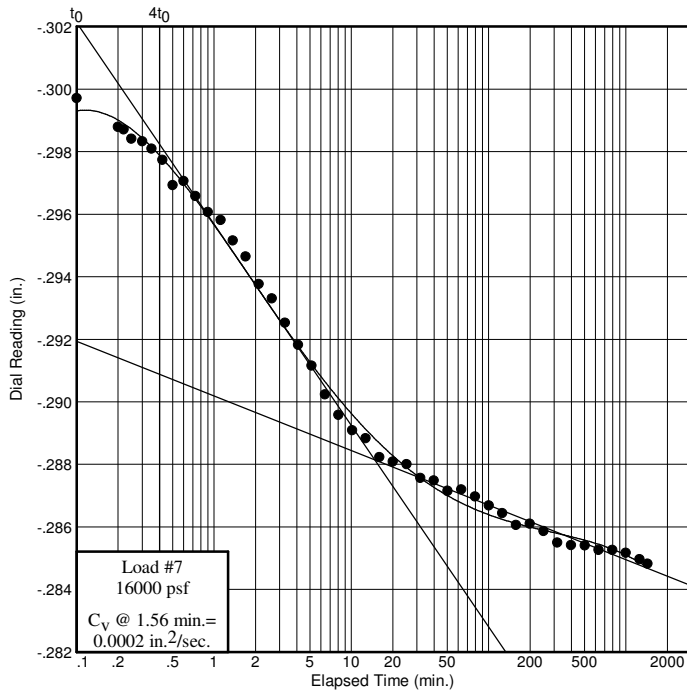
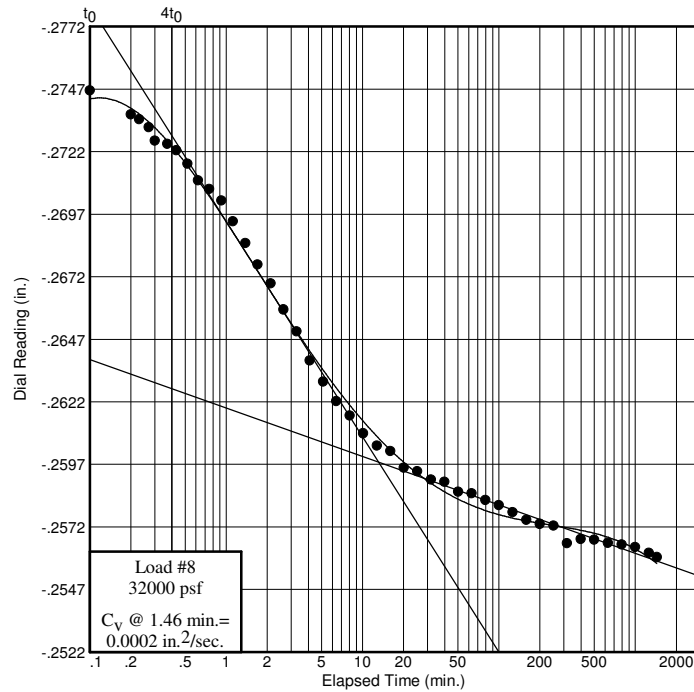
# Dial Reading vs. Time

Project No.: 0121-3070.03

Sample No.: P1

Elev./Depth: 10.0

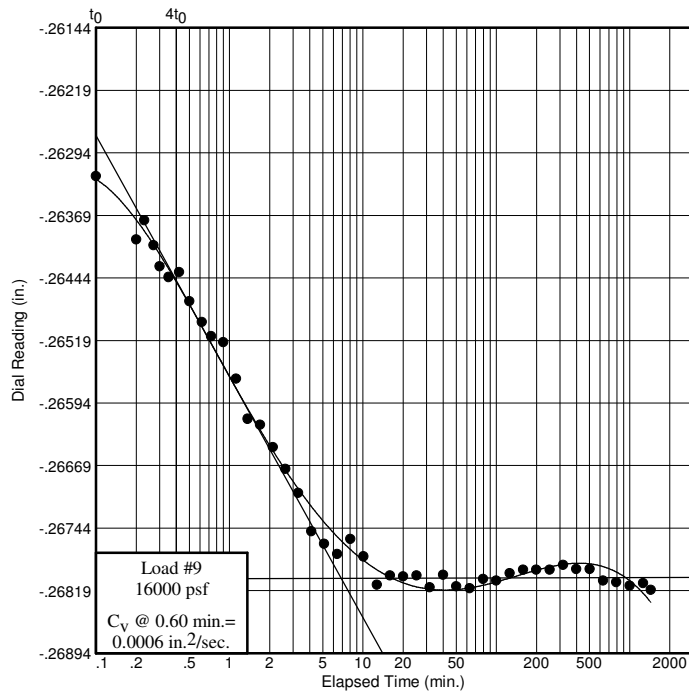
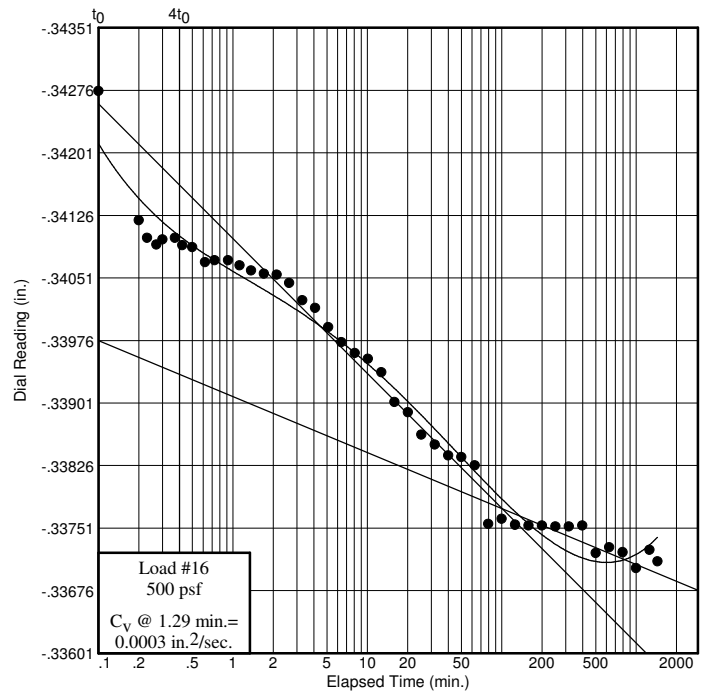
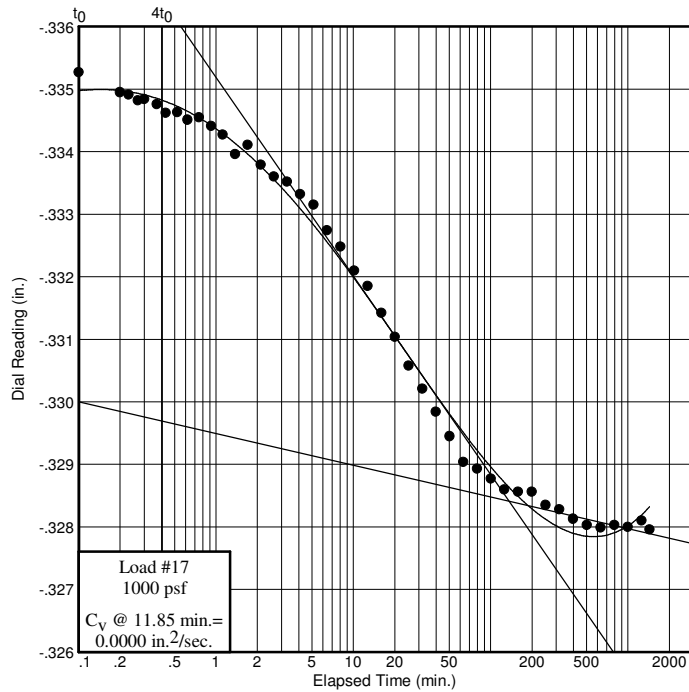
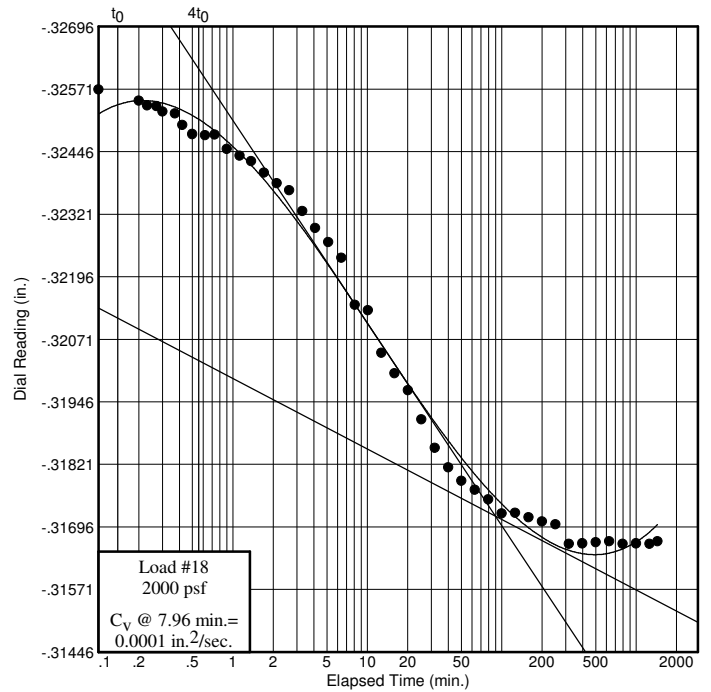
# Dial Reading vs. Time

Project No.: 0121-3070.03

Sample No.: P1

Elev./Depth: 10.0

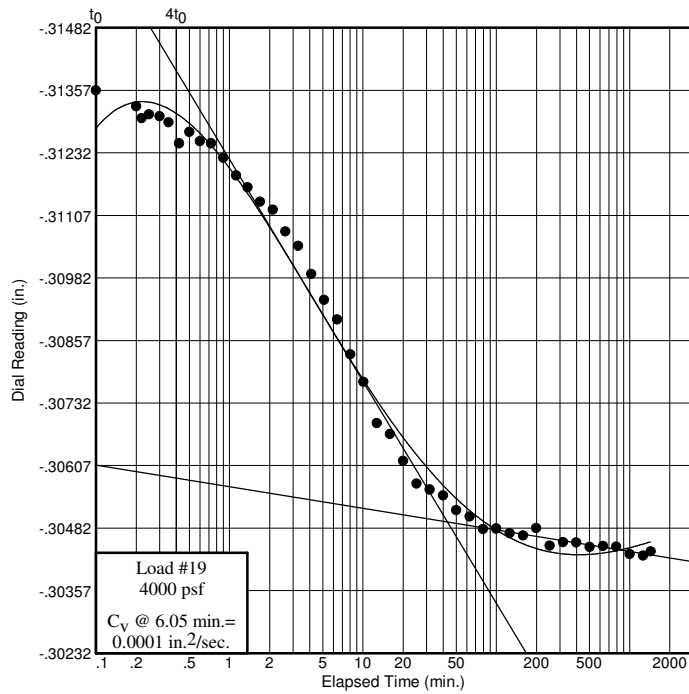
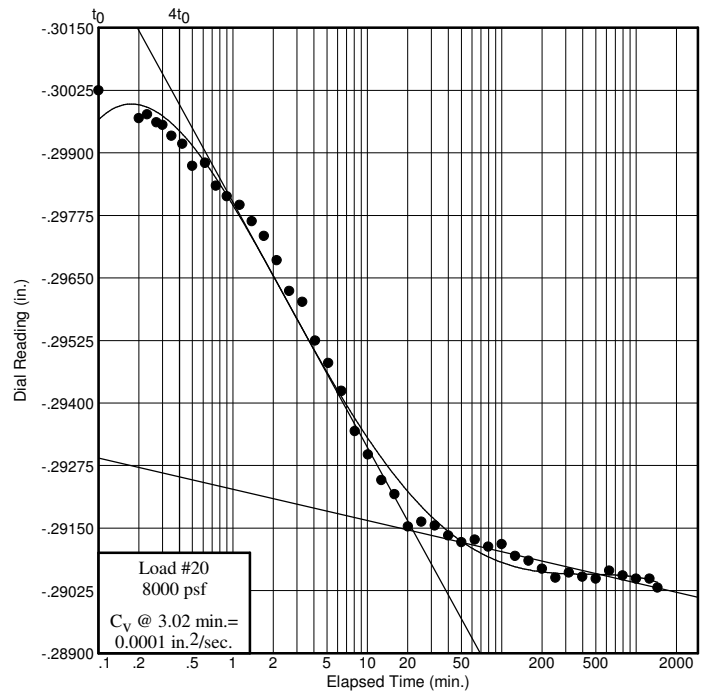
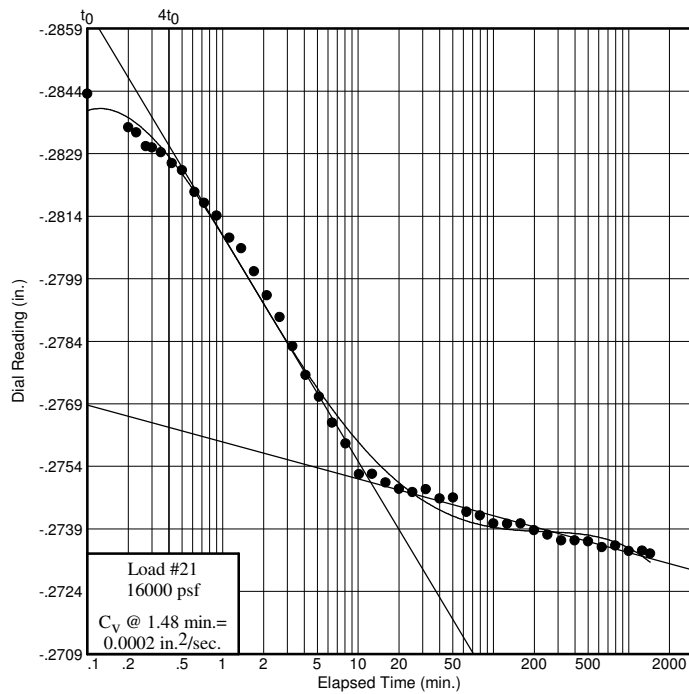
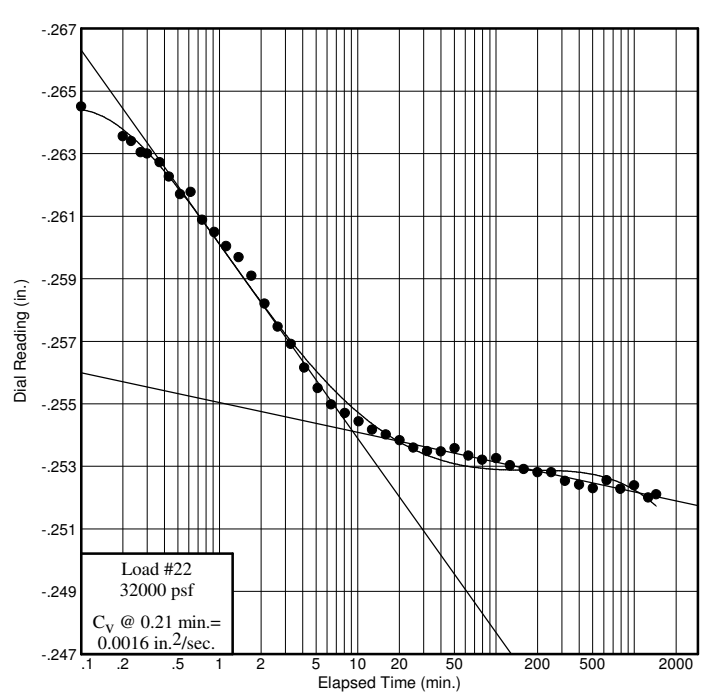
# Dial Reading vs. Time

Project No.: 0121-3070.03

Sample No.: P1

Elev./Depth: 10.0
