OHIO DEPARTMENT OF TRANSPORTATION  
OFFICE OF GEOTECHNICAL ENGINEERING

GRAIN SIZE DISTRIBUTION

## N4225519 BEL-250-8.15 PID 118151 - Retaining Wall Replacement

| <table border="1" style="width: 100%; border-collapse: collapse;"> <tr><td style="padding: 2px;">Project Manager:</td><td style="padding: 2px;">BH</td></tr> <tr><td style="padding: 2px;">Drawn by:</td><td style="padding: 2px;">IR</td></tr> <tr><td style="padding: 2px;">Checked by:</td><td style="padding: 2px;">BH</td></tr> <tr><td style="padding: 2px;">Approved by:</td><td style="padding: 2px;">TM</td></tr> </table> | Project Manager: | BH | Drawn by: | IR | Checked by: | BH | Approved by: | TM | <table border="1" style="width: 100%; border-collapse: collapse;"> <tr><td style="padding: 2px;">Project No.</td><td style="padding: 2px;">N4225519</td></tr> <tr><td style="padding: 2px;">Scale:</td><td style="padding: 2px;">N.T.S.</td></tr> <tr><td style="padding: 2px;">File Name:</td><td style="padding: 2px;">Rockcore Photos</td></tr> <tr><td style="padding: 2px;">Date:</td><td style="padding: 2px;">05/09/2023</td></tr> </table> | Project No. | N4225519 | Scale: | N.T.S. | File Name: | Rockcore Photos | Date: | 05/09/2023 | <

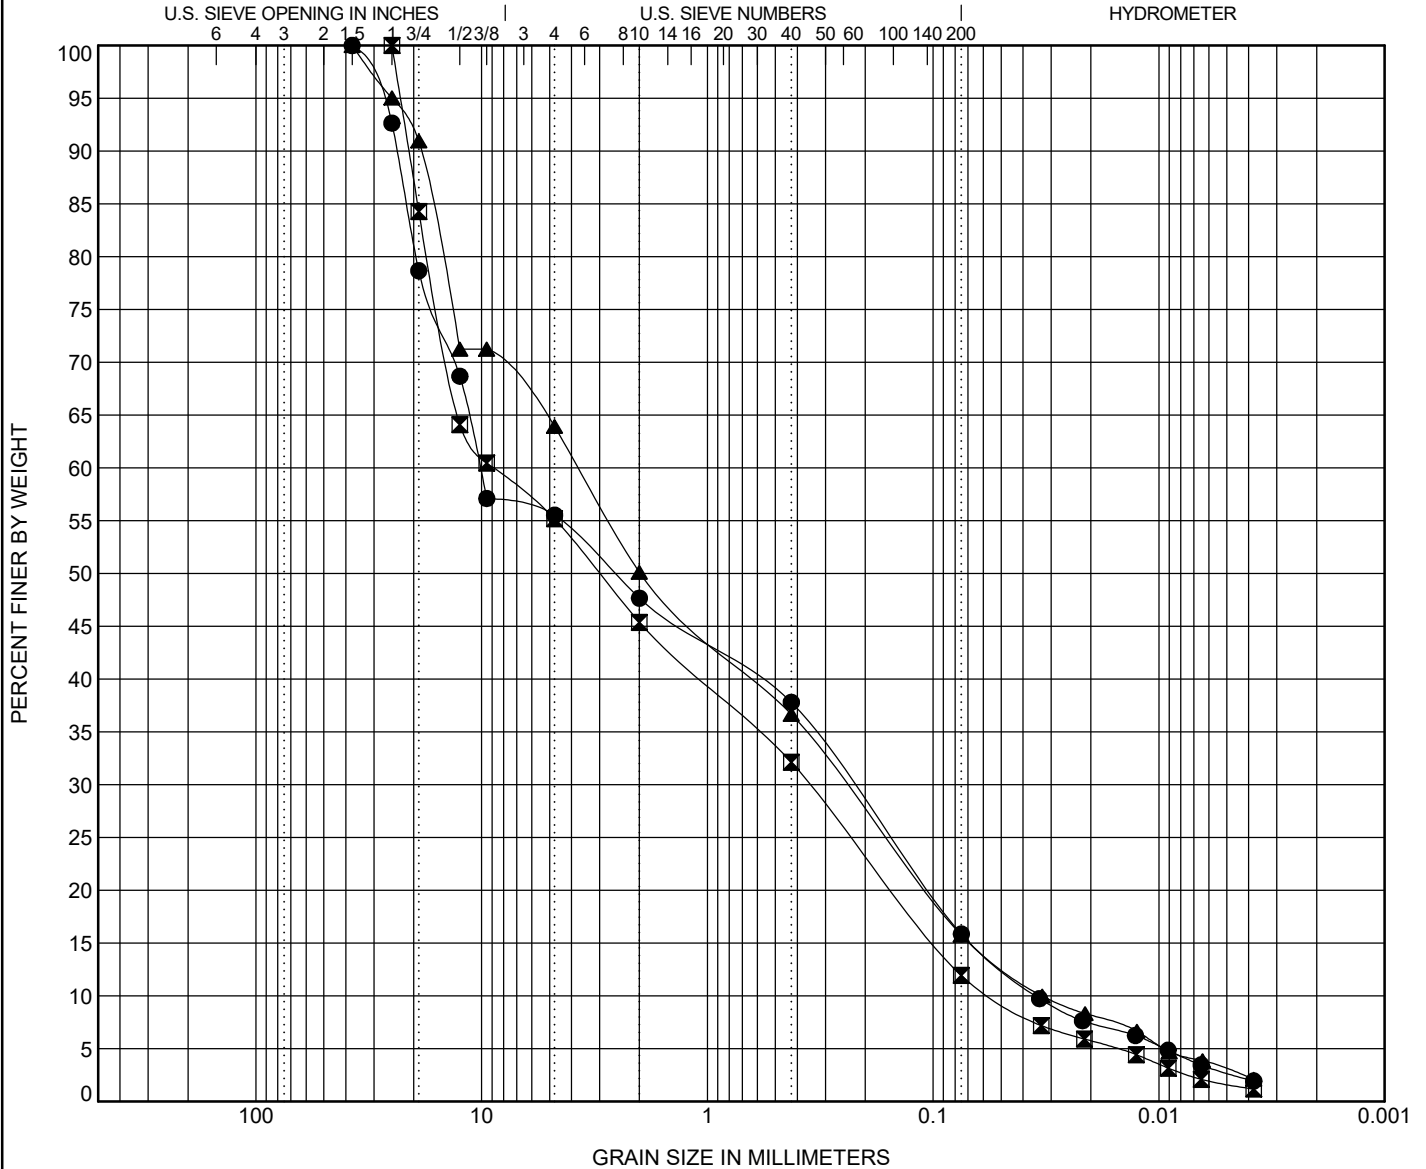
| Specimen Identification | | | ODOT (Modified AASHTO) ~ USCS Classification | | | | | | | | LL | PL | PI |
| ● | B-001-0-23 | 4.0 | A-1-b ~ SILTY GRAVEL with SAND(GM) | | | | | | | | NP | NP | NP |
| ☒ | B-001-0-23 | 6.5 | A-1-b ~ POORLY GRADED GRAVEL with SILT and SAND(GP-GM) | | | | | | | | NP | NP | NP |
| ▲ | B-001-0-23 | 11.5 | A-1-b ~ SILTY SAND with GRAVEL(SM) | | | | | | | | NP | NP | NP |
| Specimen Identification | | | D90 | D50 | D30 | D10 | %G | %CS | %FS | %M | %C | Cc | Cu |
| ● | B-001-0-23 | 4.0 | 23.736 | 2.586 | 0.229 | 0.035 | 52 | 10 | 22 | 13 | 3 | 0.15 | 290.84 |
| ☒ | B-001-0-23 | 6.5 | 20.997 | 3.009 | 0.354 | 0.054 | 55 | 13 | 20 | 10 | 2 | 0.26 | 166.48 |
| ▲ | B-001-0-23 | 11.5 | 18.62 | 1.977 | 0.245 | 0.033 | 50 | 13 | 21 | 13 | 3 | 0.49 | 112.76 |

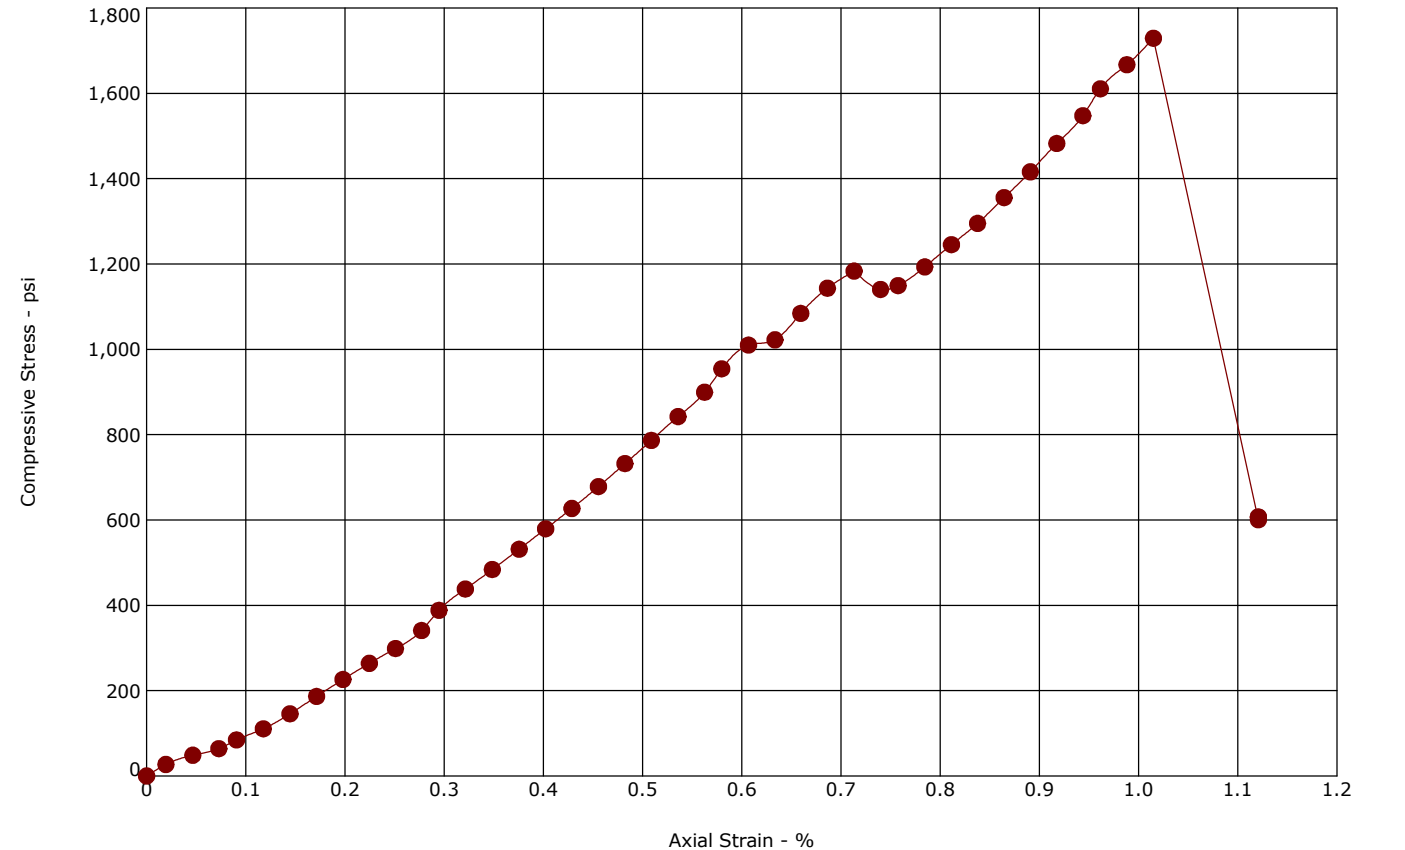
# Unconfined Compression Test

| Boring ID | Depth (Ft) | Sample type | LL | PL | PI | Fines (%) | Description |
| B-001-0-23 | 28.5 -28.8 | NQ2 | | | | | SHALE |

| Specimen Failure Mode | Specimen Test Data | |
| | Moisture Content (%): | 0.6 |
| | Failure Strain (%): | 1.01 |
