**Asbestos Survey of Bridges
1, 2, 3, 5, 7, 8, 9, 11 & 12
(Contract Document)**

**Innerbelt Bridge
Construction Contract Group 1 (CCG1)**

FINDINGS FROM AN ASBESTOS SURVEY

Eleven (11) Bridges Associated with the CUY-Innerbelt CCGI Design ODOT PID 77332

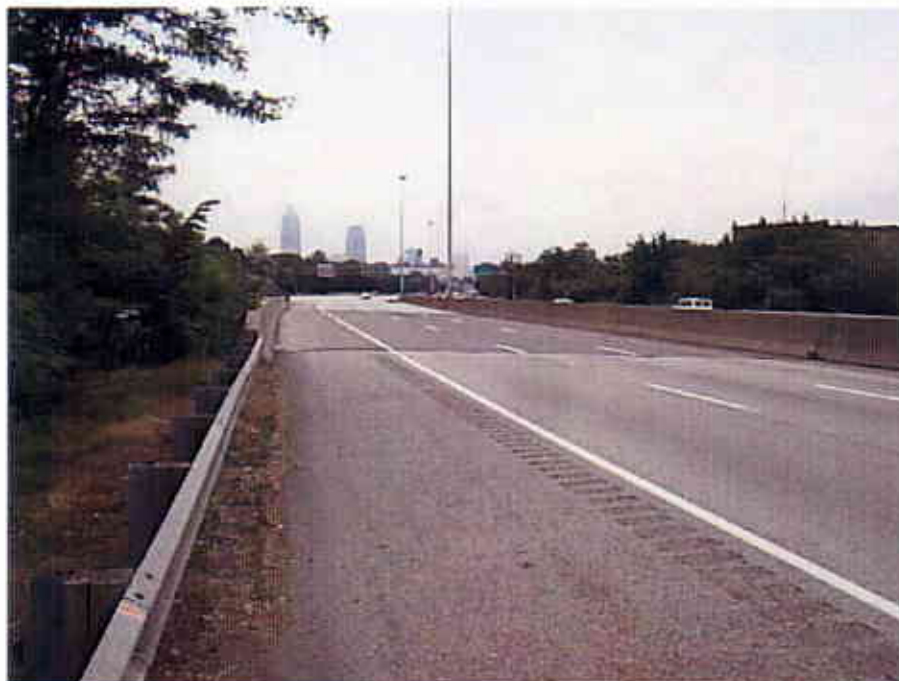
Photograph 41
View Looking North at the Top of the East Bound Lanes of the
Interstate 90 Bridge over Kenilworth Avenue (CUY-90-1506)

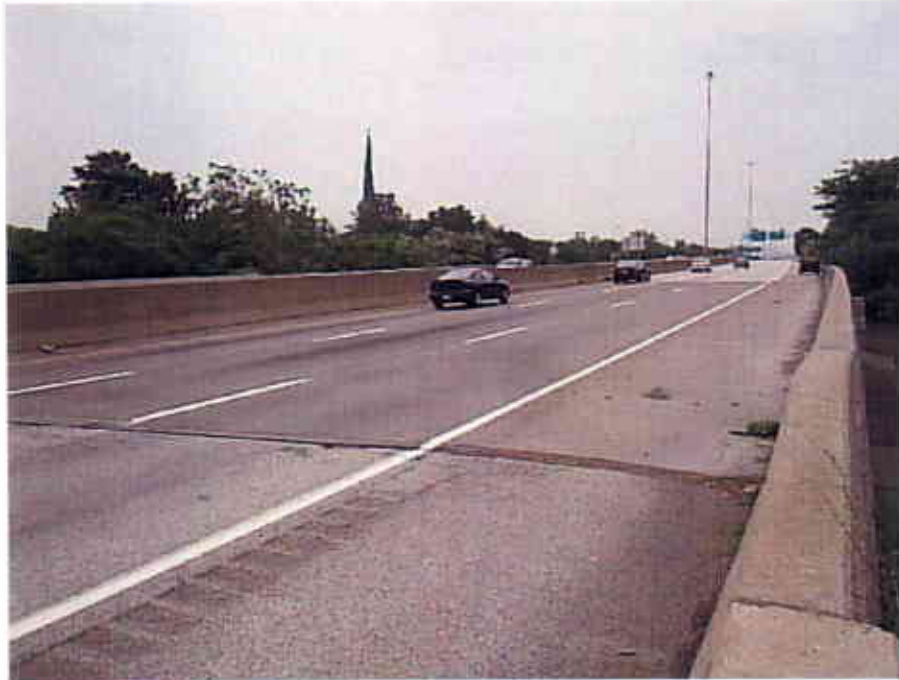
Photograph 42
View Looking North at the Top of the West Bound Lanes of the
Interstate 90 Bridge over Starkweather Avenue (CUY-90-1490L)

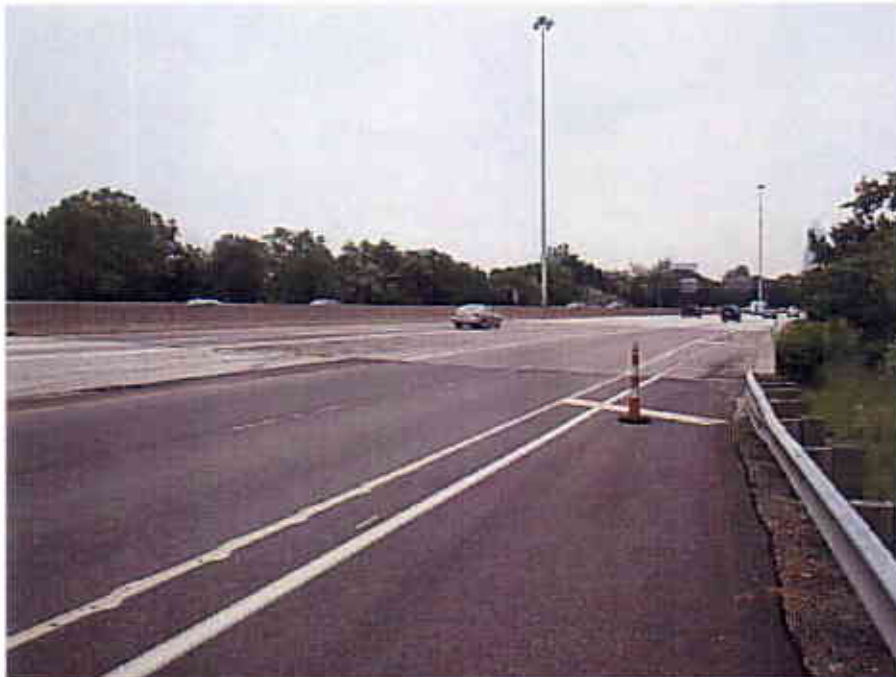
Photograph 45
View Looking South at the Top of the East Bound Lanes of the
Interstate 90 Bridge over Starkweather Avenue (CUY-90-1490R)

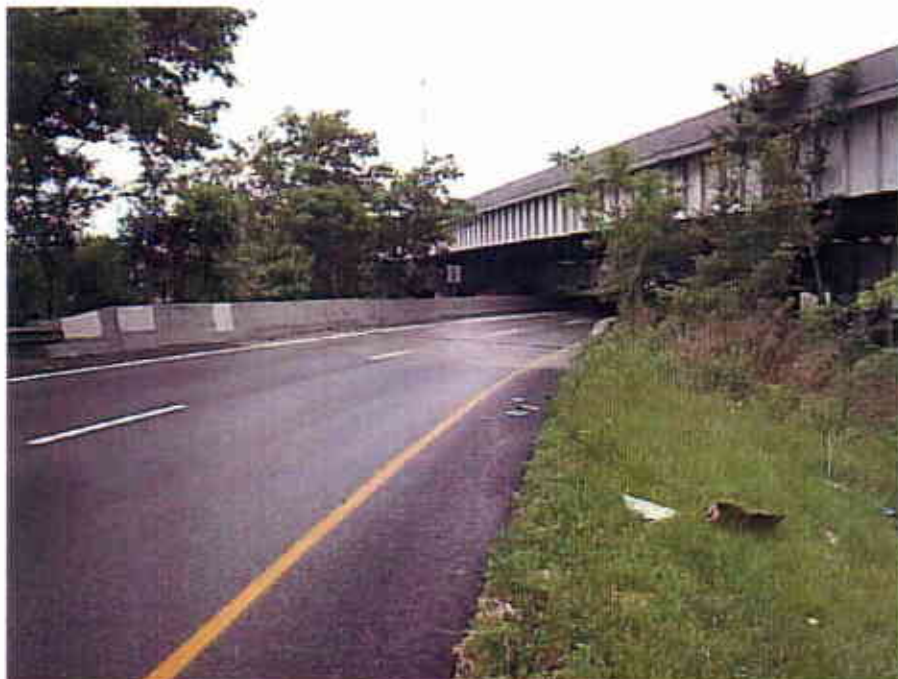
Photograph 47
View Looking South at the Underside of the East and West Bound Lanes of the
Interstate 90 Bridge over Starkweather Avenue (CUY-90-1490R)

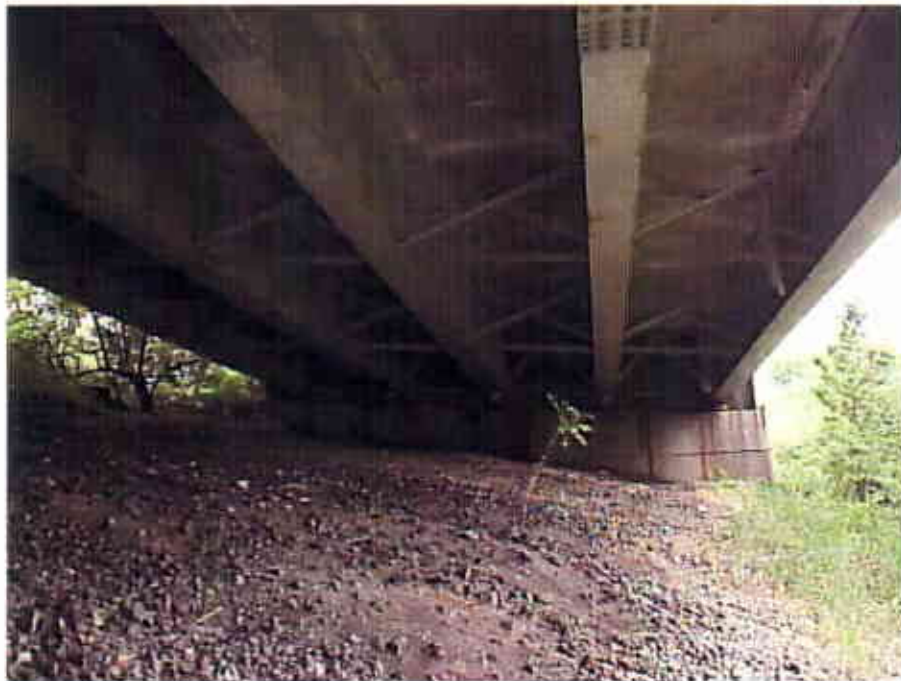
Photograph 49
View Looking North at the Underside of the East Bound Lanes of the
Interstate 90 Bridge Ramp WN under I-71 Mainline Bridge (CUY-90-1463R)

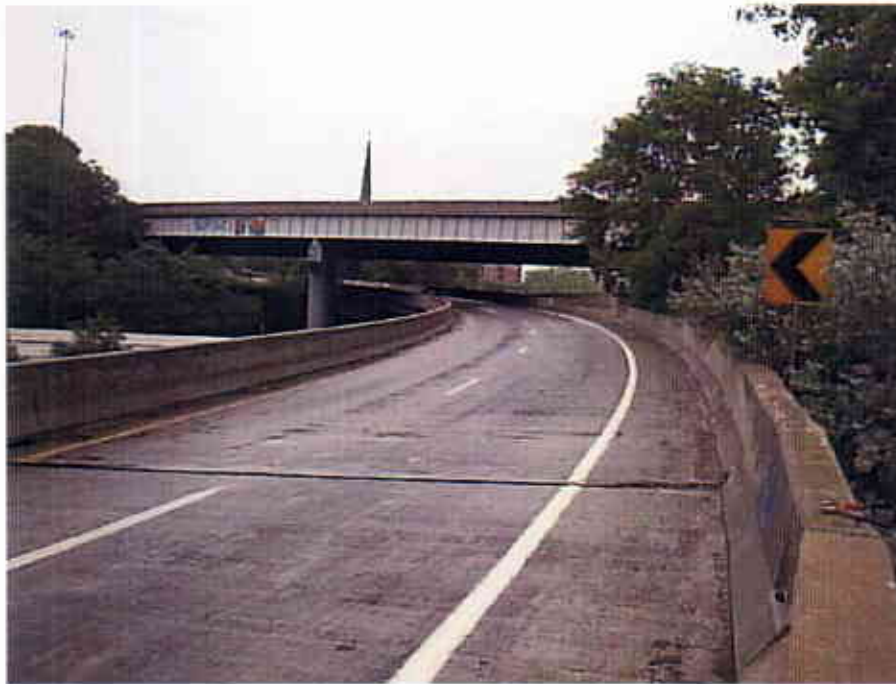
Photograph 50
View Looking West at the Underside of the East Bound Lanes of the
Interstate 90 Bridge Ramp WN under I-71 Mainline Bridge (CUY-90-1463R)
