SUE QUALITY LEVEL A TEST HOLE #2 TOLEDO, OHIO

Project: LUC 25 ANTHONY WAYNE TRAIL Date Performed: 10/12/2022 **Ohio Department of** SAM, LLC Project # 1022073581 Client: **Transportation** NATURAL GROUND **LUCAS COUNTY** Surface Material Project Location: 3223 ERAWA DR 588.65 **Utility Location:** Surface Elevation: Utility Sta./Offset: N/A Surface Condition: POOR ELECTRIC SOIL Record Utility: Trench Material: TOLEDO EDISON Utility Bedding Material: Utility Owner: N/A **Utility Found:** 2" HDPE Contact: N/A Phone/Email: N/A GOOD **Utility Condition:** JN/NB 0.96 **Utility Depth (Top):** Field Crew:

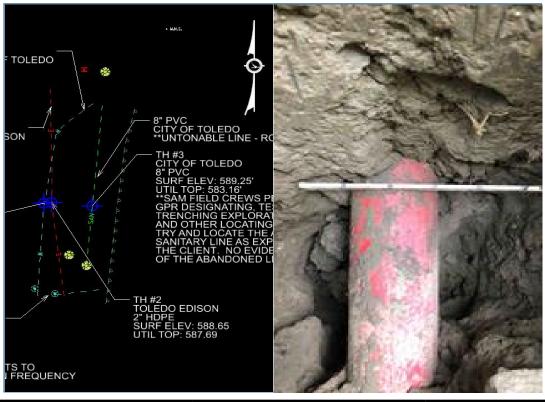
UTILITY CENTERLINE COORD.

NORTHING 709331.783
EASTING 1668716.206
TOP ELEV. 587.69

- 1.SAM, LLC laid out this Test Hole by designating the Electric line prior to hand digging the utility.
- 2. No other utilities were found during excavation
- 3. All excavation was preformed with VAC truck

- 4. The Test Hole was backfilled with Excavated Marerial.
- 5. Location and elevation determined by satellite observations utilizing ODOT VRS.
- 6. Direct measure to top of pipe utilizing ODOT VRS.
