SUE QUALITY LEVEL A
ABANDONED SANITARY
EXPLORATION
TOLEDO, OHIO

Project:	LUC 25 ANTHONY WAYNE TRAIL	Date Performed:	10/12/2022
SAM, LLC Project #	1022073581	Client:	Ohio Department of Transportation
Project Location:	LUCAS COUNTY	Surface Material	NATURAL GROUND
Utility Location:	3223 ERAWA DR	Surface Elevation:	N/A
Utility Sta./Offset:	N/A	Surface Condition:	POOR
Record Utility:	ABANDONED SANITARY	Trench Material:	SOIL
Utility Owner:	CITY OF TOLEDO	Utility Bedding Material:	N/A
Contact:	N/A	Utility Found:	N/A
Phone/Email:	N/A	Utility Condition:	N/A
Field Crew:	JN/NB	Utility Depth (Top):	N/A

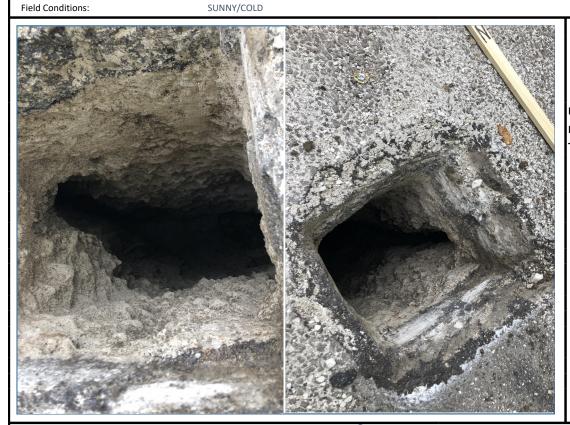
1.SAM field crews performed GPR designating, test hole trenching exploration, probing, and other locating methods to try and locate the abandoned sanitary line as explained by the client. No evidence was found of the abandoned line.

- 2. No other utilities were found during excavation
- 3. All excavation was preformed with VAC truck
- 4. The Test Hole was backfilled with Excavated Marerial.
- 5. Location and elevation determined by satellite observations utilizing ODOT VRS.
