O.D.O.T. DISTRICT 2 SURVEY OFFICE (USE ONLY)

REFERENCE NO. 23

ROUTE SR 2

COUNTY FULTON

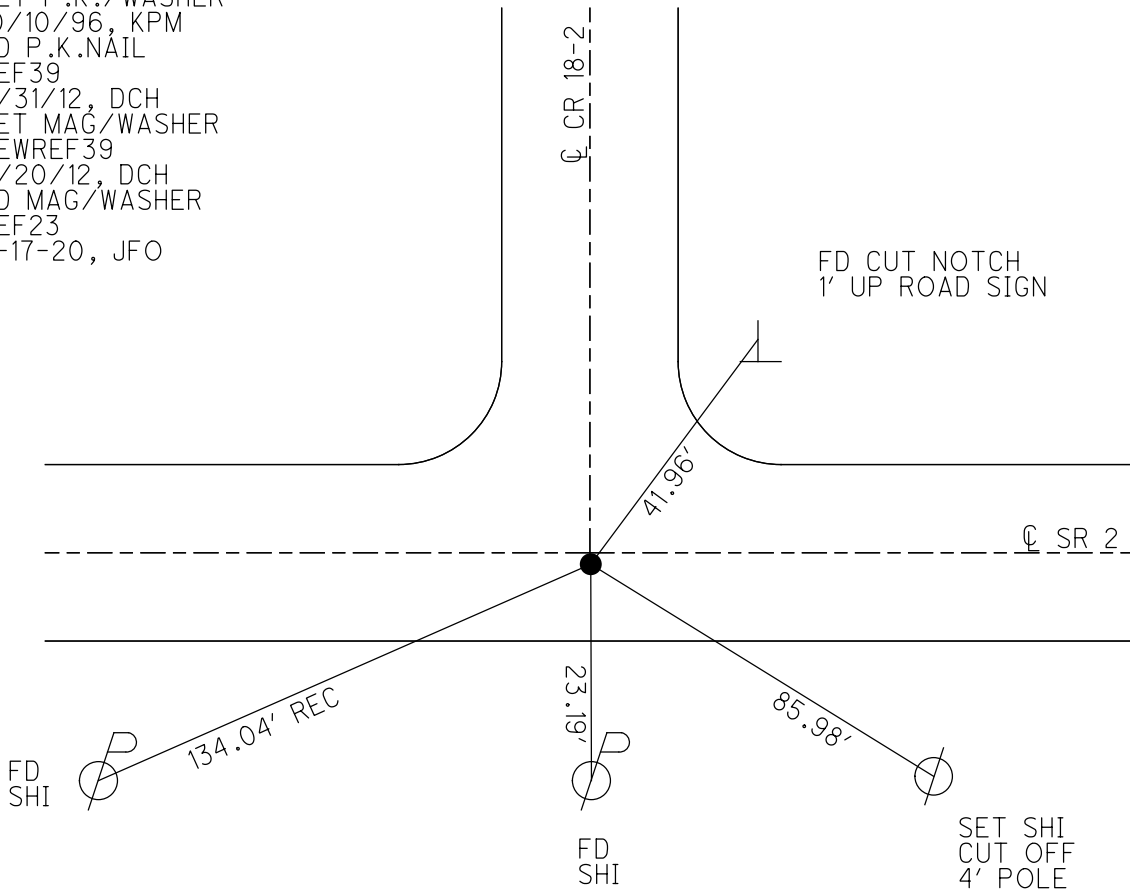
SHEET 2 OF 15

TYPE MONUMENT P.K.NAIL

ON SURFACE - ~~BELOW~~ ON

OFFSET 0.8' RT

10.4' TO RT EDGE PAVEMENT

STATION: 519+29.84

RECORD:  
 SET P.K./WASHER  
 10/10/96, KPM  
 FD P.K.NAIL  
 REF39  
 5/31/12, DCH  
 SET MAG/WASHER  
 NEWREF39  
 9/20/12, DCH  
 FD MAG/WASHER  
 REF23  
 7-17-20, JFO

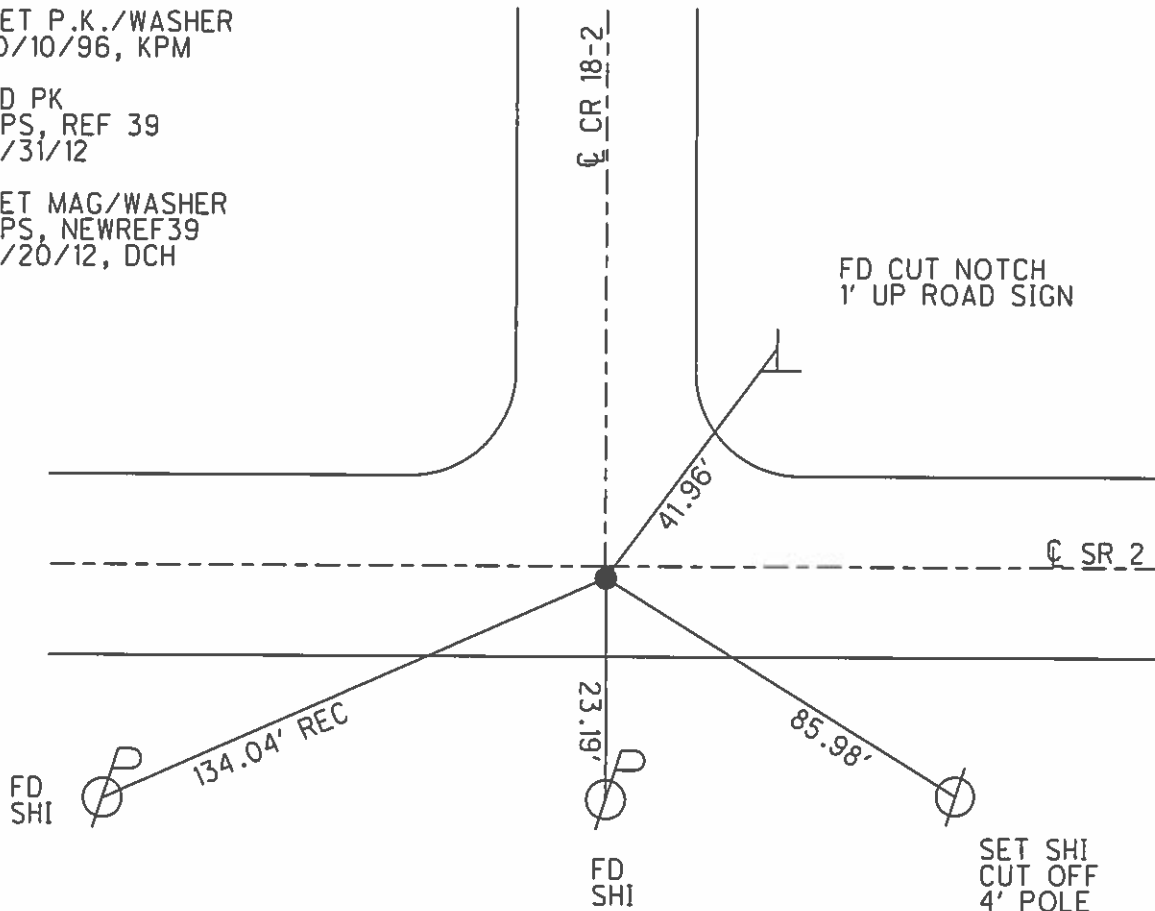
PERSONNEL \_\_\_\_\_ REFERENCE NO. 23 SHEET 2 OF 15

TYPE MONUMENT P.K.NAIL  
 ON SURFACE - ~~BELOW~~ ON  
~~LEFT~~ - ☉ PAV'T - RIGHT 0.8'  
10.4' TO RT EDGE PAVEMENT  
 S.L.M. 519+29.84

Grid: Northing: 688459.4795 Easting: 1497411.143

SET P.K./WASHER  
 10/10/96, KPM

FD PK  
 GPS, REF 39  
 5/31/12

SET MAG/WASHER  
 GPS, NEWREF39  
 9/20/12, DCH

FD CUT NOTCH  
 1' UP ROAD SIGN

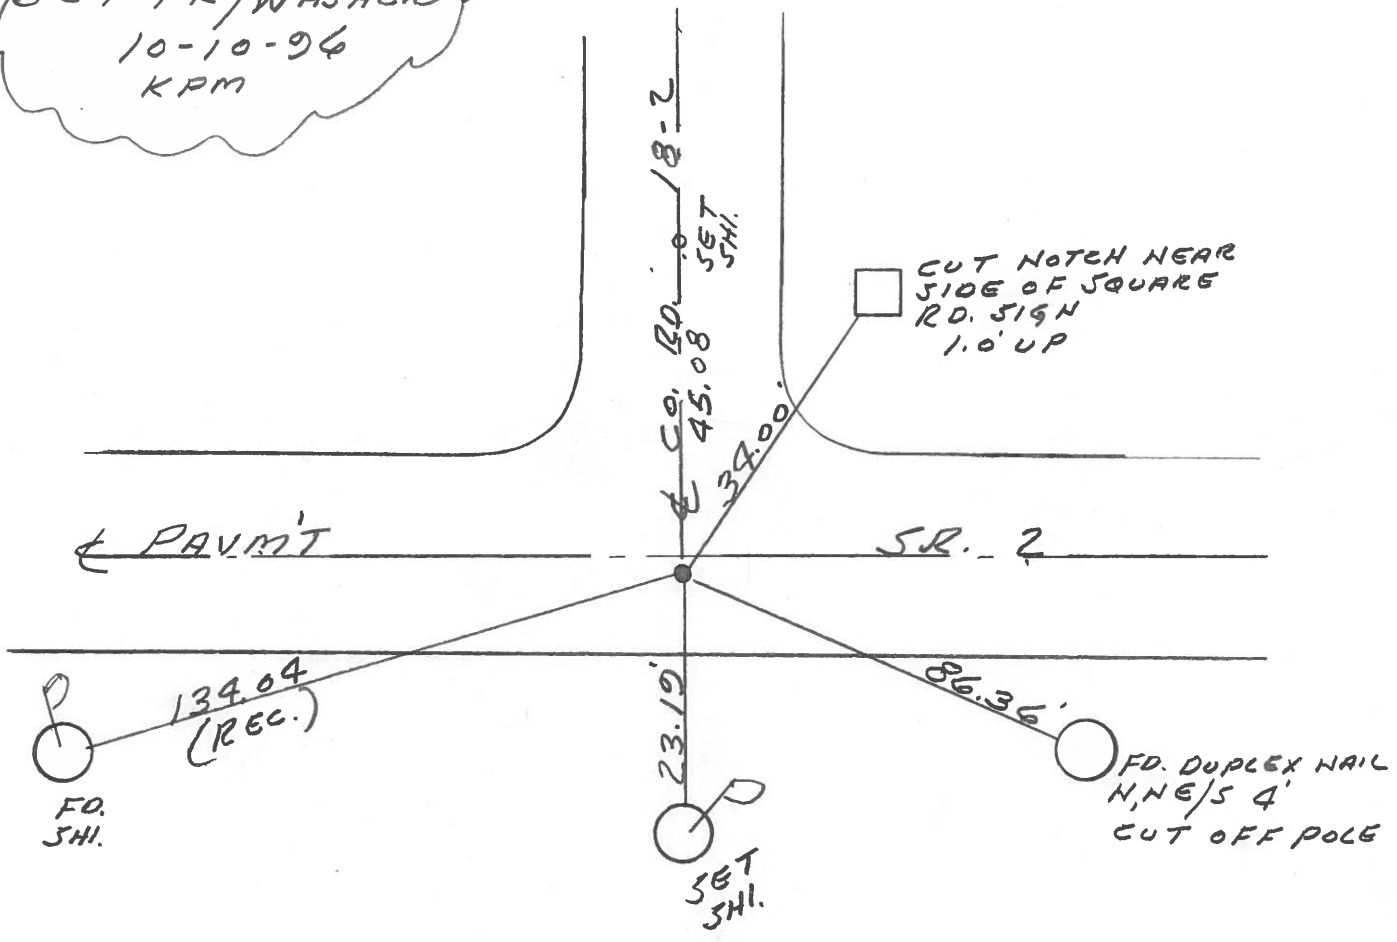
SHEET 1 OF 14

TYPE MONUMENT PK NAIL

ON SURFACE - BELOW YES

LEFT - & PAV'T. - RIGHT 0.8' ON E N.

10.4 TO RT. EDGE PAVEMENT

S.L.M. 518+21

SET PK/WASHER  
10-10-96  
KPM

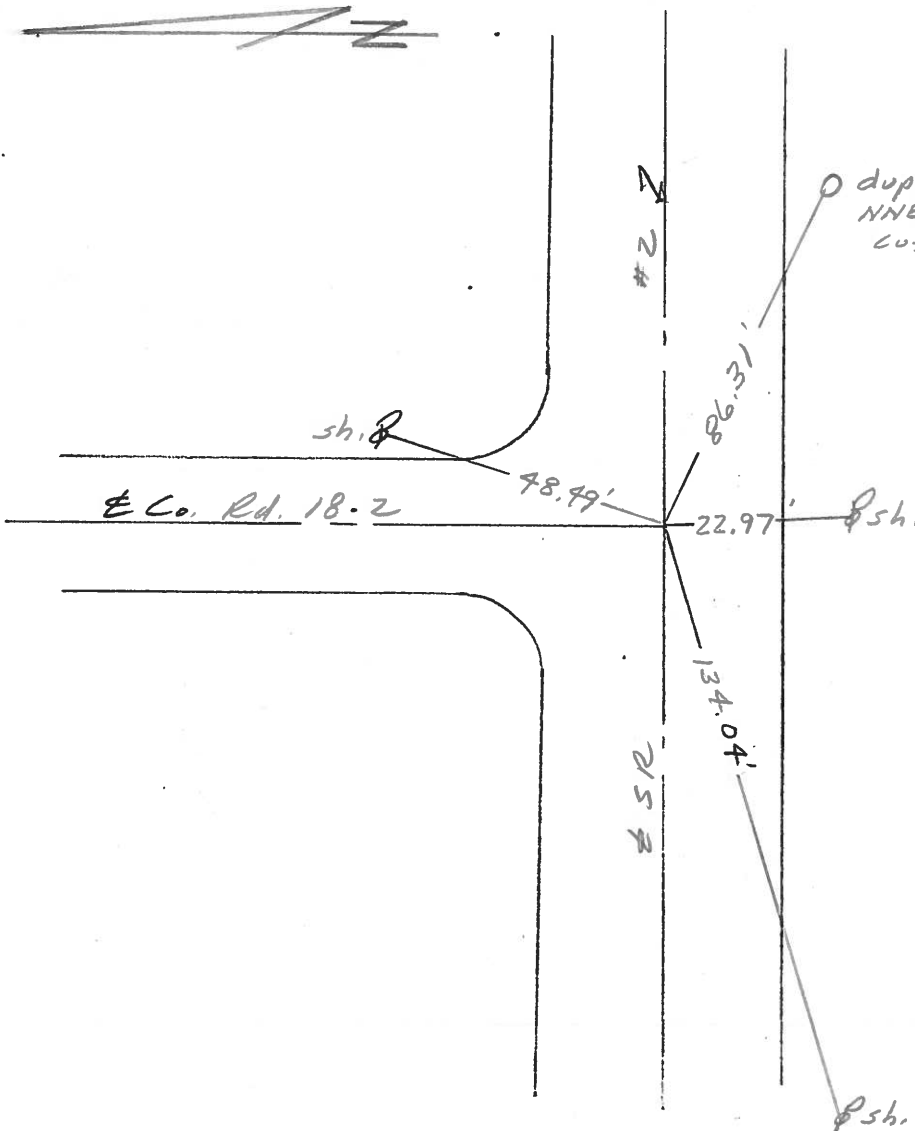
REFERENCE NO. 23 SHEET 1 OF

TYPE MONUMENT PK Nail

ON SURFACE - BELOW Surface

S.L.M. 520+36

OK 5/30/89 IRS

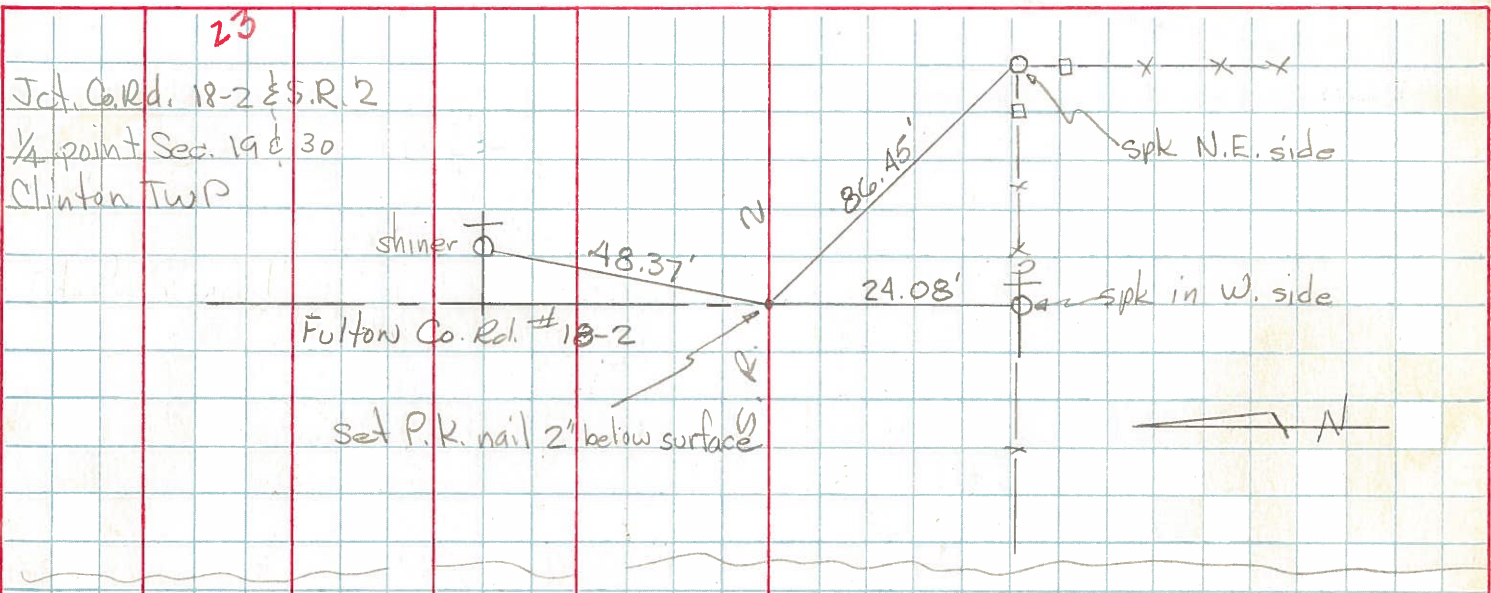
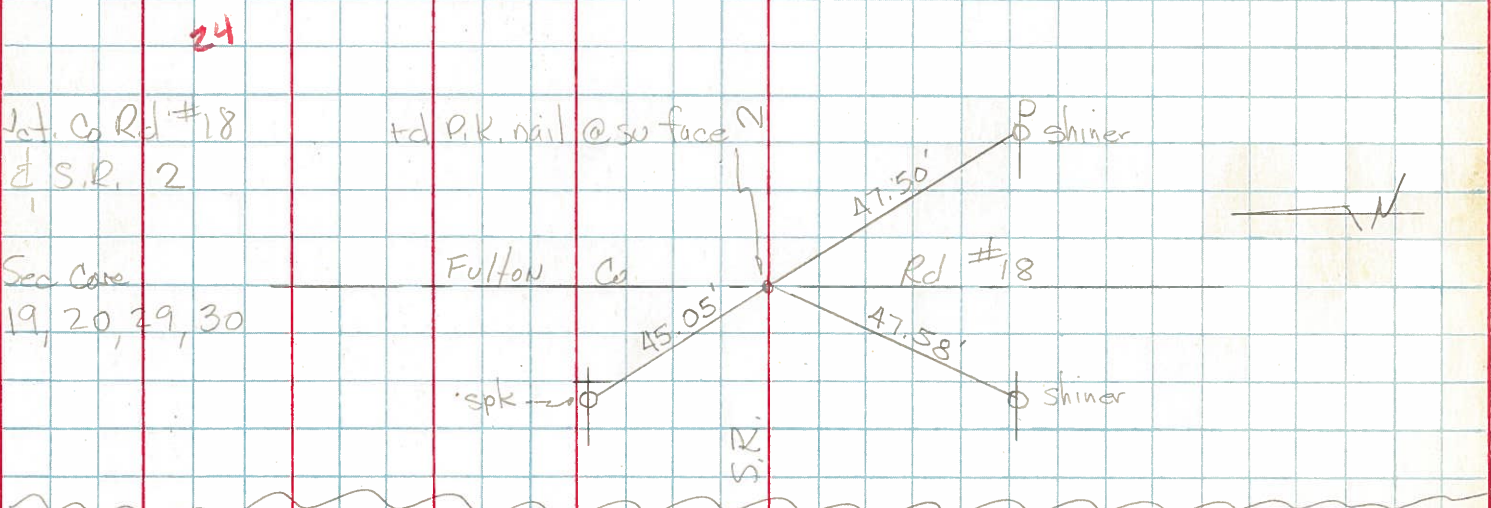
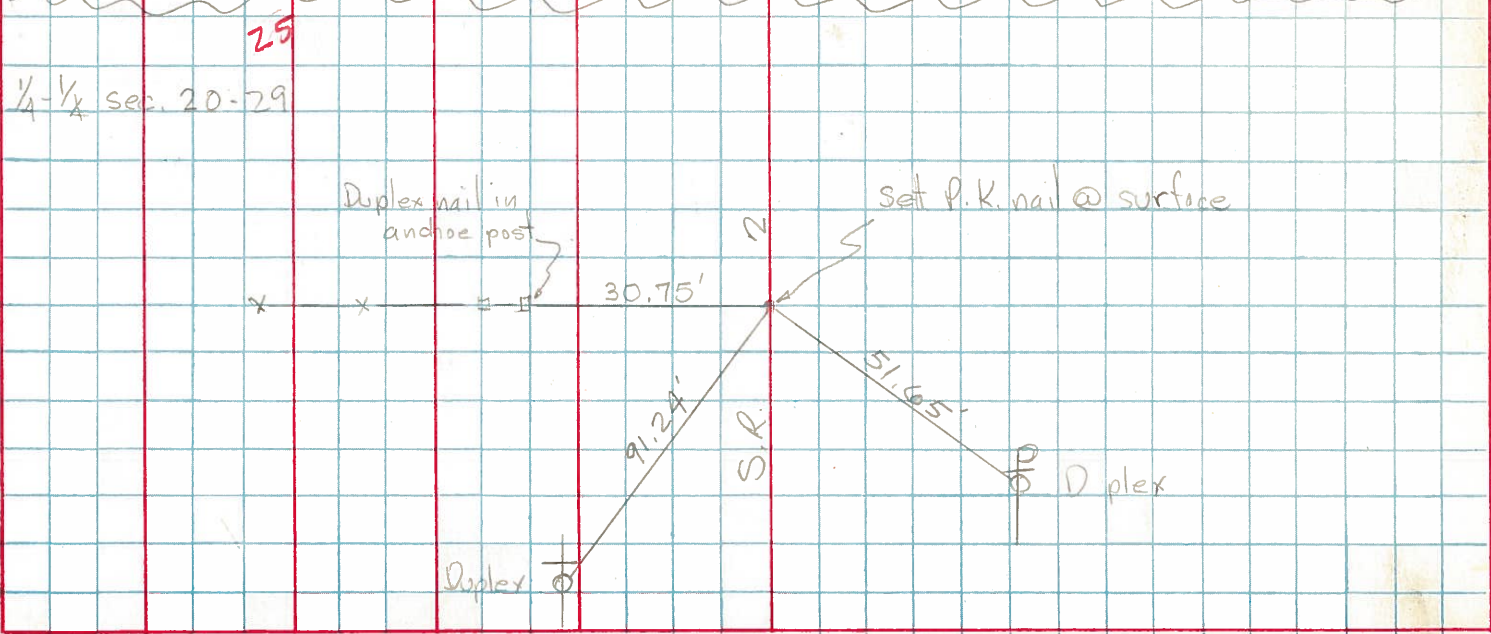
23

PERSONNEL TITLE PERSONNEL TITLE COUNTY Fu DATE 5-3-67  
 Recall Miso S. R. # 2 WEATHER Fair  
 Frikson Recorder SEC. SR#66 to Mausport TEMP. 50°  
 DESCRIPTION Witnesses to Control Points LEFT CENTER LINE RIGHT JOB NO.

Co Rd # 36  
 TWP lines  
 German & Clinton  
 Found Pk. in lead pipe in  
 Core Part (German TWP)  
 Found Pk (Clinton TWP) sp. & spike SW.  
 Ties Checked 5-3-67 JFE

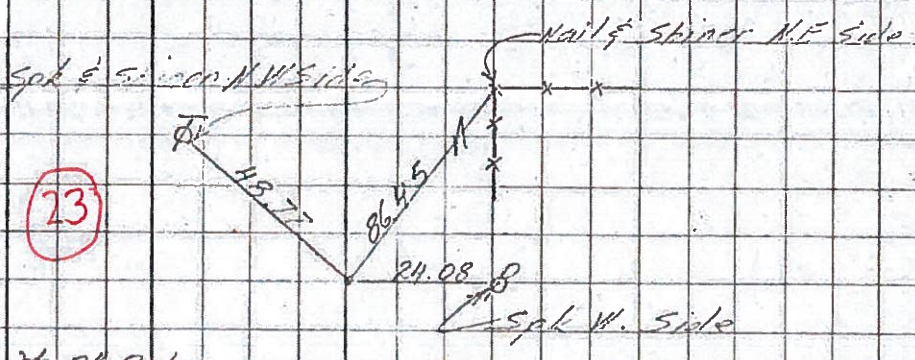
Co Rd # 83 N.  
 1/4 Cor. Sec 19-30  
 Lead pipe in Core Part 3" B. level  
 Checked 5-3-67 JFE

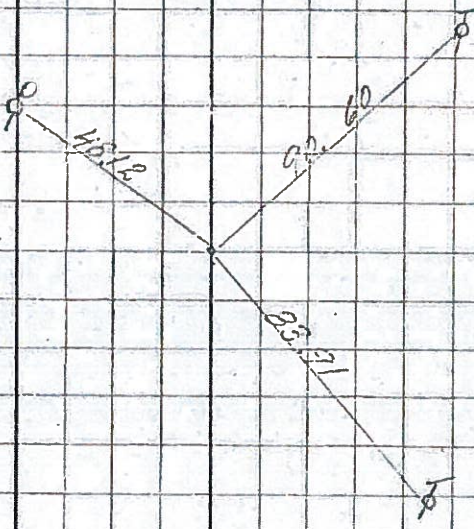
21-A

1/4 NW 1/4 Co Rd # 35  
 1/4 Cor. Sec 24-25  
 Lead pipe in Core Part 3" Below  
 Checked 5-4-67 JFE

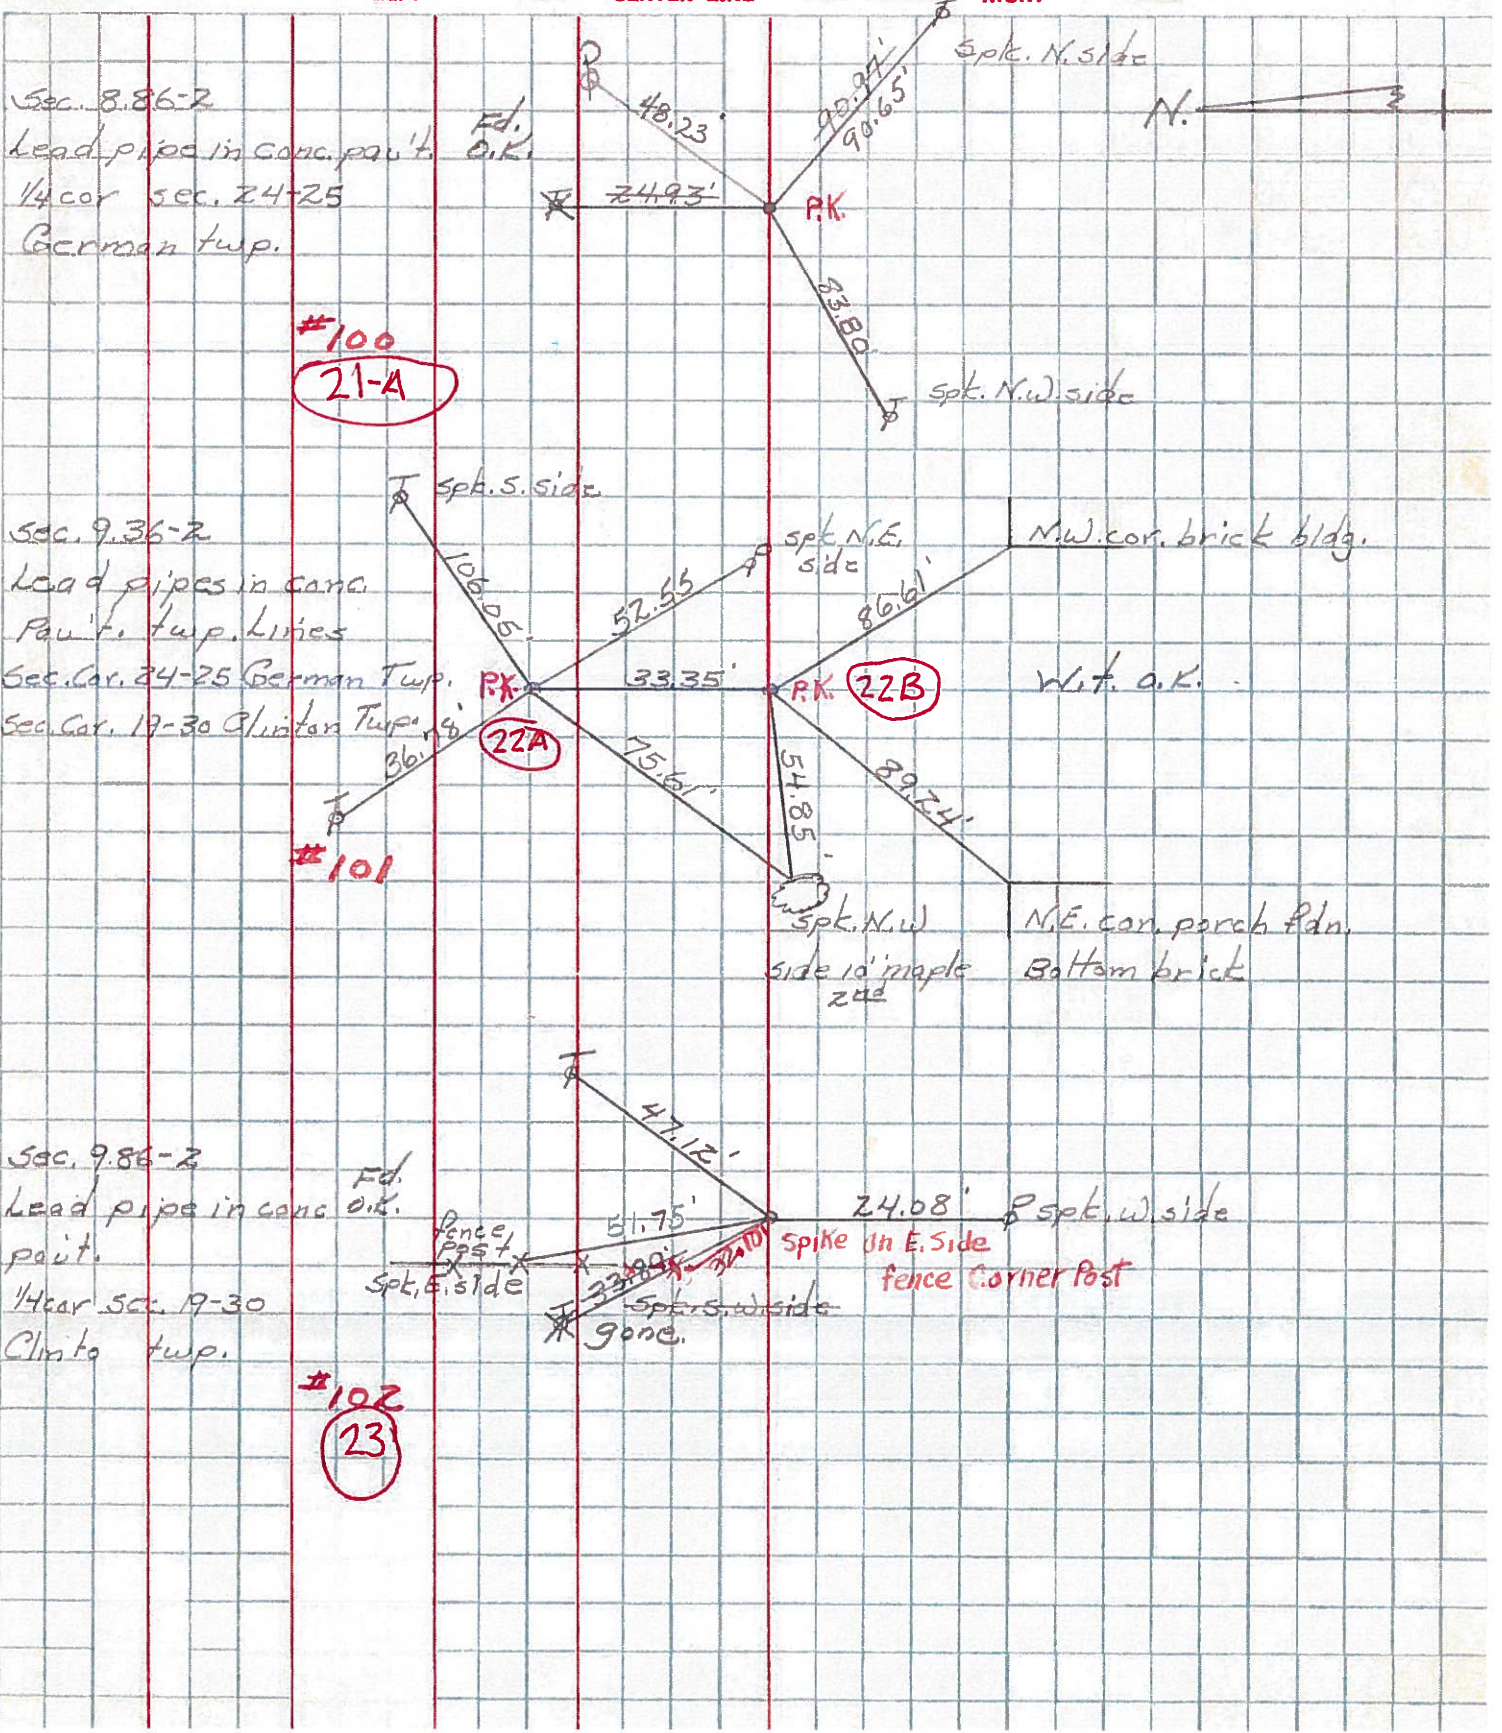
Sec. 8.86-2  
Lead pipe in conc. fault  
1/4 cor sec. 24-25  
German twp.

Sec. 9.36-2  
Lead pipes in conc.  
Fault. twp. lines  
Sec. Cor. 24-25 German Twp.  
Sec. Cor. 19-30 Clinton Twp.

Sec. 9.86-2  
Lead pipe in conc  
fault.  
1/4 cor sec. 19-30  
Clinto twp.

X  
gone.
