O.D.O.T. DISTRICT 2 SURVEY OFFICE (USE ONLY)

PERSONNEL _____ REFERENCE NO. 20 SHEET 33 OF 38
 NOTES LEU DATE 4/18/17 ROUTE US 20
 H.C. HOMAN WEATHER SUNNY COUNTY FULTON
 R.C. LEU TEMP. 55°F TOWNSHIP GORHAM
 _____ SECTION 24
 _____ T9s R1E

RECORD: P.T.
 SET P.K.NAIL
 1934 STA 193+57.69
 SLM STA 494+01.45
 FD P.K.NAIL
 5-8-98, SAH
 SET P.K./WASHER
 11-16-98, SAH
 SET MAG/WASHER
 8-16-2017, DCH

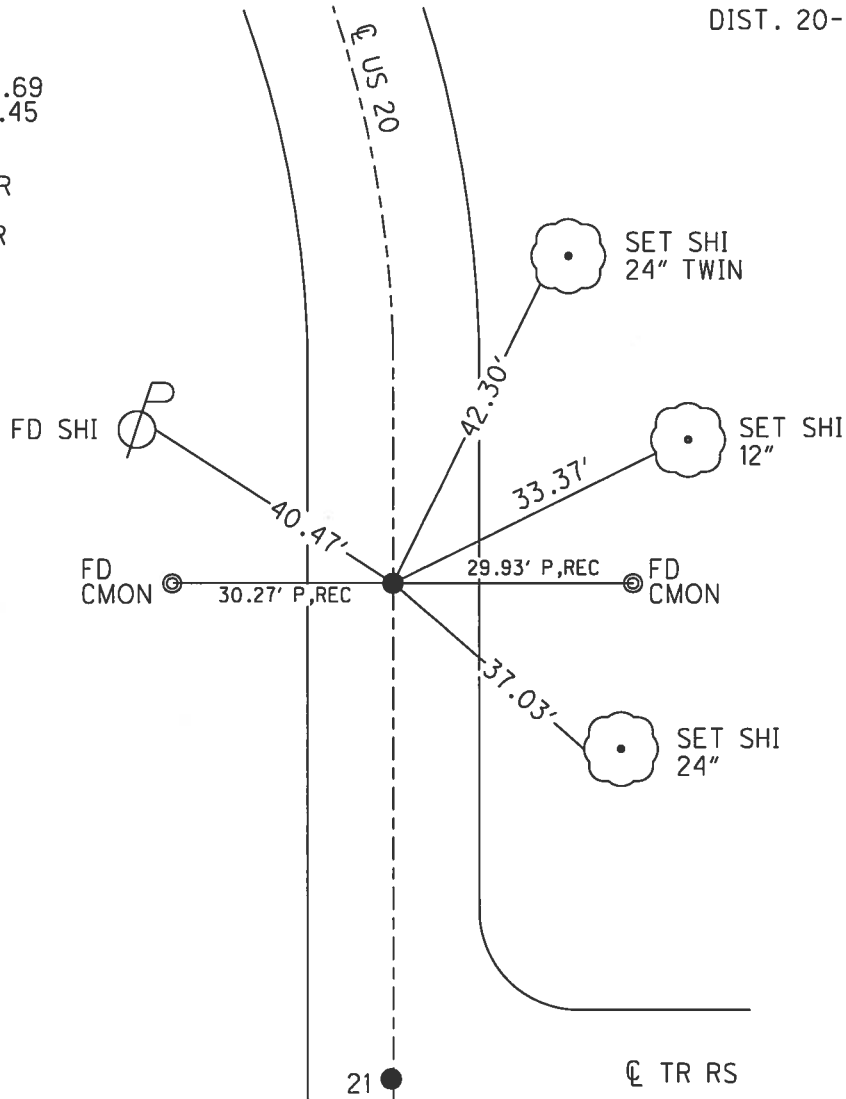
TYPE MONUMENT P.K.NAIL
 ON SURFACE - ~~BELOW~~ ON
 LEFT - ☉ PAV'T - ~~RIGHT~~ 0.8'
11.3 TO LT EDGE PAVEMENT
 S.L.M. 494+00

Grid: Northing: 736559.353 Easting: 1495902.819

DIST. 20-21= 197.14'

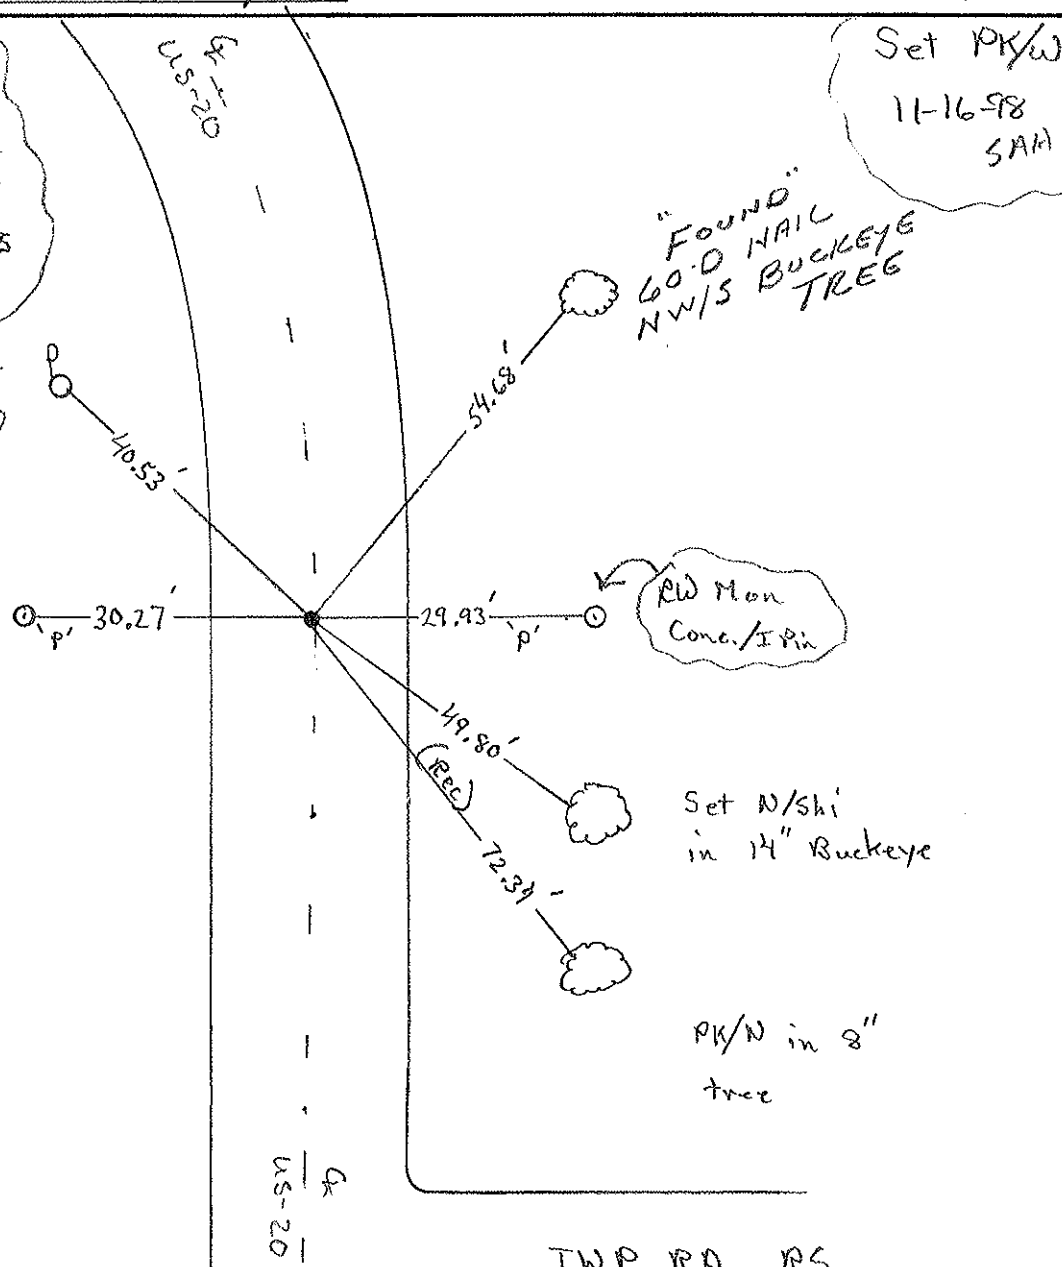
TYPE MONUMENT PK NAIL

ON SURFACE ~~BELOW~~ YES

LEFT - € PAW T. - RIGHT 0.8' Lt of 9

11.3 TO Lt. EDGE PAVEMENT

S.L.M. 15 + 057.2 SLK / 494 + 00 SLM

Set PK N as per
old Refs - PT Curve
1934 Sta 193+57.69
SLM Sta 494+61.45
11.2' to W.EOP
10.1' to E.EOP

Set N/shi
in P/A

R/W Mon
Conc./I Pin

"FOUND"
60.0 NAIL
NW/S BUCKEYE
TREE

Set N/shi
in 14" Buckeye

PK/N in 8"
tree

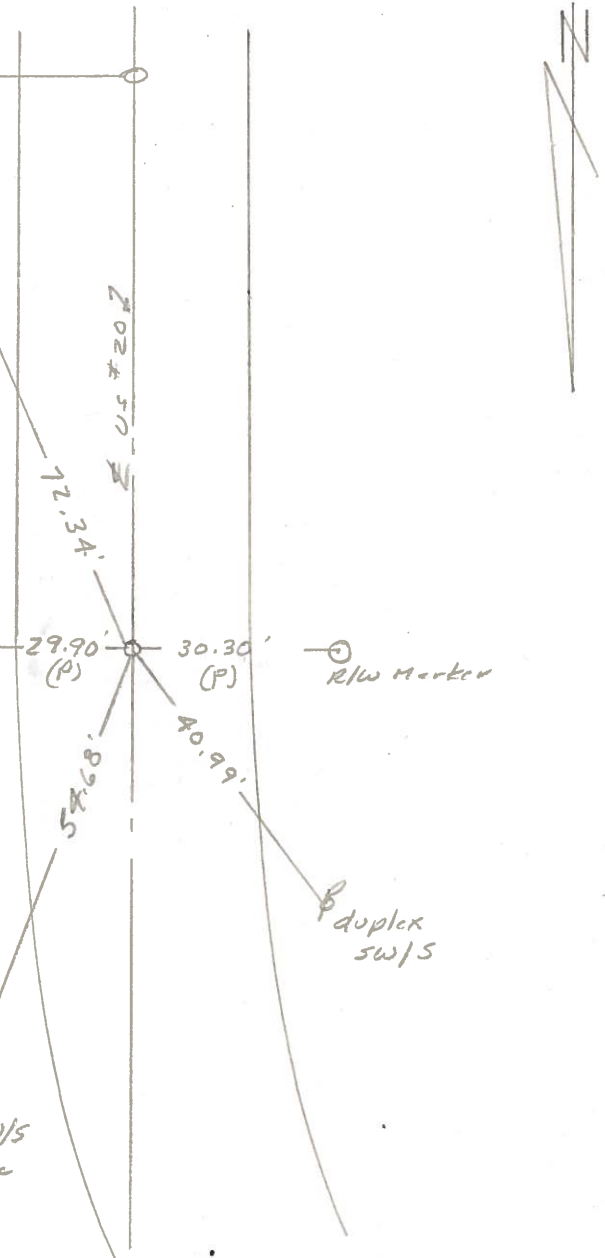
SET PK 10-17-84

pk Nail & shi.
14' 8" Tice

29.90' (P) 30.30' (P)
R/W Moni R/W Marker

Set PK Nail as per old refs.
P.T. Curve 1934 Sta. 193+57.69
SLM Sta. 494+01.45
11.2' To W. edge put
10.1' To E. edge put.

60d nail NW/S
18" Bockeye

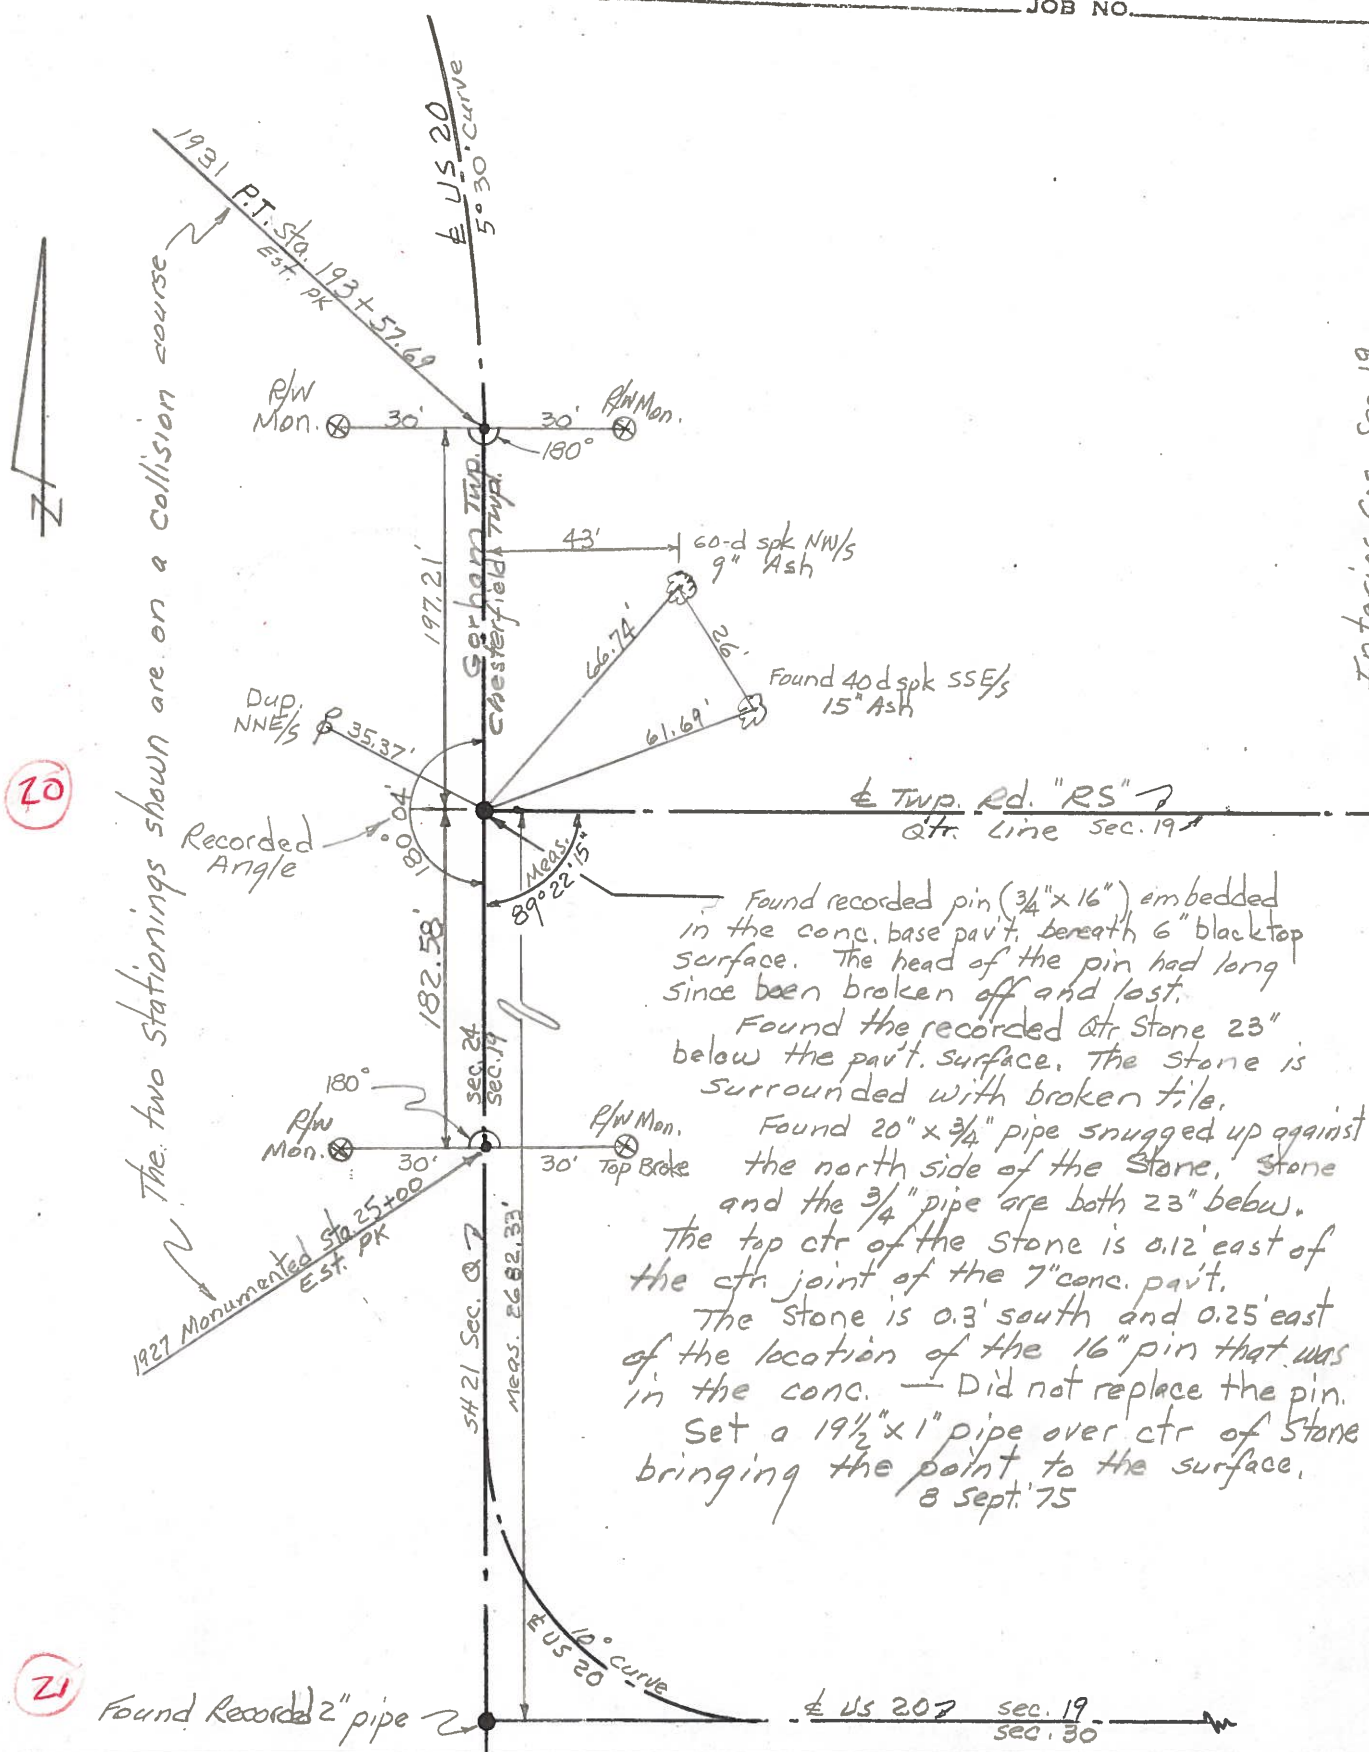
The two stationings shown are on a collision course

Found recorded pin (3/4" x 16") embedded in the conc. base pav't. beneath 6" blacktop surface. The head of the pin had long since been broken off and lost.

Found the recorded Qtr Stone 23" below the pav't. surface. The stone is surrounded with broken tile.

Found 20" x 3/4" pipe snugged up against the north side of the Stone. Stone and the 3/4" pipe are both 23" below the top ctr of the Stone is 0.12' east of the ctr joint of the 7" conc. pav't.

The stone is 0.3' south and 0.25' east of the location of the 16" pin that was in the conc. — Did not replace the pin.

Set a 1 1/2" x 1" pipe over ctr of Stone bringing the point to the surface.

Found Recorded 2" pipe

Interior Cor. Sec. 19
