O.D.O.T. DISTRICT 2 SURVEY OFFICE (USE ONLY)

PERSONNEL _____ REFERENCE NO. 2 SHEET 5 OF 10
 NOTES LOEHRKE DATE 5/22/97 ROUTE US 127
 H.C. HUSS WEATHER NICE COUNTY FULTON
 R.C. COX TEMP. 62° TOWNSHIP GORHAM
 SECTION 18
 DWG BY NIESE PID _____ T 9 N R 1 E

STATION: 180+69

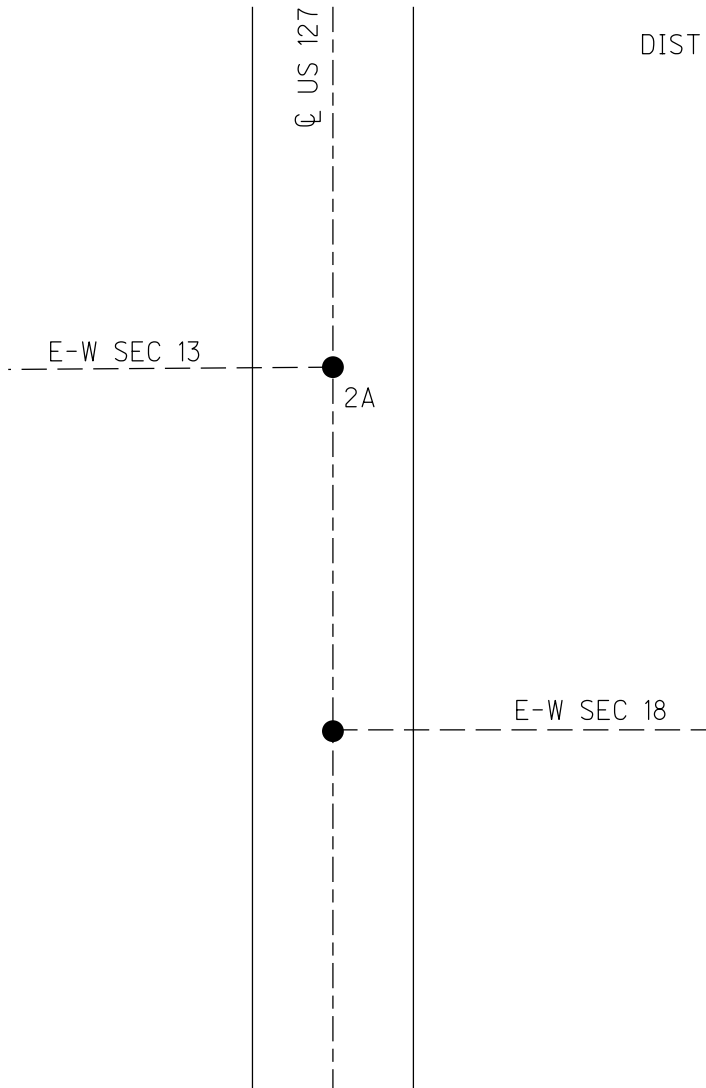
TYPE MONUMENT SM.R.R. SPIKE

~~ON SURFACE~~ - BELOW 2"

OFFSET \odot PAVEMENT 0.3' \pm : RT

11.5' TO RT EDGE PAVEMENT

RECORD:
 STA 180+08
 FD SM R.R.SPIKE
 3" DOWN
 1985
 FD SM R.R.SPIKE
 2" DOWN
 5/22/97, CL
 SET SM R.R.SPIKE
 7/2/97, CL

DIST. 2-2B= 127.85'

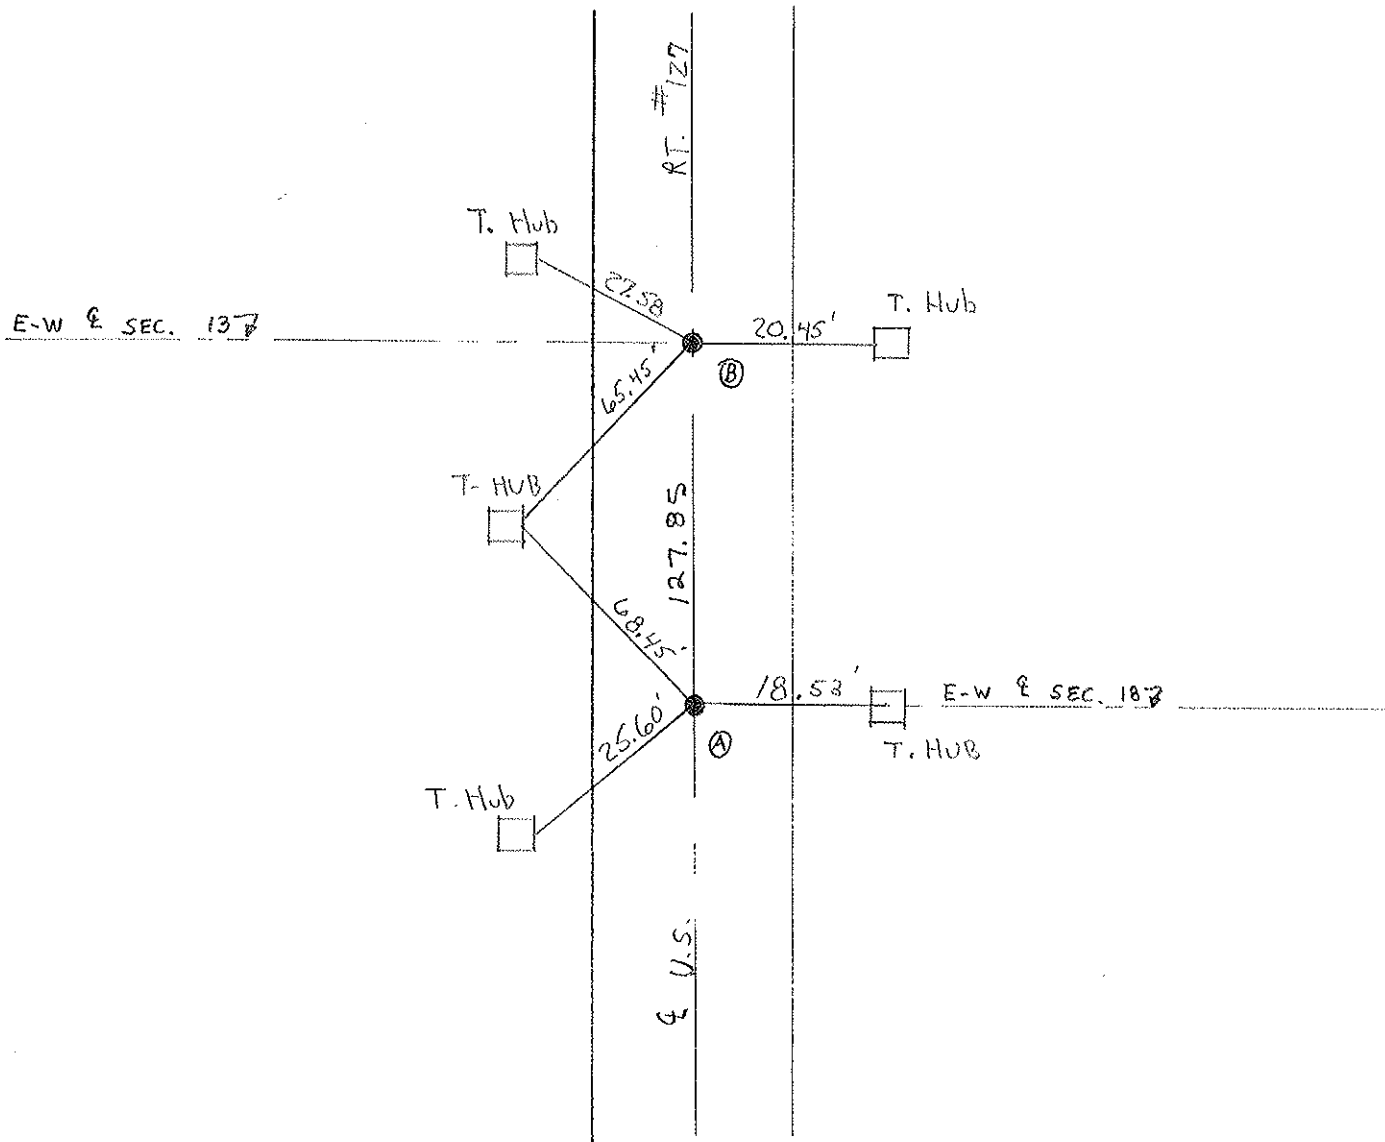
S.L.M. 180+69 181+97

TYPE MONUMENT SMALL RR. SPKS.

ON SURFACE - BELOW 2"

LEFT - 0 PAV'T. - RIGHT 0.3

11.5' TO R+ EDGE PAVEMENT

RECORD: SLM = 180+08 @ 181+36 @
 FO. SM. RR. SPKS. 3" DEEP - 1985

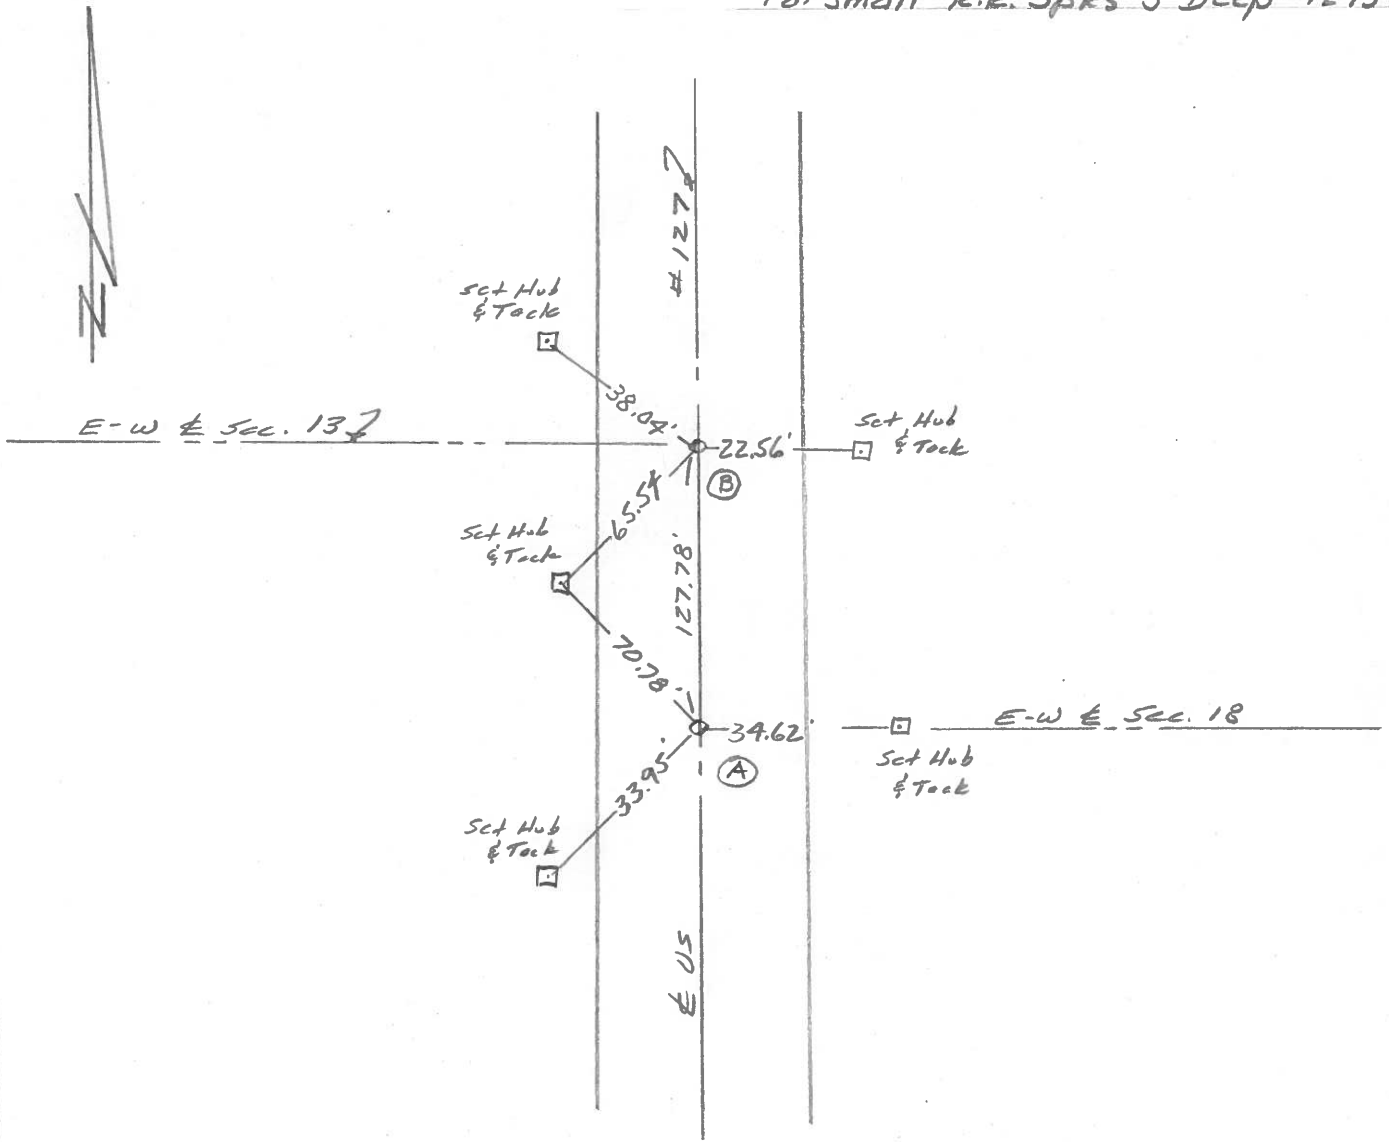
S.L.M. \textcircled{A} = 180+08, \textcircled{B} = 181+36

TYPE MONUMENT Small RR Spks

ON SURFACE - BELOW Surface

Fd. Small R.R. Spks 3" Deep - 12-13-85

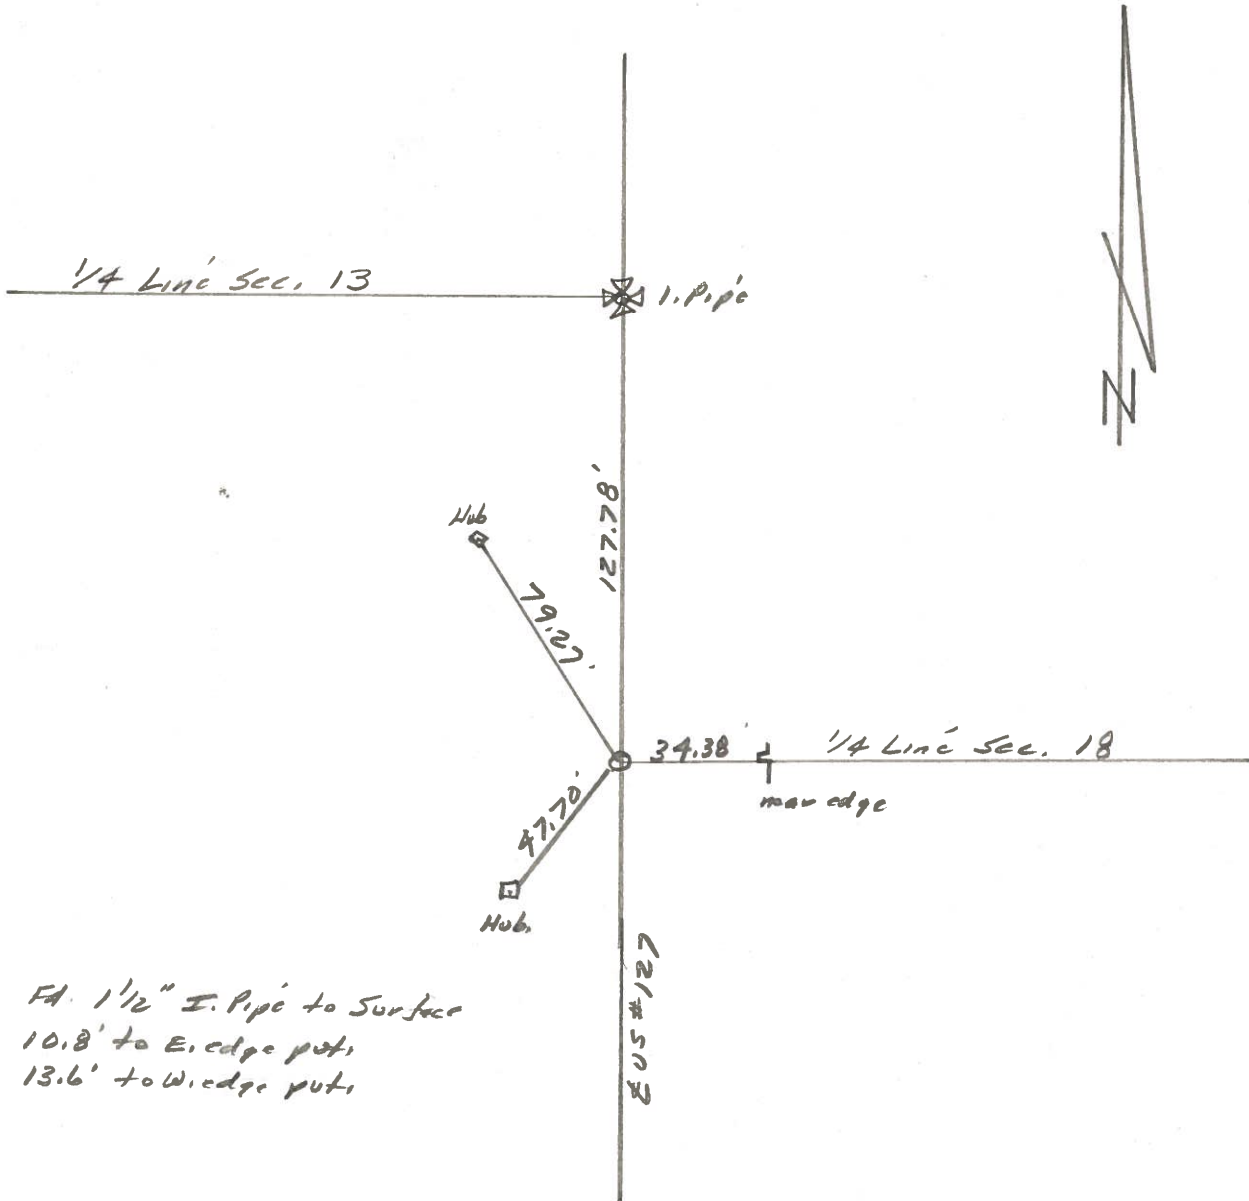
SLM BLKTON STA. 177+78

FA. 1 1/2" I. Pipe to Surface
10.8' to E. edge put,
13.6' to W. edge put

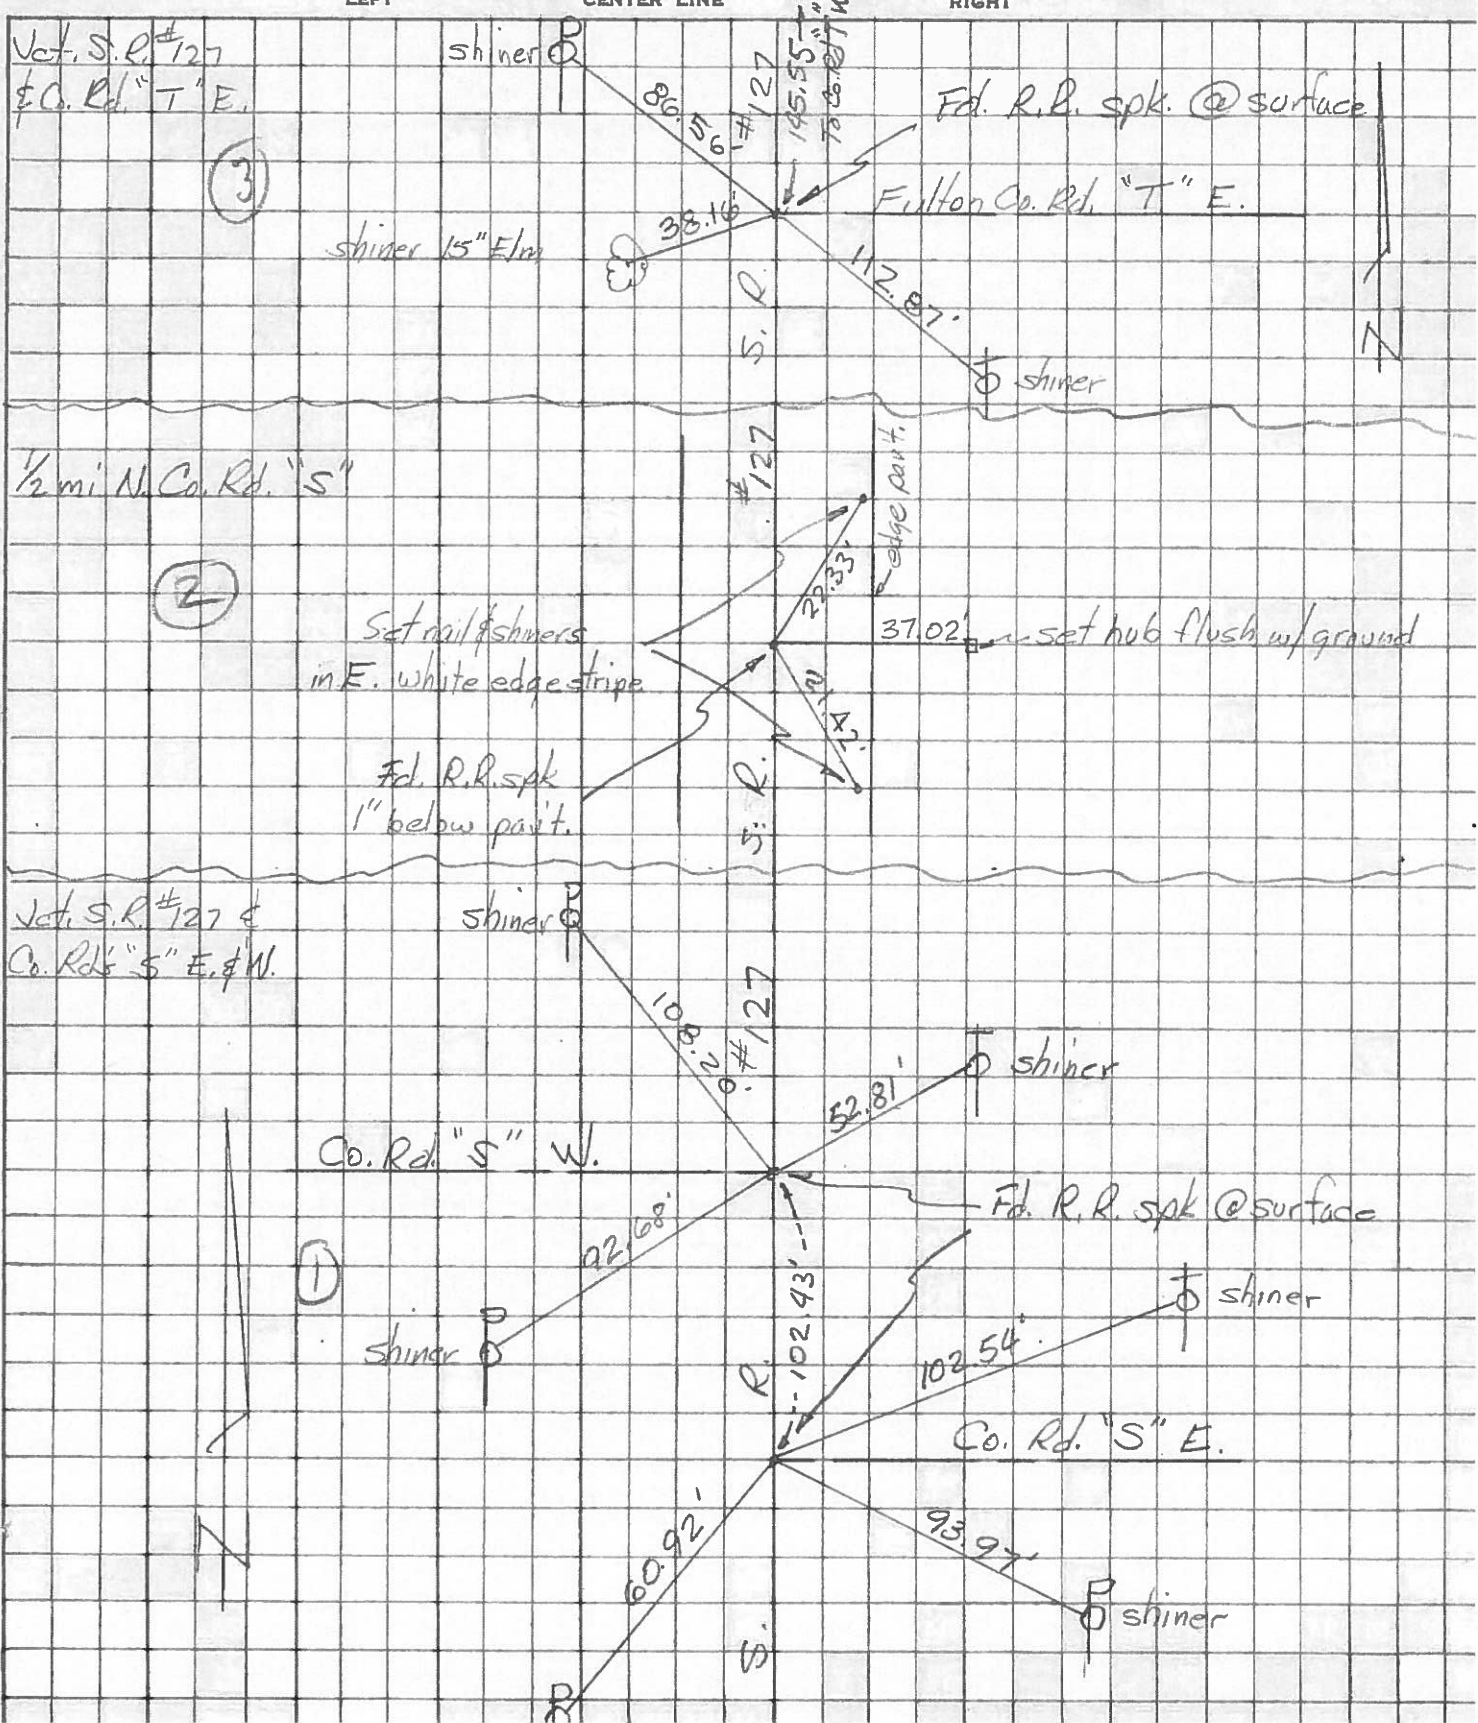
Found E. Qtr. STONE, Sec. 13
Qtr. stone with brick as recorded.
Good pyramidal shaped STONE
20" below pav't surface.
Est. 16" x 1" pipe over STONE.
Qtr. STONE is 1.3' east of ctr.
of 24' Blacktop pav't.

Found W. Qtr. STONE, Sec. 18

21 1/2" below pav't. surface,

Large Qtr. Stone with good
N-S ridge. chiseled "+" midway
on the 10" long ridge of STONE.
placed a bronze RW disc on top
of Stone. Est. 18" x 1" pipe over
the disc & Qtr. STONE.

The Qtr. Stone is 1.5' east
of ctr. of 24' Blacktop pav't.

Found RR spk on surface. Found
RR spk 2" below surface. Found
PK 5" below surface. Did NOT REPLA
Qtr. Stone was 0.5' south and 1.4' east
of the RR spks & PK.
