O.D.O.T. DISTRICT 2 SURVEY OFFICE (USE ONLY)

PERSONNEL _____ REFERENCE NO. 145 A SHEET 37 OF 66
 NOTES MOSER DATE 5/6/11 ROUTE SR 163
 H.C. MOSER WEATHER CLOUDY COUNTY OTTAWA
 R.C. HARBAUGH TEMP. 60° TOWNSHIP DANBURY
 SECTION 1-7

TYPE MONUMENT P.K./WASHER
 ON SURFACE - ~~BELOW~~ ON
 OFFSET Q PAVEMENT 11.0' LT : ~~RT~~
0.5' TO LT EDGE PAVEMENT
 STATION: 1914+37

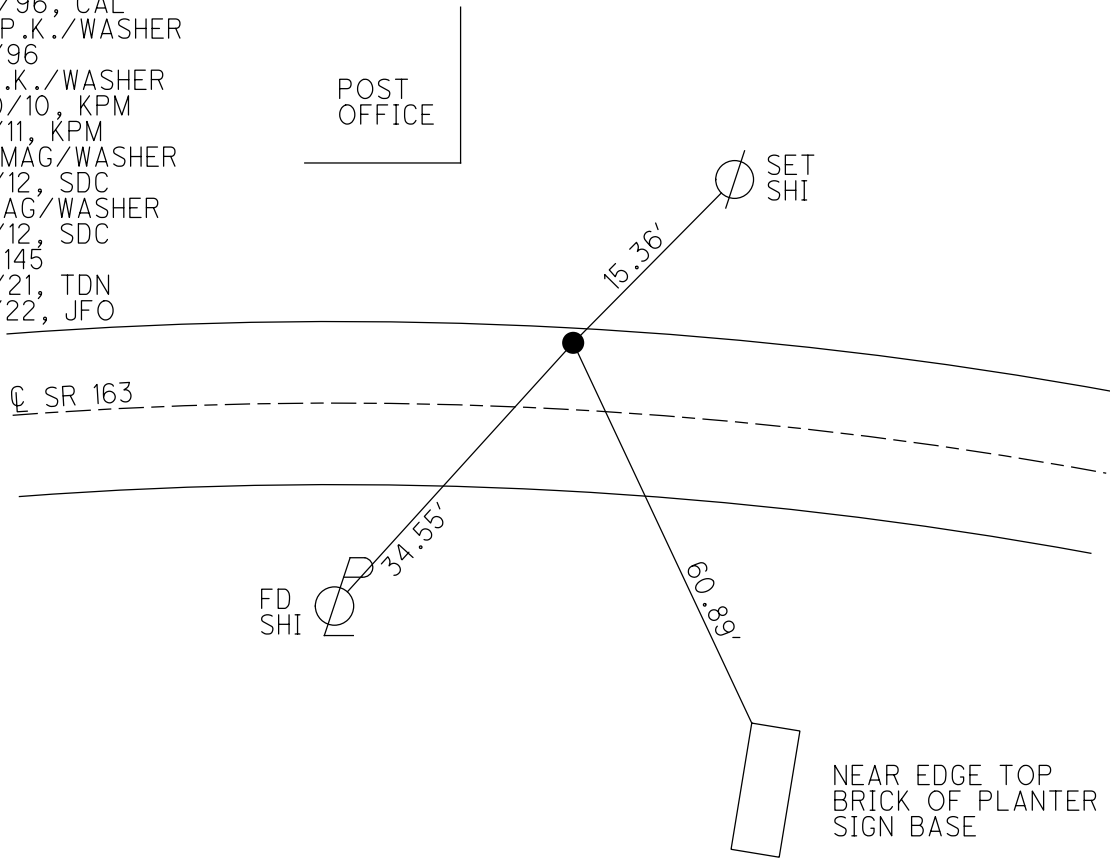
RECORD: P.I.
 $\Delta = 15^{\circ}44'$ RT
 STA 510+96.55
 FD RUSTY HOLE IN
 ASPHALT PAV'T. LAST
 REMAINING TIE WAS
 GOOD TO SAID HOLE
 4/14/96, CAL
 SET P.K./WASHER
 6/5/96
 FD P.K./WASHER
 4/30/10, KPM
 5/6/11, KPM
 SET MAG/WASHER
 11/5/12, SDC
 FD MAG/WASHER
 11/9/12, SDC
 REFA145
 6/11/21, TDN
 2/7/22, JFO

NEAR EDGE TOP
BRICK OF PLANTER
SIGN BASE

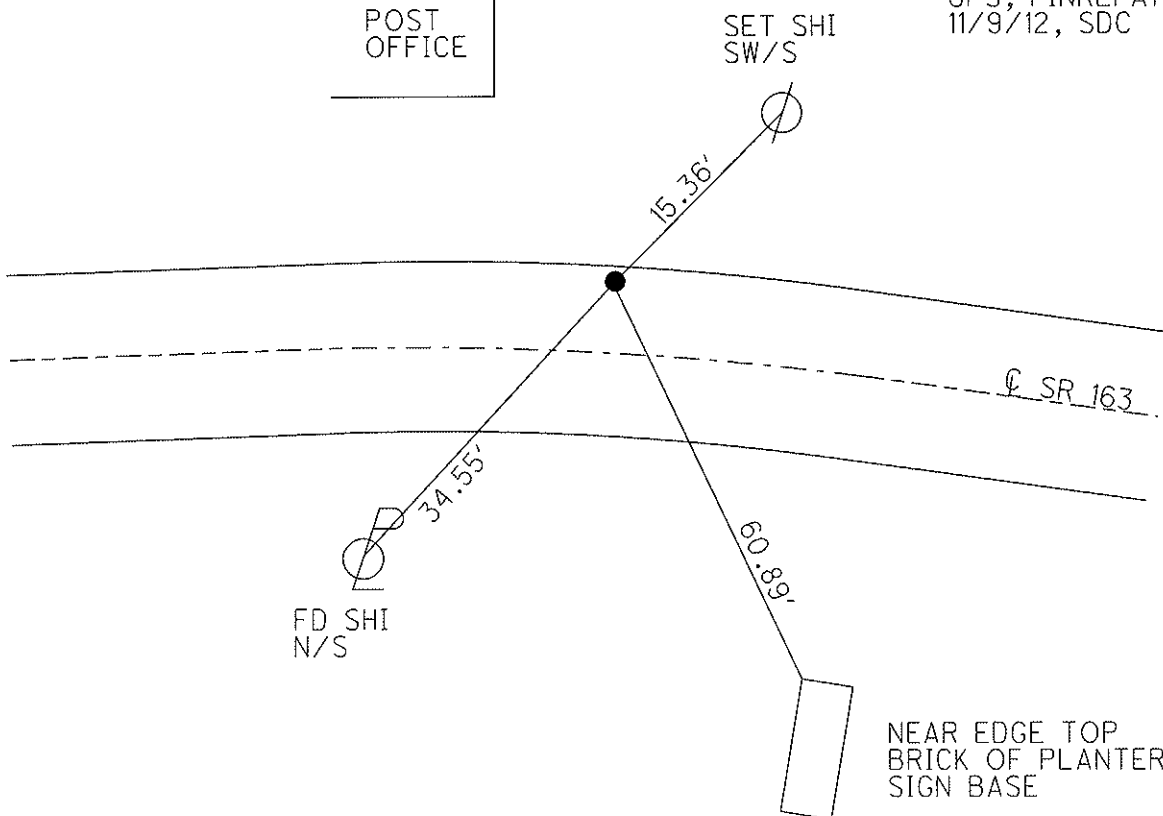
TYPE MONUMENT P.K./WASHER
 ON SURFACE - ~~BELOW~~ ON
 LEFT - ☉ PAV'T - ~~RIGHT~~ 11.0'
0.5' TO LT EDGE PAVEMENT
 S.L.M. 1914+37
 Grid: Northing: 682423.914 Easting: 1902754.559

RECORD (PLAN)
 P.I. Δ = 15° 44' RT.
 510+96.55

NOTE: FD. RUSTY HOLE IN
 ASPHALT PAV'T. LAST REMAINING
 TIE WAS GOOD TO SAID HOLE.
 4/14/96, C.A.L.

RESET P.K./WASHER
 6/5/96

FD P.K./WASHER
 GPS, SV131
 4/30/10, KPM

SET MAG/WASHER
 11/5/12, SDC

GPS, FINREFA145
 11/9/12, SDC

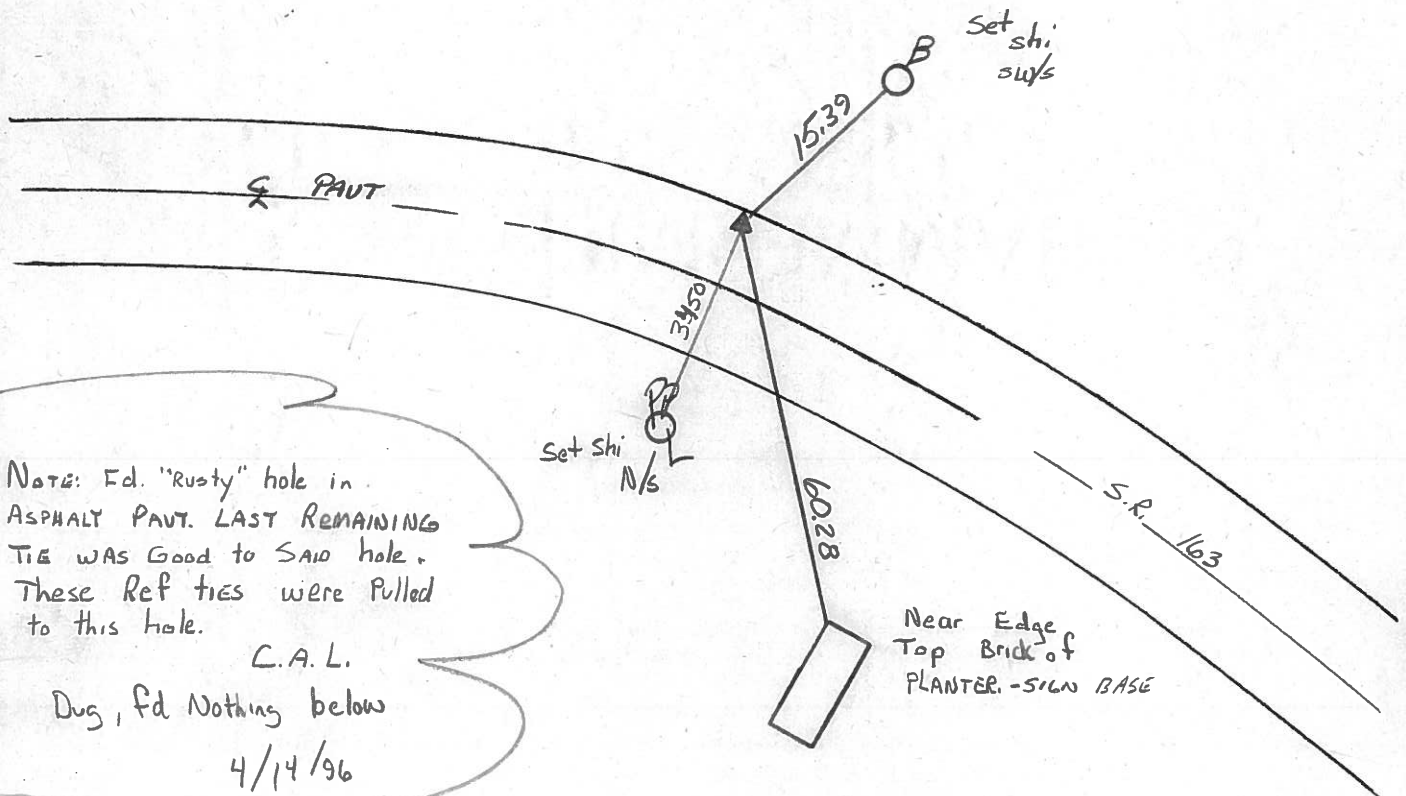
REFERENCE NO. 145A

TYPE MONUMENT "Rusty Hole"

Set P.K./WASHER
6-5-96

ON SURFACE - BELOW _____

LEFT - ℄ PAVT. - RIGHT 10.7

0.9 TO L+ EDGE PAVEMENT

S.L.M. 1914+37

PLAN RECORD P.I.
Sta 510 + 96.55
 $\Delta = 15^{\circ} 44' \text{ Rt}$

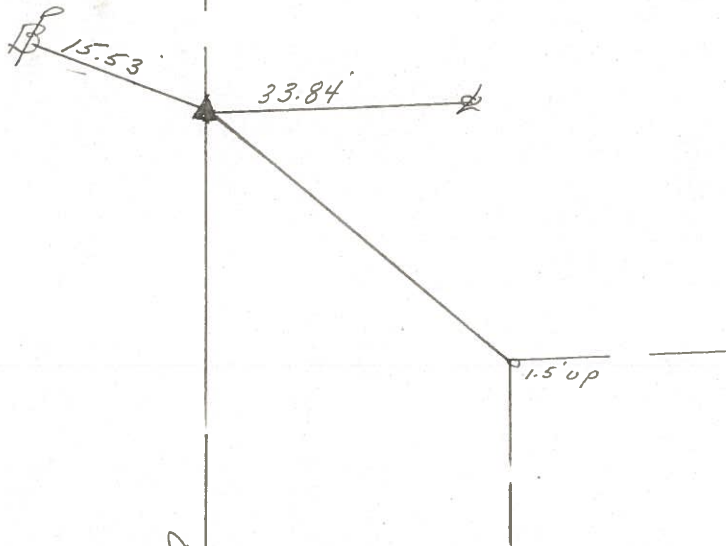
145 A

Plan
P.I. $\Delta = 15^{\circ}44'$ Rt.
510 + 96.55
set P.K. & washer atop
P.K. 1' Rt. Lt. edge
of pavement

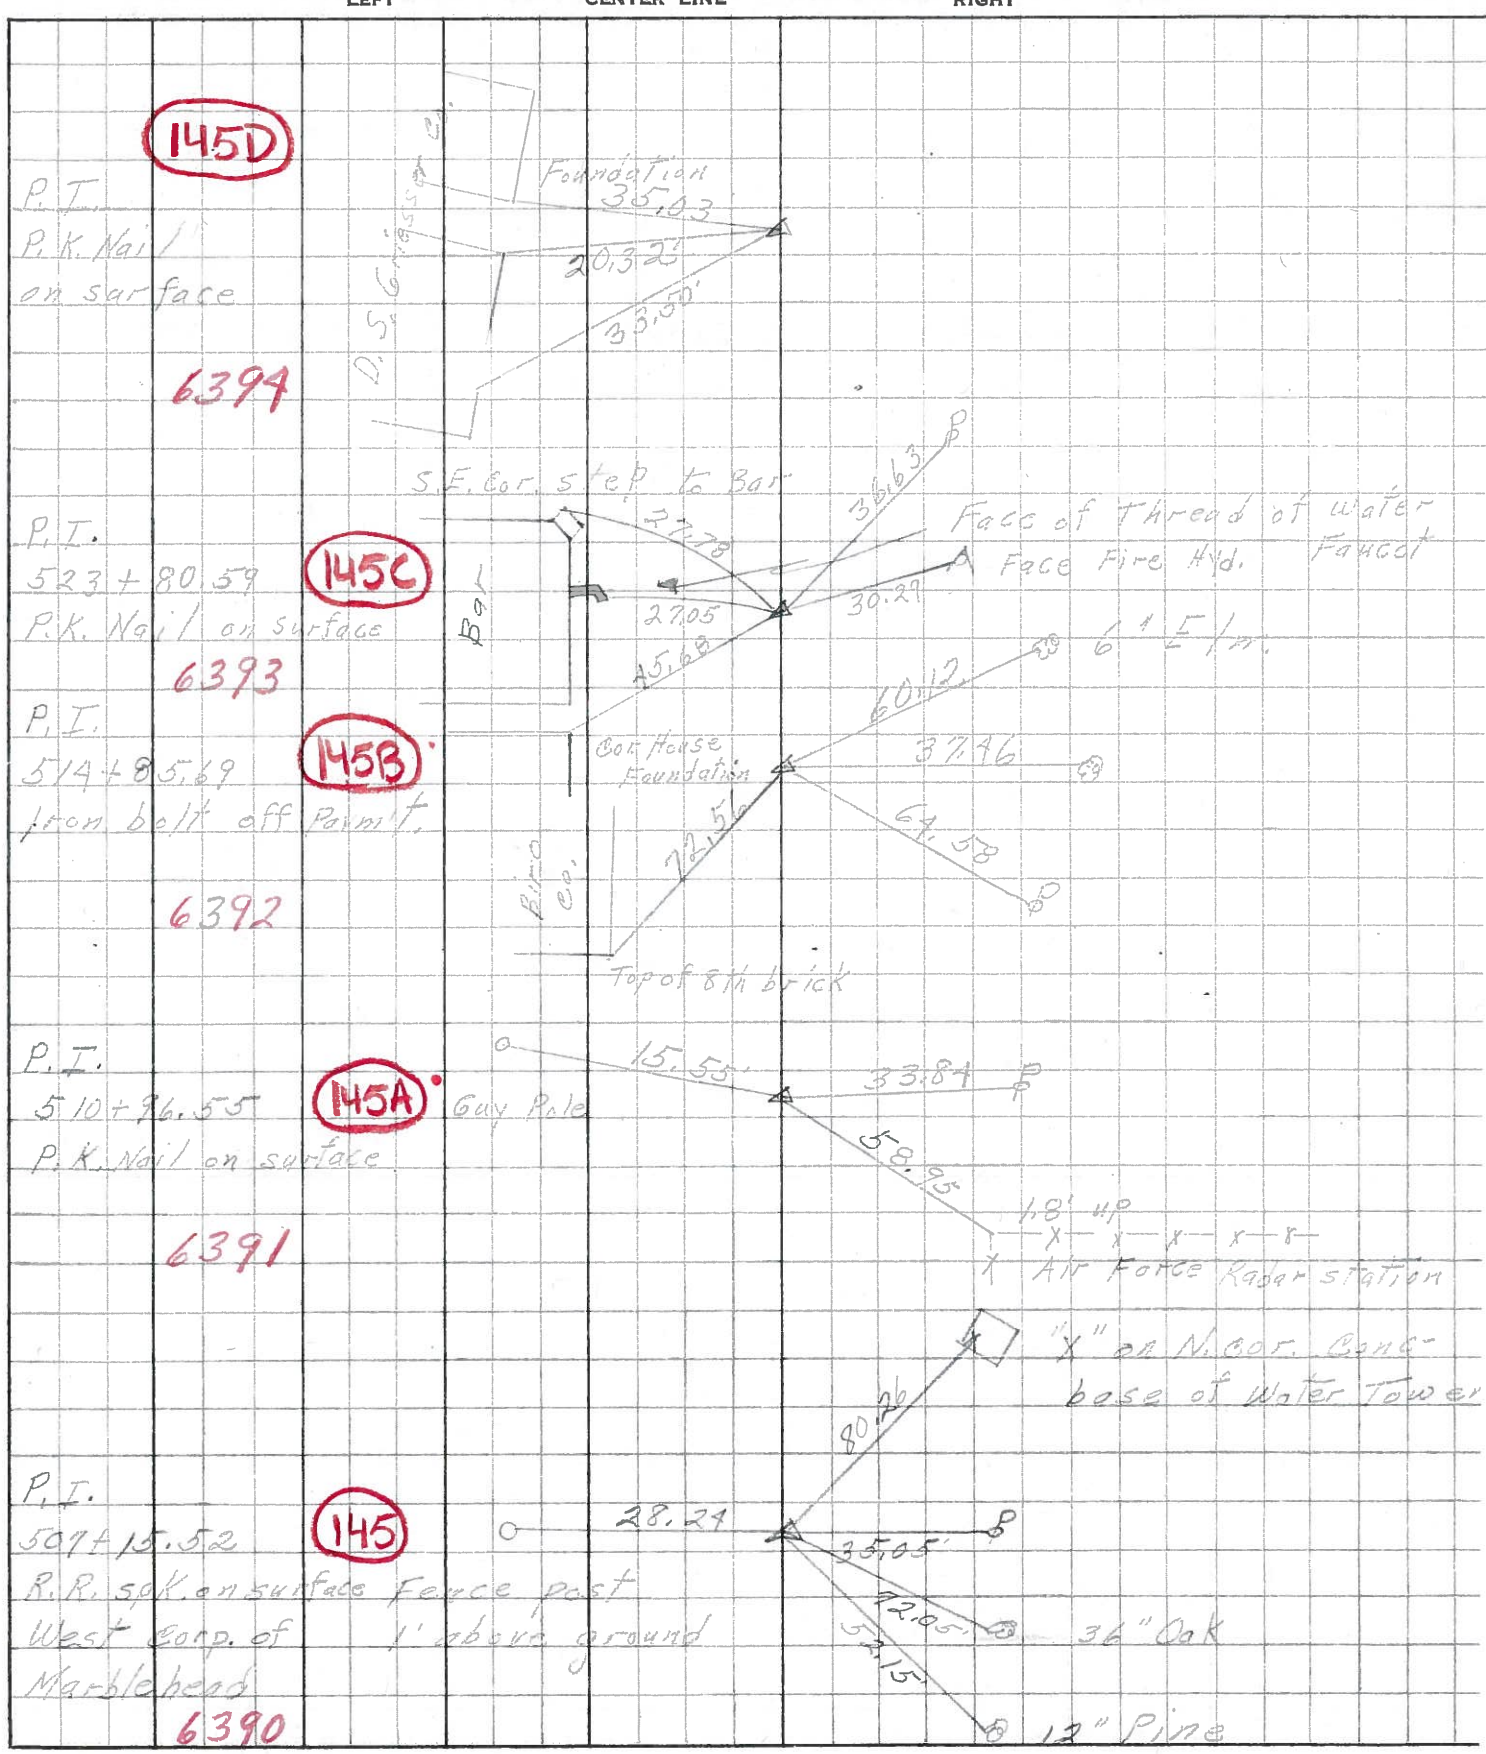
PERSONNEL	TITLE	PERSONNEL	TITLE	COUNTY	DATE	WEATHER	TEMP.
Schneider		Potts		Ottawa	9-12-68	Fair	70°
Mosser				S. R. 163			
Barbour				SEC. S.R. #269 - East			
Redding				Marblehead

DESCRIPTION Ties for Control Points JOB NO. _____
