O.D.O.T. DISTRICT 2 SURVEY OFFICE (USE ONLY)

ROUTE SR 163

COUNTY OTTAWA

TYPE MONUMENT P.K. NAIL IN STONE HEADWALL

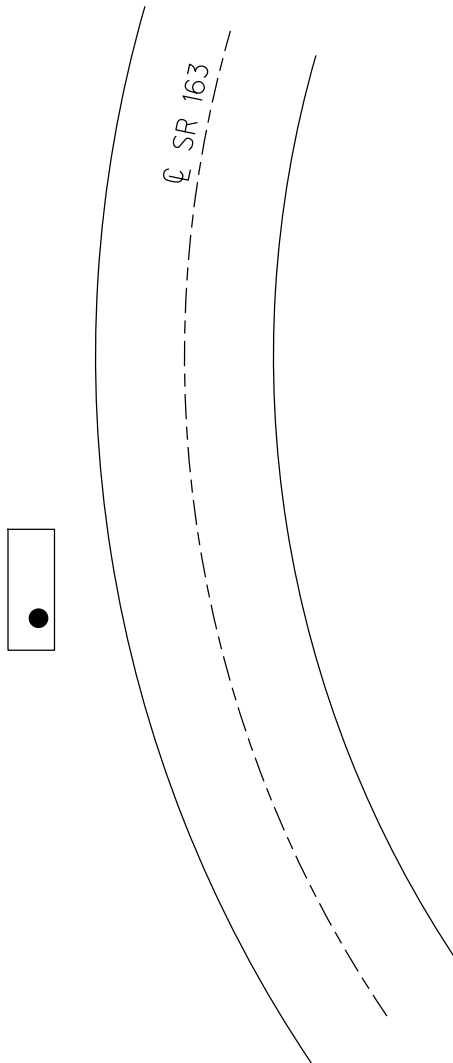
SHEET 54 OF 66

OFFSET ϕ PAVEMENT 20.7' ~~LT~~ : RT

9.0' RT OF RT EDGE PAVEMENT

STATION: 2017+86

RECORD: P.I.
 $\Delta = 36^{\circ}00'$ LT
 STA 614+33.50
 FD P.K. NAIL IN
 STONE HEADWALL
 6/5/95, MRC
 LOCATED SITE
 SHOT PAINT HOLE IN
 ROCK HEADWALL.
 PAINT PLACED BY OTHERS.
 ALL TIES GONE.
 SV147
 5/4/10, KPM

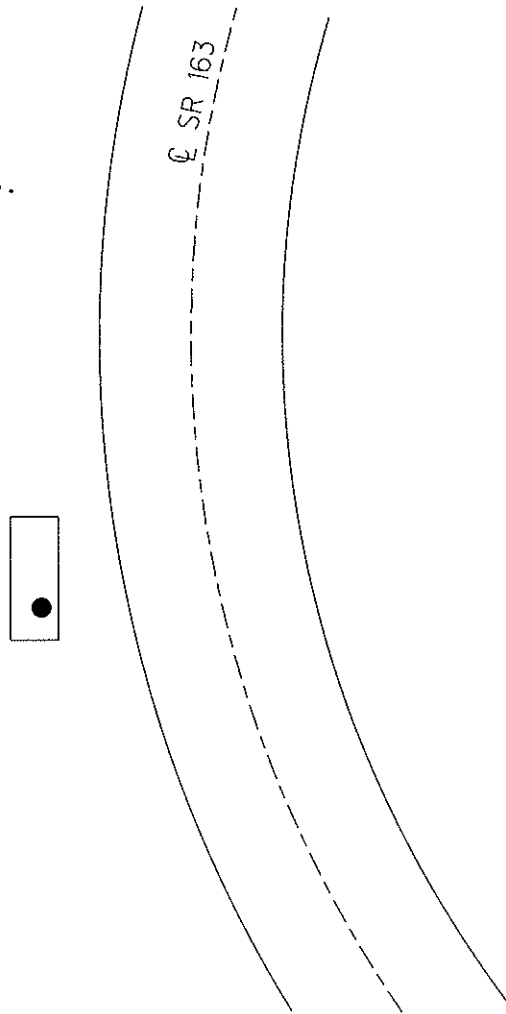
SHEET 54 OF 63

TYPE MONUMENT P.K. NAIL IN STONE HEADWALL

~~LEFT~~ - Q PAV'T - RIGHT 20.7'

9' RT TO RT EDGE PAVEMENT

S.L.M. 2017+86

LOCATED SITE.
SHOT PAINT HOLE IN
ROCK HEADWALL.
PAINT PLACED BY OTHERS.
ALL TIES GONE.
GPS, SV147
5/4/10, KPM

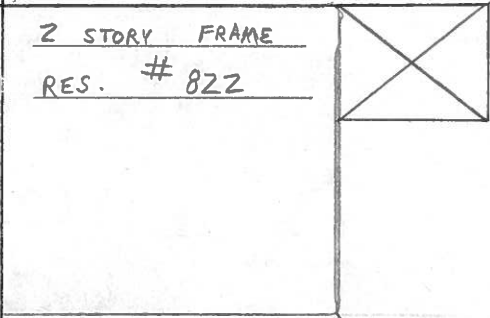
SHEET 47 OF 52

TYPE MONUMENT PK NAIL IN STONE HEADWALL
 ON SURFACE - ~~BELOW~~ YES
~~LEFT - & PAV'T. - RIGHT~~ 20.7' RT &
9' RT OF RT EDGE PAVEMENT
 S.L.M. 2017 + 86

NOT COVERED
6/10/96
M.R.C.

RECORD: P.I. $\Delta = 36^\circ 00'$ LT.
 STA 614 + 33.50

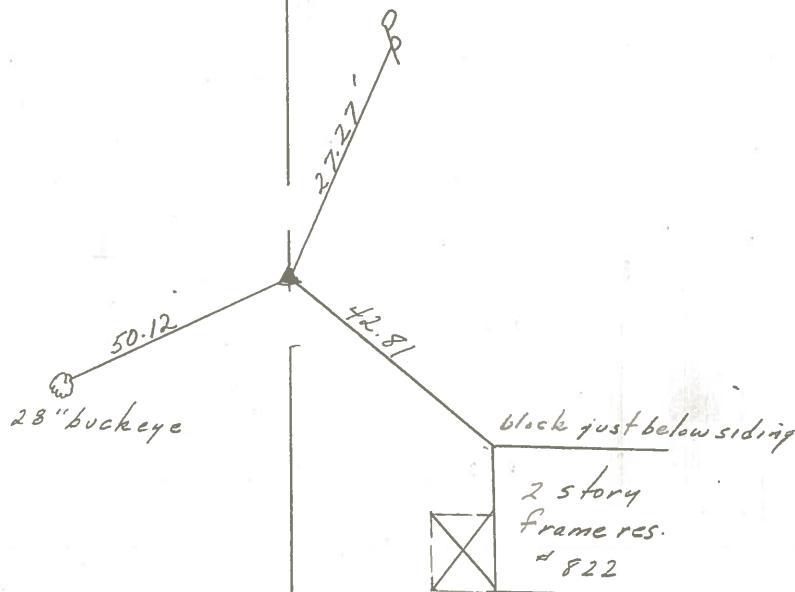
149

Plan
P.I. Δ = 36°00' Lt.
614 + 33.50
Fd. P.K. in stone
headwall - 9' Rt. - Rt. E.P.

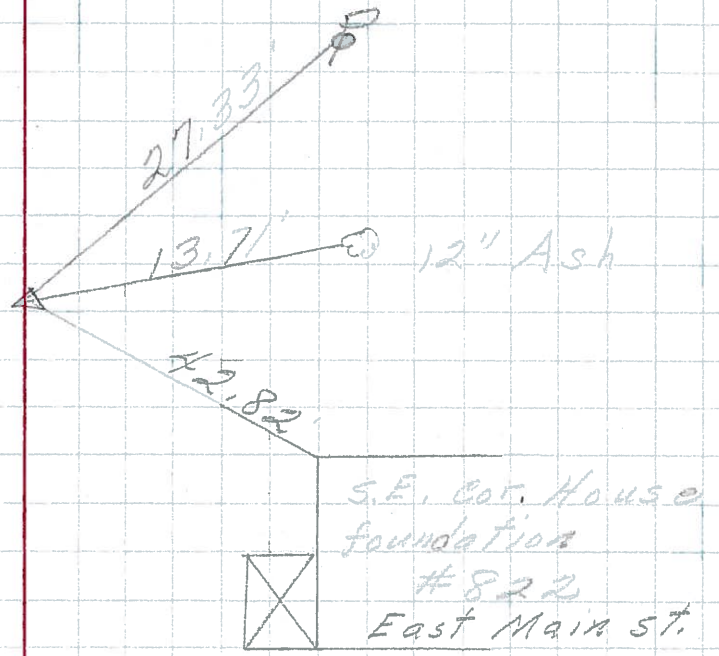
P.I. **149**
 614 + 33.50
 P.K. Nail
 on Howl.

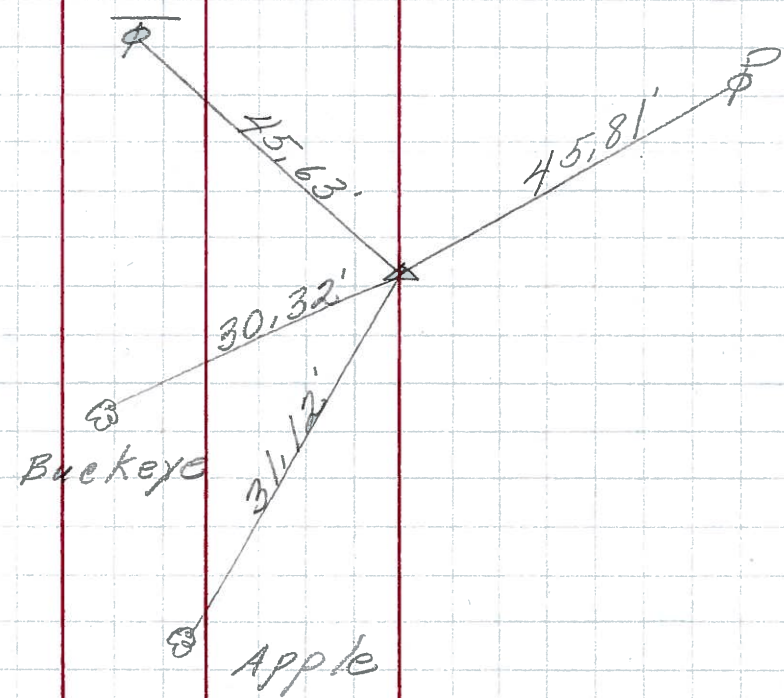
P.I. **148B**
 609 + 38.22
 P.K. Nail
