O.D.O.T. DISTRICT 2 SURVEY OFFICE (USE ONLY)

PERSONNEL _____ REFERENCE NO. 5 SHEET 6 OF 64
 NOTES RHOADES DATE 08-17-2015 ROUTE SR 19
 H.C. O'DONNELL WEATHER CLOUDY COUNTY SENECA
 R.C. HOMAN TEMP. 72°F TOWNSHIP BLOOM
 SECTION 33 & 34
 T 1 N R 16 E

TYPE MONUMENT PK & WASHER
 ON SURFACE - ~~BELOW~~ ON
~~LEFT - C~~ PAV'T - RIGHT ON
10' TO RT EDGE PAVEMENT
 S.L.M. 47+98.19

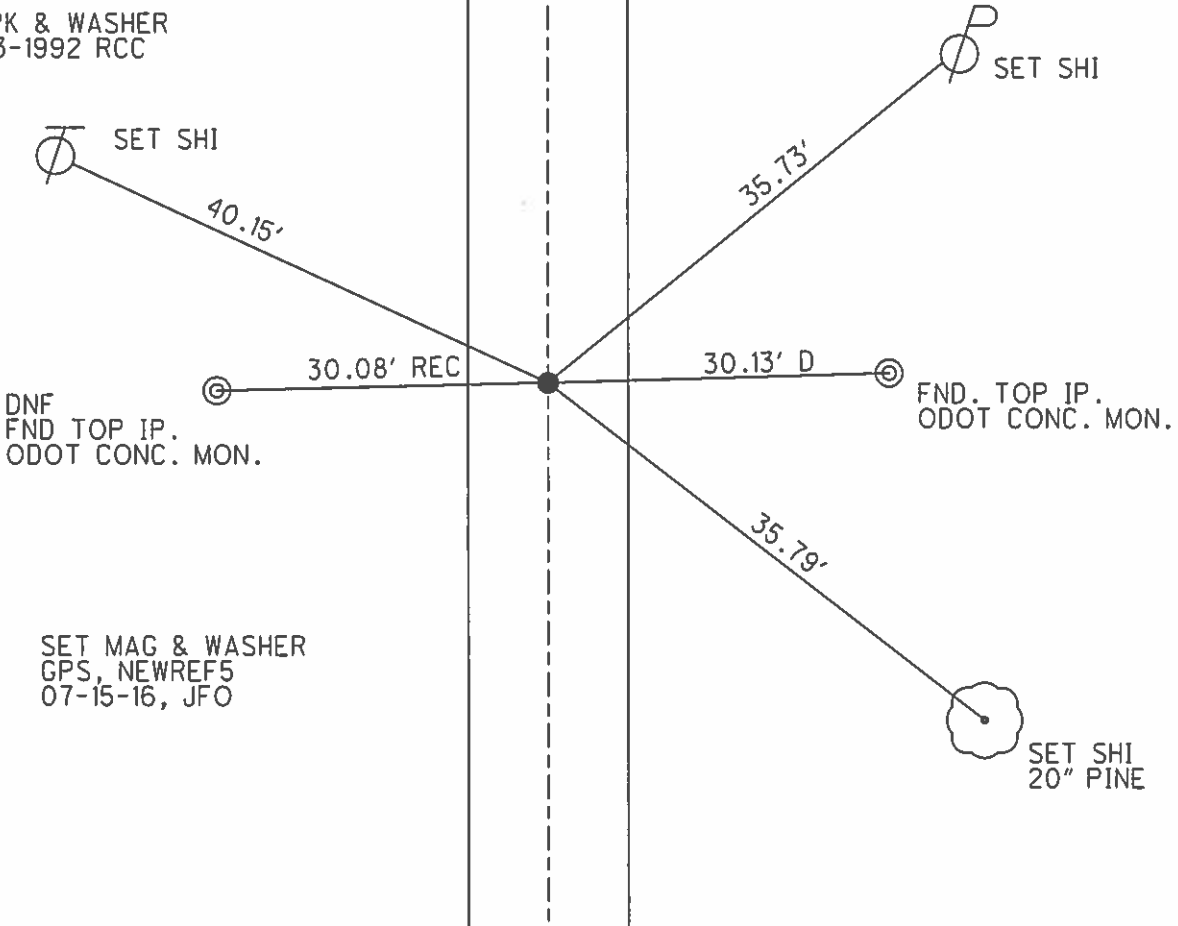
RECORD PI STA 48+00
 SET PK & WASHER ATOP
 RR. SPK. ATOP
 HARROW TOOTH
 7" BELOW SURFACE
 01-12-1984

FND PK & WASHER
 12-15-2013 JMR
 GPS REF5
 12-30-2013 TMR

SET PK & WASHER
 09-03-1992 RCC

SET MAG & WASHER
 GPS, NEWREF5
 07-15-16, JFO

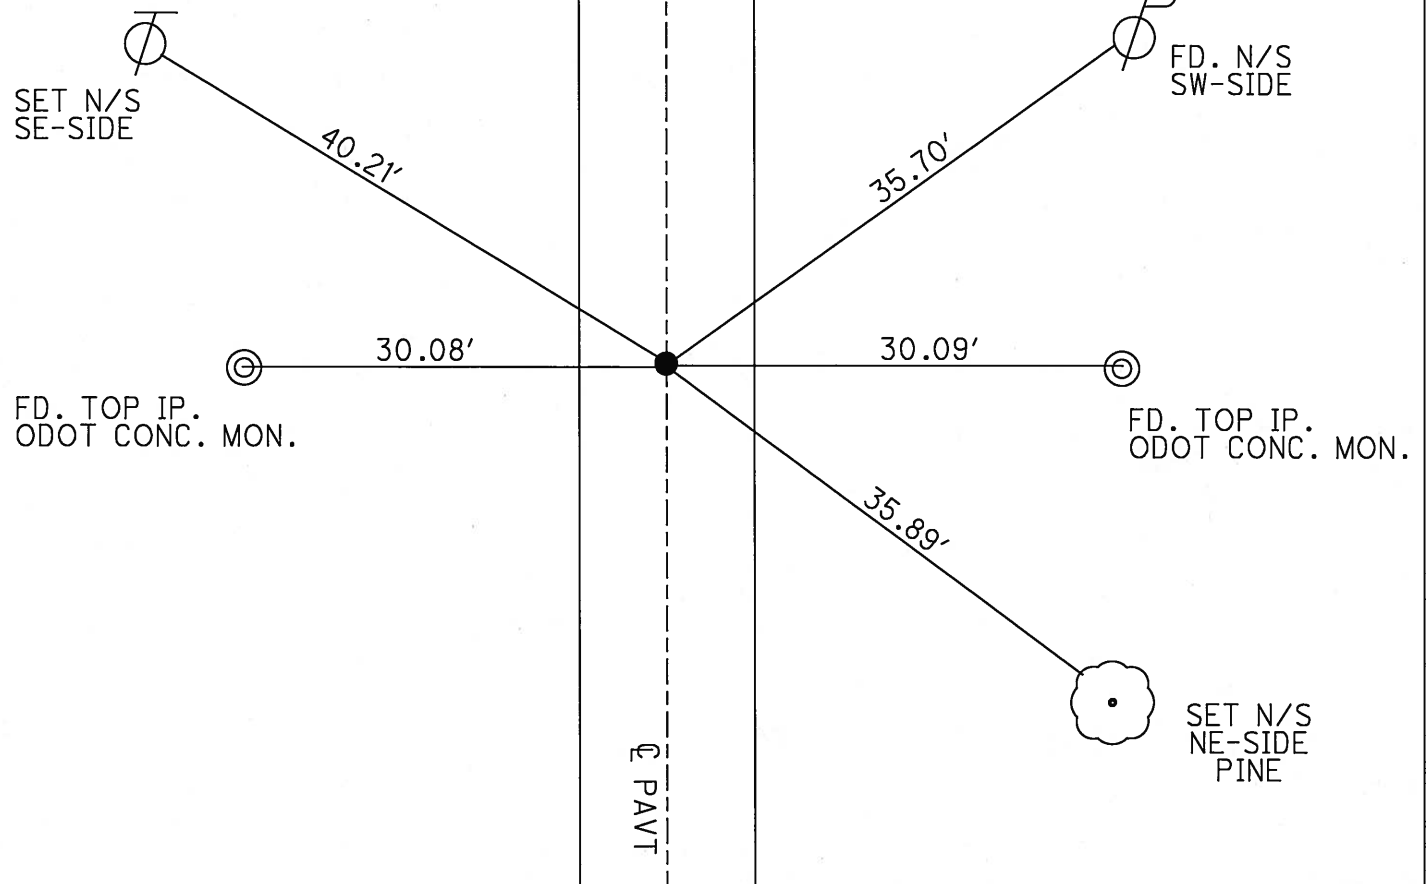
TYPE MONUMENT FD. PK./WASHER
 ON SURFACE - ~~BELOW~~ ON SURFACE
~~LEFT~~ - C PAV'T - ~~RIGHT~~ ON CL.
10' TO RT. EDGE PAVEMENT
 S.L.M. 47+99 (SV6)

RECORD STA. 48+00
 SET PK/WASHER ATOP
 RR. SPK. ATOP
 HARROW TOOTH
 7" BELOW SURFACE
 01-12-84

SET PK/WASHER
 09-03-92 RCC

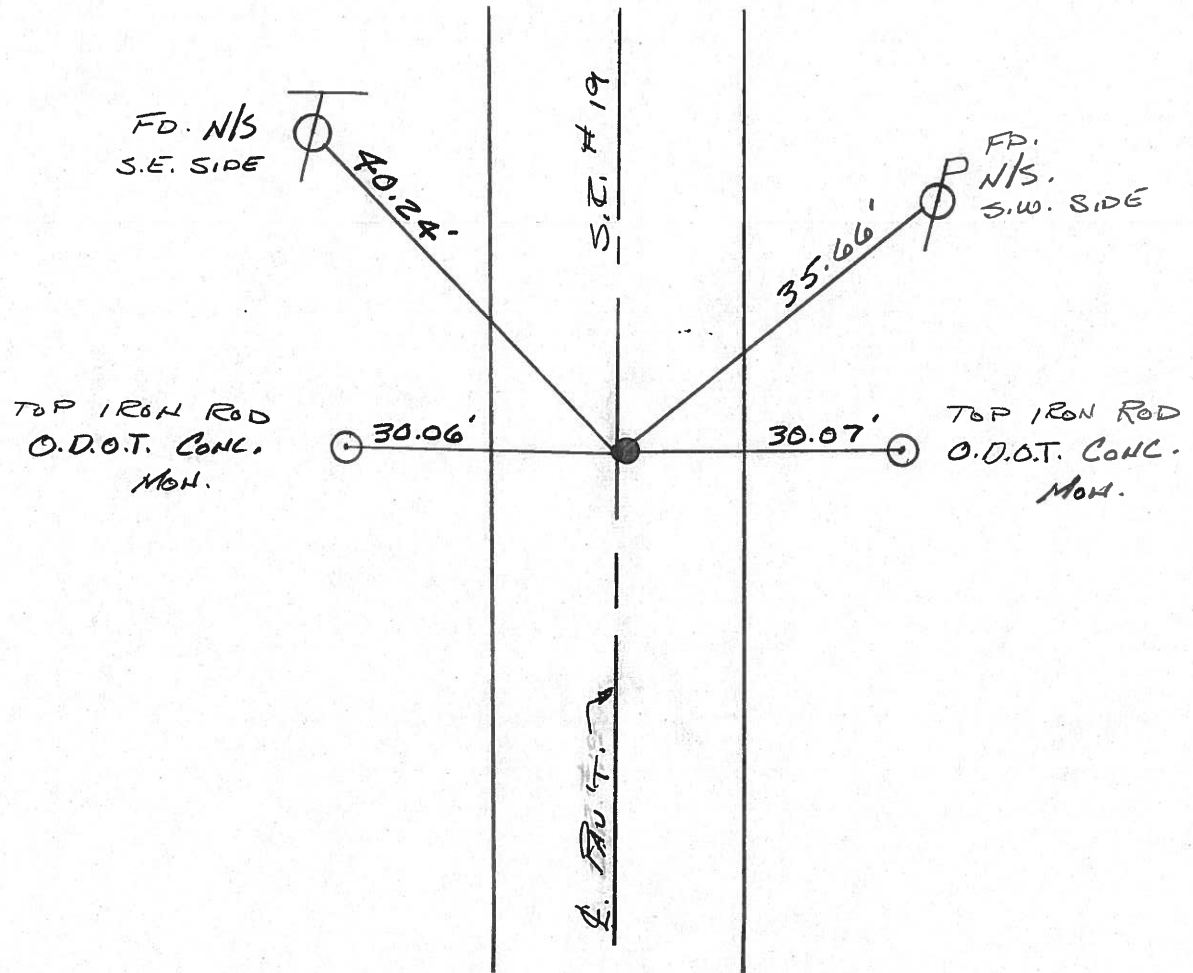
TYPE MONUMENT PK/WASHER

ON SURFACE ~~BELOW~~ YES

LEFT- & PAV'T. - ~~RIGHT~~ 0.5'

9.5 TO LT EDGE PAVEMENT

S.L.M. 48+12.5

SET PK/WASHER
9-3-1992
RCC

STA. 48+00 SET PK/WASHER
ATOP R.R. SPK.
ATOP HARROW TOOTH (7" BELOW SURFACE)

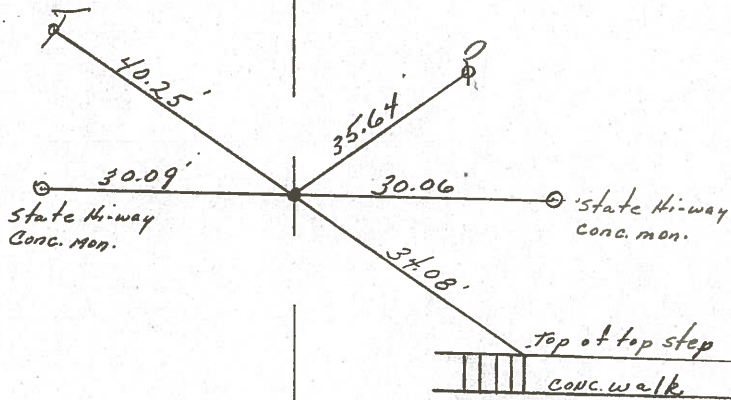
5

48+00
 Set P.K. & washer atop RR.
 spike a top harrow tooth (7"
 below surface

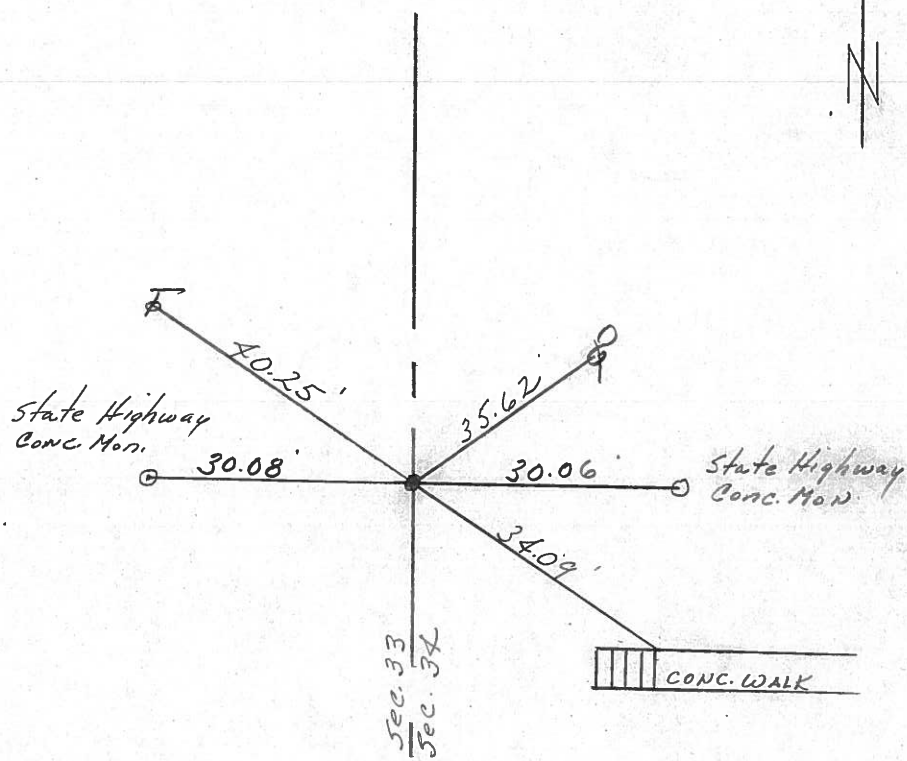
(5)

48+00
Fd. R.R. spike 1" below
surface. Harrow tooth below
and 6 7/8" below surface

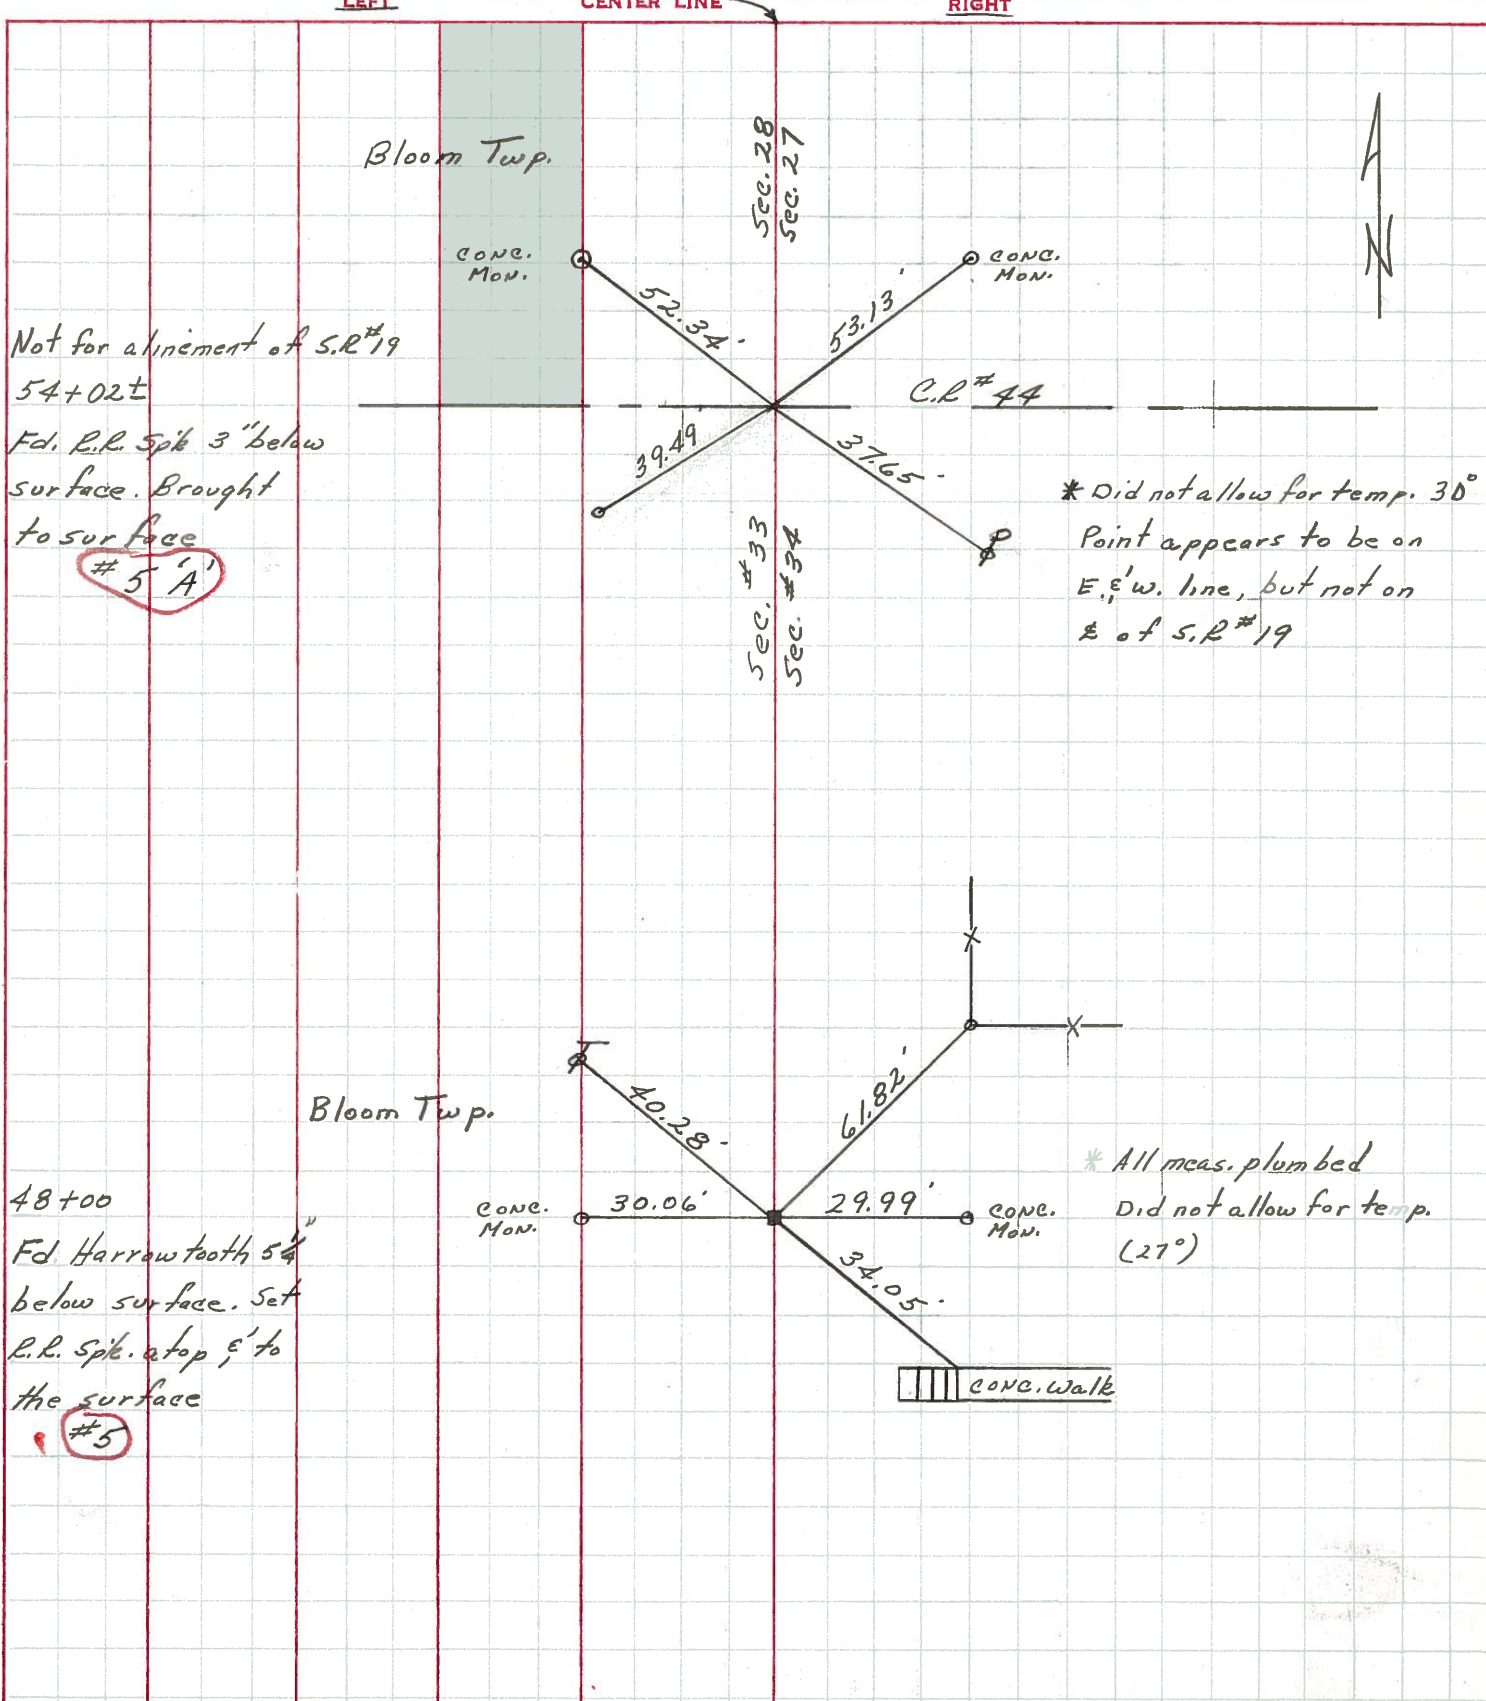
* Not for alignment of S.R. #19
 54+02±
 Fd. R.R. Spike 3" below
 surface. Brought
 to surface
 #5 'A'

* Did not allow for temp. 30°
 Point appears to be on
 E. & W. line, but not on
 E of S.R. #19

48+00
 Fd. Harrow tooth 5 1/4"
 below surface. Set
 R.R. Spike atop 6' to
 the surface
 #5

* All meas. plumbed
 Did not allow for temp.
 (27°)
