O.D.O.T. DISTRICT 2 SURVEY OFFICE (USE ONLY)

PERSONNEL _____ REFERENCE NO. 7 SHEET 9 OF 11
 NOTES RHOADES DATE 8/23/21 ROUTE SR 228
 H.C. NIESE WEATHER FOG COUNTY SENECA
 R.C. RHOADES TEMP. 73° TOWNSHIP ADAMS
 DWG BY RHOADES PID PVTRAIN SECTION 16
 T 3 N R 16 E

MONUMENT No. 971

COMMON CORNER OF SECTION 9, 10, 16, & 15

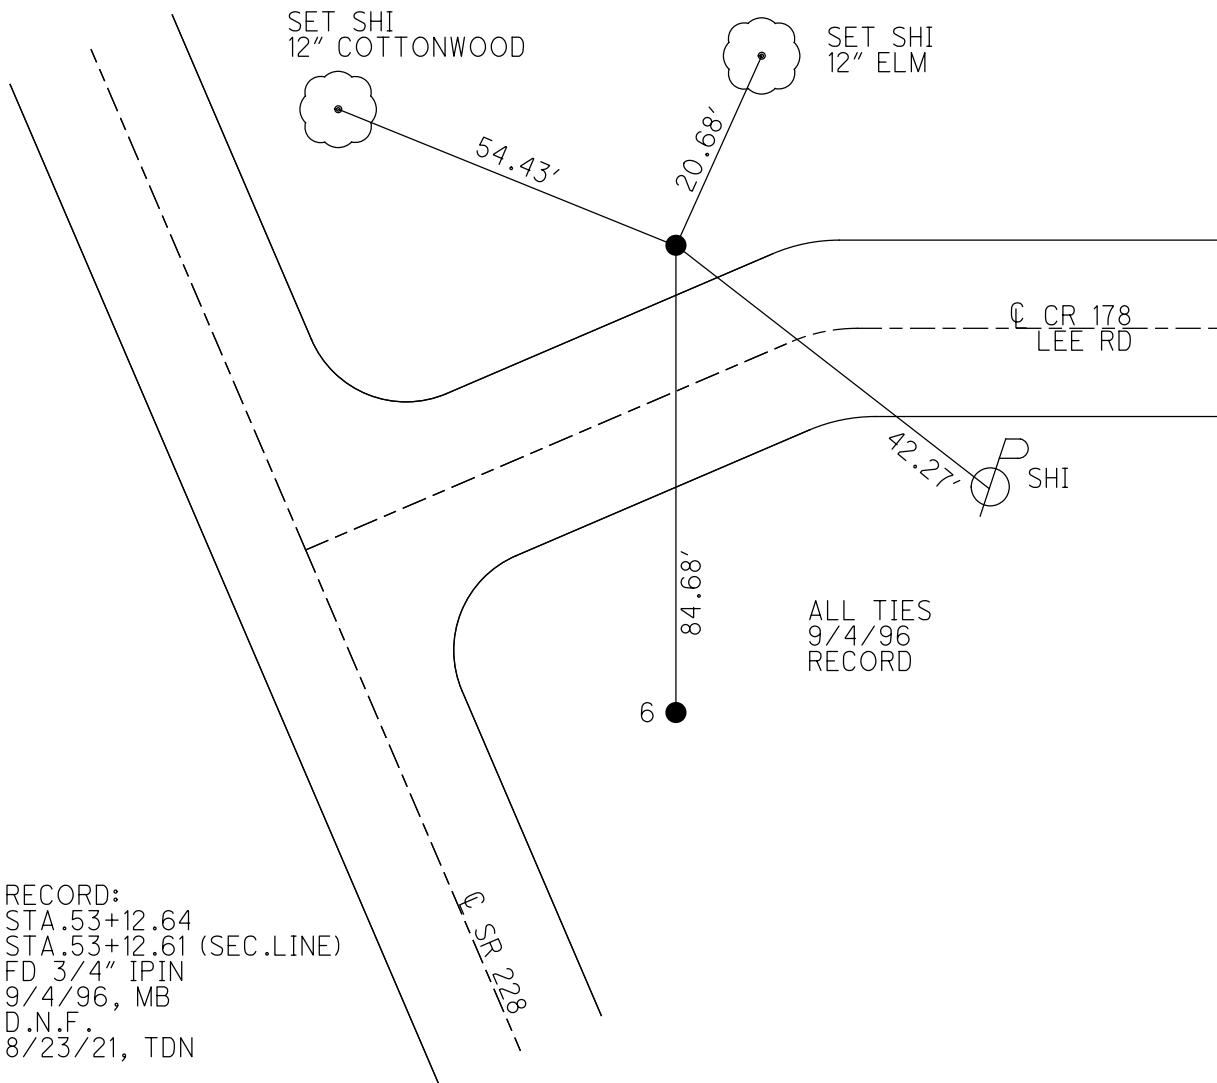
TYPE MONUMENT D.N.F.

OFFSET C PAVEMENT 12', CR 178 LT : ~~RT~~

91.1' RT TO RT EDGE PAVEMENT

STATION: 52+75

RECORD:
 STA. 53+12.64
 STA. 53+12.61 (SEC. LINE)
 FD 3/4" IPIN
 9/4/96, MB
 D.N.F.
 8/23/21, TDN

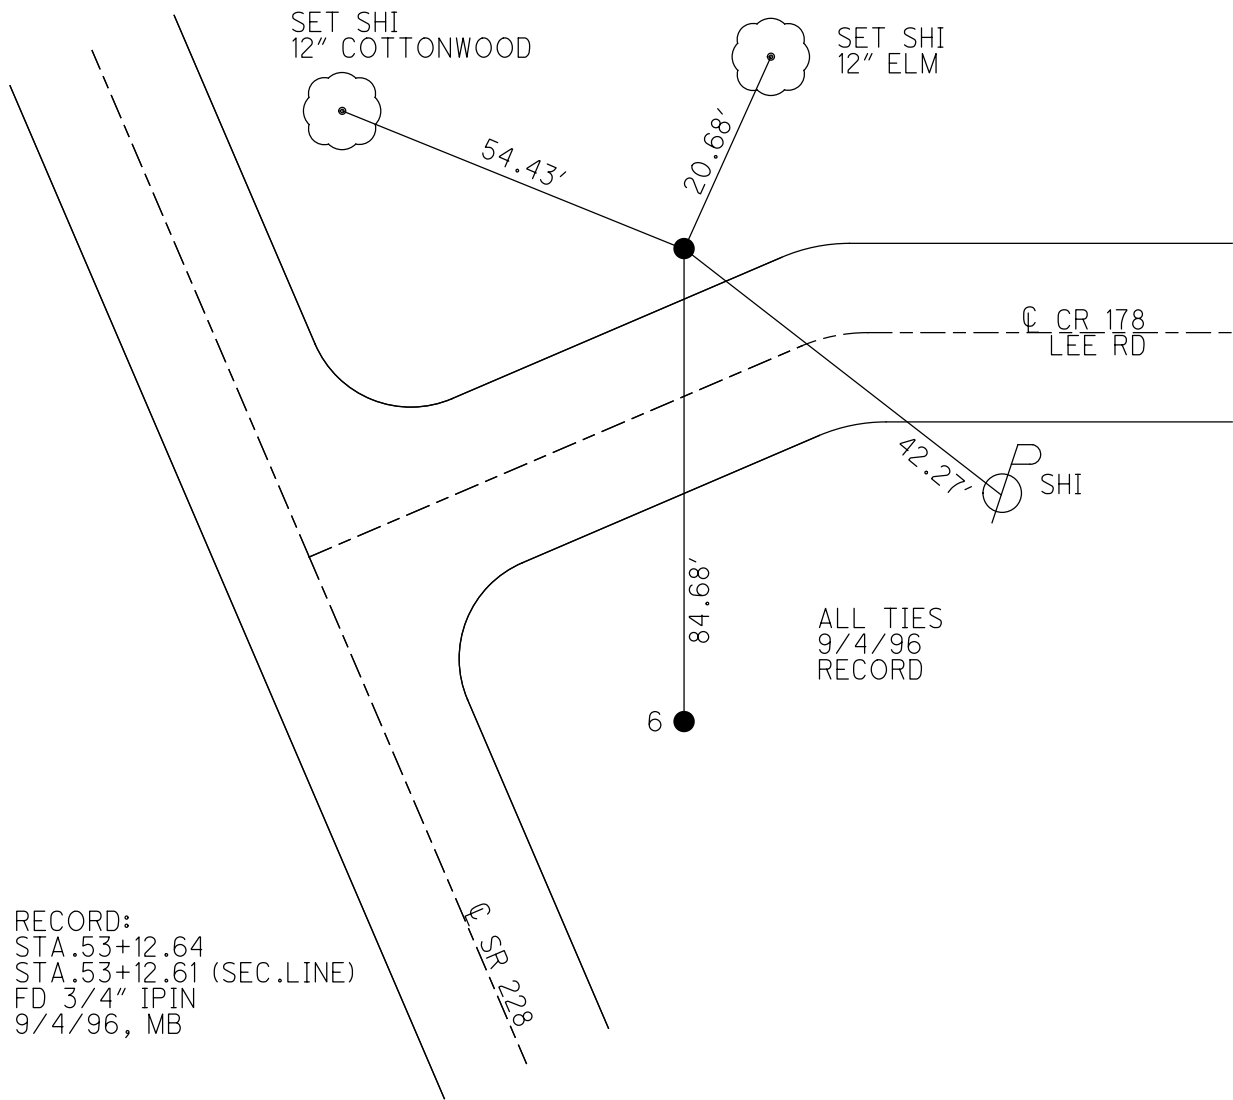
TYPE MONUMENT D.N.F.

OFFSET \odot PAVEMENT 12', CR 178 LT : ~~RT~~

91.1' RT TO RT EDGE PAVEMENT

ALL TIES
9/4/96
RECORD

RECORD:
STA. 53+12.64
STA. 53+12.61 (SEC. LINE)
FD 3/4" IPIN
9/4/96, MB

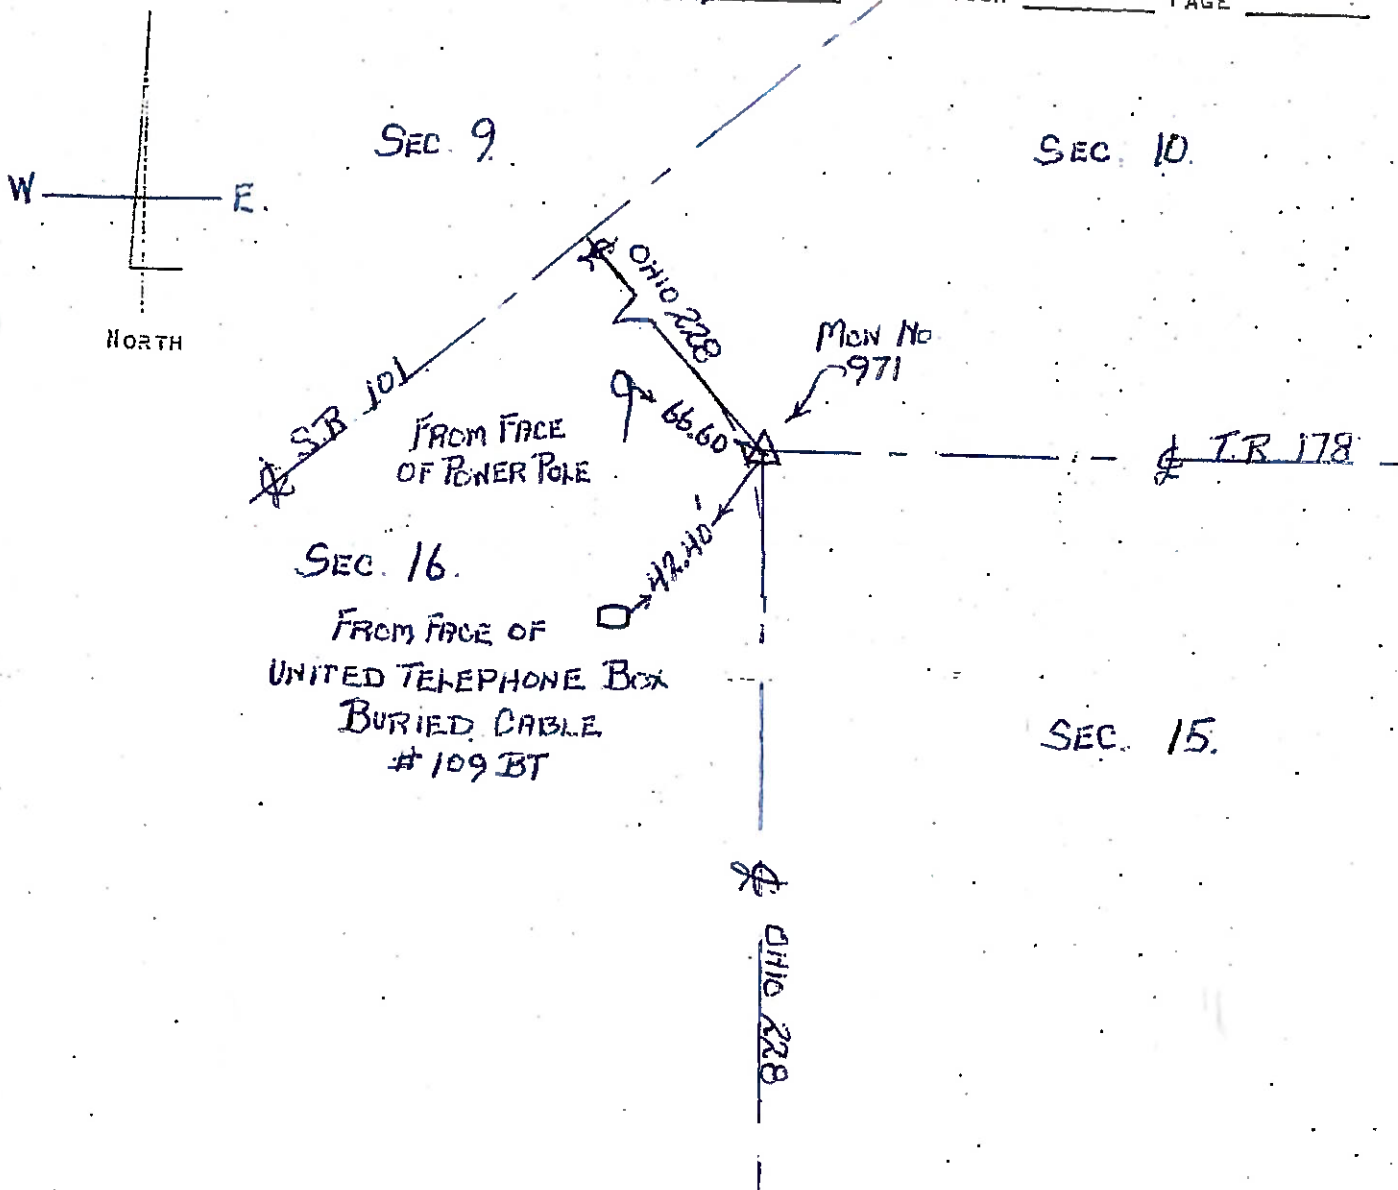
KIND OF MONUMENT 3/4" IRON ROD 30" IN LENGTH

REMARKS FOUND IRON PIN 3" BELOW PAVEMENT SURFACE IN NORTH DRIVING LANE.

FOUND JAN 23, ²⁰⁰¹~~19~~ BY F.J.P. & B.L.

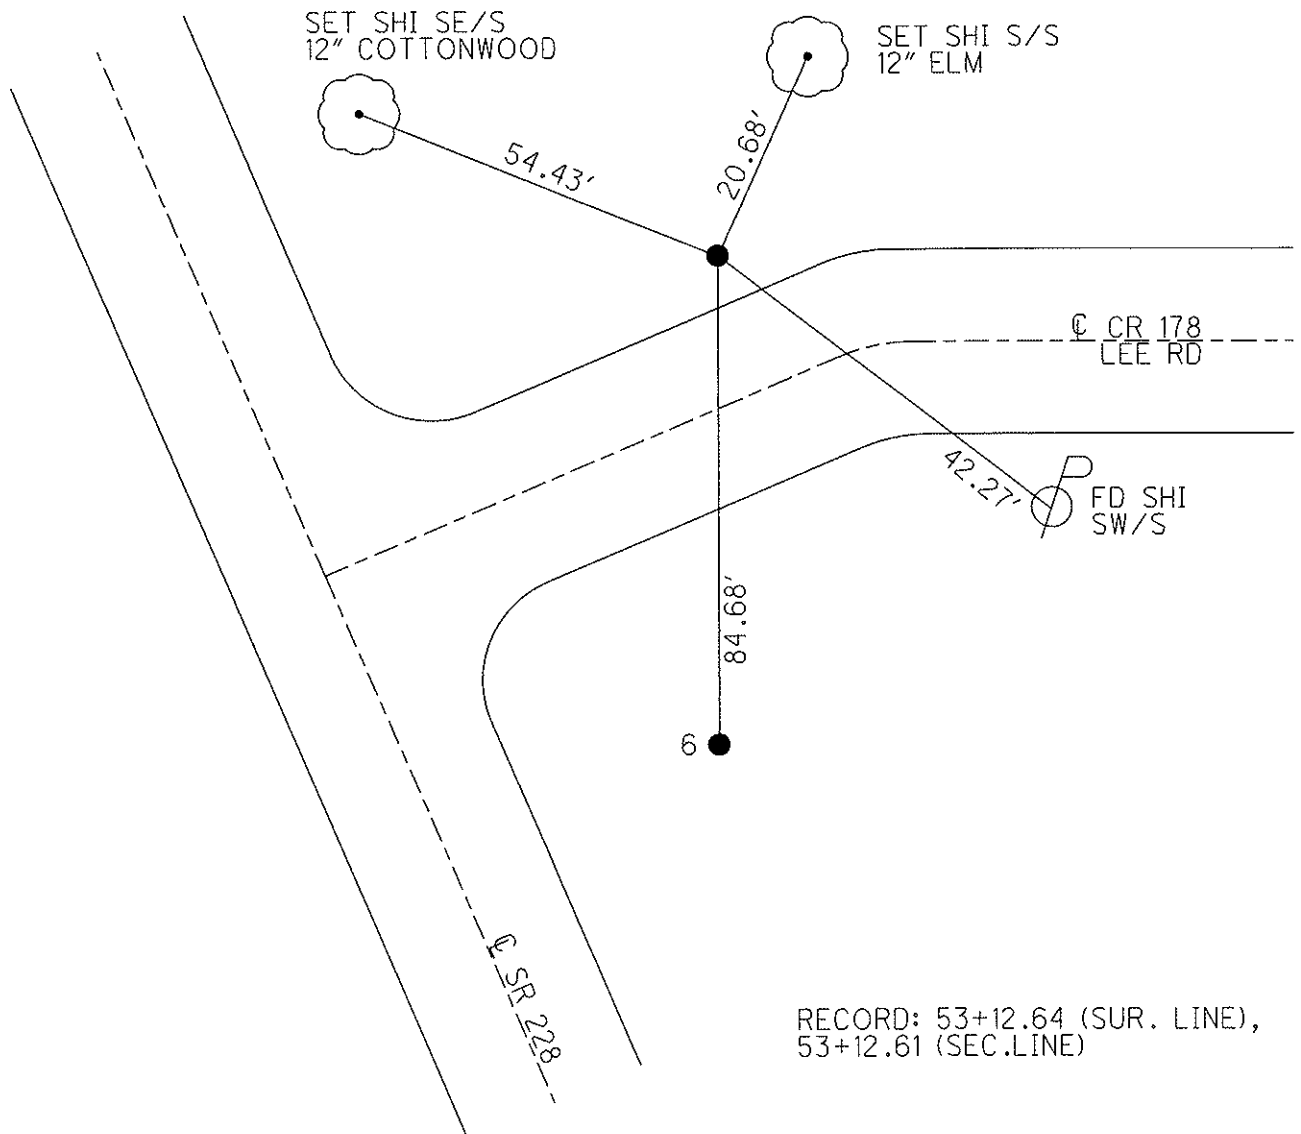
TYPE MONUMENT 3/4" REBAR IN CONC.
 ON SURFACE - ~~BELOW~~ ON
~~LEFT~~ - Q PAV'T - RIGHT 12', CR 178
91.1' RT TO RT EDGE PAVEMENT
 S.L.M. 52+75
 Grid: Northing: _____ Easting: _____

RECORD: 53+12.64 (SUR. LINE),
 53+12.61 (SEC. LINE)

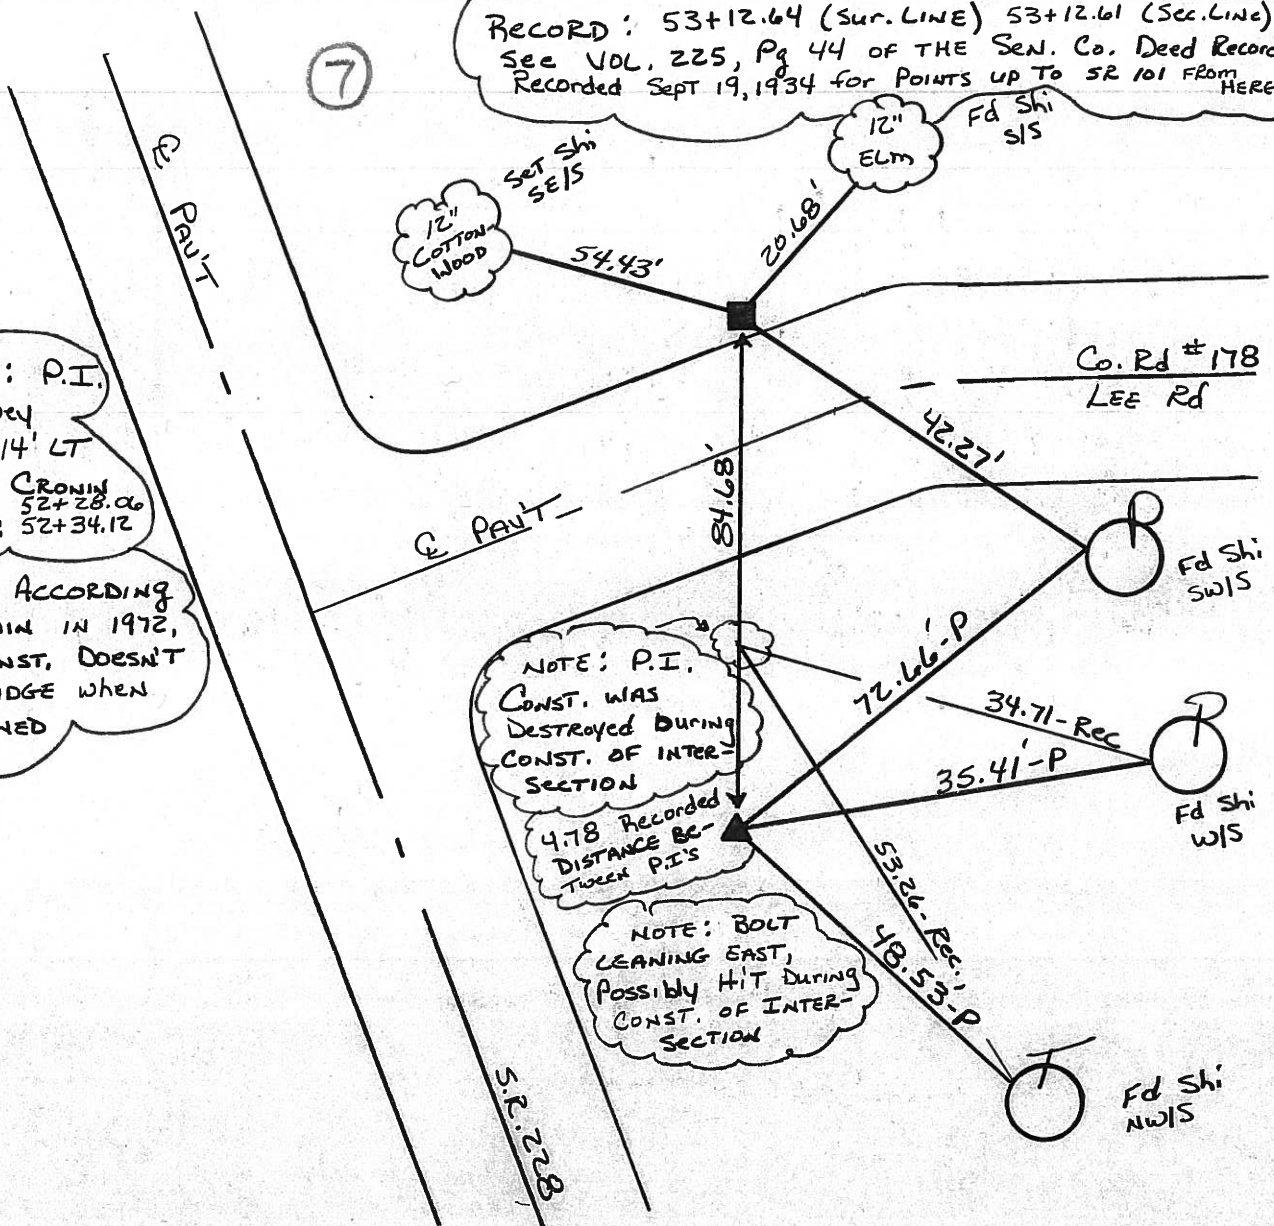
TYPE MONUMENT 3/4" REBAR IN CONC. 5/8" BOLT (LEANING)

ON SURFACE - BELOW SURFACE 12" Below

~~12' RT & Co. Rd~~ 12' RT & Co. Rd 64' RT & SR 228

RECORD: 53+12.64 (Sur. LINE) 53+12.61 (Sec. LINE)
See VOL. 225, Pg 44 of THE Sen. Co. Deed Records
Recorded Sept 19, 1934 for POINTS UP TO SR 101 FROM HERE

RECORD: ACCORDING TO CRONIN IN 1972, P.I. CONST. DOESN'T FIT BRIDGE WHEN X TURNED

NOTE: P.I. CONST. WAS DESTROYED DURING CONST. OF INTER-SECTION
4.78 Recorded DISTANCE BETWEEN P.I.'S

NOTE: BOLT LEANING EAST, POSSIBLY HIT DURING CONST. OF INTER-SECTION

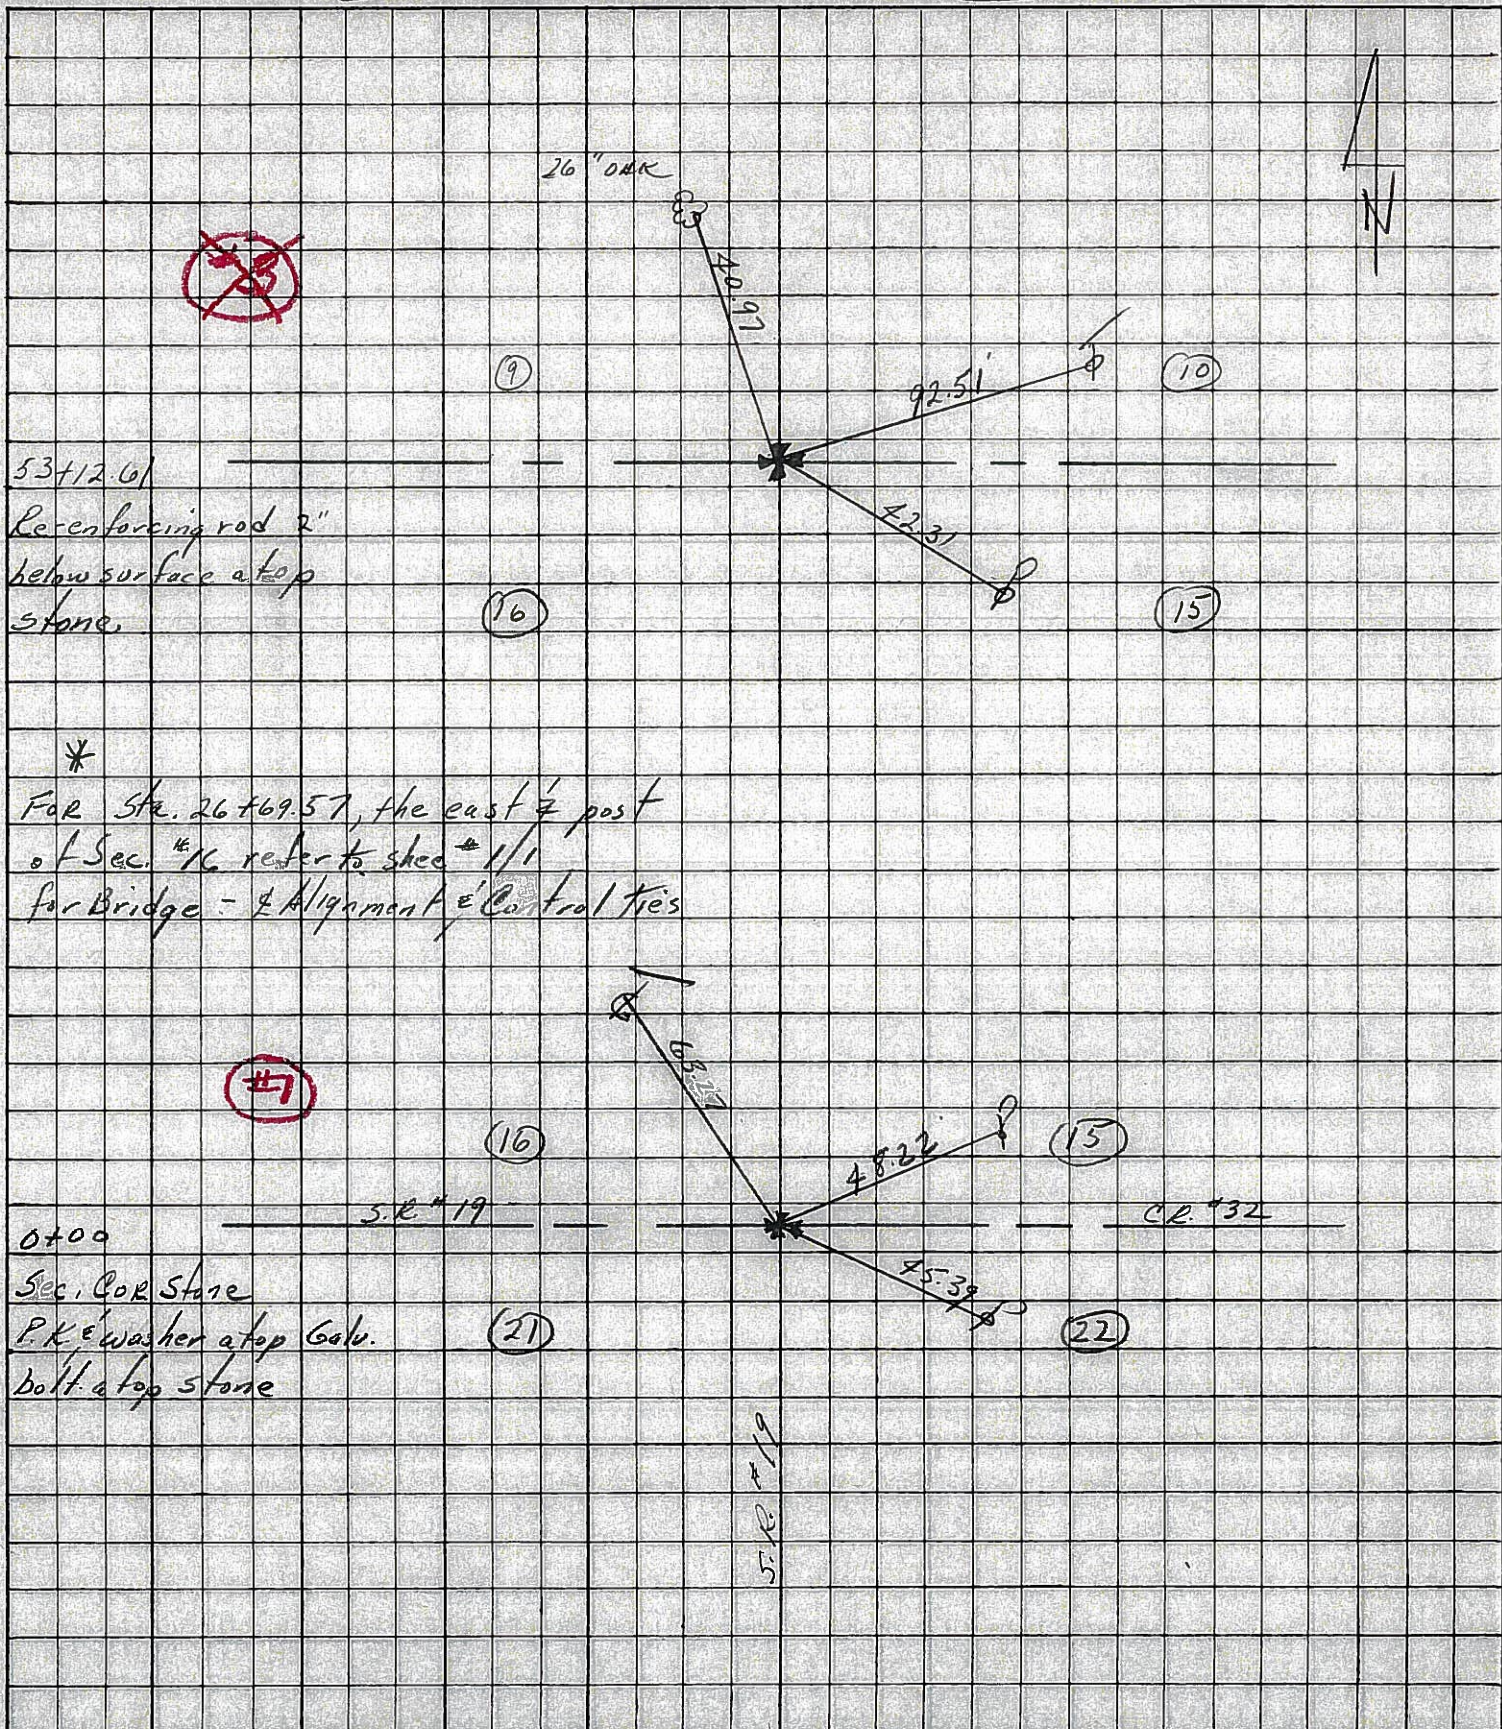
Control Point Ties

53+12.61
Re-enforcing rod 2"
below surface at top
stone.
