O.D.O.T. DISTRICT 2 SURVEY OFFICE (USE ONLY)

PERSONNEL _____ REFERENCE NO. 31 SHEET 11 OF 21
 NOTES JAMES DATE 4/24/19 ROUTE SR 582
 H.C. JAMES WEATHER CLOUDY COUNTY WOOD
 R.C. LEU TEMP. 55° TOWNSHIP WEBSTER
 DWG BY BALBAUGH PID 81000 SECTION 25
 T 6 N R 11 E

TYPE MONUMENT MAG/WASHER
 ON SURFACE - ~~BELOW~~ ON
 OFFSET CL PAVEMENT 9.6' ~~RT~~ : RT
0.2' TO RT EDGE PAVEMENT
 STATION: 554+32.24

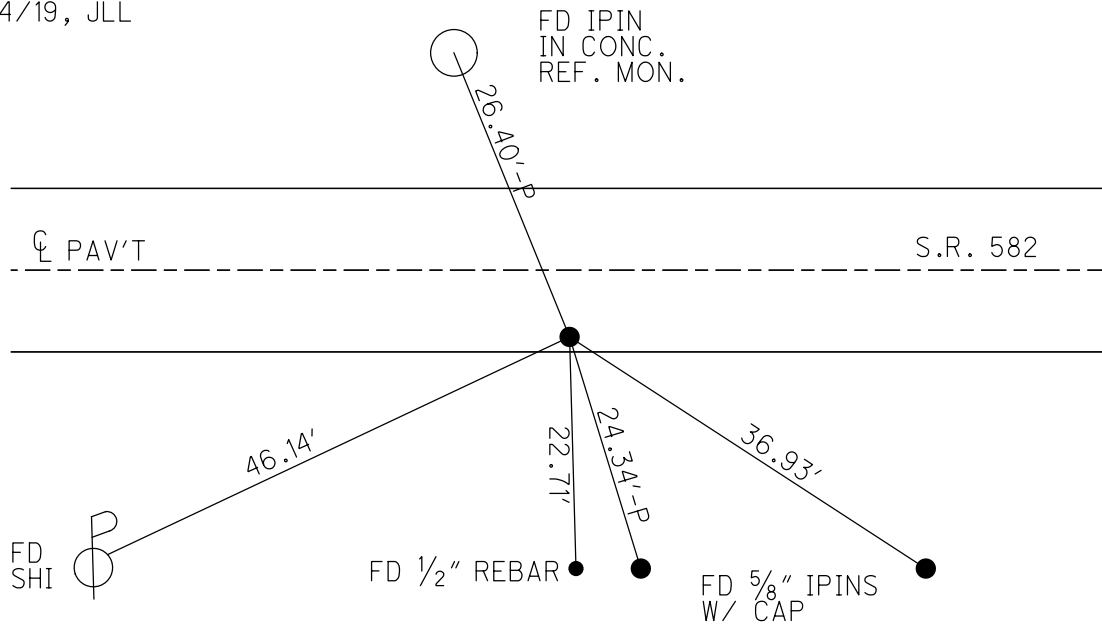
HORZ. DATUM: NAD83 (2011) GEOID: 2012A
 GRID: NORTHING: 654006.583 EASTING: 1680251.676

RECORD:
 FD P.K./WASHER
 4/19/05, MDB
 FD 1" IPIN
 10" DOWN
 PROBED TO STONE
 5' DOWN
 SET 1" IPIN ATOP STONE
 15" DOWN
 5/20/05
 SET MAG/WASHER
 9/2/05, MDB
 FD MONBOX
 W/ 1" IPIN
 NEWREF31
 11/14/19, JLL

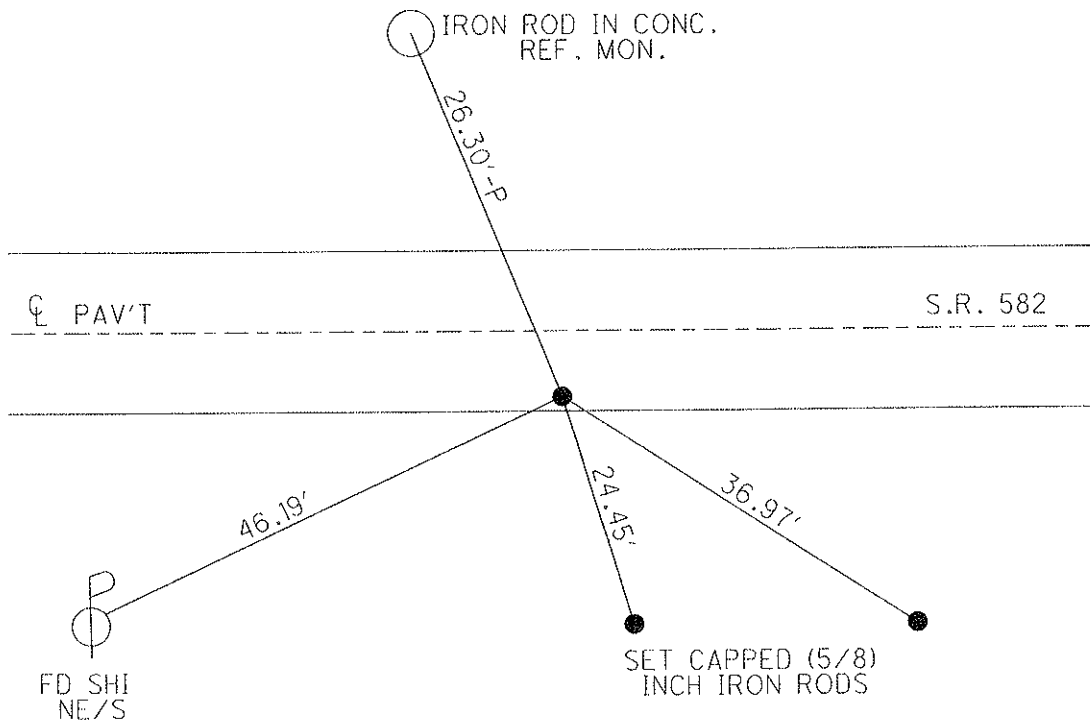
TYPE MONUMENT PK & WASHER

ON SURFACE - ~~BELOW~~ YES

~~LEFT~~ - Q PAV'T - RIGHT 9.6'

0.2' TO RT. EDGE PAVEMENT

S.L.M. 554+53

Note: On 05/20/05 dug down, fd 1" iron rod at 10", continued down 2.5' found nothing. We probed further down, found what we believed to be the stone around 5' down from surface. Reset 1" iron rod atop of assumed stone at same location as found. The 1" iron rod is 15" down from surface.

RESET MAG NAIL & WASHER
09/02/05
MDB

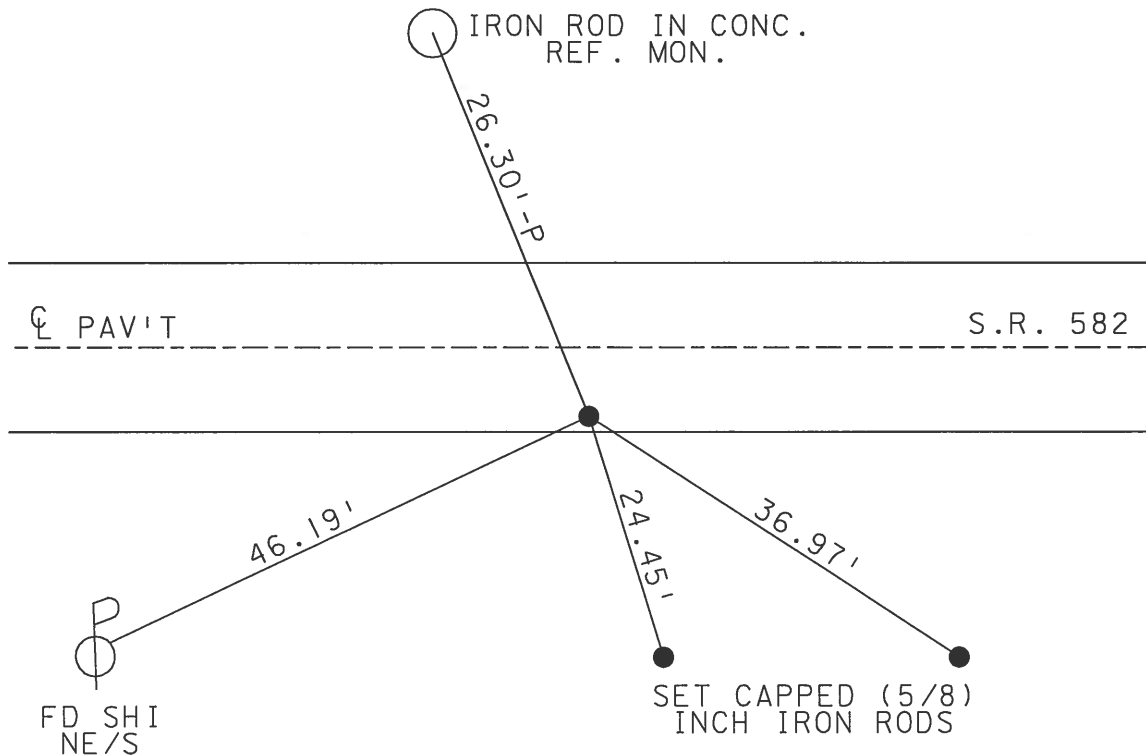
TYPE MONUMENT PK & WASHER

ON SURFACE - ~~BELOW~~ YES

~~LEFT~~ - Q PAV'T - RIGHT 9.6'

0.2' RT OF RT EDGE PAVEMENT

S.L.M. 554+53

Note: On 05/20/05 dug down, fd 1" iron rod at 10", continued down 2.5' found nothing. We probed further down, found what we believed to be the stone around 5' down from surface. Reset 1" iron rod atop of assumed stone at same location as found. The 1" iron rod is 15" down from surface.

RESET MAG NAIL & WASHER
09/02/05
MDB

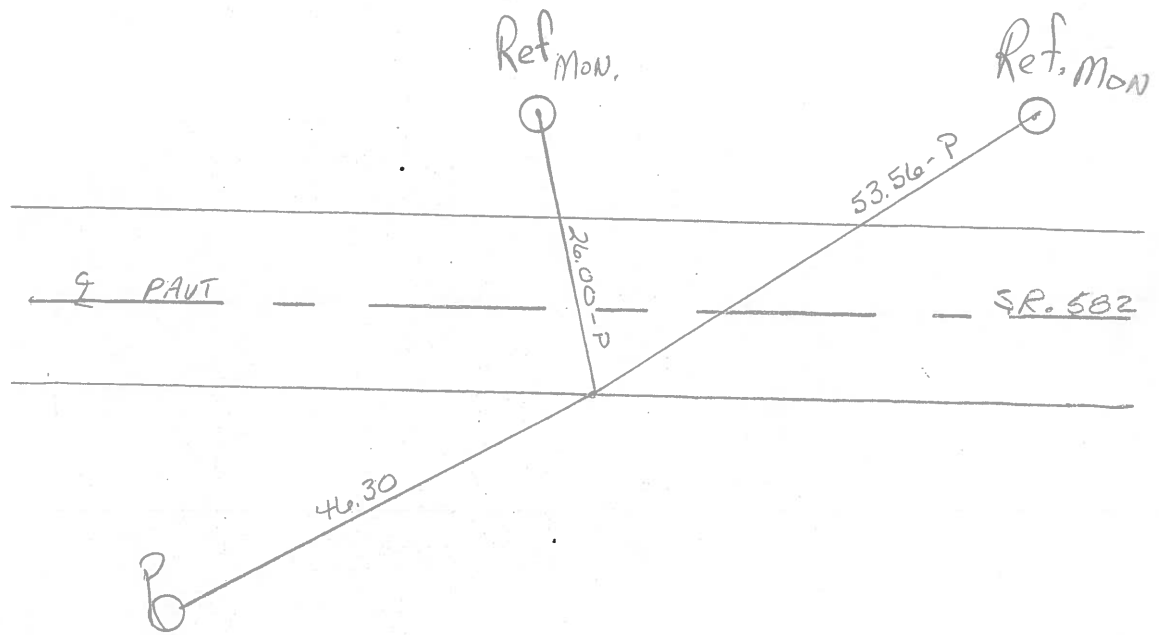
TYPE MONUMENT RR Spike

ON SURFACE - ~~BELOW~~ Yes

LEFT - 0 PAV'T. - RIGHT 9.6

0.2 RT OF ET EDGE PAVEMENT

S.L.M. 554+53

Set P.K. / WASHER
10-25-90
MB

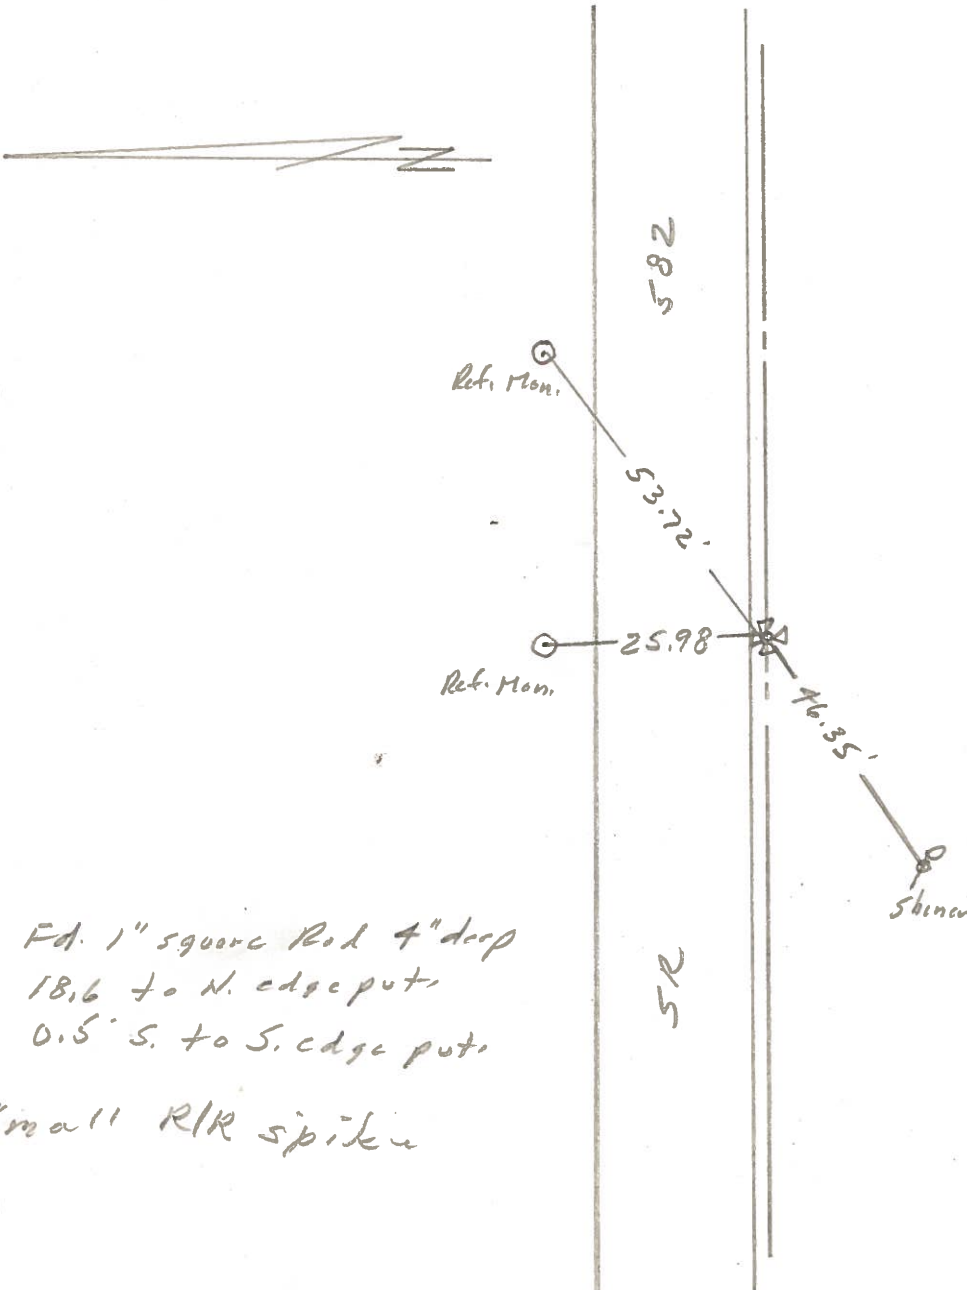
REF. NO. 31

SLM Sta. 554+61
