State of Ohio Department of Transportation
Field Notes

COUNTY WOOD DATE 12-29-93
 S. R. 65 WEATHER Cloudy
 MILTONVILLE ACCESS
 SEC. 11.16 TEMP. +20°

DESCRIPTION PAVT WIDTH'S FOR RESURFACING JOB NO. _____
 LEFT CENTER LINE RIGHT

Miltonville Access: SR 65 - QUITT ROAD

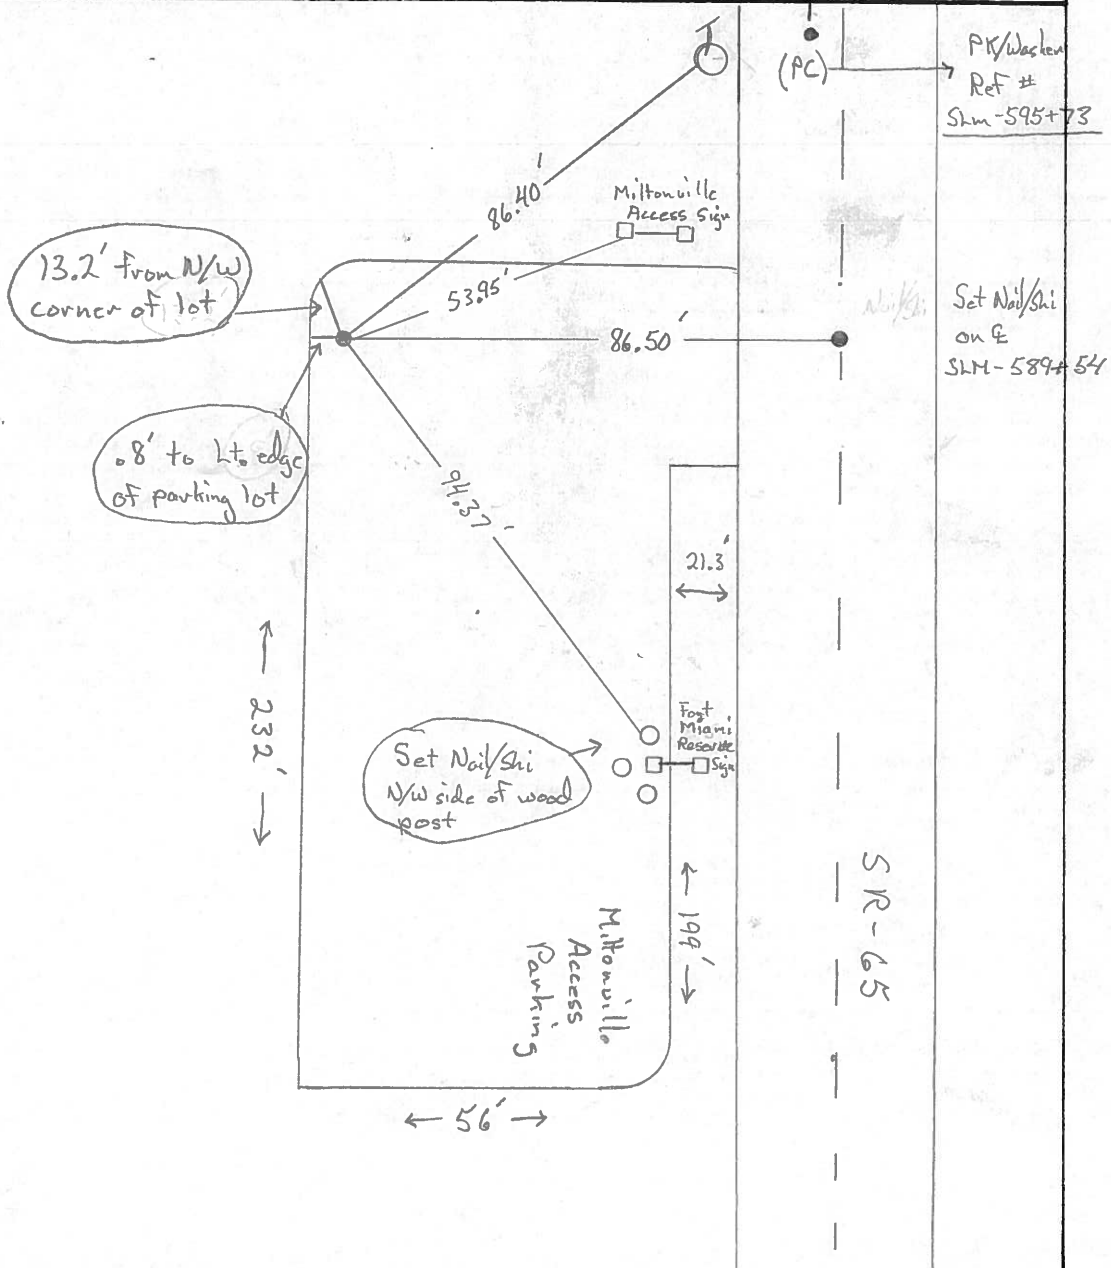
S.L.M. Miltonville Access hot

Existing lot is in good condition and clipped and sealed in summer '93 - pave with 1 3/4" 402
1 1/4" 404

lot surround on 3 sides with wood guard post

Entrance 20' x 26'

Draw Detailed sketch - measure - locate bad part areas (if any - if done, so state) - tie in to SR 65 stationing - Reference Point Sta. - Set a site Bench Mark - 100.00 elev. Profile & x-section per sketch - ALSO TAKE AND ELEVATIONS at the corners of the parking lot, AND in the center.

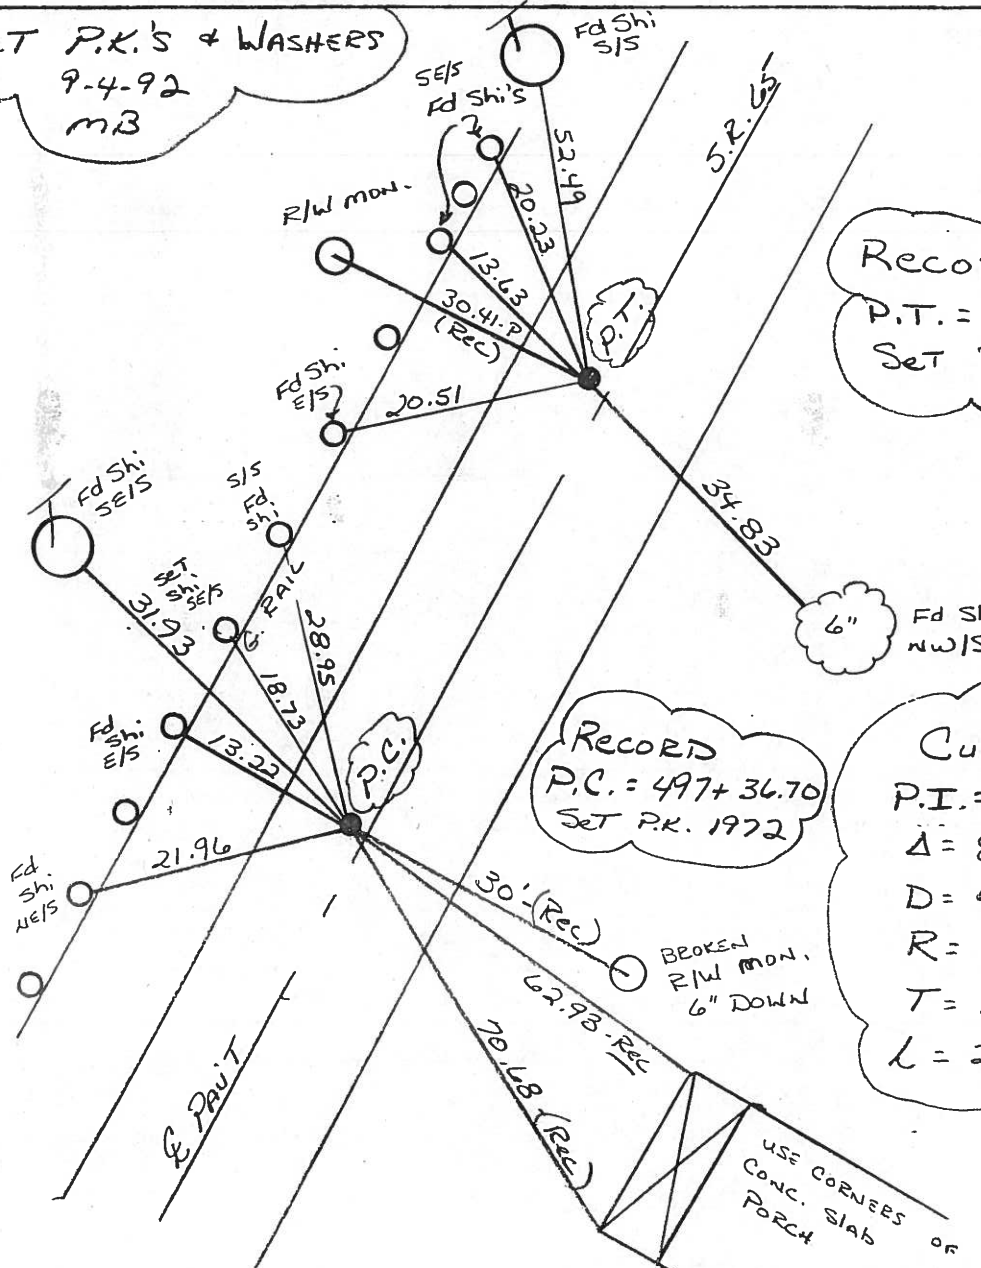
RECORD:
P.T. = 499+42.95
Set P.K. 1972

RECORD
P.C. = 497+36.70
Set P.K. 1972

CURVE DATA 1926
P.I. = 498+40.00
 $\Delta = 8^{\circ}-15'$ RT
D = 4'-0"
R = 1432.69
T = 103.30
L = 206.25

USE CORNERS OF
CONC. SLAB
PORCH

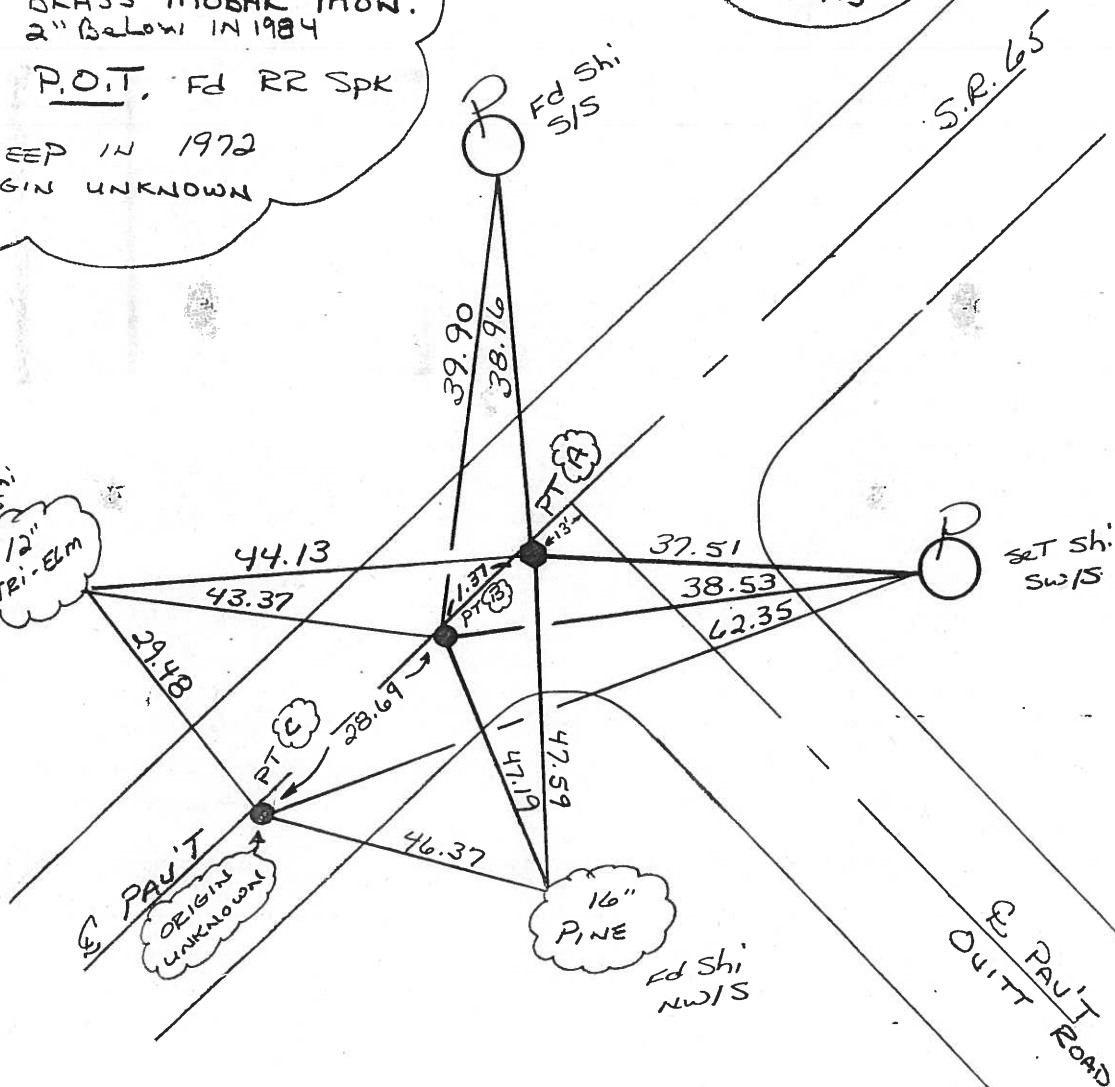
MAUMEE		46
		45
		44
Sec 17		Sec 16

Record :

PT (A) BRASS MOBAR MON.
 2" Below in 1984

PT (B) P.O.T. Fd RR SPK

4" DEEP IN 1972
 ORIGIN UNKNOWN

Reset P.K.'S & WASHERS
 9-4-92
 mB

Set Shi
 SE/S
 1/2" TRI-ELM

Fd Shi
 S/S

Set Shi
 SW/S

E PAV'T
 ORIGIN UNKNOWN

16" PINE
 Fd Shi
 NW/S

E PAV'T ROAD
 QUITT ROAD

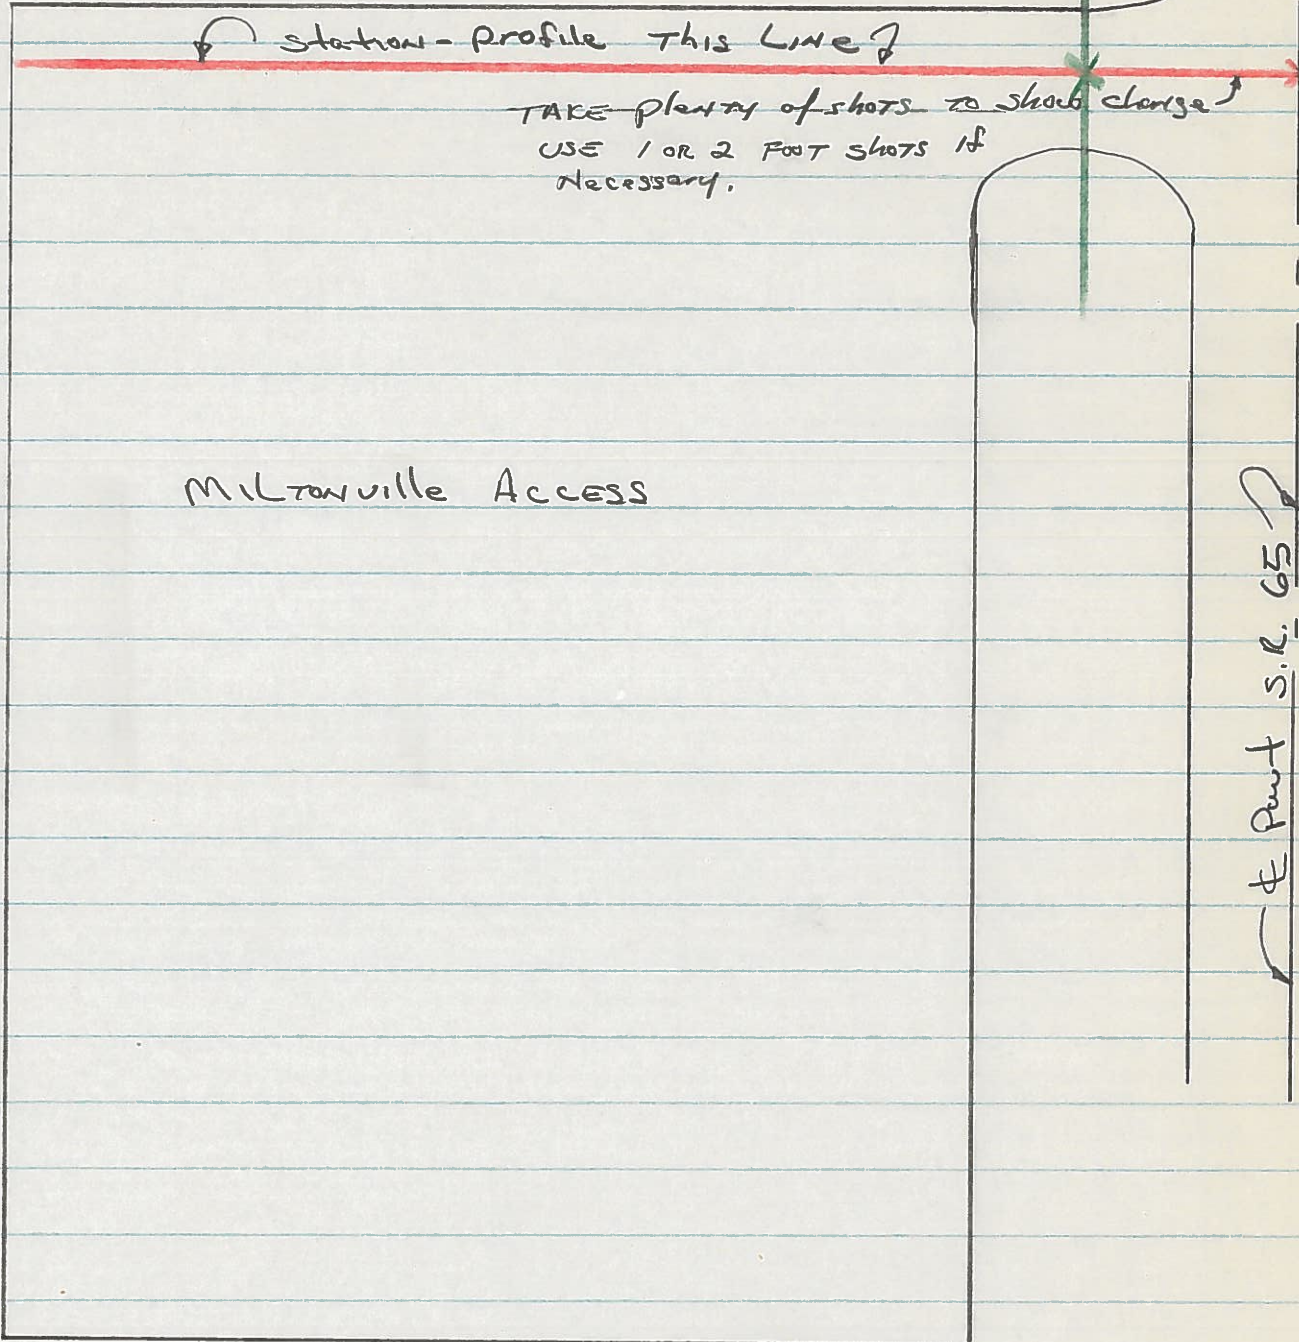
MILTONVILLE ACCESS

Station - Profile This Line

TAKE plenty of shots to show change
USE 1 OR 2 FOOT SHOTS if
Necessary.
