**Figure 6b**  
**Noise Sensitive Area D**  
(NSA D)  
Type II Noise Wall Retrofit  
TRU-80 | PID 108492  
Trumbull County, Ohio

**Figure 8a**  
**Noise Sensitive Area E**  
 (NSA E) - West of Logan Way  
 Type II Noise Wall Retrofit  
 TRU-80 | PID 108492  
 Trumbull County, Ohio

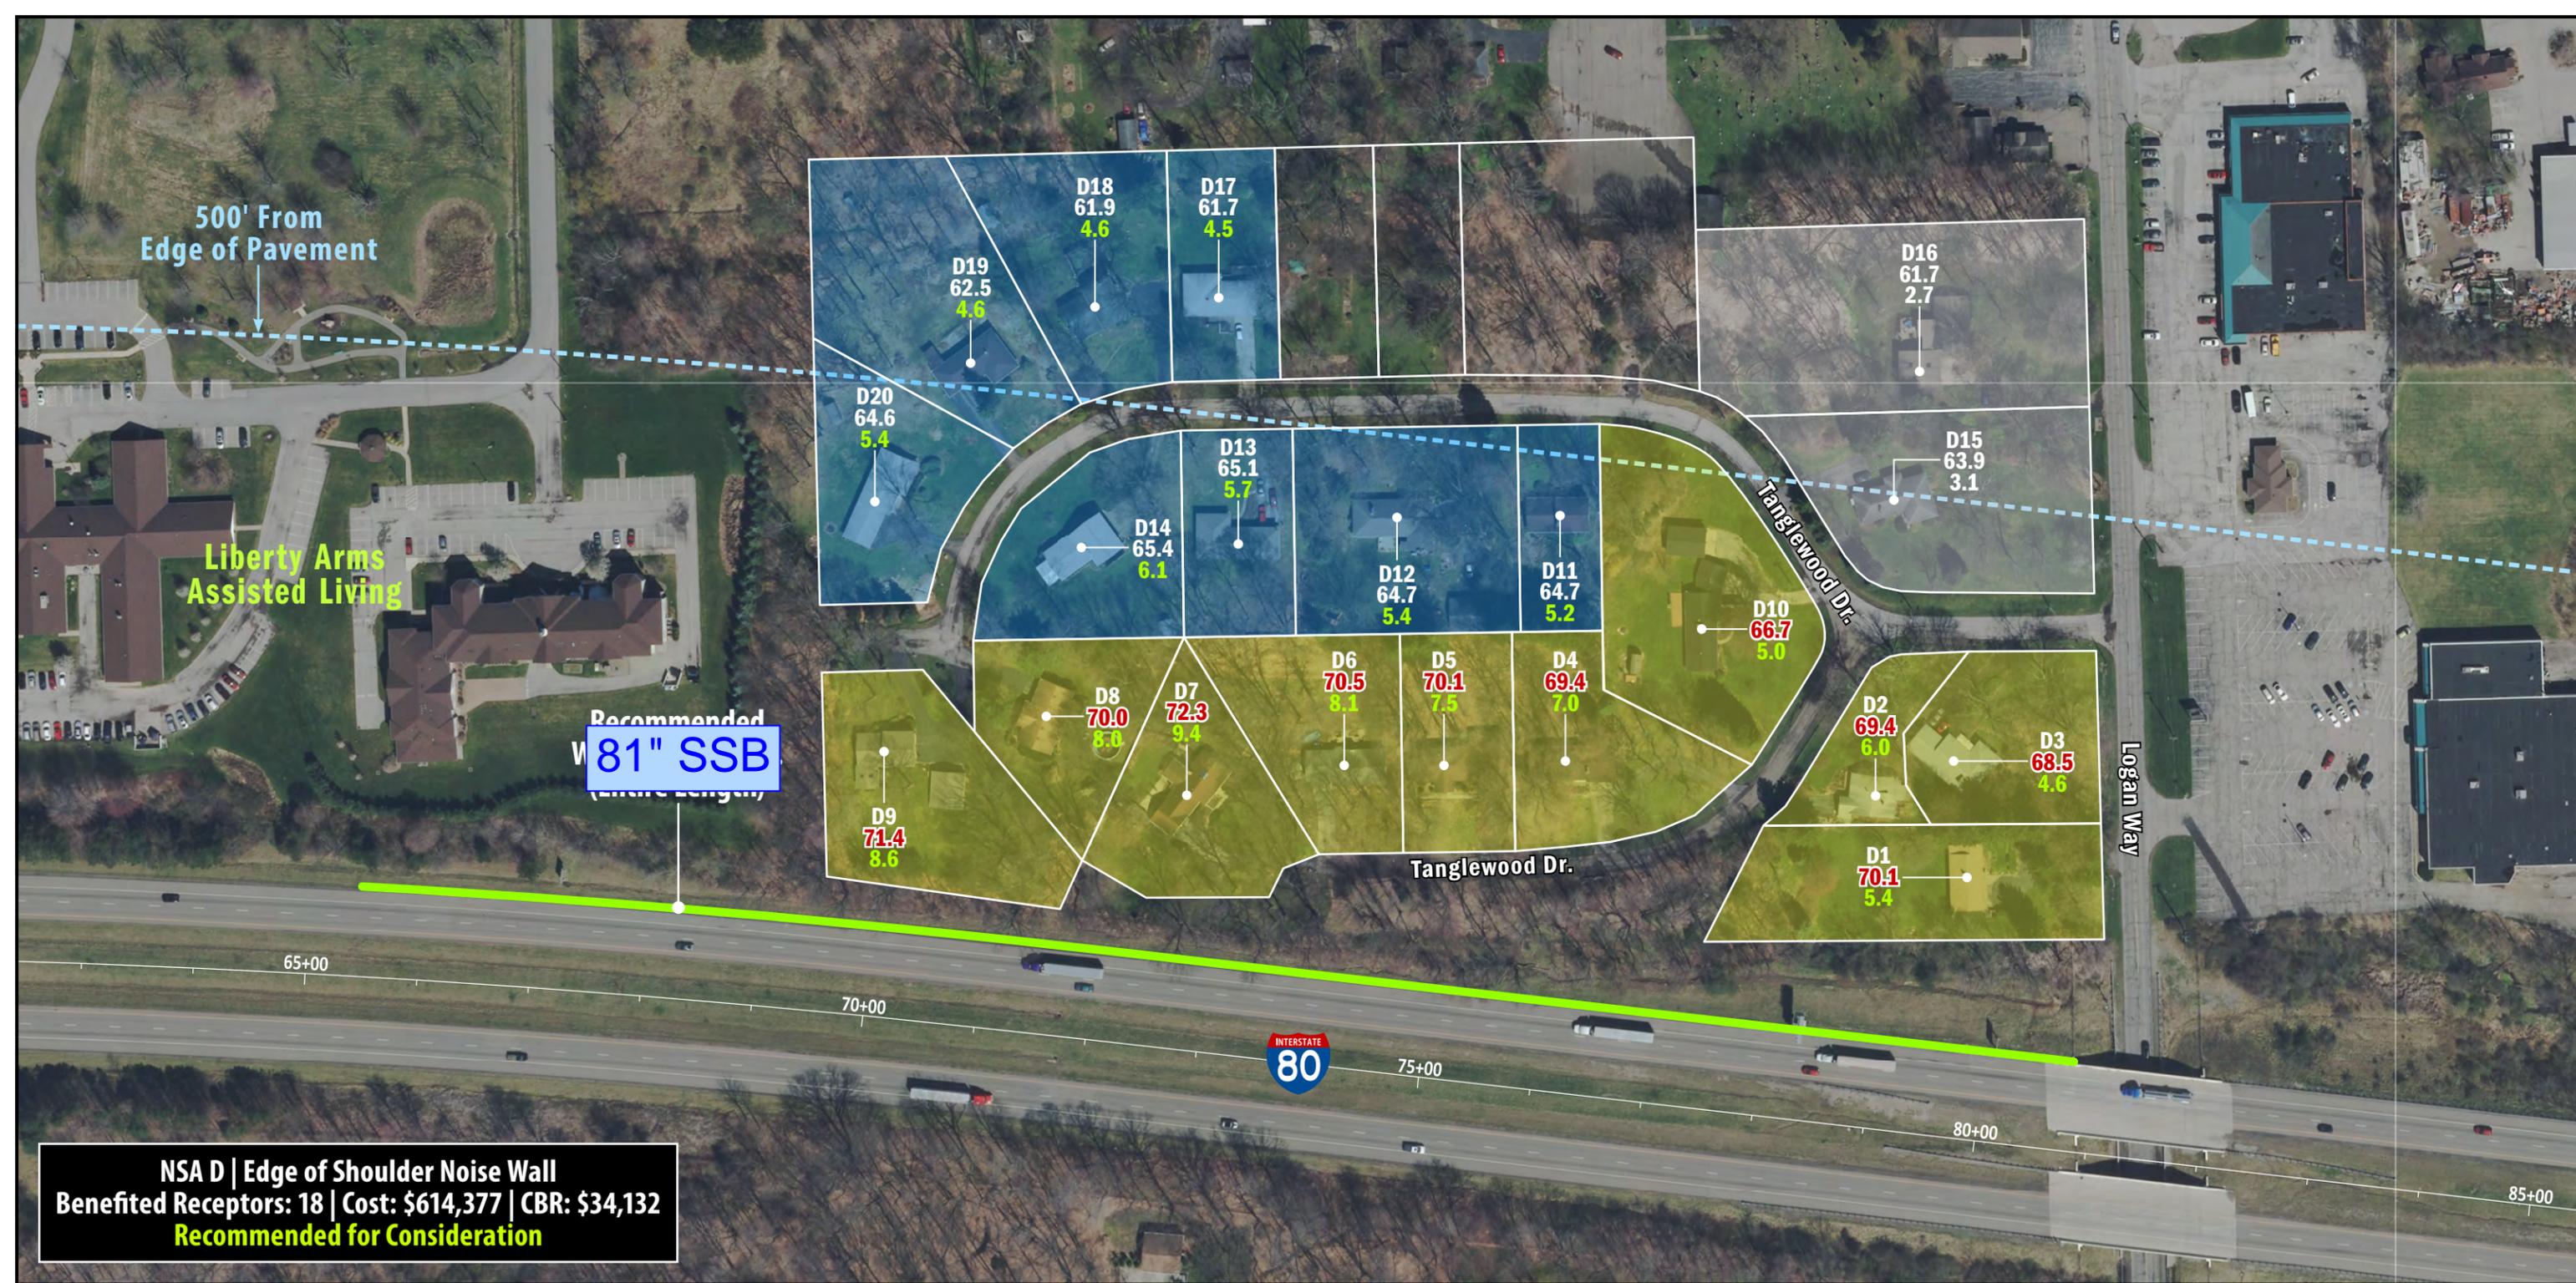
D15 Receptor ID  
63.9 Sound Level without Noise Wall | Impacts in RED  
3.1 Reduction from Wall | Benefits in GREEN

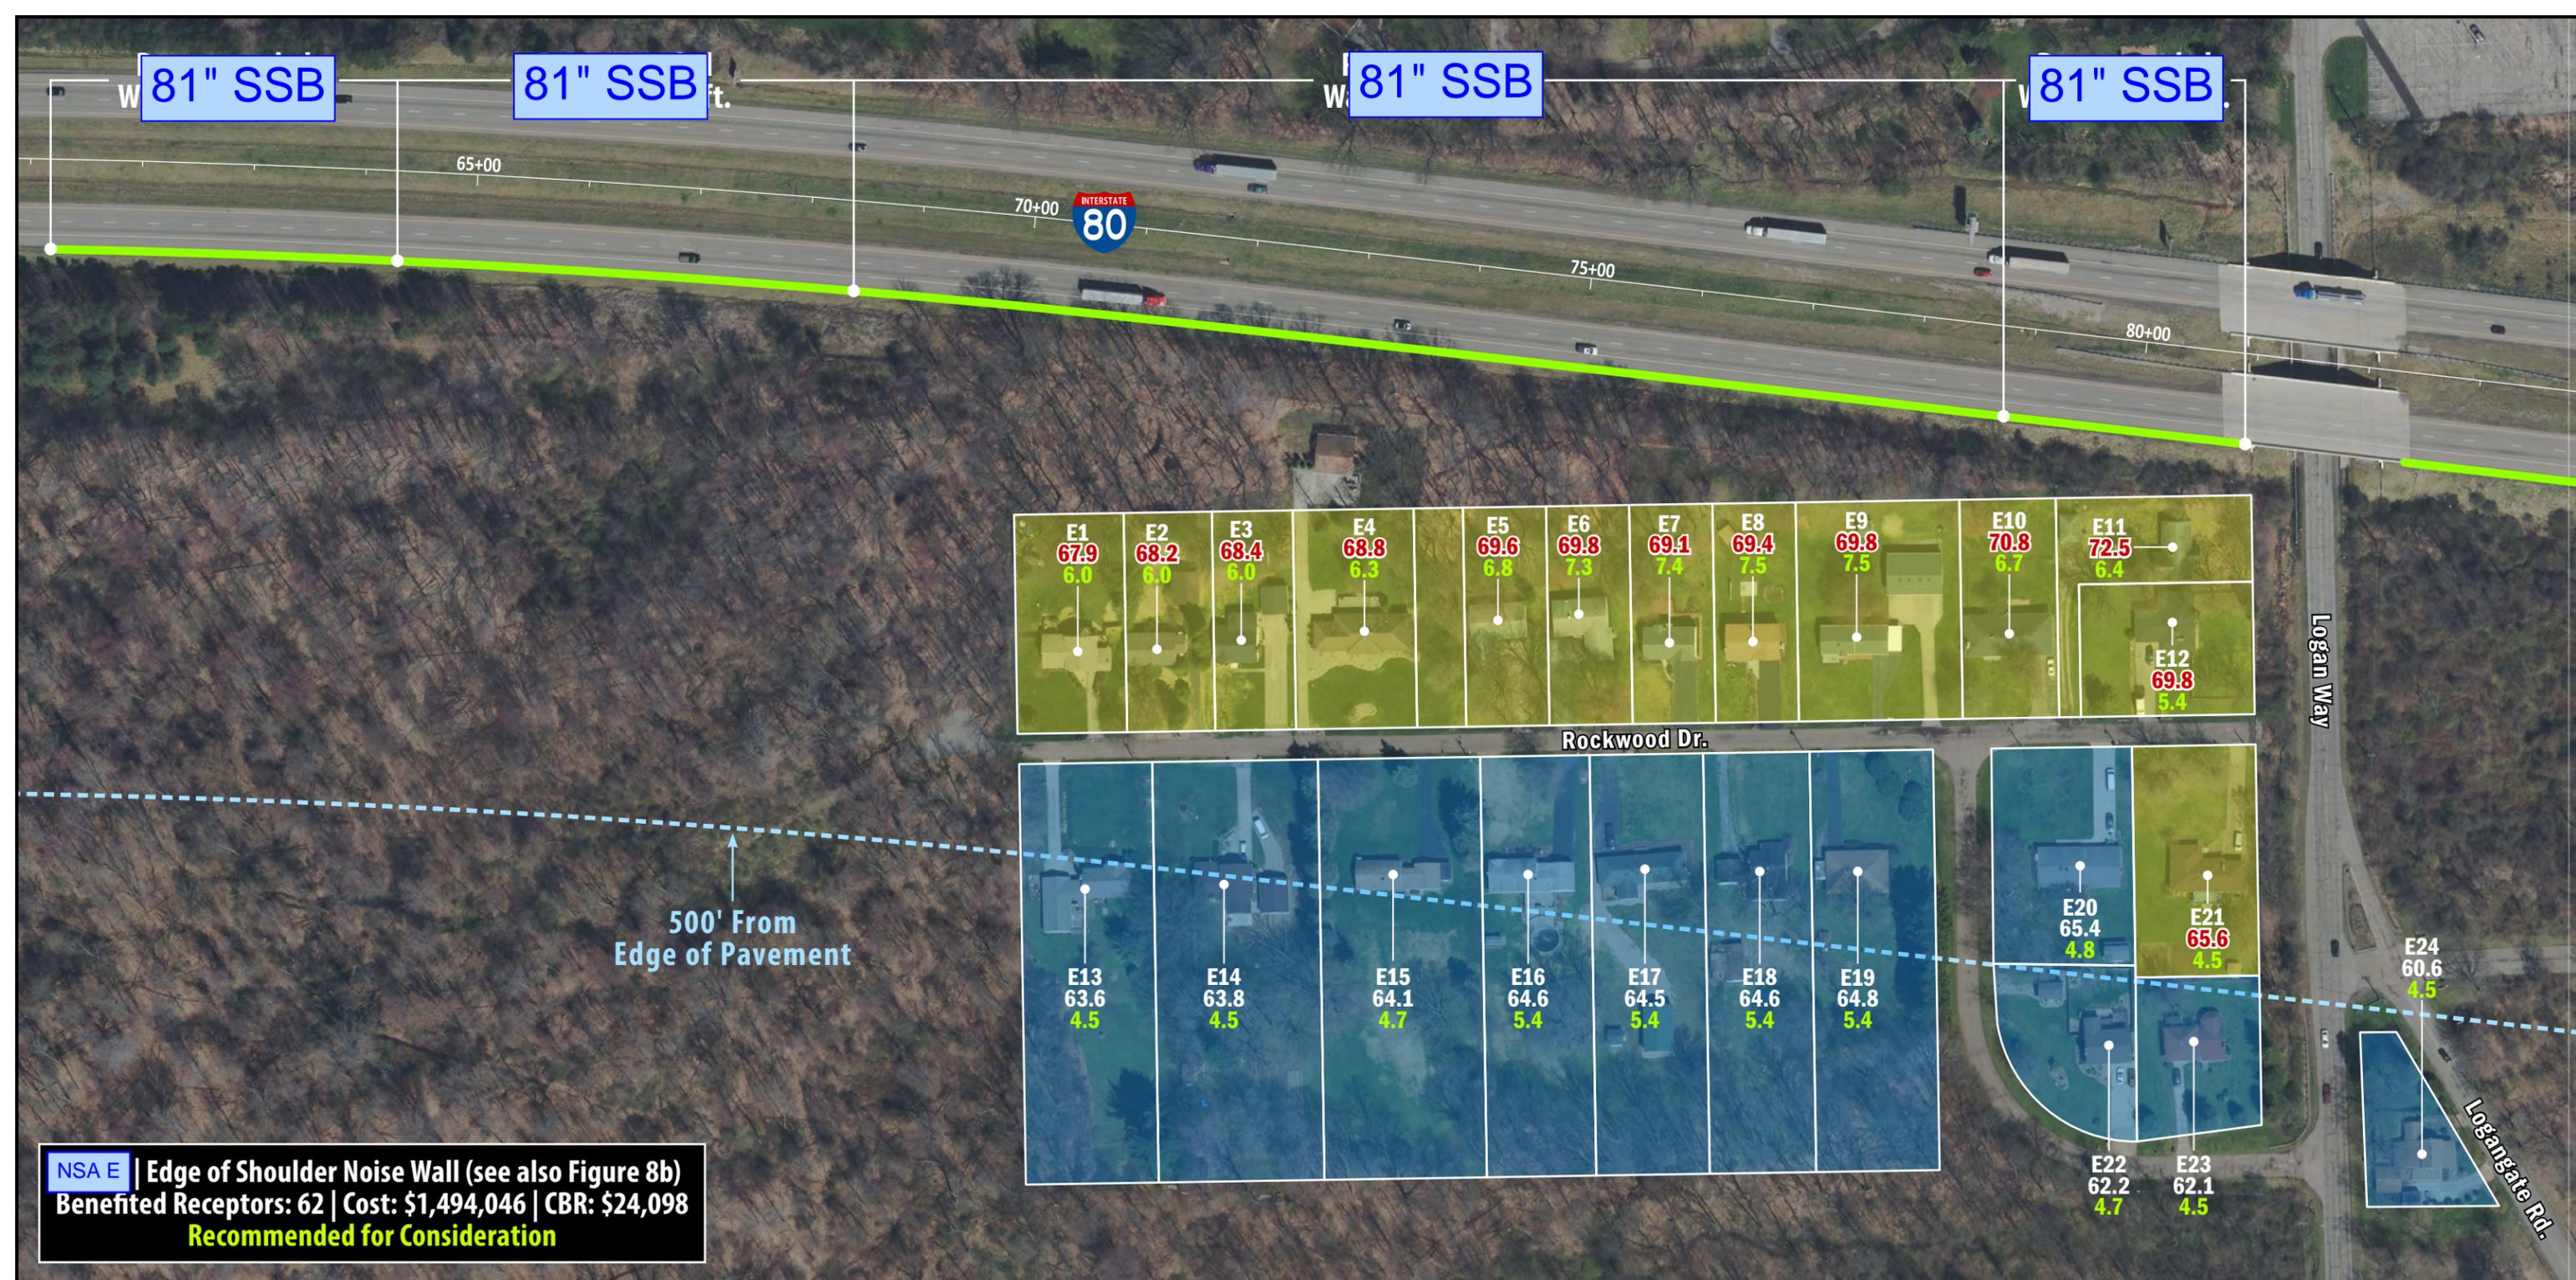
**E20 Receptor ID**  
 65.4 Sound Level without Noise Wall | Impacts in **RED**  
 4.8 Reduction from Wall | Benefits in **GREEN**

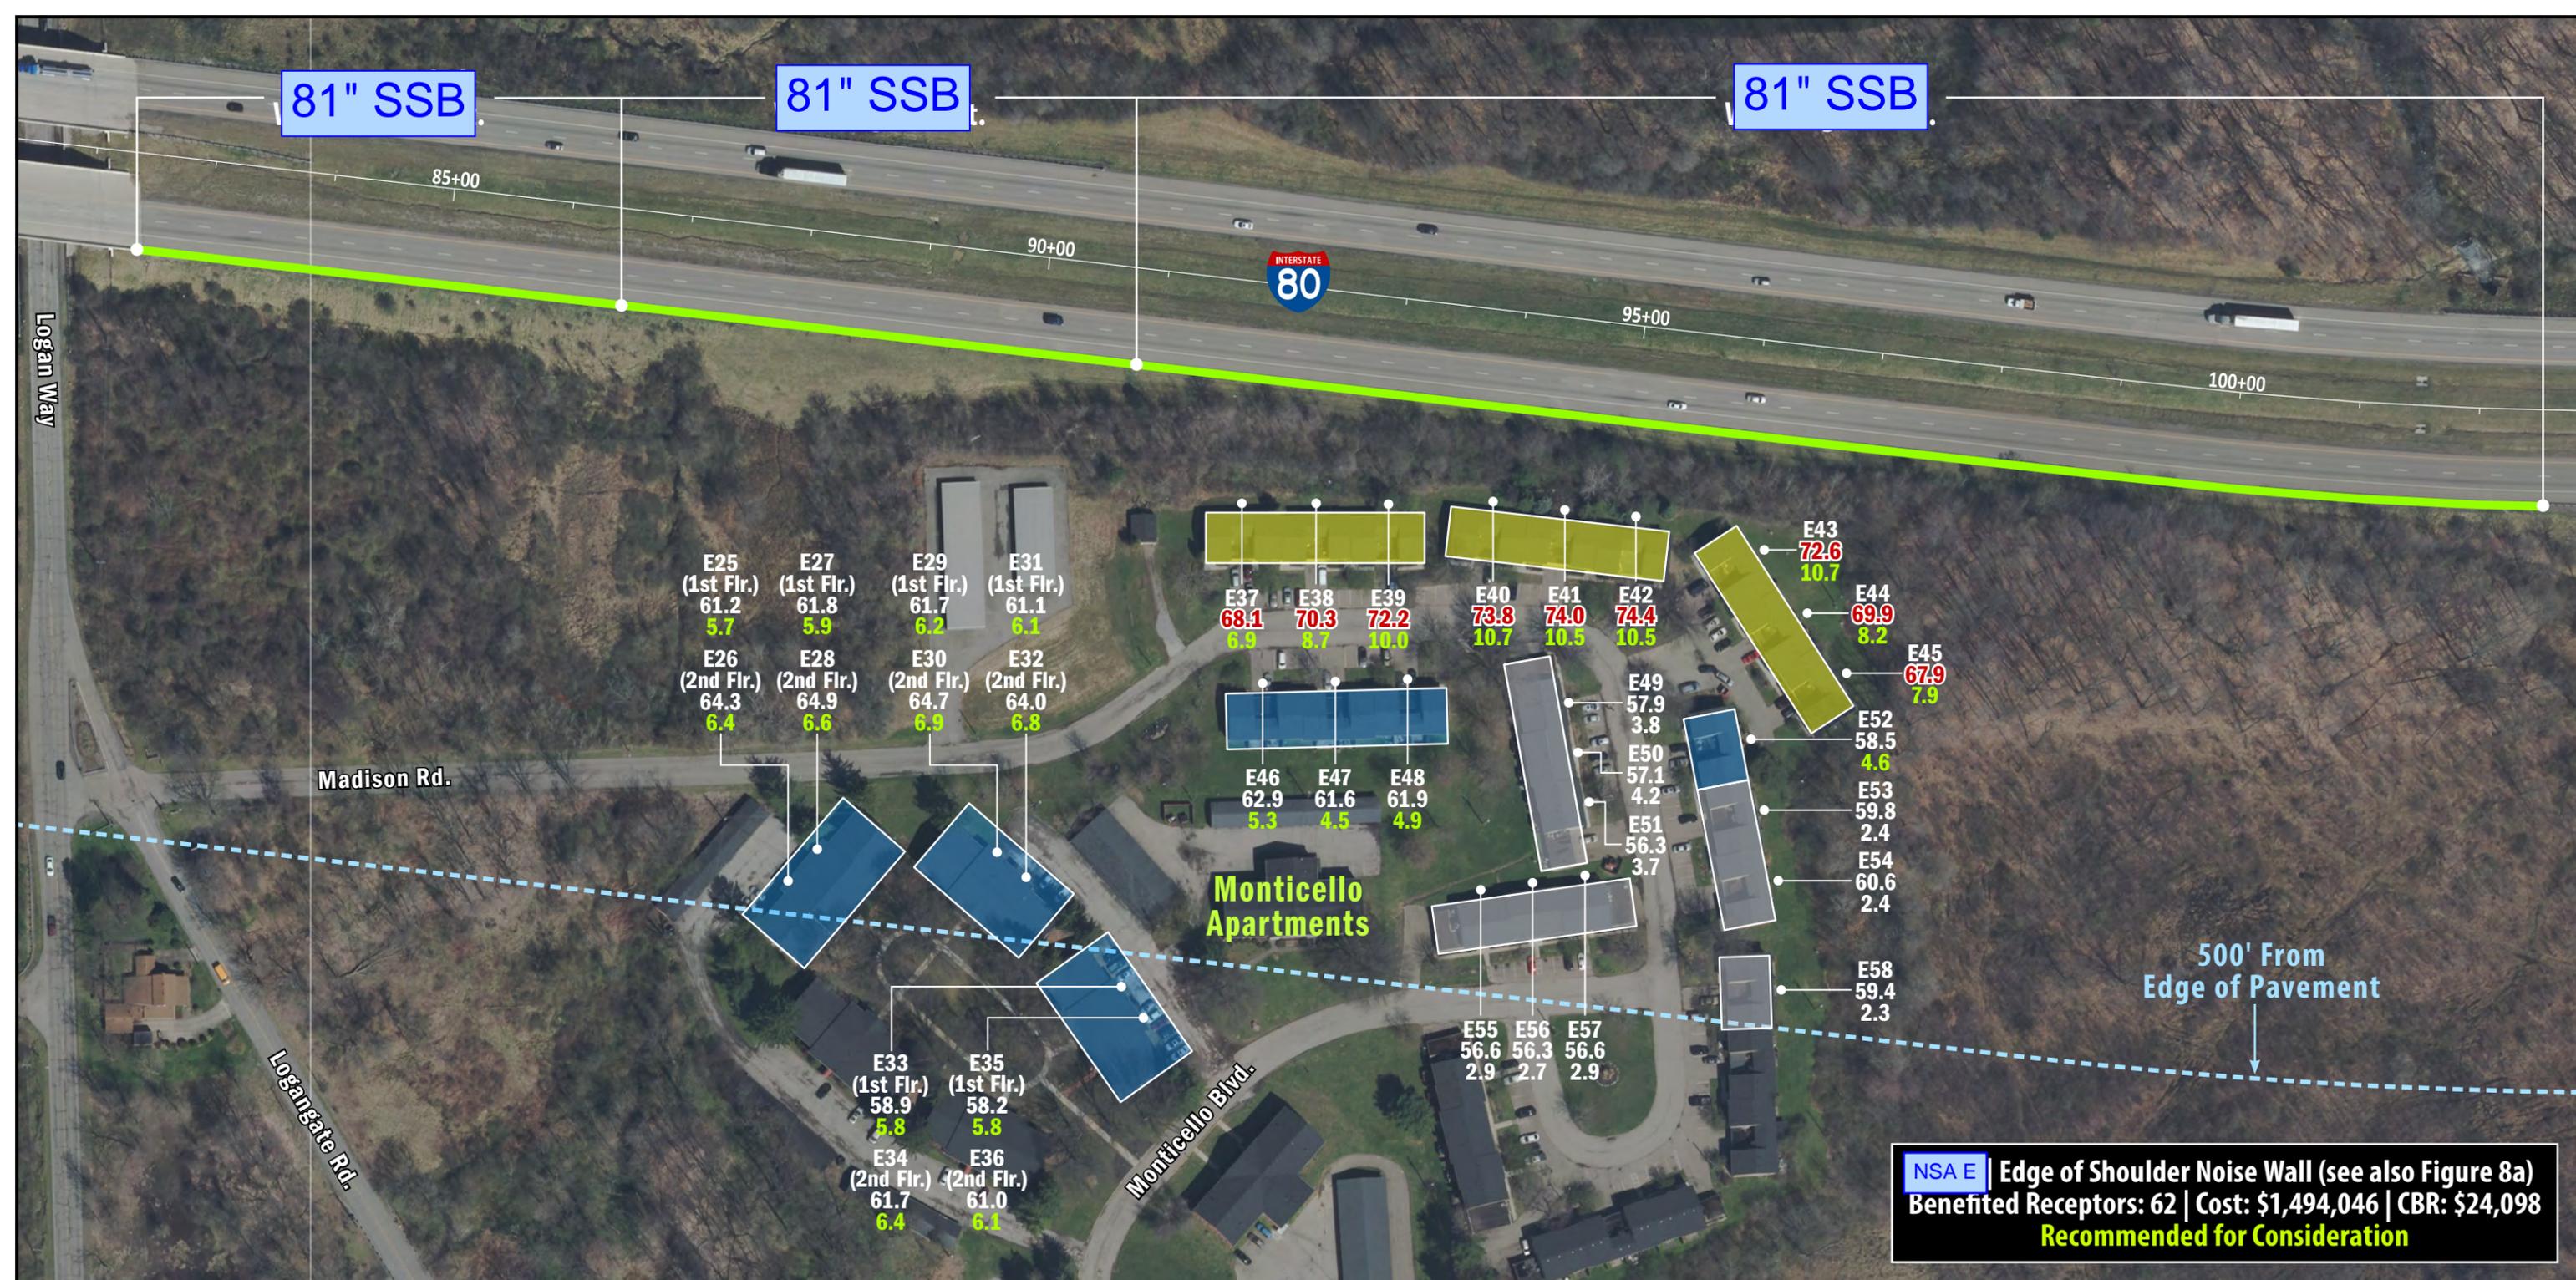
**Figure 8b**  
**Noise Sensitive Area E**  
 (NSA E) - East of Logan Way  
 Type II Noise Wall Retrofit  
 TRU-80 | PID 108492  
 Trumbull County, Ohio

**E50** Receptor ID  
 57.1 Sound Level without Noise Wall | Impacts in **RED**  
 4.2 Reduction from Wall | Benefits in **GREEN**
