## GEOTECHNICAL DESIGN MEMORANDUM

**Date:** October 03, 2025  
**To:** Mr. Craig Litmer, P.E., American StructurePoint  
**From:** Chunmei (Melinda) He, Ph.D., P.E. & Momen A. Alassi, M.Sc, E.I., NEAS Inc.  
**RE: Geotechnical Design Memorandum  
PRE-70-00.00  
PID: 117139**

This memorandum presents our geotechnical design recommendations for the proposed PRE-70-0.00 project (PID: 117139), located in Preble County, Ohio. The project involves the construction and installation of high mast light poles within the truck parking lot along Interstate 70 (IR-70). This document provides soil property information as well as our recommendations for foundation design and construction.

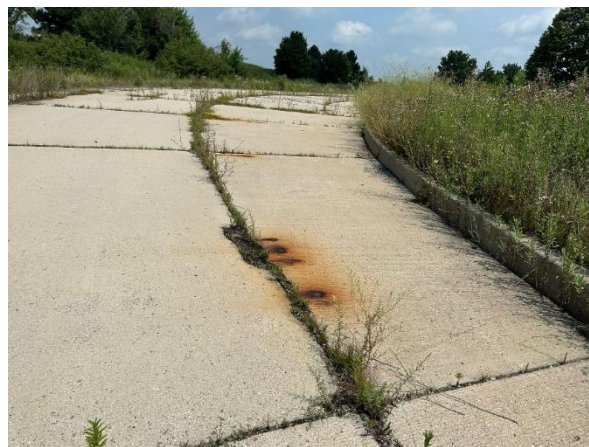
Photograph 1: Pavement conditions

At the time of our reconnaissance, pavement within the project limits was generally in good condition, though some weathering and surface wear were noted. Occasionally low severity joint spalling and iron staining were observed, along with extensive vegetation growth along pavement joints throughout the area (Photograph 1). The surrounding area was vegetated with tall grass, shrubs, and young deciduous and coniferous trees.

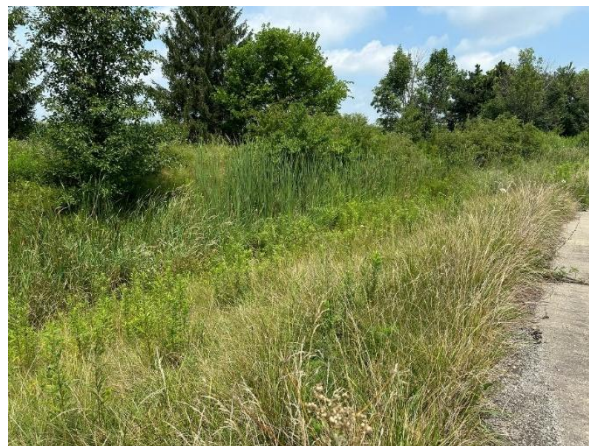
Photograph 2: Evidence of standing water

In the vicinity of B-001-0-25, standing water and the presence of cattails were observed (Photograph 2). Drainage appeared to flow northwest near B-001-0-25, and south near B-002-0-25, directing water toward the embankment. No evidence of geotechnical instability was observed during reconnaissance.
