# Structure Foundation Exploration

## Brent Spence Bridge Replacement

Project No. N1105070

March 11, 2011

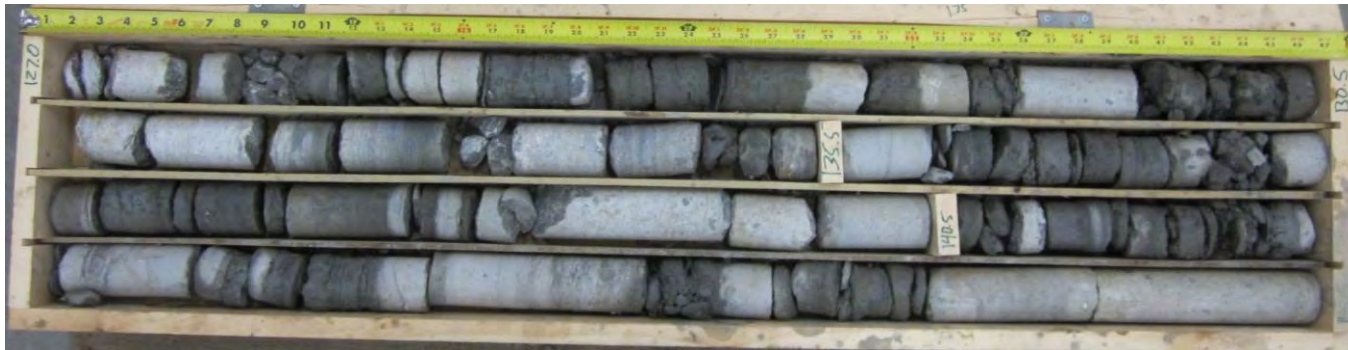
BORING NO.: L-1  
 CORE BOX NO.: 1 OF 3  
 DEPTH (ft.): 127.0-145.5  
 ELEVATION (ft.): 366.46  
 1/NQ: 127.0' – 130.5'; REC. 86%, RQD 29%  
 2/NQ: 130.5' – 135.5'; REC. 40%, RQD 0%  
 3/NQ: 135.5' – 140.5'; REC. 80%, RQD 20%  
 4/NQ: 140.5' – 145.5'; REC. 100%, RQD 52%

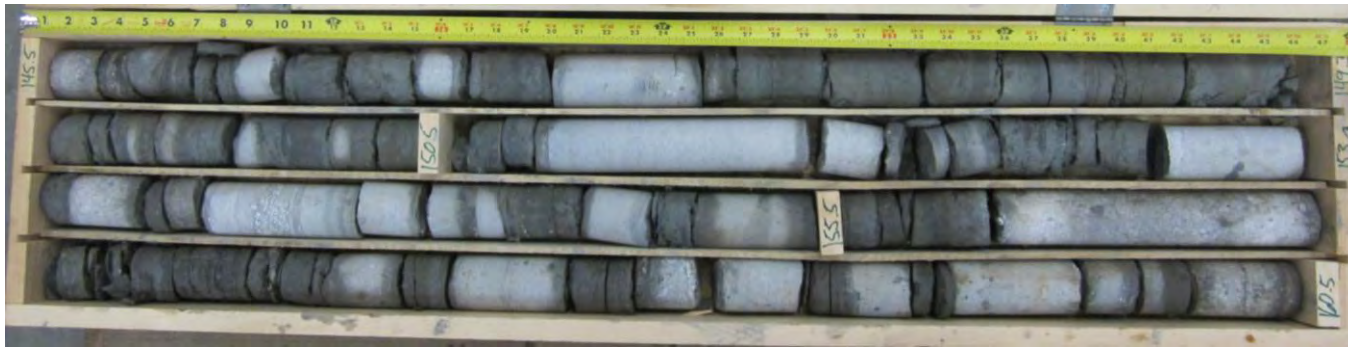
BORING NO.: L-1  
 CORE BOX NO.: 2 OF 3  
 DEPTH (ft.): 145.5-160.5  
 ELEVATION (ft.): 347.96  
 5/NQ: 145.5' – 150.5'; REC. 100%, RQD 20%  
 6/NQ: 150.5' – 155.5'; REC. 100%, RQD 54%  
 7/NQ: 155.5' – 160.5'; REC. 100%, RQD 48%

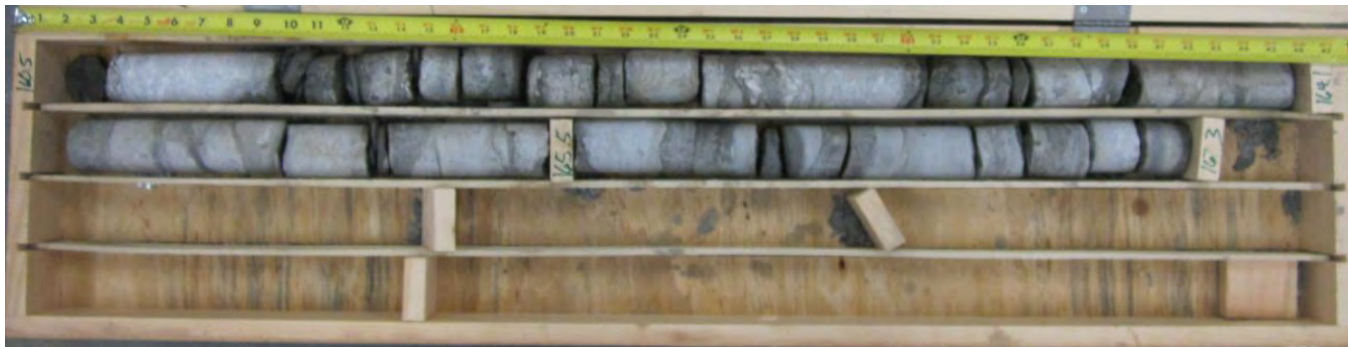
BORING NO.: L-1  
 CORE BOX NO.: 3 OF 3  
 DEPTH (ft.): 160.5-167.3  
 ELEVATION (ft.): 332.96  
 8/NQ: 160.5' – 165.5'; REC. 100%, RQD 64%  
 9/NQ: 165.5' – 167.3'; REC. 100%, RQD 61%

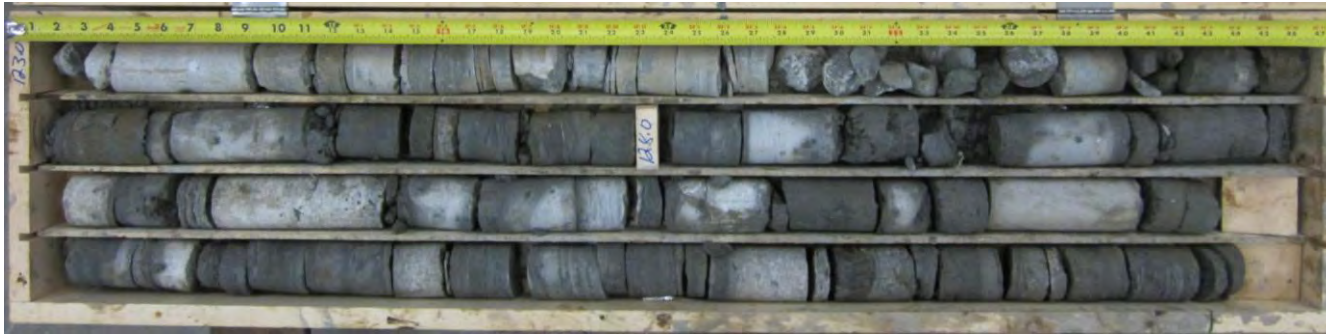
BORING NO.: L- 1A  
 CORE BOX NO.: 1 OF 3  
 DEPTH (ft.): 123.0-138.0  
 ELEVATION (ft.): 368.45  
 1/NQ: 123.0' – 128.0'; REC. 100%, RQD 16%  
 2/NQ: 128.0' – 133.0'; REC. 100%, RQD 44%  
 3/NQ: 133.0 – 138.0'; REC. 100%, RQD 24%

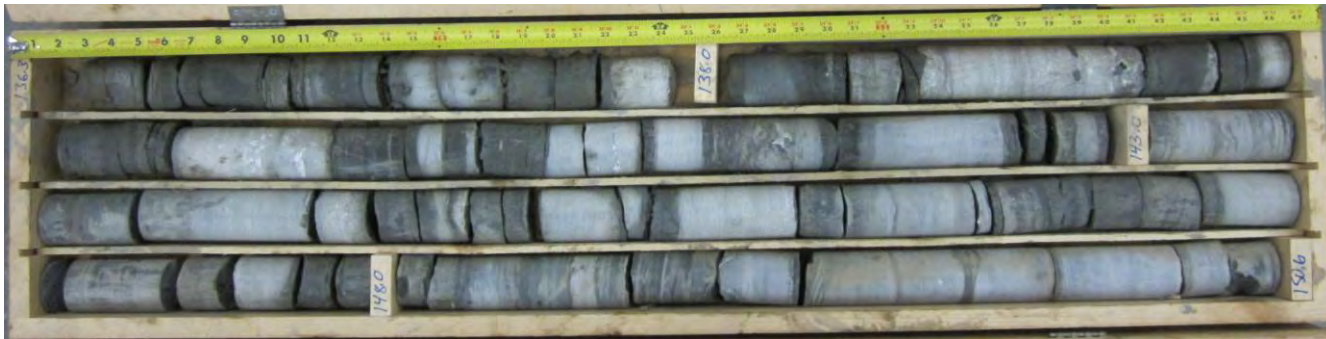
BORING NO.: L- 1A  
 CORE BOX NO.: 2 OF 3  
 DEPTH (ft.): 138.0 – 153.0  
 ELEVATION (ft.): 353.45  
 4/NQ: 138.0' – 143.0'; REC. 100%, RQD 60%  
 5/NQ: 143.0'-148.0'; REC. 100%, RQD 66%  
 6/NQ: 148.0' – 153.0'; REC. 100%, RQD 68%

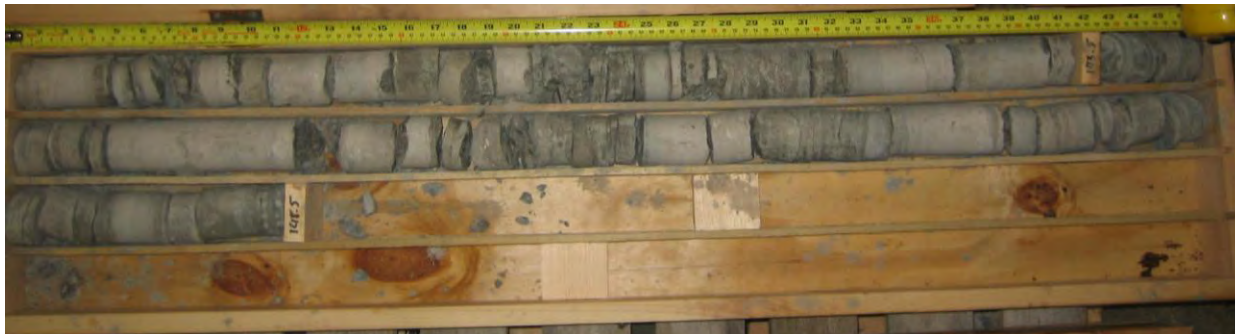
BORING NO.: L-2  
 CORE BOX NO.: 2 OF 4  
 DEPTH (ft.): 143.5-148.5  
 ELEVATION (ft.): 352.76  
 5/NQ: 143.5' – 148.5'; REC. 100%, RQD 18%

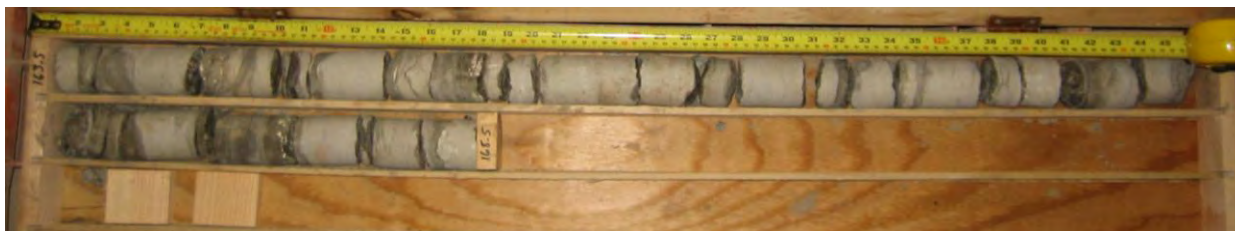
BORING NO.: L-2  
 CORE BOX NO.: 4 OF 4  
 DEPTH (ft.): 163.5-168.5  
 ELEVATION (ft.): 332.76  
 9/NQ: 163.5' – 168.5'; REC. 100%, RQD 7%

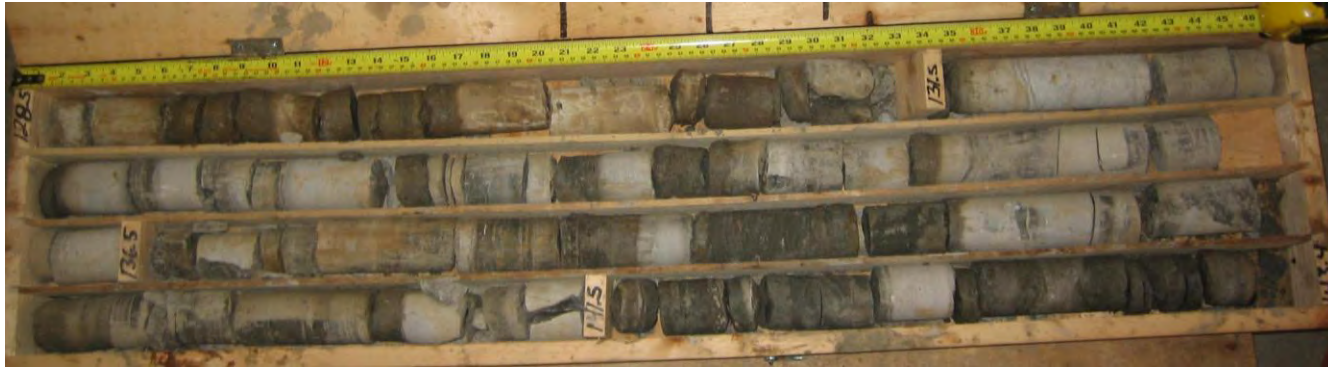
BORING NO.: L- 2A  
 CORE BOX NO.: 1 OF 3  
 DEPTH (ft.): 128.5-146.5  
 ELEVATION (ft.): 366  
 1/NQ: 128.5' – 131.5'; REC. 93%, RQD 10%  
 2/NQ: 131.5' – 136.5'; REC. 100%, RQD 30%  
 3/NQ: 136.5' – 141.5'; REC. 100%, RQD 48%  
 4/NQ: 141.5' – 146.5'; REC. 100%, RQD 42%

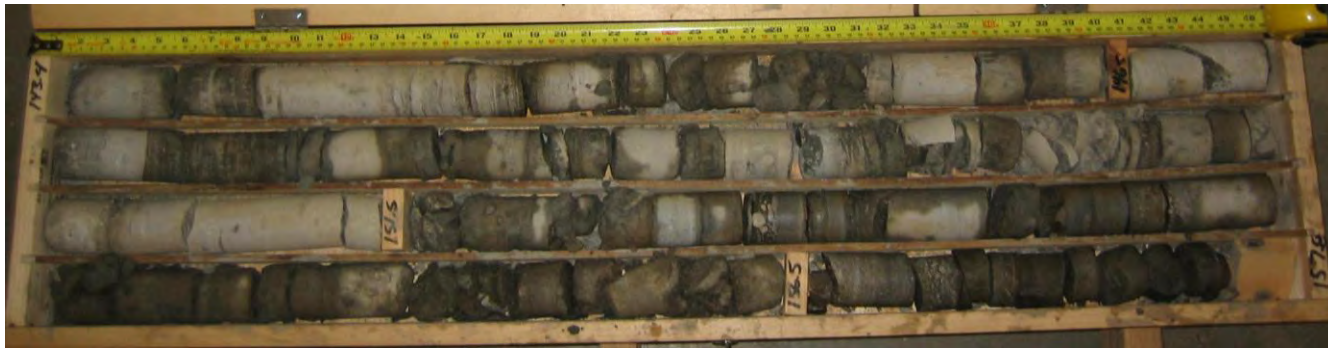
BORING NO.: L- 2A  
 CORE BOX NO.: 2 OF 3  
 DEPTH (ft.): 146.5-161.5  
 ELEVATION (ft.): 348  
 5/NQ: 146.5' – 151.5'; REC. 100%, RQD 42%  
 6/NQ: 151.5' – 156.5'; REC. 98%, RQD 24%  
 7/NQ: 156.5' – 161.5'; REC. 100%, RQD 52%

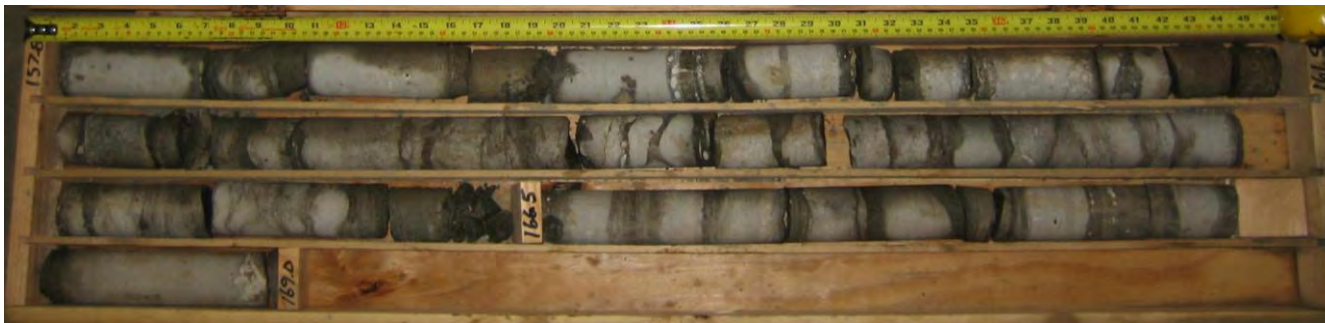
BORING NO.: L- 2A  
 CORE BOX NO.: 3 OF 3  
 DEPTH (ft.): 161.5-169.0  
 ELEVATION (ft.): 328  
 8/NQ: 161.5' – 166.5'; REC. 98%, RQD 80%  
 9/NQ: 166.5' – 169.0'; REC. 100%, RQD 100%

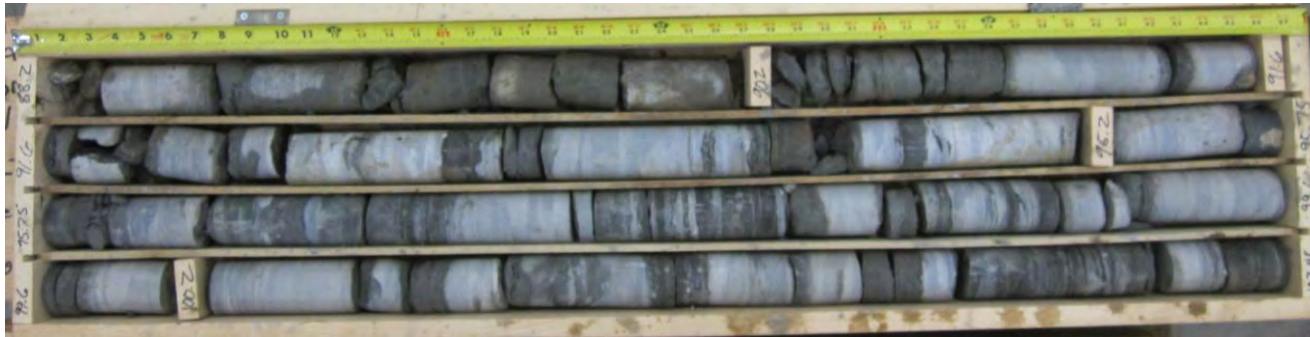
BORING NO.: L- 3  
 CORE BOX NO.: 1 OF 6  
 DEPTH (ft.): 88.2-105.2  
 ELEVATION (ft.): 370.46  
 1/NQ: 88.2' – 90.2'; REC. 100%, RQD 0%  
 2/NQ: 90.2' – 95.2'; REC. 92%, RQD 62%  
 3/NQ: 95.2' – 100.7'; REC. 87%, RQD 55%  
 4/NQ: 100.7' – 105.2'; REC. 100%, RQD 87%

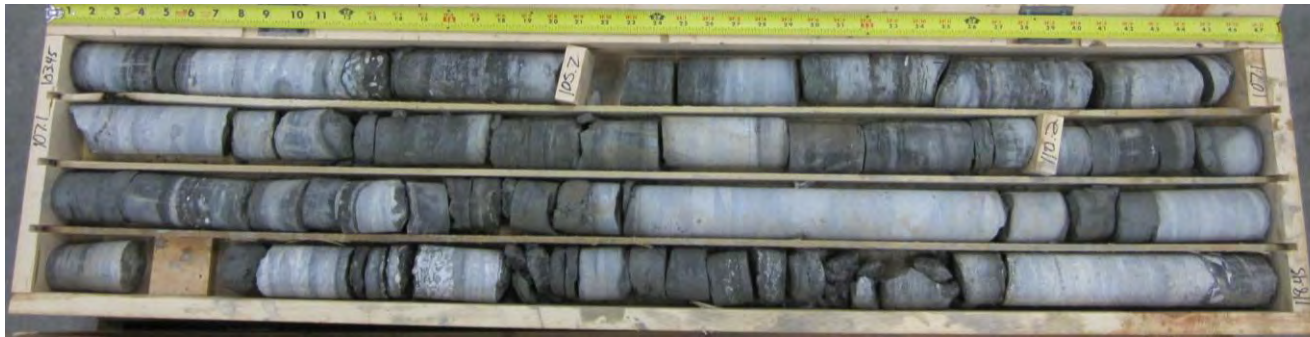
BORING NO.: L- 3  
 CORE BOX NO.: 2 OF 6  
 DEPTH (ft.): 105.2-120.2  
 ELEVATION (ft.): 353.46  
 5/NQ: 105.2' – 110.2'; REC. 100%, RQD 56%  
 6/NQ: 110.2' – 115.2'; REC. 96%, RQD 34%  
 7/NQ: 115.2' – 120.2'; REC. 100%, RQD 36%

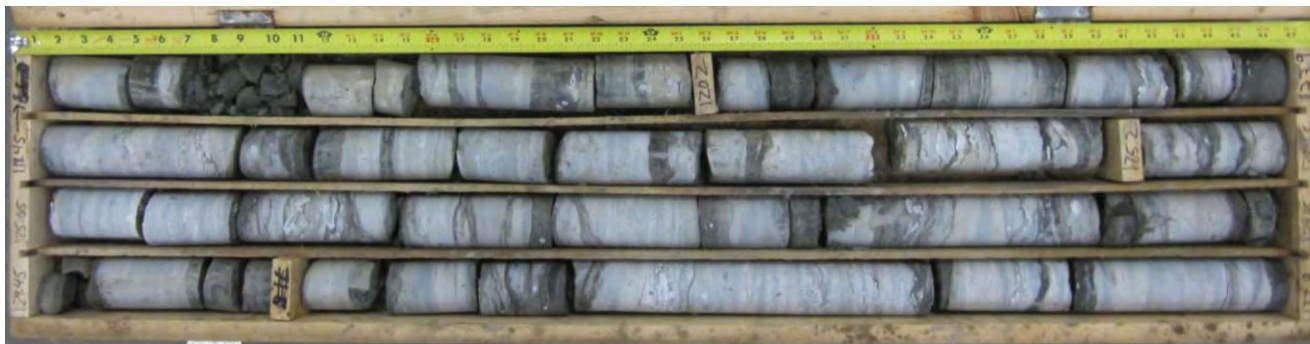
BORING NO.: L- 3  
 CORE BOX NO.: 3 OF 6  
 DEPTH (ft.): 120.2-135.2  
 ELEVATION (ft.): 338.46  
 8/NQ: 120.2' – 125.2'; REC. 100%, RQD 84%  
 9/NQ: 125.2' – 130.2'; REC. 100%, RQD 94%  
 10/NQ: 130.2' – 135.2'; REC. 100%, RQD 86%

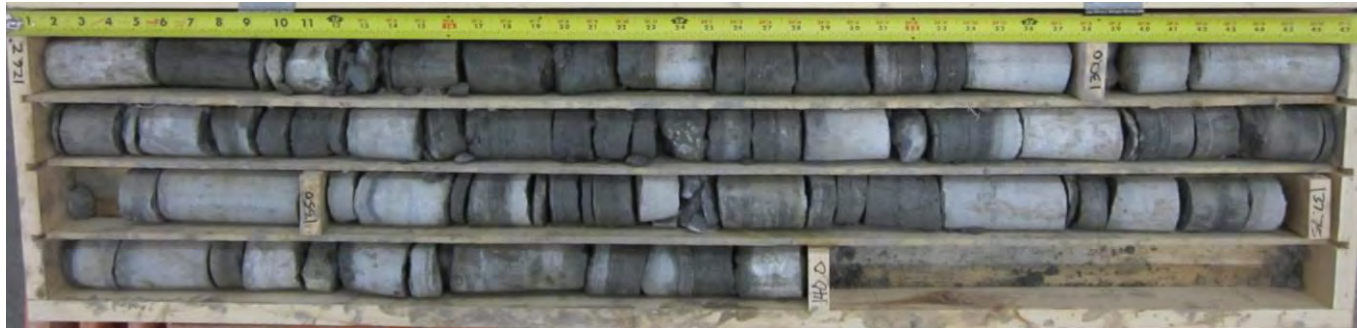
BORING NO.: L-3A  
 STA. OFFSET  
 CORE BOX NO.: 1 OF 3  
 DEPTH (ft.): 126.2-140.0  
 ELEVATION (ft.): 369.85  
 1/NQ: 126.2' – 130.0'; REC. 84%, RQD 32%  
 2/NQ: 130.0 – 135.0'; REC. 100%, RQD 25%  
 3/NQ: 135.0 – 140.0'; REC. 100%, RQD 35%

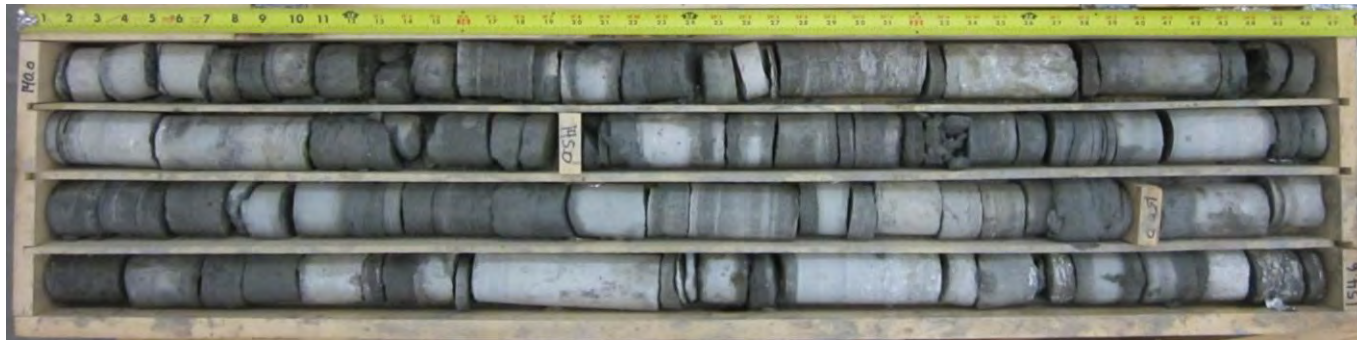
BORING NO.: L-3A  
 STA. OFFSET  
 CORE BOX NO.: 2 OF 3  
 DEPTH (ft.): 140.0-155.0  
 ELEVATION (ft.): 356.05  
 4/NQ: 140.0' – 145.0'; REC. 100%, RQD 50%  
 5/NQ: 145.0' – 150.0'; REC. 100%, RQD 50%  
 6/NQ: 150.0' – 155.0'; REC. 100%, RQD 40%

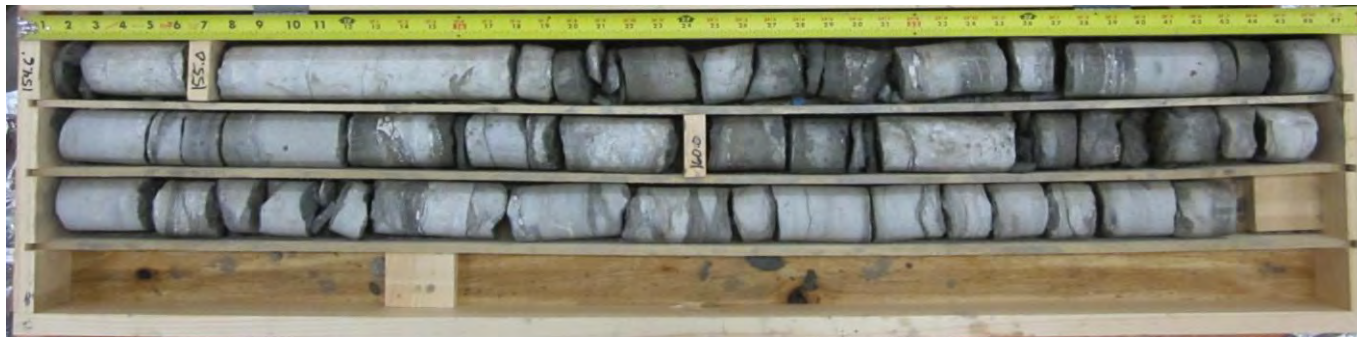
BORING NO.: L-3A  
 STA. OFFSET  
 CORE BOX NO.: 3 OF 3  
 DEPTH (ft.): 155.5-165.0  
 ELEVATION (ft.): 341.05  
 7/NQ: 155.0' – 160.0'; REC. 100%, RQD 66%  
 8/NQ: 160.0'-165.0'; REC. 100%, RQD 22%

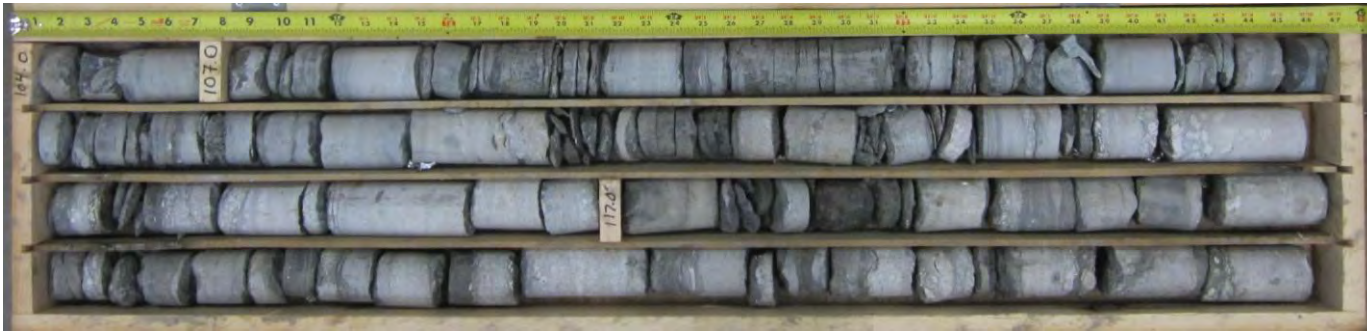
BORING NO.: L-4  
 CORE BOX NO.: 1 OF 3  
 DEPTH (ft.): 104.0-127.0  
 ELEVATION (ft.): 375.97  
 1/NQ: 104.0'-107.0'; REC. 17%, RQD 0%  
 2/NQ: 107.0'-117.0'; REC. 90%, RQD 12%  
 3/NQ: 117.0'-127.0'; REC. 98%, RQD 20%

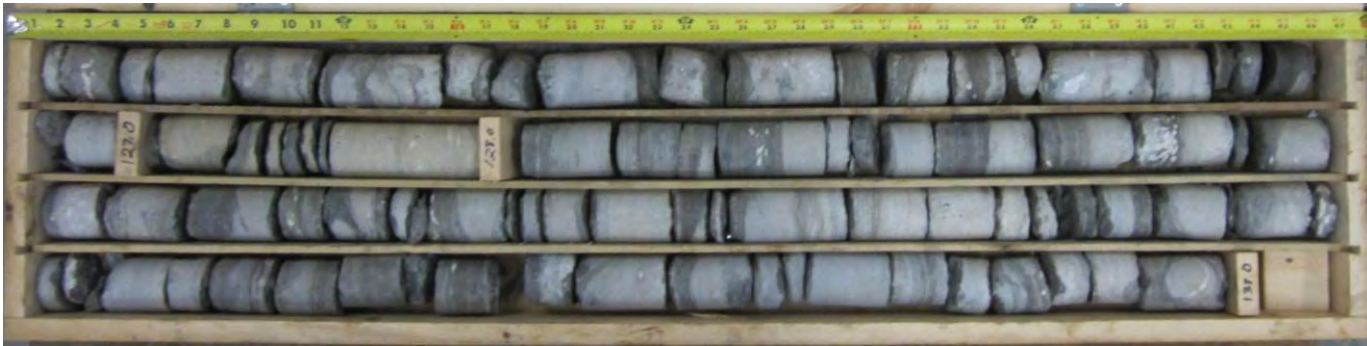
BORING NO.: L-4  
 CORE BOX NO.: 2 OF 3  
 DEPTH (ft.): 127.0-138.0  
 ELEVATION (ft.): 352.97  
 4/NQ: 127.0'-128.0'; REC. 100%, RQD 50%  
 5/NQ: 128.0'-138.0'; REC. 99%, RQD 0%

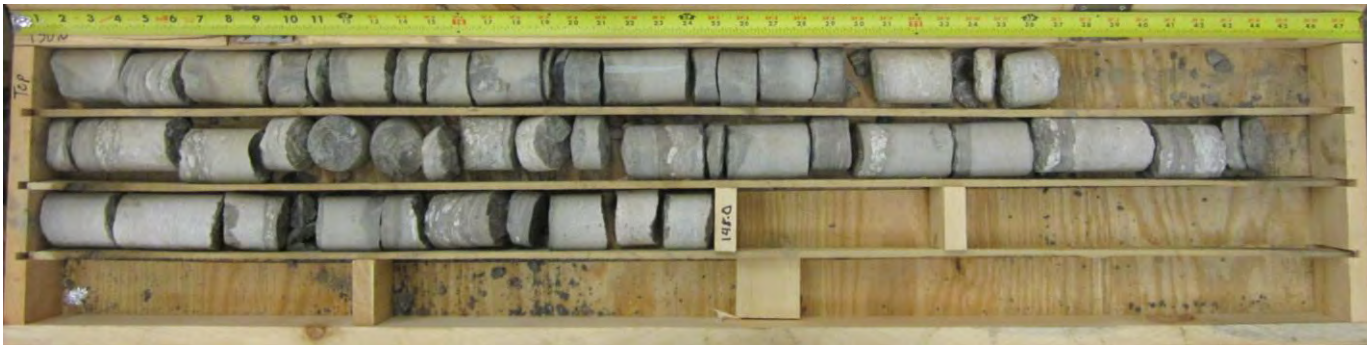
BORING NO.: L-4  
 CORE BOX NO.: 3 OF 3  
 DEPTH (ft.): 138.0-148.0  
 ELEVATION (ft.): 341.97  
 6/NQ: 138.0'-148.0'; REC. 94%, RQD 21%

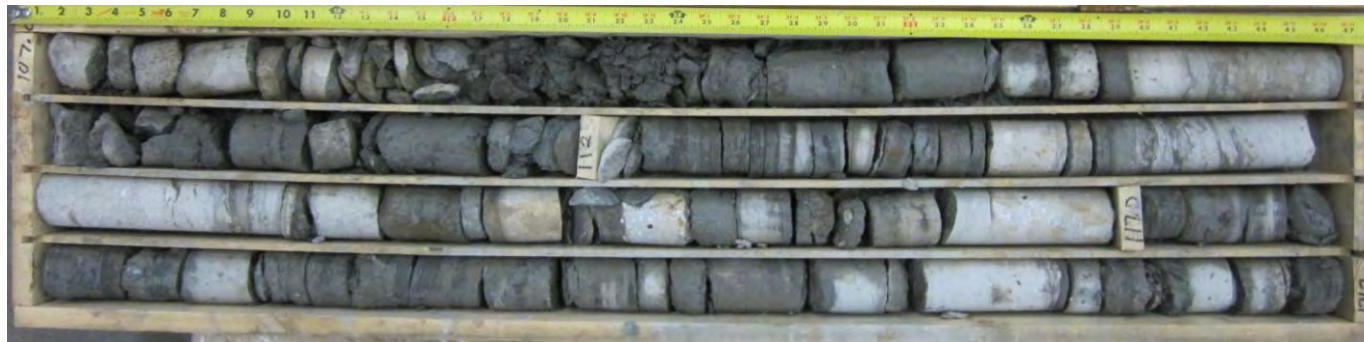
BORING NO.: L- 5  
 CORE BOX NO.: 1 OF 3  
 DEPTH (ft.): 107.0-122.0  
 ELEVATION (ft.): 379.33  
 1/NQ: 107.0'-112.0'; REC. 100%, RQD 32%  
 2/NQ: 112.0'-117.0'; REC. 100%, RQD 46%  
 3/NQ: 117.0'-122.0'; REC. 100%, RQD 38%

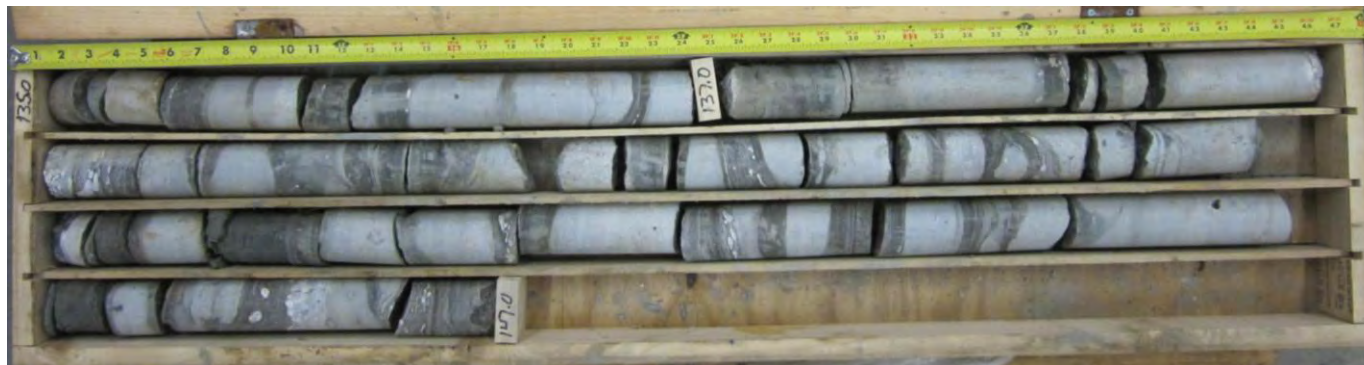
BORING NO.: L- 5  
 CORE BOX NO.: 3 OF 3  
 DEPTH (ft.): 135.0-147.0  
 ELEVATION (ft.): 351.33  
 7/NQ: 137.0'-142.0'; REC. 100%, RQD 66%  
 8/NQ: 142.0'-147.0'; REC. 100%, RQD 84%

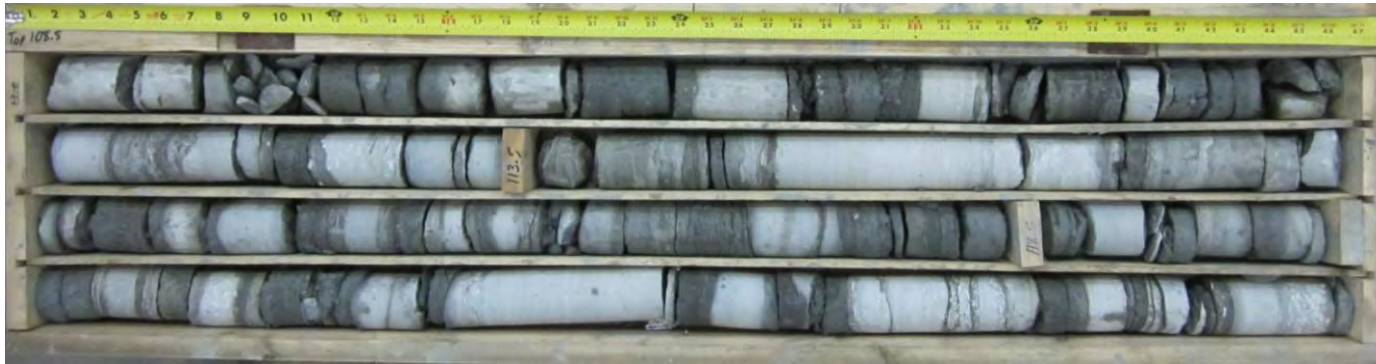
BORING NO.: L- 6  
 CORE BOX NO.: 1 OF 3  
 DEPTH (ft.): 108.5-123.5  
 ELEVATION (ft.): 377.19  
 1/NQ: 108.5'-113.5'; REC. 98%, RQD 11%  
 2/NQ: 113.5'-118.5'; REC. 100%, RQD 64%  
 3/NQ: 118.5'-123.5'; REC. 100%, RQD 50%

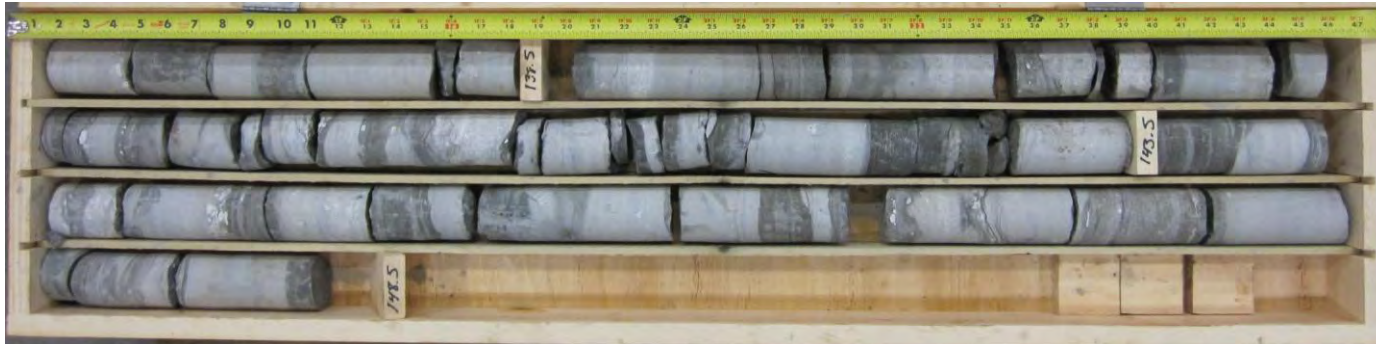
BORING NO.: L- 6  
 CORE BOX NO.: 3 OF 3  
 DEPTH (ft.): 138.5-143.5  
 ELEVATION (ft.): 347.19  
 7/NQ: 138.5'-143.5'; REC. 100%, RQD 76%  
 8/NQ: 143.5'-148.5'; REC. 100%, RQD 82%

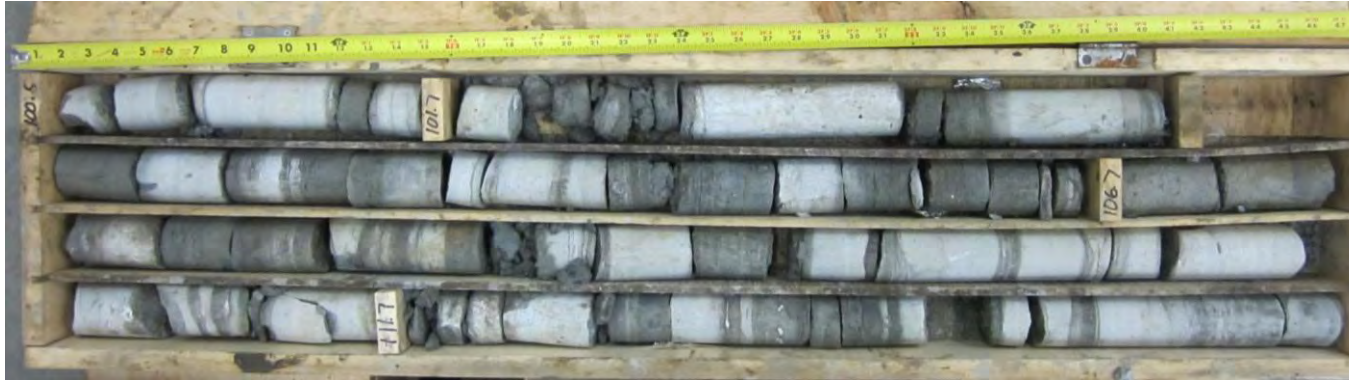
BORING NO.: L-7  
 CORE BOX NO.: 1 OF 3  
 DEPTH (ft.): 100.5-116.7  
 ELEVATION (ft.): 383.91  
 1/NQ: 100.5'-101.7'; REC. 100%, RQD 33%  
 2/NQ: 101.7'-106.7'; REC. 100%, RQD 48%  
 3/NQ: 106.7'-111.7'; REC. 100%, RQD 70%  
 4/NQ: 111.7'-116.7'; REC. 100%, RQD 82%

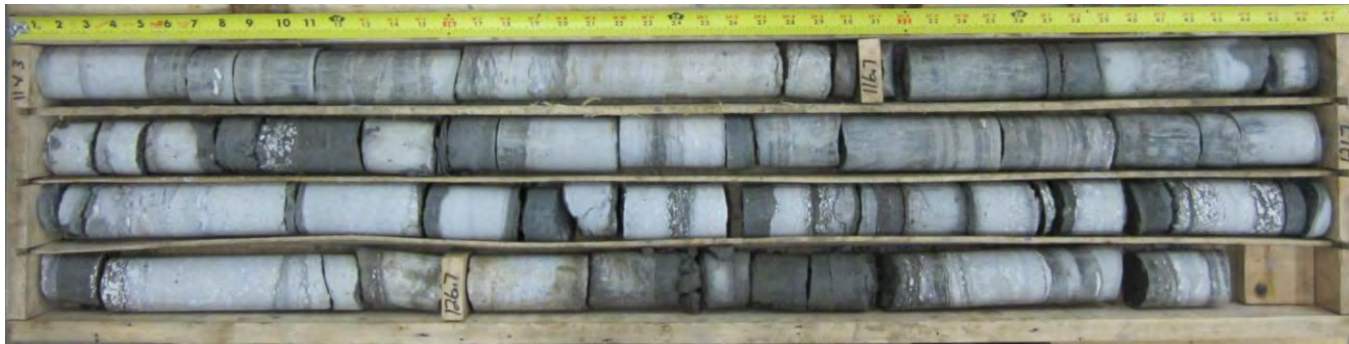
BORING NO.: L-7  
 CORE BOX NO.: 2 OF 3  
 DEPTH (ft.): 116.7-131.7  
 ELEVATION (ft.): 367.71  
 5/NQ: 116.7'-121.7'; REC. 100%, RQD 84%  
 6/NQ: 121.7'-126.7'; REC. 100%, RQD 56%  
 7/NQ: 126.7'-131.7'; REC. 100%, RQD 76%

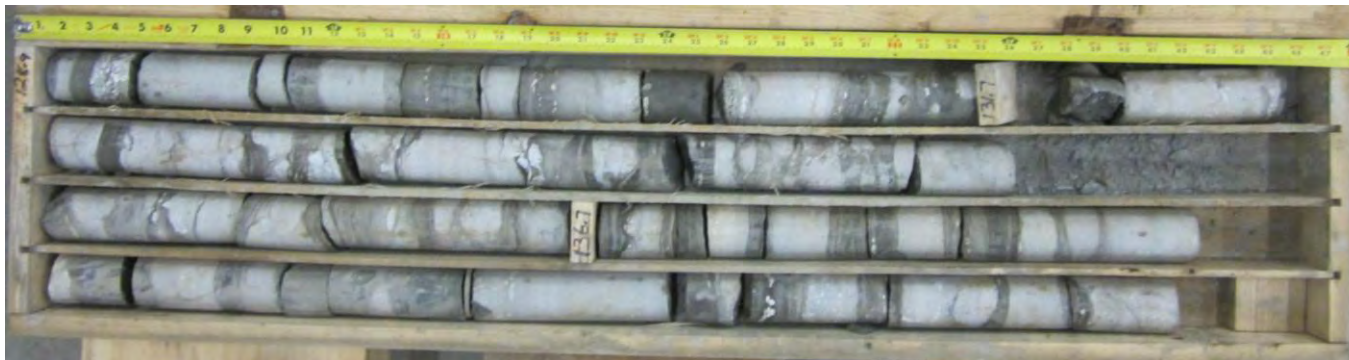
BORING NO.: L-7  
 CORE BOX NO.: 3 OF 3  
 DEPTH (ft.): 131.7-141.7  
 ELEVATION (ft.): 352.71  
 8/NQ: 131.7'-136.7'; REC. 100%, RQD 92%  
 9/NQ: 136.7'-141.7'; REC. 100%, RQD 90%

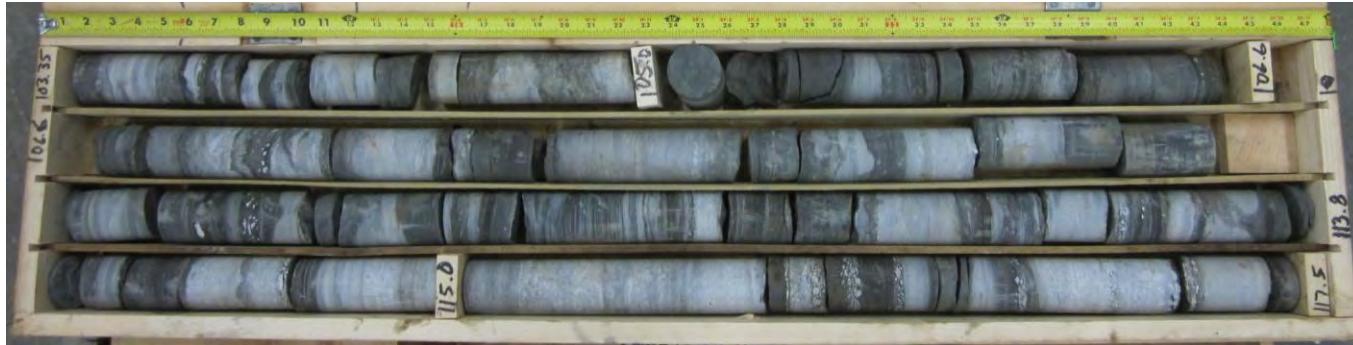
BORING NO.: R-1  
 CORE BOX NO.: 2 OF 6  
 DEPTH (ft.): 105.0-120.0  
 ELEVATION (ft.): 353.04  
 5/NQ: 105.0'-110.0'; REC. 100%, RQD 66%  
 6/NQ: 110.0' - 115.0'; REC. 96%, RQD 70%  
 7/NQ: 115.0' - 120.0'; REC. 100%, RQD 80%

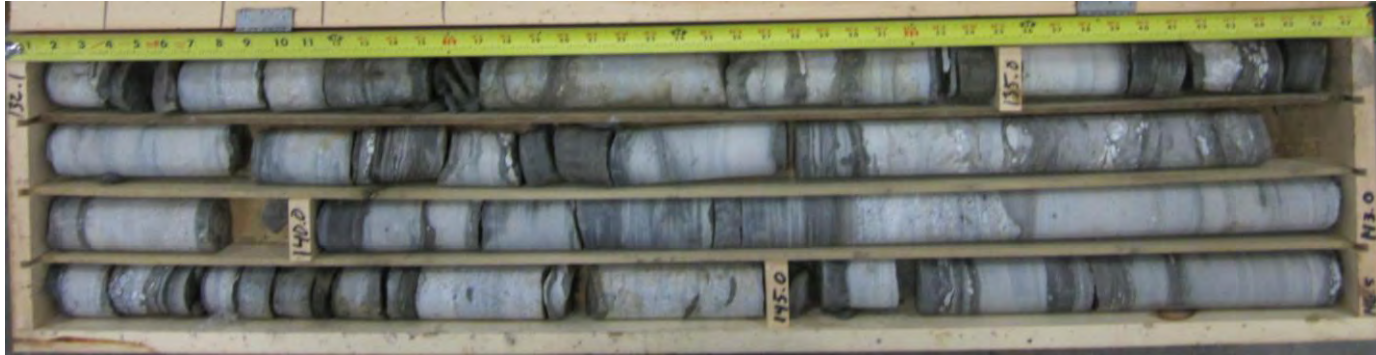
BORING NO.: R-1  
 CORE BOX NO.: 4 OF 6  
 DEPTH (ft.): 135.0-150.0  
 ELEVATION (ft.): 323.04  
 11/NQ: 135.0'-140.0'; REC. 98%, RQD 72%  
 12/NQ: 140.0'-145.0'; REC. 100%, RQD 76%  
 13/NQ: 145.0'-150.0'; REC. 100%, RQD 78%

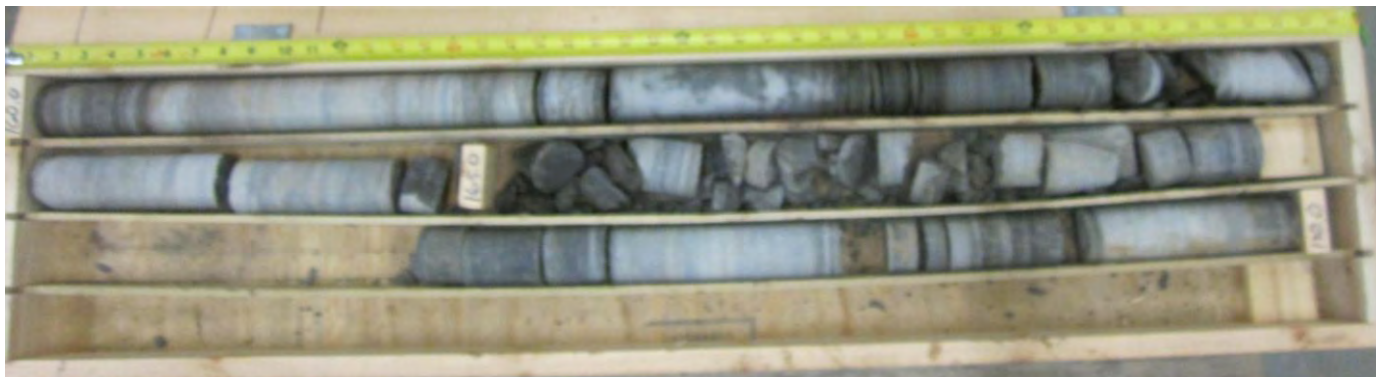
BORING NO.: R-1  
 CORE BOX NO.: 6 OF 6  
 DEPTH (ft.): 160.0-170.0  
 ELEVATION (ft.): 298.04  
 16/NQ: 160.0'-165.0'; REC. 100%, RQD 74%  
 17/NQ: 165.0'-170.0'; REC. 86%, RQD 38%

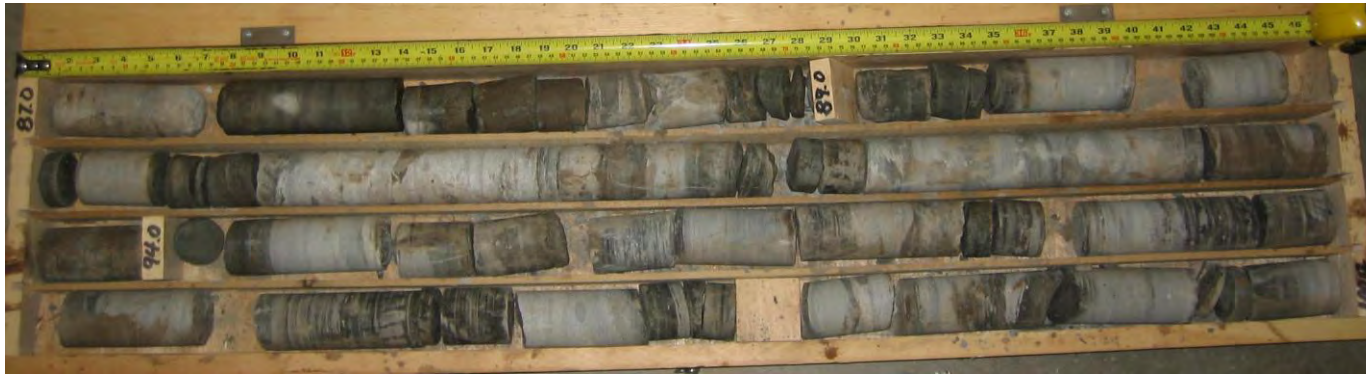
BORING NO.: R-2  
 CORE BOX NO.: 1 OF 6  
 DEPTH (ft.): 87.0-104.0  
 ELEVATION (ft.): 371.1  
 1/NQ: 87.0'-89.0'; REC. 100%, RQD 45%  
 2/NQ: 89.0'-94.0'; REC. 100%, RQD 74%  
 3/NQ: 94.0'-99.0'; REC. 86%, RQD 80%  
 4/NQ: 99.0'-104.0'; REC. 94%, RQD 82%

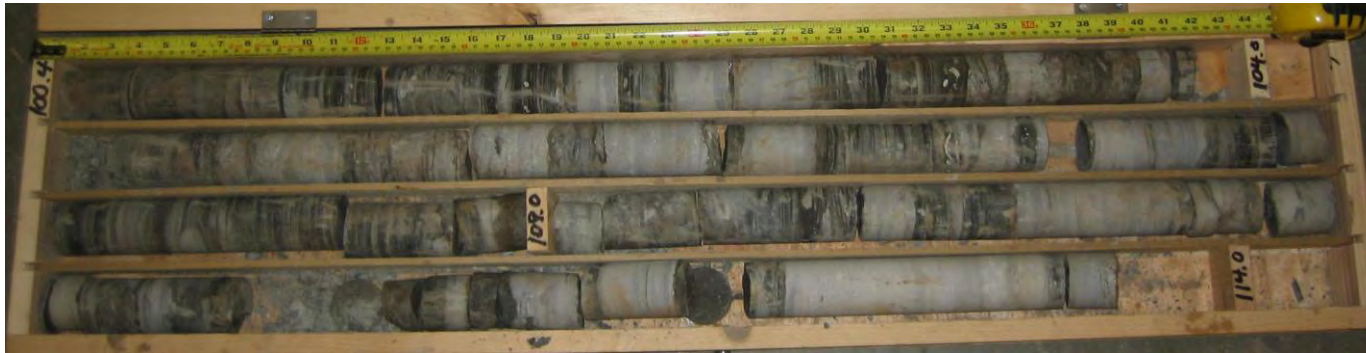
BORING NO.: R-2  
 CORE BOX NO.: 2 OF 6  
 DEPTH (ft.): 104.0-114.0  
 ELEVATION (ft.): 354.1  
 5/NQ: 104.0'-109.0'; REC. 96%, RQD 92%  
 6/NQ: 109.0'-114.0'; REC. 98%, RQD 74%

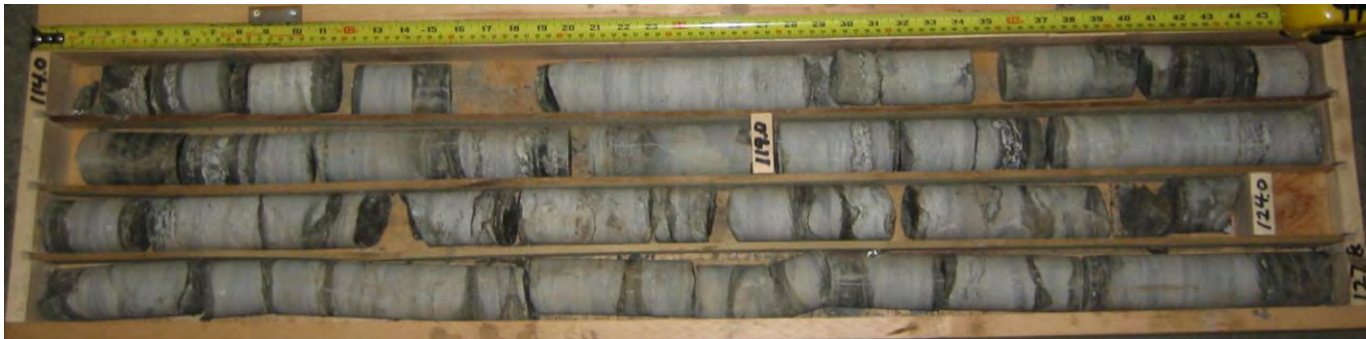
BORING NO.: R-2  
 CORE BOX NO.: 3 OF 6  
 DEPTH (ft.): 114.0-134.0  
 ELEVATION (ft.): 344.1  
 7/NQ: 114.0'-119.0'; REC. 100%, RQD 88%  
 8/NQ: 119.0'-124.0'; REC. 94%, RQD 76%  
 9/NQ: 124.0'-129.0'; REC. 94%, RQD 76%  
 10/NQ: 129.0'-134.0'; REC. 100%, RQD 76%

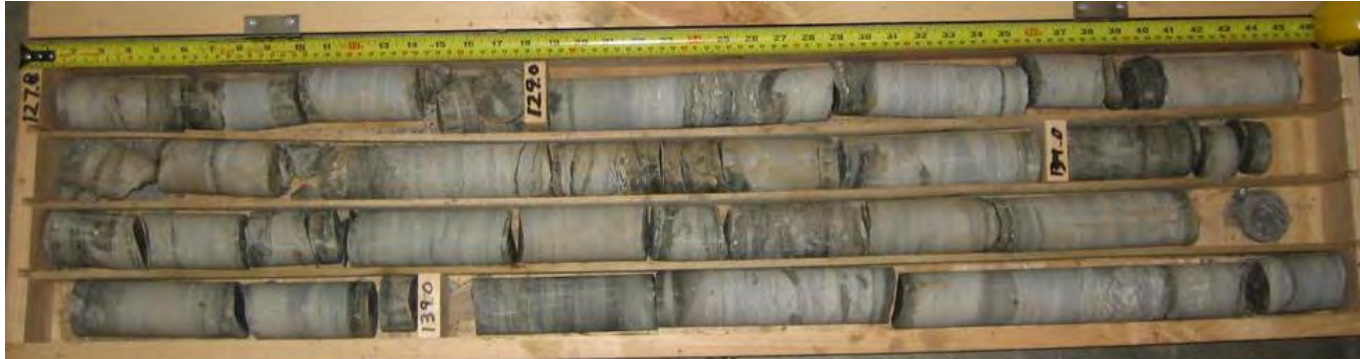
BORING NO.: R-2  
 CORE BOX NO.: 4 OF 6  
 DEPTH (ft.): 134.0-144.0  
 ELEVATION (ft.): 324.1  
 11/NQ: 134.0'-139.0'; REC. 100%, RQD 86%  
 12/NQ: 139.0'-144.0'; REC. 100%, RQD 72%

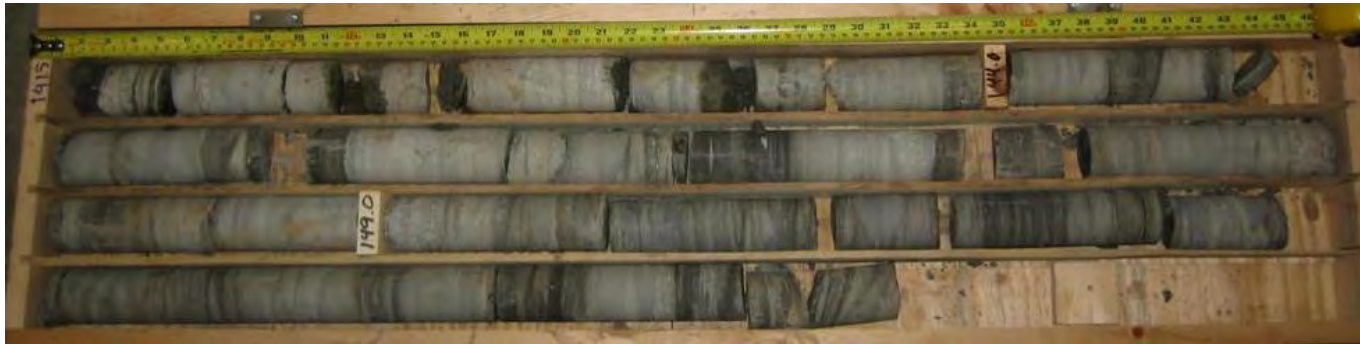
BORING NO.: R-2  
 CORE BOX NO.: 5 OF 6  
 DEPTH (ft.): 144.0-154.0  
 ELEVATION (ft.): 314.1  
 13/NQ: 144.0'-149.0'; REC. 100%, RQD 100%  
 14/NQ: 149.0'-154.0'; REC. 100%, RQD 82%

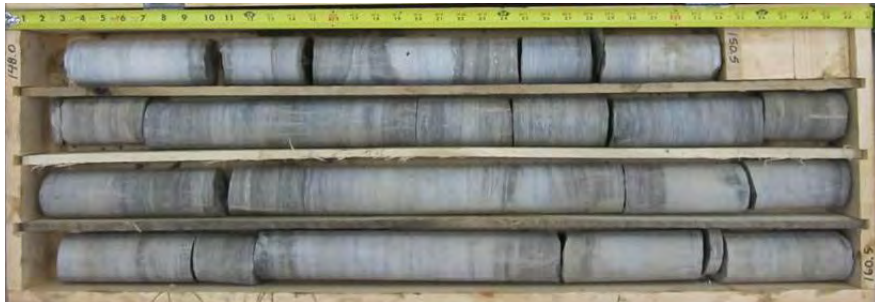
BORING NO.: R-2A  
 CORE BOX NO.: 6 OF 9  
 DEPTH (ft.): 148.0-160.5  
 ELEVATION (ft.): 308.64  
 11/NQ: 10.5'-160.5'; REC. 95%, RQD 90%

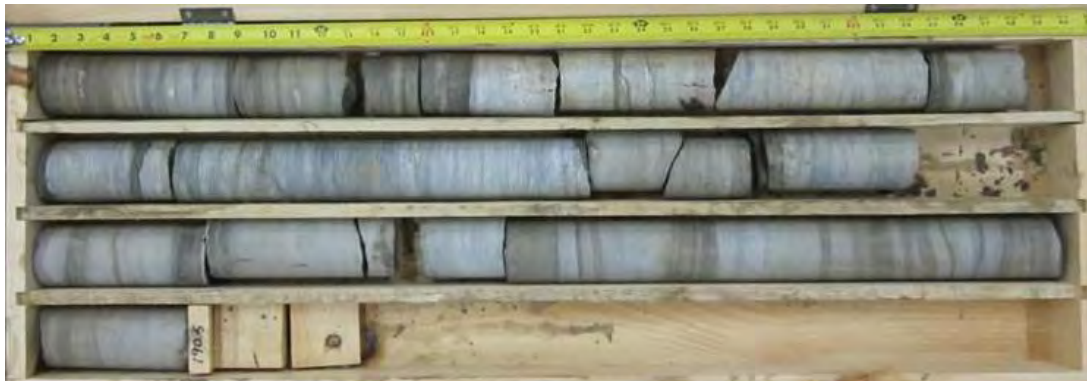
BORING NO.: R-2A  
 CORE BOX NO.: 9 OF 9  
 DEPTH (ft.): 180.5-190.5  
 ELEVATION (ft.): 276.14  
 14/NQ: 180.5'-190.5'; REC. 94%, RQD 84%

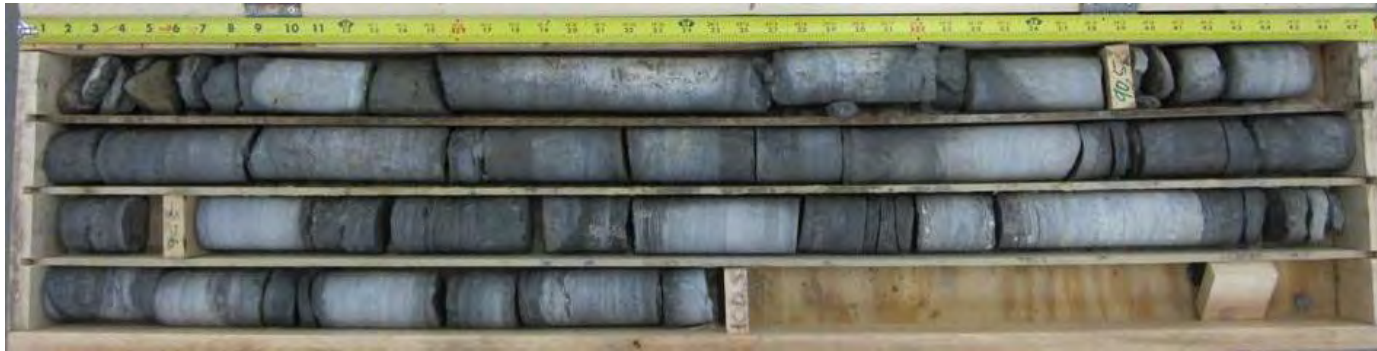
BORING NO.: R-3  
 CORE BOX NO.: 1 OF 6  
 DEPTH (ft.): 86.5-100.5  
 ELEVATION (ft.): 371.51  
 1/NQ: 86.5'-90.5'; REC. 80%, RQD 50%  
 2/NQ: 90.5'-95.5'; REC. 92%, RQD 42%  
 3/NQ: 95.5'-100.5'; REC. 100%, RQD 62%

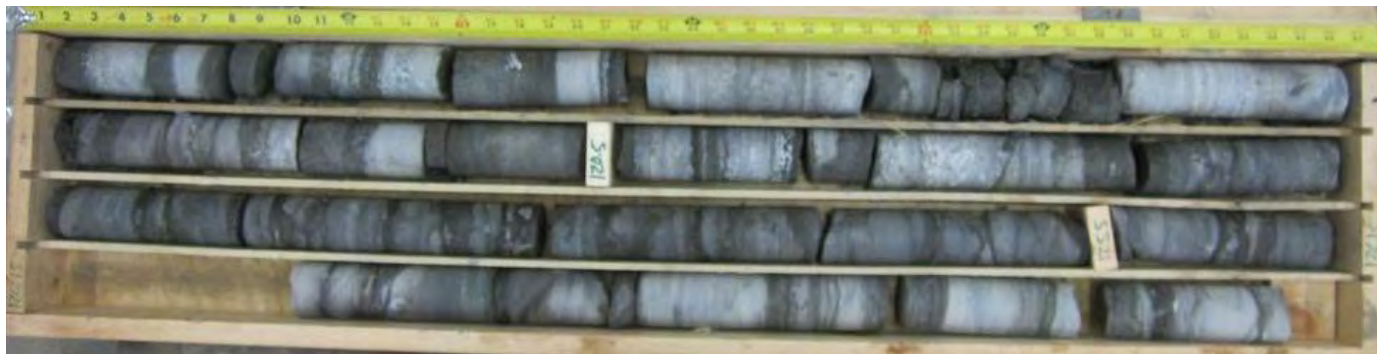
BORING NO.: R-3  
 CORE BOX NO.: 3 OF 6  
 DEPTH (ft.): 115.5-130.5  
 ELEVATION (ft.): 342.51  
 7/NQ: 115.5'-120.5'; REC. 100%, RQD 96%  
 8/NQ: 120.5'-125.5'; REC. 100%, RQD 100%  
 9/NQ: 125.5'-130.5'; REC. 100%, RQD 92%

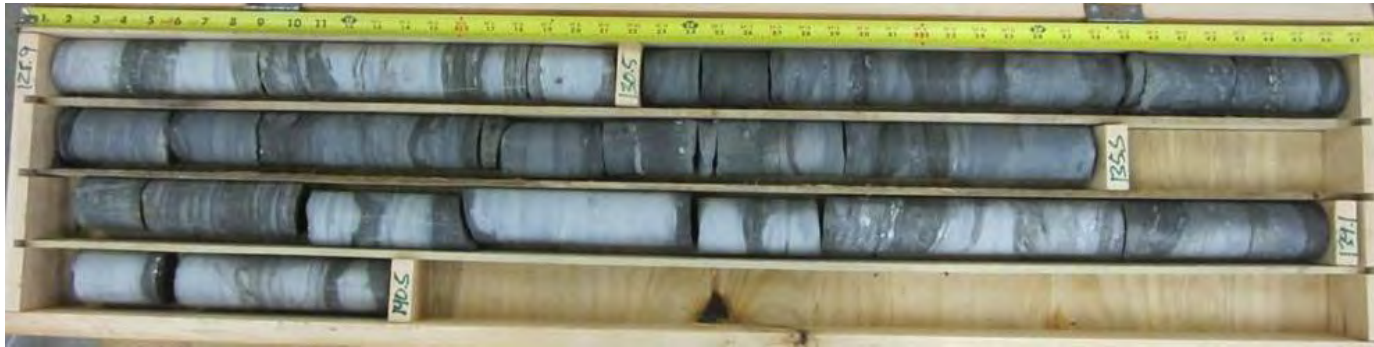
BORING NO.: R-3  
 CORE BOX NO.: 4 OF 6  
 DEPTH (ft.): 130.5-140.5  
 ELEVATION (ft.): 327.51  
 10/NQ: 130.5'-135.5'; REC. 80%, RQD 84%  
 11/NQ: 135.5'-140.5'; REC. 90%, RQD 90%

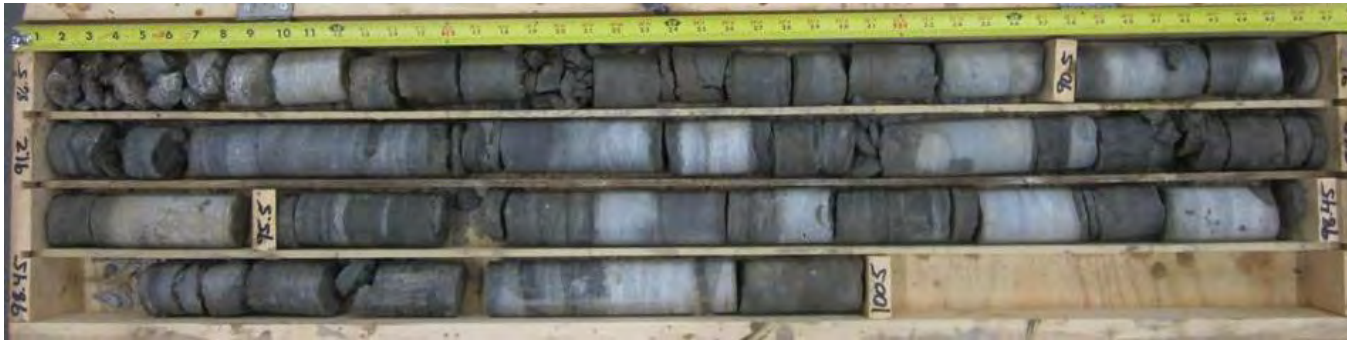
BORING NO.: R-4  
 CORE BOX NO.: 1 OF 6  
 DEPTH (ft.): 86.5-100.5  
 ELEVATION (ft.): 371.48  
 1/NQ: 86.5'-90.5'; REC. 73%, RQD 0%  
 2/NQ: 90.5'-95.5'; REC. 100%, RQD 56%  
 3/NQ: 95.5'-100.5'; REC. 100%, RQD 54%

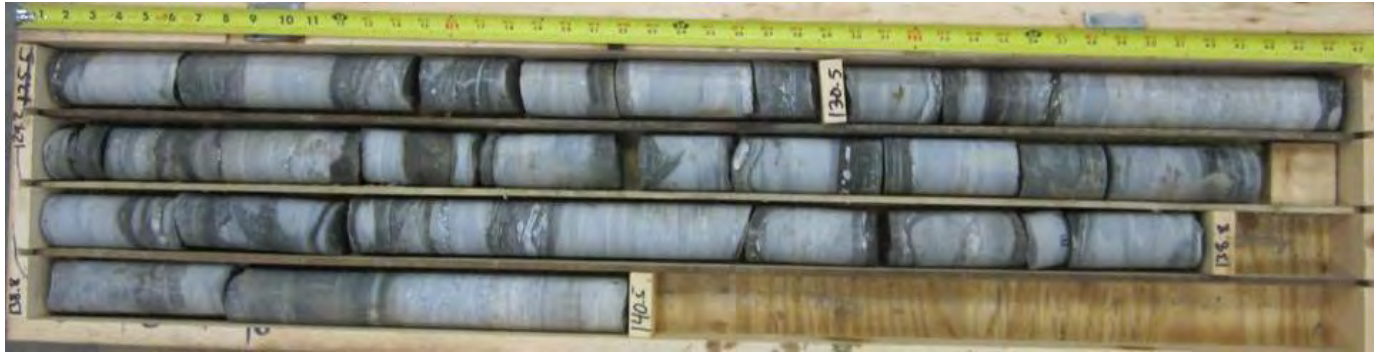
BORING NO.: R-4  
 CORE BOX NO.: 4 OF 6  
 DEPTH (ft.): 130.5-140.5  
 ELEVATION (ft.): 327.48  
 10/NQ: 130.5'-135.5'; REC. 100%, RQD 72%  
 11/NQ: 135.5'-140.5'; REC. 100%, RQD 94%

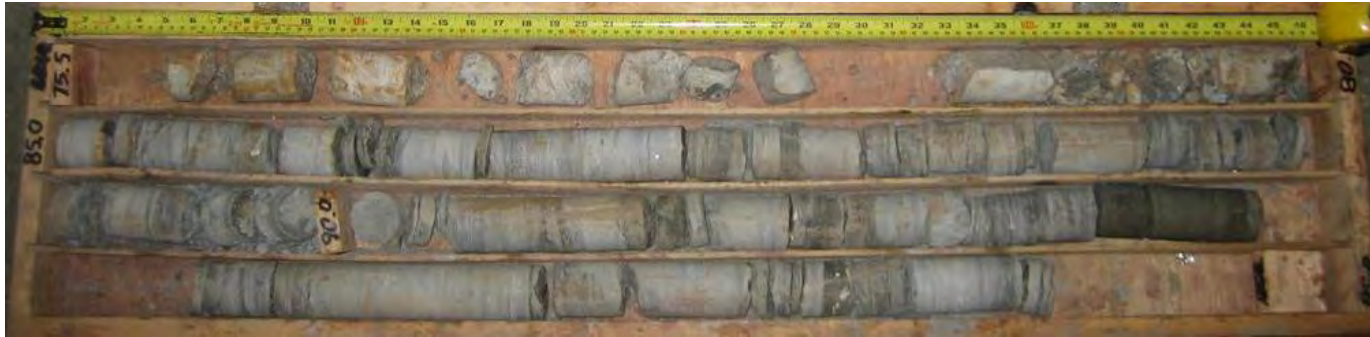
BORING NO.: R-5  
 CORE BOX NO.: 1 OF 6  
 DEPTH (ft.): 75.5-95.0  
 ELEVATION (ft.): 373.59  
 1/NQ: 85.0'-90.0'; REC. 88%, RQD 25%  
 2/NQ: 90.0'-95.0'; REC. 100%, RQD 66%  
 3/NQ: 95.0'-100.0'; REC. 100%, RQD 20%

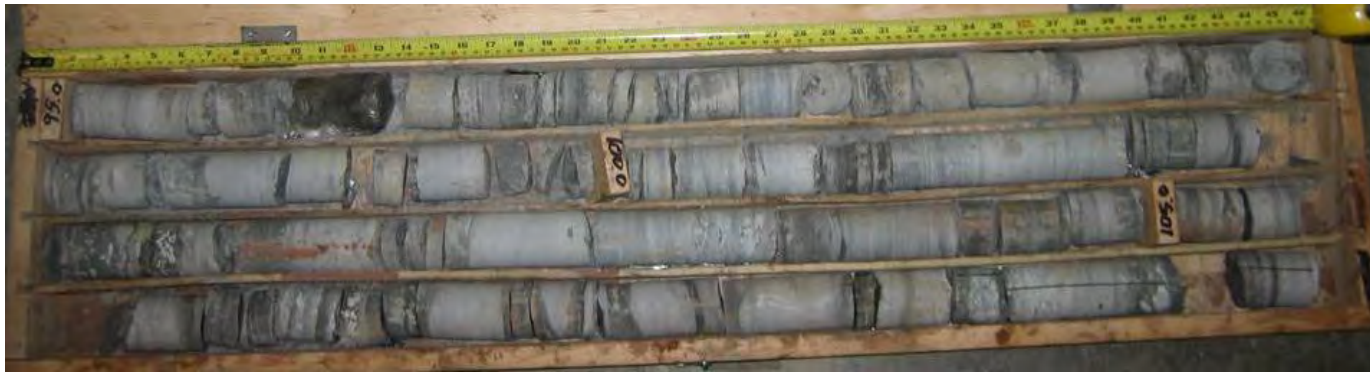
BORING NO.: R-5  
 CORE BOX NO.: 2 OF 6  
 DEPTH (ft.): 95.0-110.0  
 ELEVATION (ft.): 363.59  
 4/NQ: 100.0'-105.0'; REC. 100%, RQD 58%  
 5/NQ: 105.0'-110.0'; REC. 96%, RQD 84%

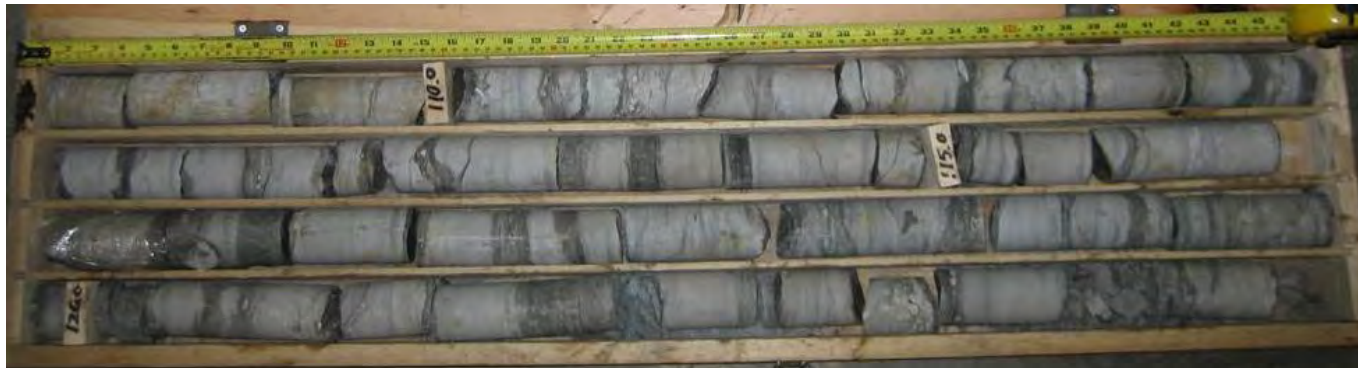
BORING NO.: R-5  
 CORE BOX NO.: 3 OF 6  
 DEPTH (ft.): 110.0-125.0  
 ELEVATION (ft.): 348.59  
 6/NQ: 110.0'-115.0'; REC. 100%, RQD 98%  
 7/NQ: 115.0'-120.0'; REC. 94%, RQD 76%  
 8/NQ: 120.0'-125.0'; REC. 100%, RQD 80%
