# Structure Foundation Exploration

## Brent Spence Bridge Replacement

Project No. N1105070

March 11, 2011

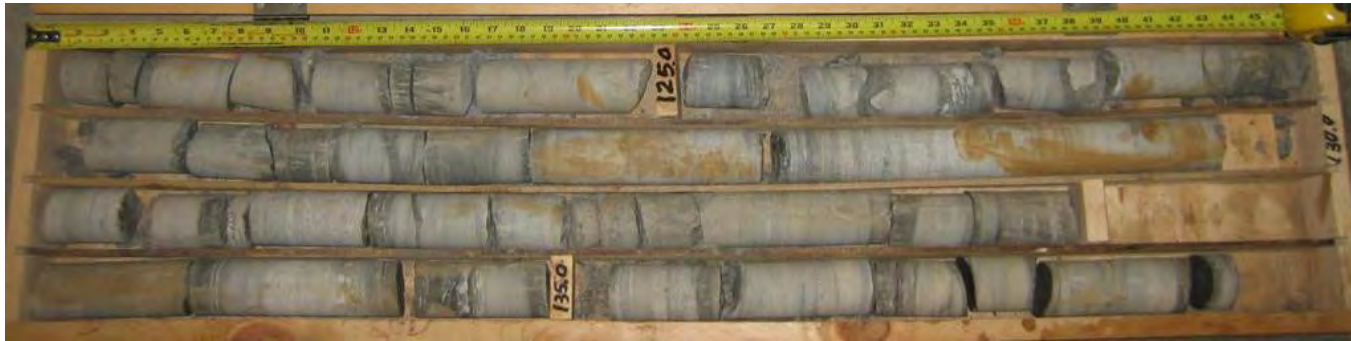
BORING NO.: R-5  
 CORE BOX NO.: 4 OF 6  
 DEPTH (ft.): 125.0-140.0  
 ELEVATION (ft.): 333.59  
 9/NQ: 125.0'-130.0'; REC. 100%, RQD 94%  
 10/NQ: 130.0'-135.0'; REC. 88%, RQD 36%  
 11/NQ: 135.0'-140.0'; REC. 100%, RQD 96%

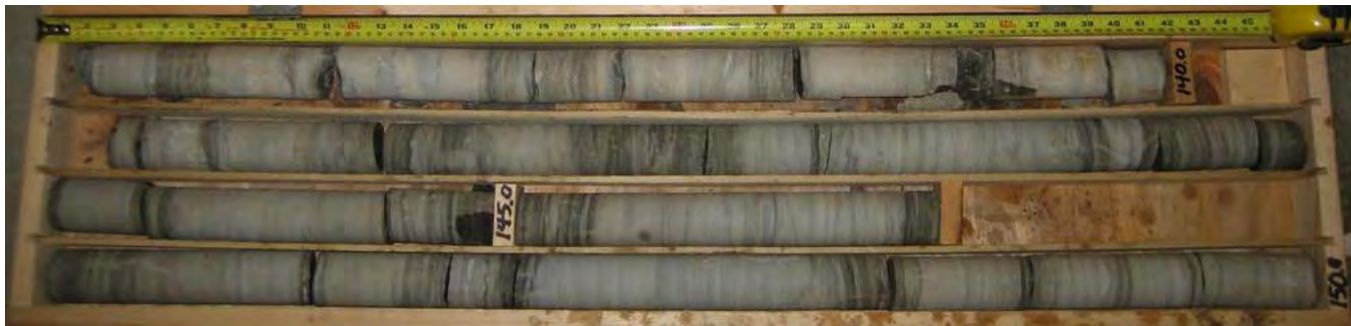
BORING NO.: R-5  
 CORE BOX NO.: 5 OF 6  
 DEPTH (ft.): 140.0-150.0  
 ELEVATION (ft.): 318.59  
 12/NQ: 140.0'-145.0'; REC. 100%, RQD 98%  
 13/NQ: 145.0'-150.0'; REC. 100%, RQD 100%

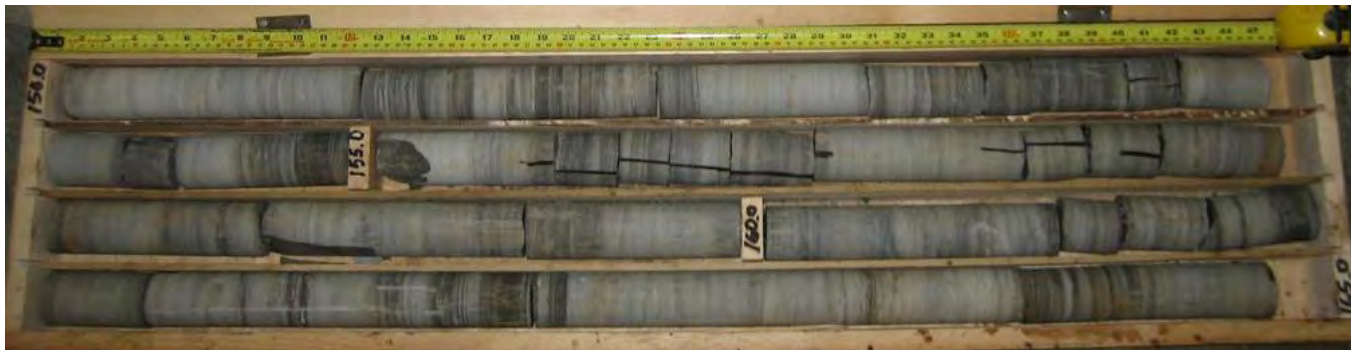
BORING NO.: R-5  
 CORE BOX NO.: 6 OF 6  
 DEPTH (ft.): 150.0-165.0  
 ELEVATION (ft.): 308.59  
 14/NQ: 150.0'-155.0'; REC. 92%, RQD 92%  
 15/NQ: 155.0'-160.0'; REC. 96%, RQD 96%  
 16/NQ: 160.0'-165.0'; REC. 100%, RQD 100%

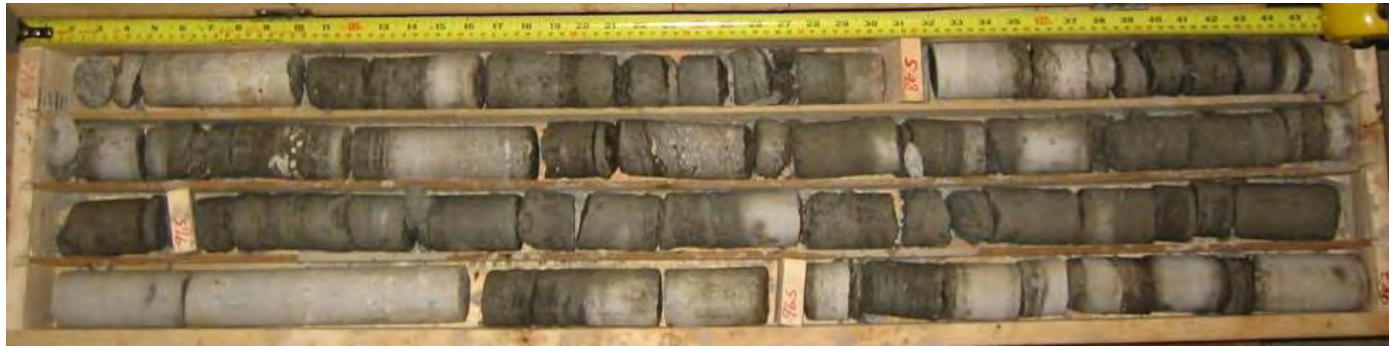
BORING NO.: R-6  
 CORE BOX NO.: 1 OF 6  
 DEPTH (ft.): 84.0-96.2  
 ELEVATION (ft.): 373  
 1/NQ: 84.0'-86.5'; REC. 92%, RQD 48%  
 2/NQ: 86.5'-91.5'; REC. 100%, RQD 48%  
 3/NQ: 91.5'-96.1'; REC. 50%, RQD 48%

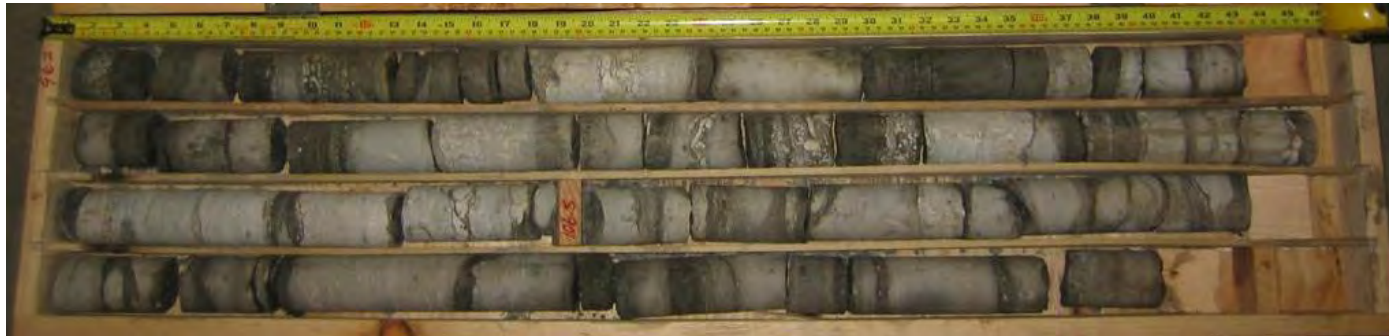
BORING NO.: R-6  
 CORE BOX NO.: 2 OF 6  
 DEPTH (ft.): 96.2-111.5  
 ELEVATION (ft.): 360.8  
 4/NQ: 96.1'-101.5'; REC. 93%, RQD 63%  
 5/NQ: 101.5'-106.5'; REC. 100%, RQD 82%  
 6/NQ: 106.5'-111.5'; REC. 100%, RQD 78%

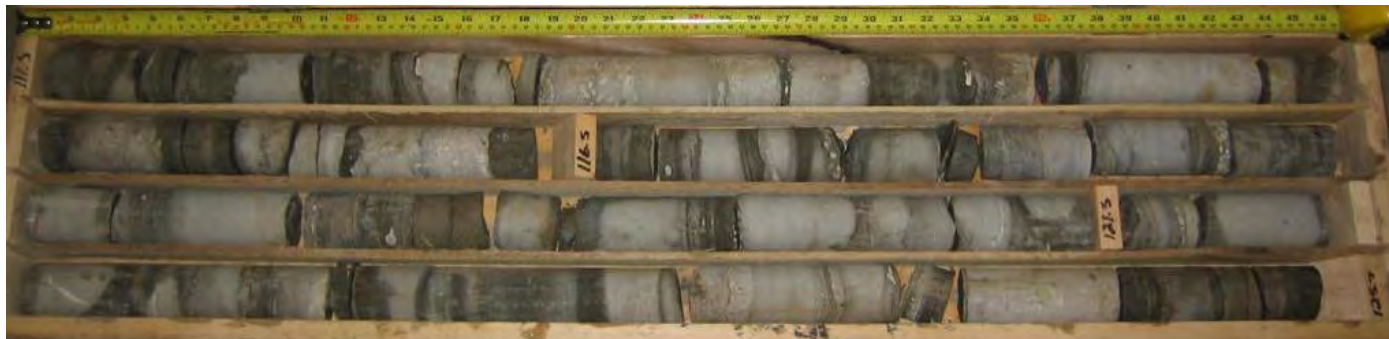
BORING NO.: R-6  
 CORE BOX NO.: 3 OF 6  
 DEPTH (ft.): 111.5-125.7  
 ELEVATION (ft.): 345.5  
 7/NQ: 111.5'-116.5'; REC. 100%, RQD 86%  
 8/NQ: 116.5'-121.5'; REC. 100%, RQD 82%  
 9/NQ: 121.5'-126.5'; REC. 100%, RQD 84%

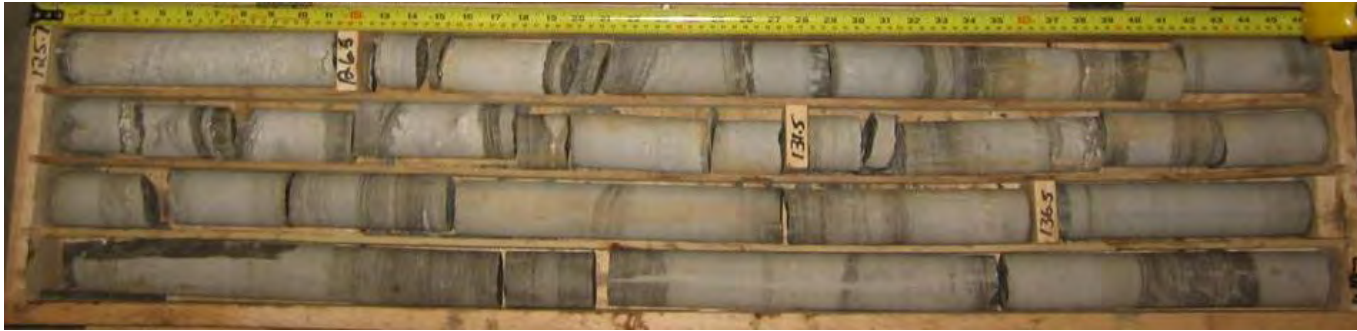
BORING NO.: R-6  
 CORE BOX NO.: 4 OF 6  
 DEPTH (ft.): 125.7-140.7  
 ELEVATION (ft.): 331.3  
 10/NQ: 126.5'-131.5'; REC. 100%, RQD 72%  
 11/NQ: 131.5'-136.5'; REC. 90%, RQD 76%  
 12/NQ: 136.5'-141.5'; REC. 100%, RQD 84%

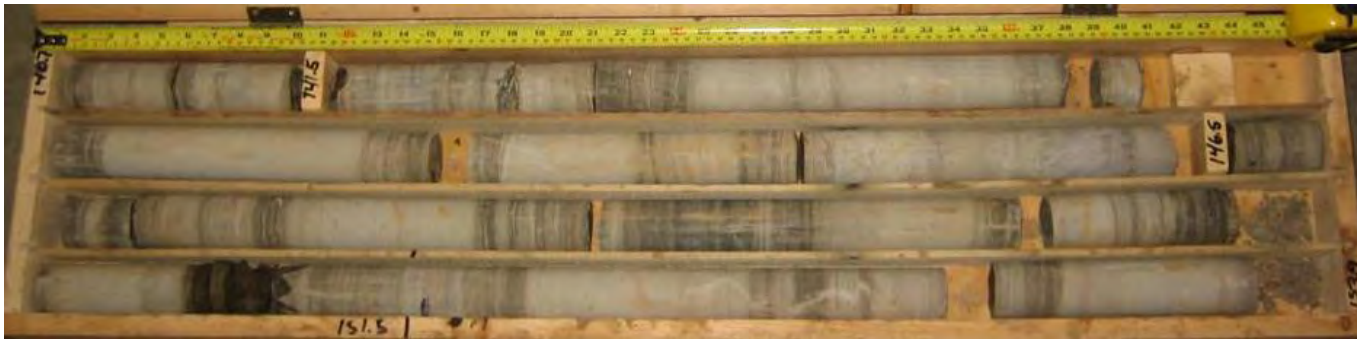
BORING NO.: R-6  
 CORE BOX NO.: 5 OF 6  
 DEPTH (ft.): 140.7-153.9  
 ELEVATION (ft.): 316.3  
 13/NQ: 141.5'-146.5'; REC. 100%, RQD 100%  
 14/NQ: 146.5'-151.6'; REC. 100%, RQD 100%  
 15/NQ: 151.5'-156.5'; REC. 100%, RQD 100%

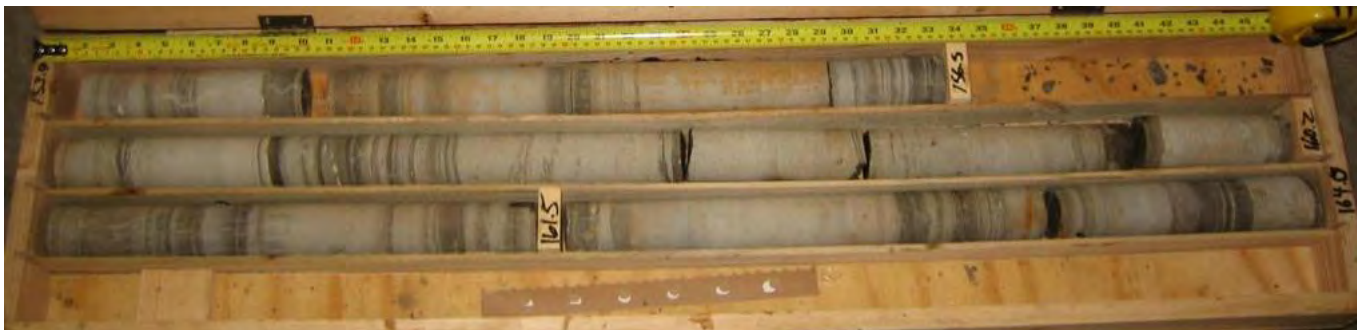
BORING NO.: R-6  
 CORE BOX NO.: 6 OF 6  
 DEPTH (ft.): 153.9-164.0  
 ELEVATION (ft.): 303.1  
 16/NQ: 156.5'-161.5'; REC. 83%, RQD 83%  
 17/NQ: 161.5'-164.0'; REC. 92%, RQD 92%

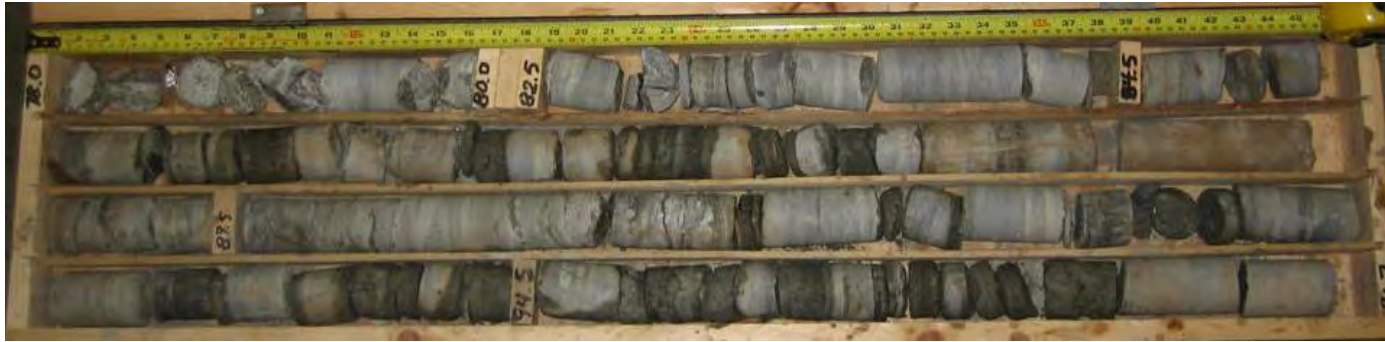
BORING NO.: R-7  
 CORE BOX NO.: 1 OF 6  
 DEPTH (ft.): 78.0-96.7  
 ELEVATION (ft.): 376.0  
 1/NQ: 82.5'-84.5'; REC. 85%, RQD 25%  
 2/NQ: 84.5'-89.5'; REC. 94%, RQD 20%  
 3/NQ: 89.5'-94.5'; REC. 94%, RQD 20%  
 4/NQ: 94.5'-99.5'; REC. 100%, RQD 40%

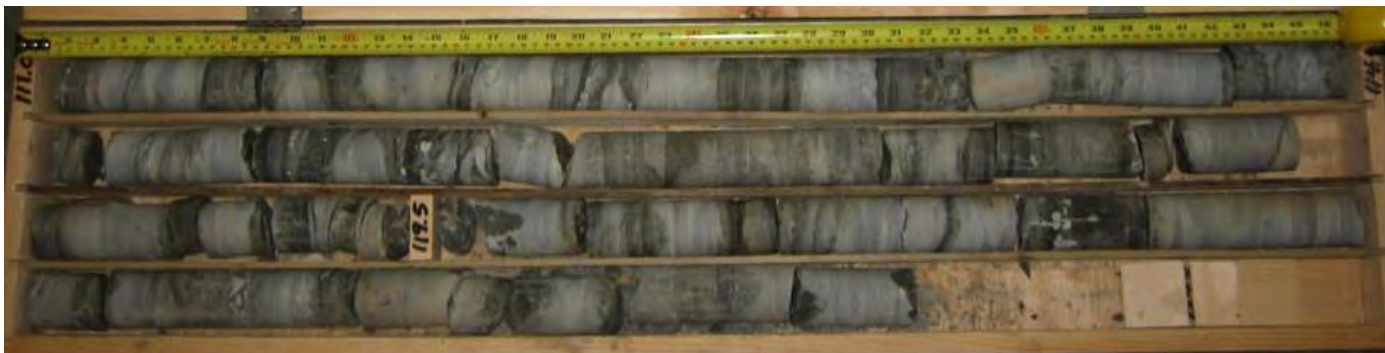
BORING NO.: R-7  
 CORE BOX NO.: 3 OF 6  
 DEPTH (ft.): 111.0-124.5  
 ELEVATION (ft.): 343  
 8/NQ: 114.5'-119.5'; REC. 92%, RQD 70%  
 9/NQ: 119.5'-124.5'; REC. 100%, RQD 66%

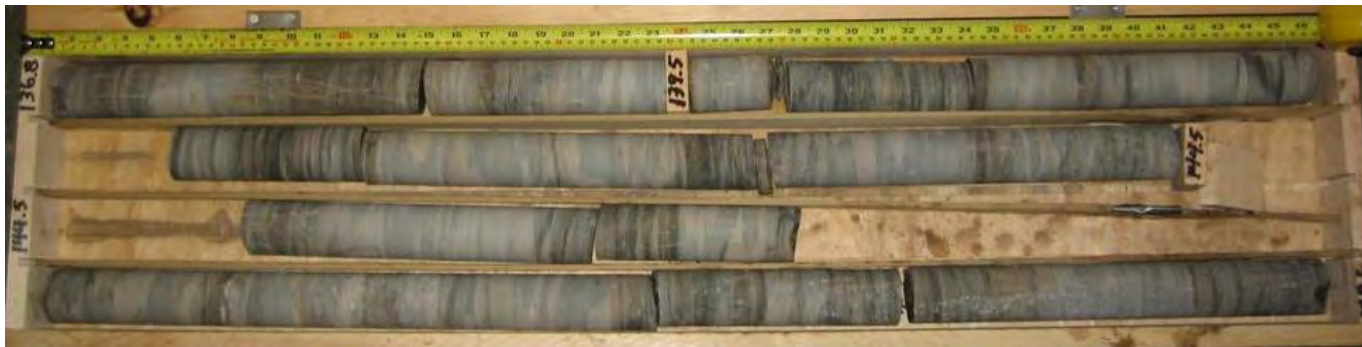
BORING NO.: R-7  
 CORE BOX NO.: 5 OF 6  
 DEPTH (ft.): 136.8-149.5  
 ELEVATION (ft.): 317.2  
 13/NQ: 139.5'-144.5'; REC. 96%, RQD 90%  
 14/NQ: 144.5'-149.5'; REC. 100%, RQD 100%

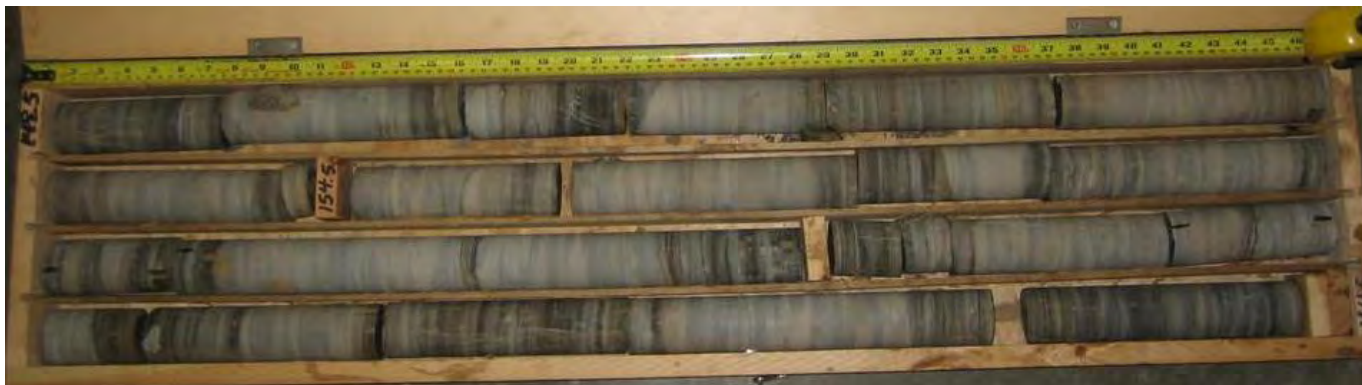
BORING NO.: R-7  
 CORE BOX NO.: 6 OF 6  
 DEPTH (ft.): 149.5-164.5  
 ELEVATION (ft.): 304.5  
 15/NQ: 149.5'-154.5'; REC. 94%, RQD 90%  
 16/NQ: 154.5'-159.5'; REC. 100%, RQD 100%  
 17/NQ: 159.5'-164.5'; REC. 100%, RQD 94%

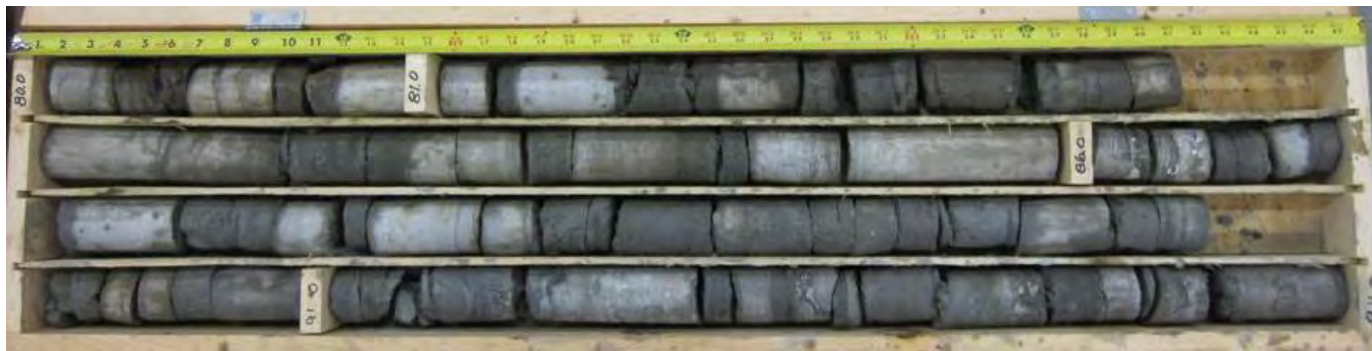
BORING NO.: R-8  
 CORE BOX NO.: 1 OF 6  
 DEPTH (ft.): 80.0-94.0  
 ELEVATION (ft.): 375.70  
 1/NQ: 80.0'-81.0'; REC. 100%, RQD 40%  
 2/NQ: 81.0'-86.0'; REC. 100%, RQD 44%  
 3/NQ: 86.0'-91.0'; REC. 94%, RQD 20%  
 4/NQ: 91.0'-96.0'; REC. 100%, RQD 60%

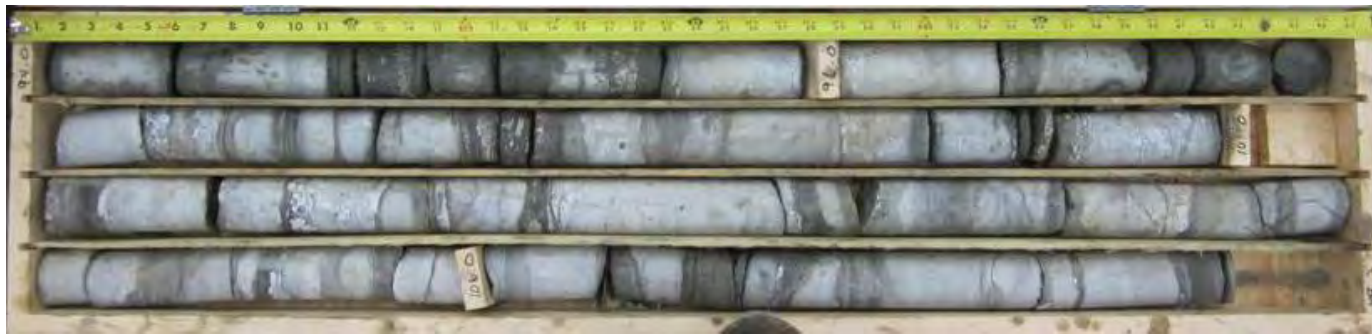
BORING NO.: R-8  
 CORE BOX NO.: 2 OF 6  
 DEPTH (ft.): 94.0-108.2  
 ELEVATION (ft.): 361.7  
 5/NQ: 96.0'-101.0'; REC. 94%, RQD 68%  
 6/NQ: 101.0'-106.0'; REC. 100%, RQD 90%  
 7/NQ: 106.0'-111.0'; REC. 100%, RQD 80%

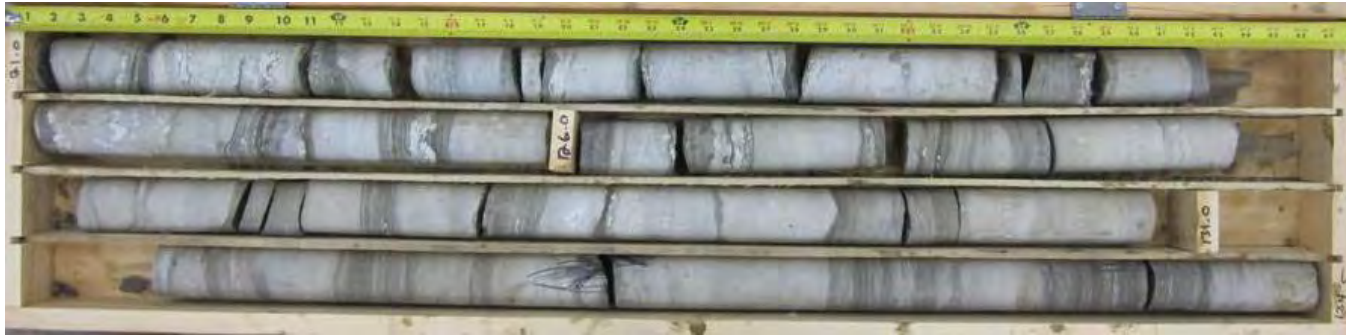
BORING NO.: R-8  
 CORE BOX NO.: 4 OF 6  
 DEPTH (ft.): 121.0-134.5  
 ELEVATION (ft.): 334.7  
 10/NQ: 121.0'-126.0'; REC. 100%, RQD 82%  
 11/NQ: 126.0'-131.0'; REC. 100%, RQD 96%  
 12/NQ: 131.0'-136.0'; REC. 100%, RQD 100%

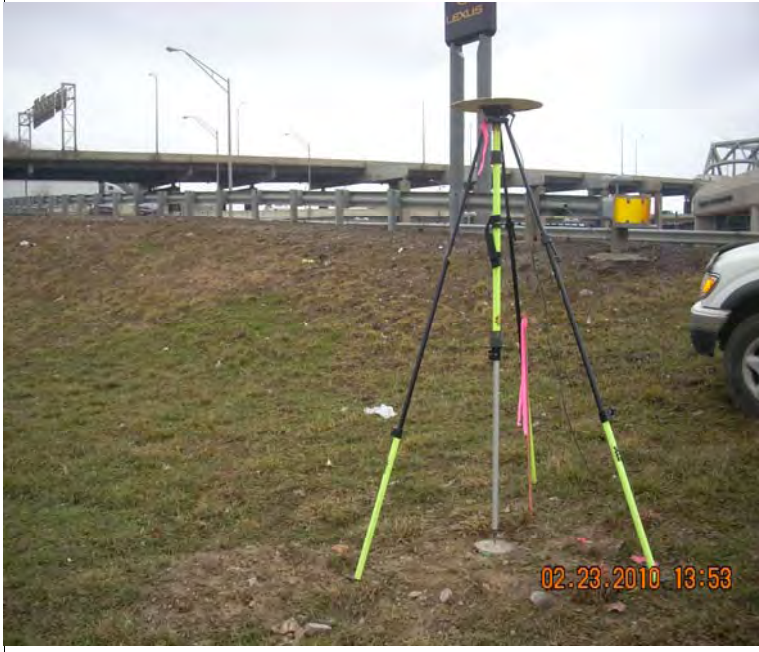
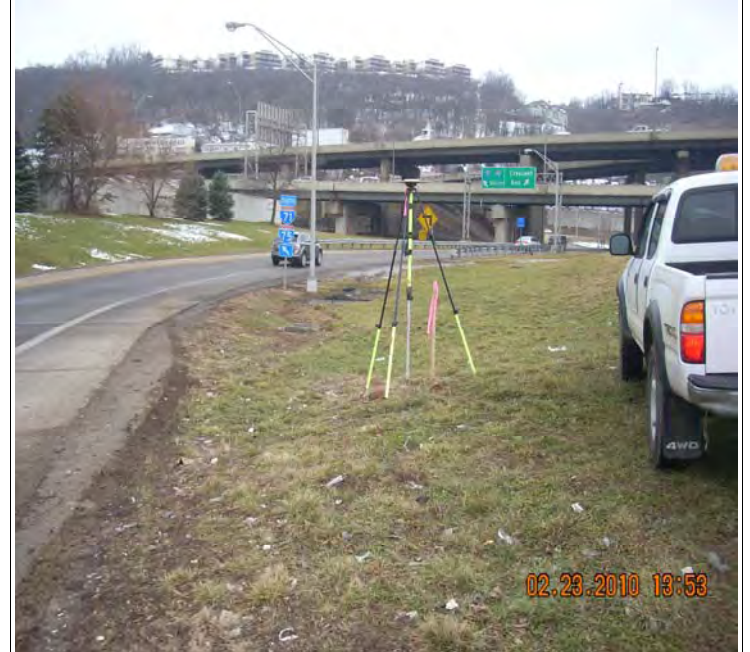
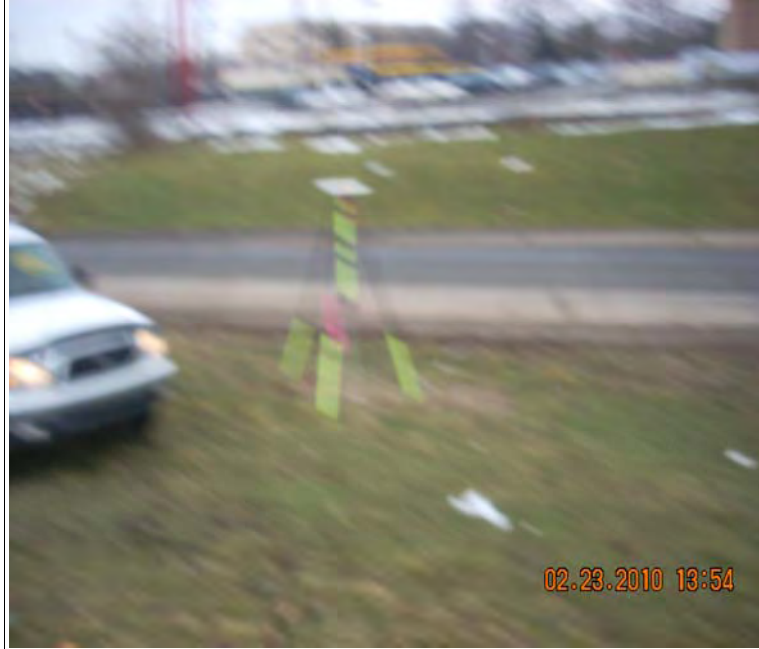
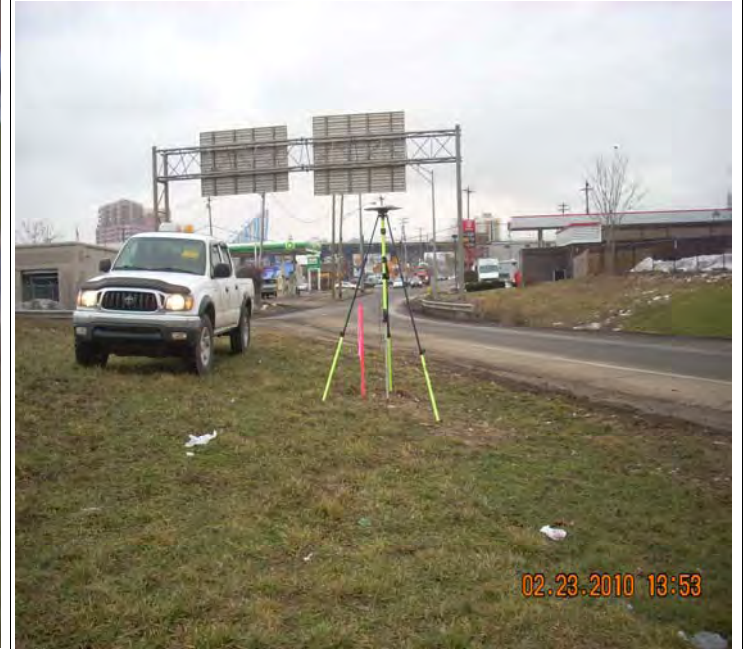
Site/Quad  Covington	Station Description (Description is to be complete) (type, size, depth set, etc.) Concrete Monument 5/8" Rebar 2 1/2" Aluminum Cap 24" Concrete			Station Designation  MON 11	
Locality/County  Kenton				Stamping on Mark  I75-I71 CONTROL	
Date Set or Found (Date, with S or F)  2/22/2010 S	Latitude 39°05'11.19732"N	Longitude 84°31'17.39378"W	Horiz. Datum NAD83	Zone KY Single	Vert. Datum 1988
	Northing (KY SP1Z) (US Survey Feet) 4,285,659.91	Easting (KY SP1Z) (US Survey Feet) 5,270,007.96	Elevation 496.51	Derived From Level	Order Accuracy 3rd
Person filling out form  AFS	Northing (OH SPSZ) (US Survey Feet) 402122.39	Easting (OH SPSZ) (US Survey Feet) 1394753.18	Geoid Model Geoid 09	Ellipsoid Ht. 384.64	Other Info.
Established by Agency  Photo Science, Inc.	Project Factor	Back Station I.D.	Datum Azimuth - Distance to back station  ° ' " (ft)		
Scale Factor 1.00012828	Elev. Factor 0.99998164	Ahead Station I.D.	Datum Azimuth - Distance to ahead station  ° ' " (ft)

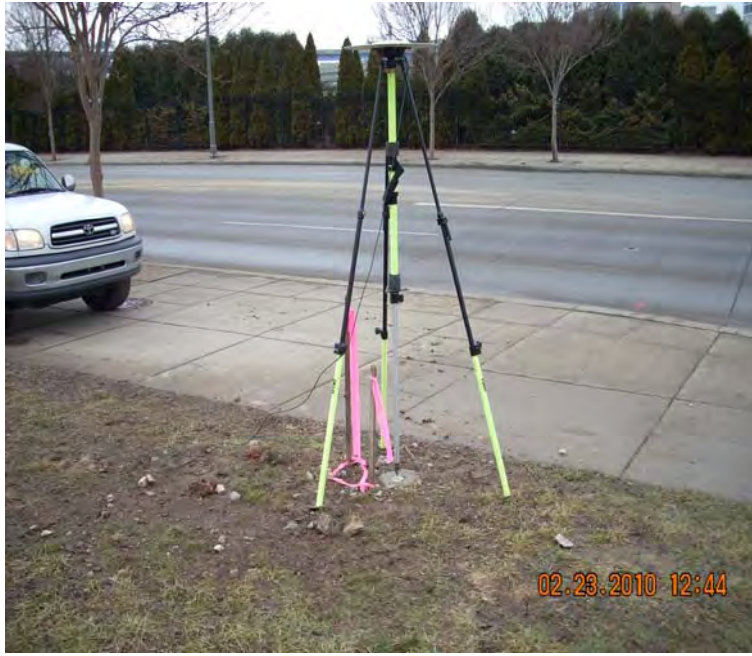
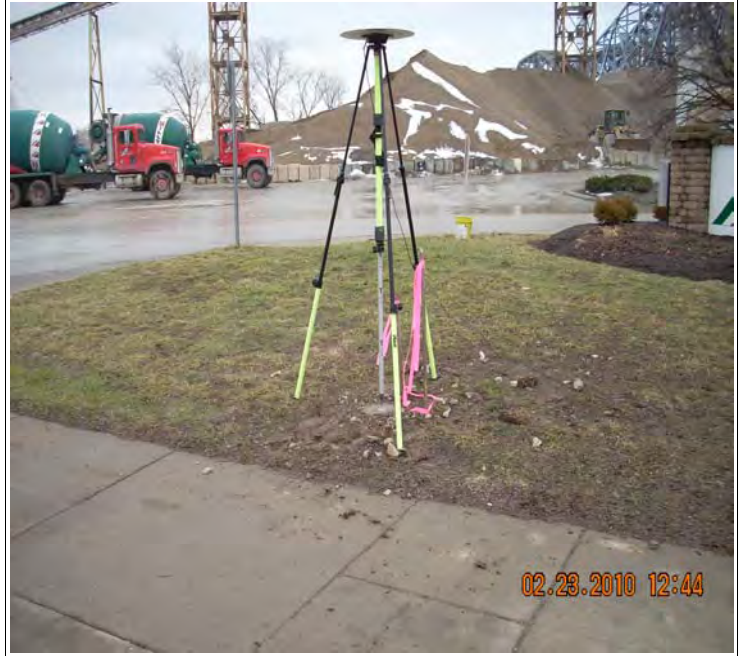
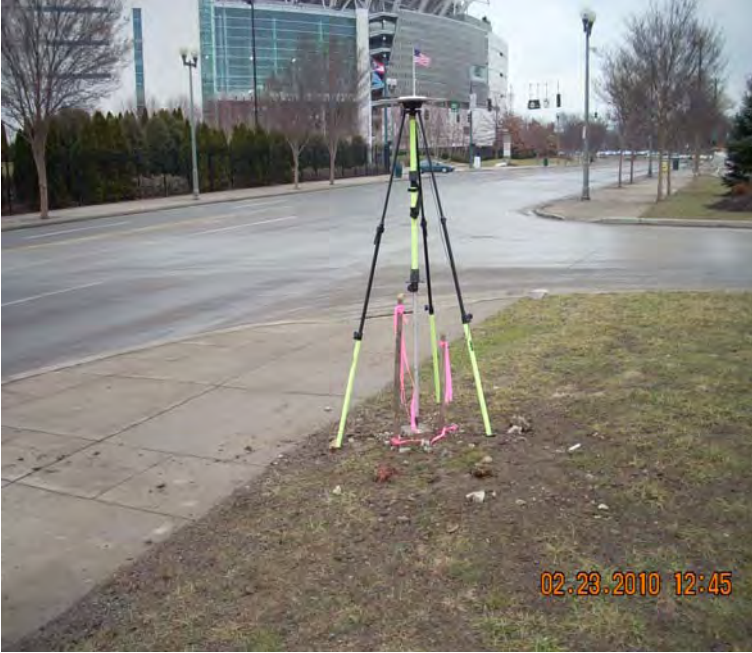
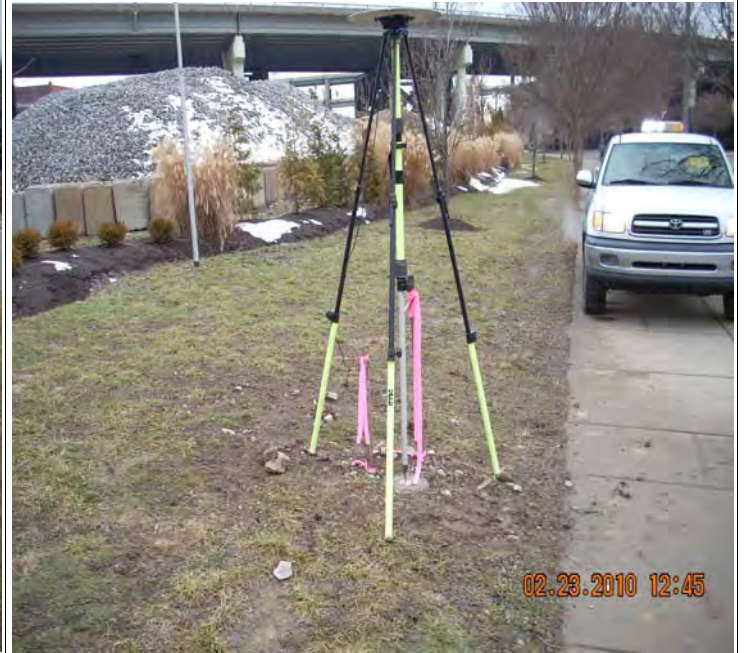
Site/Quad <b>Covington</b>	Station Description (Description is to be complete) (type, size, depth set, etc.) <b>Concrete Monument 5/8" Rebar 2 1/2" Aluminum Cap 24" Concrete</b>			Station Designation <b>MON 12</b>	
Locality/County <b>Hamilton</b>				Stamping on Mark <b>I75-I71 CONTROL</b>	
Date Set or Found (Date, with S or F)  <b>2/22/2010 S</b>	Latitude <b>39°05'39.45612"N</b>	Longitude <b>84°31'08.62875"W</b>	Horiz. Datum <b>NAD83</b>	Zone <b>KY Single</b>	Vert. Datum <b>1929</b>
	Northing (KY SP1Z) (US Survey Feet) <b>4,288,528.22</b>	Easting (KY SP1Z) (US Survey Feet) <b>5,270,661.40</b>	Elevation <b>486.48</b>	Derived From Level	Order Accuracy <b>3rd</b>
Person filling out form  <b>AFS</b>	Northing (OH SPSZ) (US Survey Feet) <b>404965.15</b>	Easting (OH SPSZ) (US Survey Feet) <b>1395508.02</b>	Geoid Model <b>Geoid 09</b>	Ellipsoid Ht. <b>374.55</b>	Other Info.
Established by Agency  <b>Photo Science, Inc.</b>	Project Factor	Back Station I.D.	Datum Azimuth - Distance to back station  ° ' " (ft)
