**CUY-90-14.90**

**West Slope Stability Report  
(Reference Document)**

**Innerbelt Bridge  
Construction Contract Group 1 (CCG1)**

**SLOPE STABILITY  
EVALUATION  
REPORT**

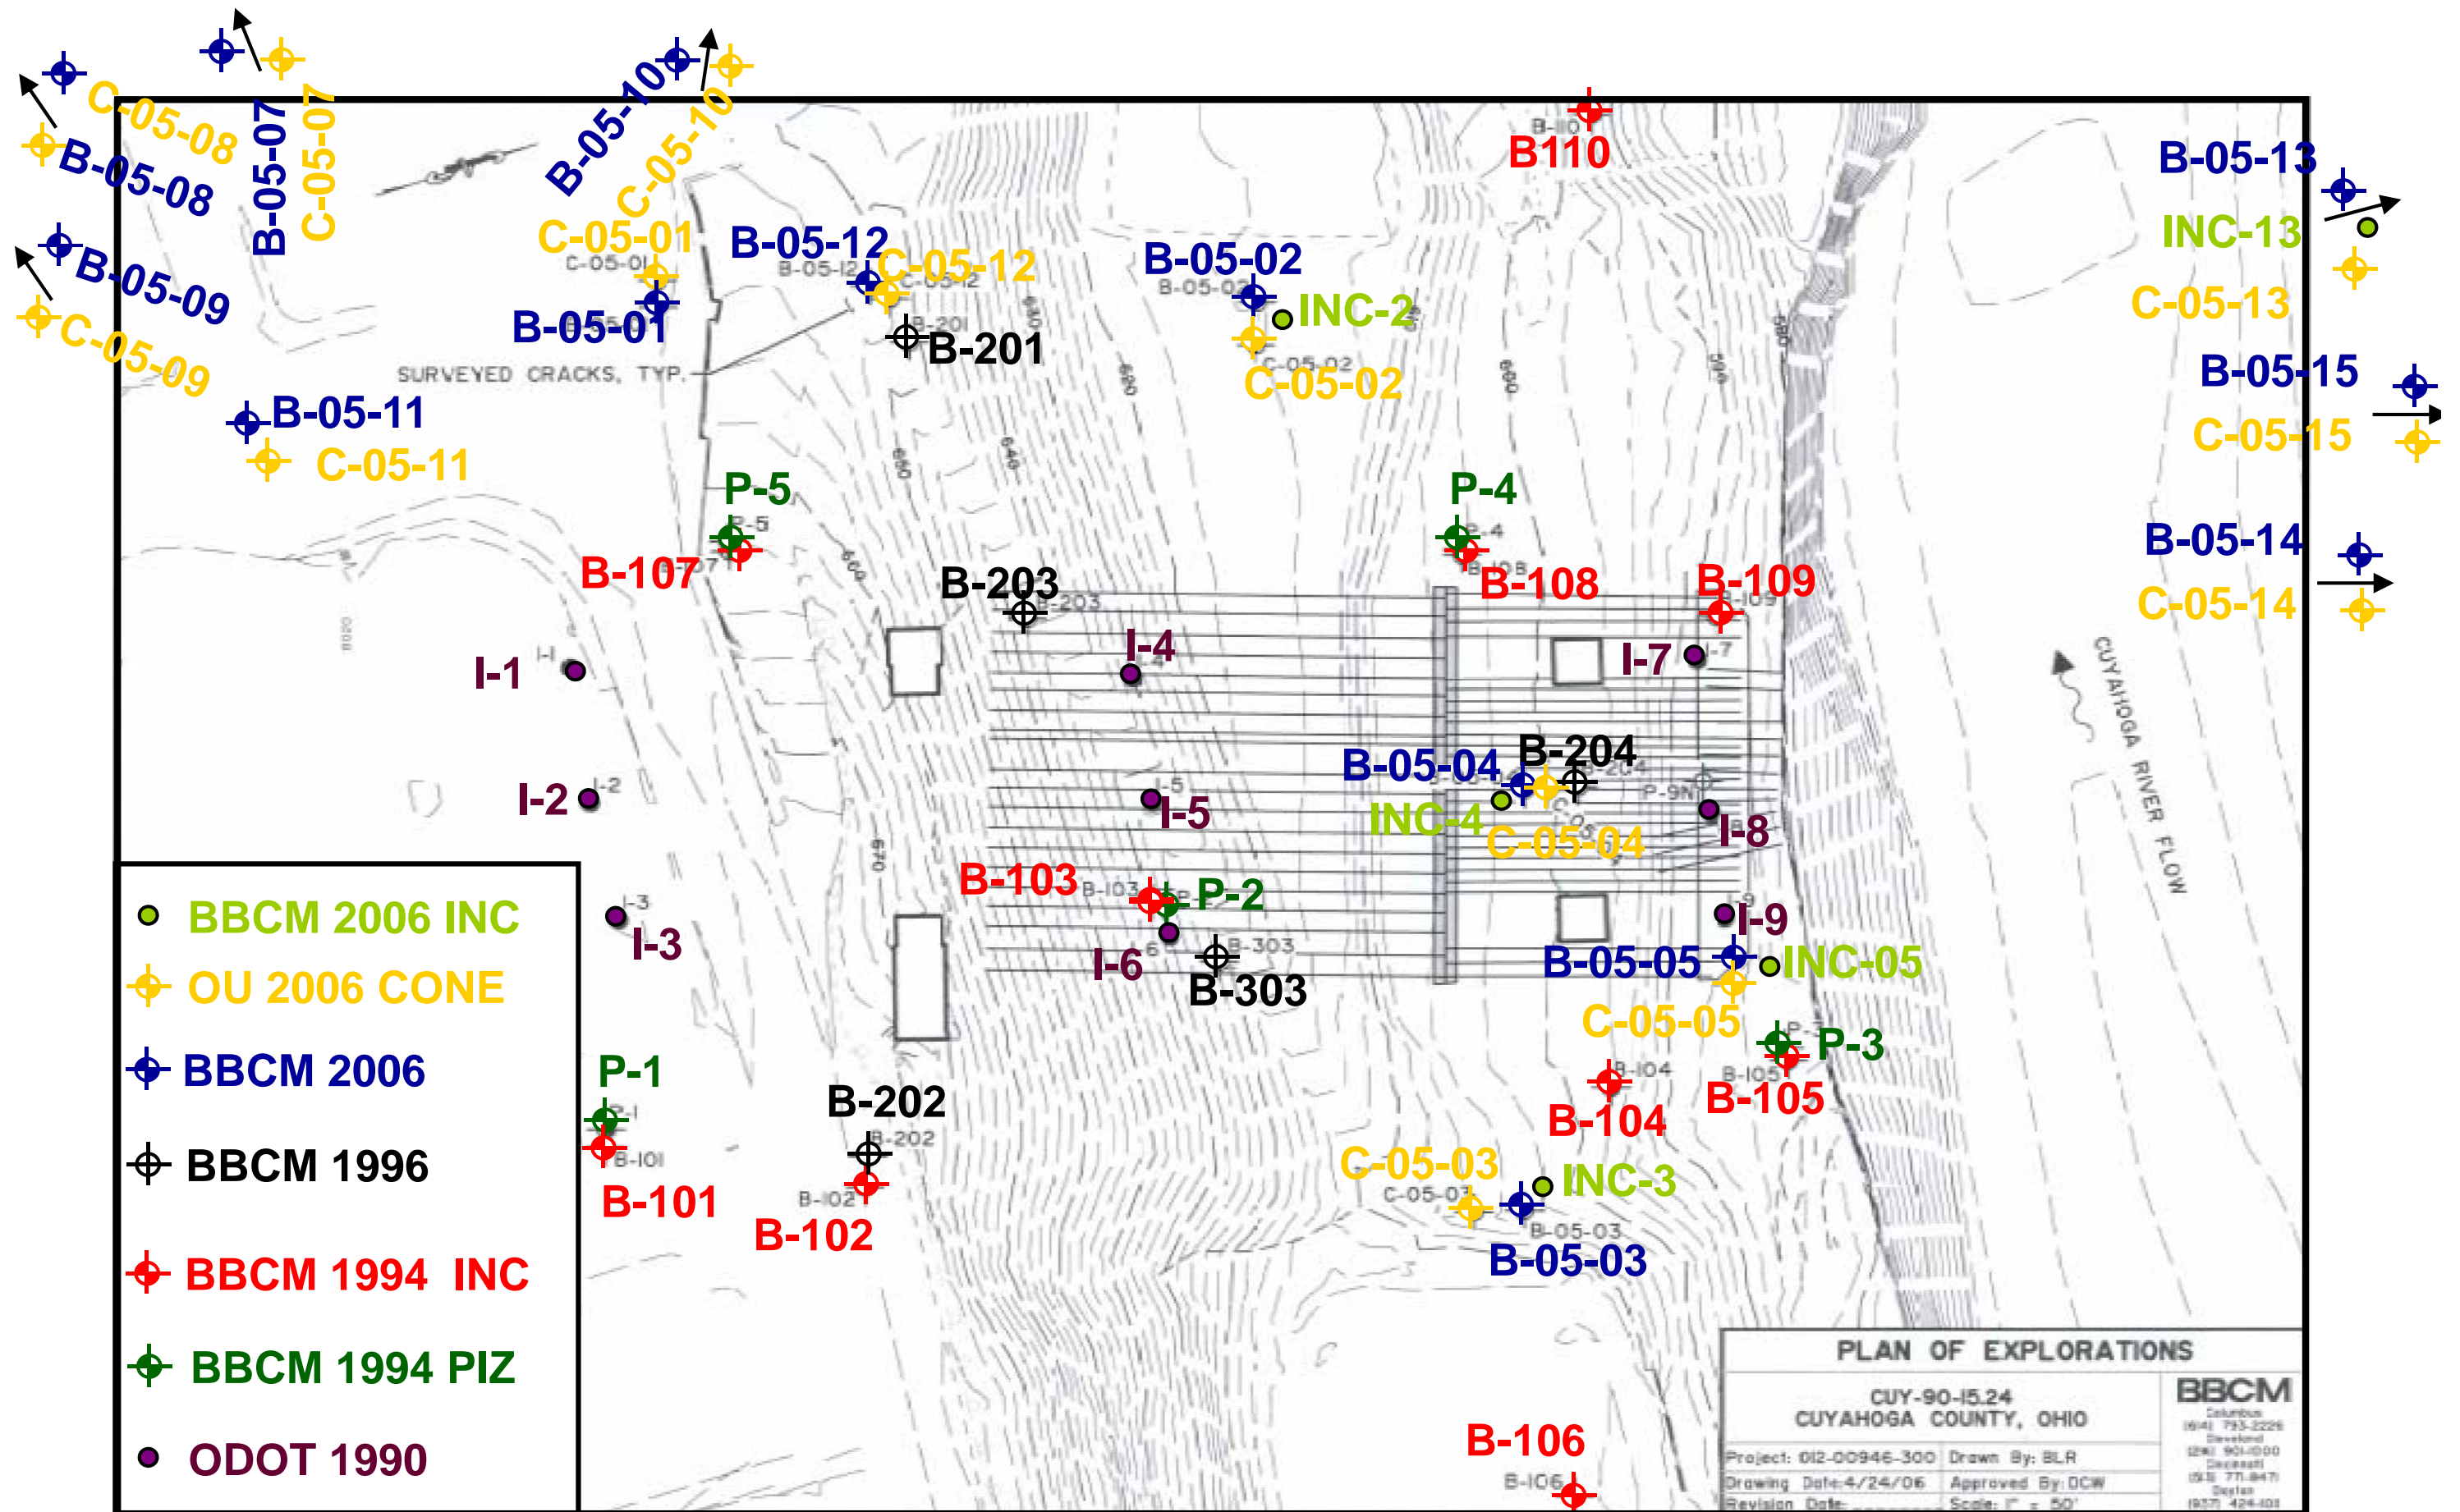
PLATE 2

**PLAN OF BORINGS**

Original Borings Numbering-before 2009. 2009 boring numbering next page

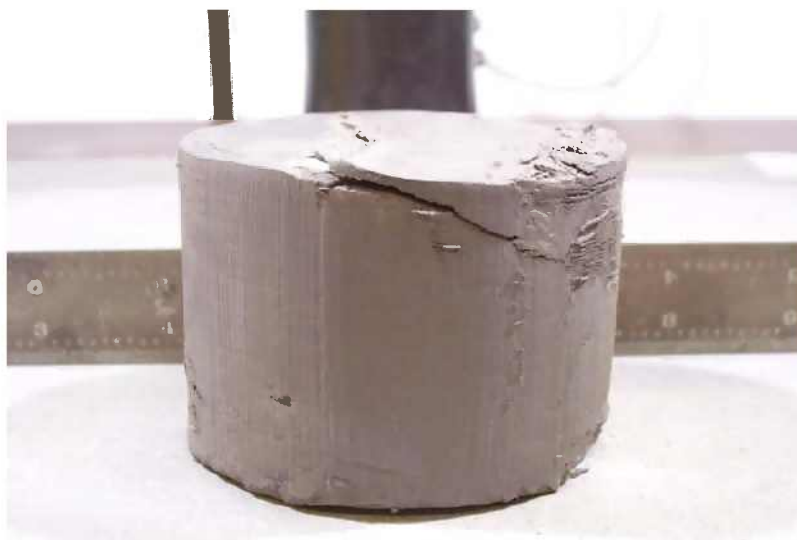
Extruded sample showing in-situ shear plane. Side view.  
Direct Simple Shear test, DSS-2 was trimmed from this piece.

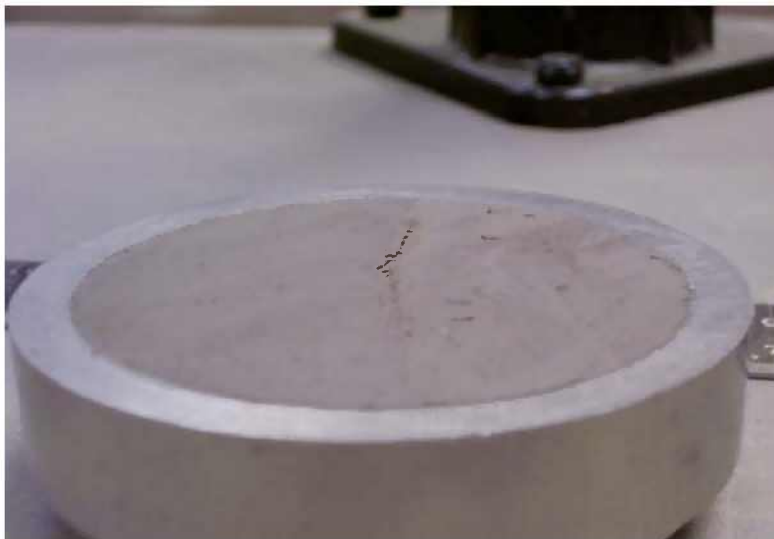
Sample in trimming ring showing an in-situ shear plane in the material as received. Residual Shear test (RS-2), angled view.

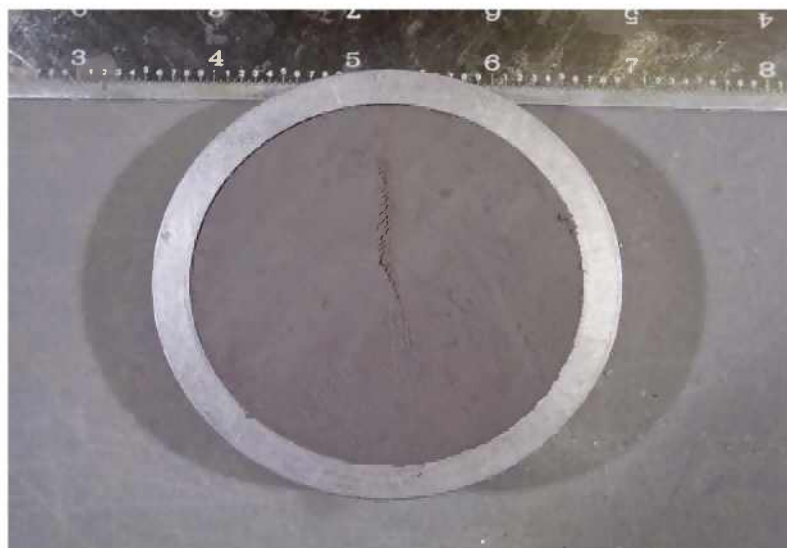
Same sample, in trimming ring showing an in-situ shear plane in the material as received. Residual Shear test (RS-2), top view.

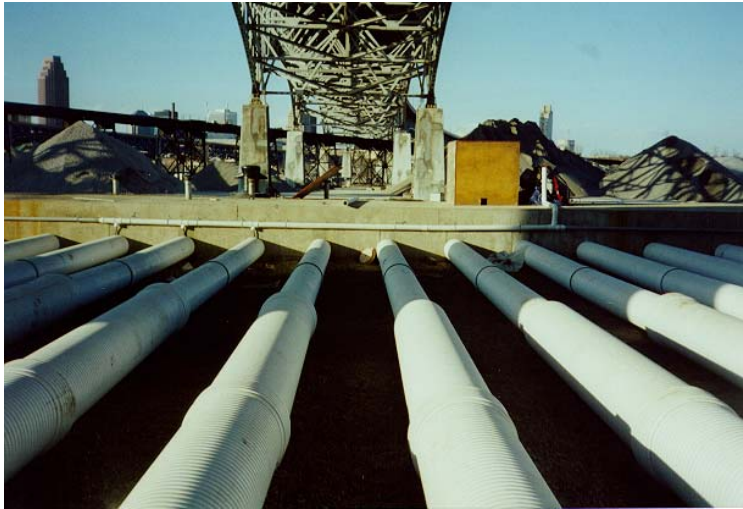
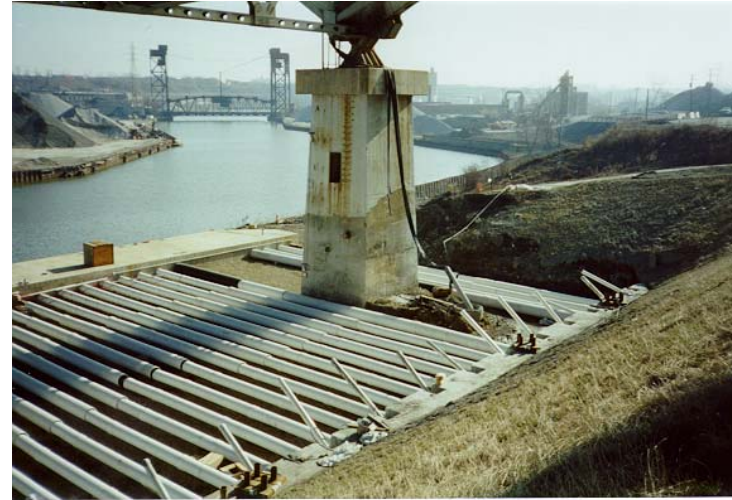
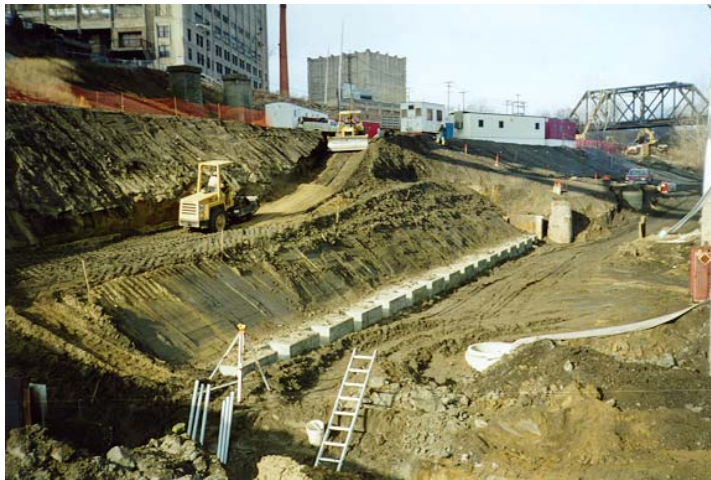
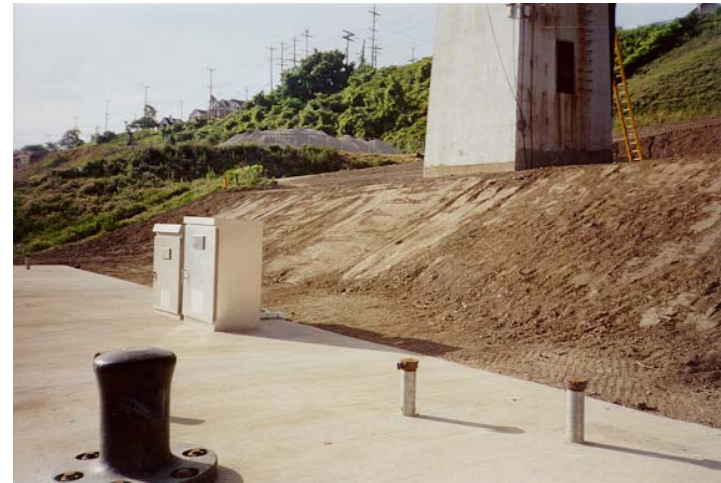
Figure 5.19 Photo showing the construction of the tie beams and the buildup of fill on top

Tie beam measurements are experiencing a steady state condition with no indication of any trend to vary with time except for slight stress changes which are most likely a result of changes in temperature. Note that there is a relatively high frictional resistance from the soil around and on top of the beams. The tie beams were insulated in a 24" diameter corrugated PVC, pipe which was filled with concrete after tensioning of the anchors. Due to the corrugated pipe and the concrete filling, the tie beams are acting as a composite 24" diameter corrugated section. The steel beam inside the section is not indicating any increase in stress in response to the movement of the caps. The force transmitted through the PVC composite sections has to overcome the friction of the surrounding soil. It appears that the drilled shaft cap and the pile cap are moving similar distances laterally, which allows the tie beams to remain in a constant state of stress. Pictures in Figure 5.19 show the construction of the tie beams and the placement of substantial embankment on top of the tie beams.

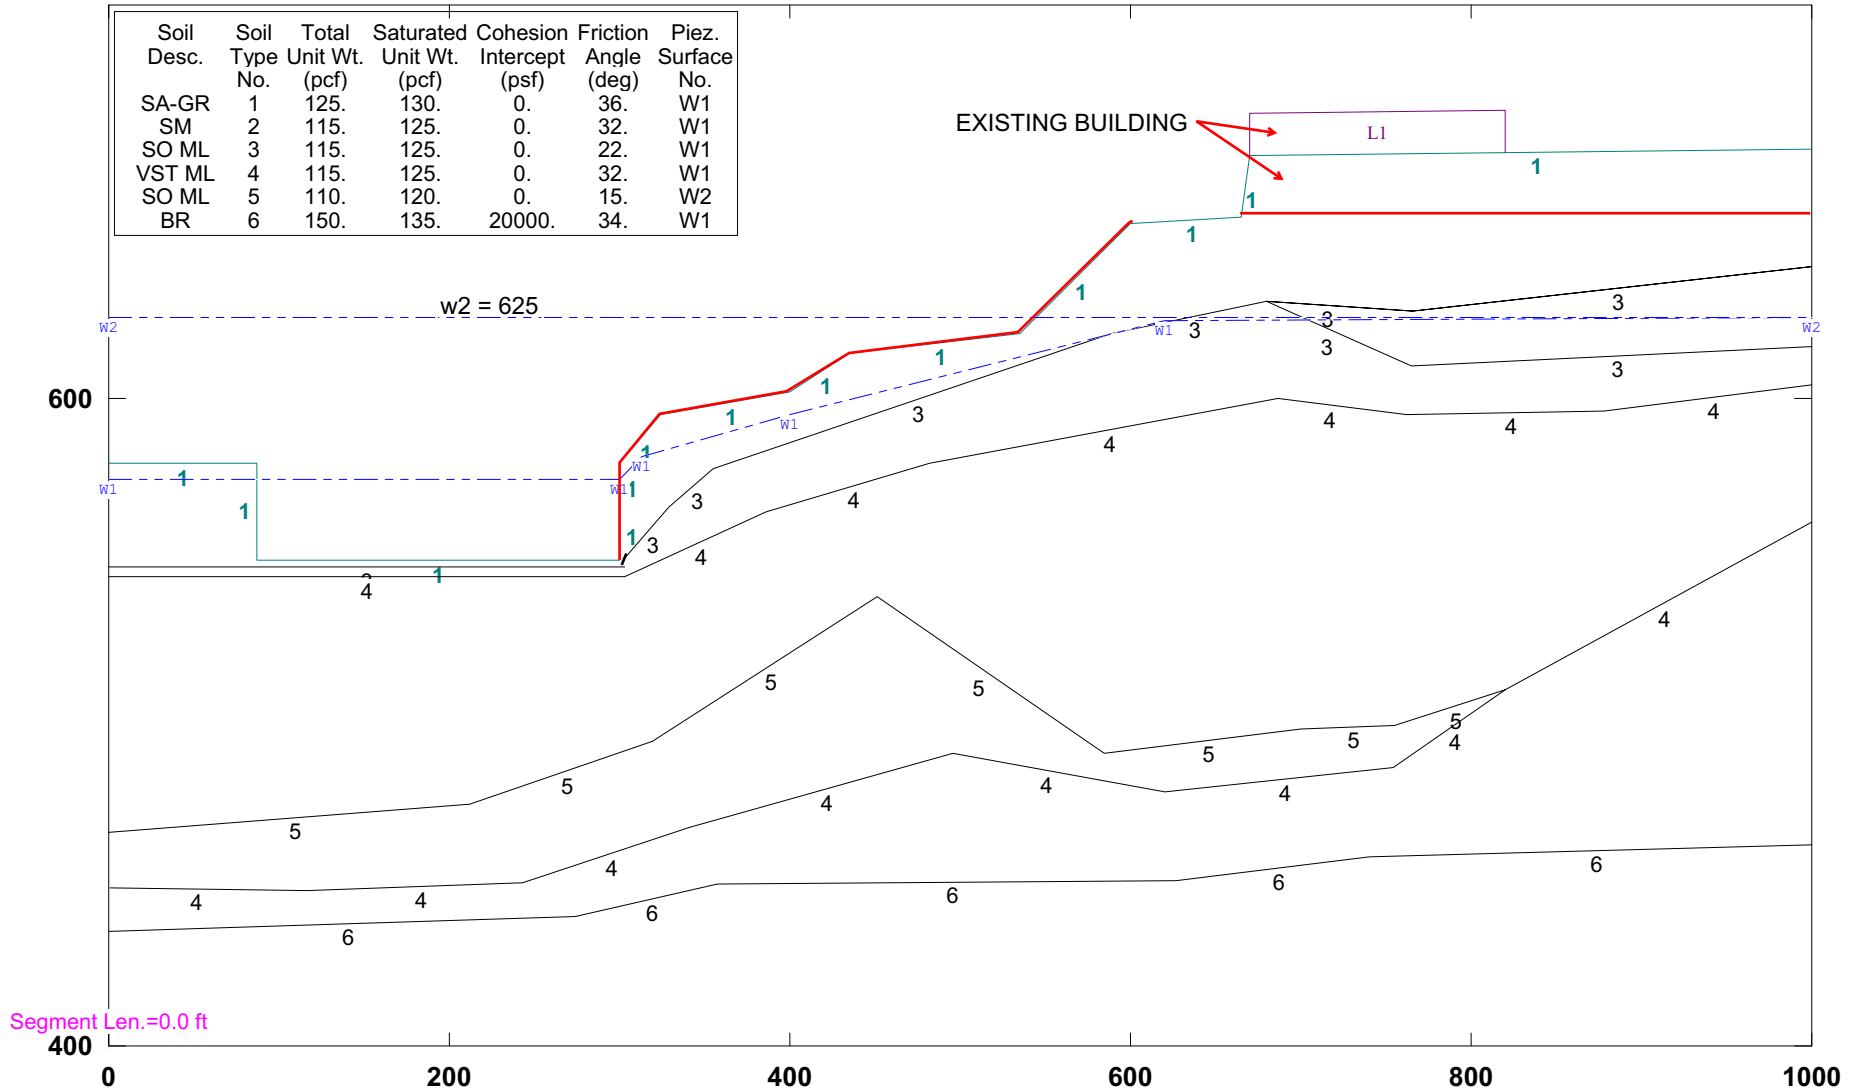
**Figure 7B.1: Geometry and Material Properties at Section A-A.**

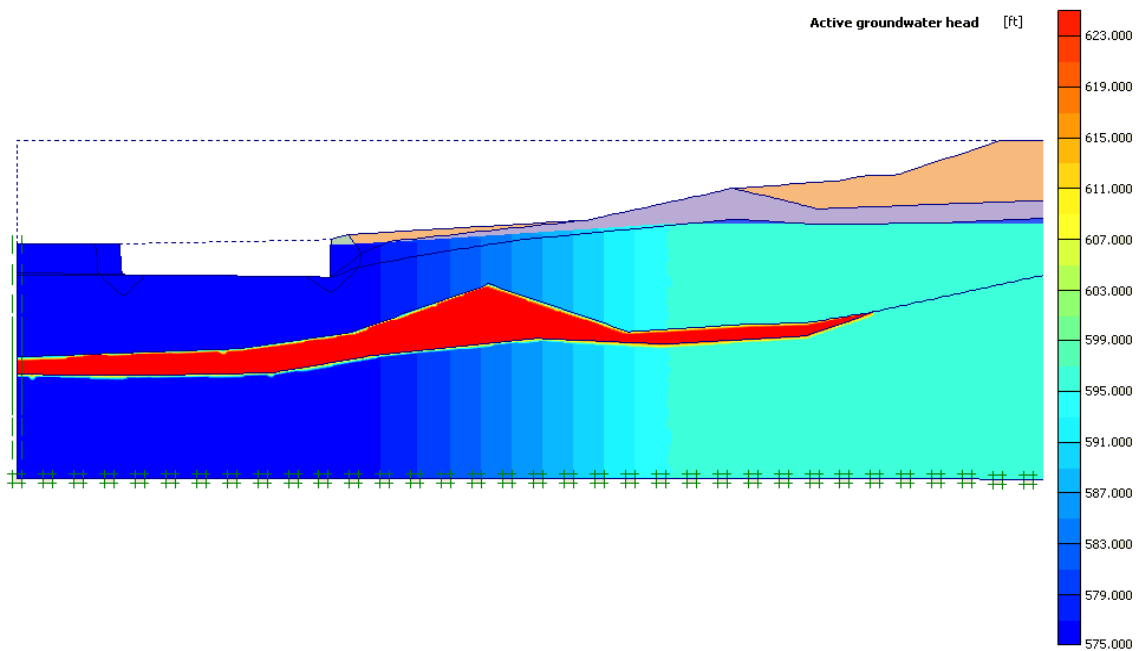
Figure 1 shows a plot of the groundwater heads for the assumed existing conditions with w2 applied in the strata 5 zone, and w1 applied to all other soils.

Figure 1: Ground Water Heads for Elevated Pore Pressure Conditions

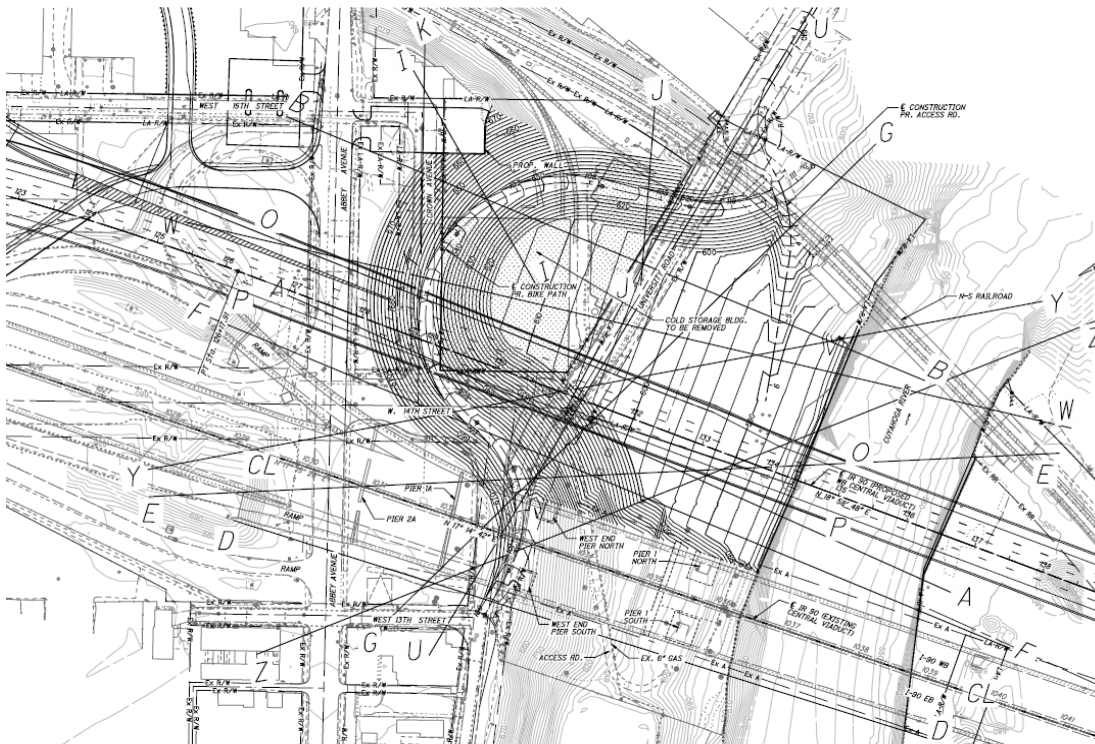
Figure 5: Proposed Slope Grading - Alternative 5

E.L. Robinson developed several alternative grading plans. Geocomp selected two of the alternatives on which to perform the independent stability analyses. Originally, Alternative 2 was selected as the most likely alternative. Later Alternative 5 developed as the preferred alternative. The two alternatives are shown in Figures 4 and 5.

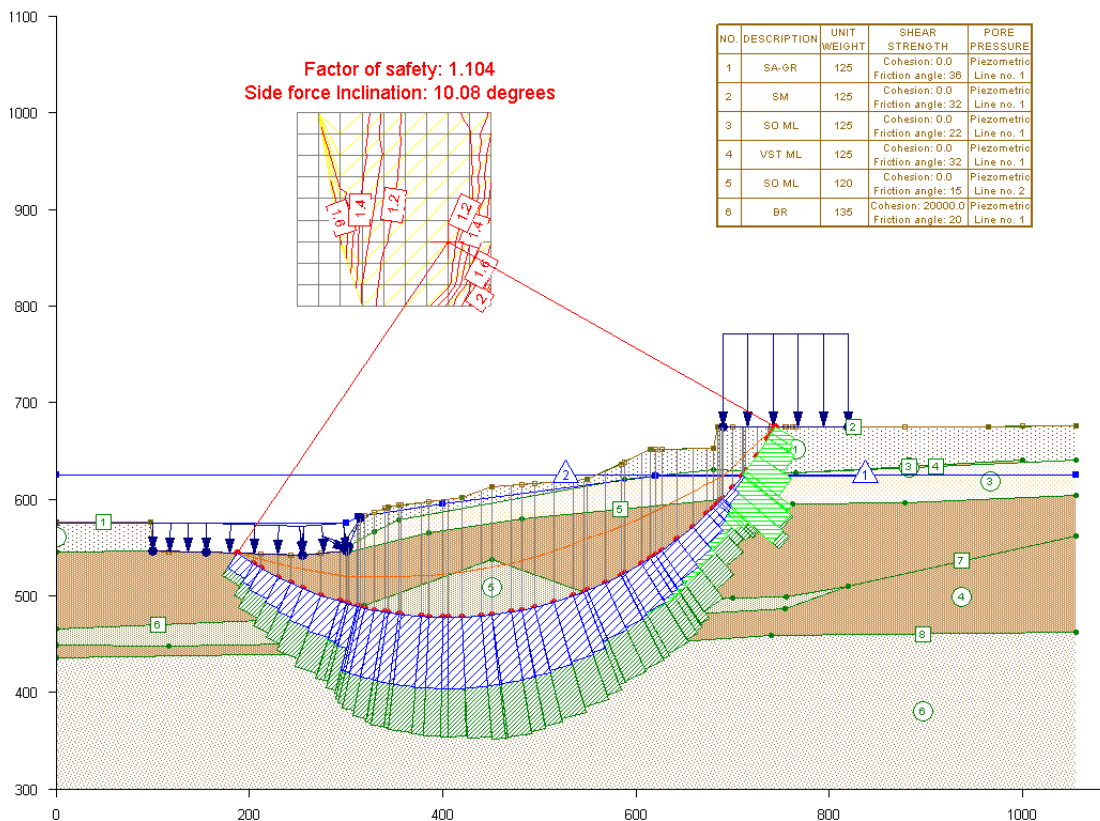
- The geometry and soil parameters
- Minimum factor of safety obtained and the failure surface for that minimum.
- Pore pressure acting on this failure surface.
- Total or normal stress on this failure surface.
- Location of line of thrust for the side forces.

Figure 6: Typical UTEXAS4 Results

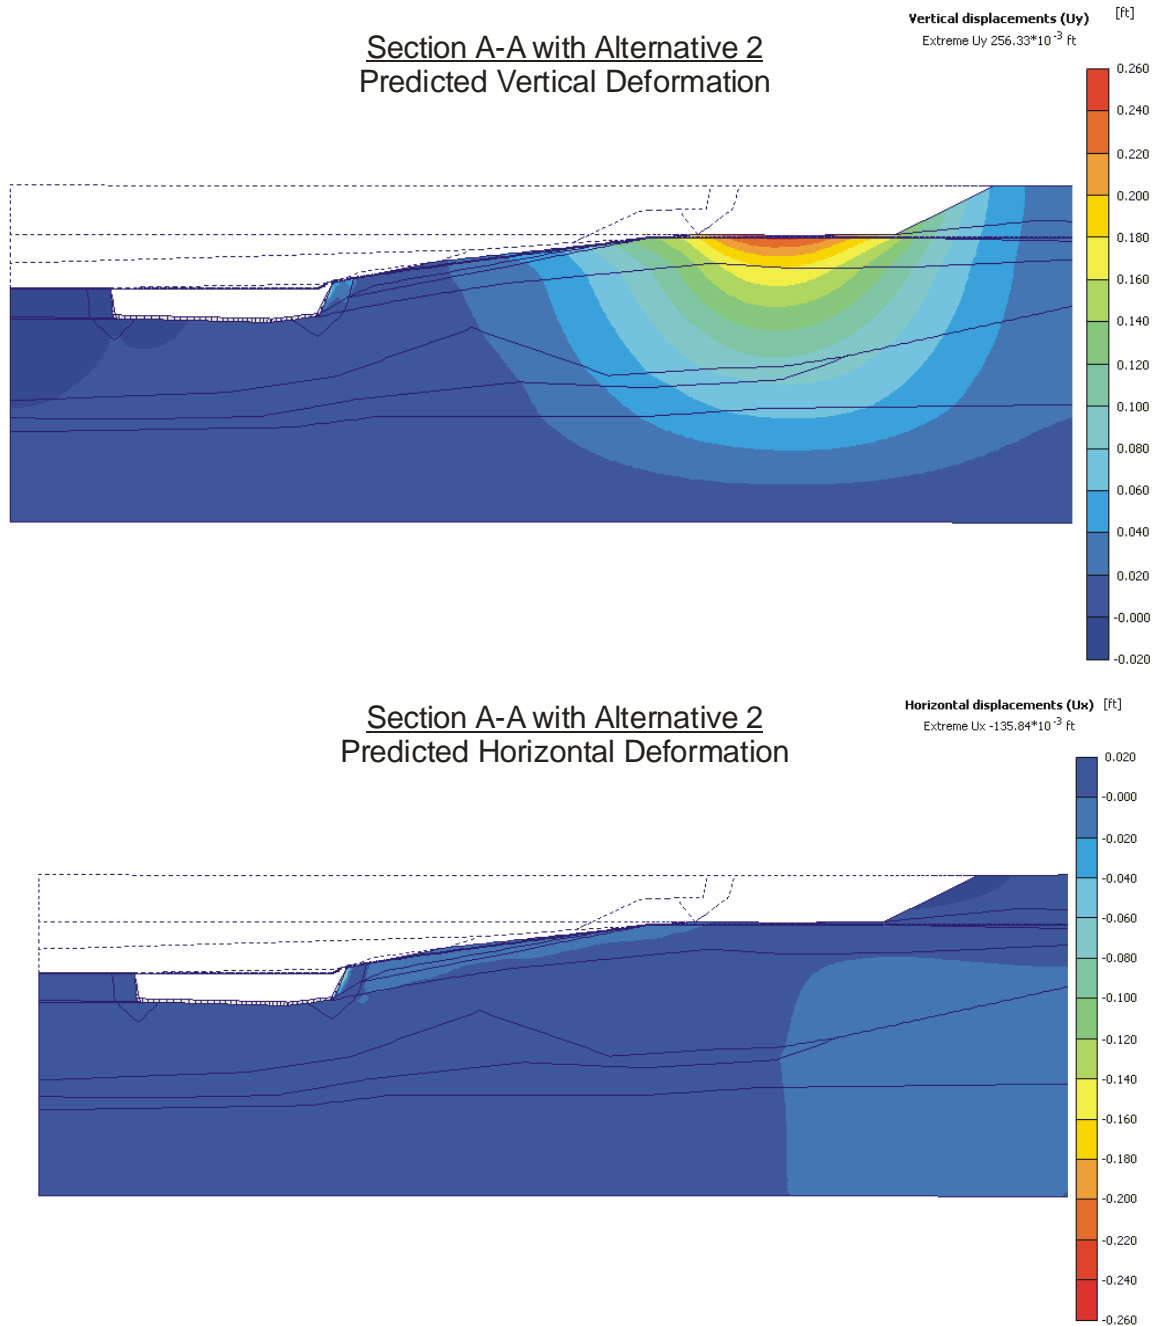
Predicted maximum movements in the vicinity of the railroad are approximately ¼ inch at the ground surface. These are not sufficient to cause distress to the foundations of the existing railroad bridge.

Figure 10: Predicted Deformations for Section A-A Alternative 2

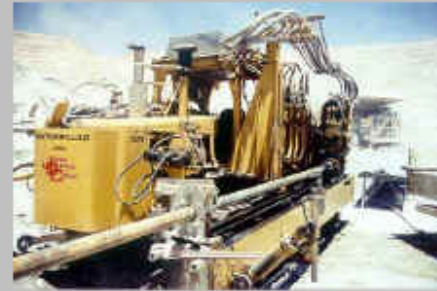
Custom Horizontal Drilling Machine, Designed and Built by Jensen Drilling Company

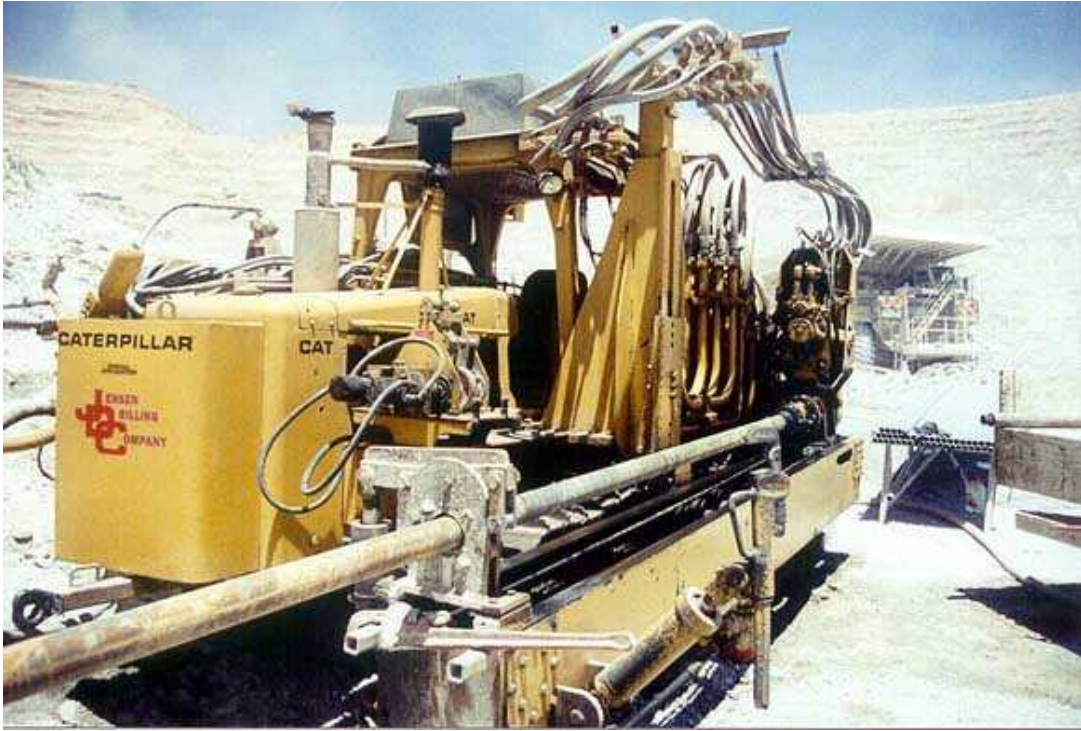
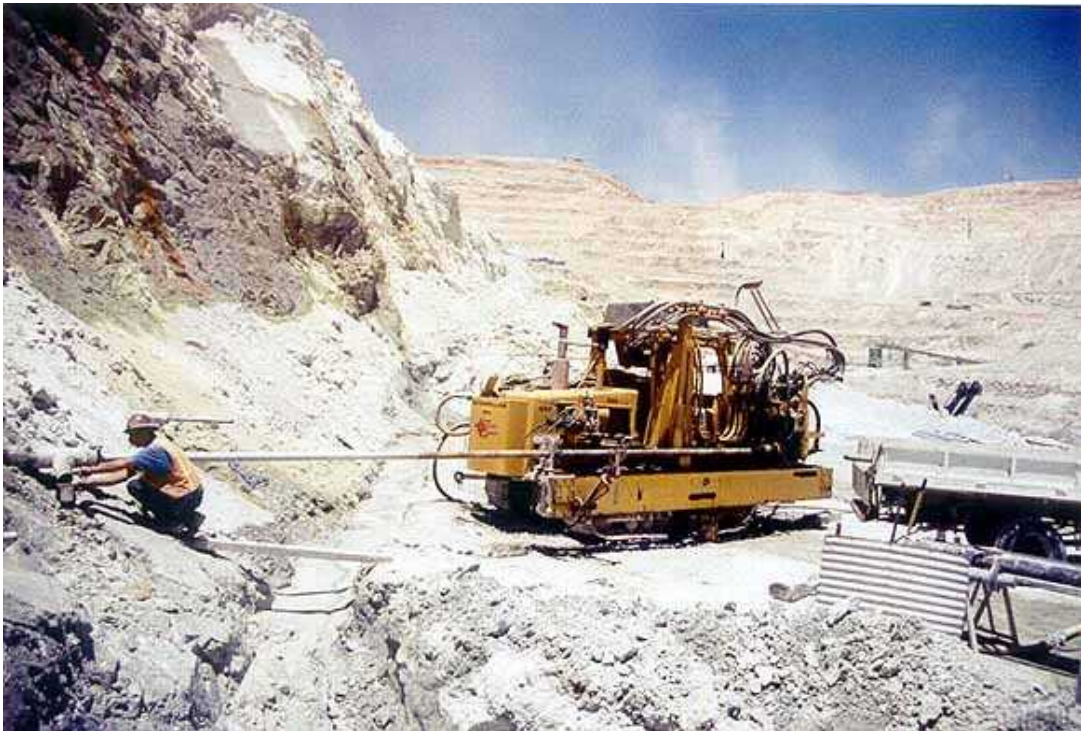
**Figure 8.2: Pictures of horizontal drain installation equipment**
