CONSOLIDATION TEST REPORT

Project No. 0121- Project: SCI-823-0.00 Source: TR-14	Client: TranSystems, Inc. Sample No.: ST-1 Elev./Depth: 13.0	Remarks:
--	---	-----------------

Project No.: 0121-3070.03

Project: SCI-823-0.00

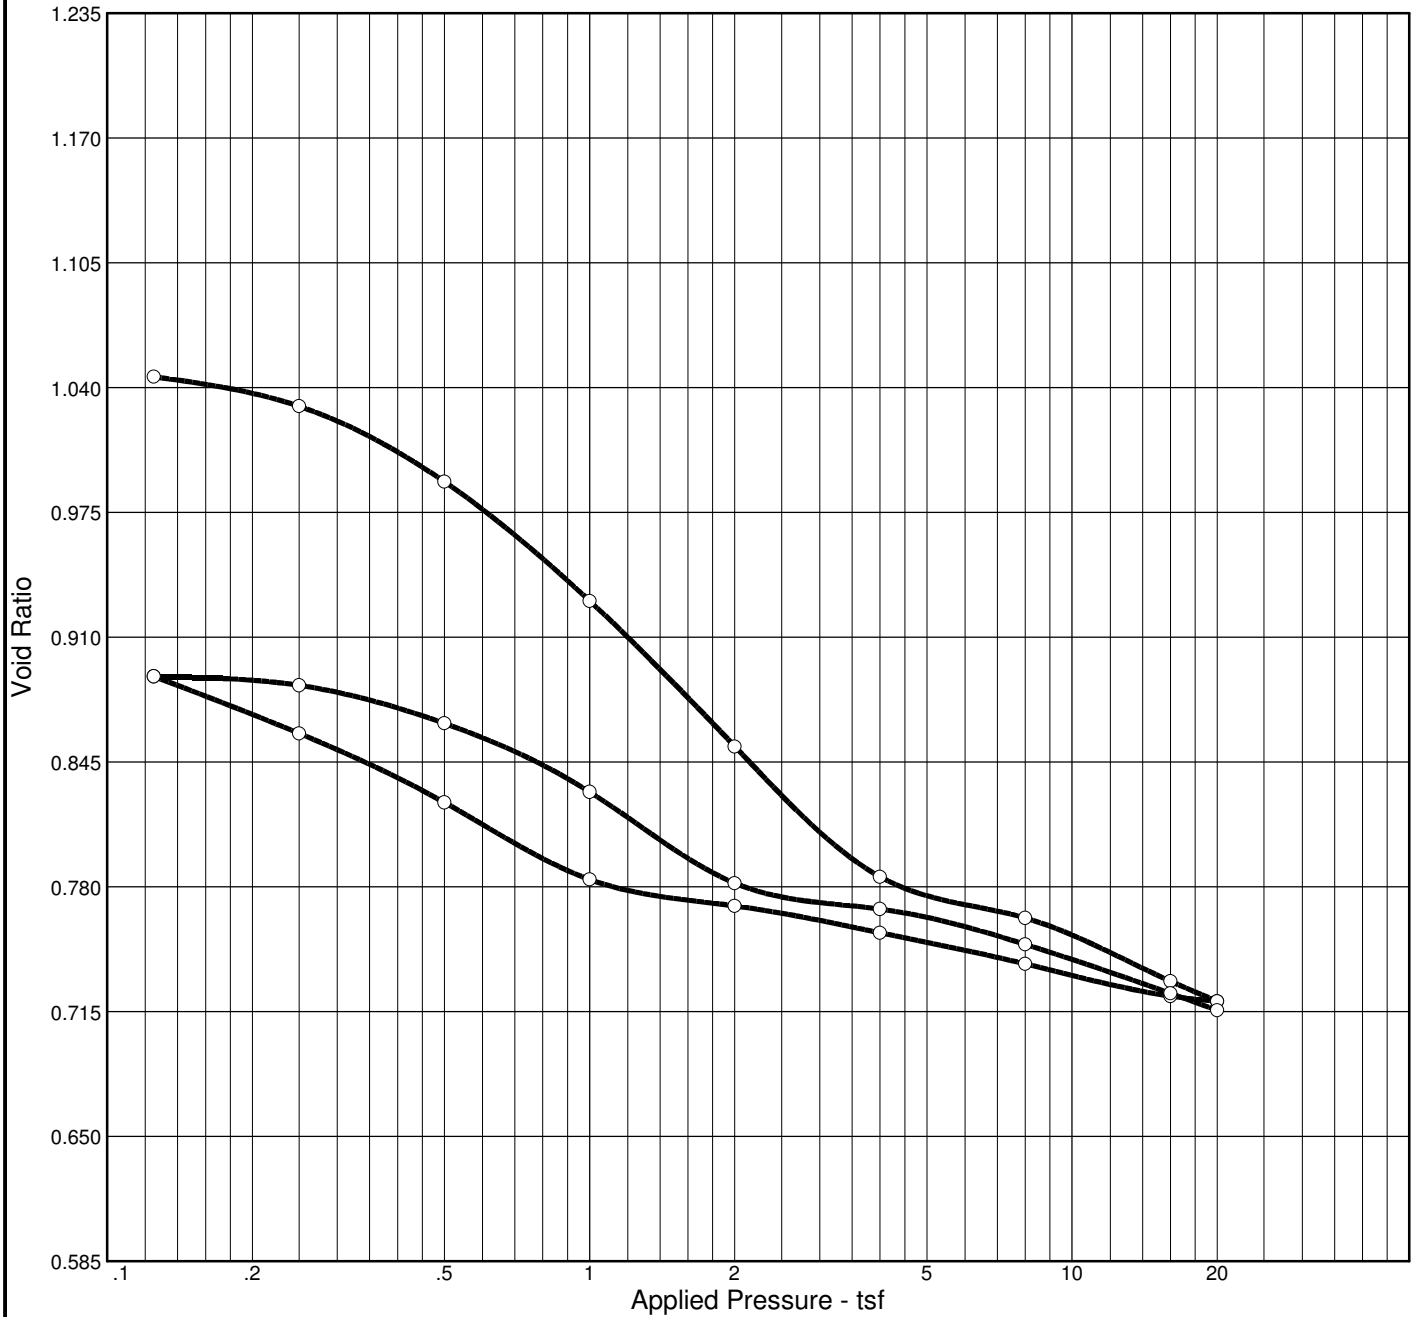
Natural	Dry Dens. (pcf)	LL	PI	Sp. Gr.	Overburden (tsf)	P _c (tsf)	C _c	C _r	Swell Press. (tsf)	Heave %	e ₀
Sat. Moist.	85.4	65	37	2.82		0.71	0.26	0.08			1.061
98.3 %	37.0 %

MATERIAL DESCRIPTION	USCS	AASHTO
Fat clay	CH	A-7-6(44)
