Since all quantified excavation will need to be removed and embankment filled to achieve final condition grading, the final MOT excavation and embankment values are equal and are the sum of the above excavation and embankment

MAINTENANCE OF TRAFFIC - PHASE 4  
CROSS SECTIONS - I.R. 90 WB TEMPORARY PAVEMENT (EAST)

| PROJECT ID | |
| 82382 | |

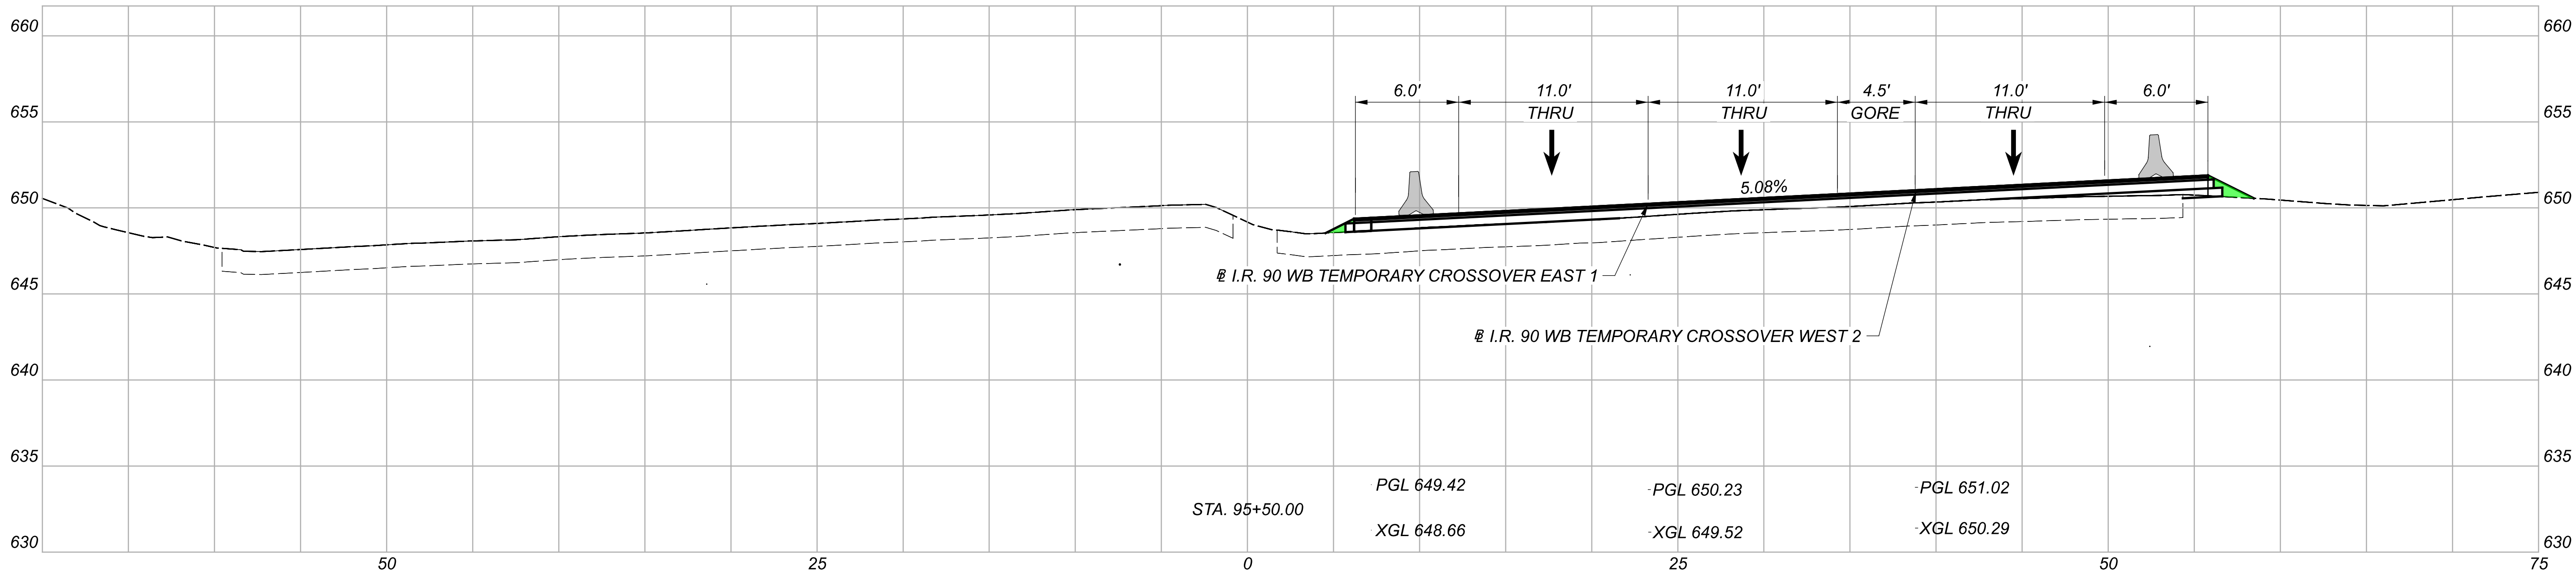
| 230 | 2696 |

MAINTENANCE OF TRAFFIC - PHASE 4  
CROSS SECTIONS - I.R. 90 WB TEMPORARY PAVEMENT (EAST)

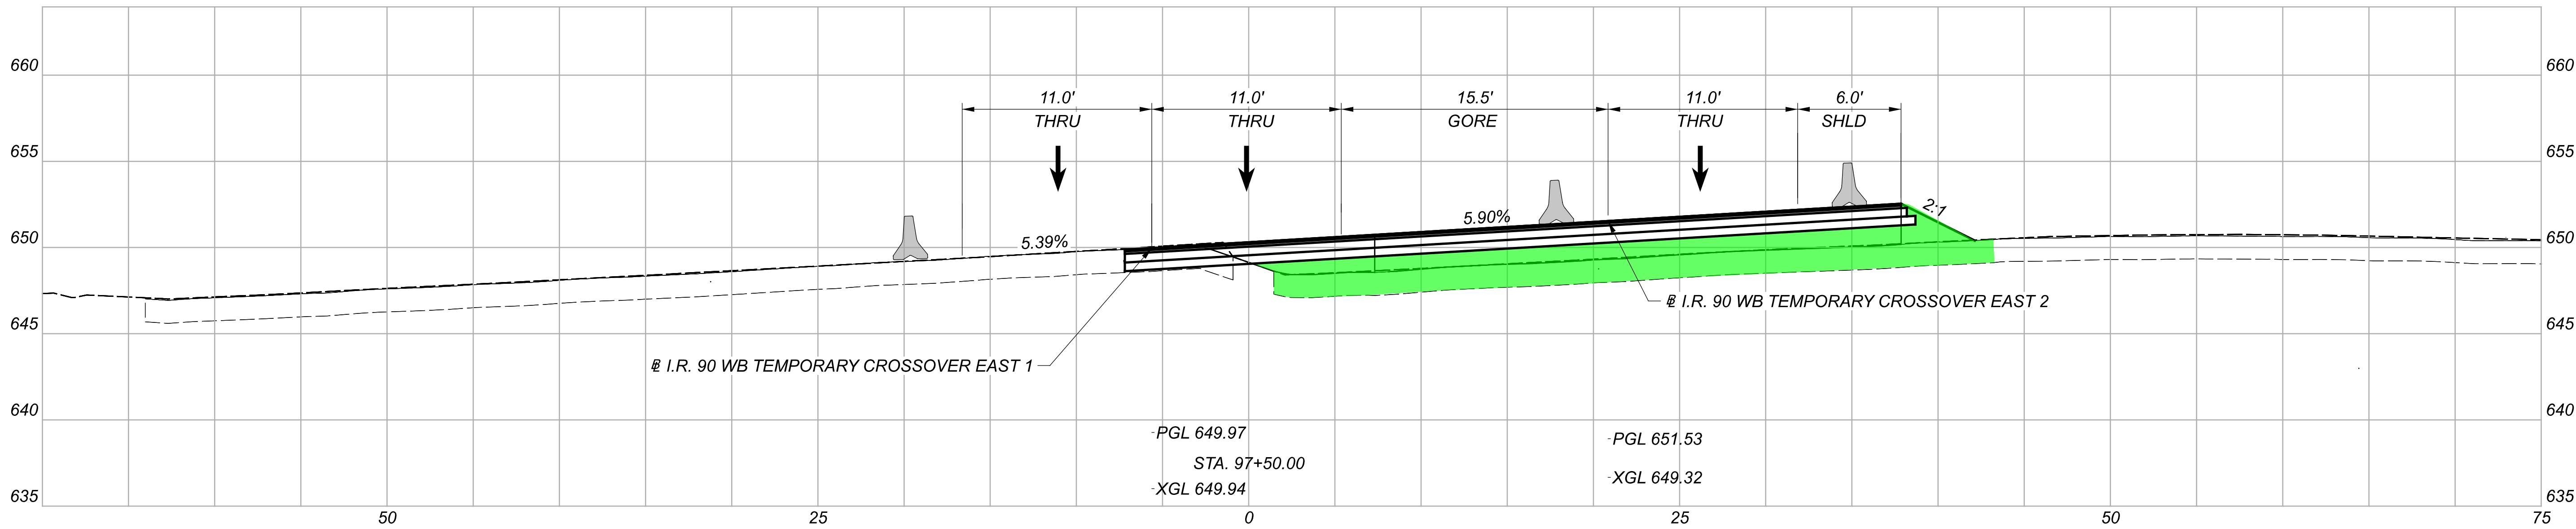
| 231 | 2696 |

MAINTENANCE OF TRAFFIC - PHASE 4  
CROSS SECTIONS - I.R. 90 WB TEMPORARY PAVEMENT (EAST)

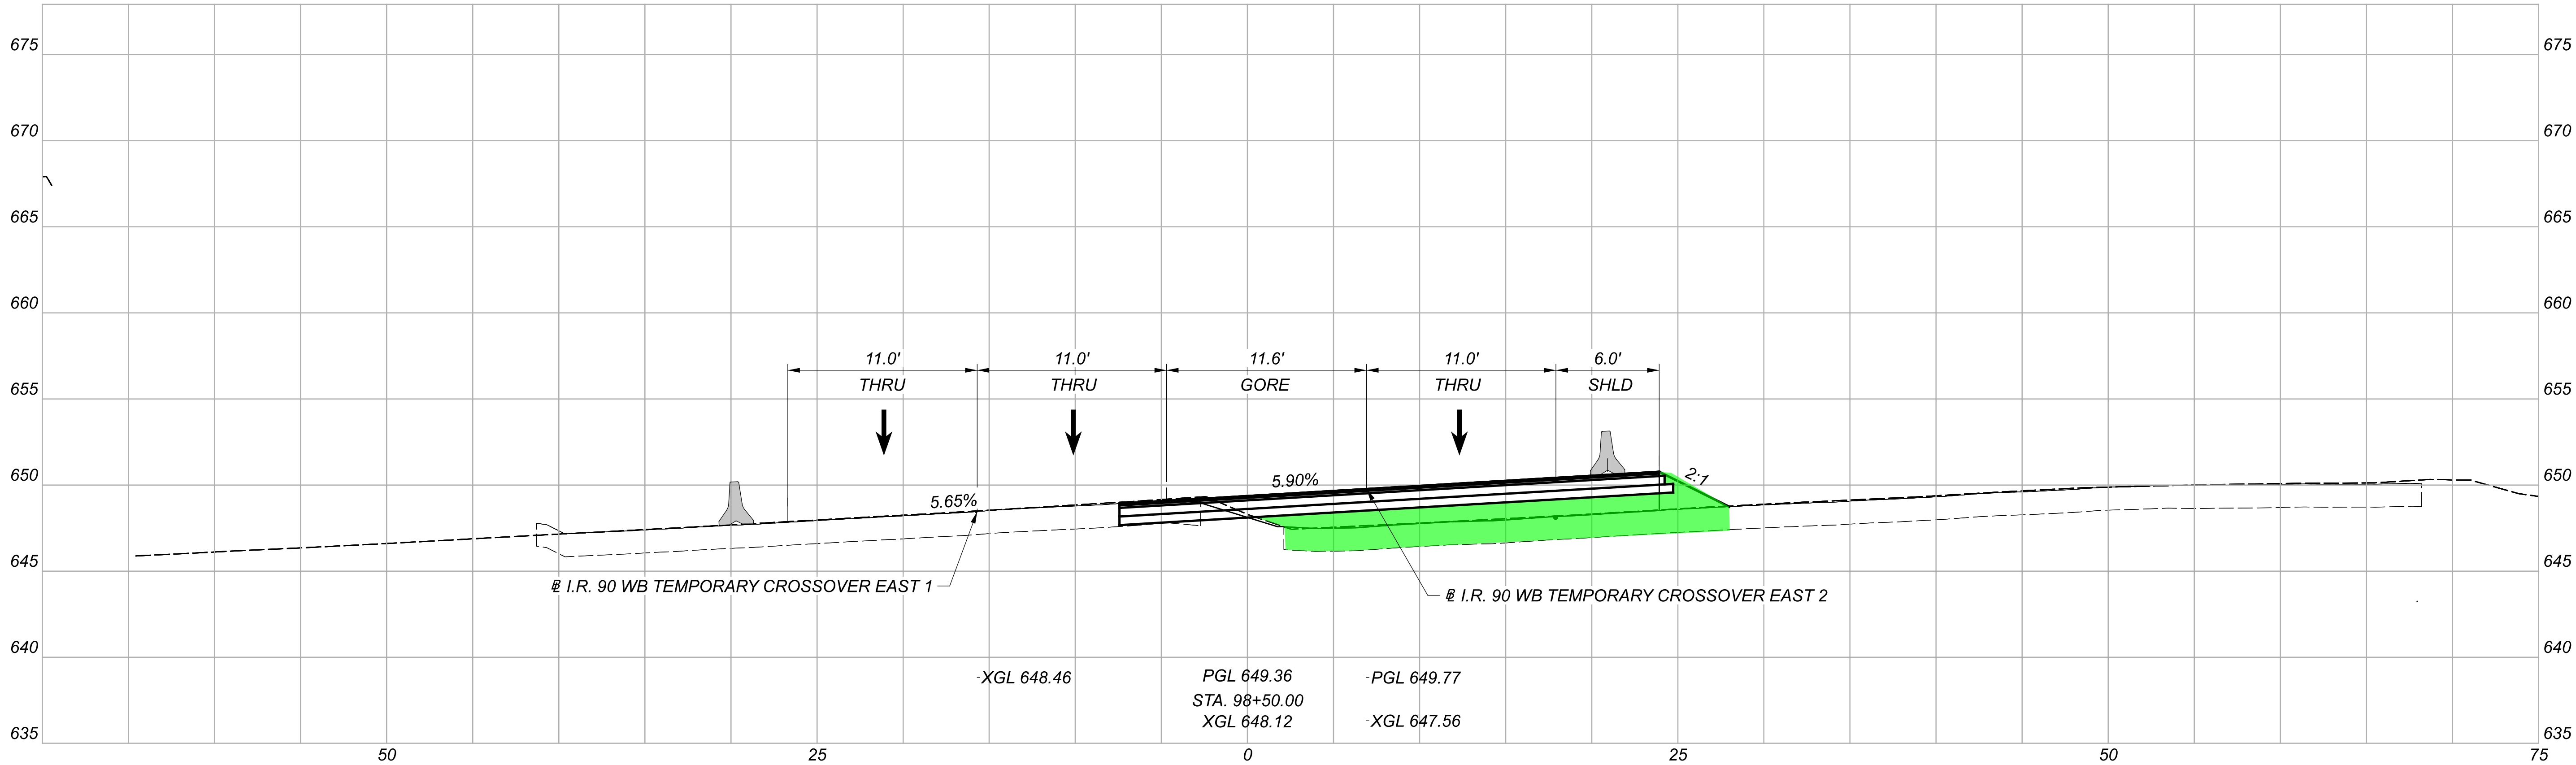
| SHEET | 232 |

MAINTENANCE OF TRAFFIC - PHASE 4  
CROSS SECTIONS - I.R. 90 WB TEMPORARY PAVEMENT (EAST)

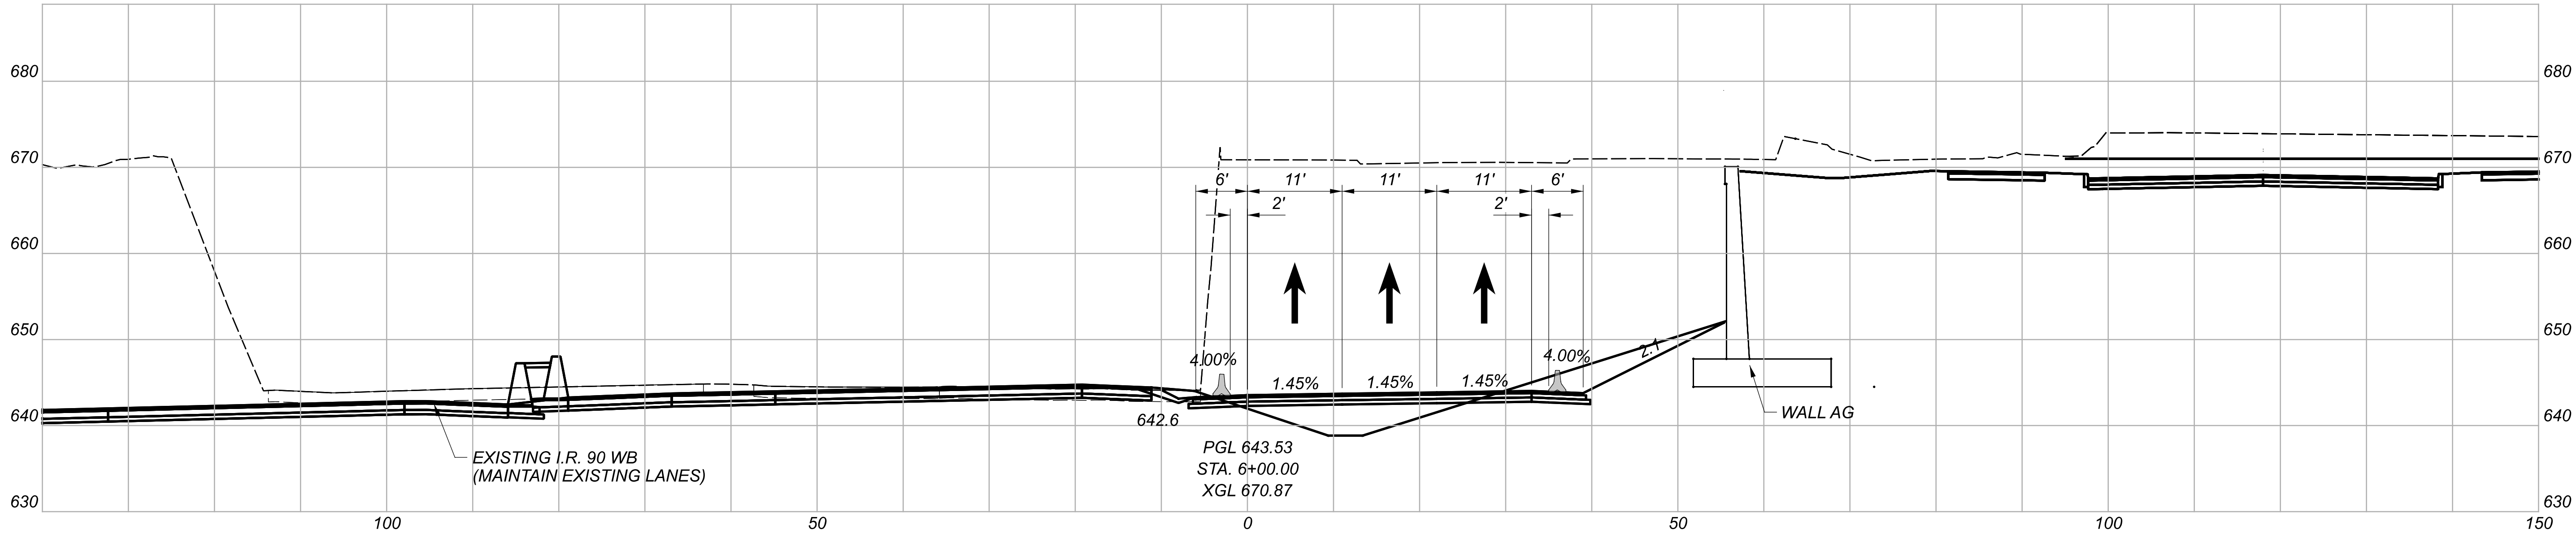
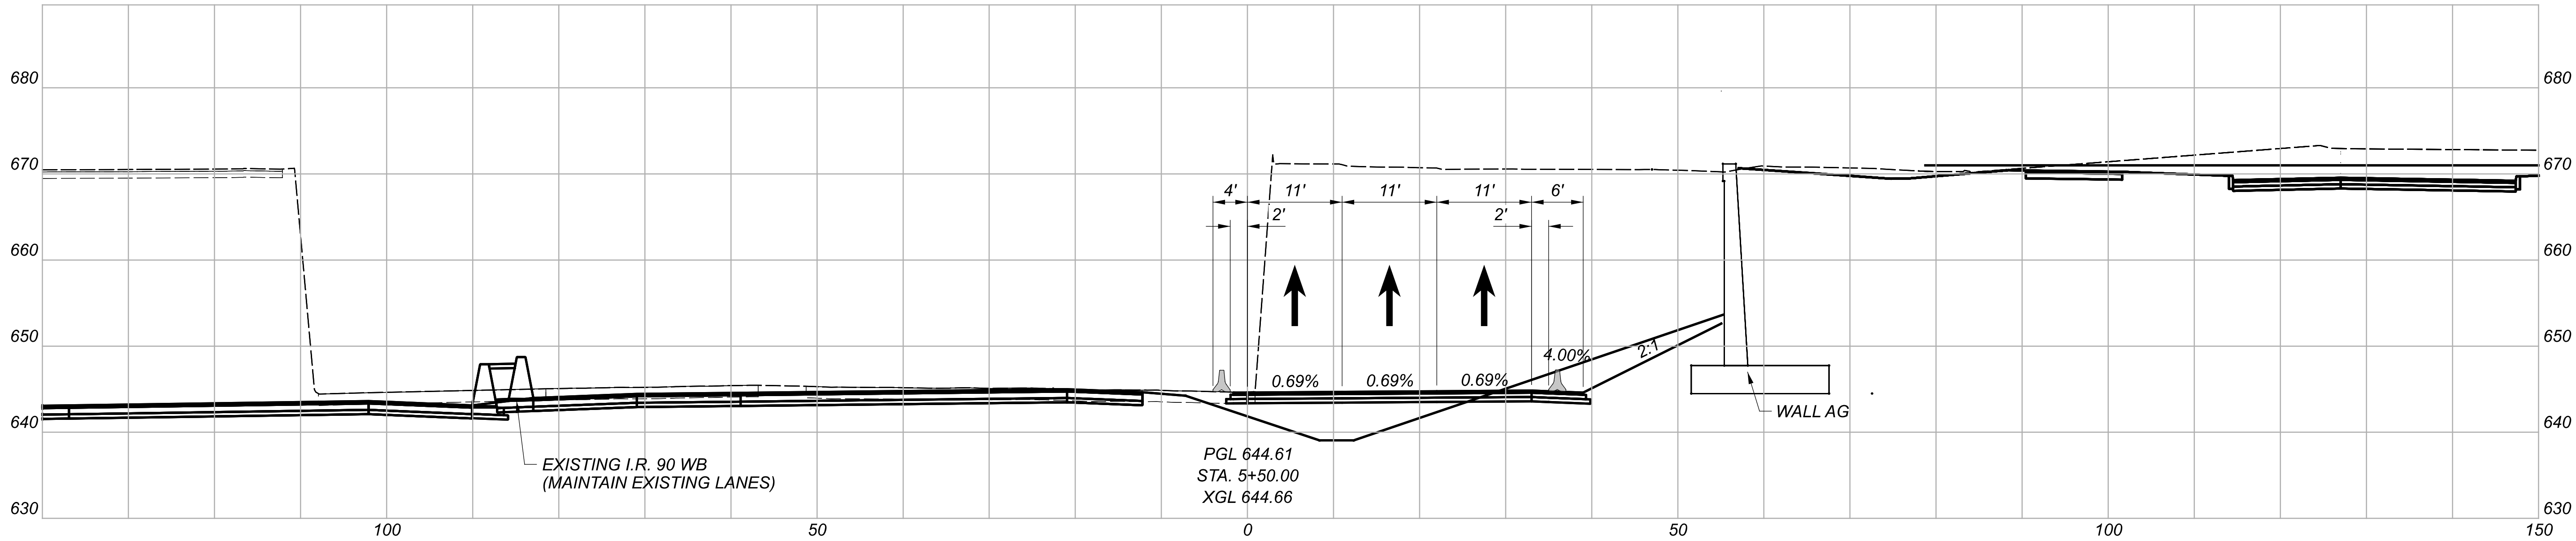
| 205 | 2696 |

MAINTENANCE OF TRAFFIC - PHASE 4  
CROSS SECTIONS - I.R. 90 EASTBOUND TEMPORARY RUNAROUND

| Crossover | | End Area Volumes taken from XS | | | | | | | | | | | | | | | | | | | | | | Totals (CY) |
|---|---|---|---|---|---|---|---|---|---|---|---|---|---|---|---|---|---|---|---|---|---|---|---|---|
| Phase 4 Runaround | Station | 2+00 | 2+50 | Covered by final condition + cut/fill to construct Wall AG & Bridge 13 | | | 6+50 | 7+00 | 7+50 | 8+00 | 8+50 | 9+00 | Covered by Final condition | 16+50 | 17+00 | 17+50 | 18+00 | | | | | | | |
| | Excavation (Area - SF) | 3.6 | 7.7 | | | | 16 | 24 | 20 | 21 | 9 | 1 | | 8 | 7 | 7 | 22 | | | | | | | |
| | Excavation (Vol - CF) | | 282.5 | | | | 400 | 1000 | 1100 | 1025 | 750 | 250 | | 200 | 375 | 350 | 725 | | | | | 239 | | |
| | Embankment (Area - SF) | 0 | 0.4 | | | | 0.4 | 0.4 | 0.4 | 0.4 | 0.4 | 69 | | 67 | 36 | 14 | | | | | | | | |
| | Embankment (Vol - CF) | | 10 | | | | 10 | 20 | 20 | 20 | 20 | 1725 | | 3400 | 2575 | 1250 | | | | | 336 | | | |

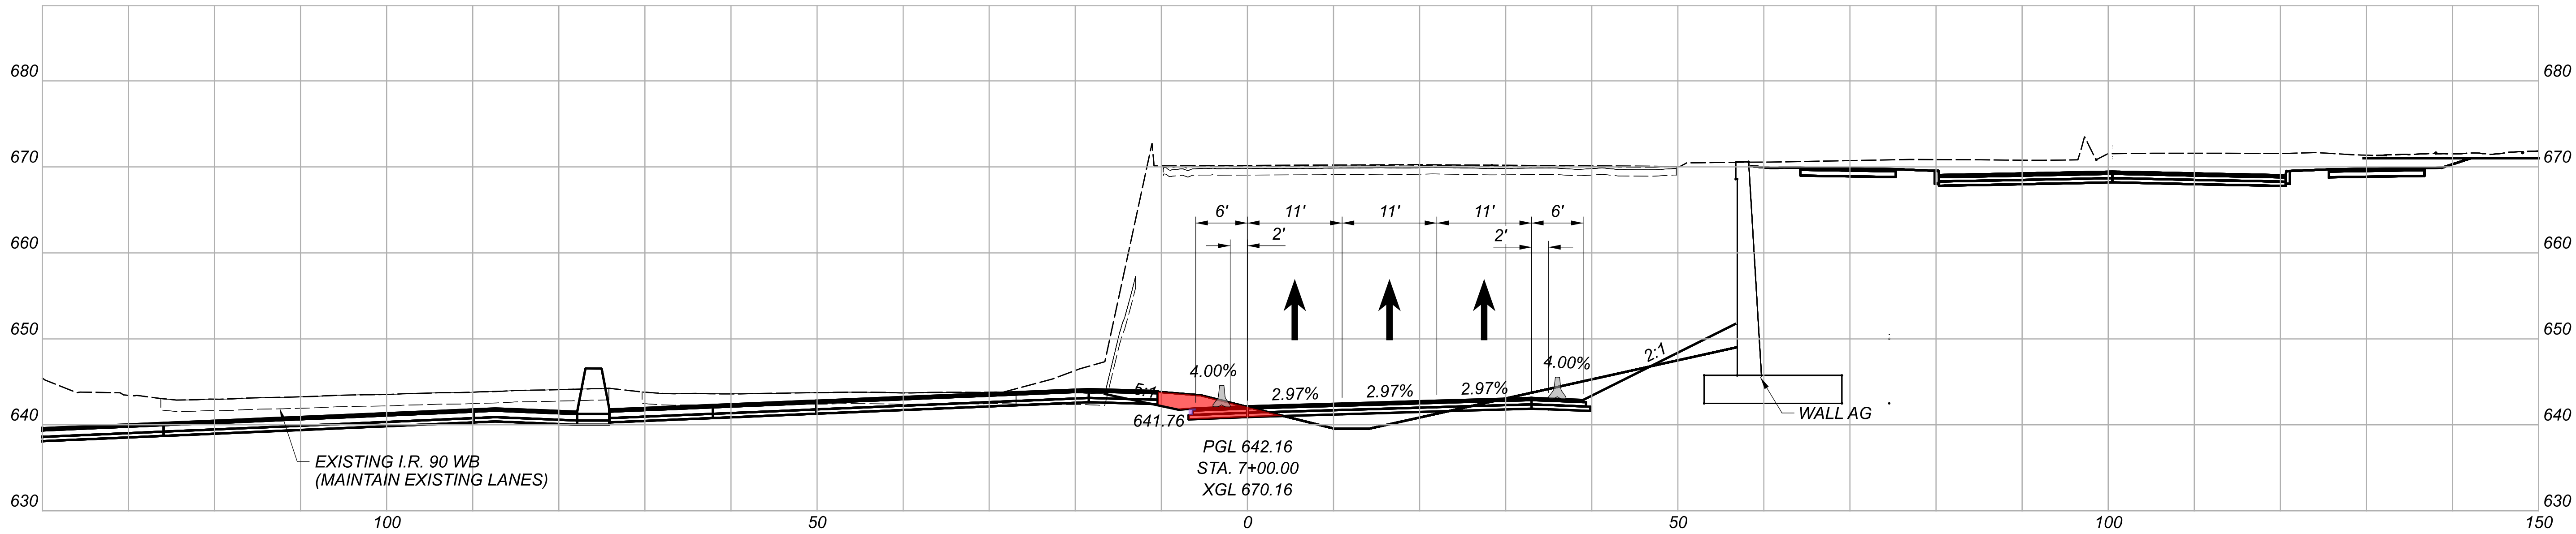
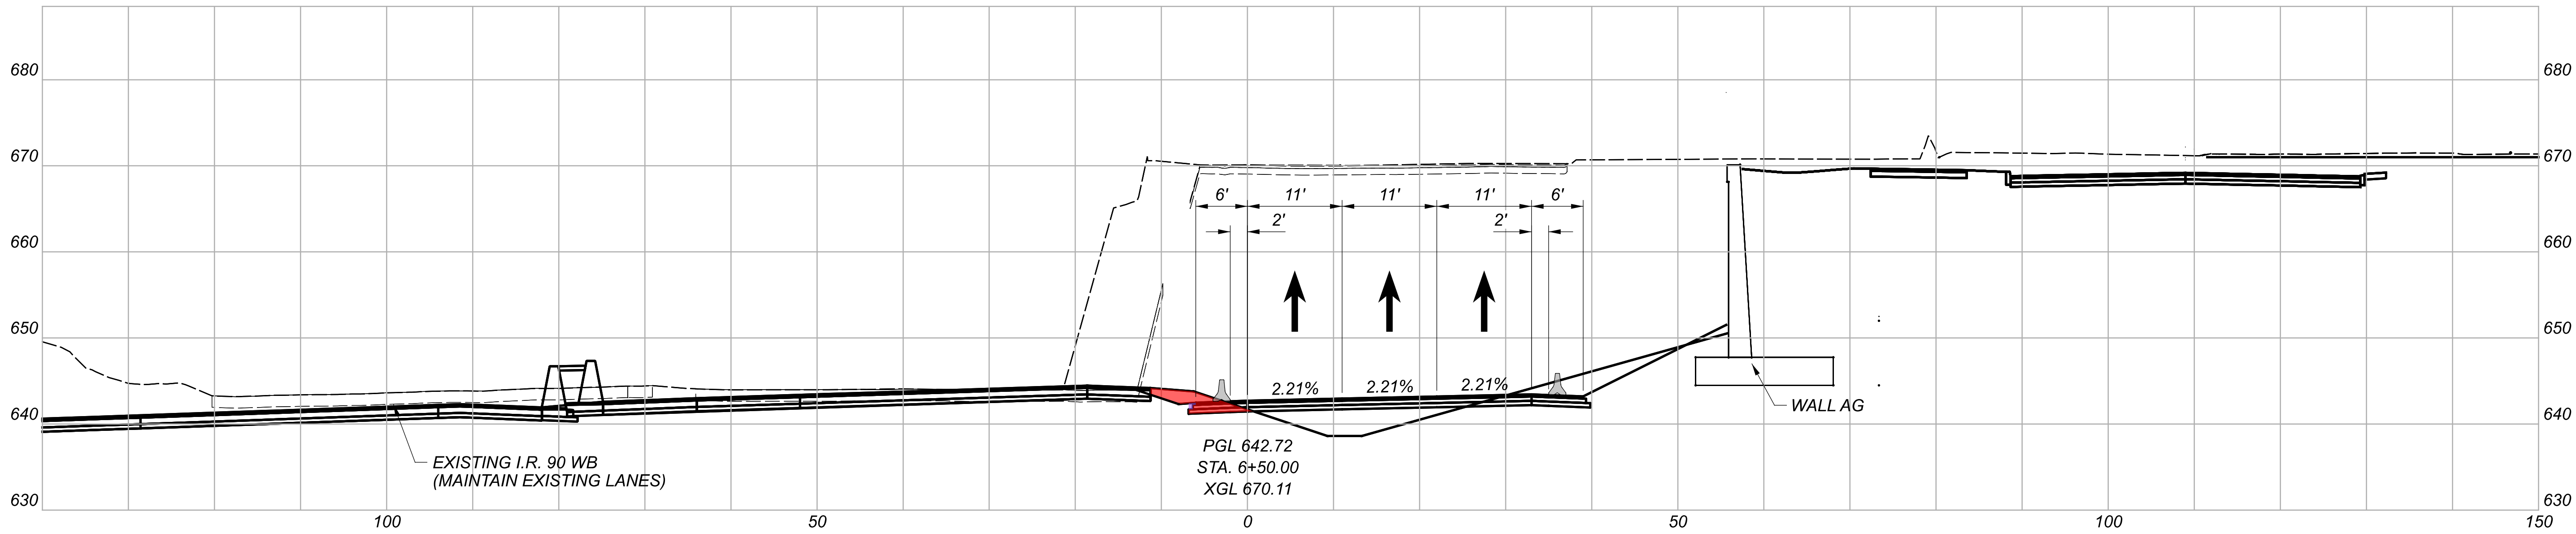
| 206 | 2696 |

MAINTENANCE OF TRAFFIC - PHASE 4  
CROSS SECTIONS - I.R. 90 EASTBOUND TEMPORARY RUNAROUND

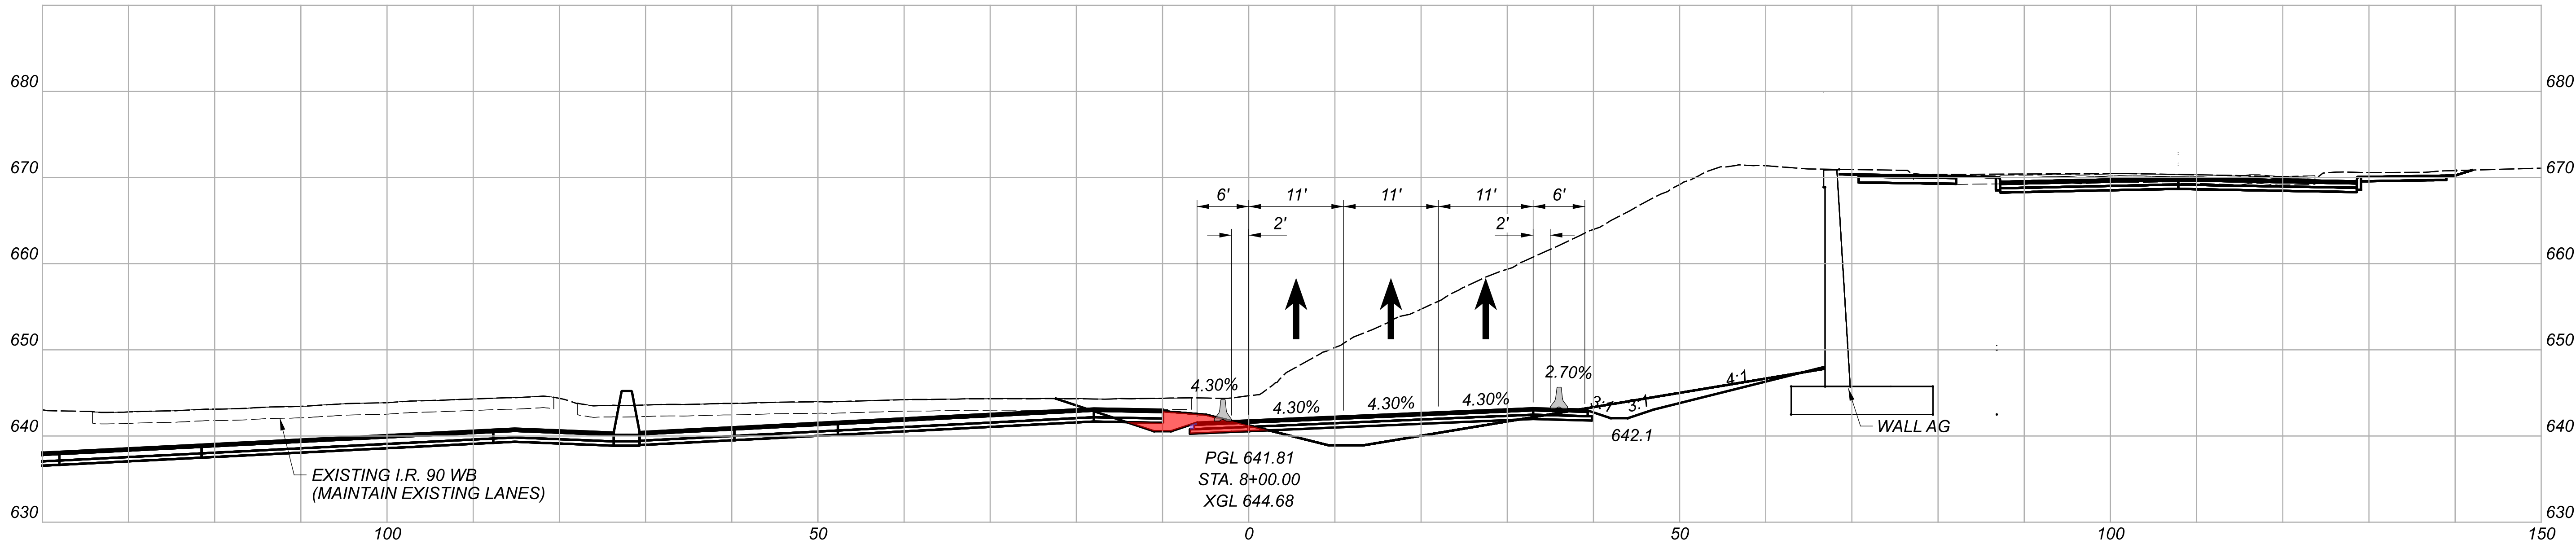
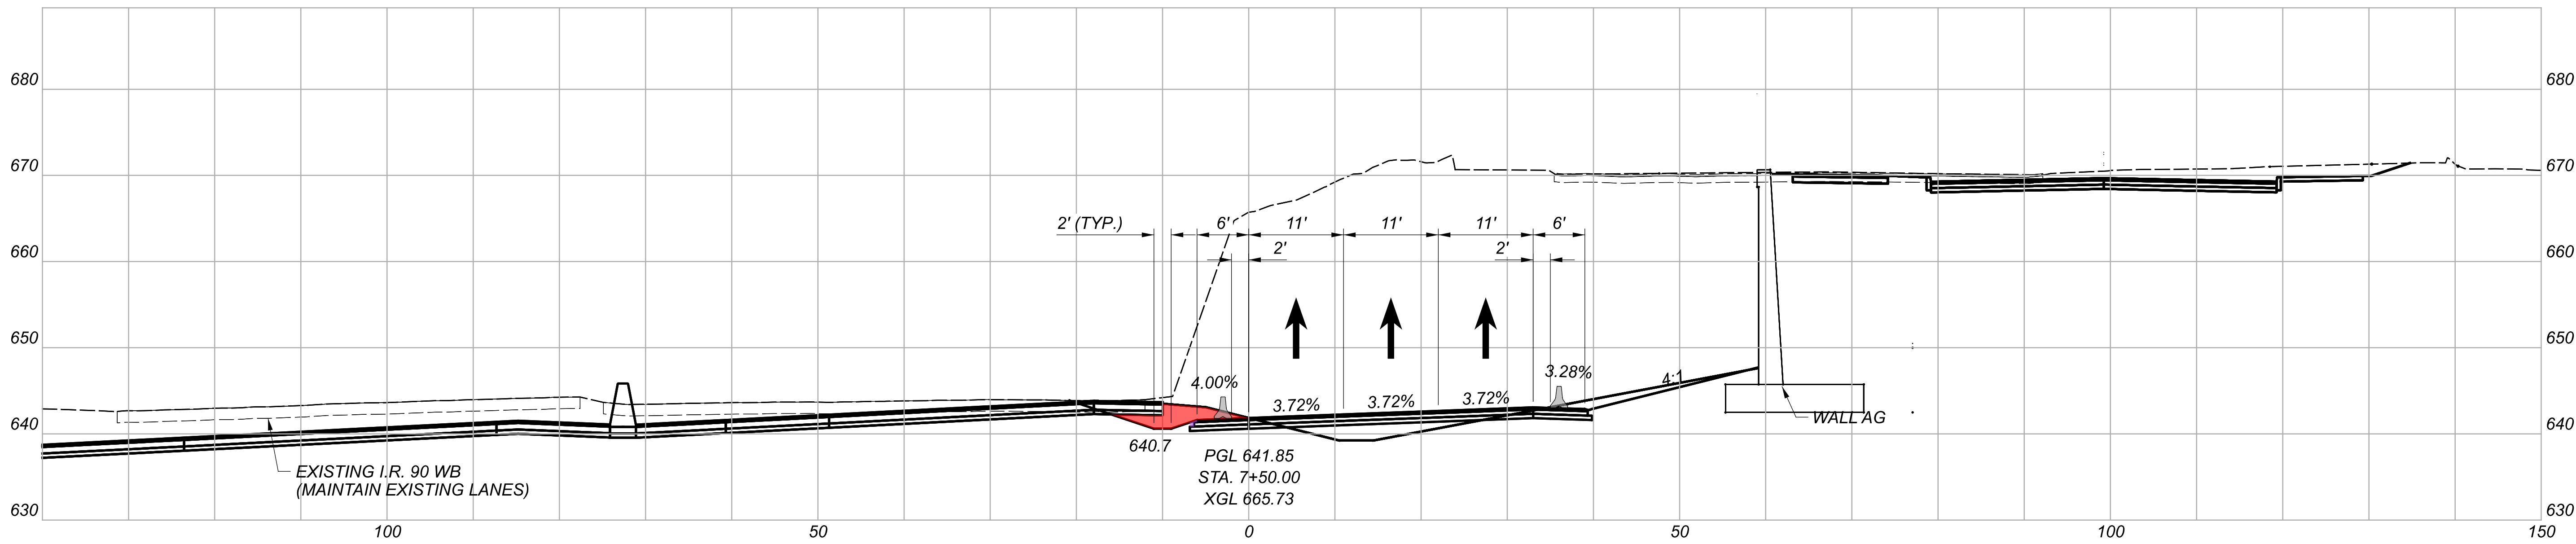
207

MAINTENANCE OF TRAFFIC - PHASE 4  
CROSS SECTIONS - I.R. 90 EASTBOUND TEMPORARY RUNAROUND

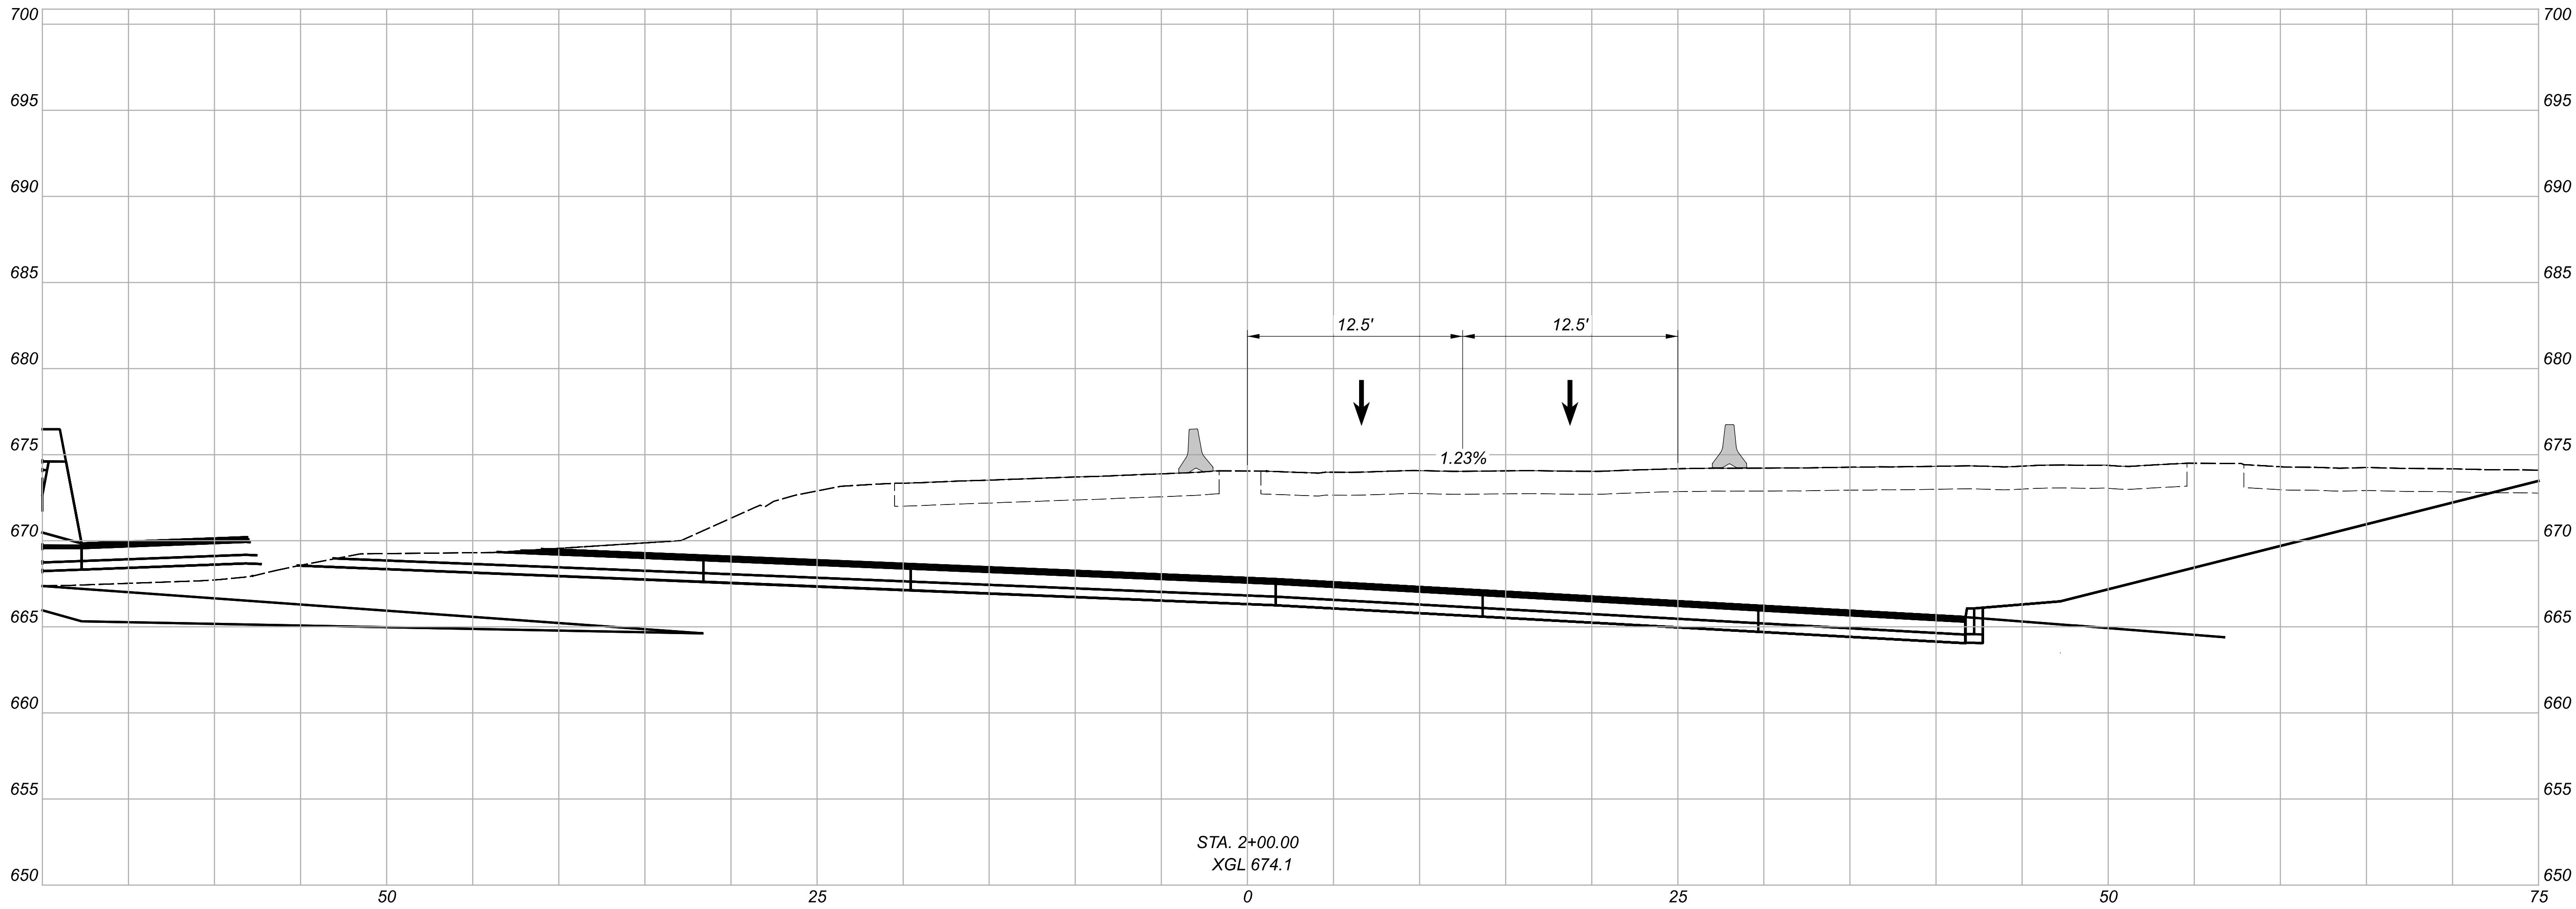
235

MAINTENANCE OF TRAFFIC - PHASE 5  
CROSS SECTIONS - I.R. 90 WB EAST TEMPORARY CROSSOVER

| Crossover | | End Area Volumes taken from XS | | | | | | | | | | | | | | | | | | | | | | Totals (CY) |
|---|---|---|---|---|---|---|---|---|---|---|---|---|---|---|---|---|---|---|---|---|---|---|---|---|
| Phase 5 East I-90 Temp Crossover | Station | 3+00 | 3+50 | 4+00 | 4+50 | 5+00 | 5+50 | 6+00 | 6+50 | 7+00 | | | | | | | | | | | | | | |
| | Excavation (Area - SF) | Excavation covered by final condition | | | | | | 1 | 12 | 3 | | | | | | | | | | | | | | |
| | Excavation (Vol - CF) | | | | | | | 25 | 325 | 375 | | | | | | | | | | | | 27 | | |
| | Embankment (Area - SF) | 4 | 18 | 8 | 0.5 | 0 | | | | | | | | | | | | | | | | | | |
| | Embankment (Vol - CF) | | | | 212.5 | 12.5 | | | | | | | | | | | | | | | | 8 | | |

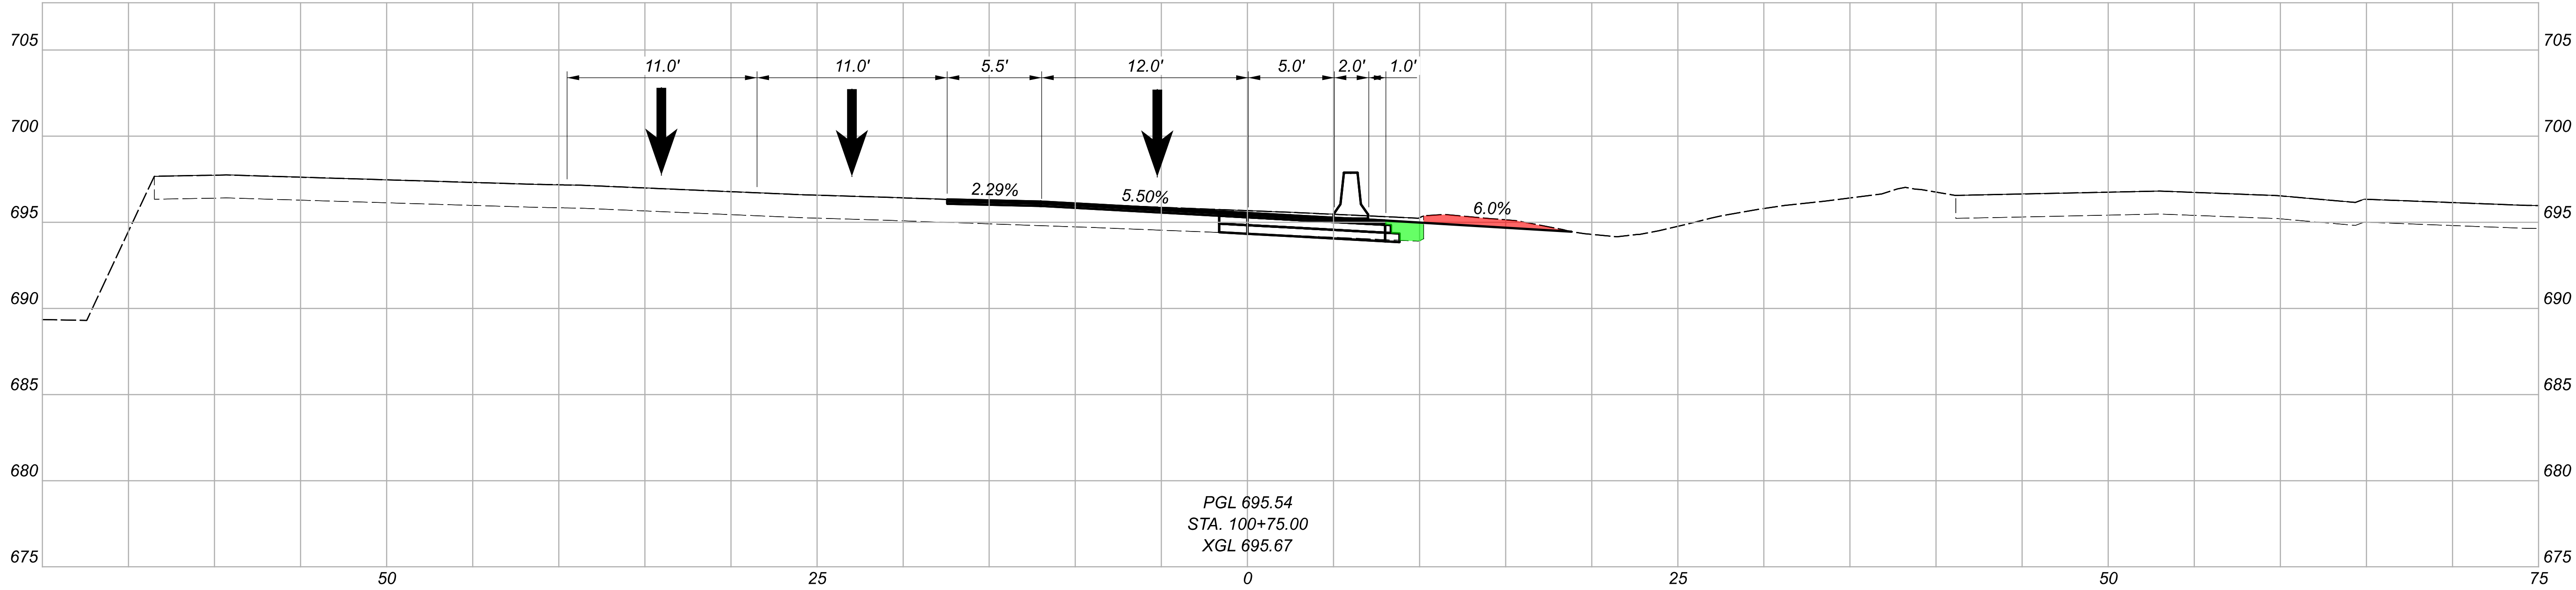
| 241 | 2696 |

MAINTENANCE OF TRAFFIC - PHASE 5  
CROSS SECTIONS - I.R. 90 WB WEST TEMPORARY CROSSOVER

| Crossover | | End Area Volumes taken from XS | | | | | | | | | | | | | | | | | | | | | | Totals (CY) |
|---|---|---|---|---|---|---|---|---|---|---|---|---|---|---|---|---|---|---|---|---|---|---|---|---|
| Phase 5 West I-90 Temp Crossover | Station | 100+25 | 100+50 | 100+75 | 101+00 | 101+25 | 101+50 | 101+75 | 102+00 | 102+25 | 102+50 | 102+75 | 103+00 | 103+25 | 103+50 | 103+75 | 104+00 | 104+25 | 104+50 | 104+75 | 105+00 | 105+25 | | |
| | Excavation (Area - SF) | 0 | 0 | 4 | 12 | 16 | 15 | 19 | 26 | 38 | 52 | 46 | 40 | 37 | 34 | 29 | 28 | 25 | 18 | 11 | 8 | 9 | | |
| | Excavation (Vol - CF) | | | 50 | 200 | 350 | 387.5 | 425 | 562.5 | 800 | 1125 | 1225 | 1075 | 962.5 | 887.5 | 787.5 | 712.5 | 662.5 | 537.5 | 362.5 | 237.5 | 212.5 | 428 | |
| | Embankment (Area - SF) | 0 | 4 | 2 | 1 | 0.4 | 0.4 | 0.4 | 0.2 | 0.4 | 0.4 | 5 | 2 | 2 | 3 | 6 | 8 | 1 | 0.4 | 0.4 | 0.4 | 0.4 | | |
| | Embankment (Vol - CF) | | 50 | 75 | 37.5 | 17.5 | 10 | 10 | 7.5 | 7.5 | 10 | 67.5 | 87.5 | 50 | 62.5 | 112.5 | 175 | 112.5 | 17.5 | 10 | 10 | 10 | 35 | |

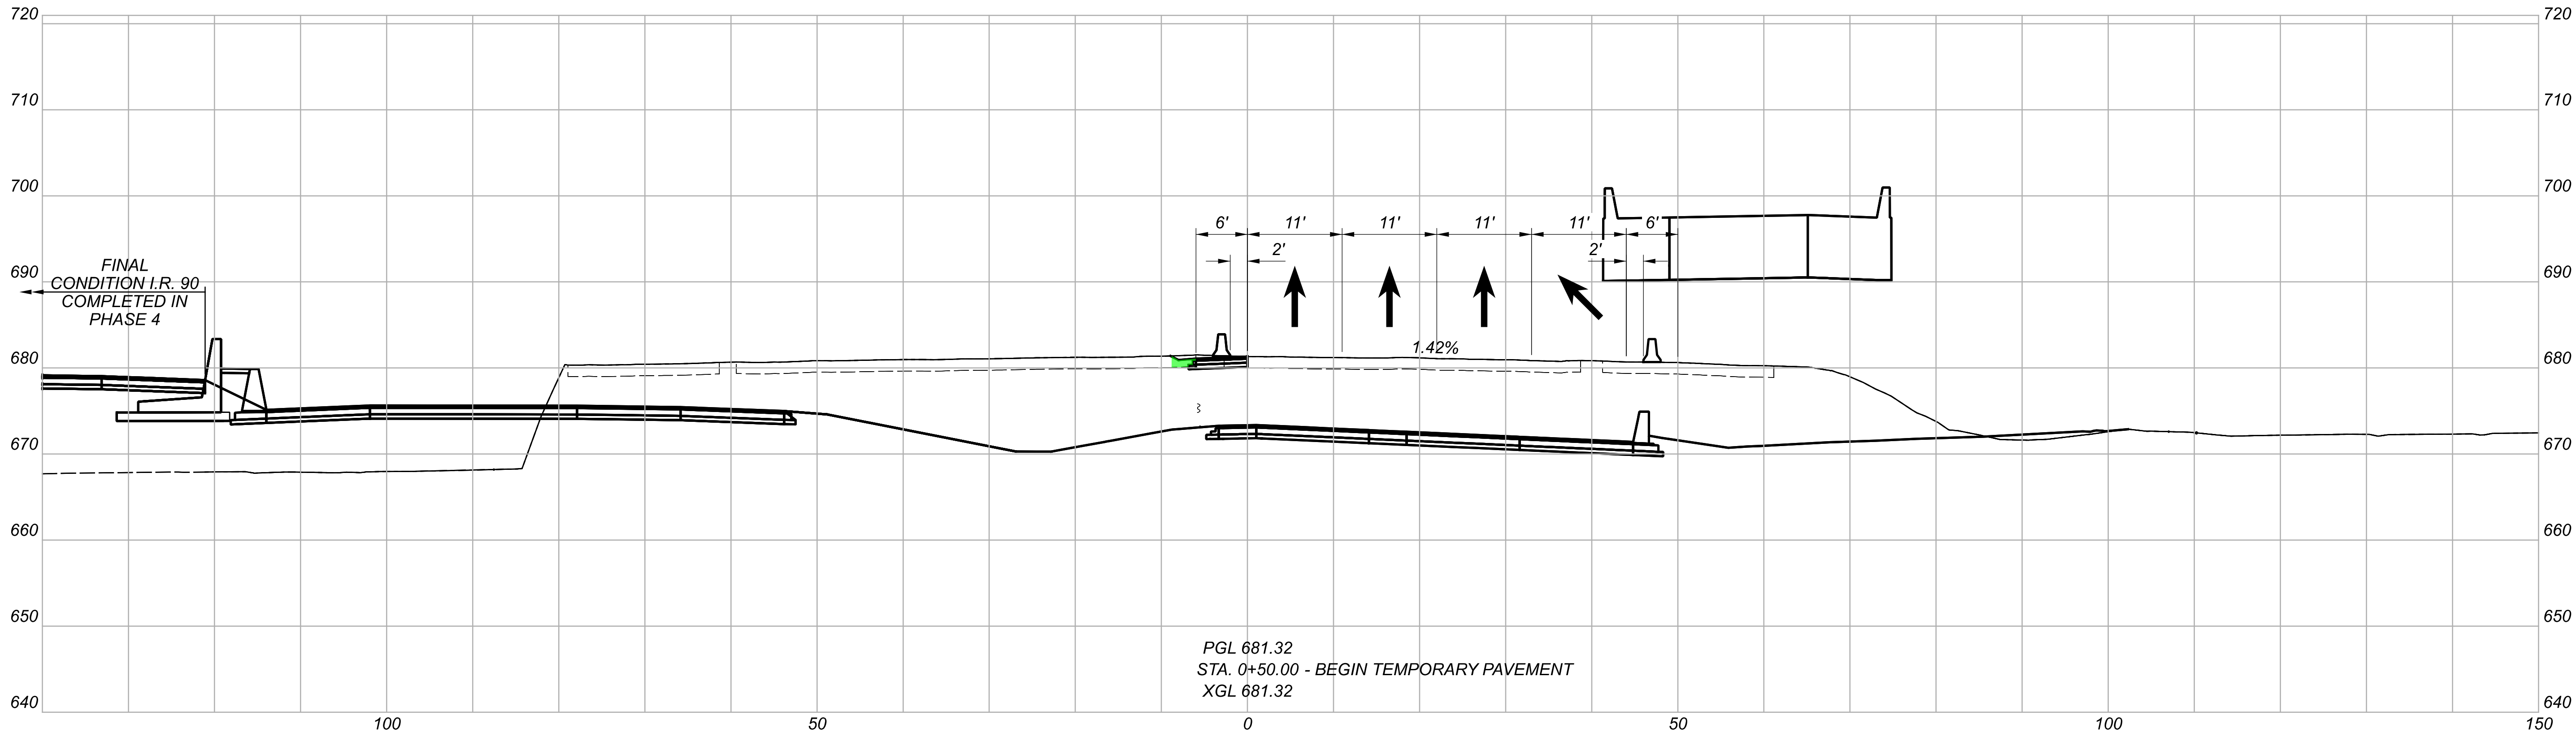
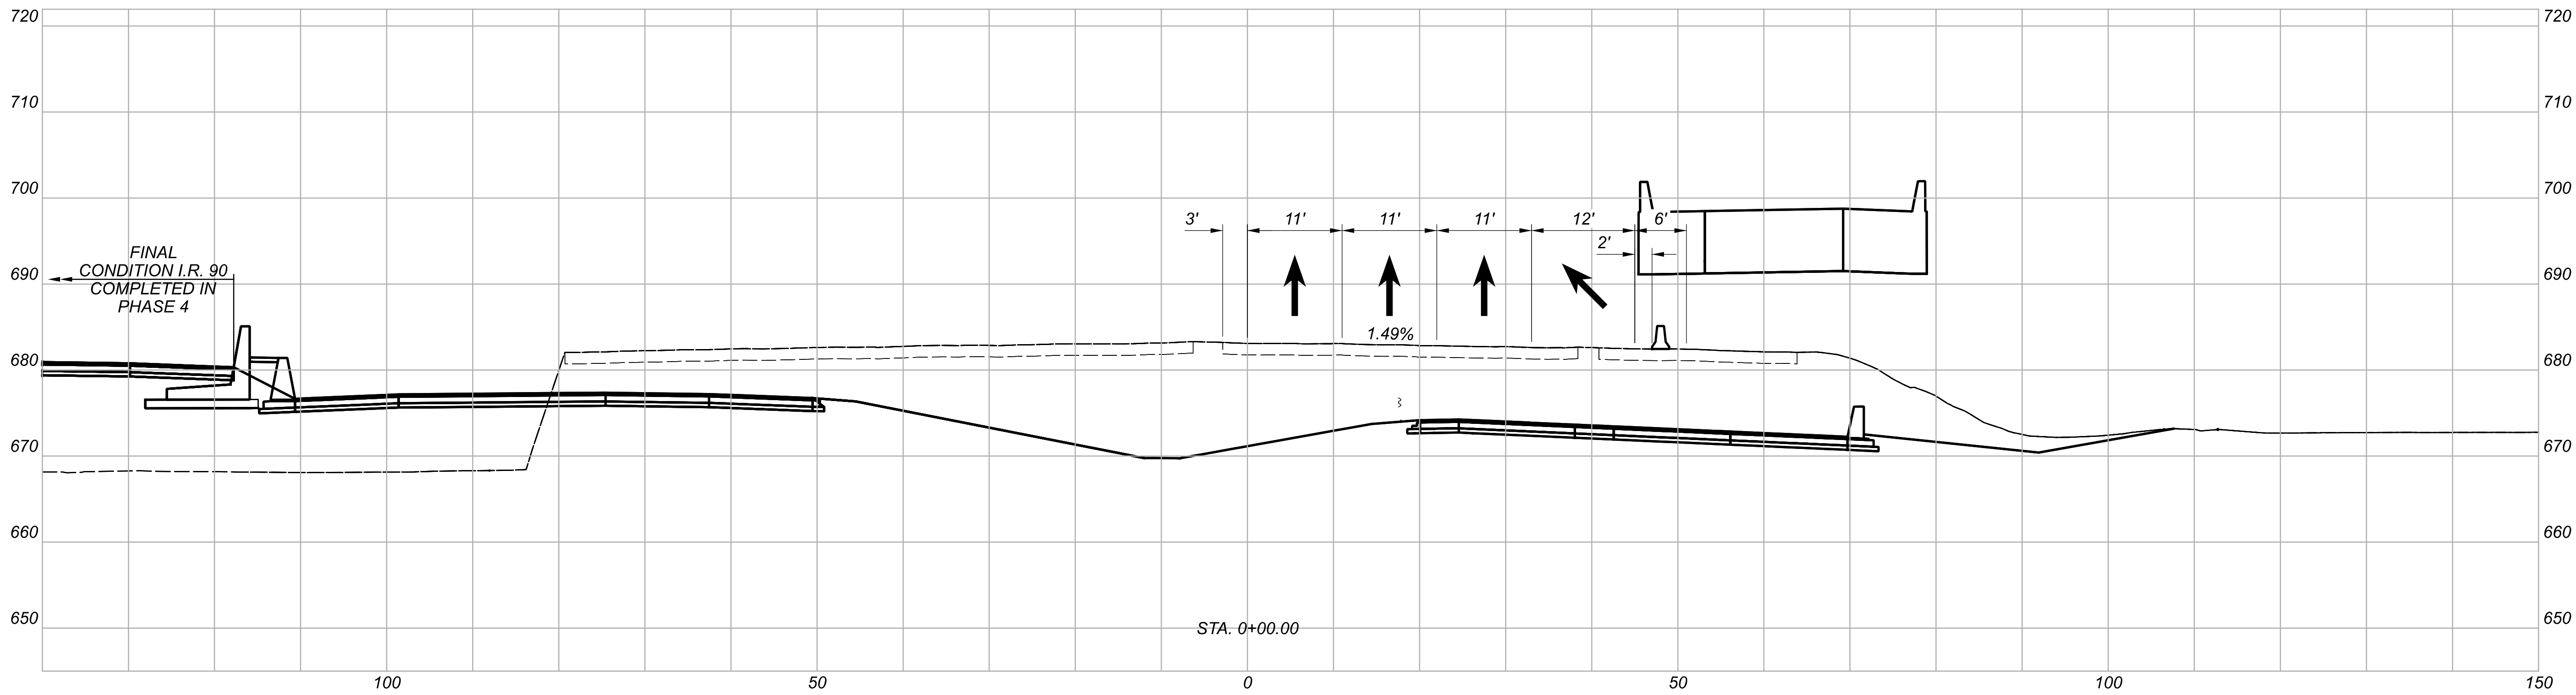
| 251 | 2696 |

MAINTENANCE OF TRAFFIC - PHASE 7  
CROSS SECTIONS - I.R. 90 EASTBOUND TEMPORARY CROSSOVER

| Crossover | | End Area Volumes taken from XS | | | | | | | | | | | | | | | | | | | | | | Totals (CY) |
|---|---|---|---|---|---|---|---|---|---|---|---|---|---|---|---|---|---|---|---|---|---|---|---|---|
| Phase 7 I-90 EB Crossover | Station | 0+00 | 0+50 | 1+00 | 1+50 | 2+00 | 2+50 | 3+00 | 3+50 | 4+00 | 4+50 | 5+00 | 5+50 | 6+00 | 6+50 | 7+00 | 7+50 | | | | | | | |
| | Excavation (Area - SF) | Excavation covered by final condition excavation | | | | | | | | | 5 | 6 | 10 | 13 | 8 | 9 | 16 | 22 | Excavation covered by final condition 8+00 to 11+50 | | | | | |
| | Excavation (Vol - CF) | | | | | | | | | | 125 | 275 | 400 | 575 | 525 | 425 | 625 | 950 | | | | | 144 | |
| | Embankment (Area - SF) | 0 | 2 | 3 | 3 | 4 | 10 | 18 | 24 | 22 | 9 | 10 | 11 | 1 | 1 | 1 | 1 | | | | | | | |
| | Embankment (Vol - CF) | | 50 | 125 | 150 | 175 | 350 | 700 | 1050 | 1150 | 775 | 475 | 525 | 300 | 50 | 50 | 50 | | | | | | 221 | |
