Since all quantified excavation will need to be removed and embankment filled to achieve final condition grading, the final MOT excavation and embankment values are equal and are the sum of the above excavation and embankment

MAINTENANCE OF TRAFFIC - PHASE 4  
CROSS SECTIONS - I.R. 90 WB TEMPORARY PAVEMENT (EAST)

| PROJECT ID | |
| 82382 | |

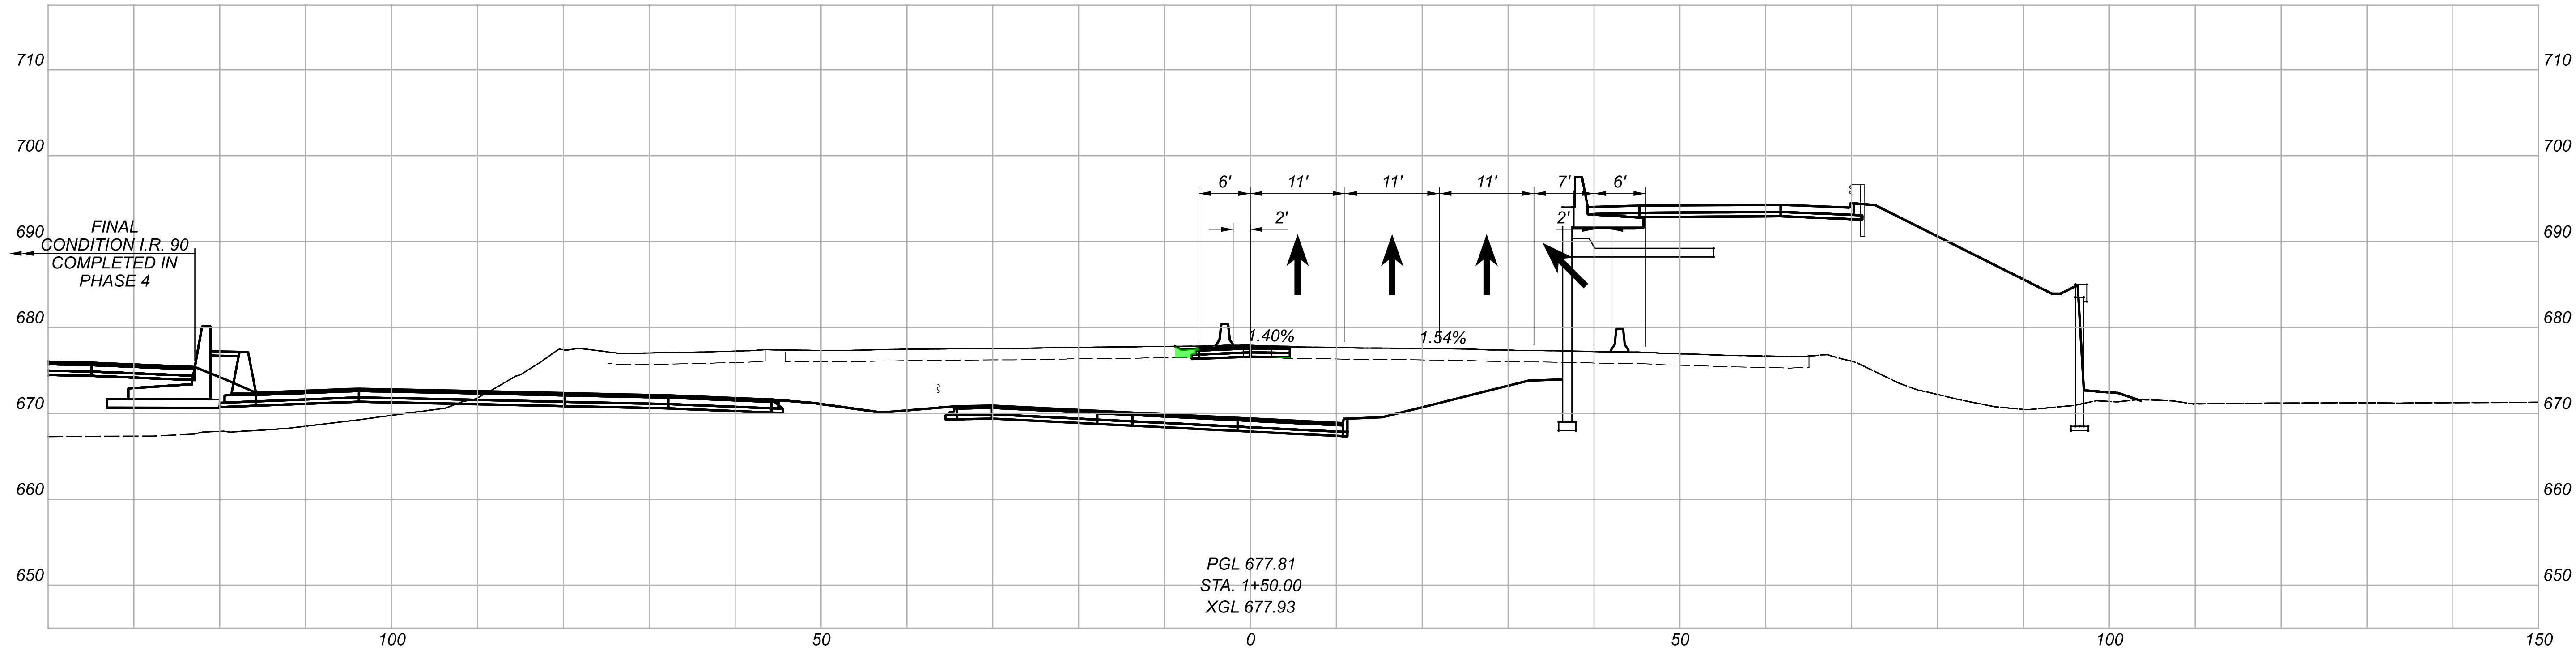
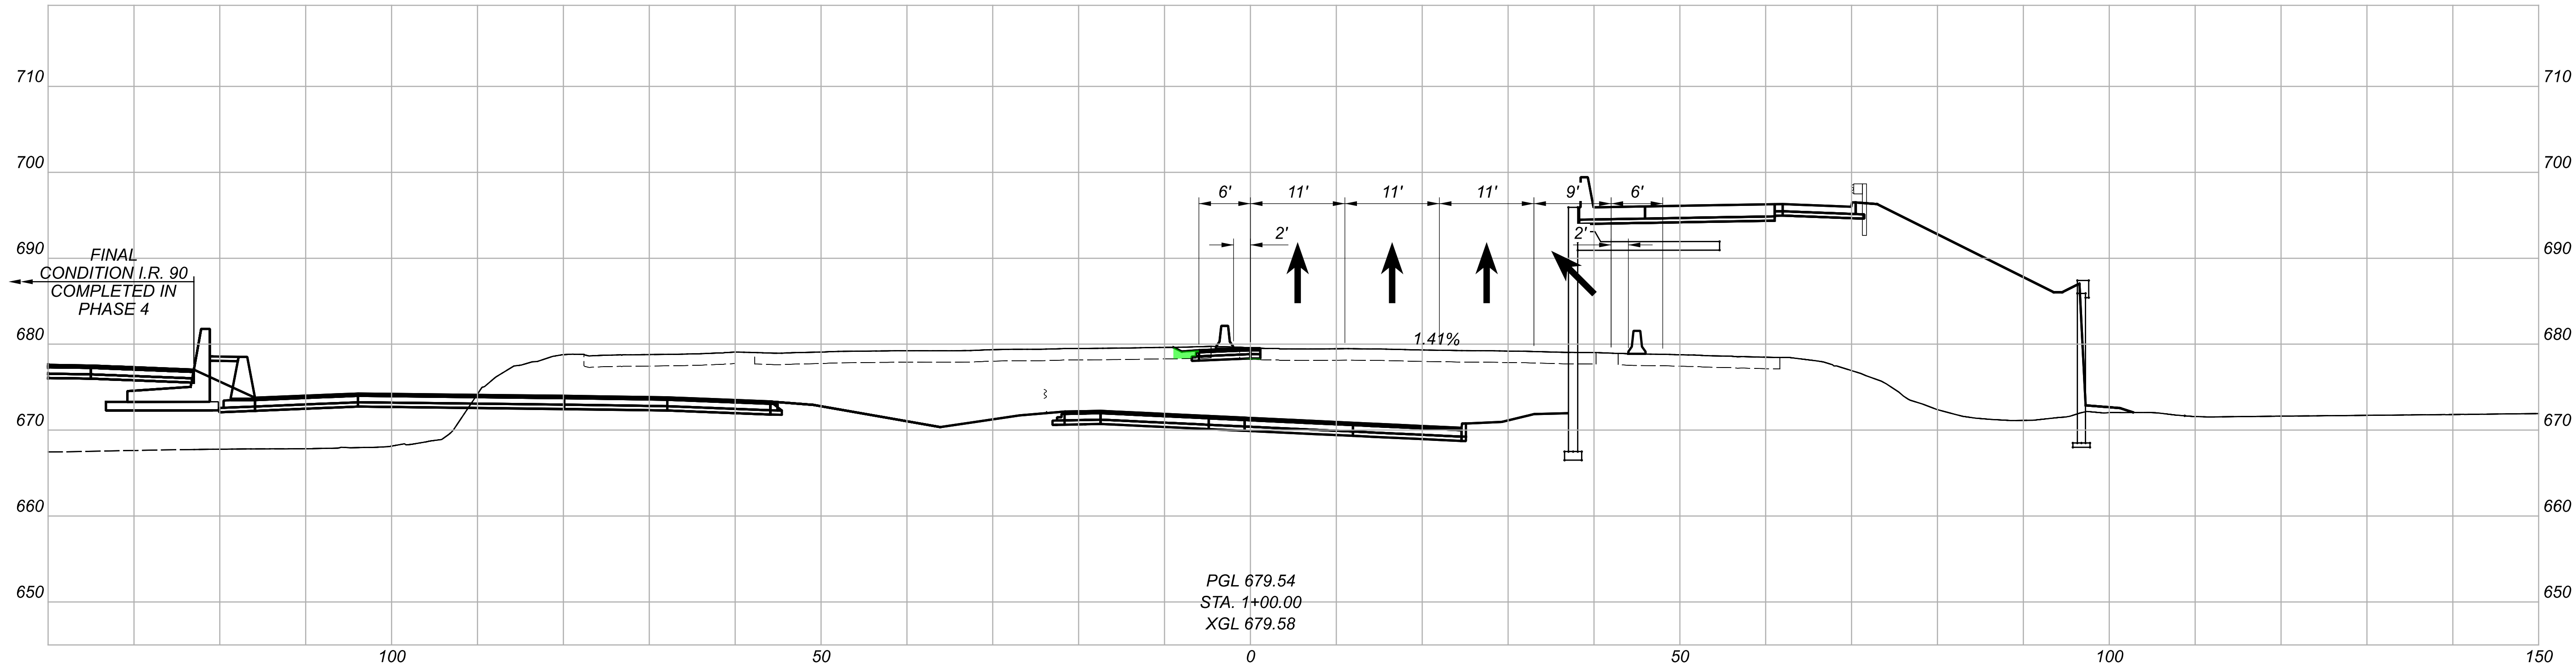
SHEET TOTAL  
252 2696

MAINTENANCE OF TRAFFIC - PHASE 7  
CROSS SECTIONS - I.R. 90 EASTBOUND TEMPORARY CROSSOVER

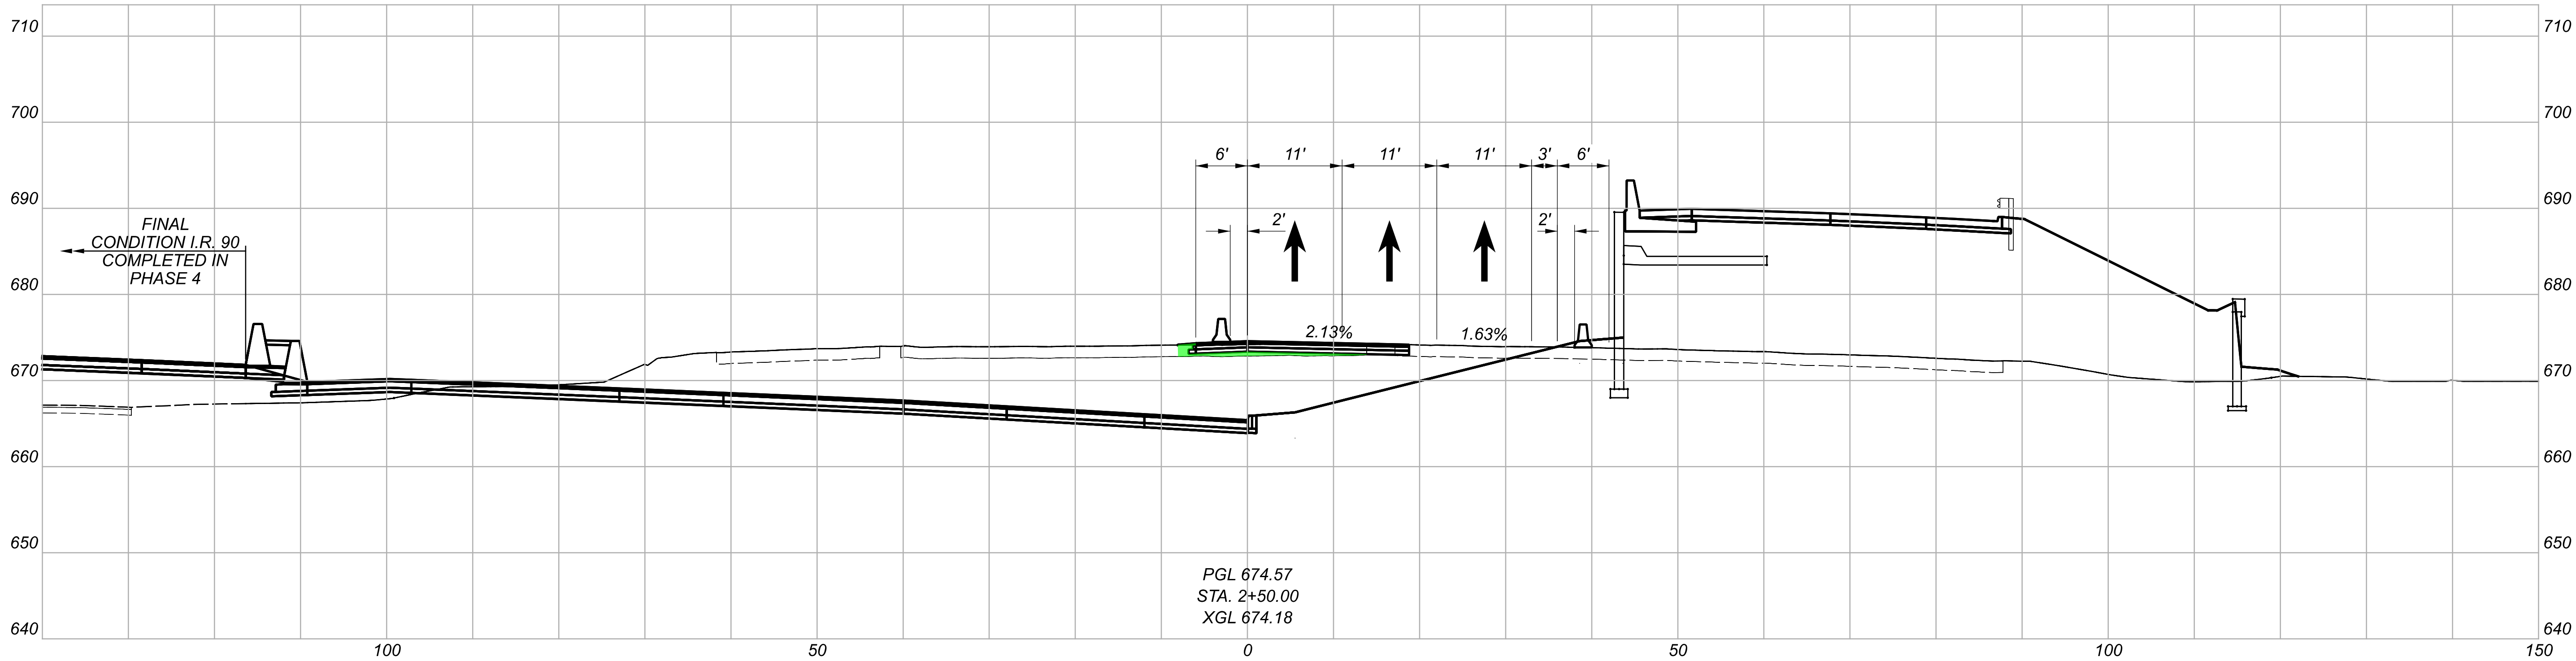
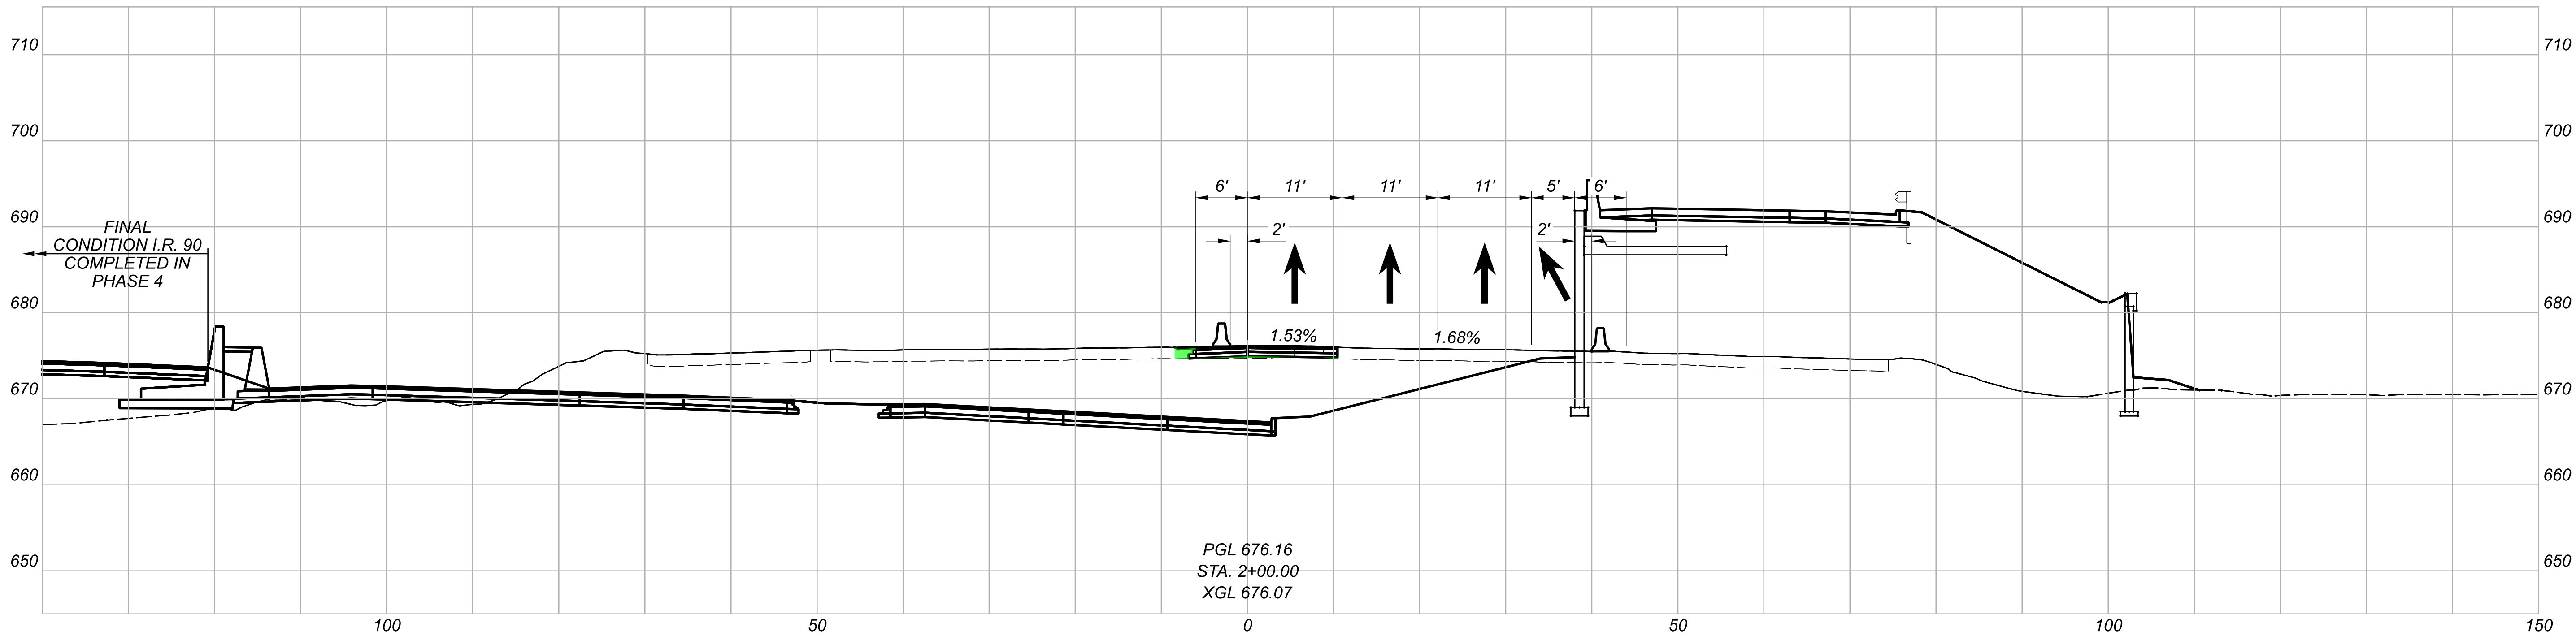
| 253 | 2696 |

MAINTENANCE OF TRAFFIC - PHASE 7  
CROSS SECTIONS - I.R. 90 EASTBOUND TEMPORARY CROSSOVER

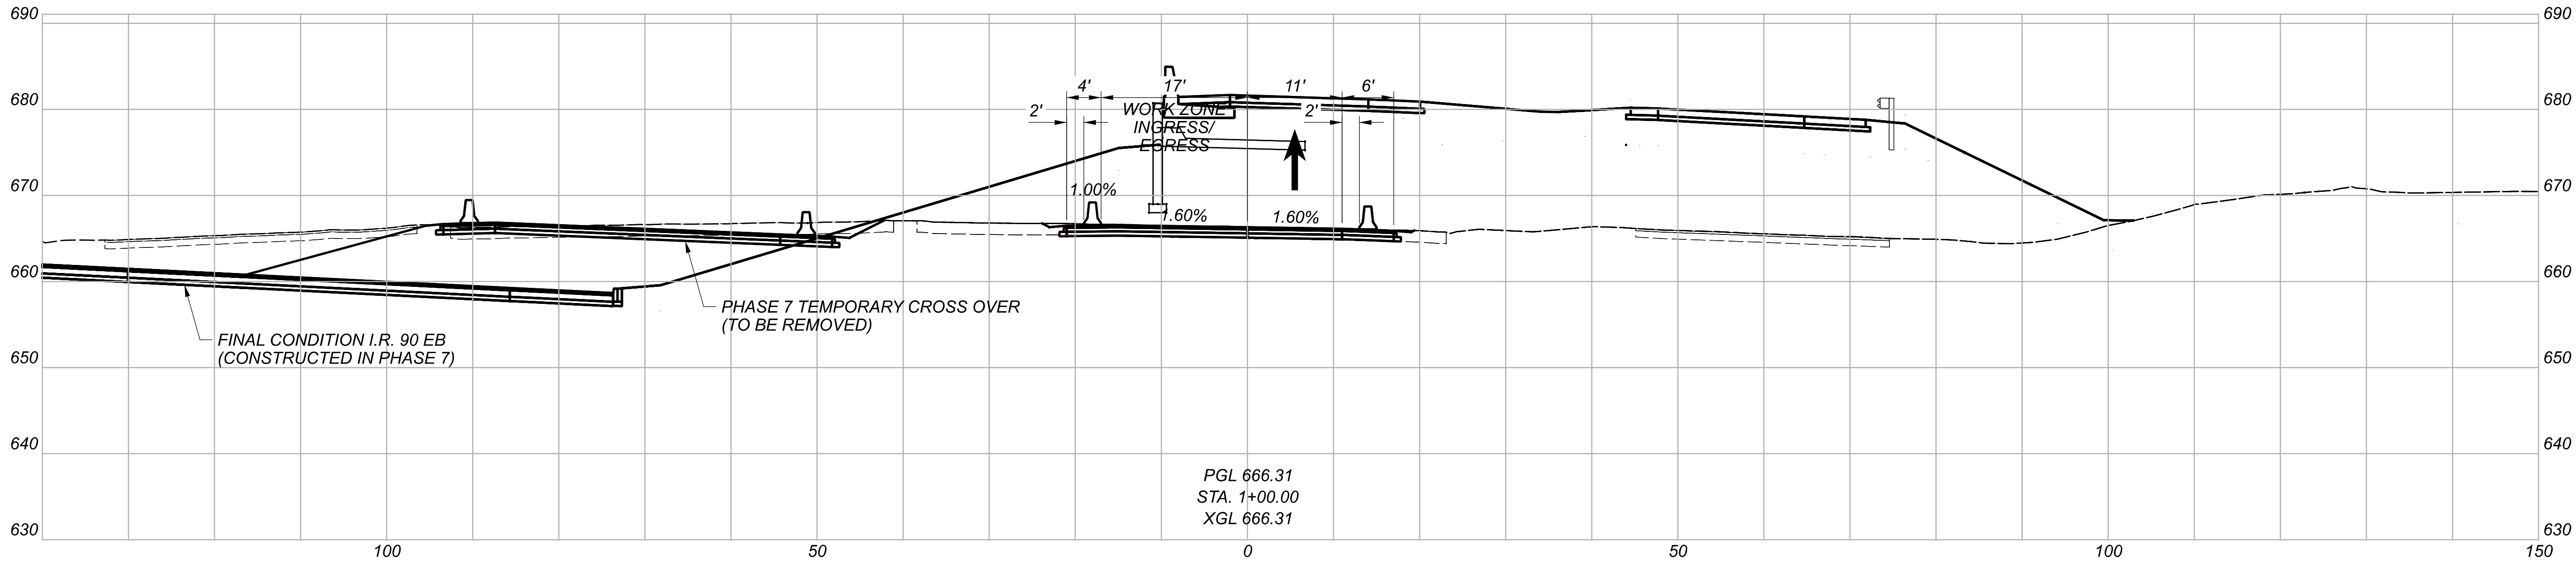
| 275 | 2696 |

MAINTENANCE OF TRAFFIC - PHASE 8  
CROSS SECTIONS - TEMPORARY RAMP H5 TO I.R. 90 EB

| Crossover | | End Area Volumes taken from XS | | | | | | | | | | | | | | | | | | | | | | Totals (CY) |
|---|---|---|---|---|---|---|---|---|---|---|---|---|---|---|---|---|---|---|---|---|---|---|---|---|
| Phase 8 Temp Ramp H5 to 90 | Station | 0+00 | 0+50 | 1+00 | 1+50 | 2+00 | 2+50 | 3+00 | 3+50 | 4+00 | 4+50 | Covered by final condition + cut/fill to construct Wall AG & Bridge 13 | | | | | | | | | | | | |
| | Excavation (Area - SF) | | | 0.3 | 13 | 37 | 70 | 104 | 136 | 171 | 115 | | | | | | | | | | | | | |
| | Excavation (Vol - CF) | | | 7.5 | 332.5 | 1250 | 2675 | 4350 | 6000 | 7675 | 7150 | | | | | | | | | | | | | 1090 |
| | Embankment (Area - SF) | | | | | 0.5 | 1 | 1 | 1 | 1 | 0.5 | | | | | | | | | | | | | |
| | Embankment (Vol - CF) | | | | | 12.5 | 37.5 | 50 | 50 | 50 | 37.5 | | | | | | | | | | | | | 9 |

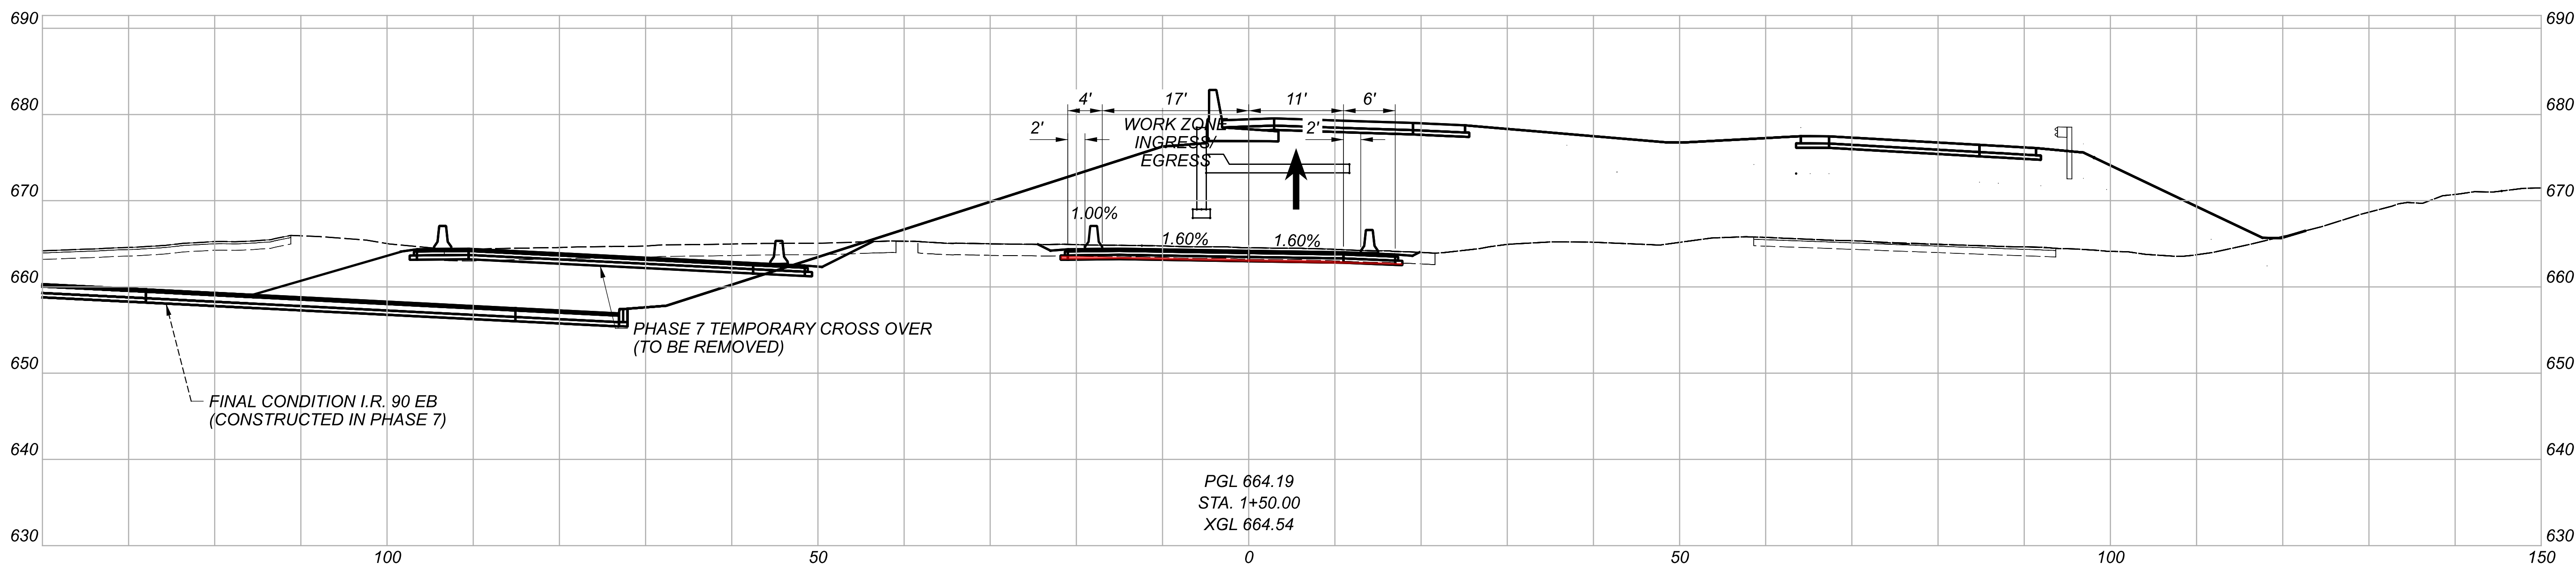
| 276 | 2696 |

MAINTENANCE OF TRAFFIC - PHASE 8  
 CROSS SECTIONS - TEMPORARY RAMP H5 TO I.R. 90 EB

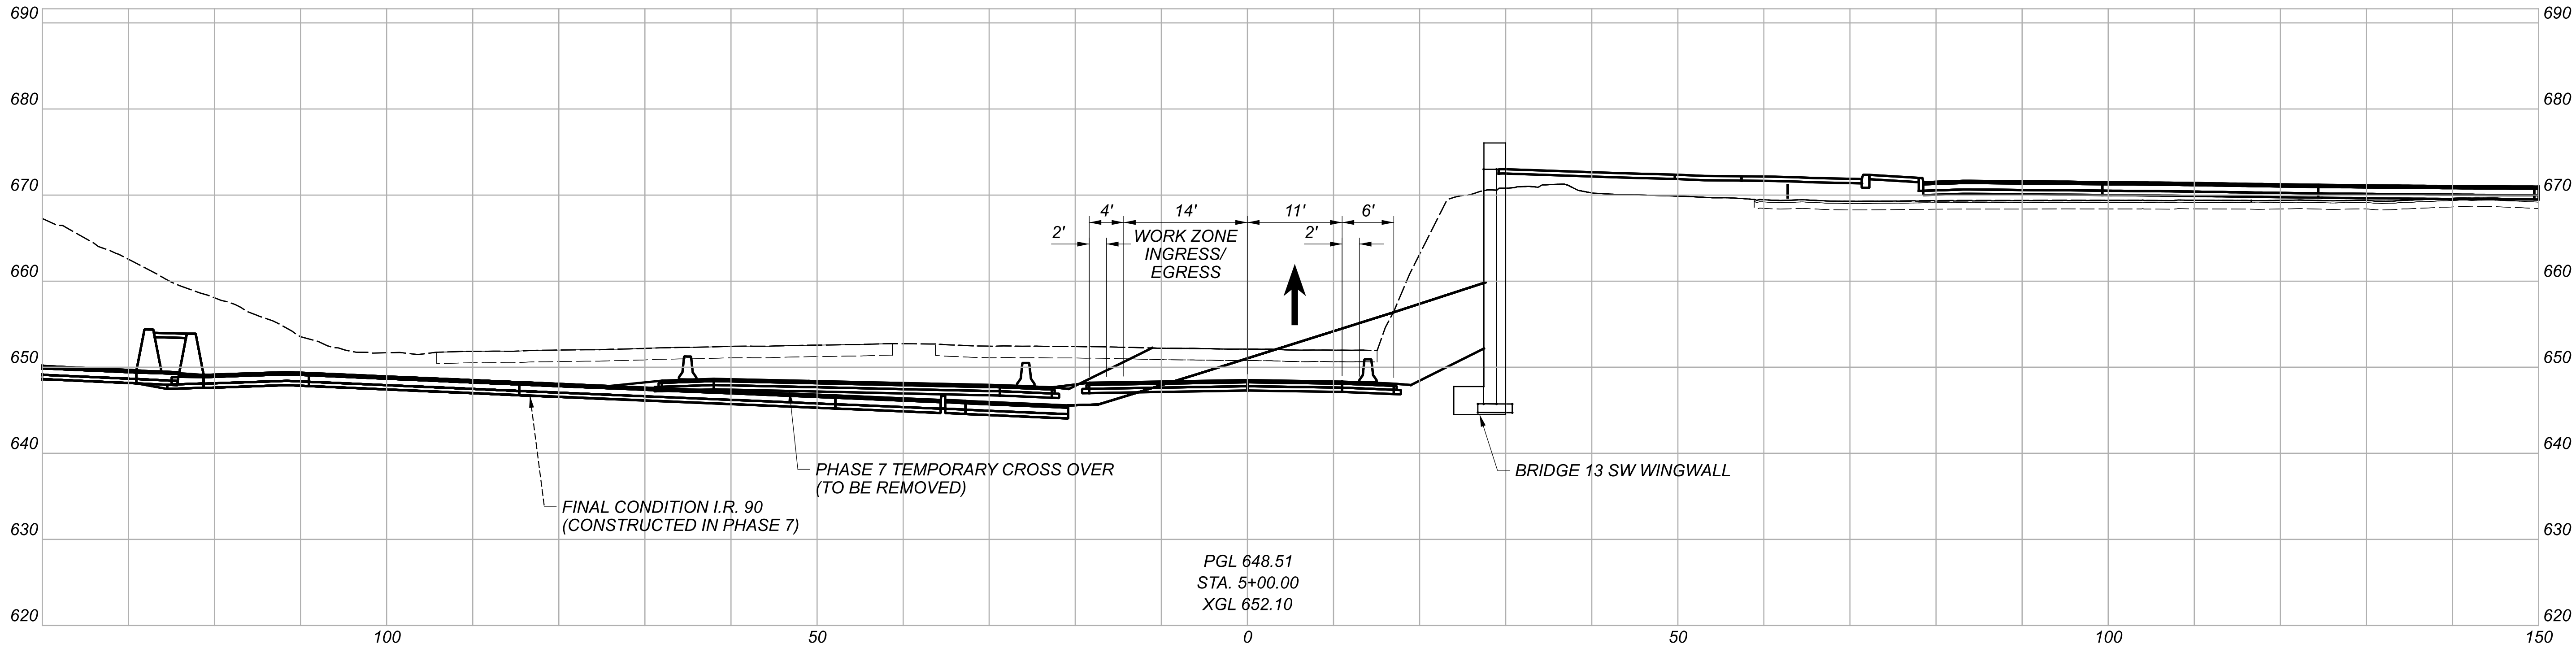
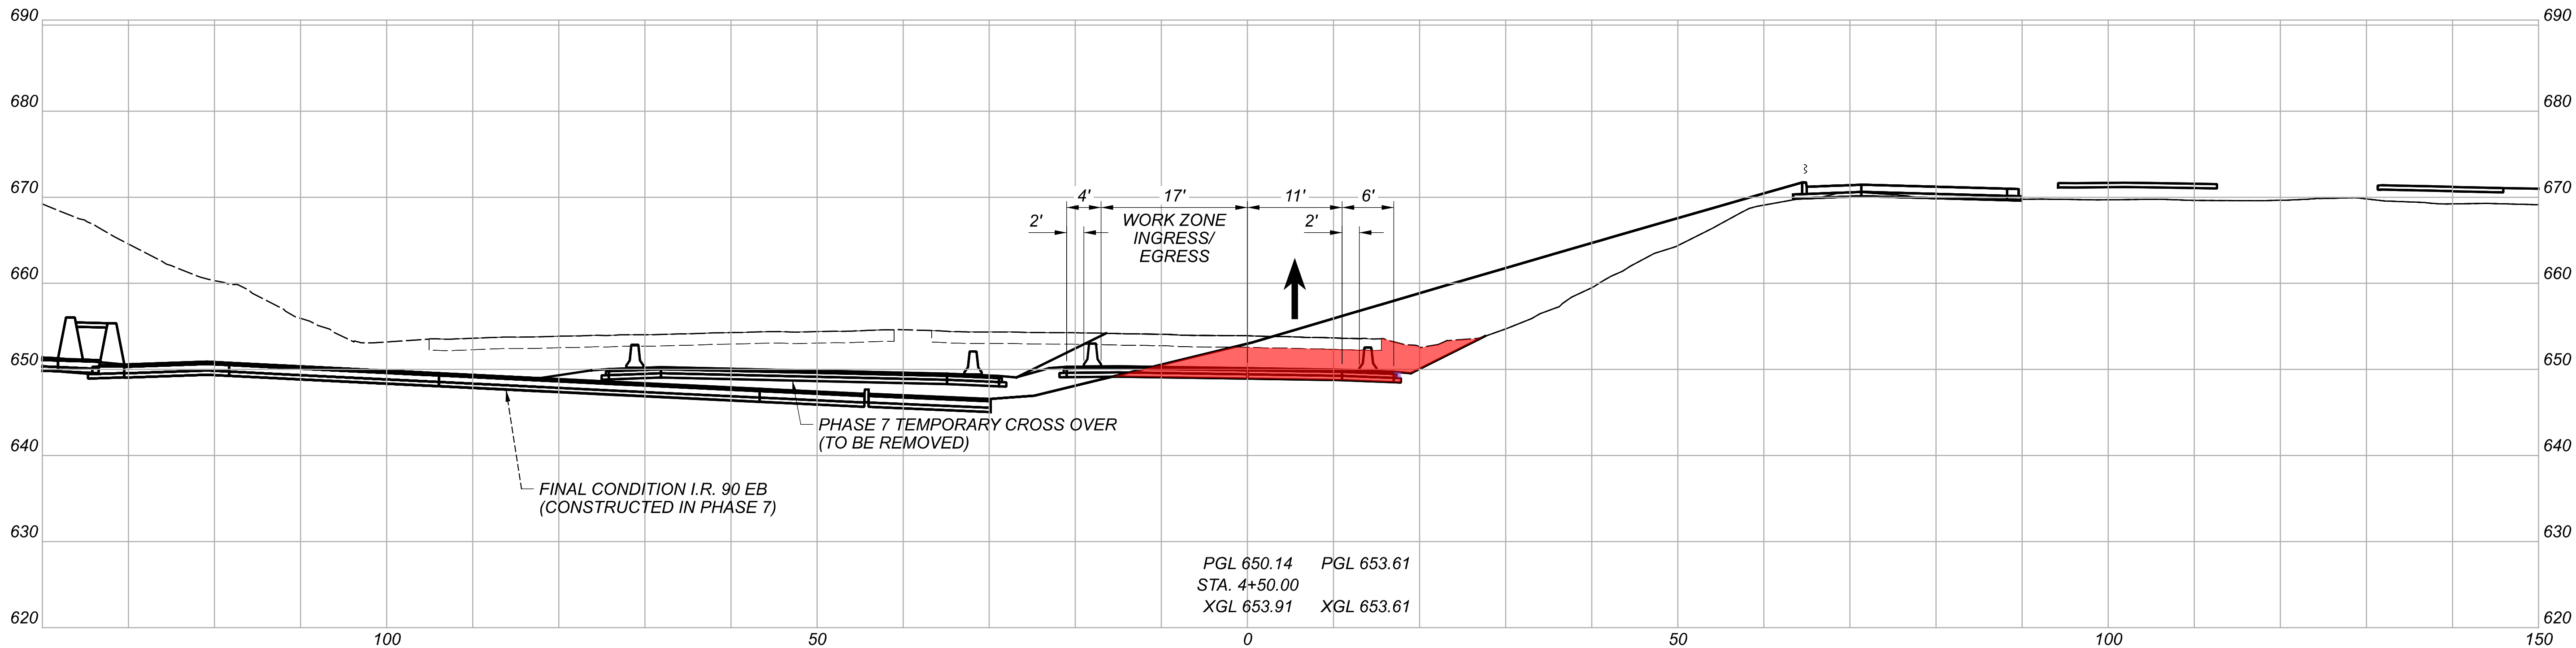
| SHEET | TOTAL |
|---|---|
| 279 | 2696 |

MAINTENANCE OF TRAFFIC - PHASE 8  
CROSS SECTIONS - TEMPORARY RAMP H5 TO I.R. 90 EB

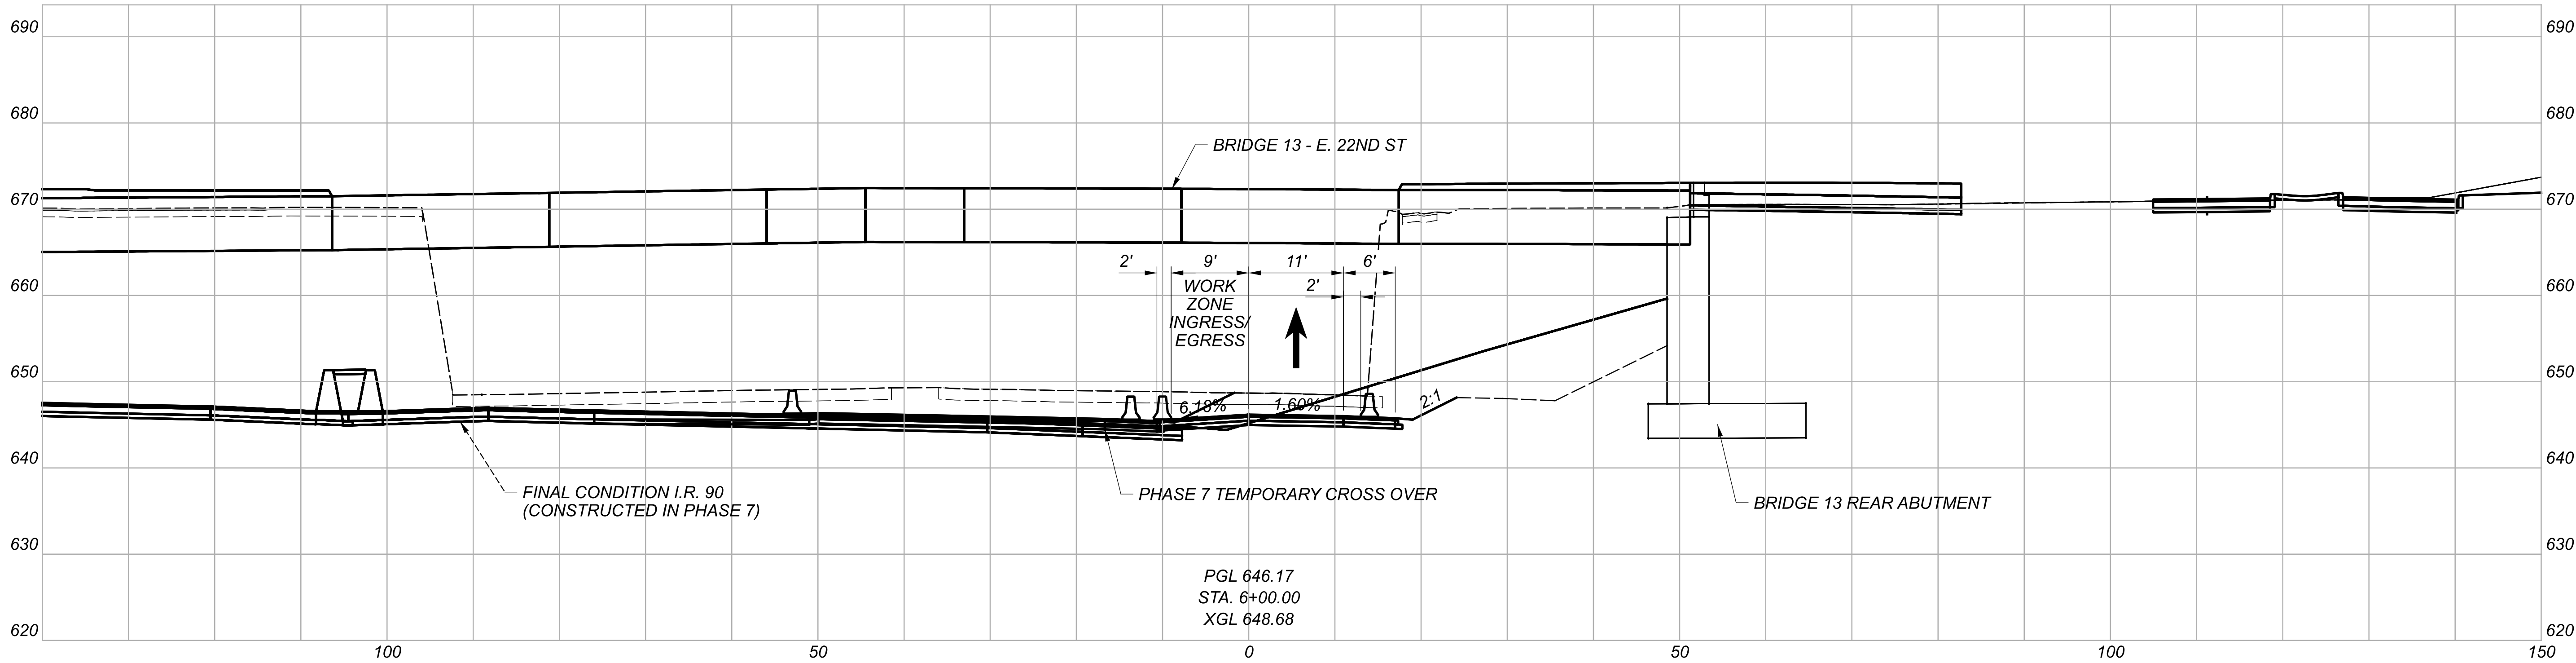
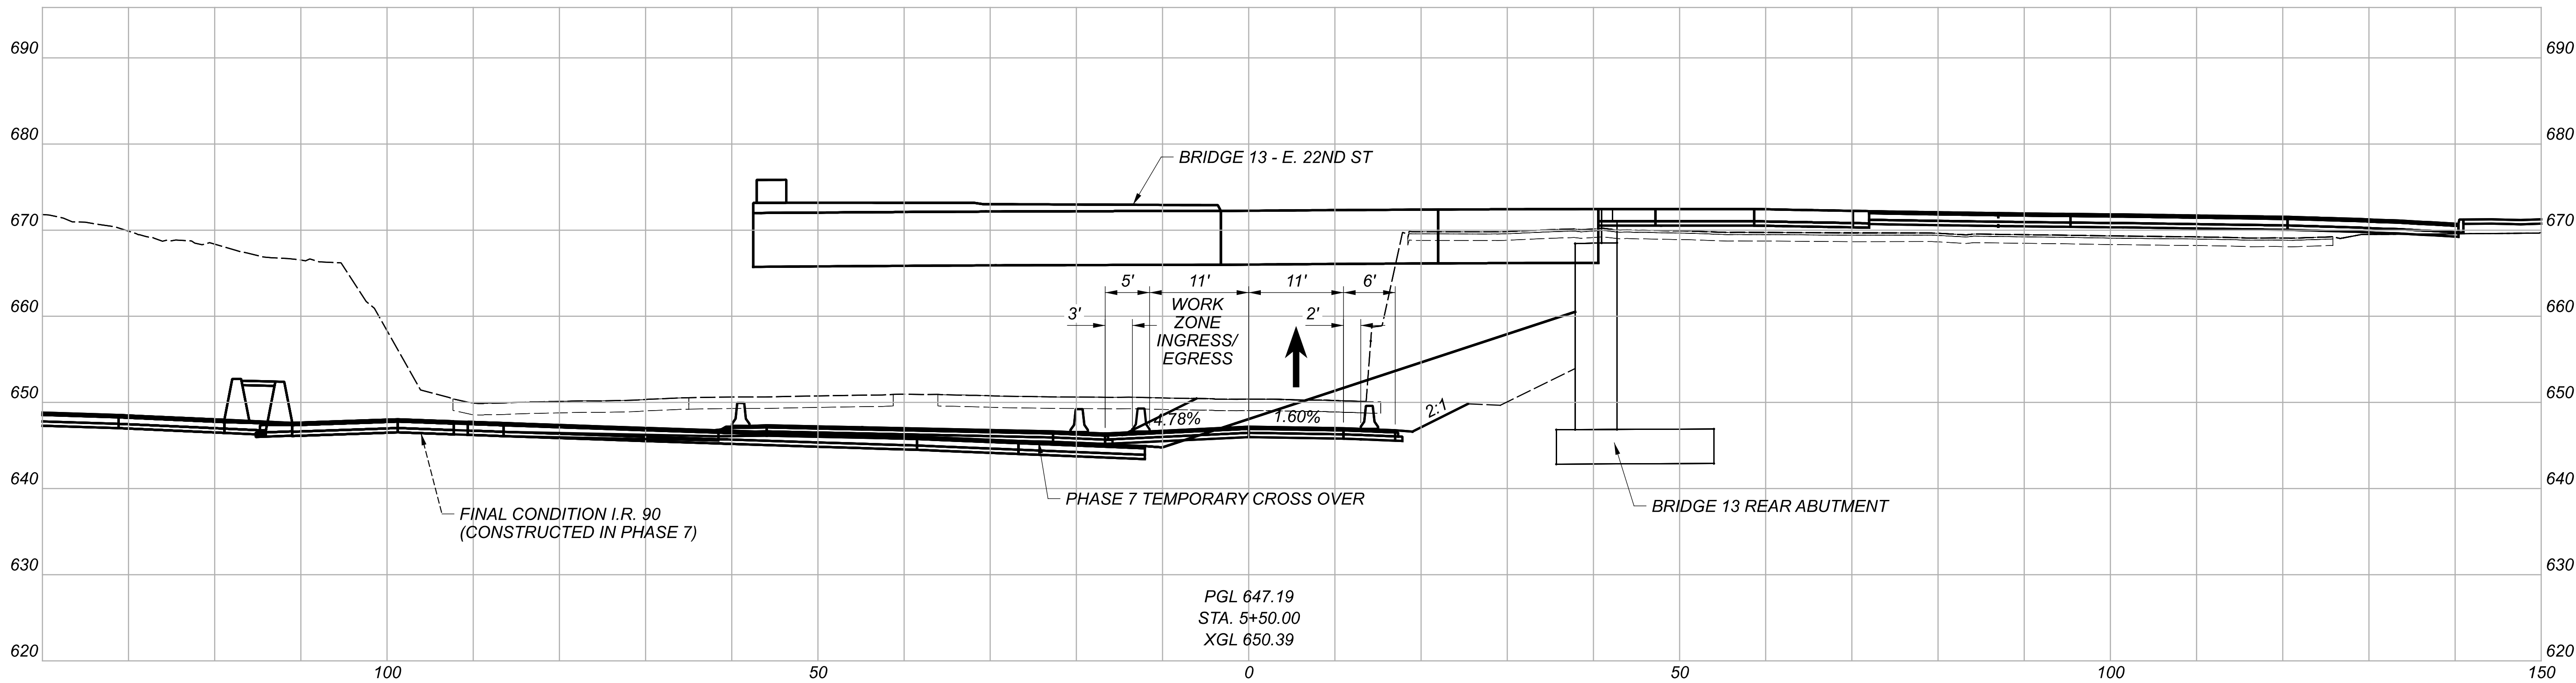
| 280 | 2696 |

MAINTENANCE OF TRAFFIC - PHASE 8  
CROSS SECTIONS - TEMPORARY RAMP H5 TO I.R. 90 EB
