LOR-6/611-0683/0031

## Inspection Notes

7-30-2026

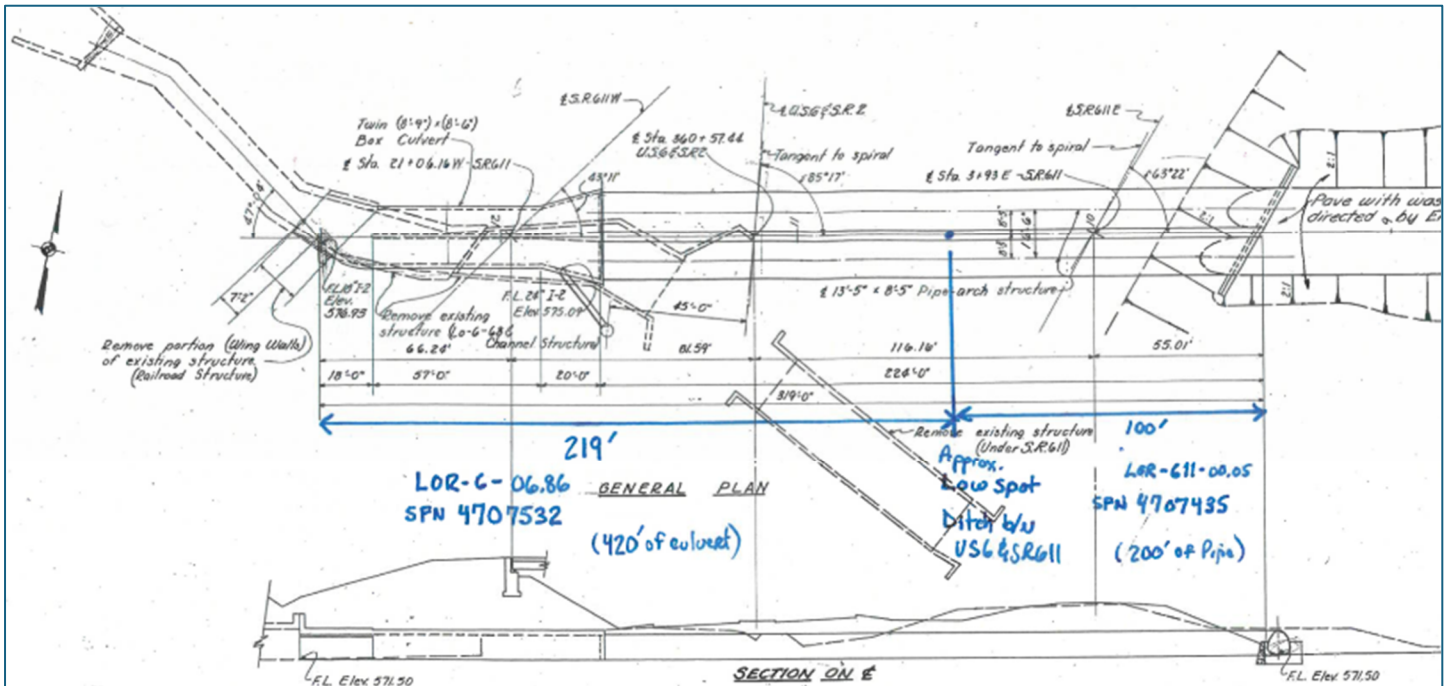
From the plans the USR6 portion (219' linear) consists of:

- CIP concrete box: 95' each cell (190' total)
- Steel Pipe Arch: 124' each cell (248' total)

From the plans the SR611 portion (100' linear) consists of:

- Steel Pipe Arch: 100' each cell (200' total)
