Subject: Asbestos Inspection of MAH-680-0791E (SFN #5007348/PID 103883) I.R 680 Ramp E Bridge over Dewey Ave in Youngstown, OH 44502 (L&A 20-0076)

Bulk Sample Diagram

Inventory Bridge Number: MAH-680-0791E
Structure File Number: 5007348
Date Sampled: March 17, 2022
Surveyors: Matt Geiger AHES# 35832
 Will Arnold AHES# 545305

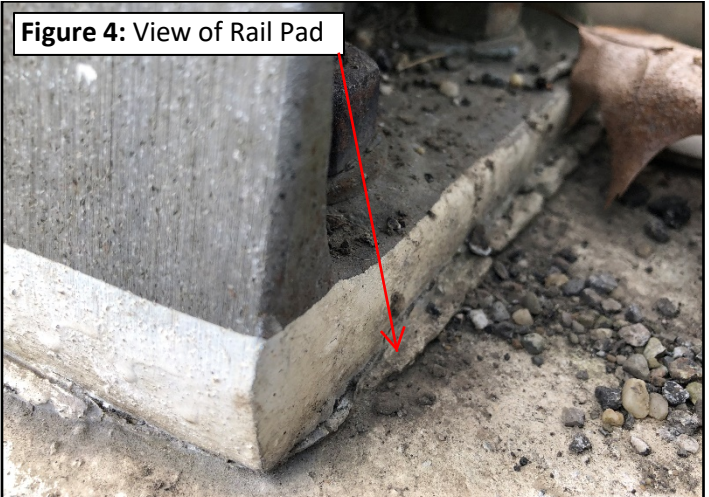
Under the current EPA/NESHAP regulations, materials that contain greater than 1% asbestos are considered to be an asbestos-containing material (ACM). Therefore, three samples of the Rail Pad were found to be Asbestos Containing Material as defined by U.S. EPA/NESHAP regulations.

Any contractors disturbing this material must adhere to OSHA 29 CFR 1910 and 29 CFR 1926. The rail pad is located between the concrete parapet wall and the aluminum railing. This material is gray in color and encompasses a total of approximately 25 square feet on the South side of the bridge. An image depicting the material can be found in Figure 4 of Appendix B. This material is a Category II asbestos containing material, as defined by EPA, that would become friable if disturbed from renovation/ demolition activities. Any contractors disturbing this material must adhere to OSHA 29 CFR 1910 and 29 CFR 1926.
