Subject: Asbestos Inspection of the MOT 00075 23710 Bridge (SFN #5709199/PID 114842) Chessie System Railroad over I-75 in Vandalia, Ohio 45377 (L&A 20-0061)

# APPENDIX B BULK SAMPLE DIAGRAM

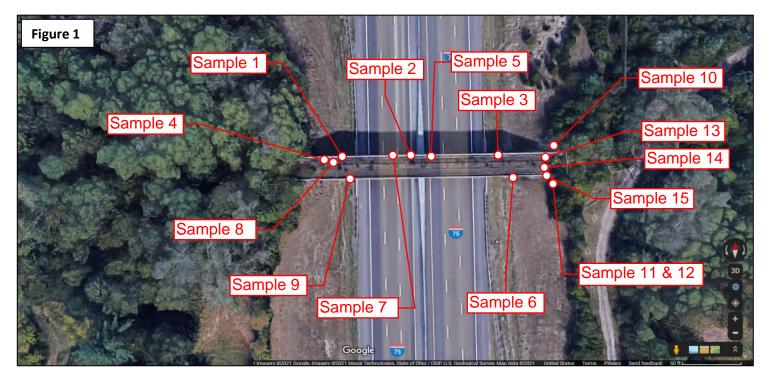
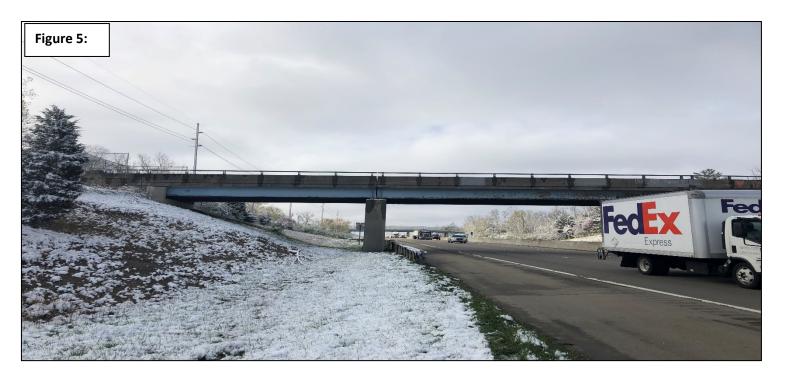
The survey consisted of an inspection of all accessible areas of the bridge to determine the presence, location and quantities of asbestos-containing materials. Bulk samples were collected from suspect materials that could potentially be impacted during demolition/renovation work activities. A diagram of the bridge and asbestos bulk sampling locations can be found in **Appendix B**.
