APPENDIX A – ANTHONY WAYNE BRIDGE ACOUSTIC EMISSION MONITORING REPORT (MISTRAS)

Anthony Wayne Bridge Acoustic Emission Monitoring Report

Location: Toledo, Ohio

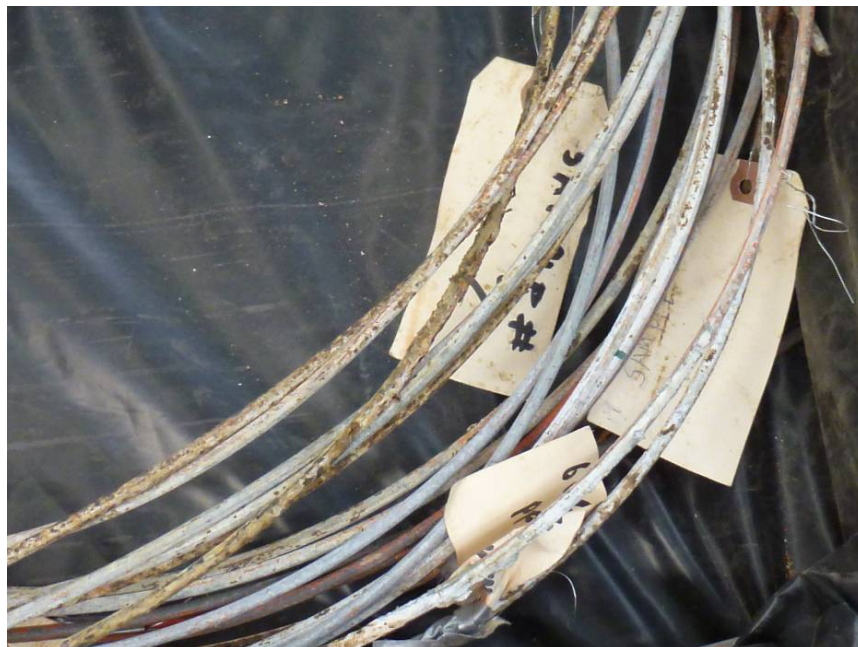
A total of thirteen sample wires, approximately 0.192 in. original diameter and different lengths, were submitted for tensile testing to failure of the specimens in accordance with standard ASTM A370 and E8. The submitted wire samples in the as-received condition are shown in Fig. 2. The customer tag indications of wire locations in the main cable are given in Table 2 along with corrosion stage determined by LPI during preliminary evaluation. All wire surfaces were examined using a binocular microscope at low and high magnification. Typical wire surfaces with different corrosion stages are shown in Fig. 3. Wire surfaces in the as-received condition are shown in Figs. 4 through 10. LPI also evaluated the corrosion stage of each wire after tensile testing since during tensile testing more wire surface was exposed as a result of spalled paint coatings and corrosion/product deposits.

Fig. 2 Main cable wire samples in the as received condition.

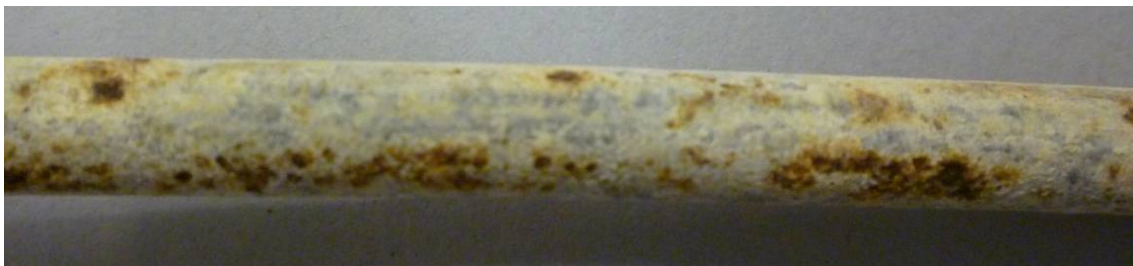
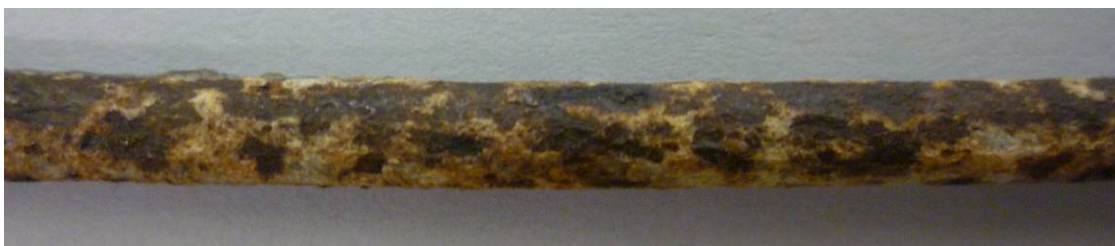
Fig. 3 Typical wire surfaces with different corrosion stages.

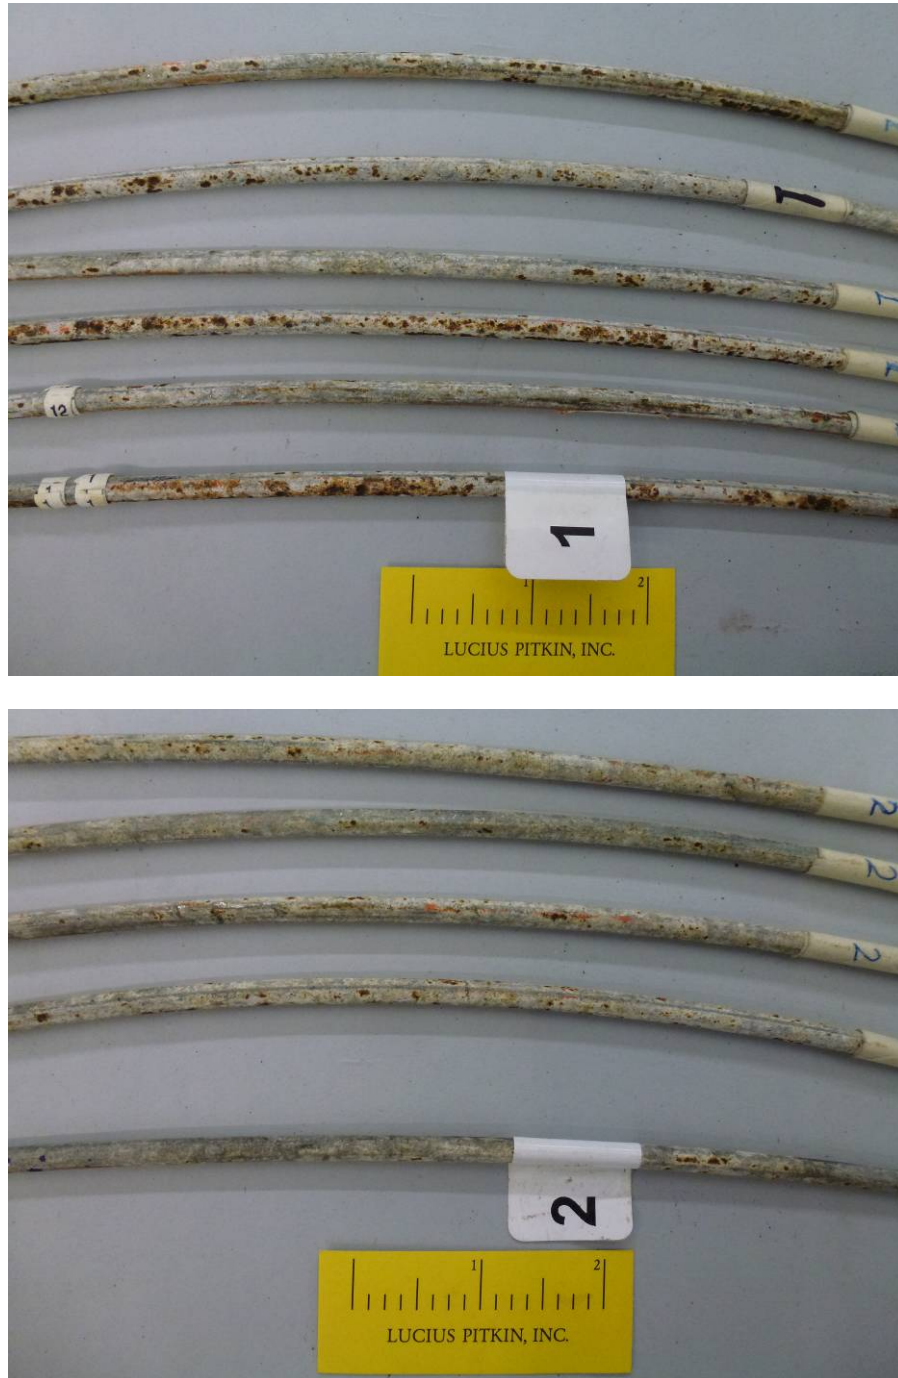
Fig. 4 Views of wire 1 and 2 surfaces (see Table 2).

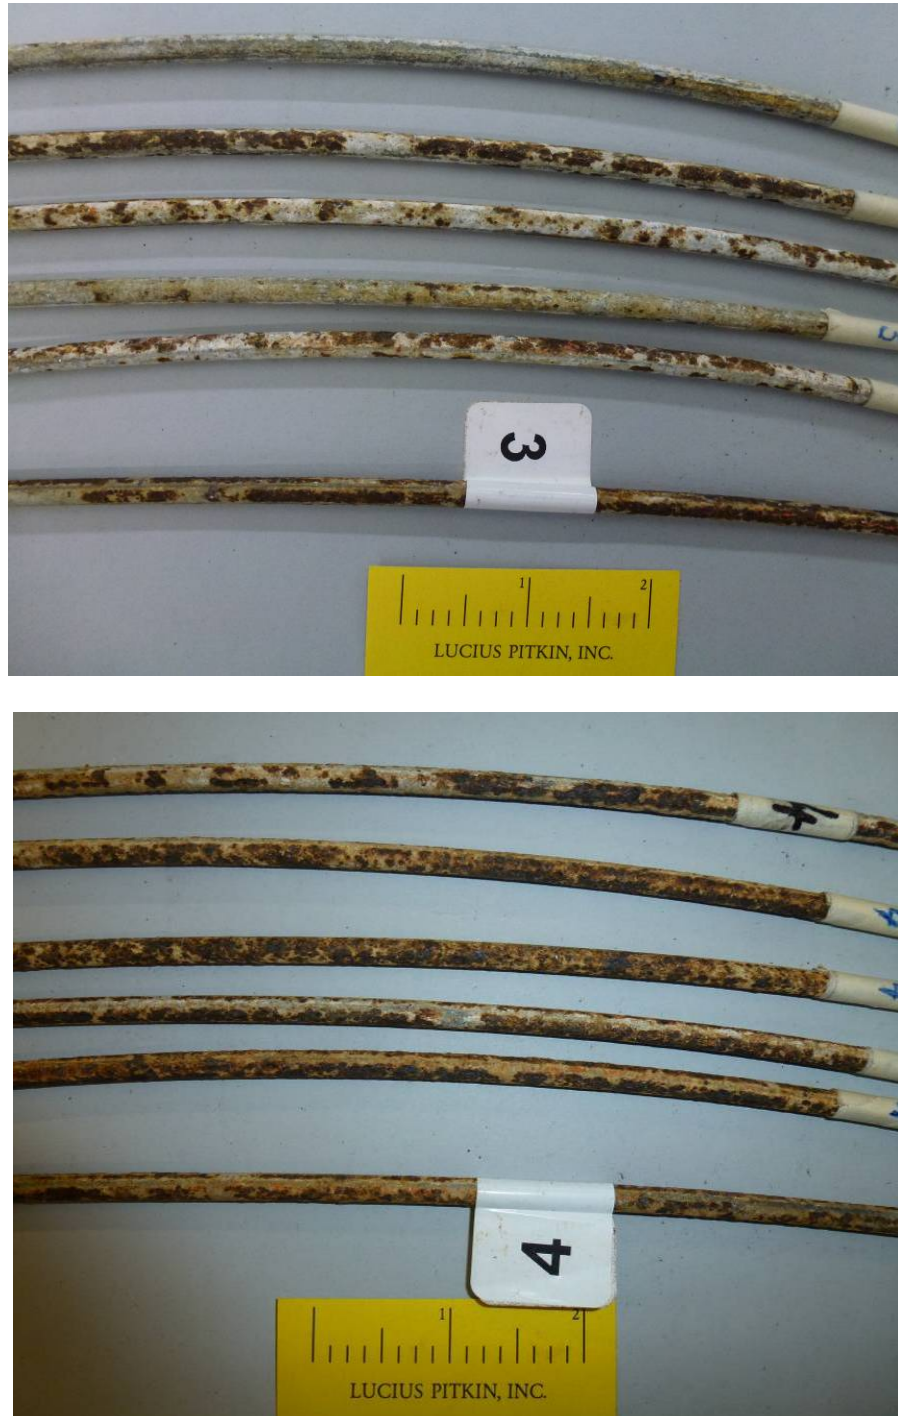
Fig. 5 Views of wire 3 and 4 surfaces (see Table 2).

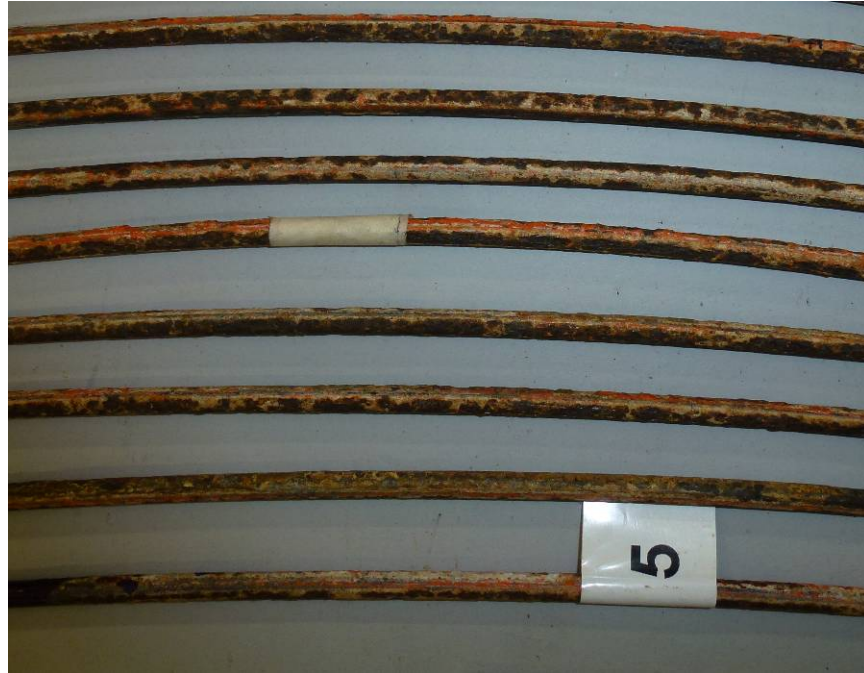
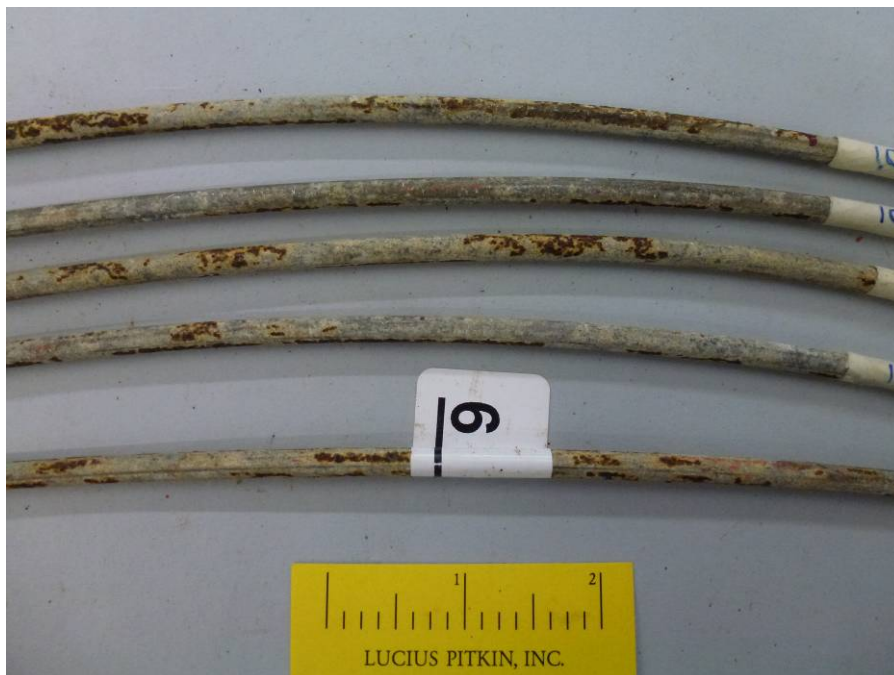
Fig. 6 Views of wire 5 and 6 surfaces (see Table 2).

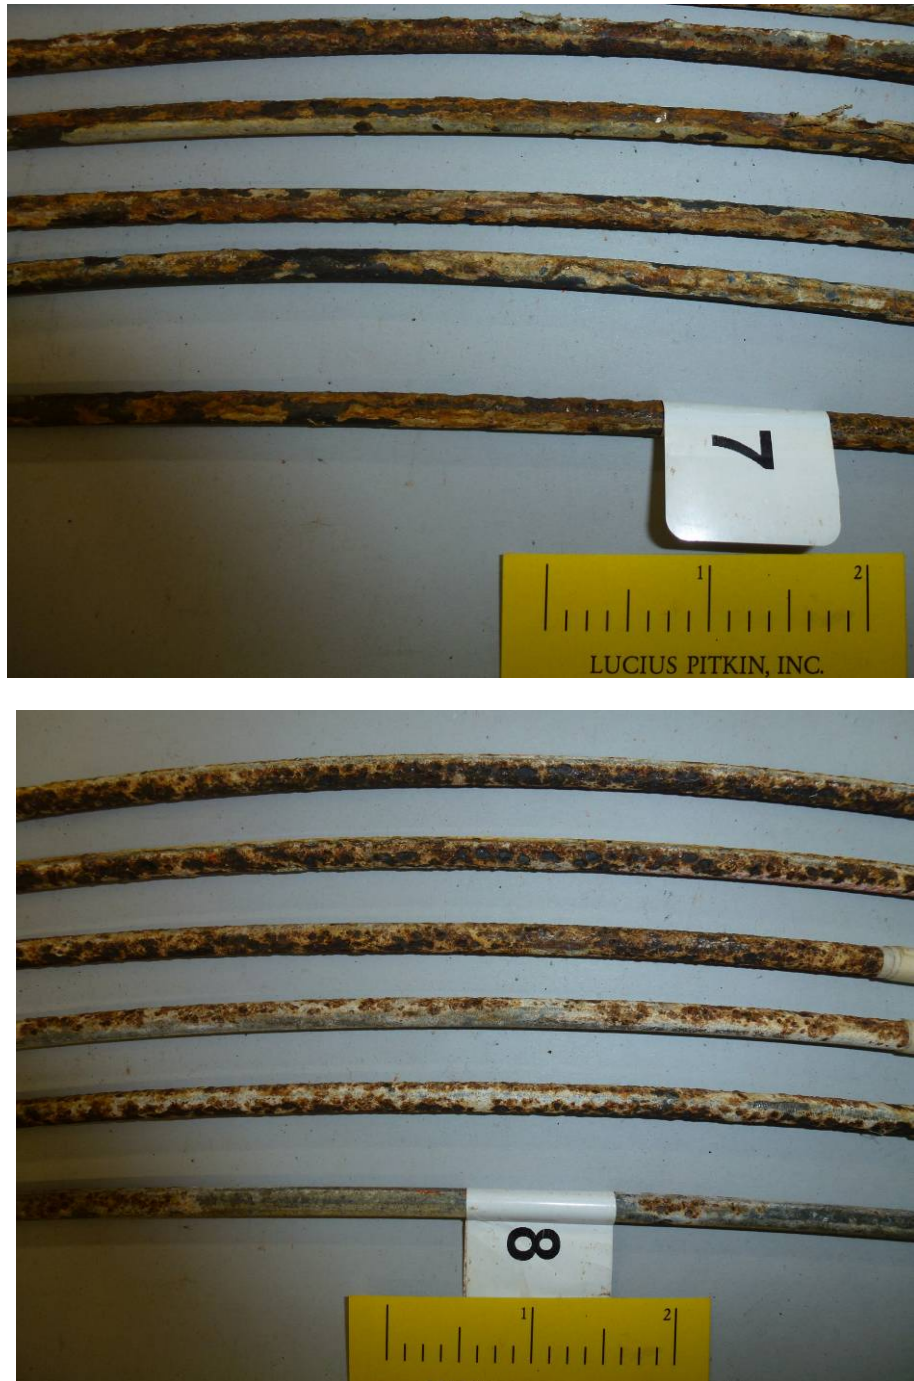
Fig. 7 Views of wire 7 and 8 surfaces (see Table 2).

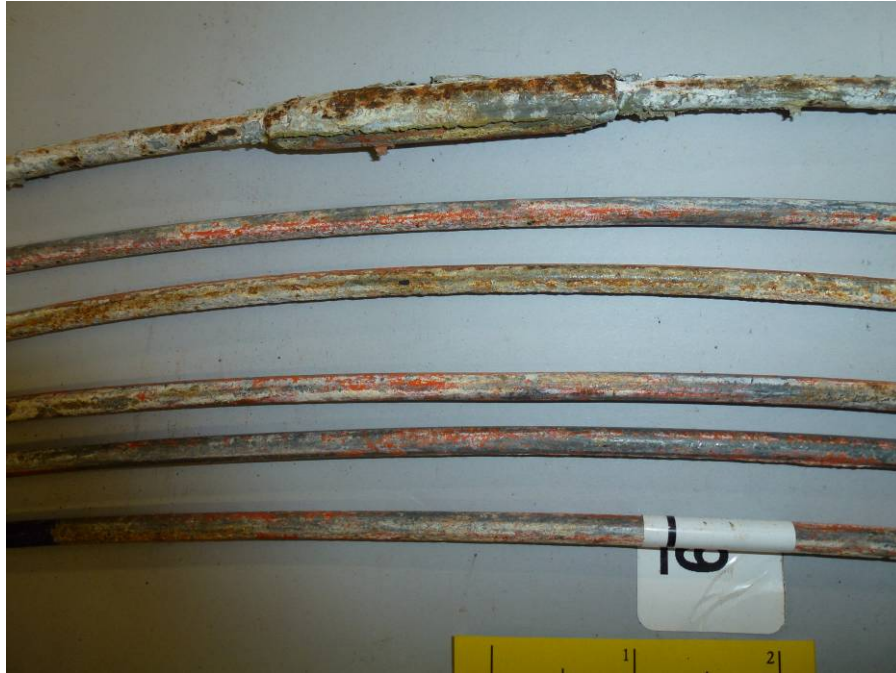
Fig. 8 Views of wire 9 and 10 surfaces (see Table 2).

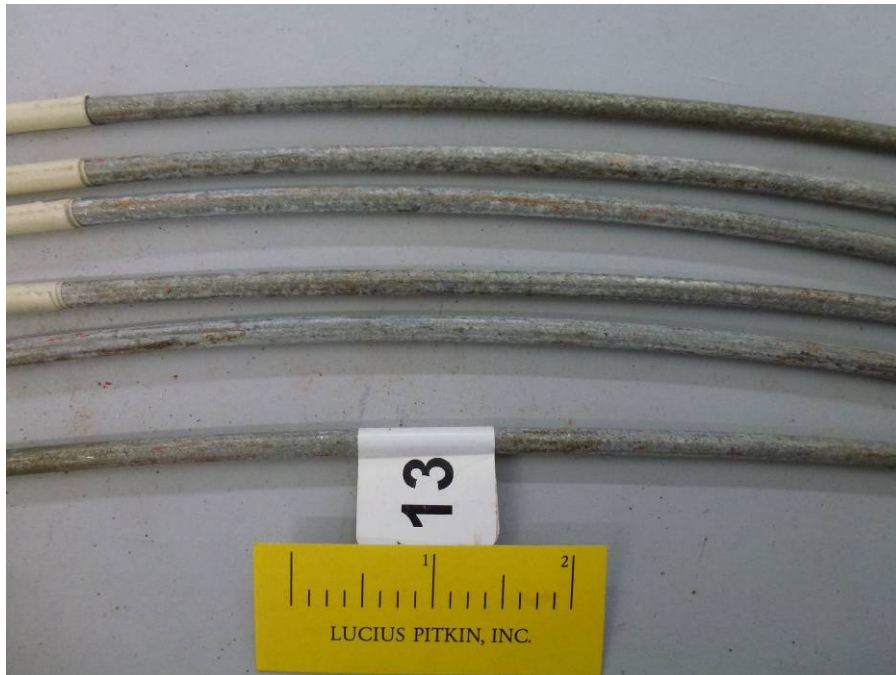
Fig. 10 Views of wire 13 surfaces (see Table 2).

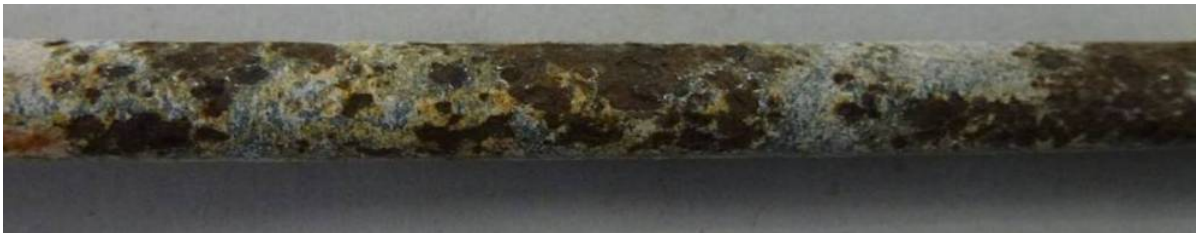
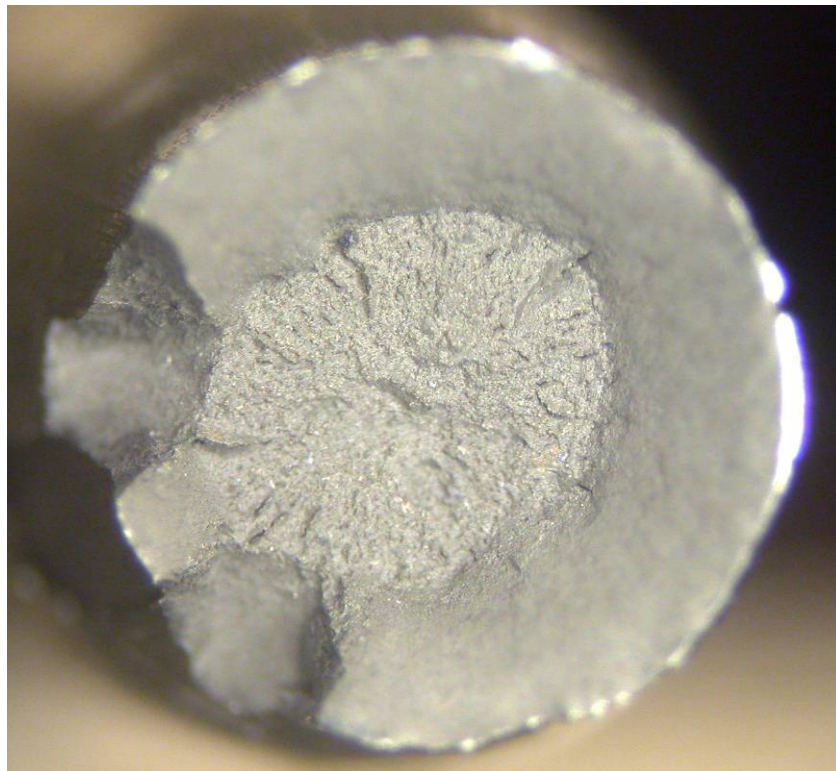
Fig.13 Wire 1-1 surface (top) and fracture surface after tensile testing (bottom).

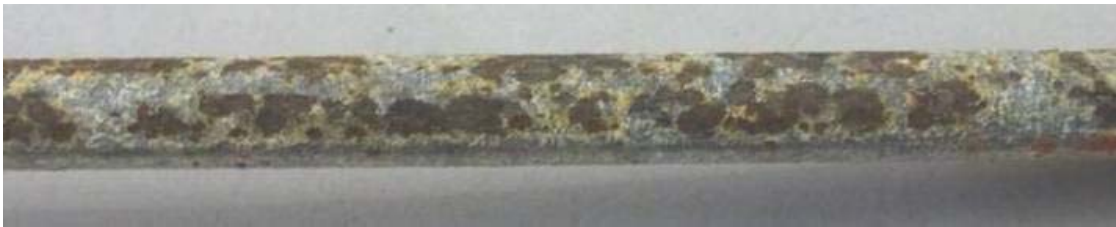
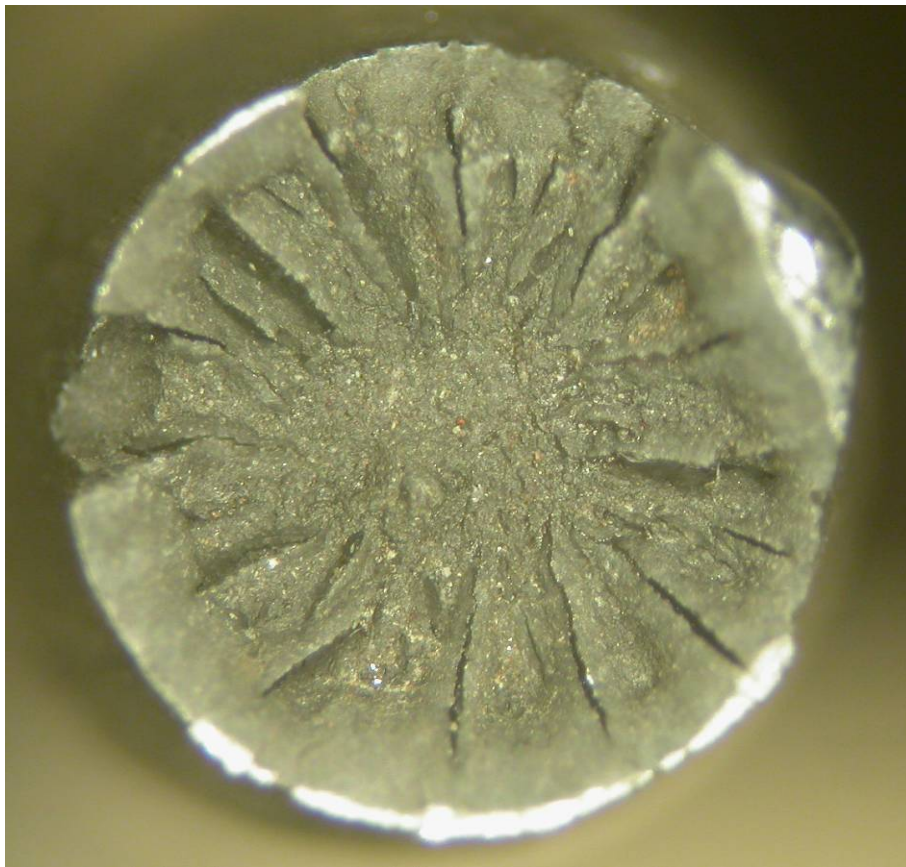
Fig.15 Wire 1-3 surface (top) and fracture surface after tensile testing (bottom).

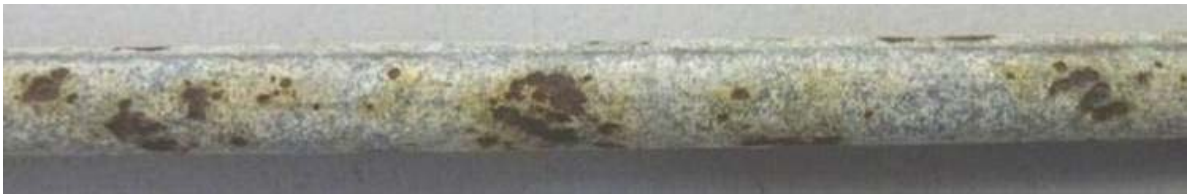
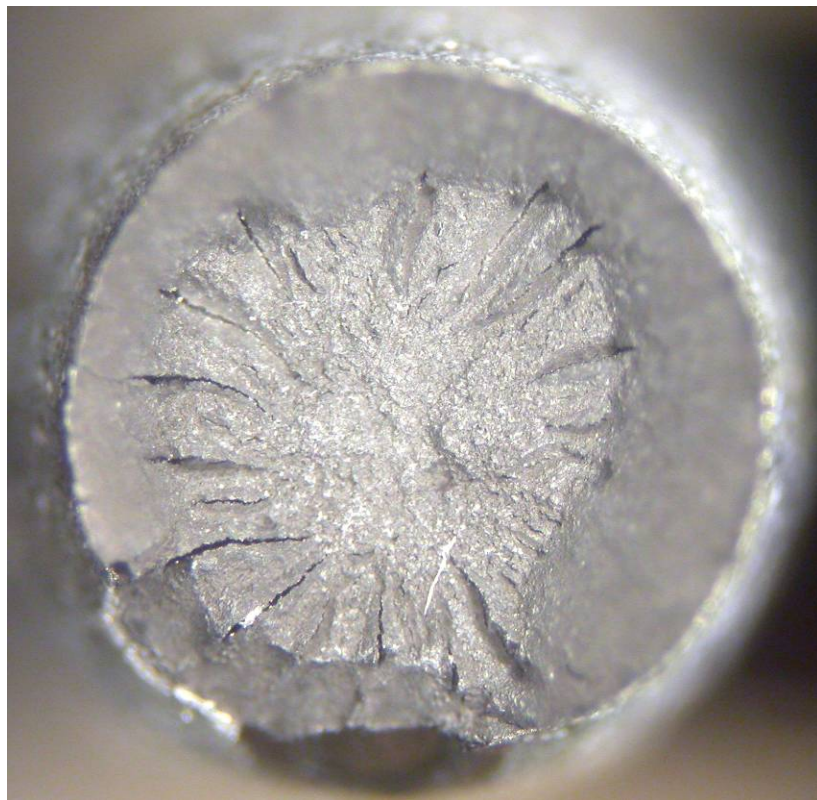
Fig.16 Wire 1-4 surface (top) and fracture surface after tensile testing (bottom).

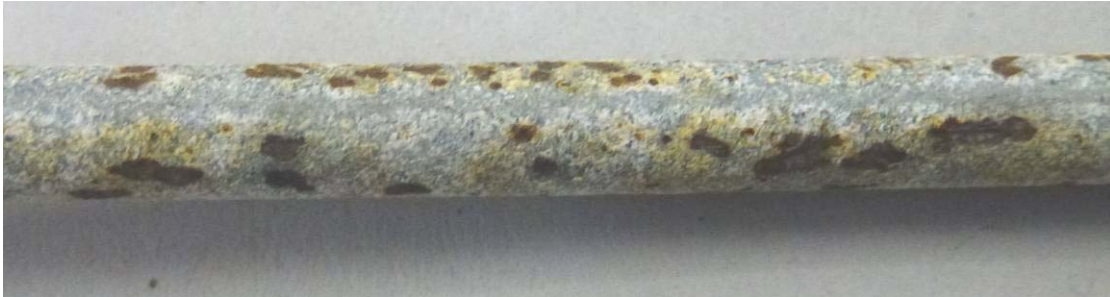
Fig.17 Wire 1-5 surface (top) and fracture surface after tensile testing (bottom).

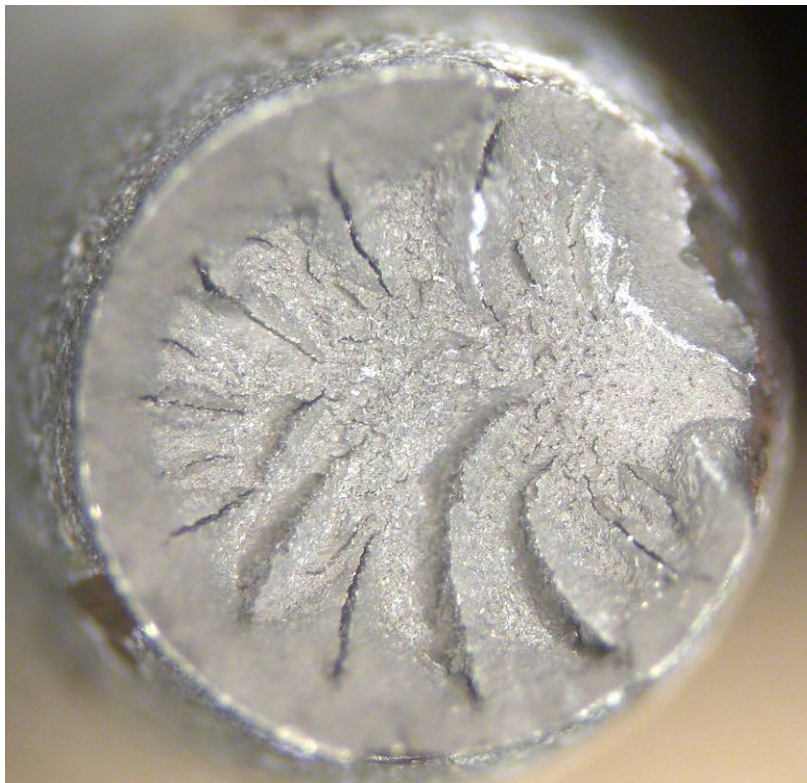
Fig.18 Wire 1-6 surface (top) and fracture surface after tensile testing (bottom).

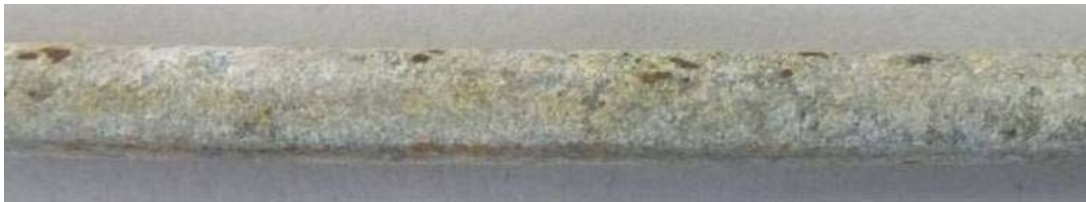
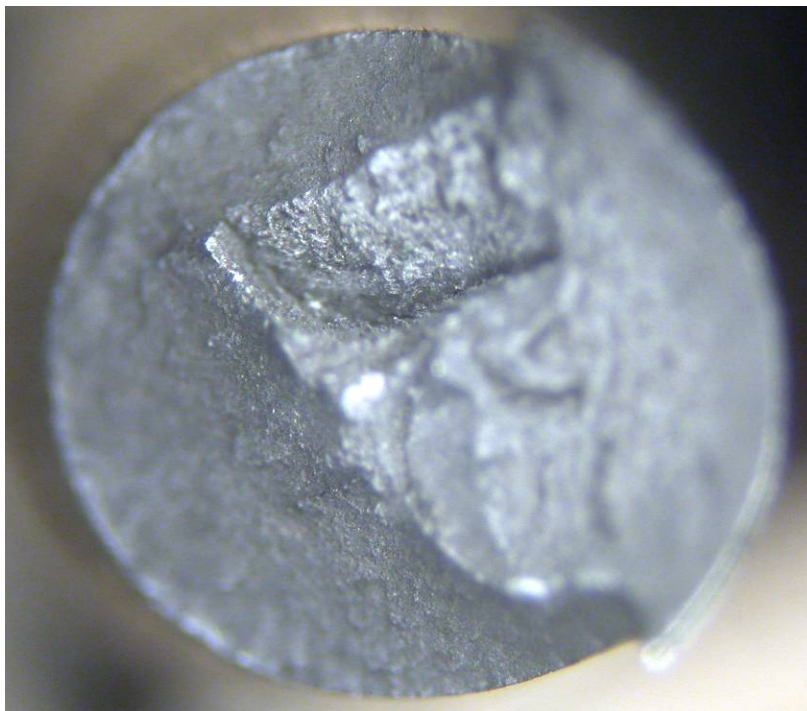
Fig. 19 Wire 2-1 surface (top) and fracture surface after tensile testing (bottom).

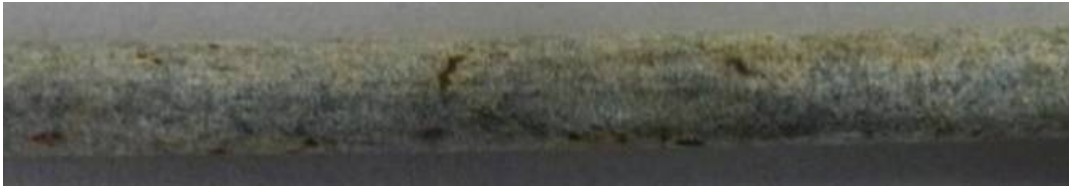
Fig. 21 Wire 2-3 surface (top) and fracture surface after tensile testing (bottom).

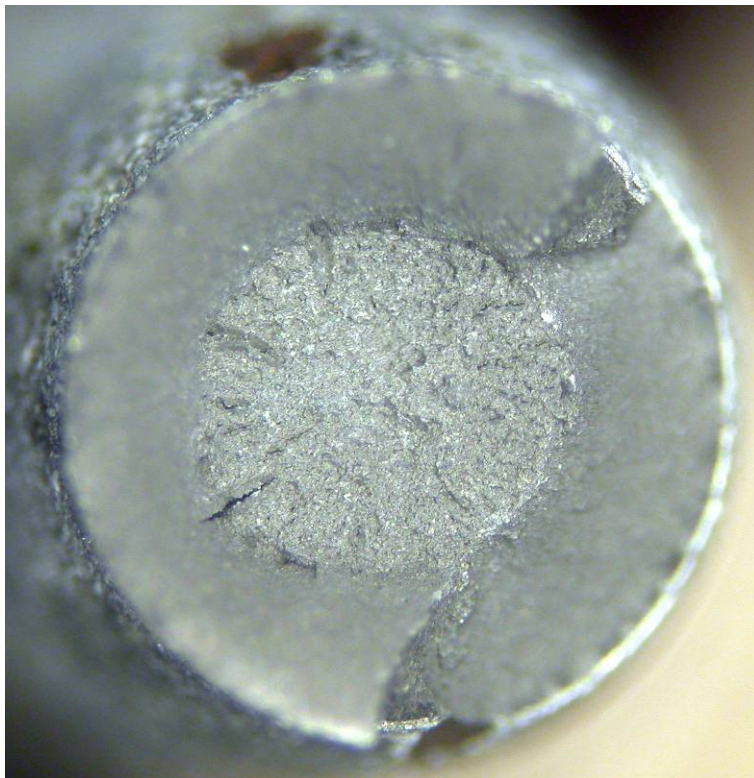
Fig. 22 Wire 2-4 surface (top) and fracture surface after tensile testing (bottom).

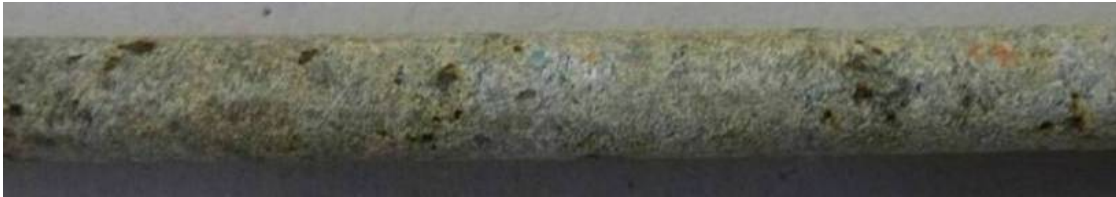
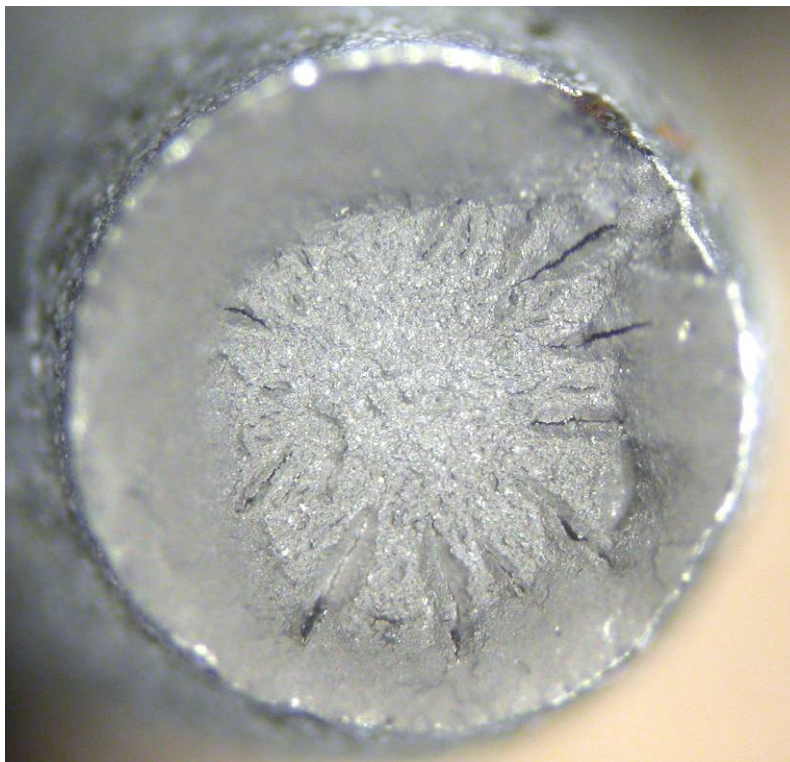
Fig. 23 Wire 2-5 surface (top) and fracture surface after tensile testing (bottom).

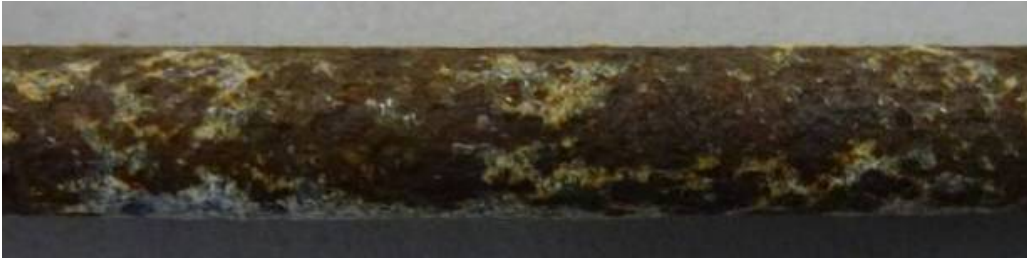
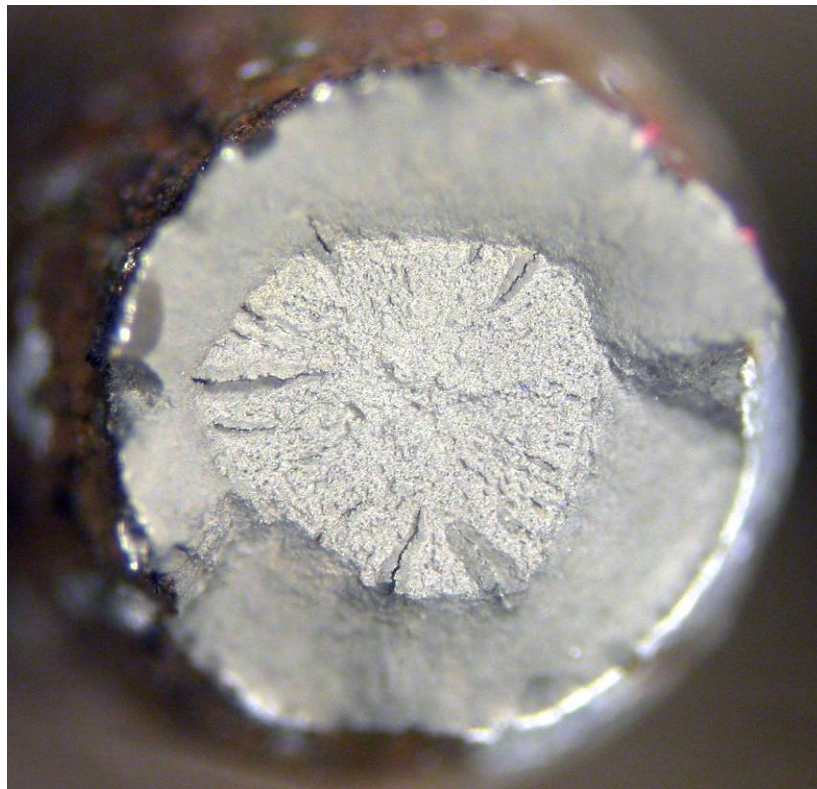
Fig. 24 Wire 3-1 surface (top) and fracture surface after tensile testing (bottom).

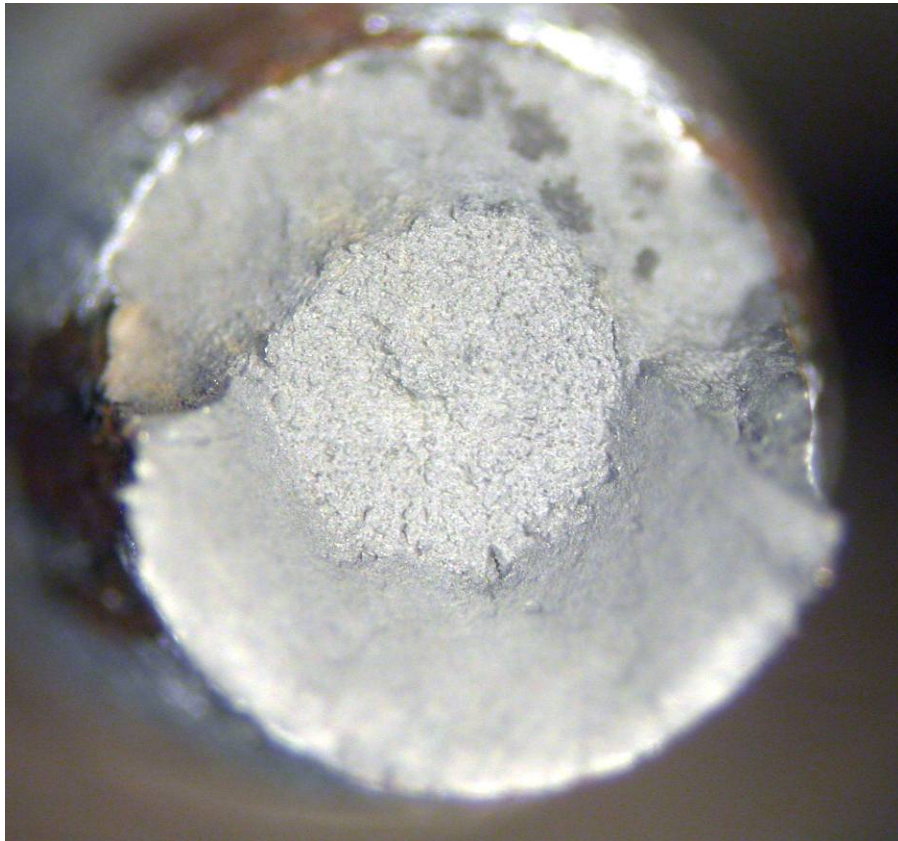
Fig. 25 Wire 3-2 surface (top) and fracture surface after tensile testing (bottom).

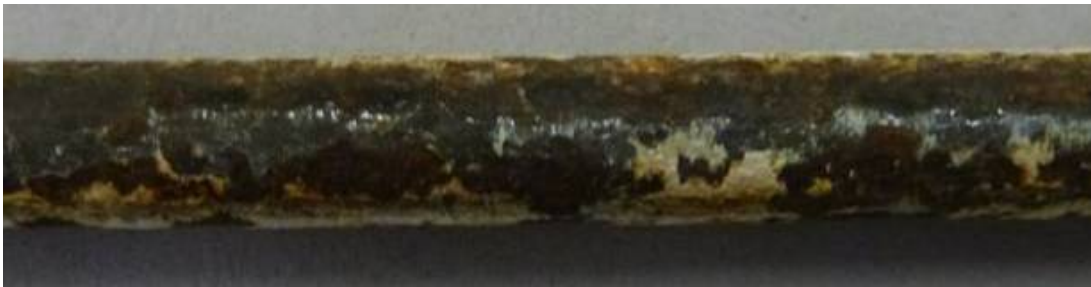
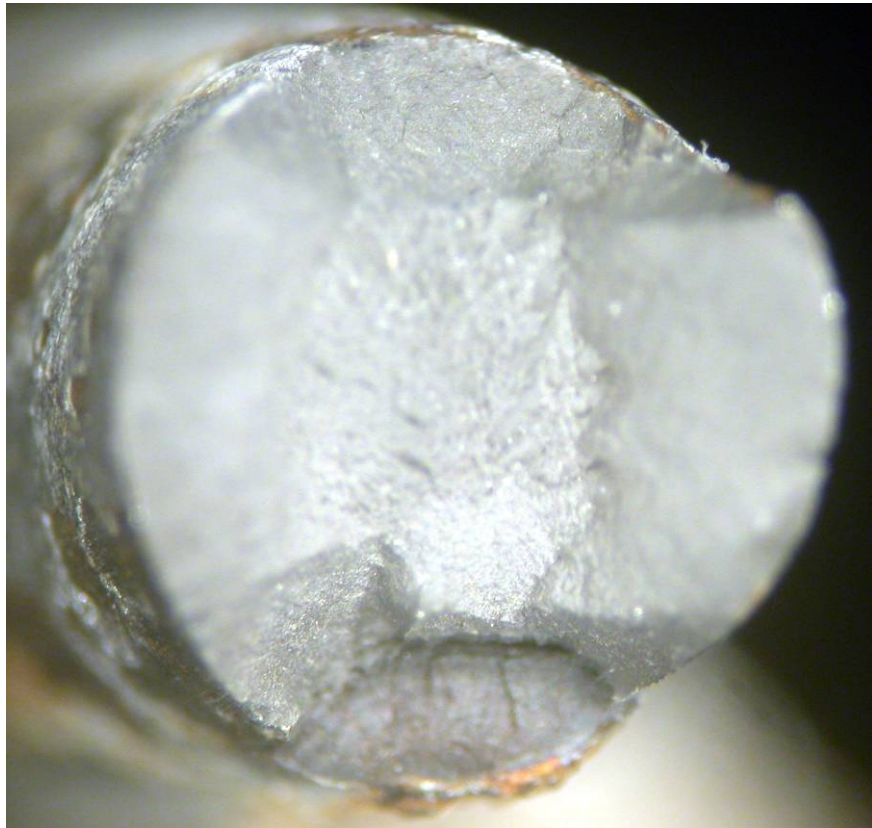
Two wires, 3-3 and 7-4, exhibited stepped fracture surface profiles which were indicative of pre-existing corrosion cracks.

Fig. 26 Wire 3-3 surface (top) and fracture surface after tensile testing (bottom).

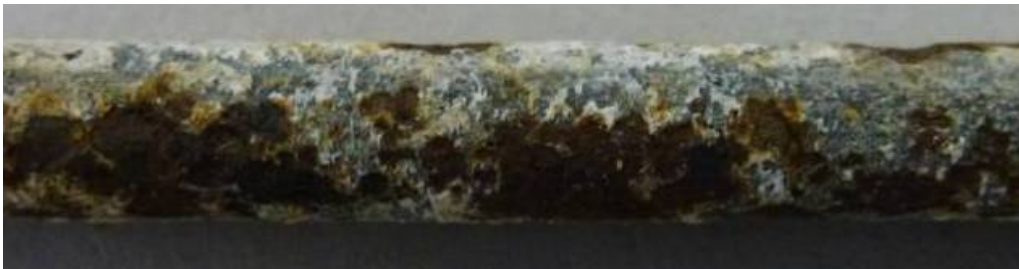
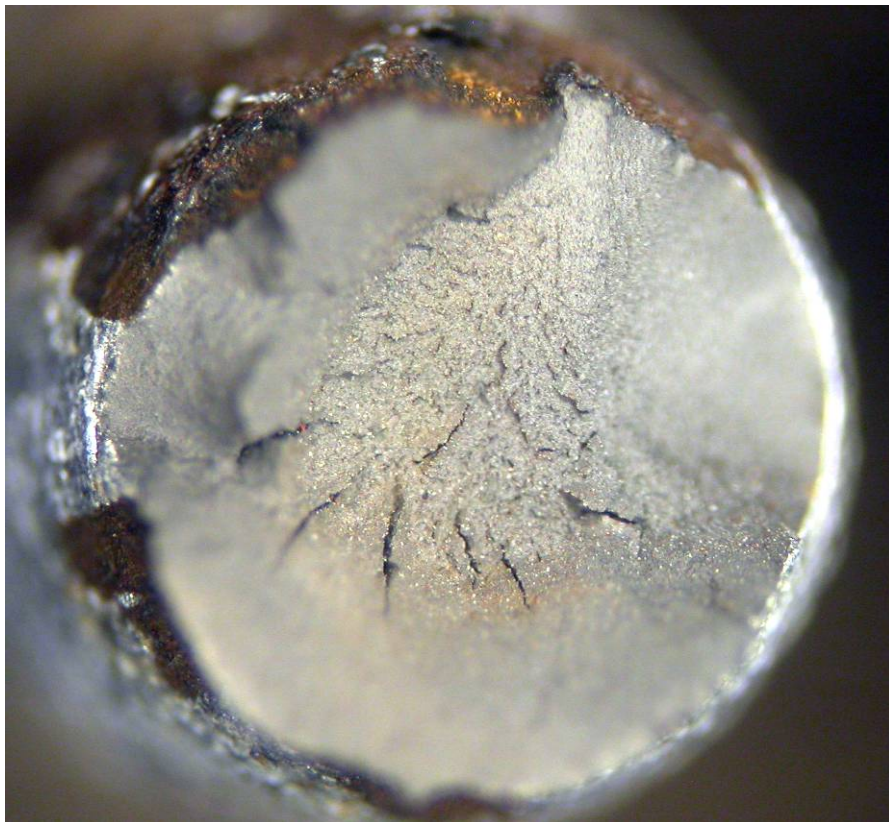
Fig. 27 Wire 3-4 surface (top) and fracture surface after tensile testing (bottom).

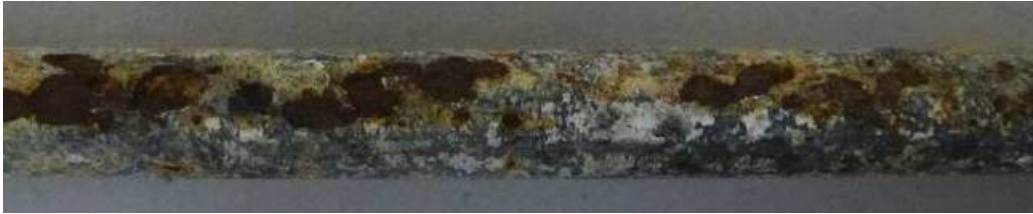
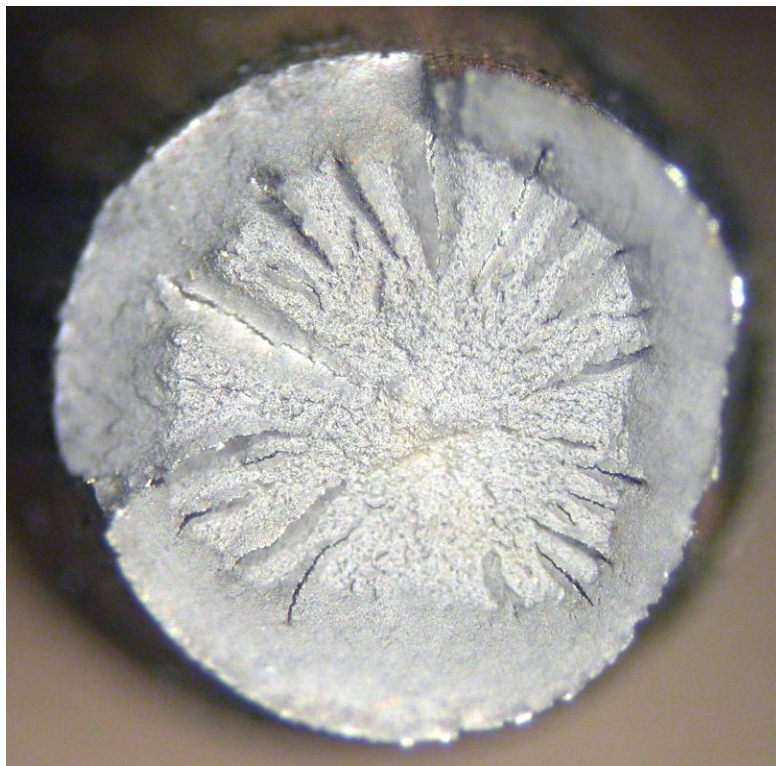
Fig. 28 Wire 3-5 surface (top) and fracture surface after tensile testing (bottom).

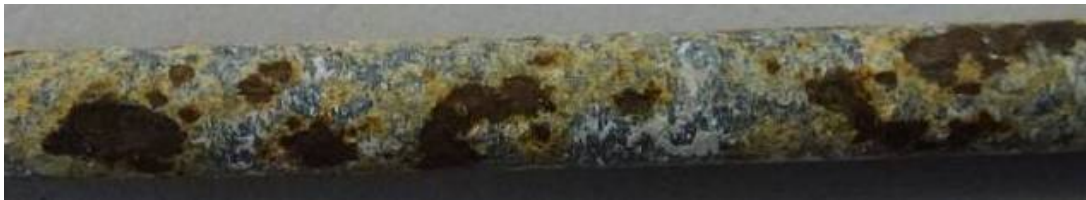
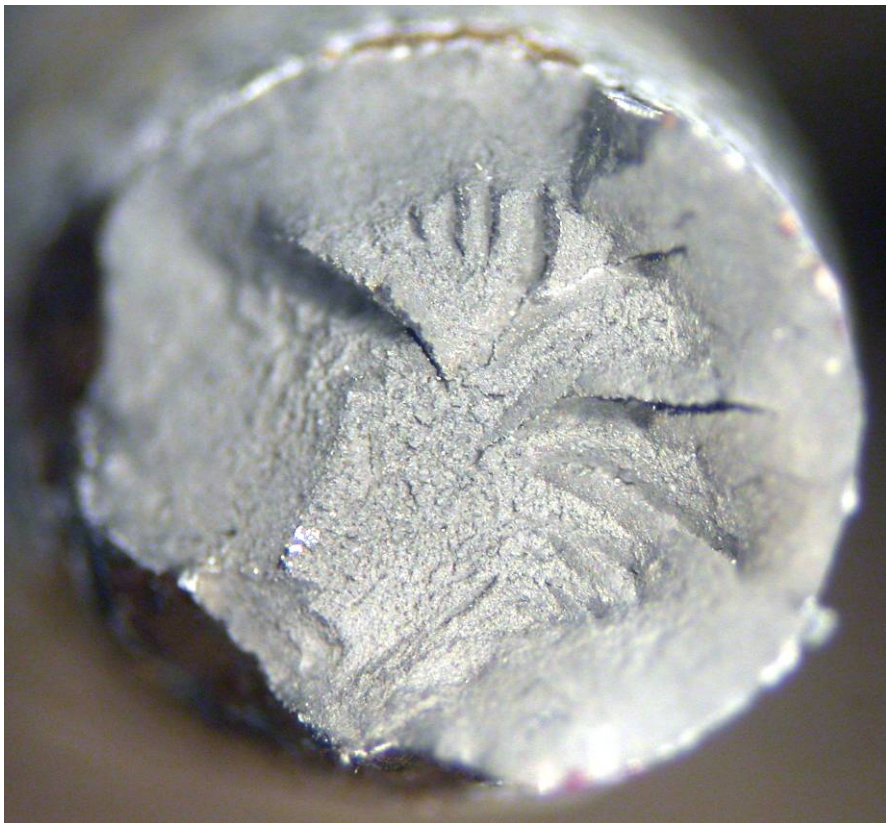
Fig. 29 Wire 3-6 surface (top) and fracture surface after tensile testing (bottom).

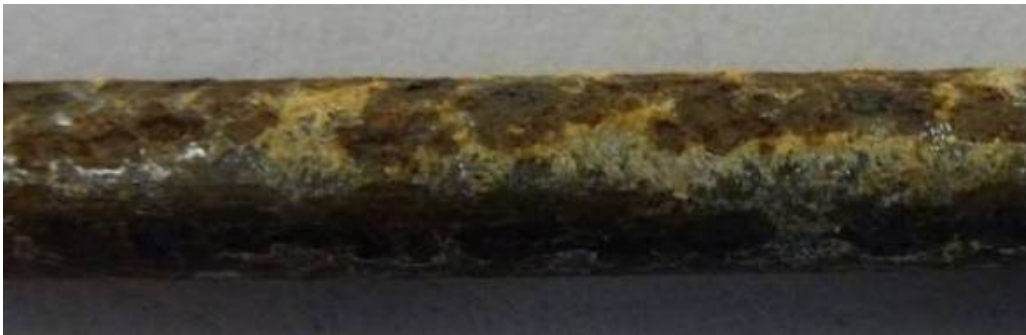
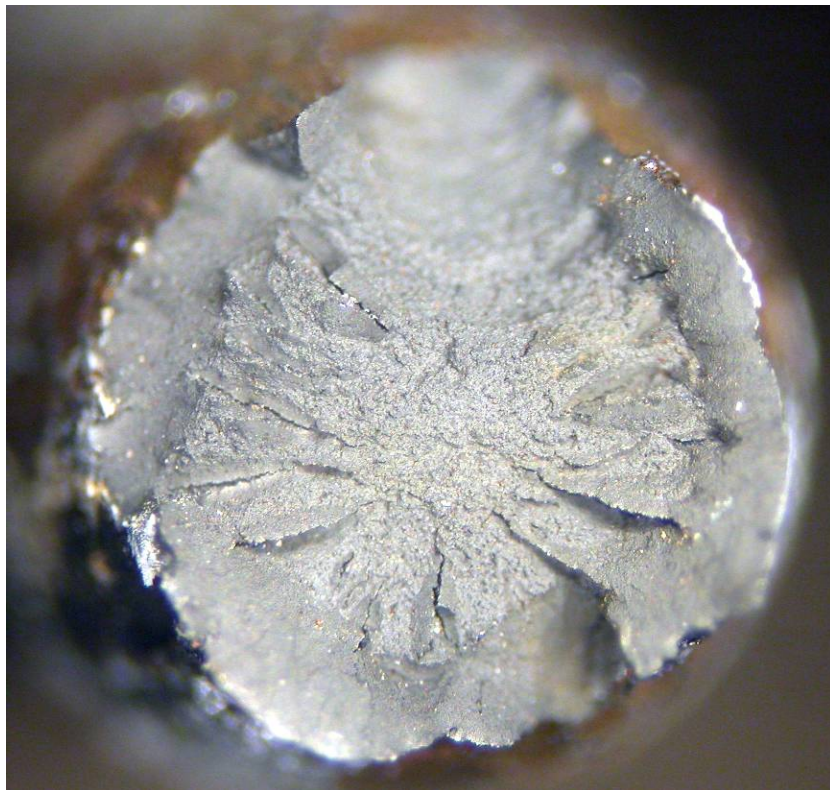
Fig. 30 Wire 4-1 surface (top) and fracture surface after tensile testing (bottom).

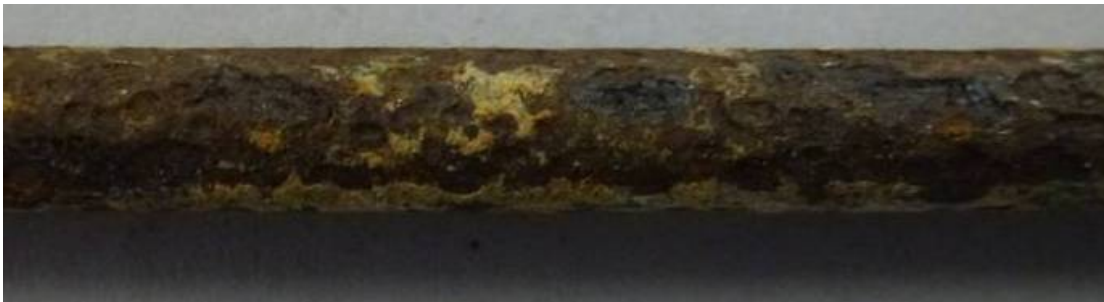
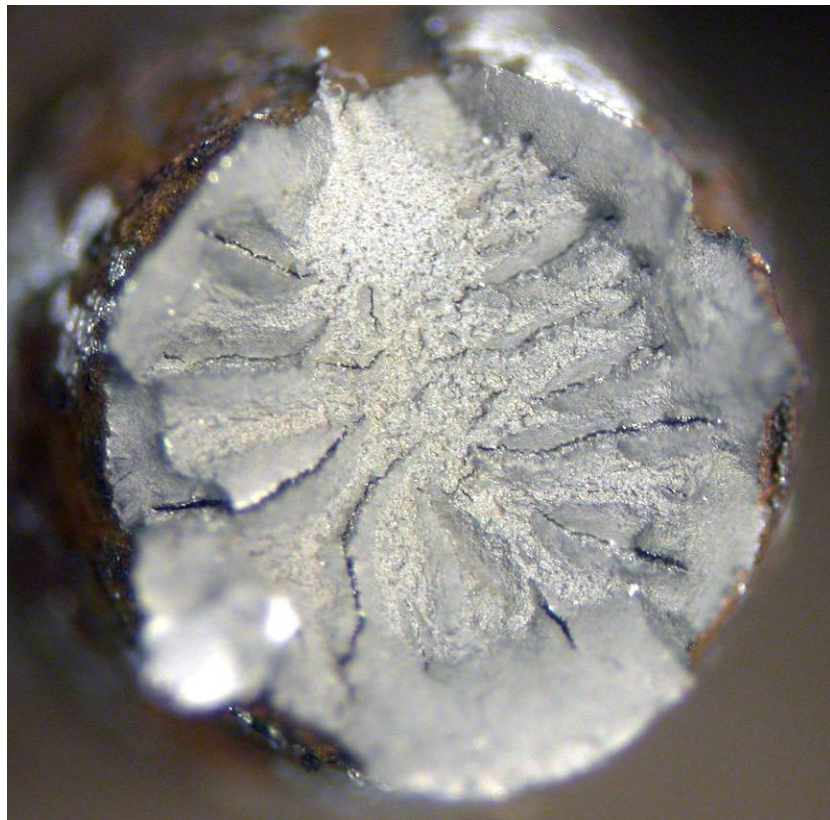
Fig. 31 Wire 4-2 surface (top) and fracture surface after tensile testing (bottom).

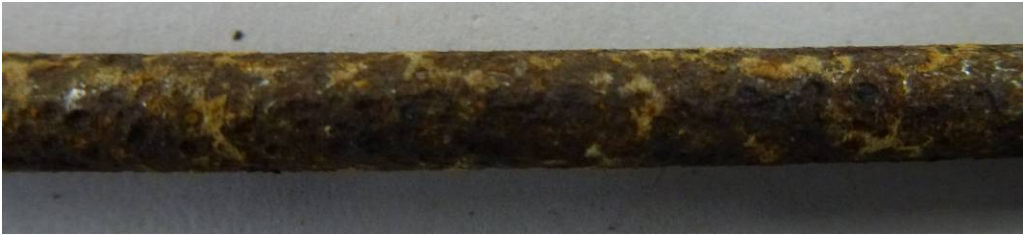
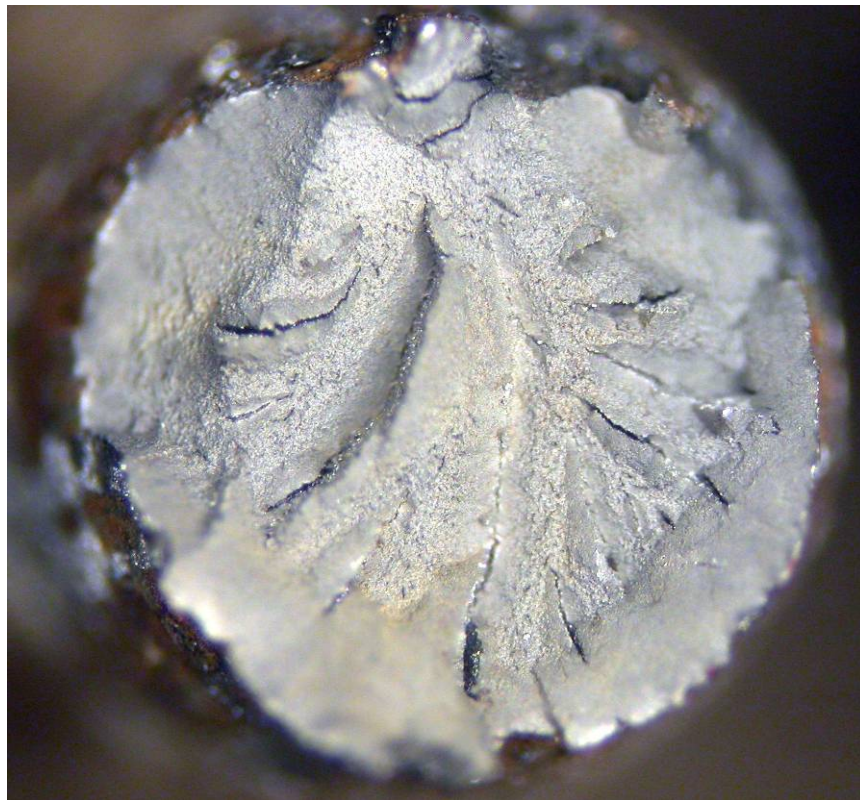
Fig. 32 Wire 4-3 surface (top) and fracture surface after tensile testing (bottom).
