APPENDIX A – ANTHONY WAYNE BRIDGE ACOUSTIC EMISSION MONITORING REPORT (MISTRAS)

Anthony Wayne Bridge Acoustic Emission Monitoring Report

Location: Toledo, Ohio

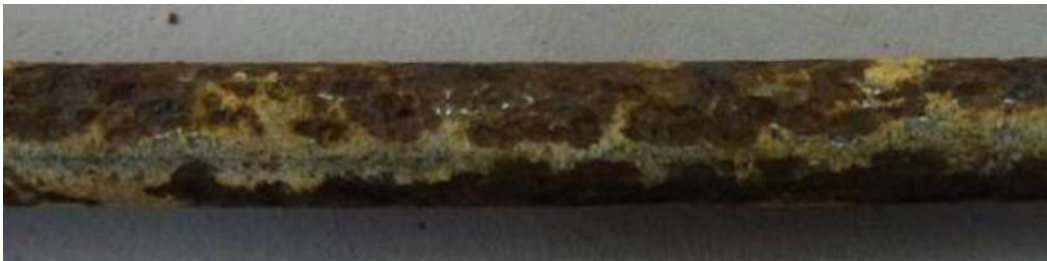
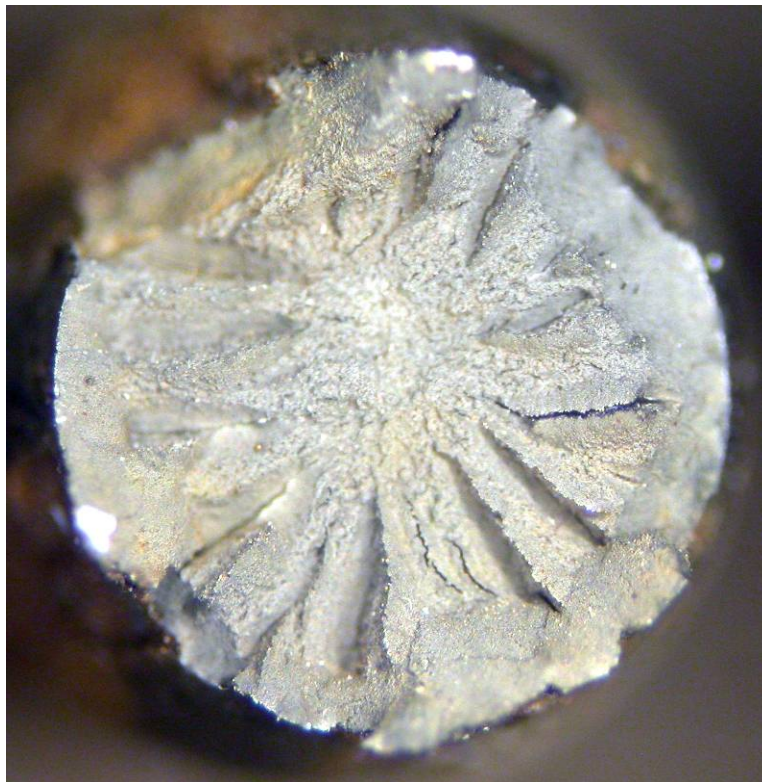
Fig. 33 Wire 4-4 surface (top) and fracture surface after tensile testing (bottom).

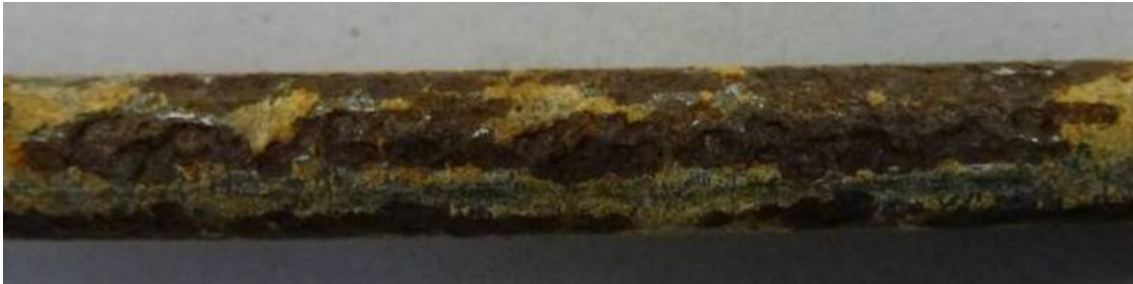
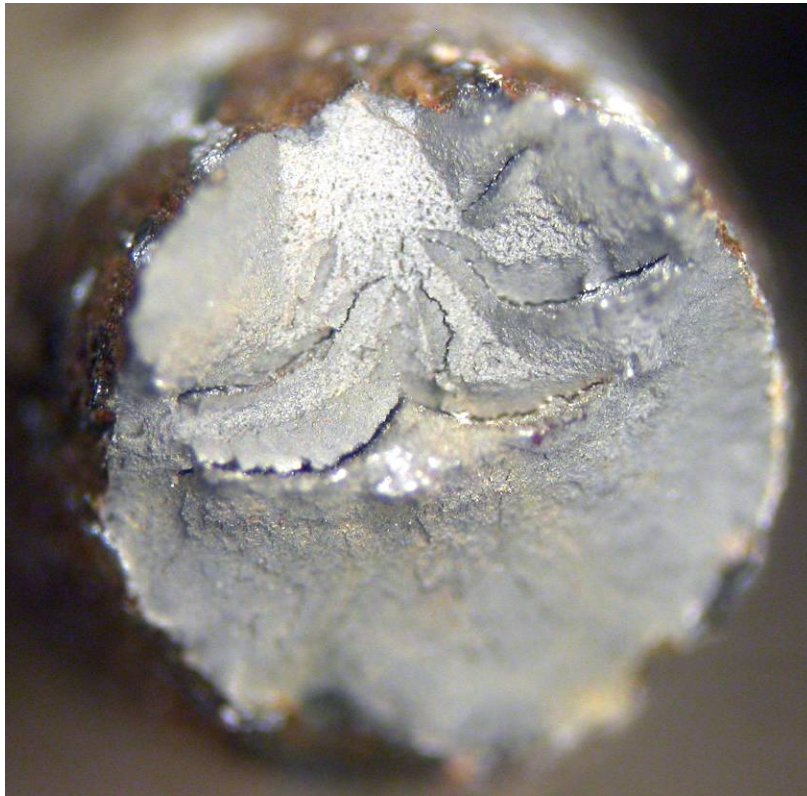
Fig. 34 Wire 4-5 surface (top) and fracture surface after tensile testing (bottom).

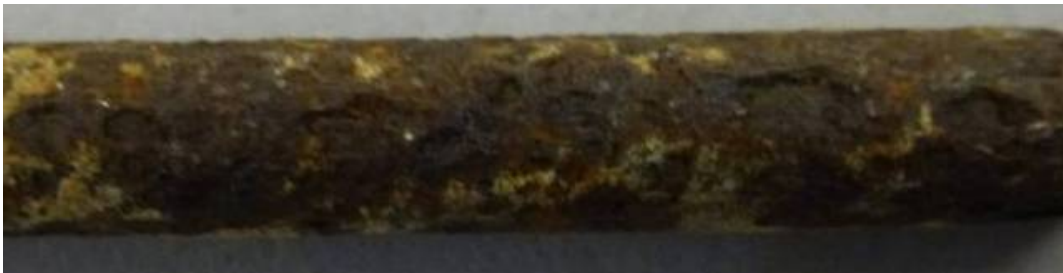
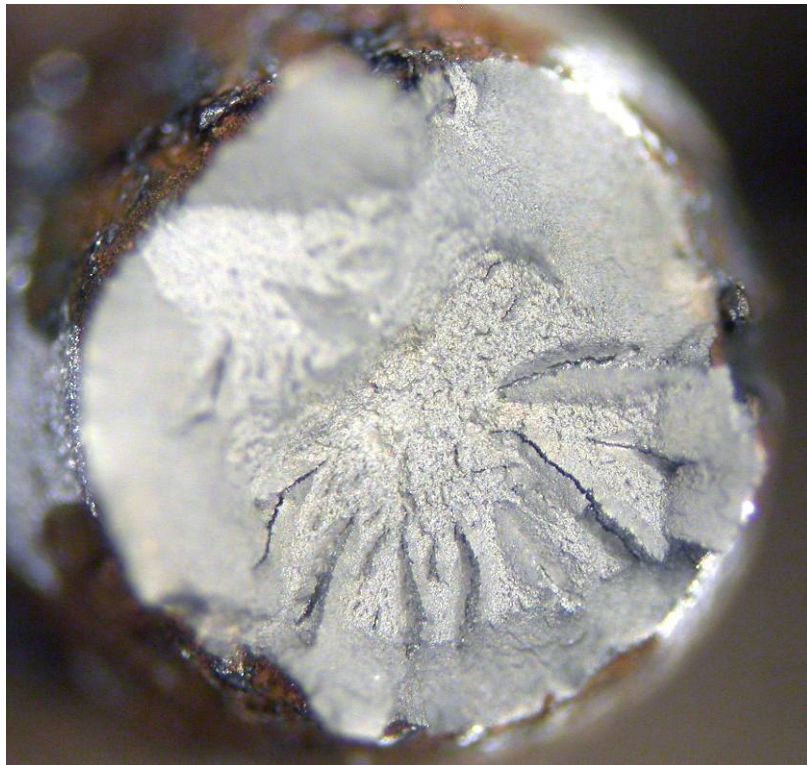
Fig. 35 Wire 4-6 surface (top) and fracture surface after tensile testing (bottom).

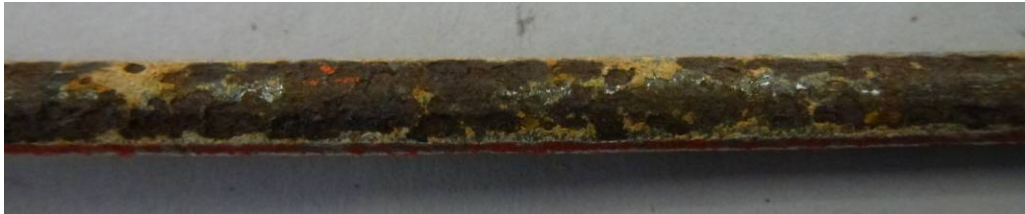
Fig. 36 Wire 5-1 surface (top) and fracture surface after tensile testing (bottom).

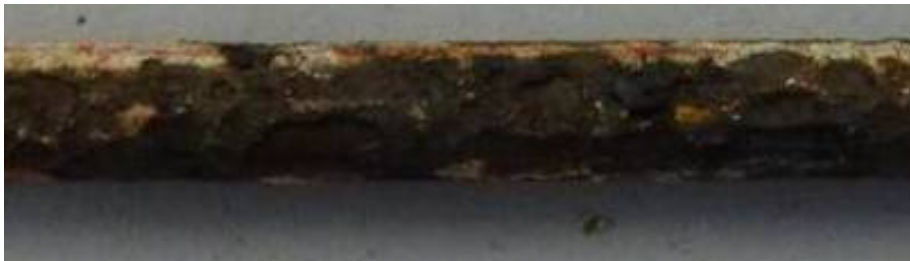
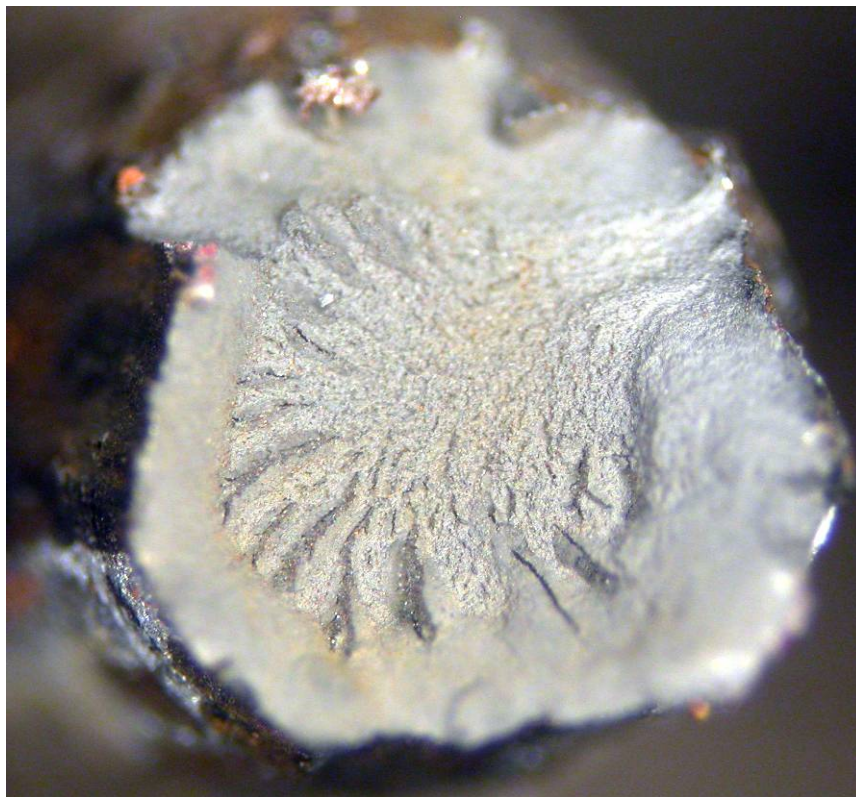
Fig. 37 Wire 5-2 surface (top) and fracture surface after tensile testing (bottom).

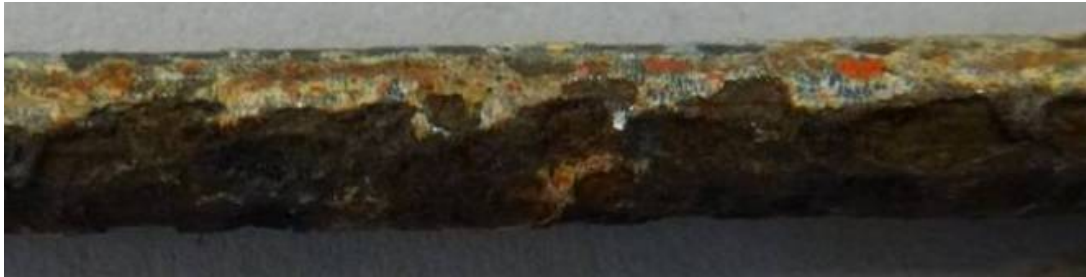
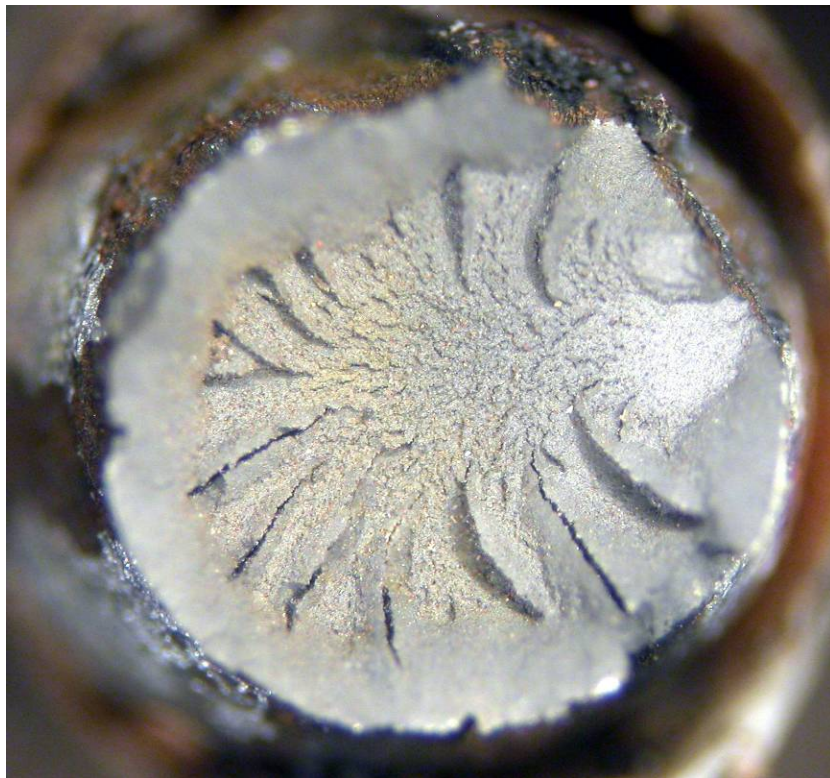
Fig. 38 Wire 5-3 surface (top) and fracture surface after tensile testing (bottom).

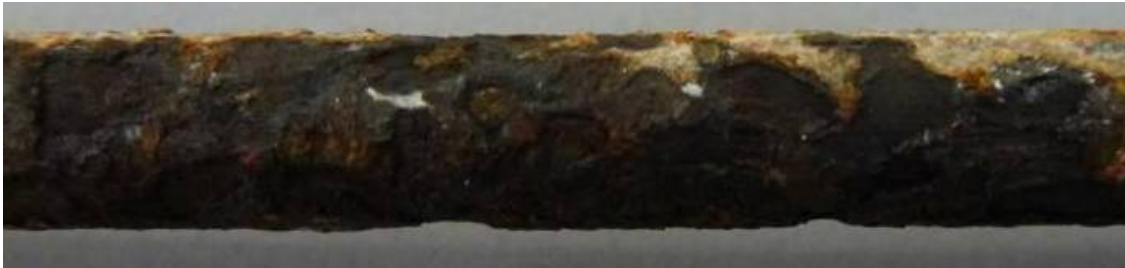
Fig. 39 Wire 5-4 surface (top) and fracture surface after tensile testing (bottom).

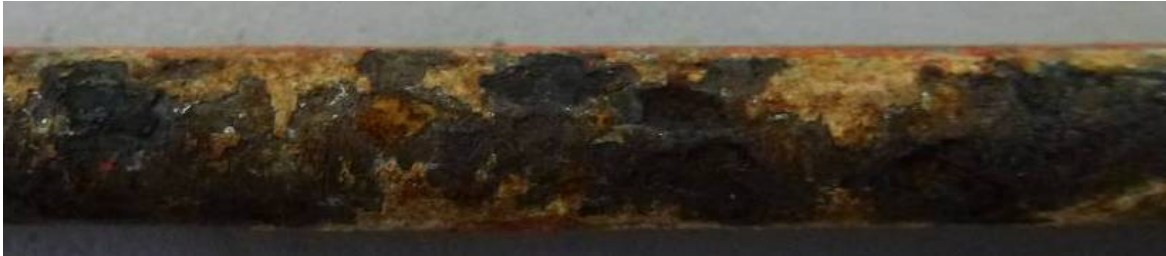
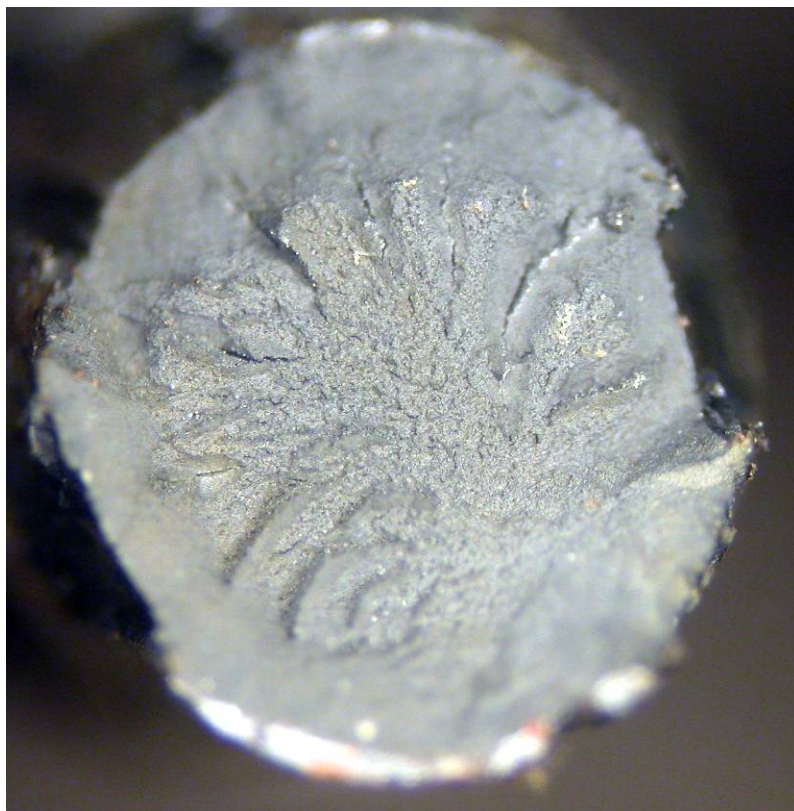
Fig. 40 Wire 5-5 surface (top) and fracture surface after tensile testing (bottom).

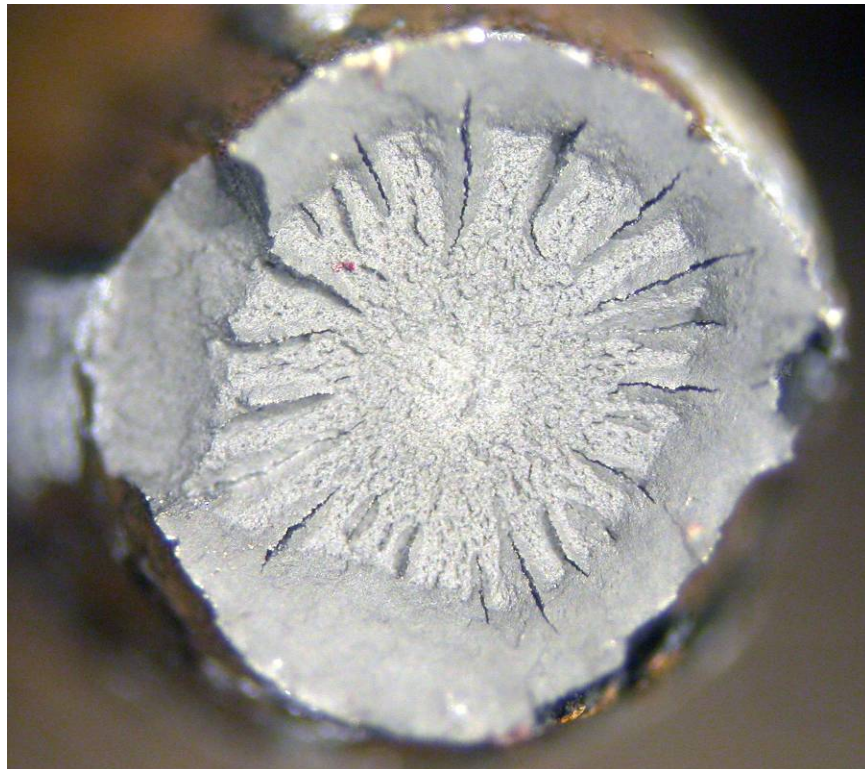
Fig. 41 Wire 5-6 surface (top) and fracture surface after tensile testing (bottom).

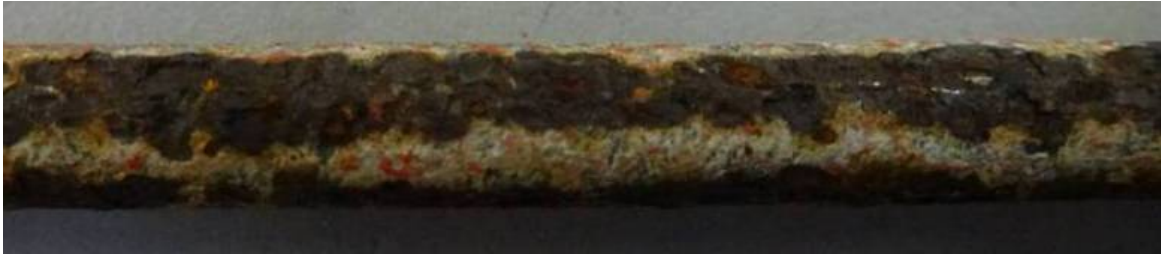
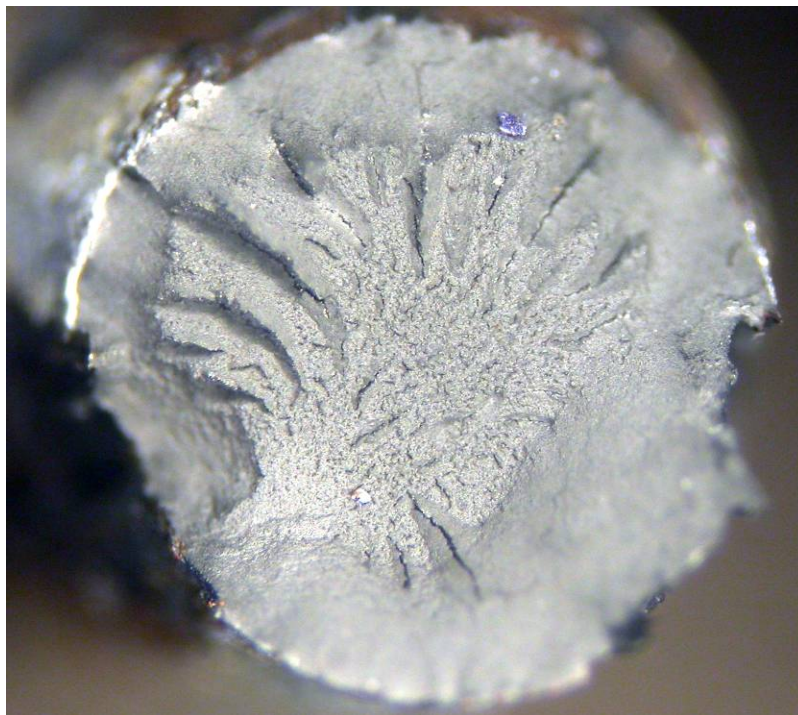
Fig. 42 Wire 5-7 surface (top) and fracture surface after tensile testing (bottom).

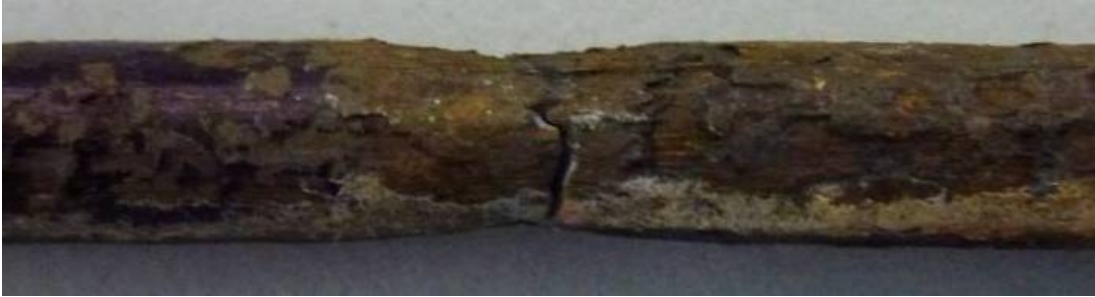
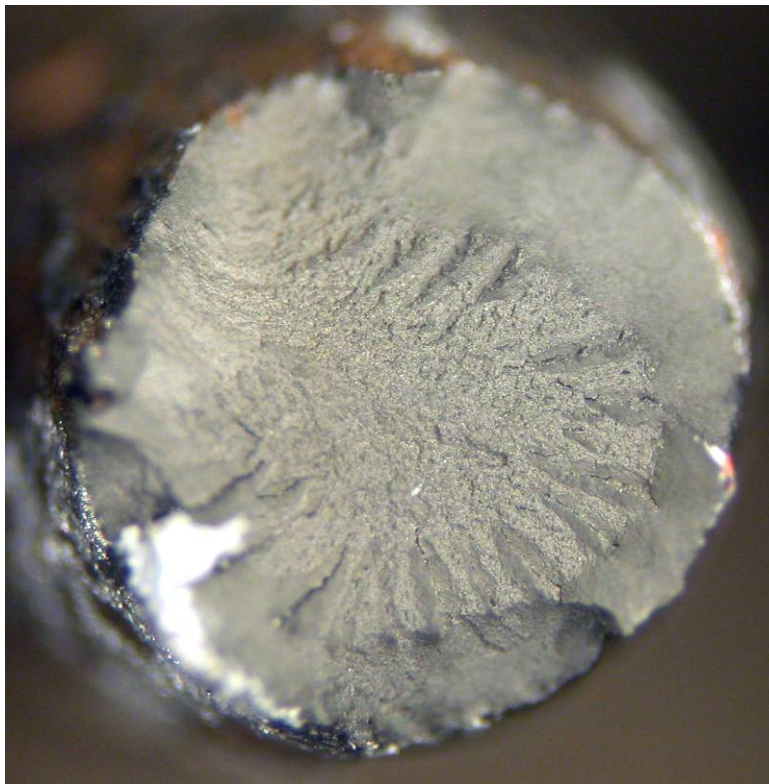
Fig. 43 Wire 5-8 surface (top) and fracture surface after tensile testing (bottom).

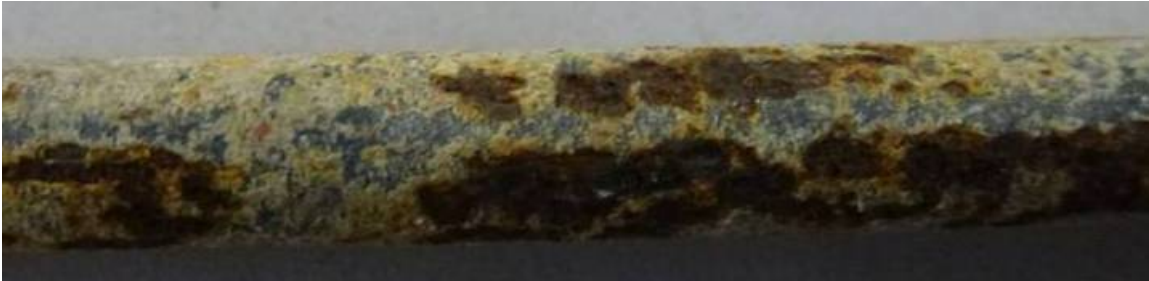
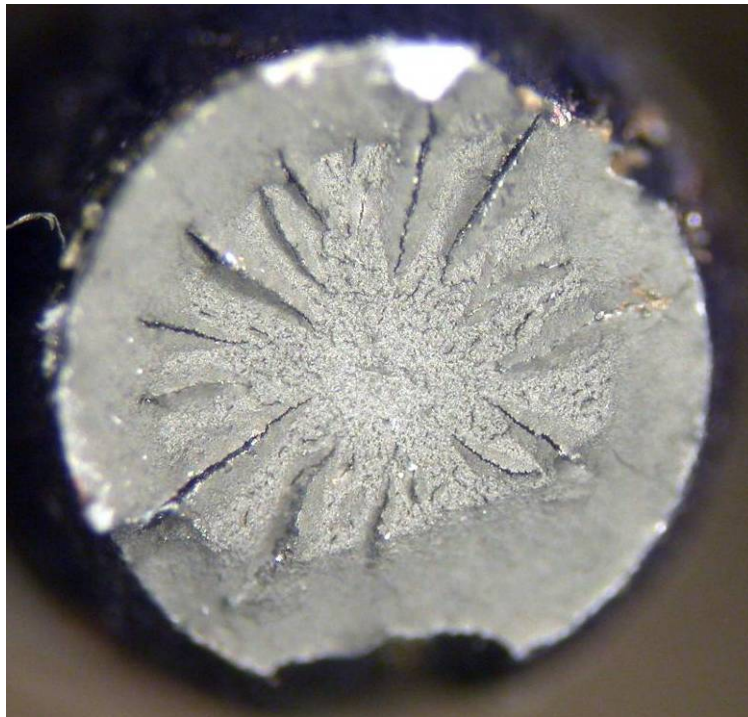
Fig. 44 Wire 6-1 surface (top) and fracture surface after tensile testing (bottom).

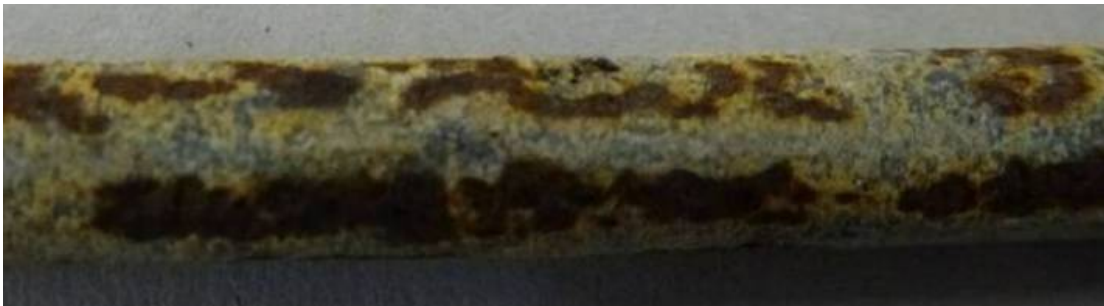
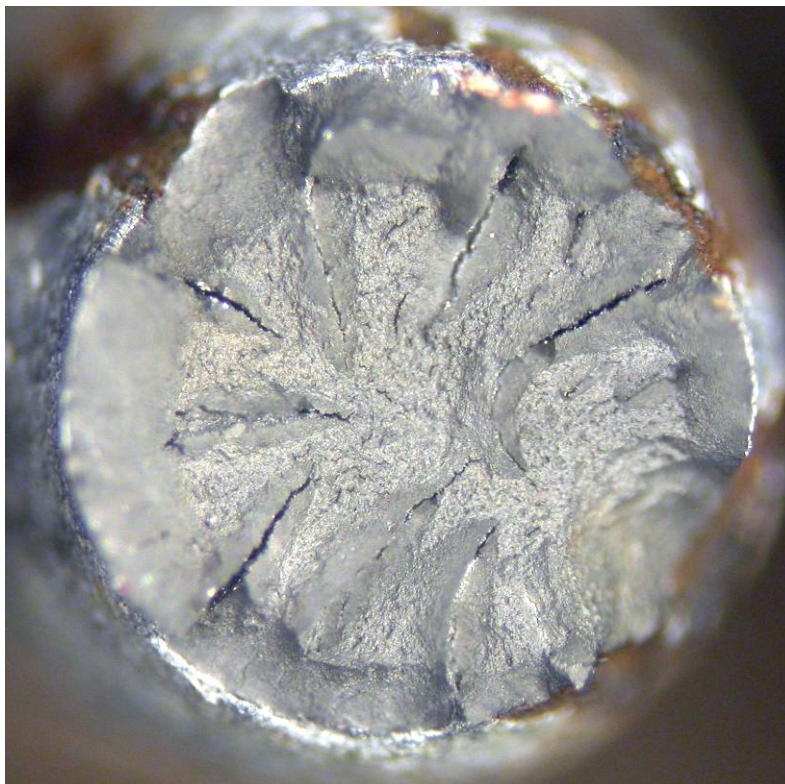
Fig. 45 Wire 6-2 surface (top) and fracture surface after tensile testing (bottom).

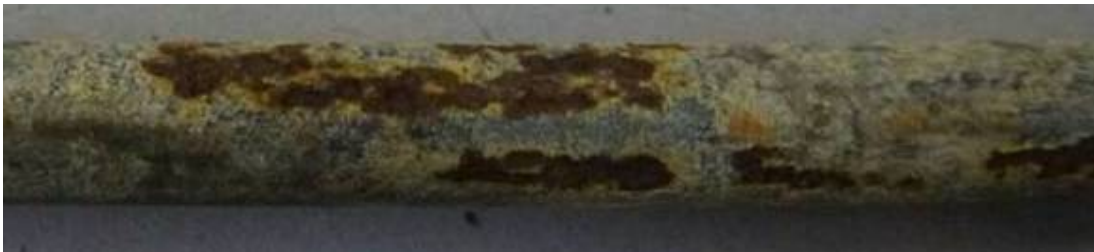
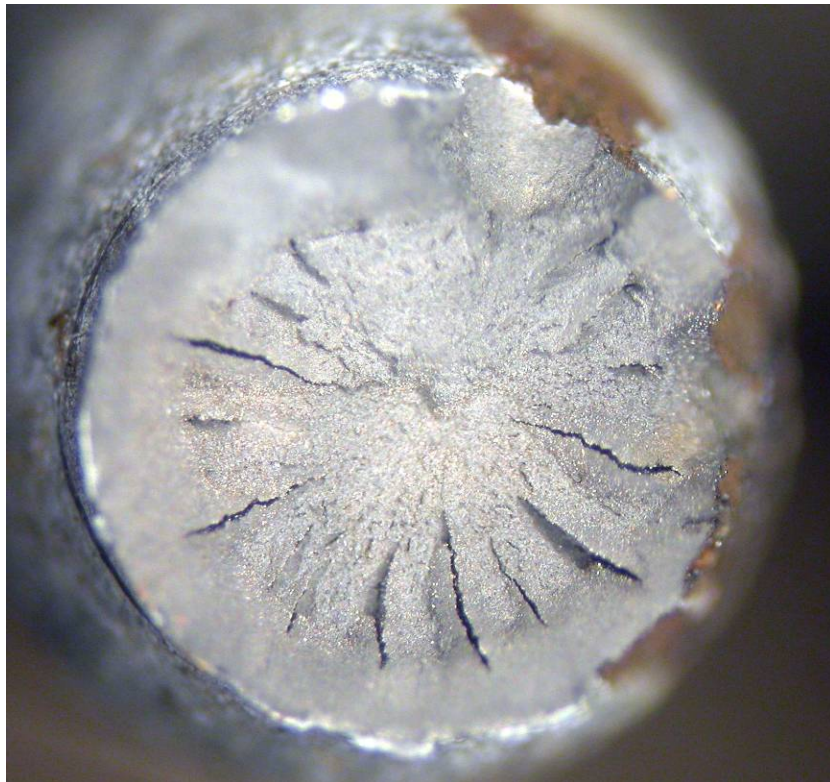
Fig. 46 Wire 6-3 surface (top) and fracture surface after tensile testing (bottom).

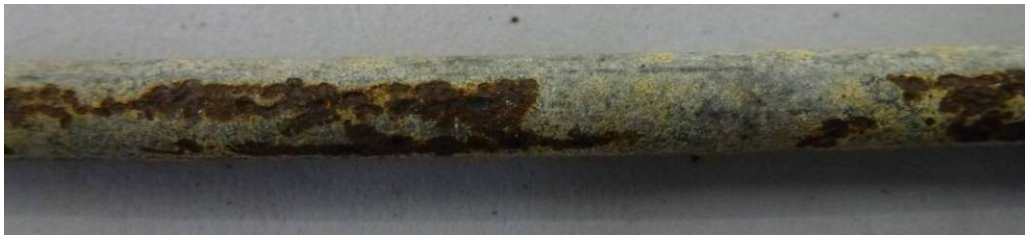
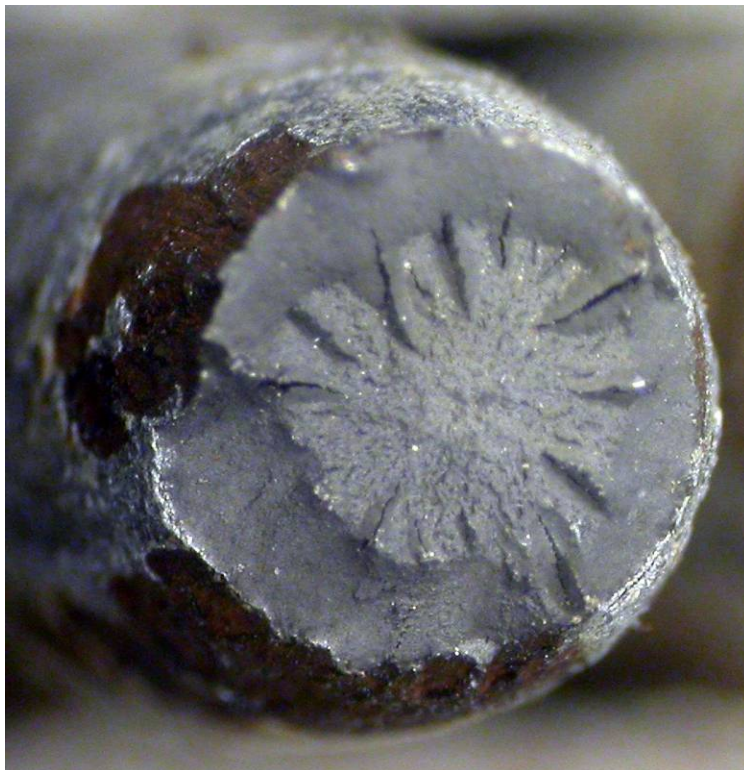
Fig. 47 Wire 6-4 surface (top) and fracture surface after tensile testing (bottom).

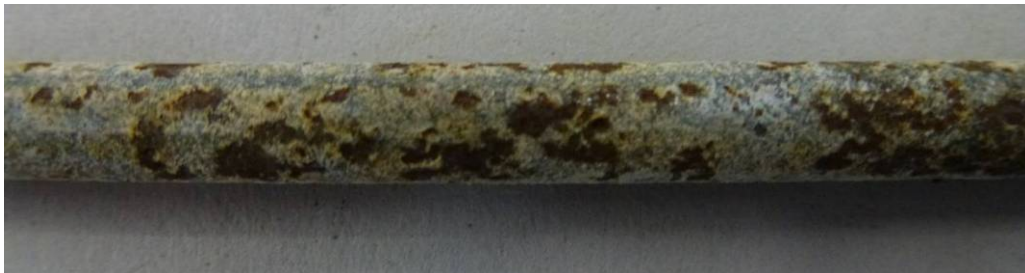
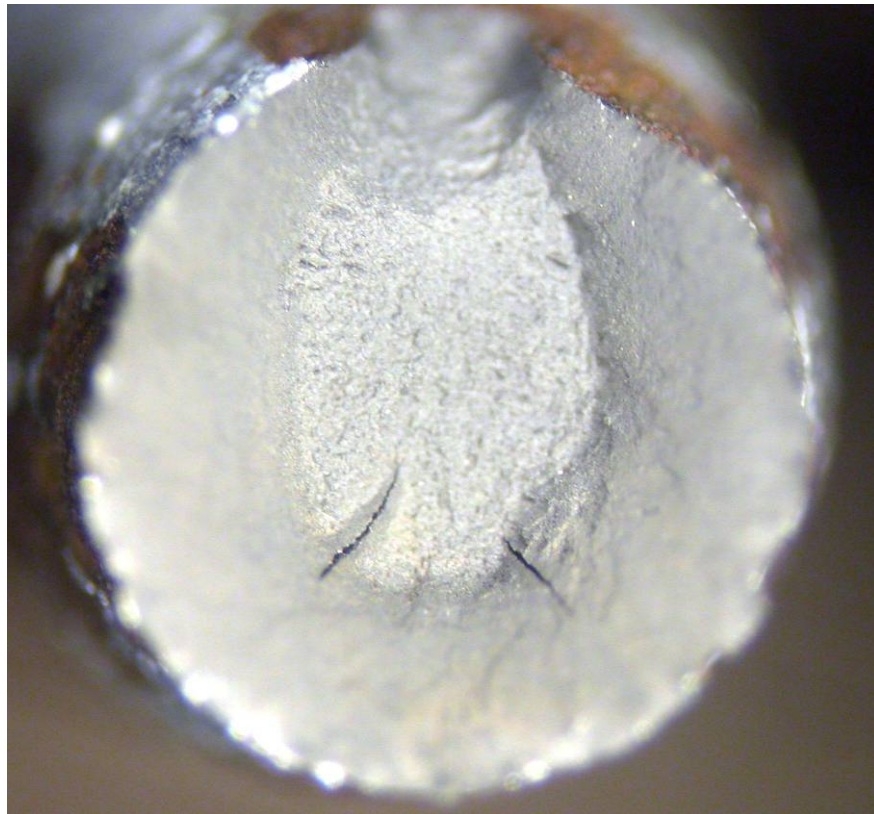
Fig. 48 Wire 6-5 surface (top) and fracture surface after tensile testing (bottom).

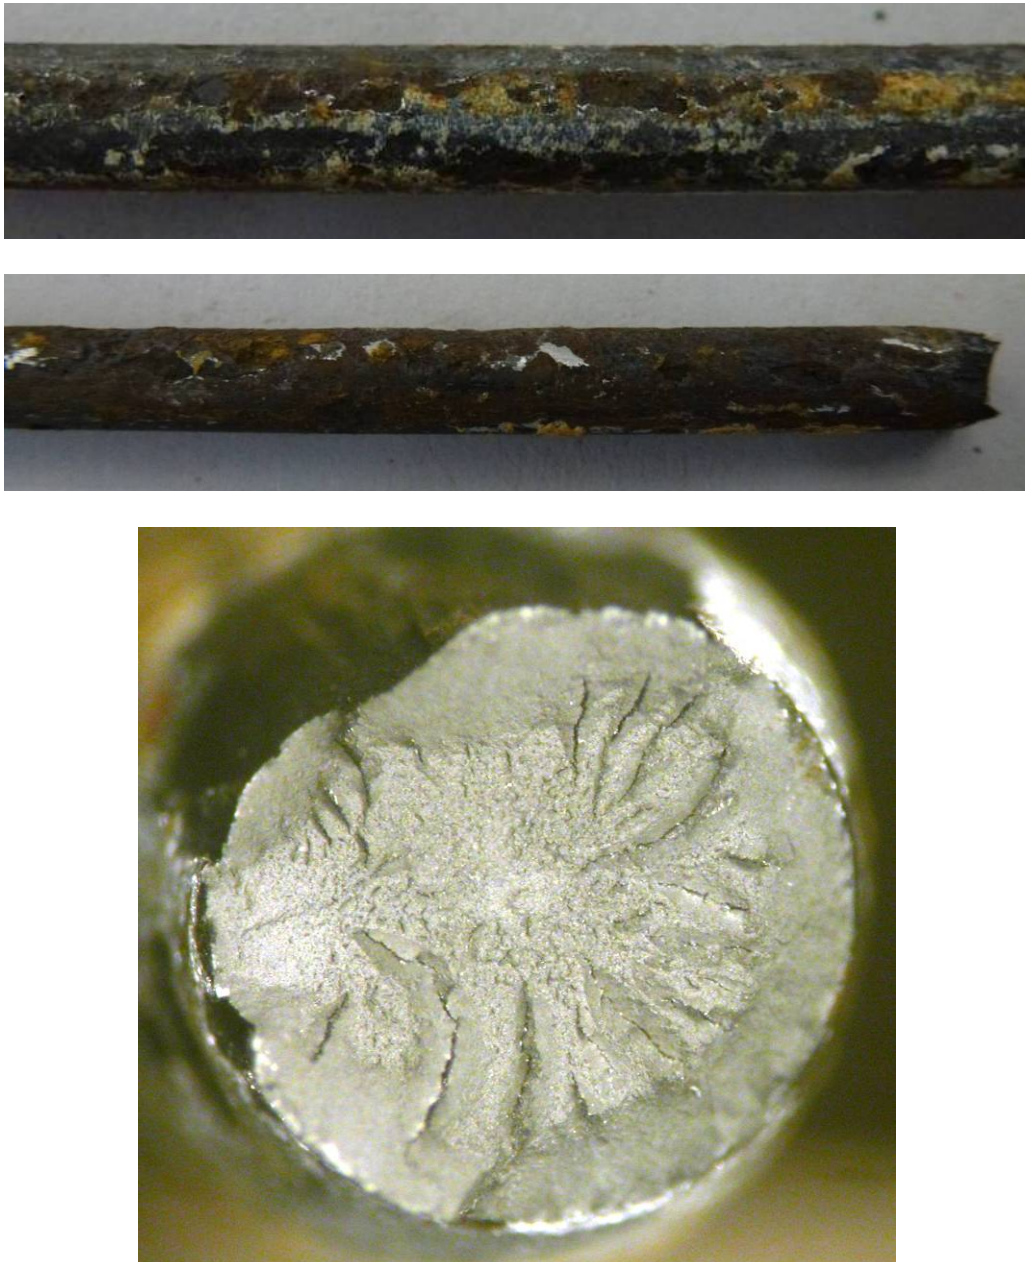
Fig. 49 Wire 7-1 surface (top) and fracture surface after tensile testing (bottom).

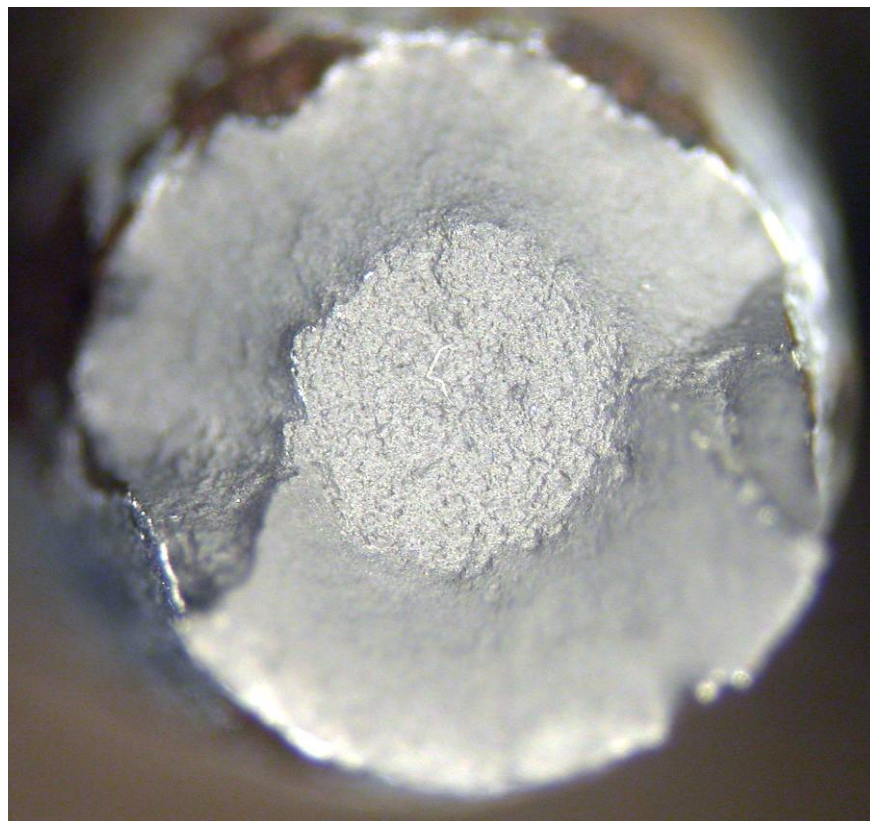
Fig. 50 Wire 7-2 surface (top) and fracture surface after tensile testing (bottom).

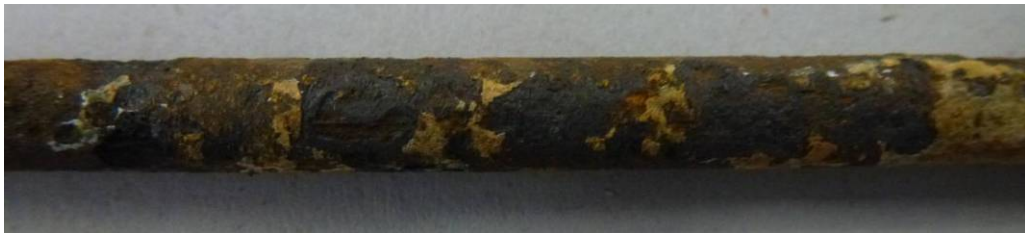
Fig. 51 Wire 7-3 surface (top) and fracture surface after tensile testing (bottom).

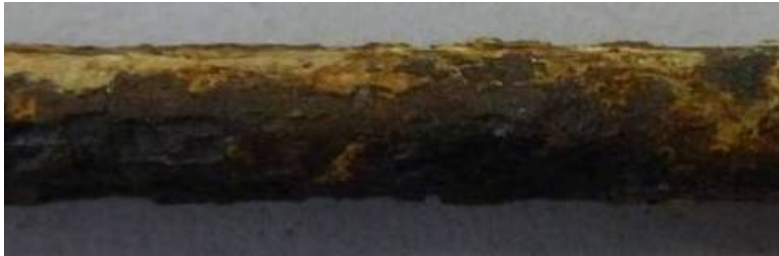
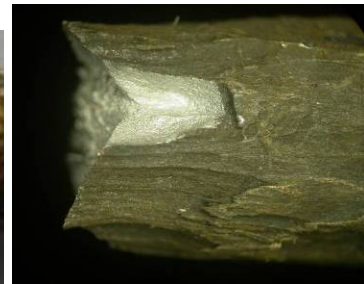
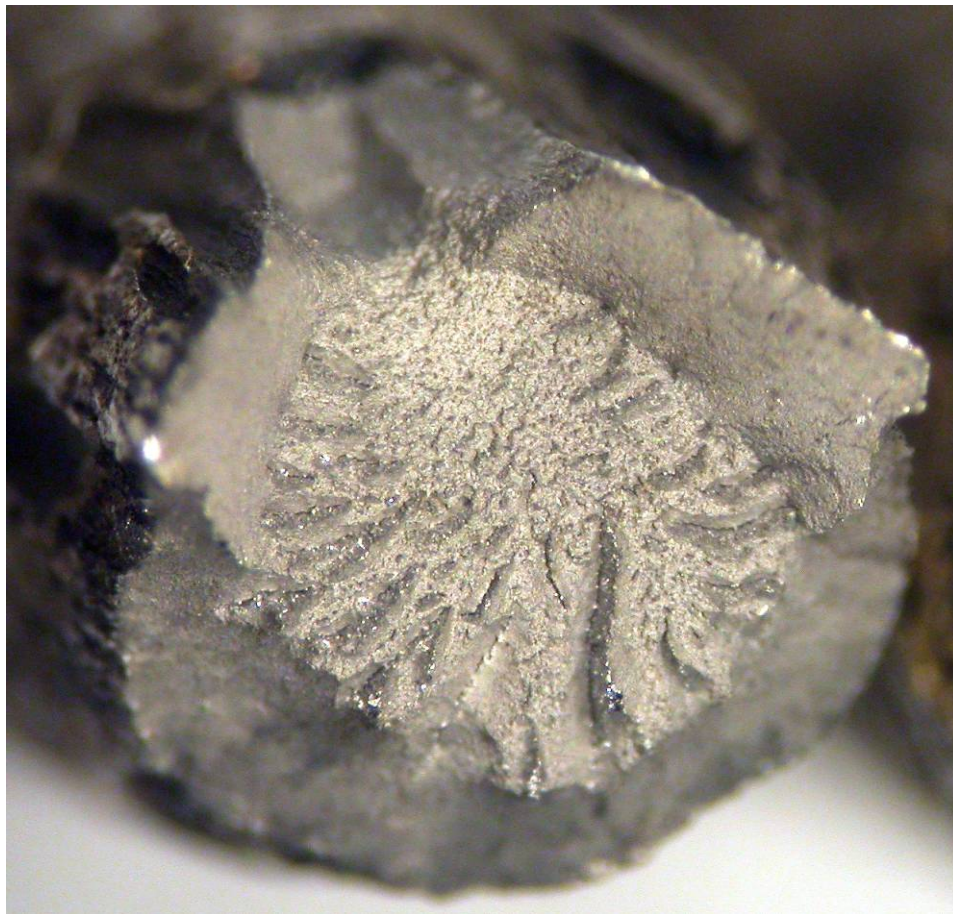
Fracture surfaces of specimens 1-2 and 13-6 exhibited cup-cone profiles. Examination of the fracture surfaces of the ten lower mechanical properties wires revealed that the fractures initiated at surface pitting corrosion zones, as shown in Figs. 97 through 119. Two wires, 3-3 and 7-4, exhibited stepped fracture profiles. EDS analyses of these steps on the fracture surfaces revealed high percentages of oxygen, indicating that the wires contained pre-existing corrosion cracks. However, SEM analysis revealed that the final fracture region exhibited microvoid coalescence, which is indicative of final ductile overload fracture. Other specimens (5-4, 5-7, 6-4, 8-1, 11-2, 12-4) exhibited a somewhat cup-cone profile with crack initiation from surface corrosion pits, which reduced the wires' cross-section. Specimen 9-6 exhibited low elongation since it was tested with an original butt splice (see Fig. 66). However, the wire fractured remote from the butt splice area with a cup-cone profile.

Fig. 52 Wire 7-4 surface (top) and fracture surface after tensile testing (bottom).

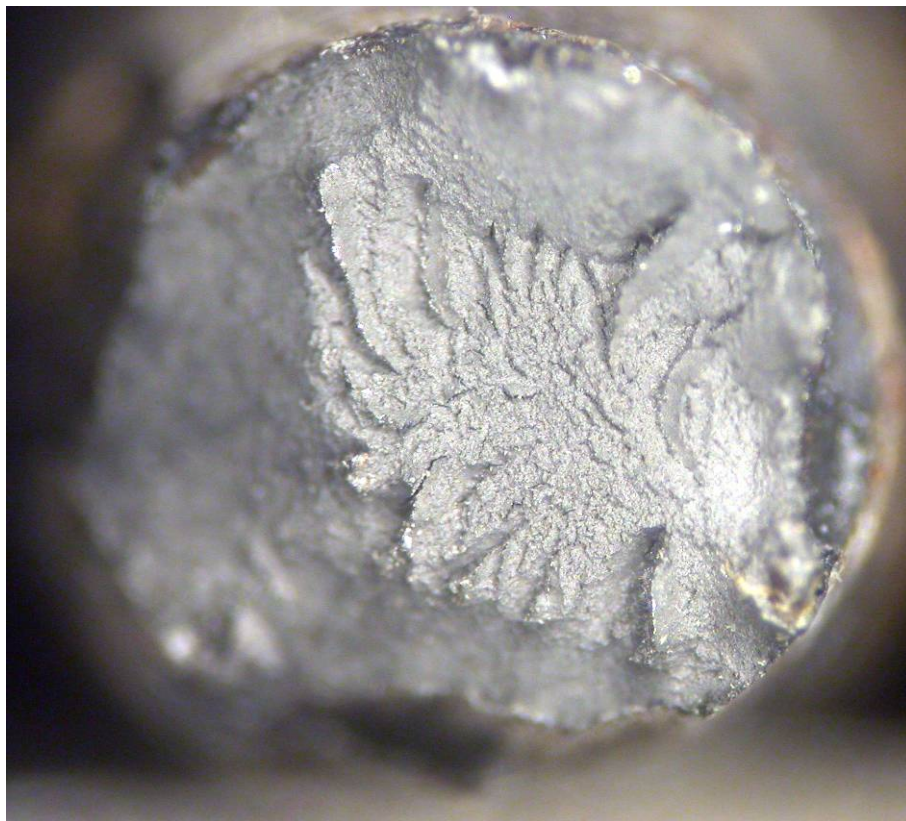
Fig. 53 Wire 7-5 surface (top) and fracture surface after tensile testing (bottom).

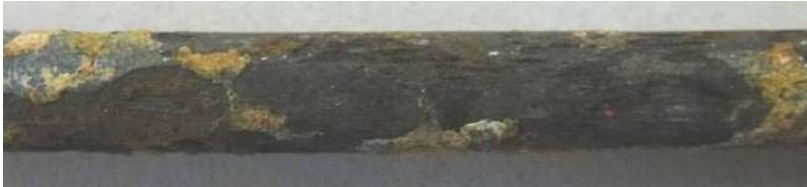
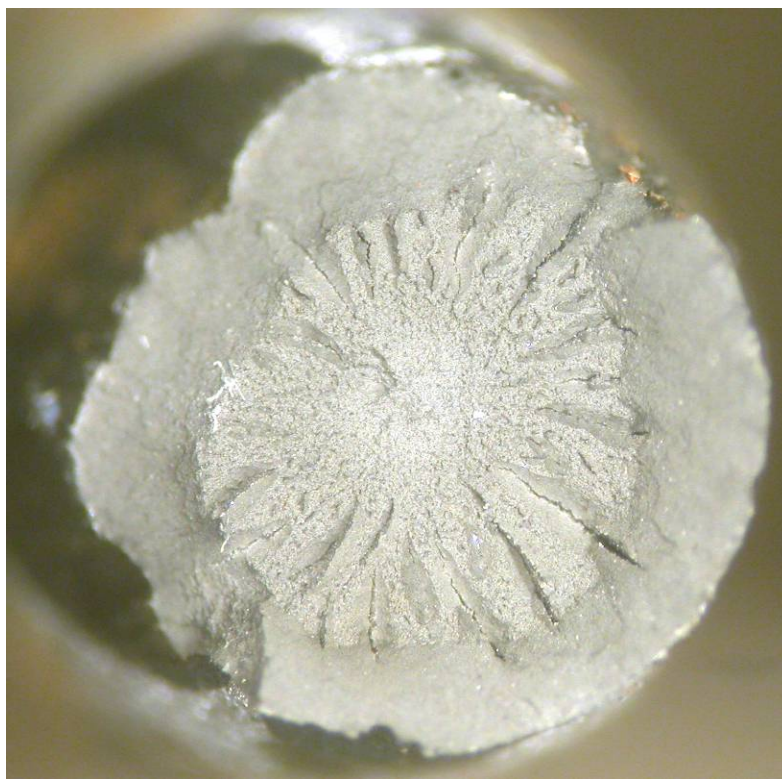
Fig. 54 Wire 7-6 surface (top) and fracture surface after tensile testing (bottom).

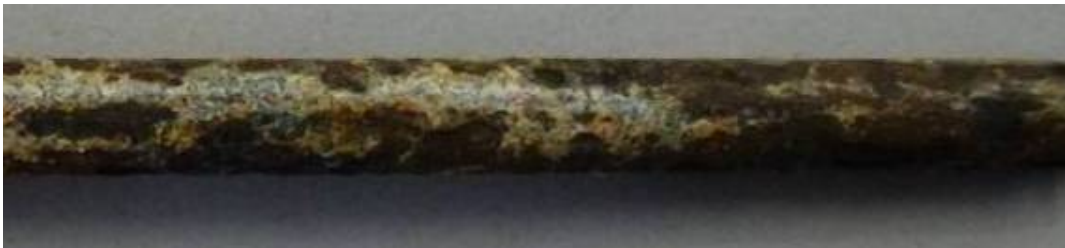
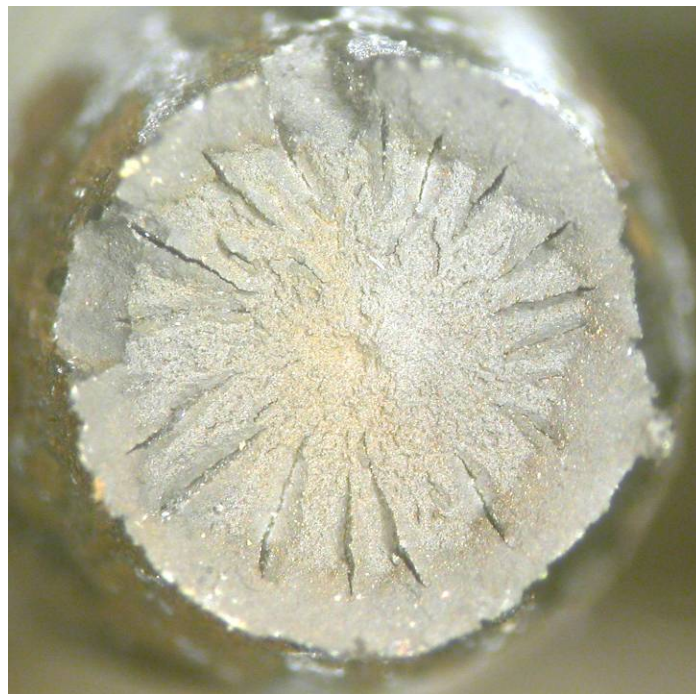
Fig. 56 Wire 8-2 surface (top) and fracture surface after tensile testing (bottom).

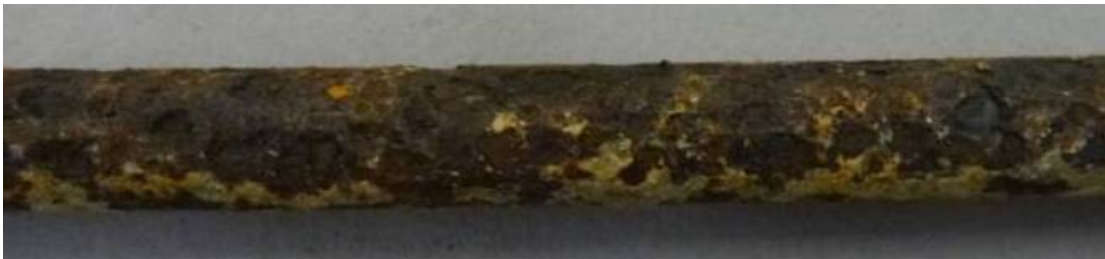
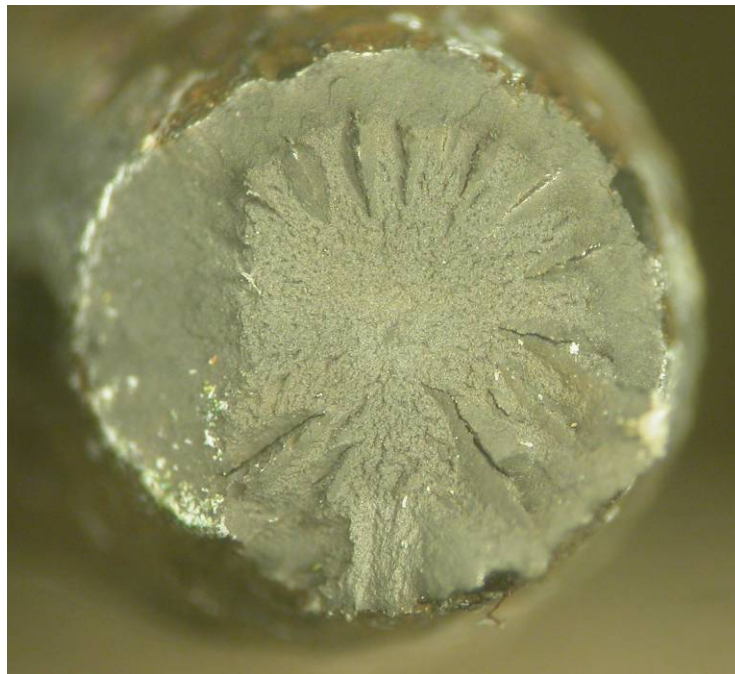
Fig. 57 Wire 8-3 surface (top) and fracture surface after tensile testing (bottom).

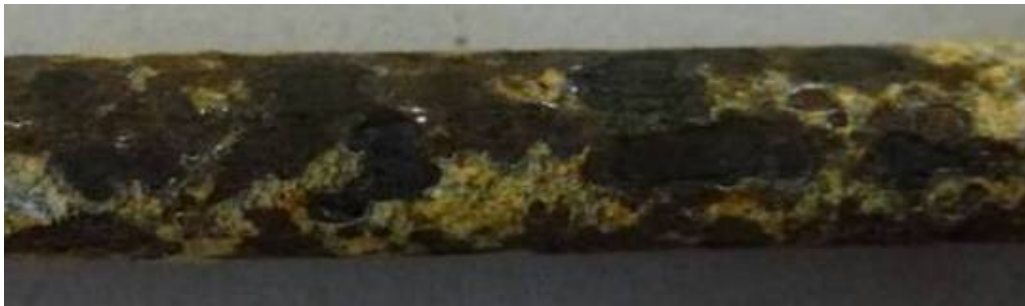
Fig. 58 Wire 8-4 surface (top) and fracture surface after tensile testing (bottom).

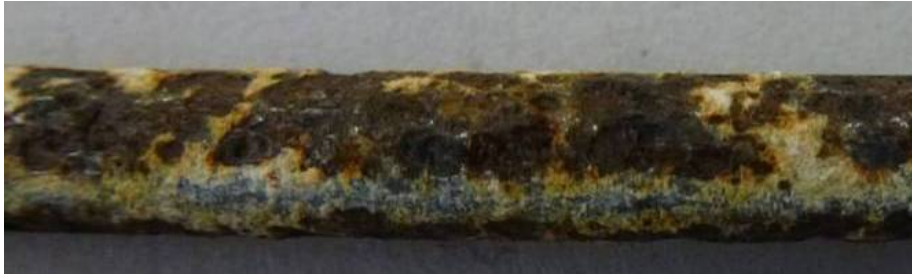
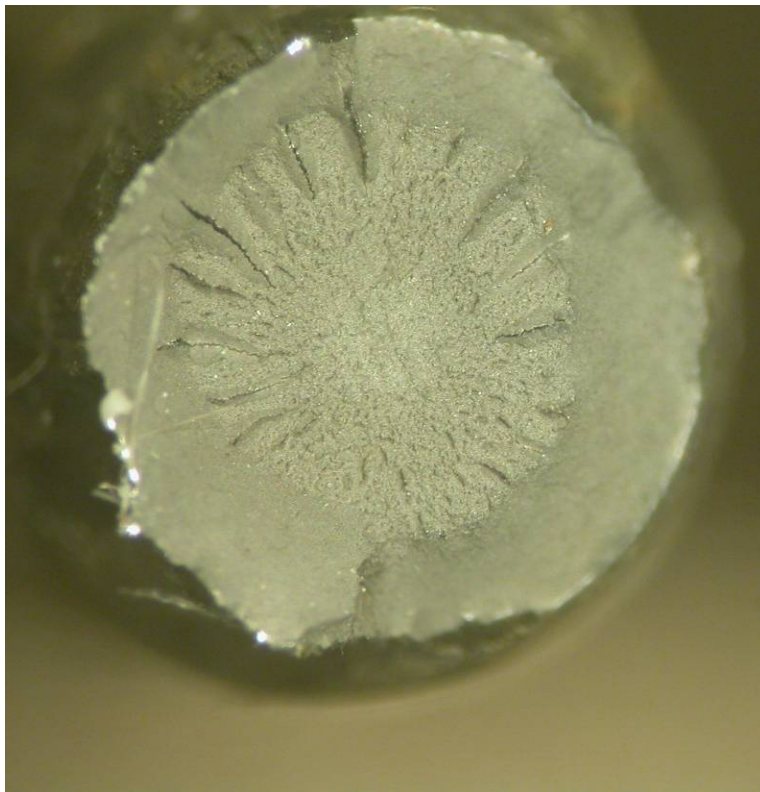
Fig. 60 Wire 8-6 surface (top) and fracture surface after tensile testing (bottom).

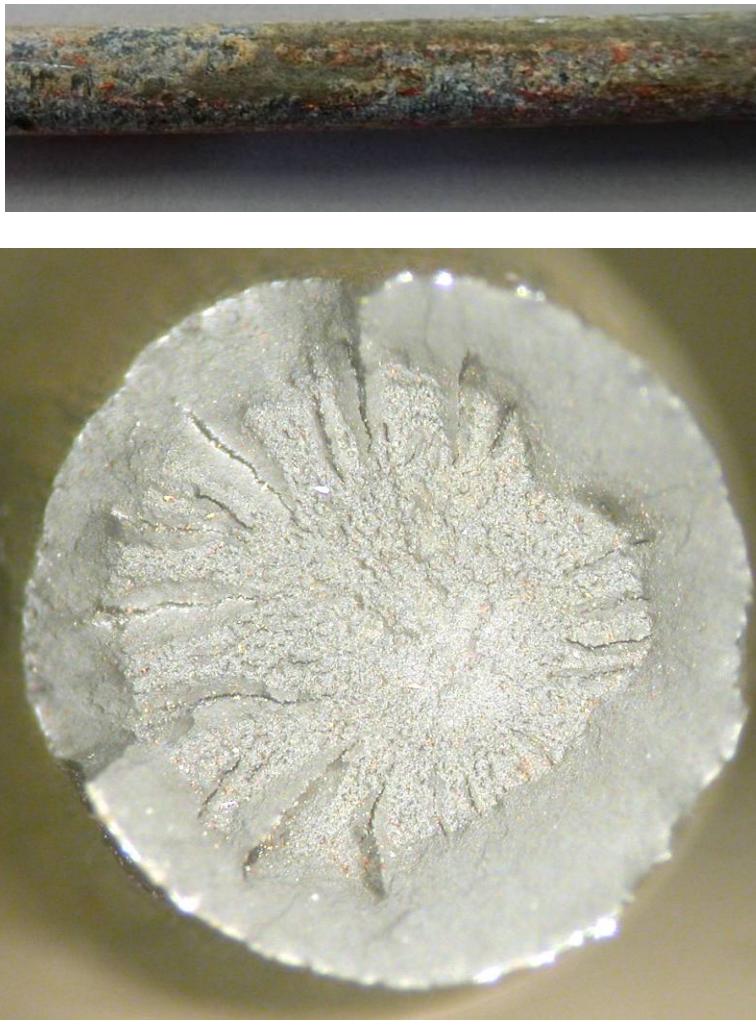
Fig. 61 Wire 9-1 surface (top) and fracture surface after tensile testing (bottom).

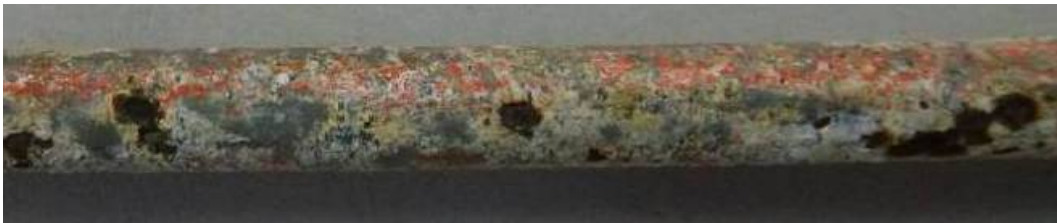
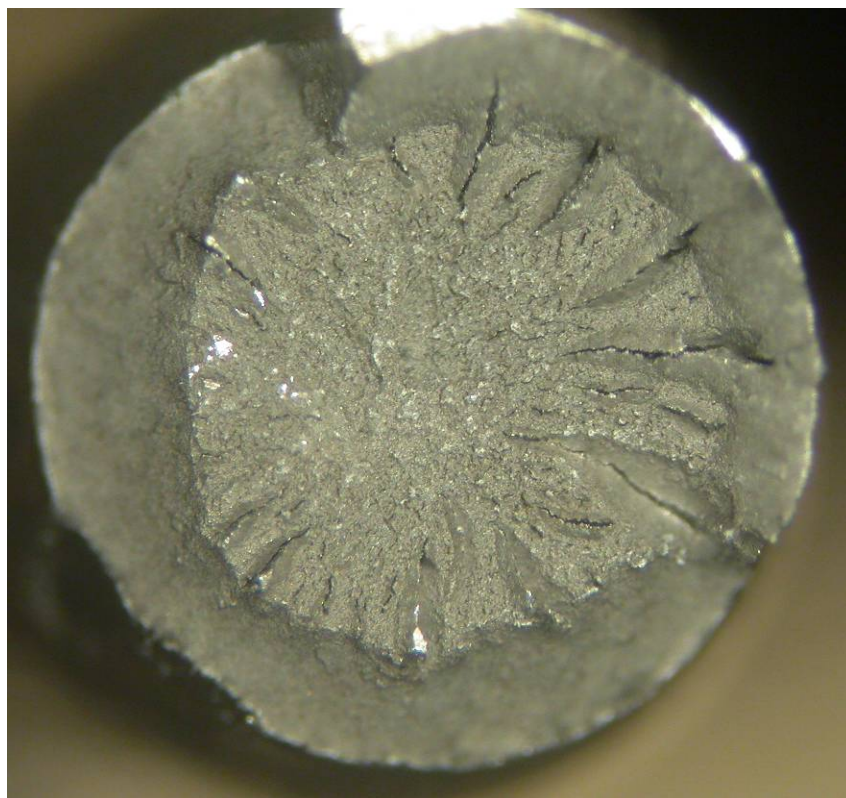
Fig. 62 Wire 9-2 surface (top) and fracture surface after tensile testing (bottom).
