APPENDIX A – ANTHONY WAYNE BRIDGE ACOUSTIC EMISSION MONITORING REPORT (MISTRAS)

Anthony Wayne Bridge Acoustic Emission Monitoring Report

Location: Toledo, Ohio

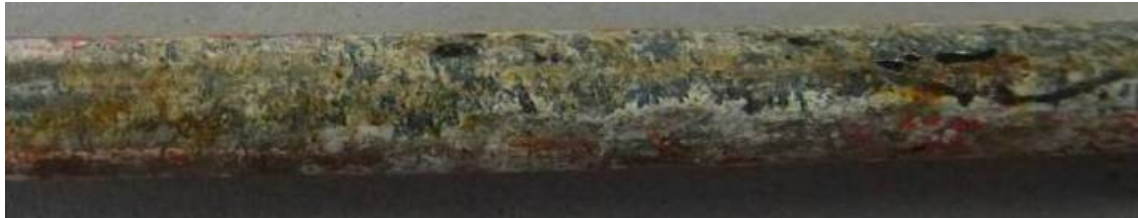
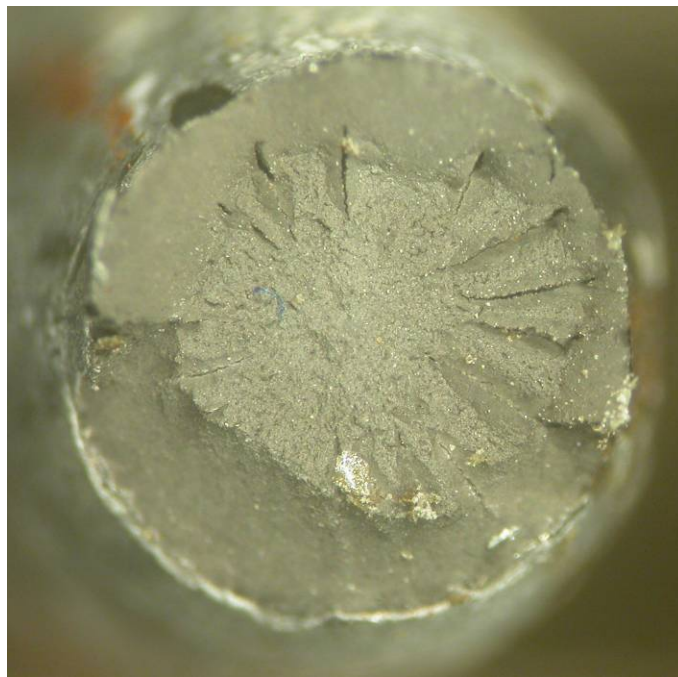
Fig. 63 Wire 9-3 surface (top) and fracture surface after tensile testing (bottom).

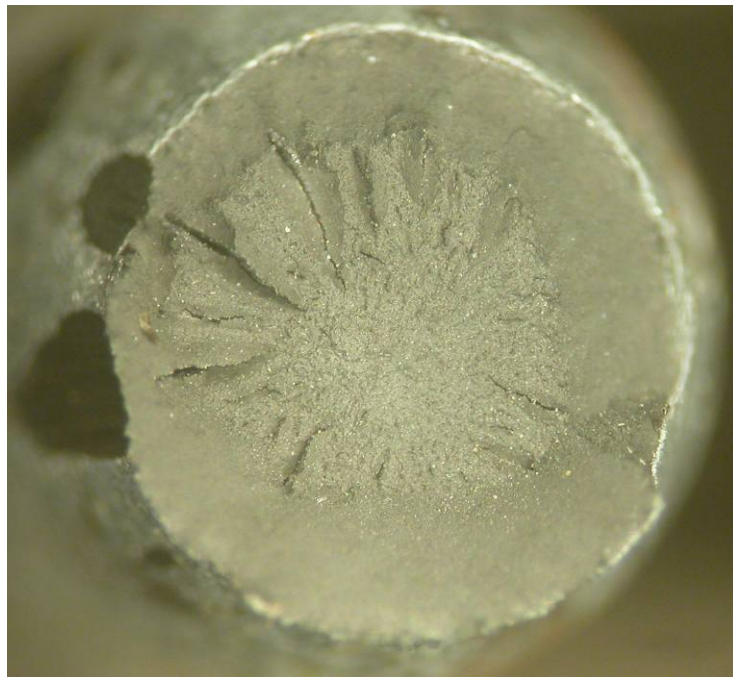
Fig. 64 Wire 9-4 surface (top) and fracture surface after tensile testing (bottom).

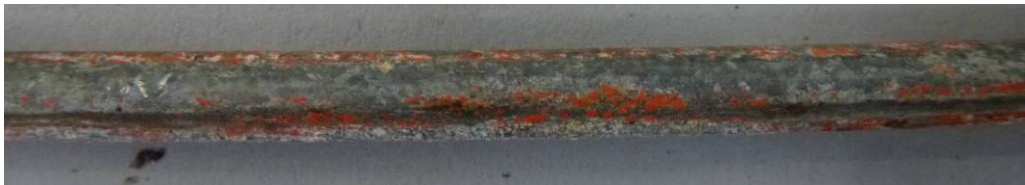
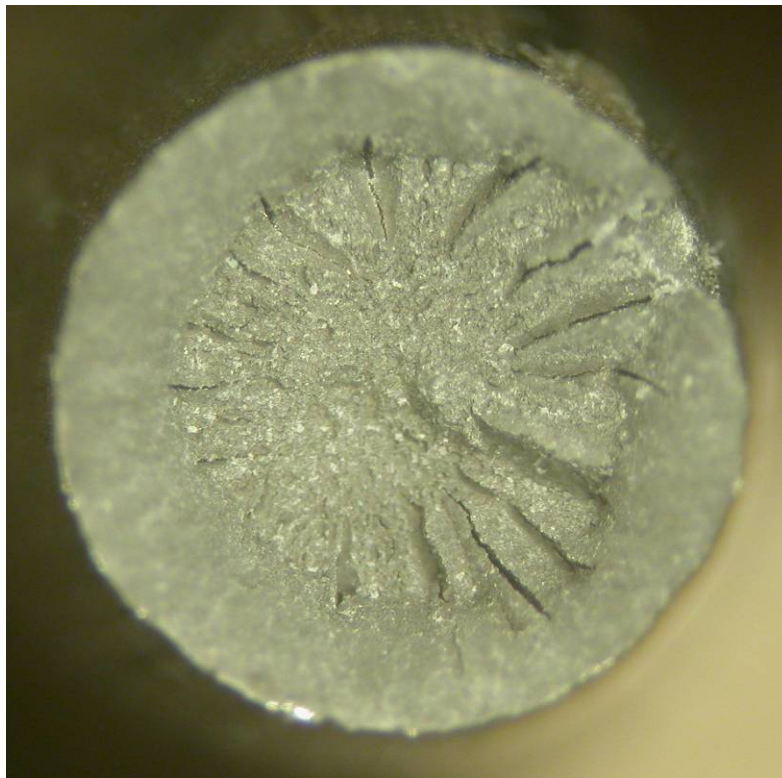
Fig. 65 Wire 9-5 surface (top) and fracture surface after tensile testing (bottom).

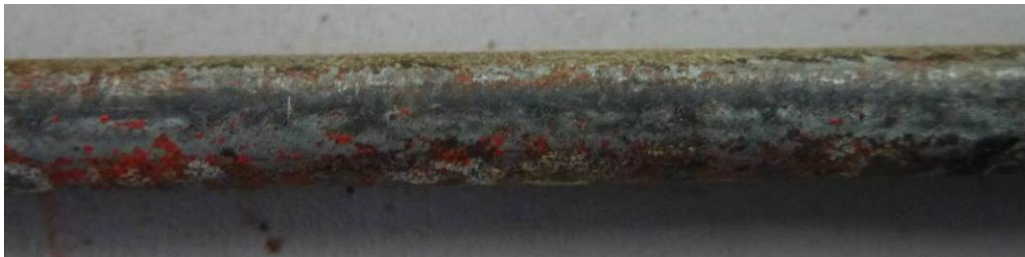
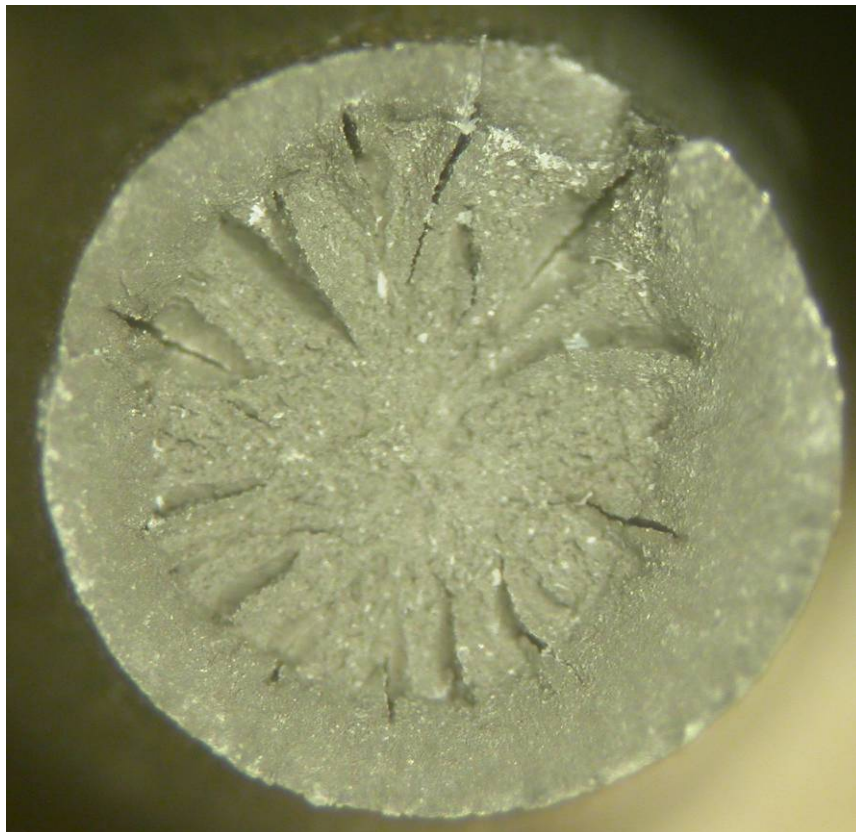
Fig. 67 Wire 10-1 surface (top) and fracture surface after tensile testing (bottom).

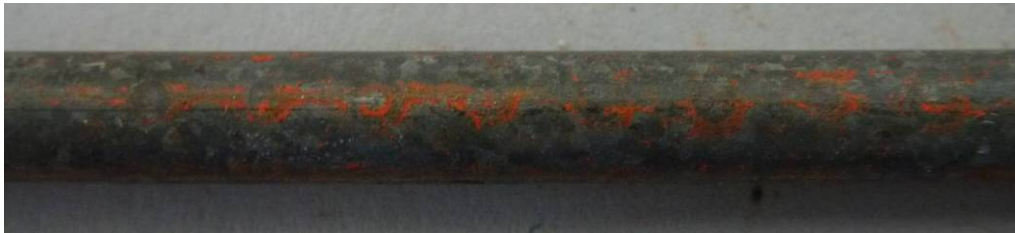
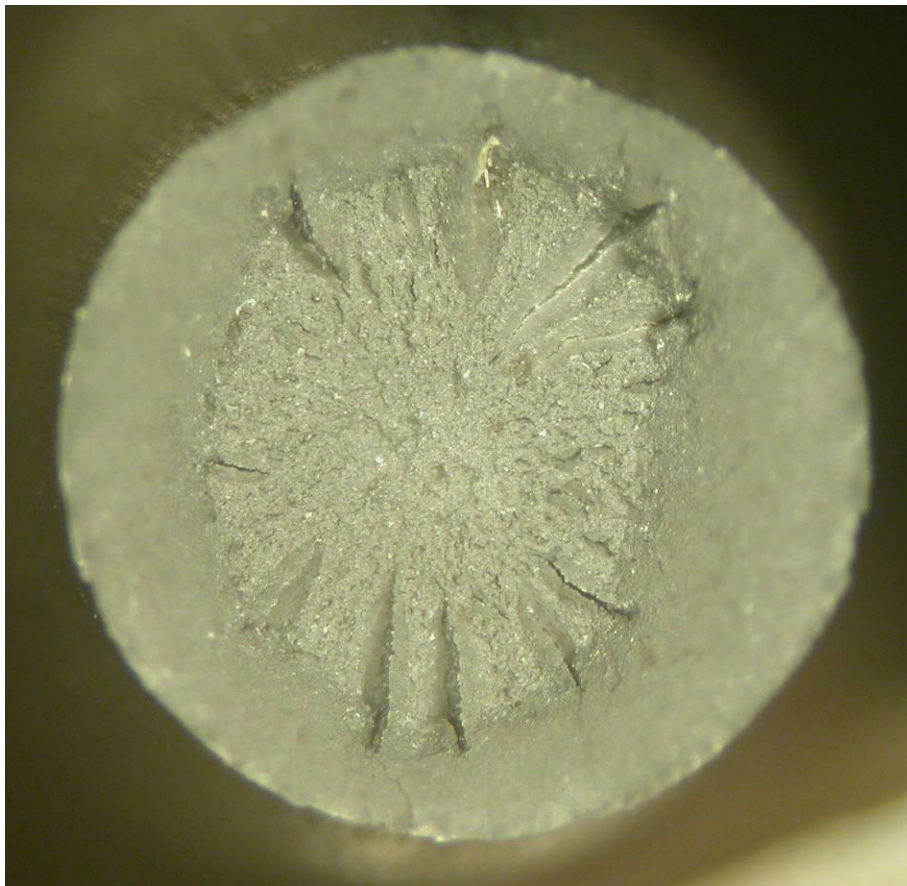
Fig. 68 Wire 10-2 surface (top) and fracture surface after tensile testing (bottom).

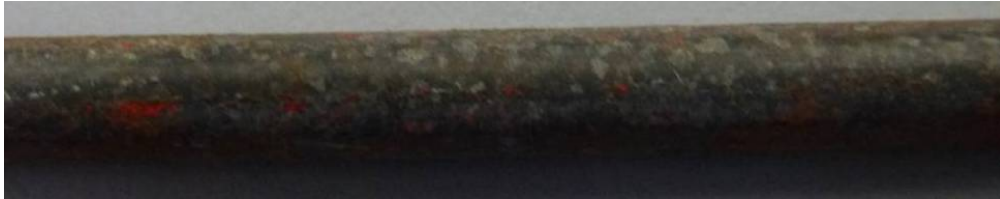
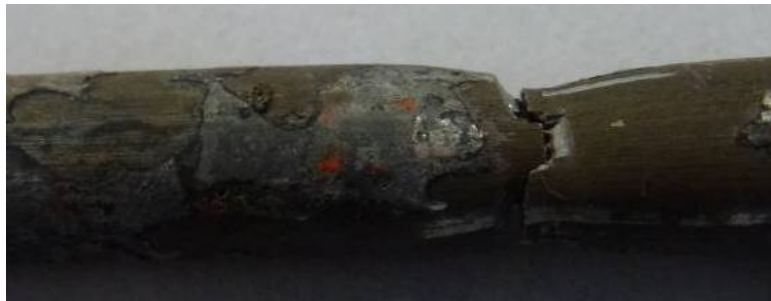
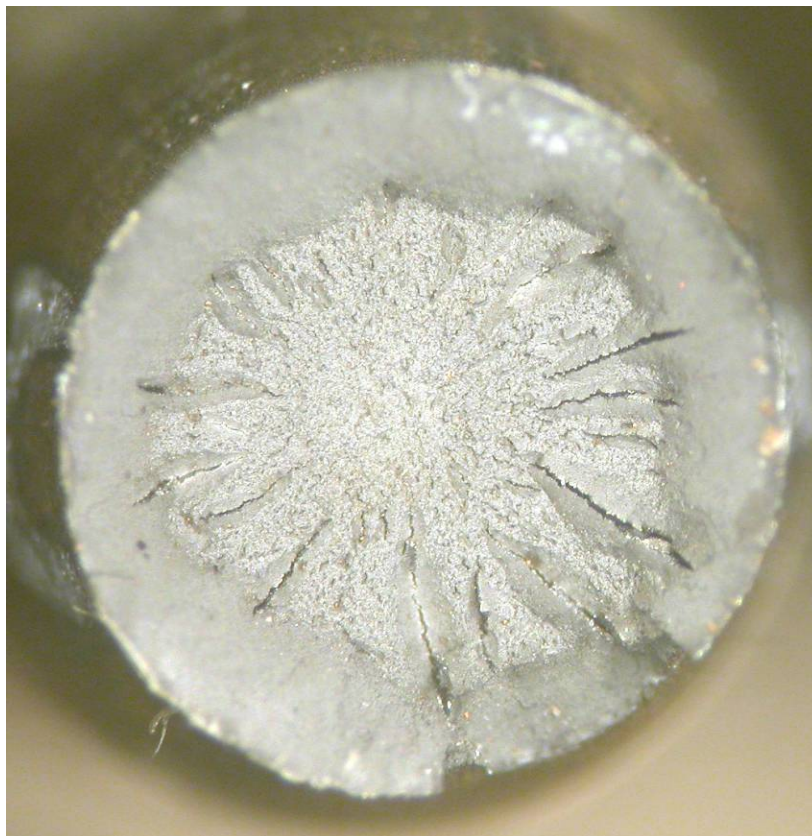
Fig. 69 Wire 10-3 surface (top) and fracture surface after tensile testing (bottom).

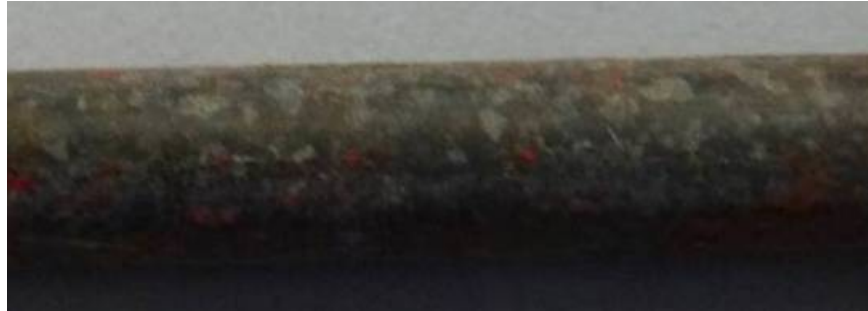
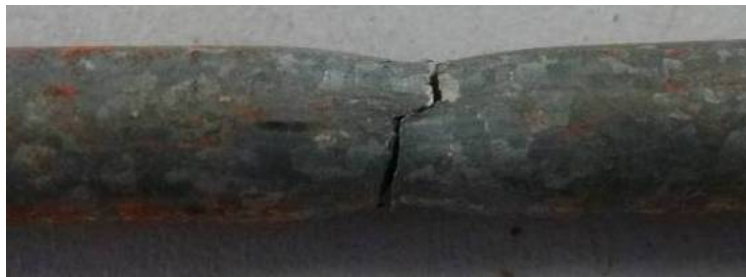
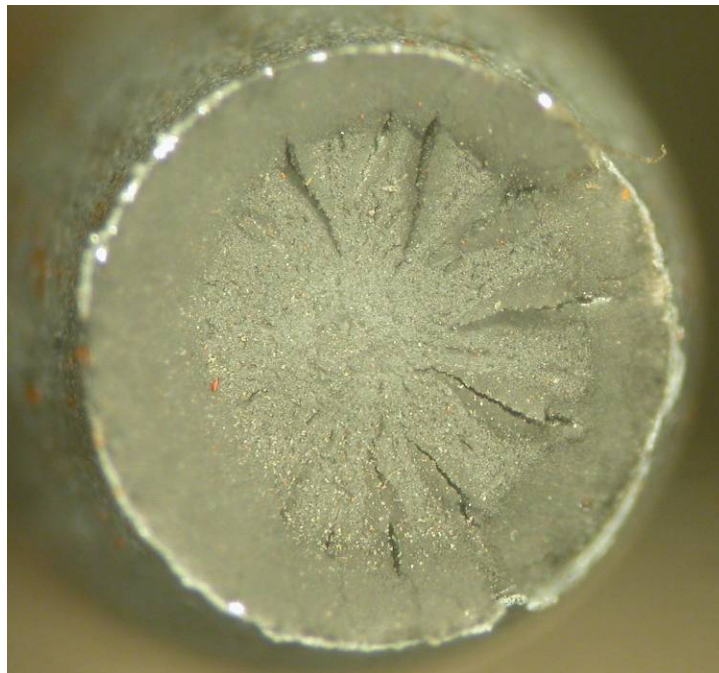
Fig. 70 Wire 10-4 surface (top) and fracture surface after tensile testing (bottom).

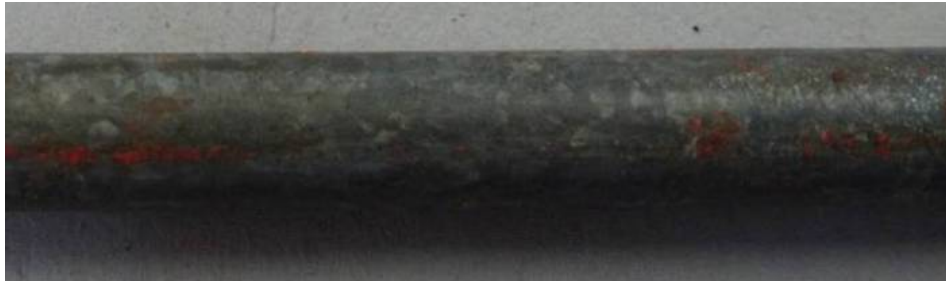
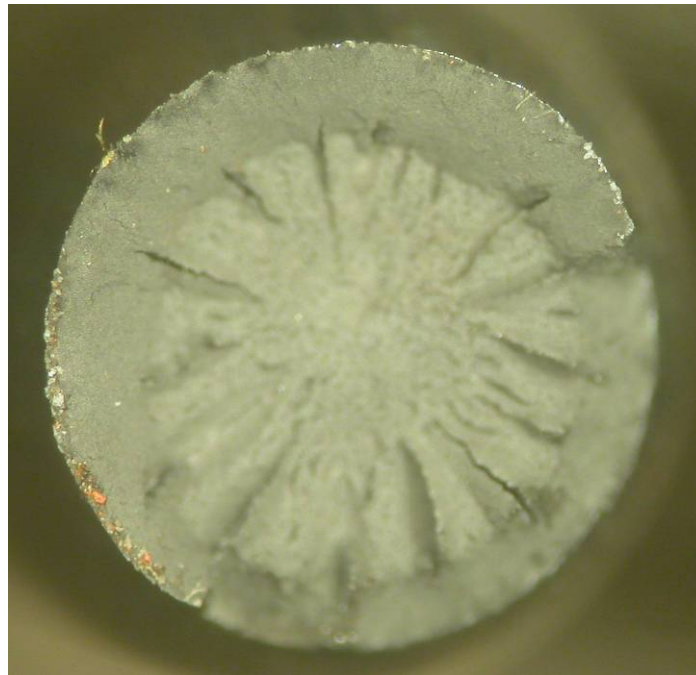
Fig. 71 Wire 10-5 surface (top) and fracture surface after tensile testing (bottom).

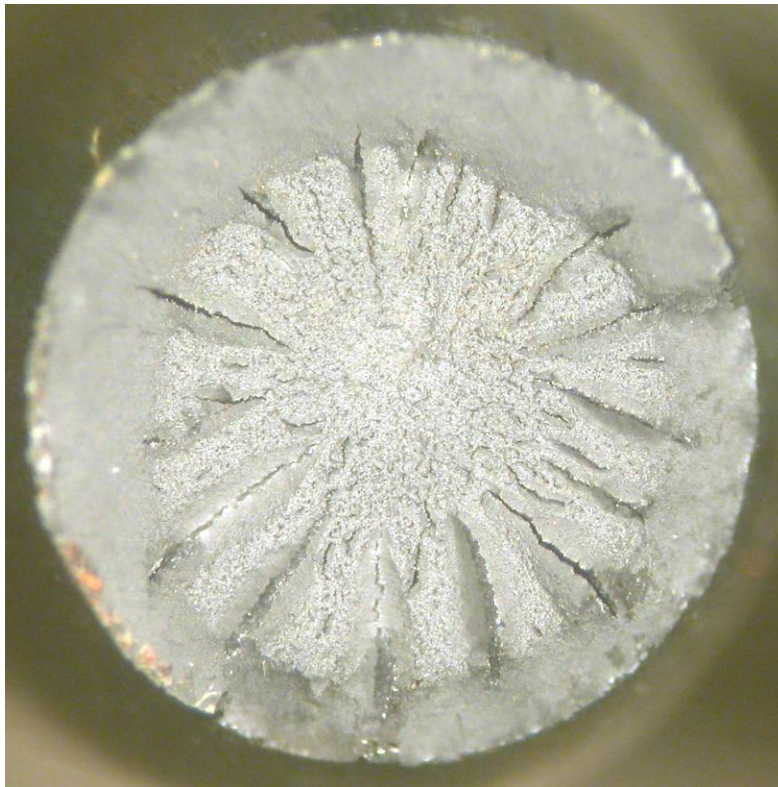
Fig. 72 Wire 10-6 surface (top) and fracture surface after tensile testing (bottom).

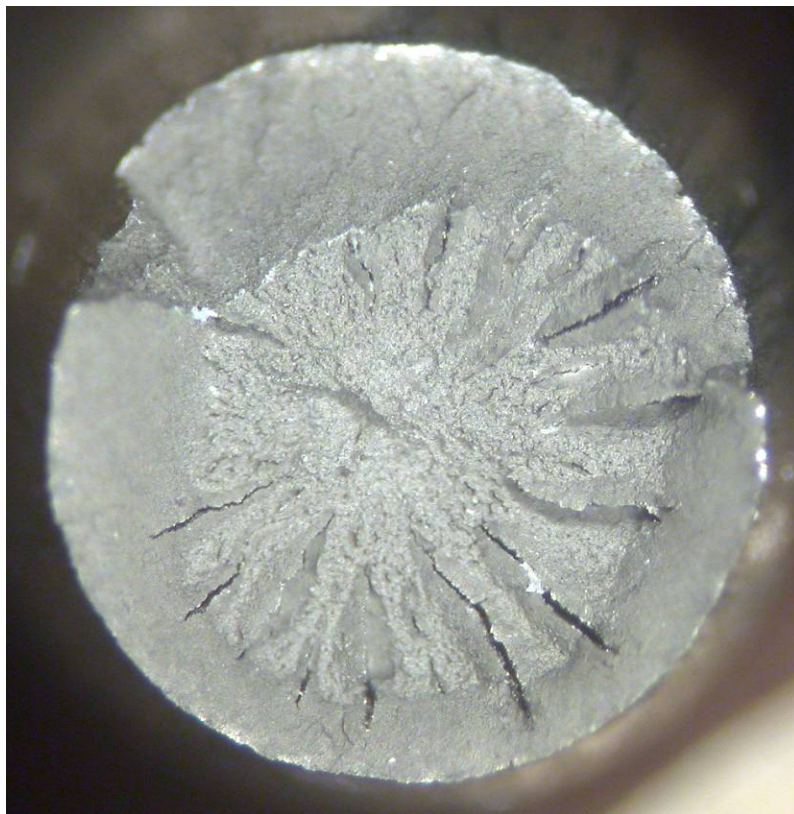
Fig. 73 Wire 10-7 surface (top) and fracture surface after tensile testing (bottom).

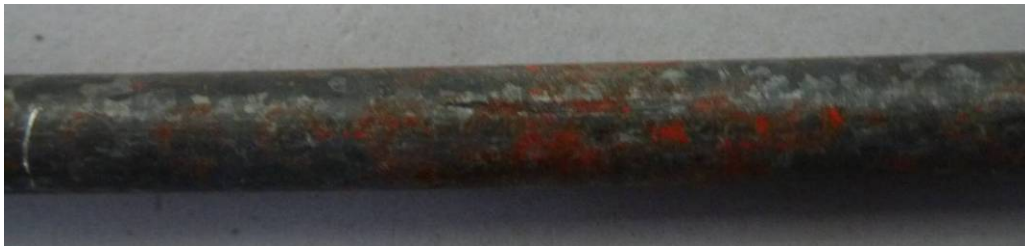
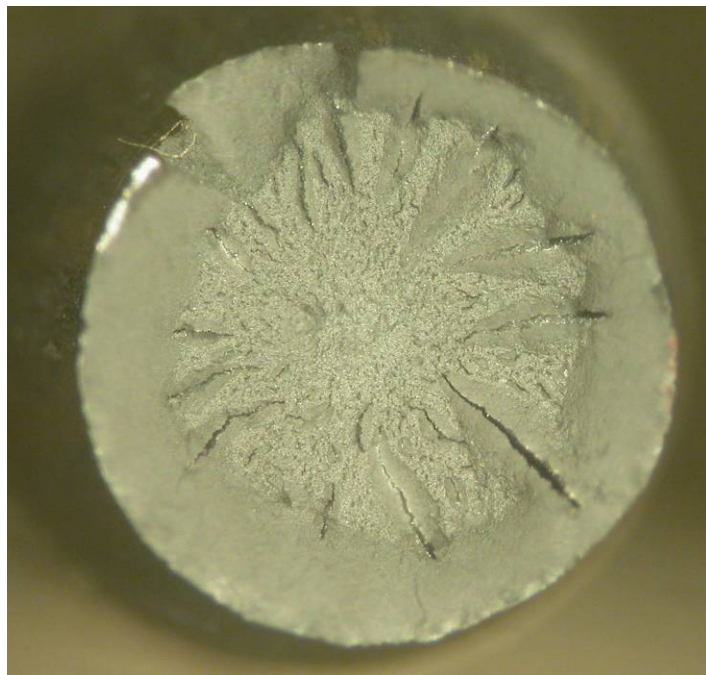
Fig. 74 Wire 10-8 surface (top) and fracture surface after tensile testing (bottom).

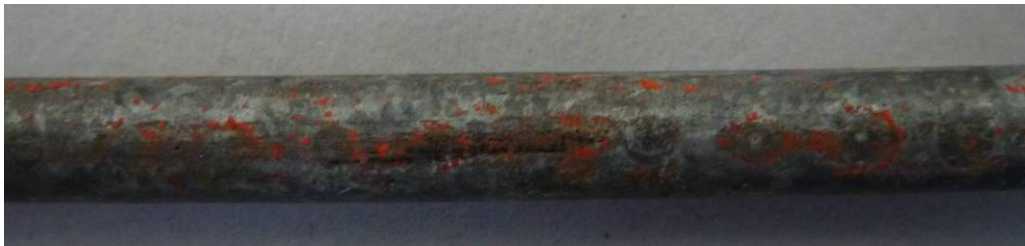
Fig. 75 Wire 10-9 surface (top) and fracture surface after tensile testing (bottom).

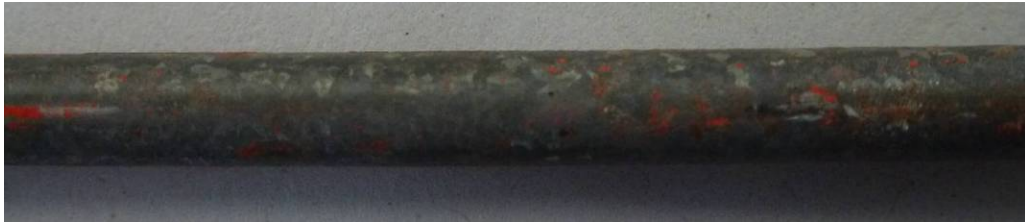
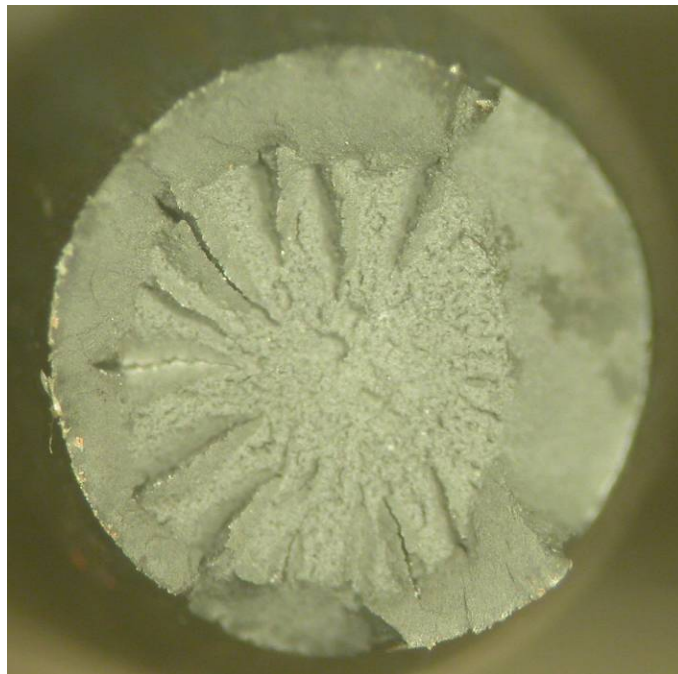
Fig. 76 Wire 10-10 surface (top) and fracture surface after tensile testing (bottom).

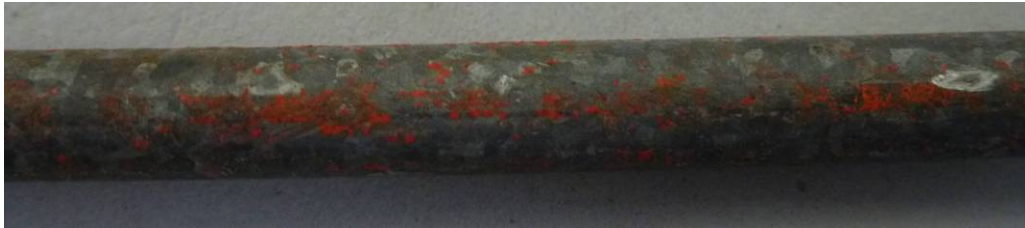
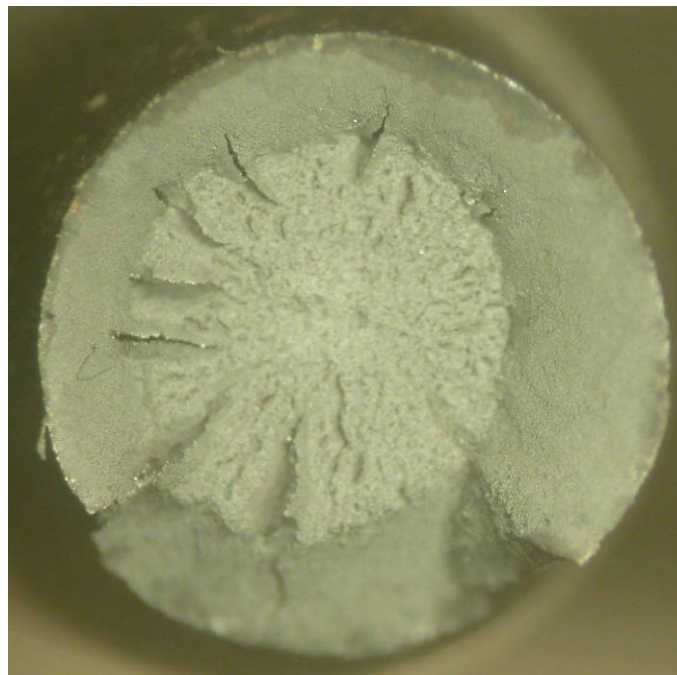
Fig. 77 Wire 10-11 surface (top) and fracture surface after tensile testing (bottom).

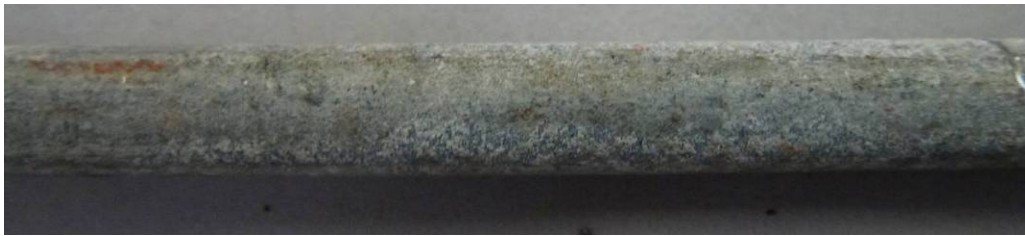
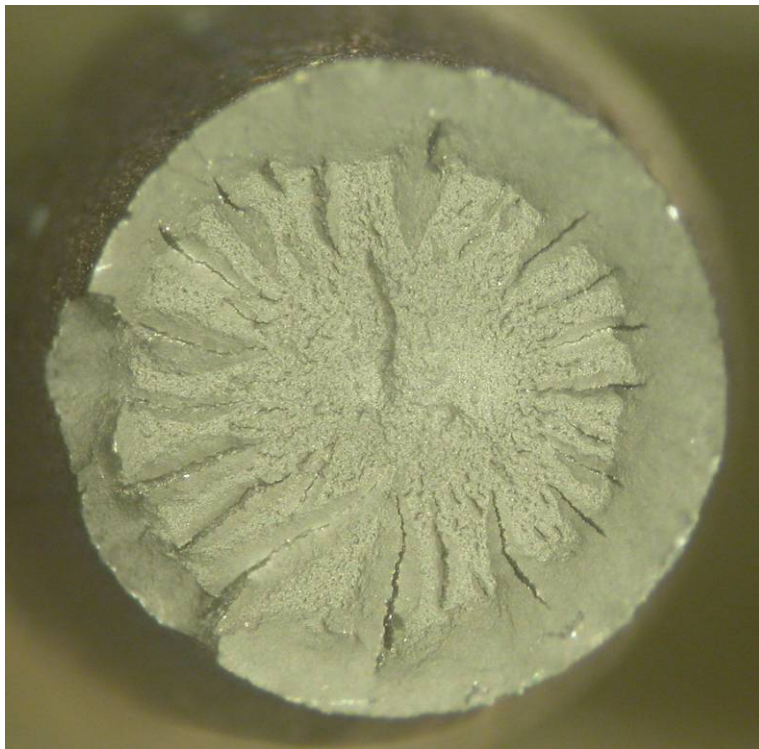
Fig. 78 Wire 11-1 surface (top) and fracture surface after tensile testing (bottom).

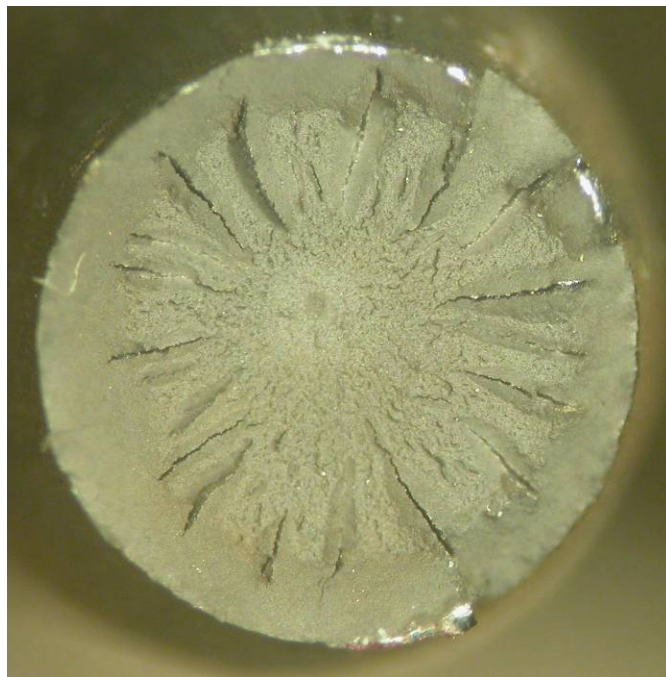
Fig. 79 Wire 11-2 surface (top) and fracture surface after tensile testing (bottom).

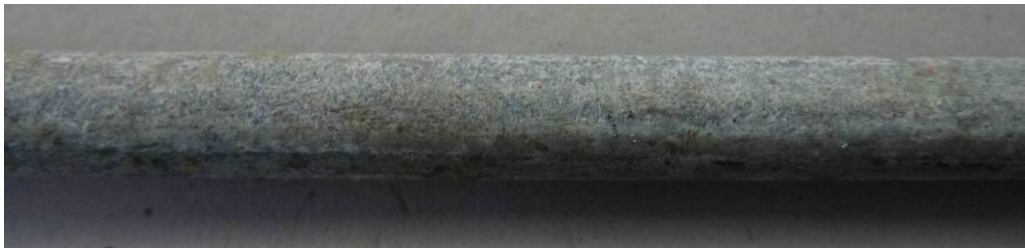
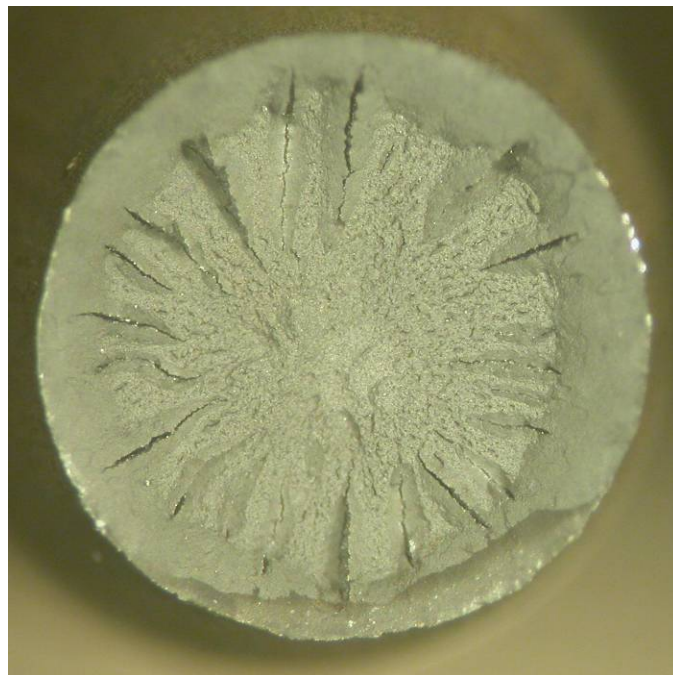
Fig. 80 Wire 11-3 surface (top) and fracture surface after tensile testing (bottom).

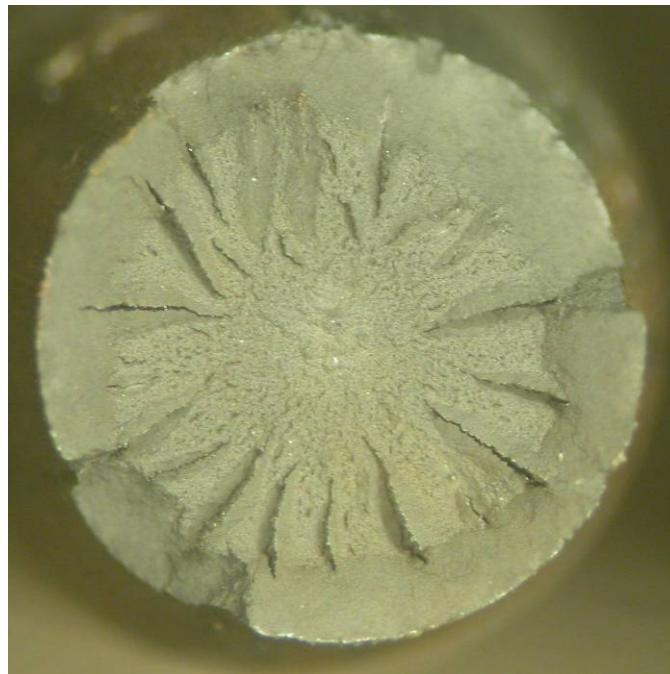
Fig. 81 Wire 11-4 surface (top) and fracture surface after tensile testing (bottom).

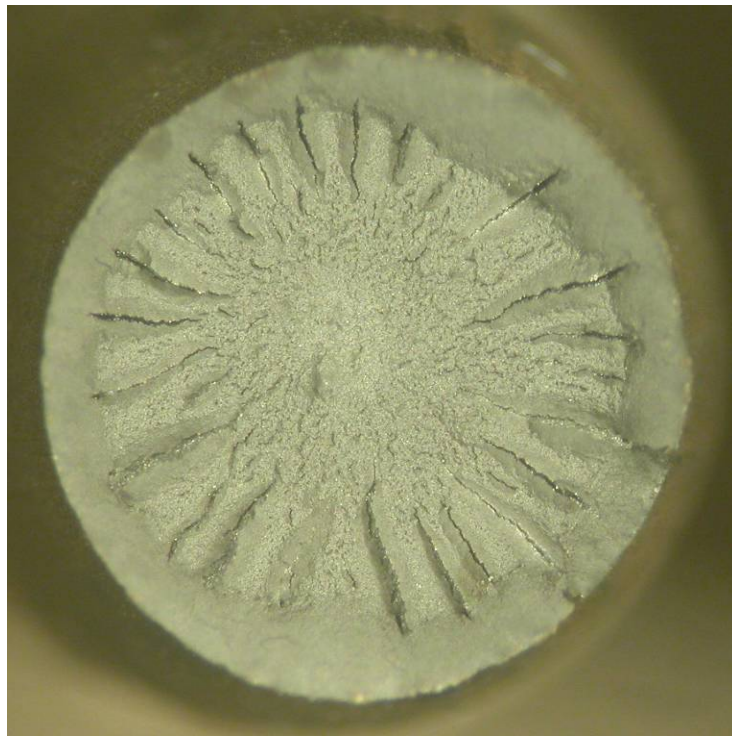
Fig. 82 Wire 11-5 surface (top) and fracture surface after tensile testing (bottom).

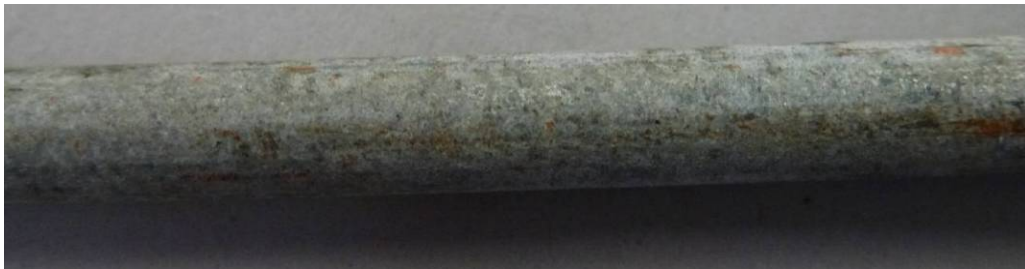
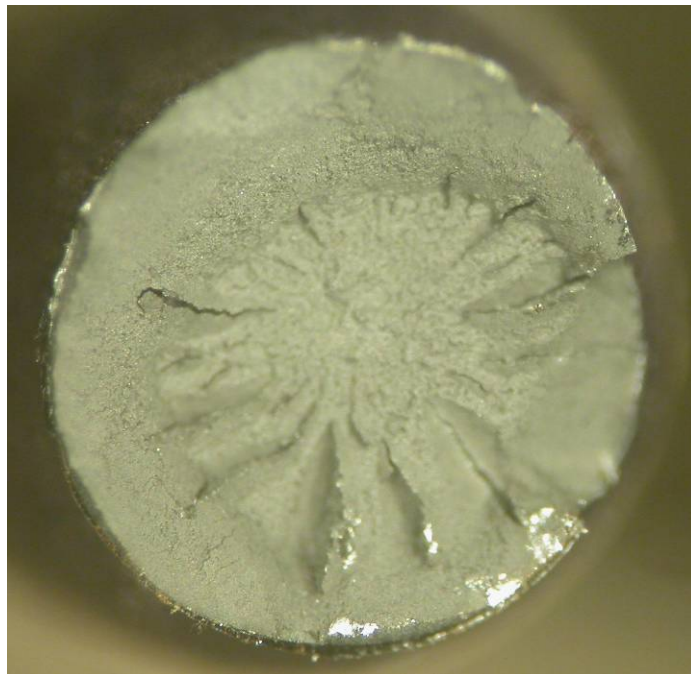
Fig. 83 Wire 11-6 surface (top) and fracture surface after tensile testing (bottom).

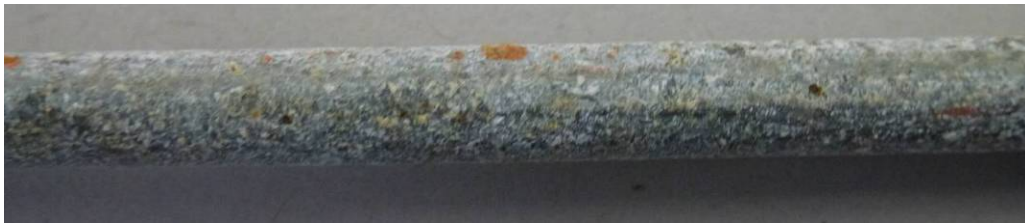
Fig. 84 Wire 12-1 surface (top) and fracture surface after tensile testing (bottom).

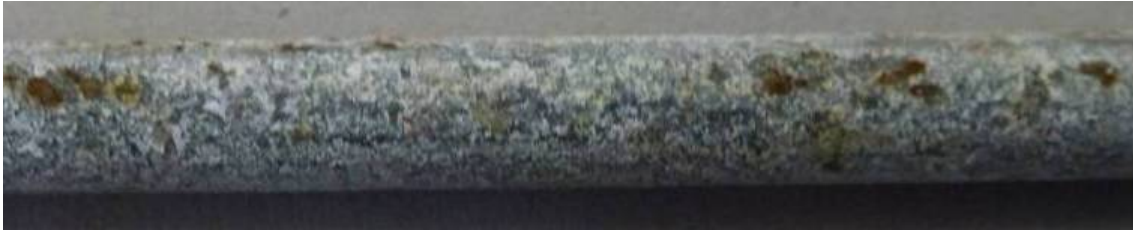
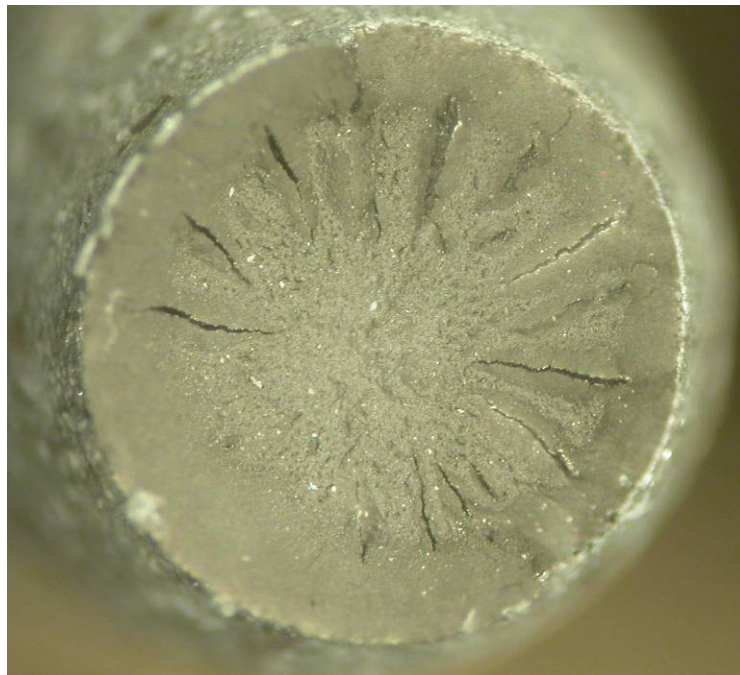
Fig. 85 Wire 12-2 surface (top) and fracture surface after tensile testing (bottom).

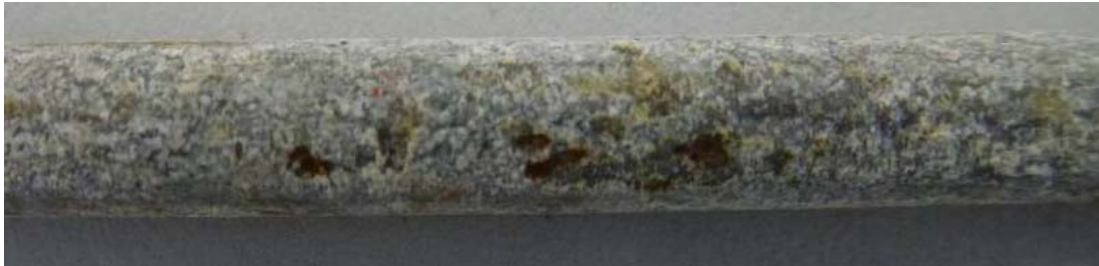
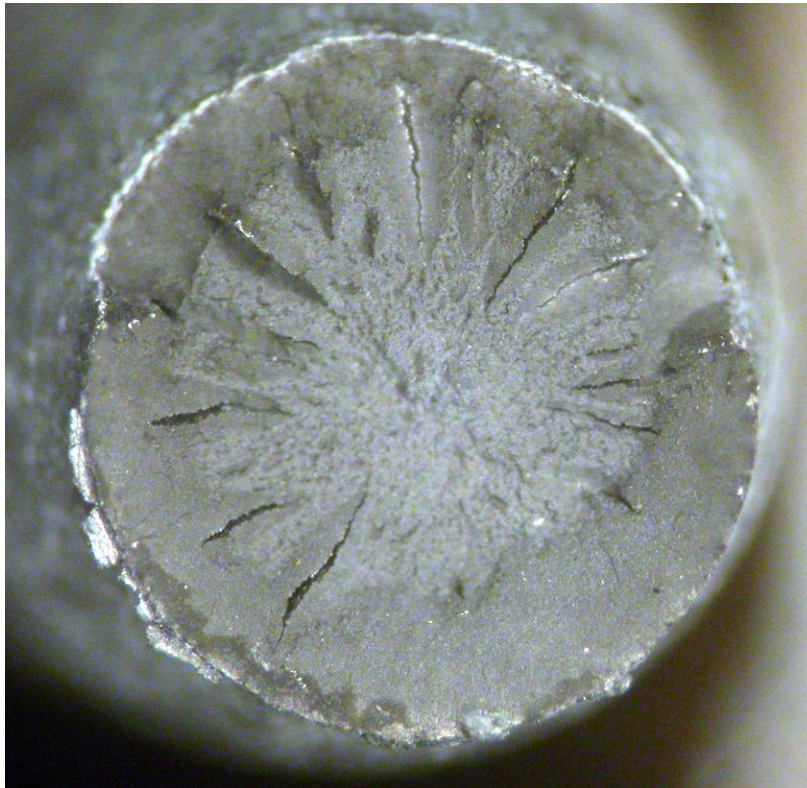
Fig. 86 Wire 12-3 surface (top) and fracture surface after tensile testing (bottom).

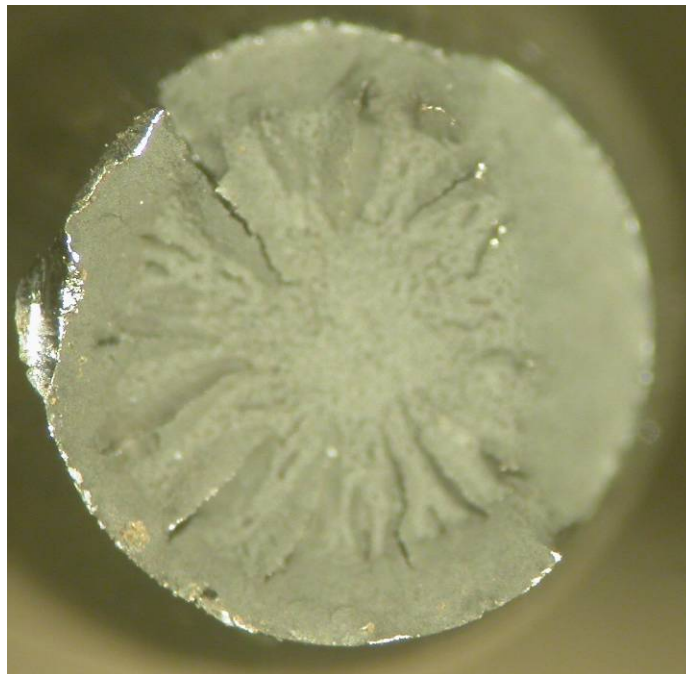
Fig. 87 Wire 12-4 surface (top) and fracture surface after tensile testing (bottom).

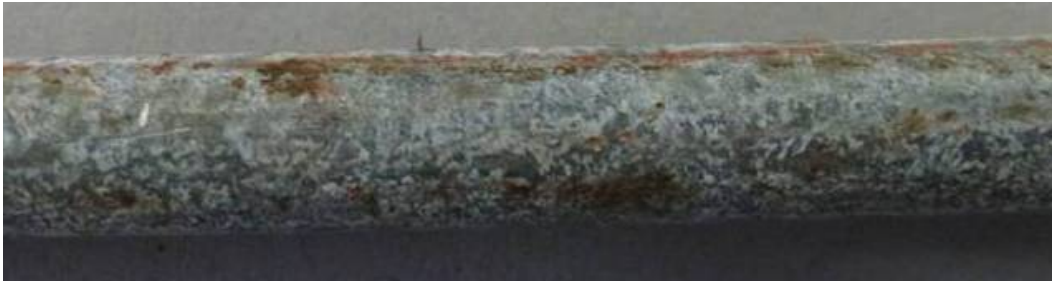
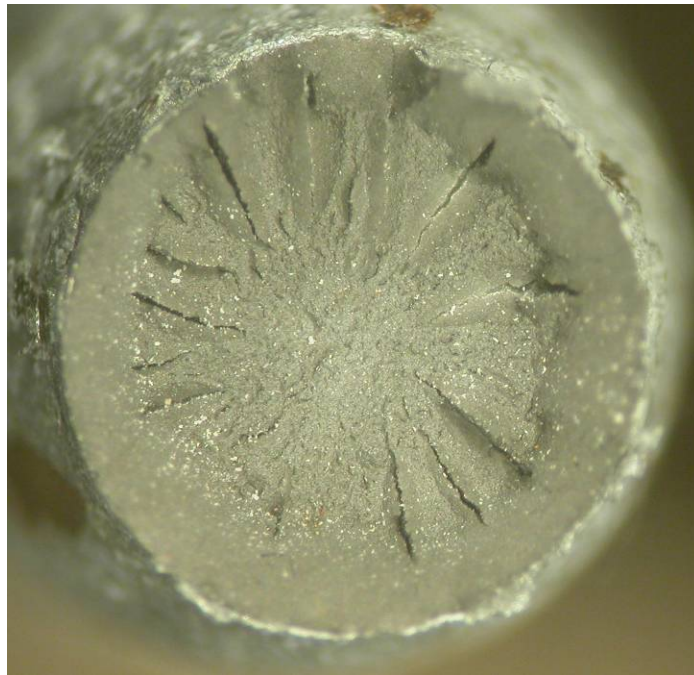
Fig. 88 Wire 12-5 surface (top) and fracture surface after tensile testing (bottom).

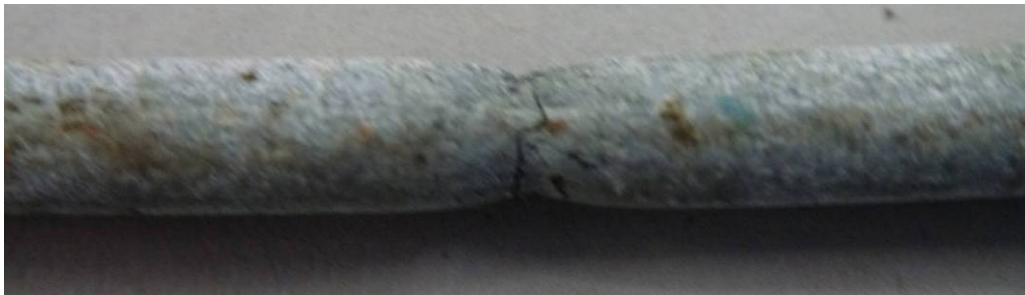
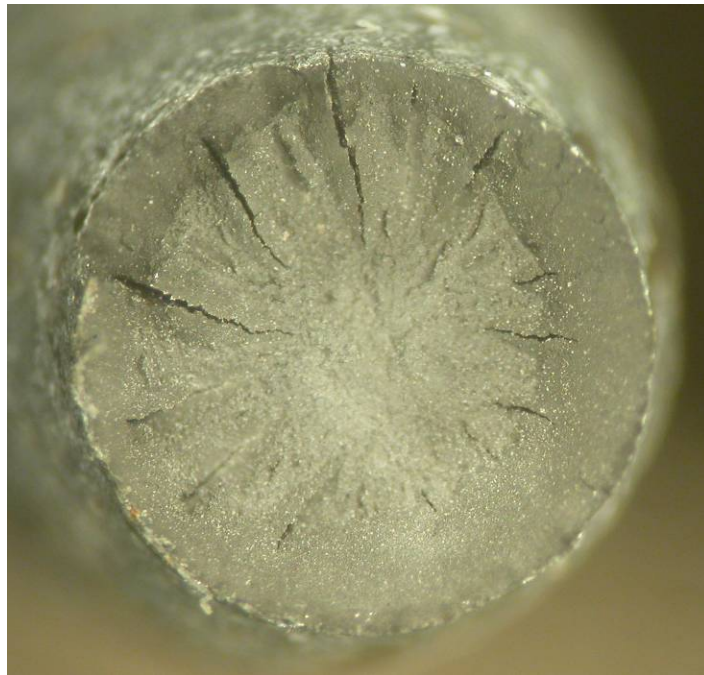
Fig. 89 Wire 12-6 surface (top) and fracture surface after tensile testing (bottom).

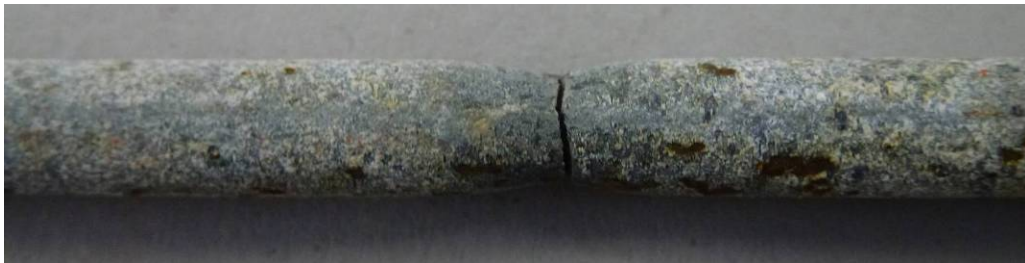
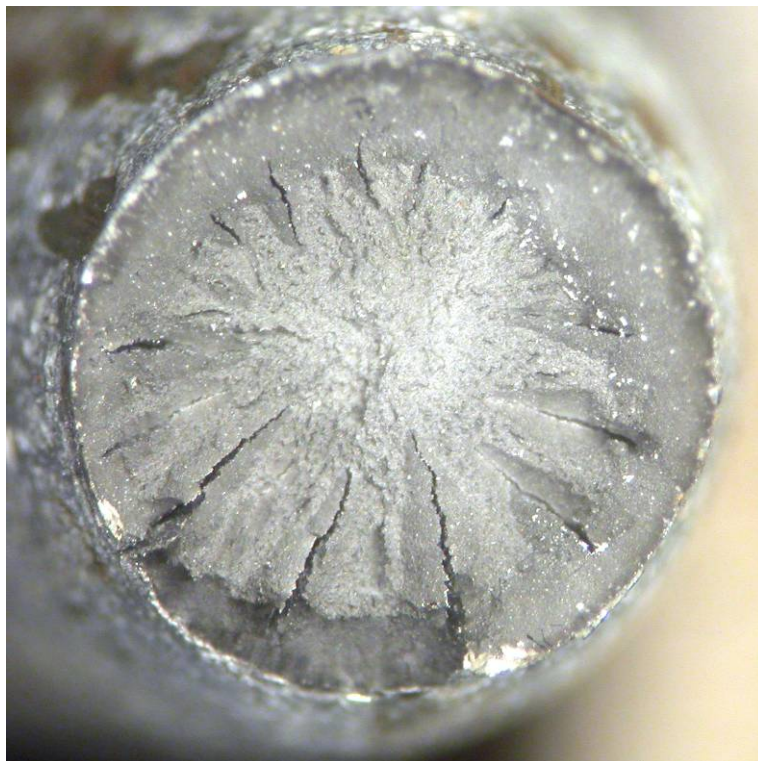
Fig. 90 Wire 12-7 surface (top) and fracture surface after tensile testing (bottom).

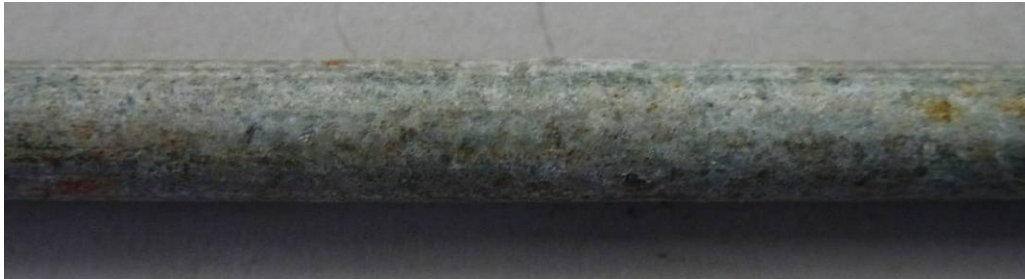
Fig. 91 Wire 13-1 surface (top) and fracture surface after tensile testing (bottom).

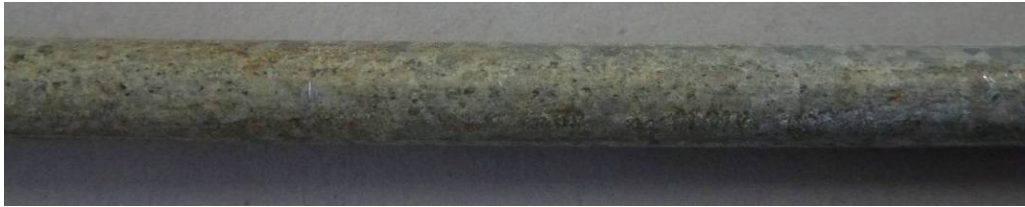
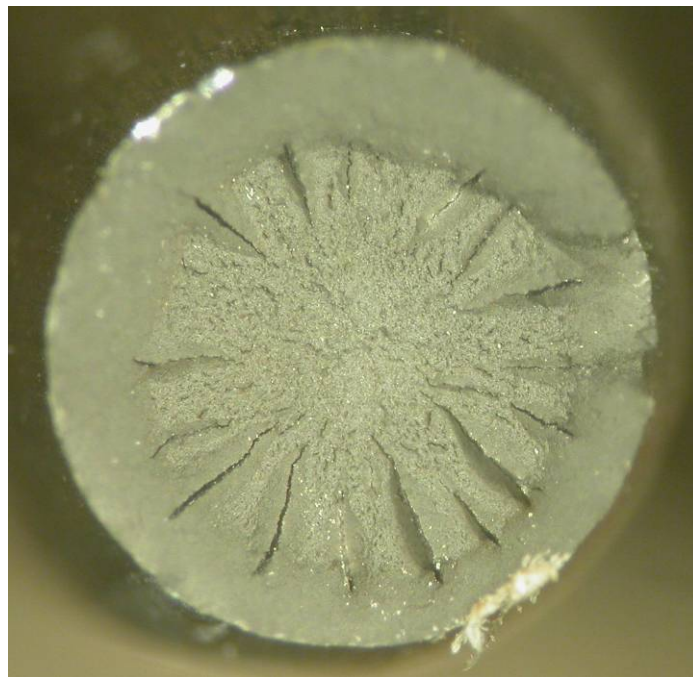
Fig. 92 Wire 13-2 surface (top) and fracture surface after tensile testing (bottom).

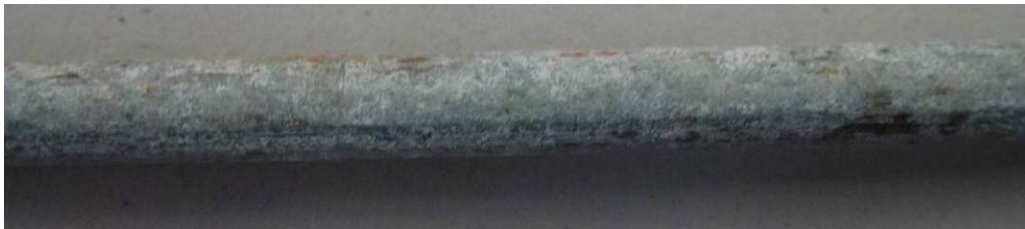
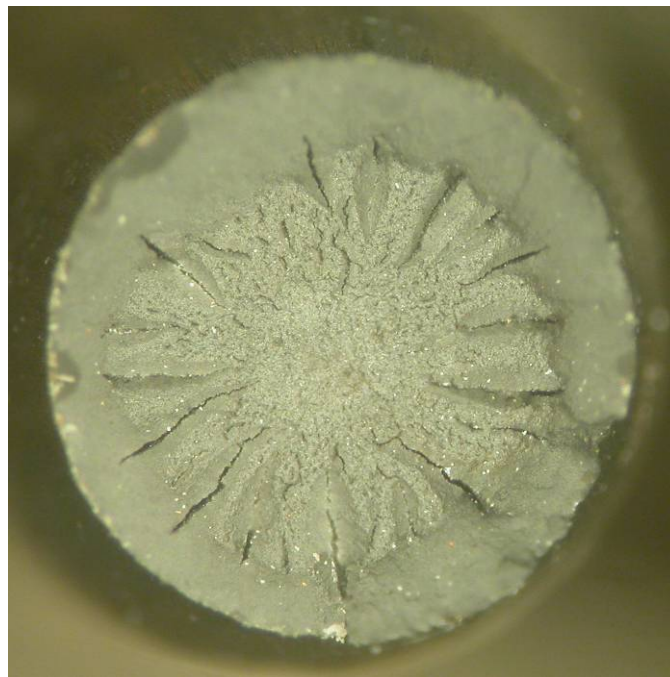
Fig. 93 Wire 13-3 surface (top) and fracture surface after tensile testing (bottom).

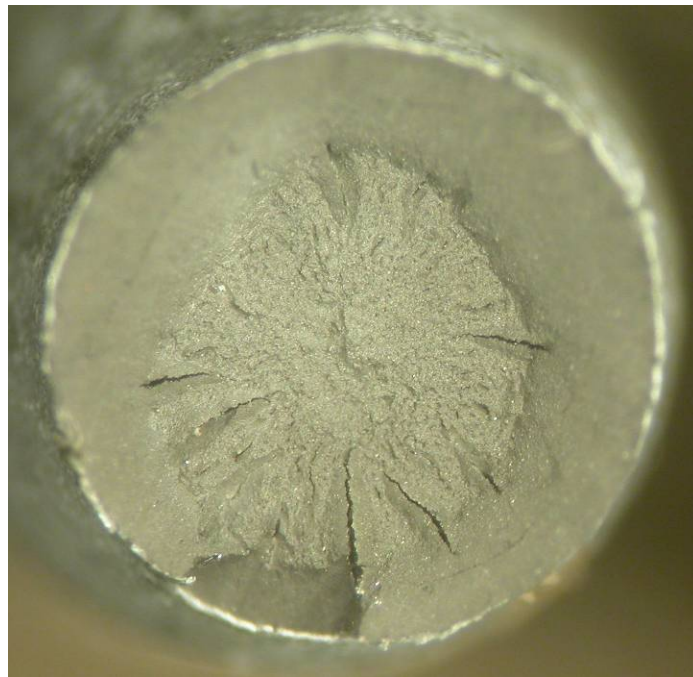
Fig. 94 Wire 13-4 surface (top) and fracture surface after tensile testing (bottom).

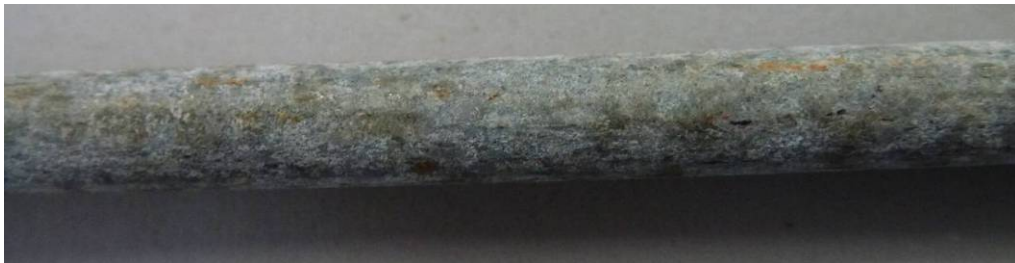
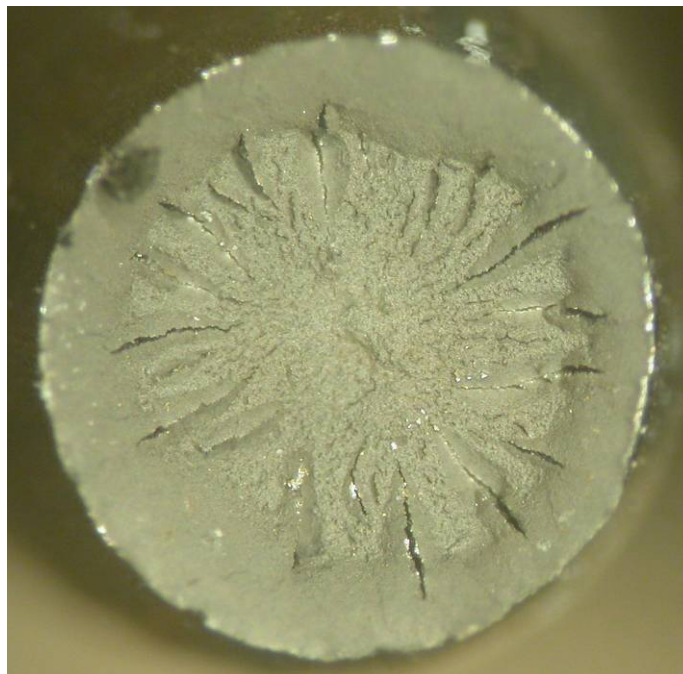
Fig. 95 Wire 13-5 surface (top) and fracture surface after tensile testing (bottom).

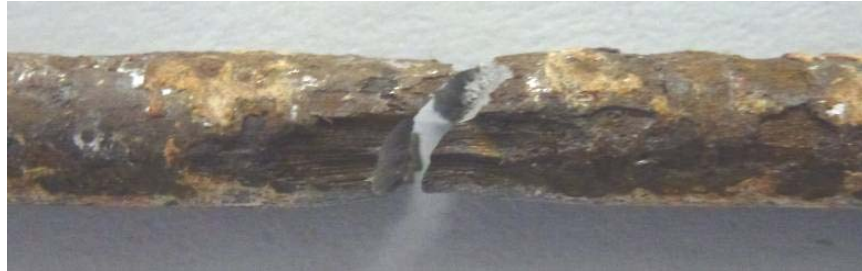
Fig. 100 Wire 5-4 fracture profile (top) and fracture surfaces (bottom).
