APPENDIX A – ANTHONY WAYNE BRIDGE ACOUSTIC EMISSION MONITORING REPORT (MISTRAS)

Anthony Wayne Bridge Acoustic Emission Monitoring Report

Location: Toledo, Ohio

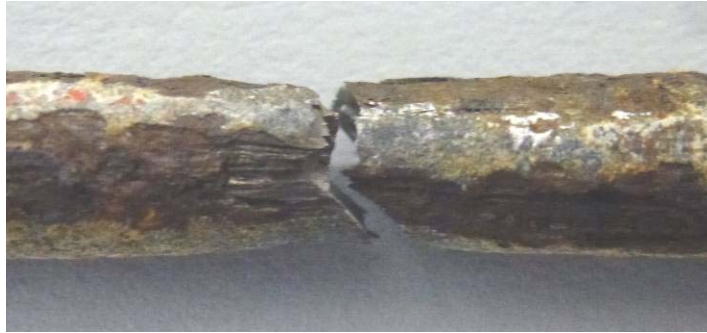
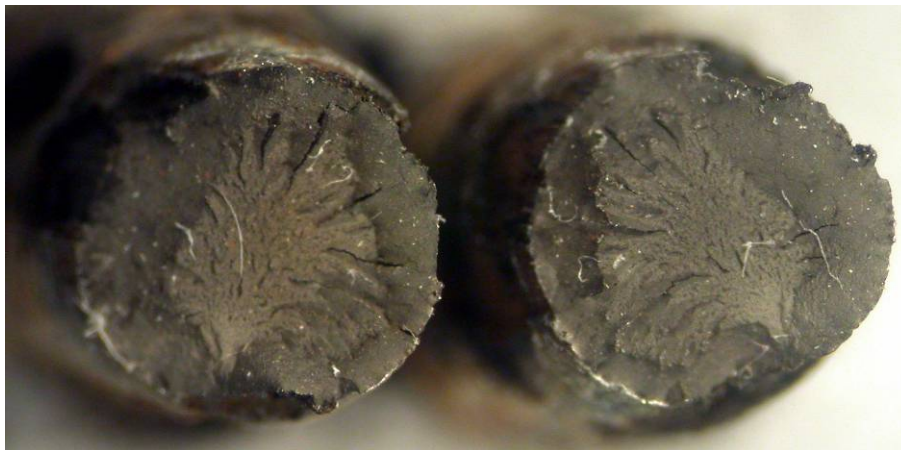
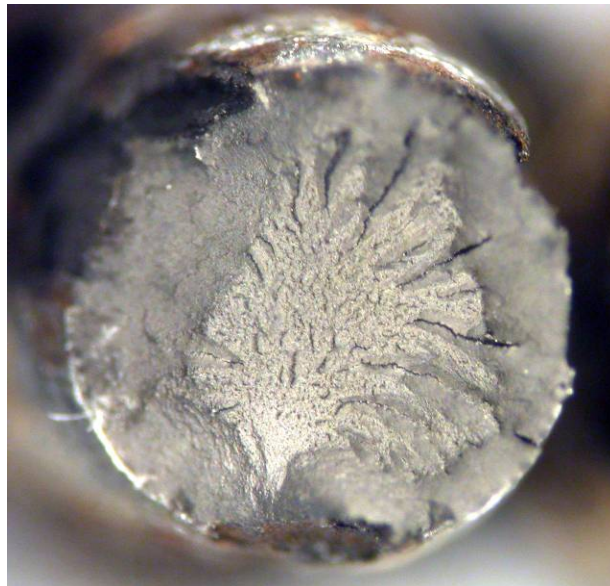
Fig. 102 Wire 5-7 fracture profile (top) and fracture surfaces (bottom).

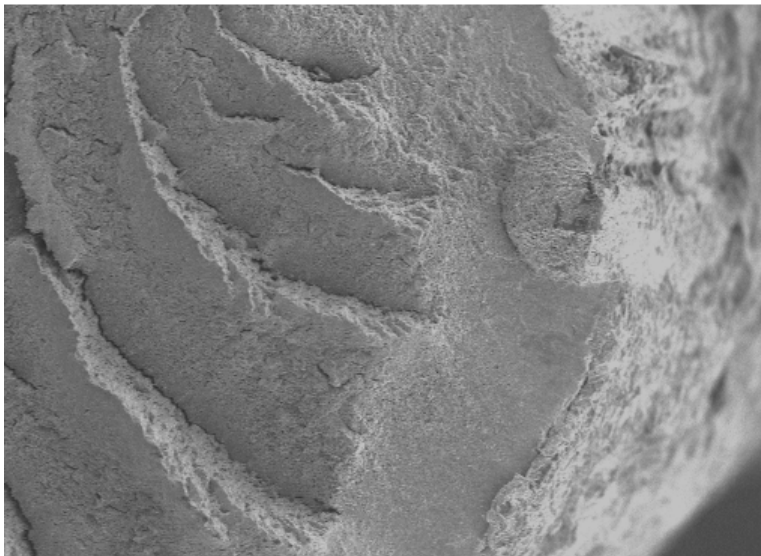
Fig. 103 Scanning electron micrograph of wire 5-7 fracture surface.

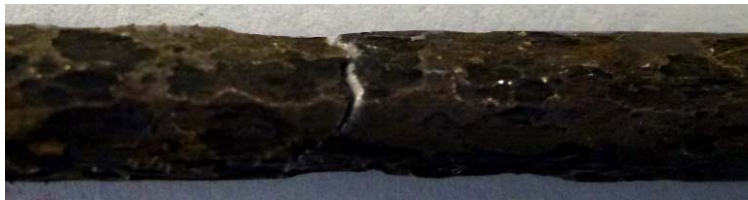
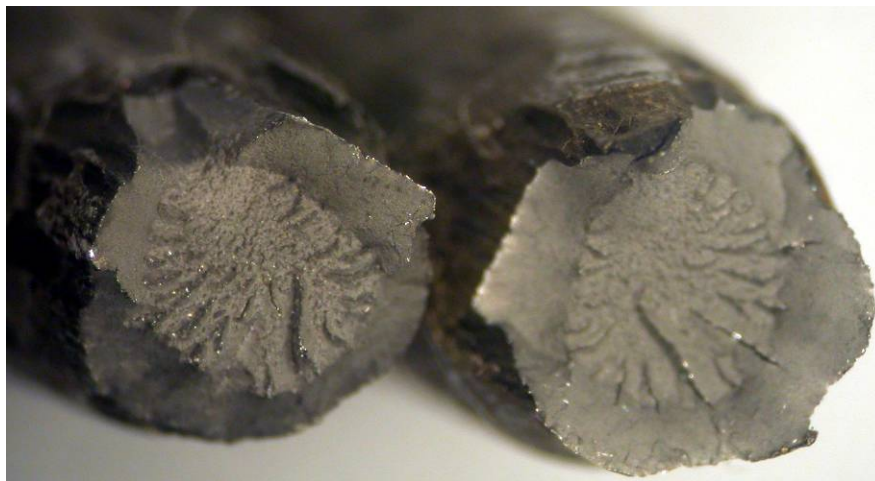
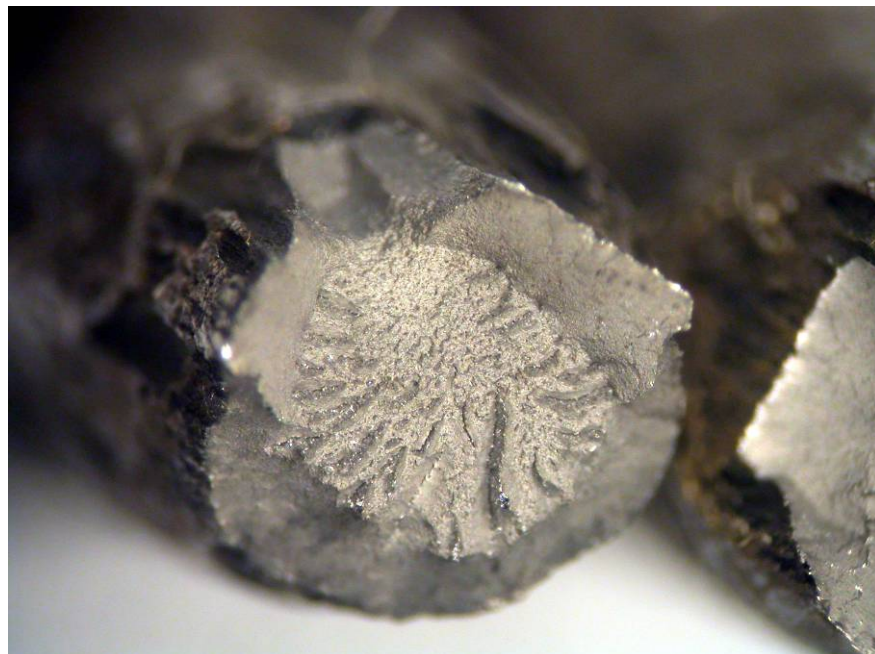
Fig. 104 Wire 7-4 fracture profile (top) and fracture surfaces (bottom).

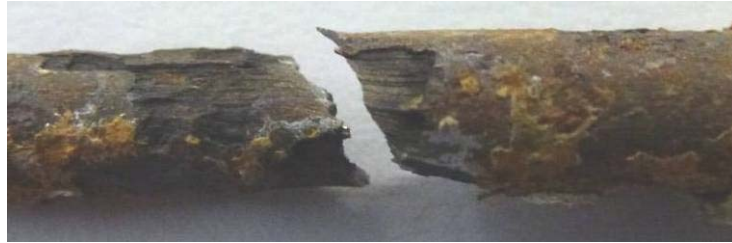
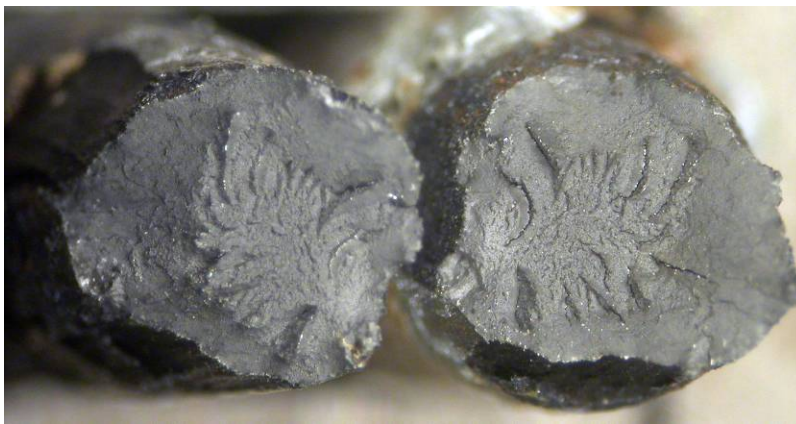
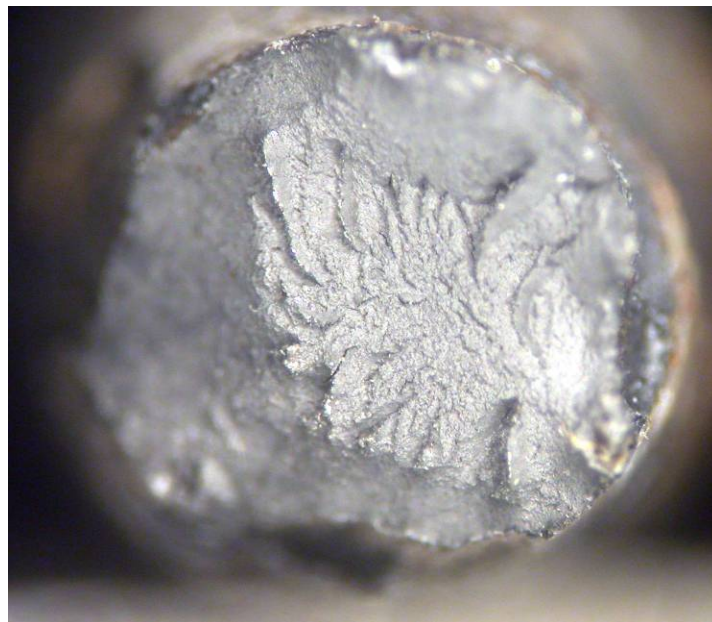
Fig. 106 Wire 7-5 fracture profile (top) and fracture surfaces (bottom).

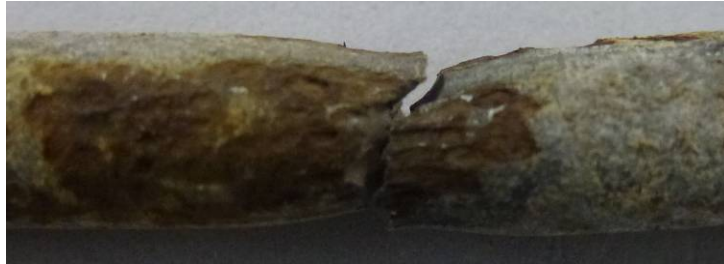
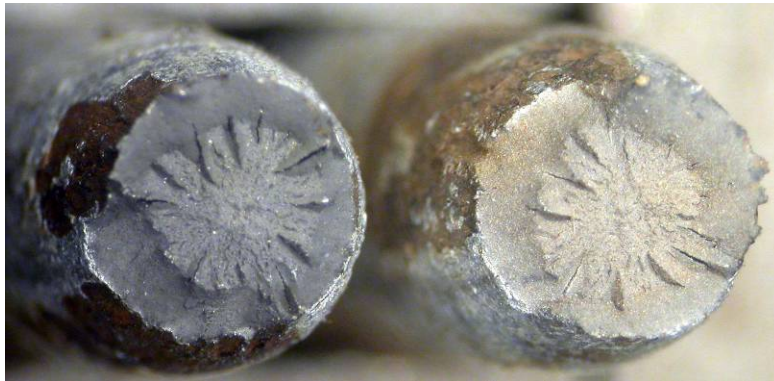
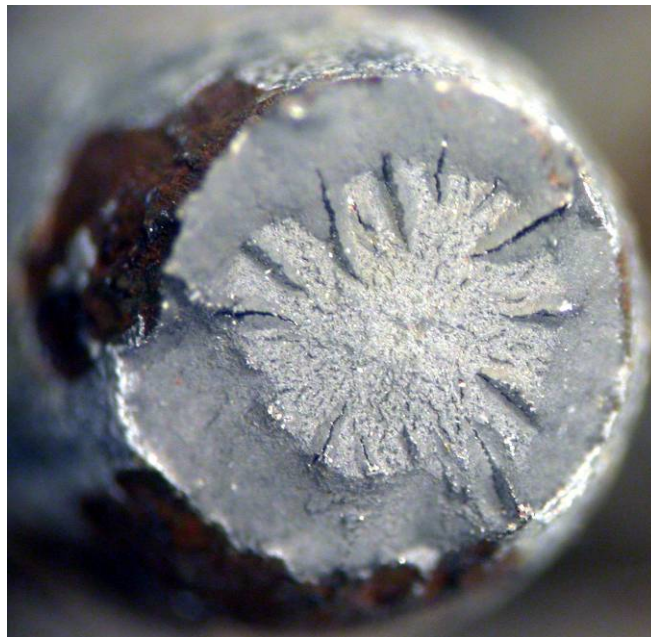
Fig. 108 Wire 6-4 fracture profile (top) and fracture surfaces (bottom).

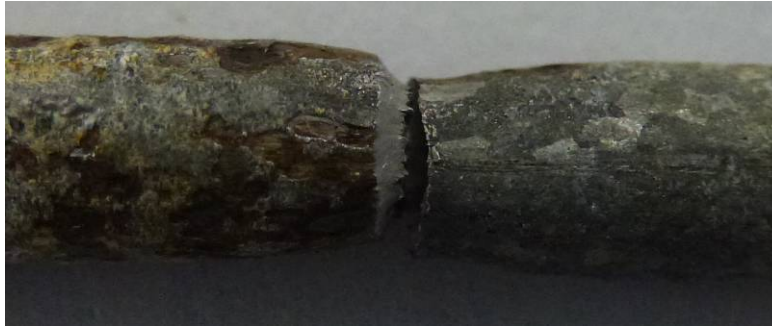
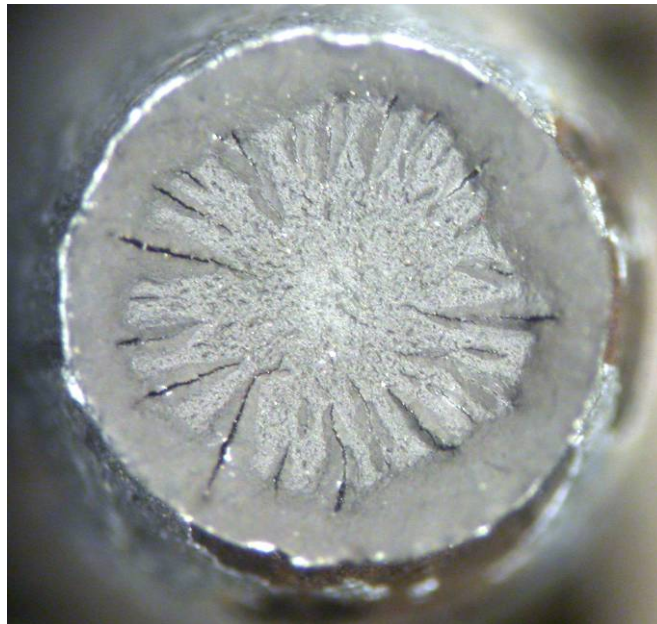
Fig. 110 Wire 8-1 fracture profile (top) and fracture surfaces (bottom).

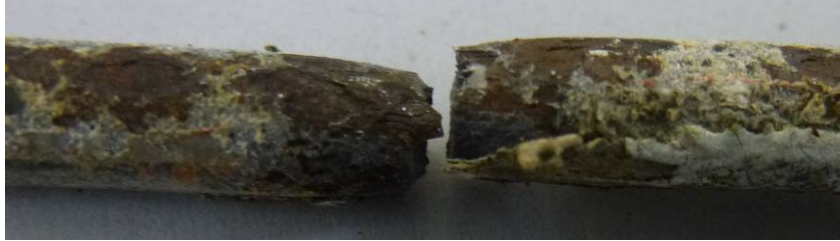
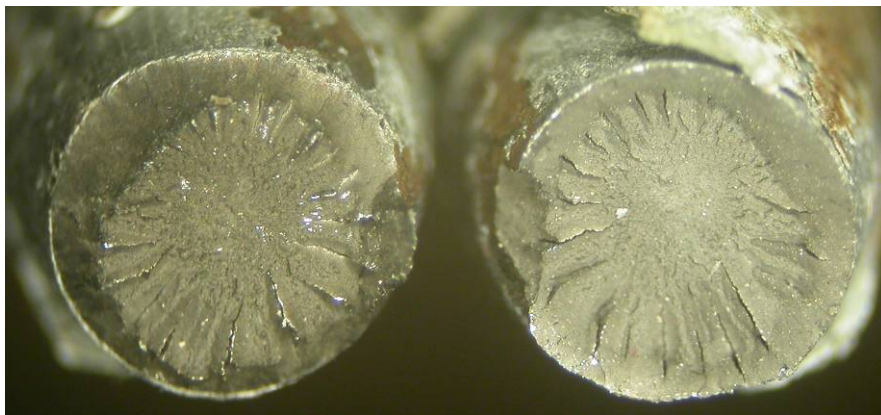
Fig. 112 Wire 9-6 fracture profile (top) and fracture surfaces (bottom).

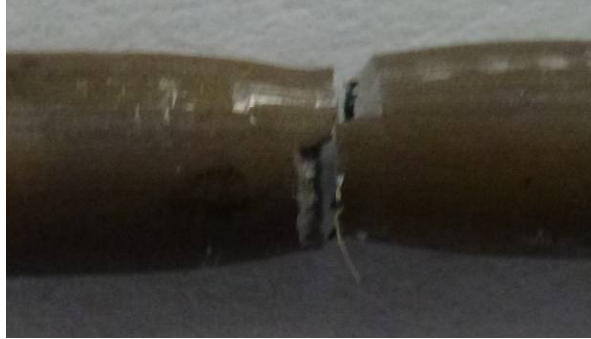
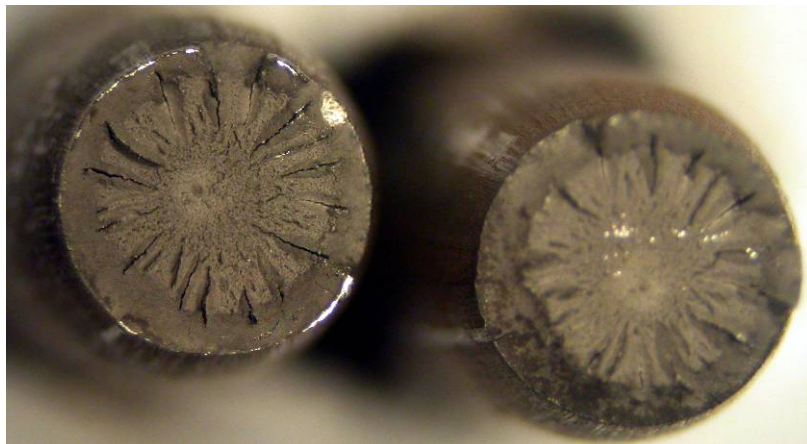
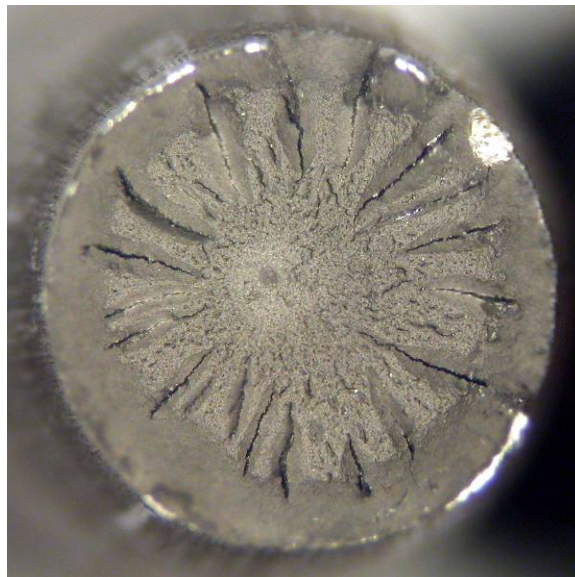
Fig. 114 Wire 11-2 fracture profile (top) and fracture surfaces (bottom).

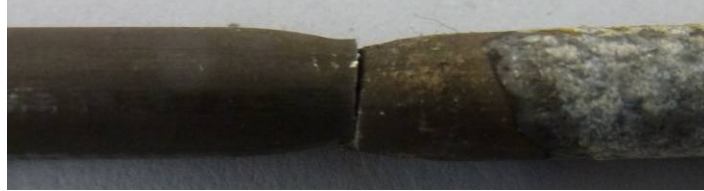
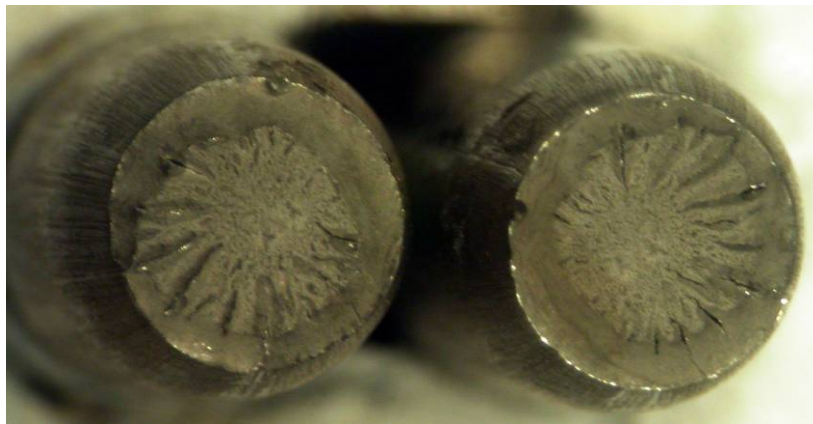
Fig. 116 Wire 12-4 fracture profile (top) and fracture surfaces (bottom).

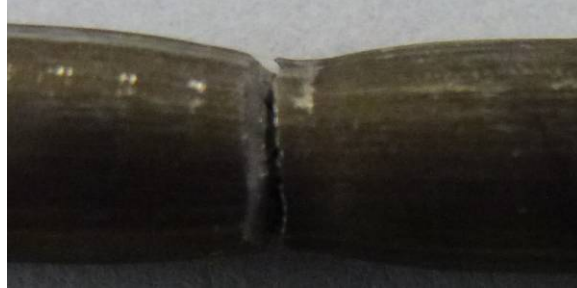
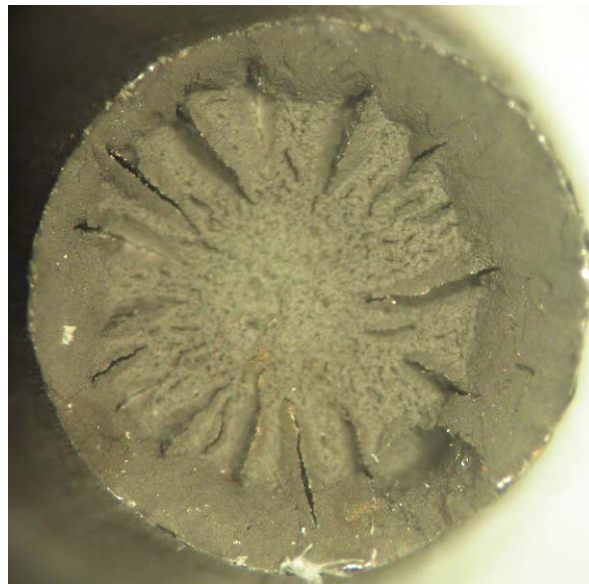
Fig. 118 Wire 13-6 fracture profile (top) and fracture surfaces (bottom).
