PHYSICAL CONDITION REPORT
2024 ROUTINE ELEMENT LEVEL AND NSTM
INSPECTION

INSPECTION MAY 2024
REPORT AUGUST 2024

ANTHONY WAYNE BRIDGE
LUC-002-1862
SFN: 4800303

Ohio Department of Transportation, District 2
317 E Poe Rd
Bowling Green, OH 43402

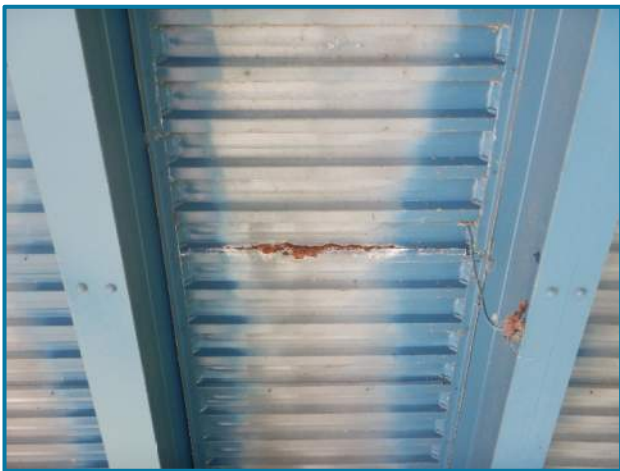
Photo 3 – Isolated corrosion of the stay-in-place forms and minor efflorescence between Beams 4 and 5 in Span 1W (looking east).

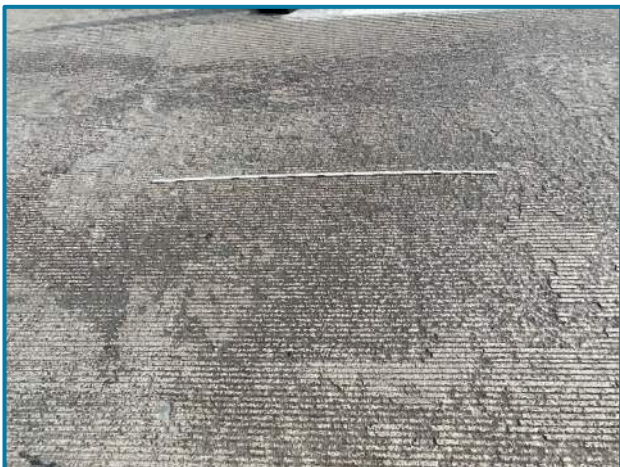
Photo 4 – Isolated area of moderate abrasion/wear in the Main Suspension Span near Tower C (looking north).

The integral concrete deck wearing surface is in good condition overall with isolated minor spalls and hairline longitudinal and transverse cracks throughout. There are several areas of moderate abrasion/wear scattered throughout the suspension spans (see Photo 4). The areas of abrasion also include minor popouts and chipping of the grooved wearing surface.

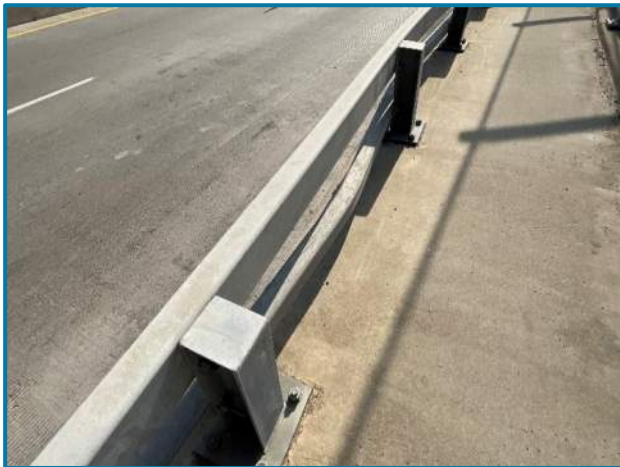
- Span 8W, South Railing at Rear Abutment (see Photo 11).
- Span 7W, South Railing Post at Pier 7W (see Photo 11).

Photo 11 – Impact damage to south railing in Span 8W at Rear Abutment (looking northeast).

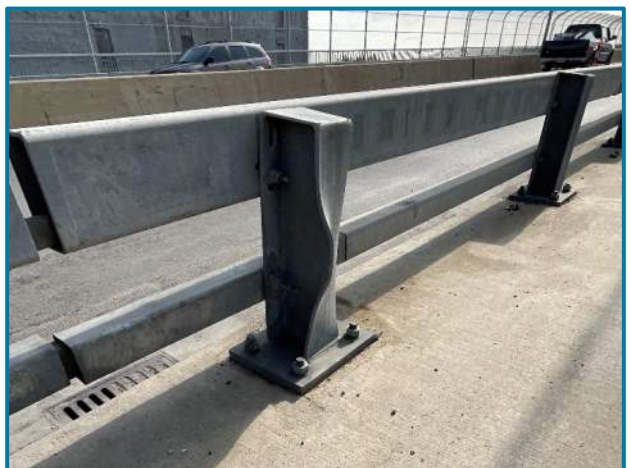
Photo 12 – Impact damage to south railing post in Span 7W at Pier 7W (looking northeast).

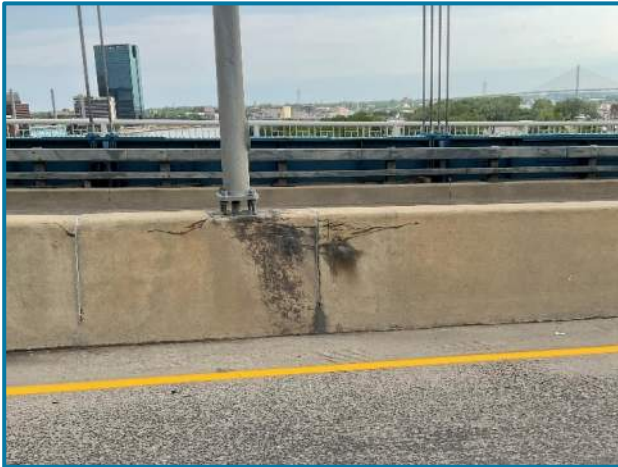
The reinforced concrete bridge railing, which includes the median barrier along the centerline of the bridge, is in satisfactory condition overall with isolated spalls, isolated minor delaminations, and longitudinal cracking at light poles (see Photo 13). Full height vertical cracks, typically at 3' spacing with light rust staining, and hairline transverse cracks are present throughout (see Photo 14).

Photo 13 – Longitudinal cracking and delamination under light pole in Main Suspension Span between Floorbeams 47 and 48 on the south face (looking north).

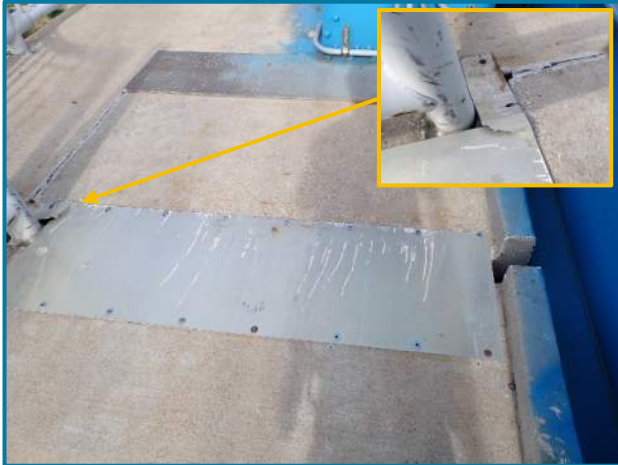
Photo 18 – Aluminum plate covering 5" gap between sidewalk panels with a 4 1/2" long tear at the railing post on the south sidewalk, east of Tower C (looking west).

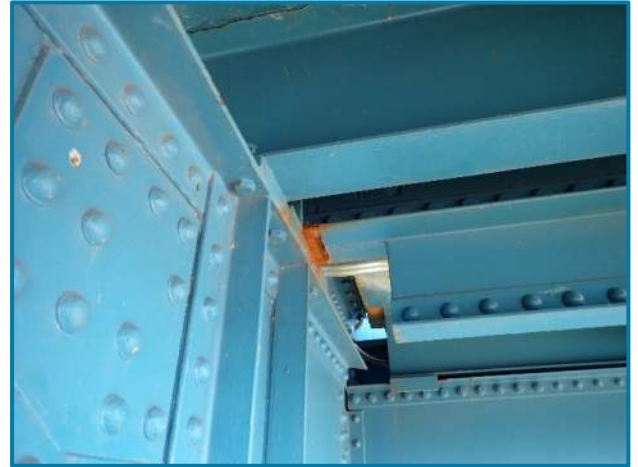
Photo 17 – Signs of expansion at the sidewalk stringers (looking north at Right Stringer 2 on at Floorbeam 12).

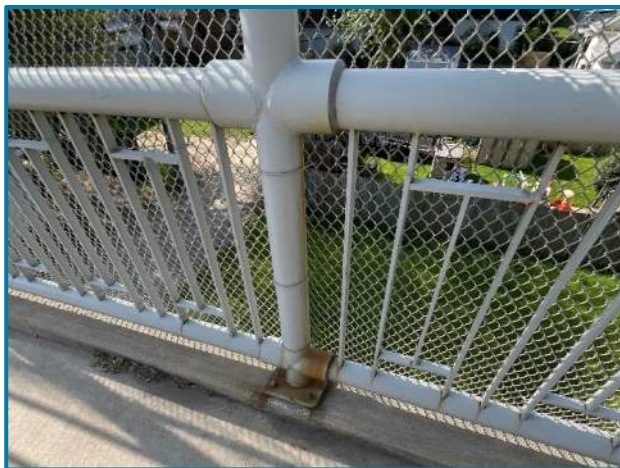
The sidewalk railing is in good condition overall with isolated areas of surface corrosion without section loss (see Photo 20). A fence is attached to the railing in all spans except the main suspension span over the Maumee River.

Photo 20 – Typical condition of the sidewalk railing in Span 12E at the south sidewalk (looking south).

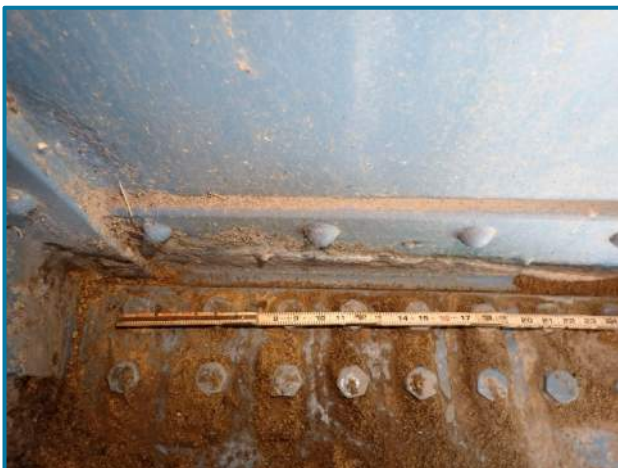
Photo 22 – 1/4" deep pitting of bottom flange angle and rivet head loss up to 100% at Left Girder in Main Suspension Span at Floorbeam 39 (looking north).

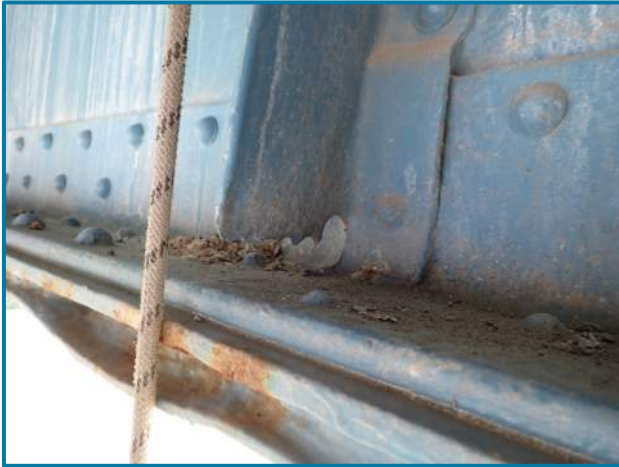
Photo 24 – Pack rust between the bottom flange cover plates with rust staining on the Right Girder between Floorbeams 30 and 31 in the Main Suspension Span (looking southeast). Note the 100% section loss to the base of the transverse stiffener.

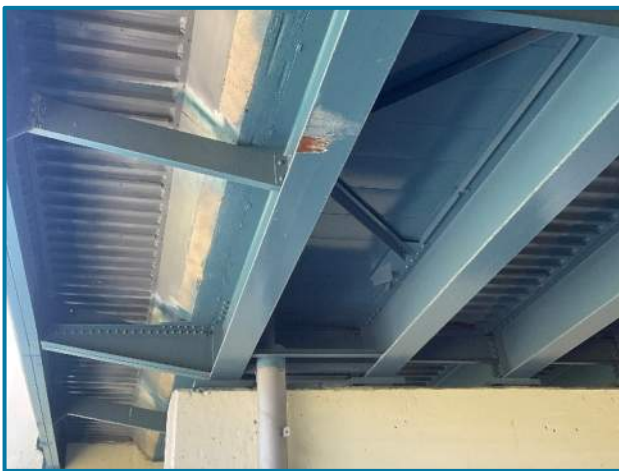
Photo 26 – Minor impact scrapes and surface corrosion of Girder S2 in Span 14E (looking east).

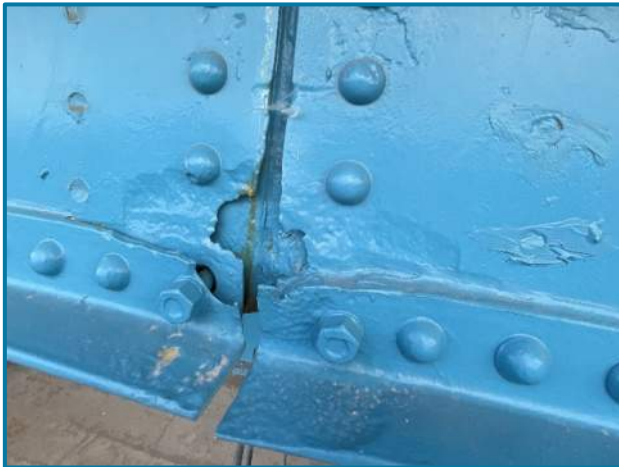
Photo 28 – Typical advanced section loss to the bottom flange angle and web plate at the cantilever sidewalk brackets (looking north at Right Stringer 2 at Floorbeam 2 in Span 4E).

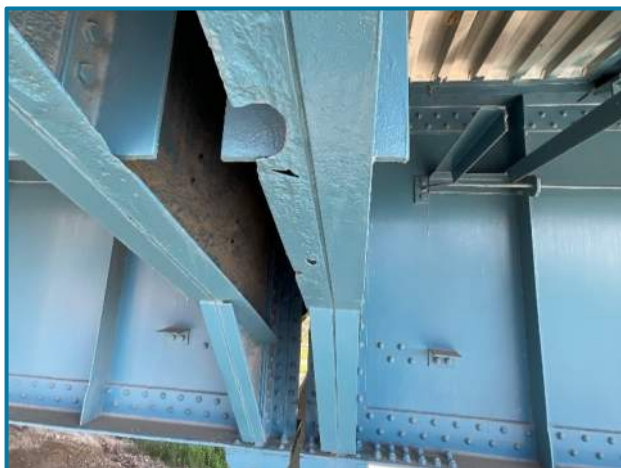
Photo 30 – Areas of 100% section loss to Floorbeam 0 bottom flange in Span 5W at south cantilever floorbeam bracket (looking north).

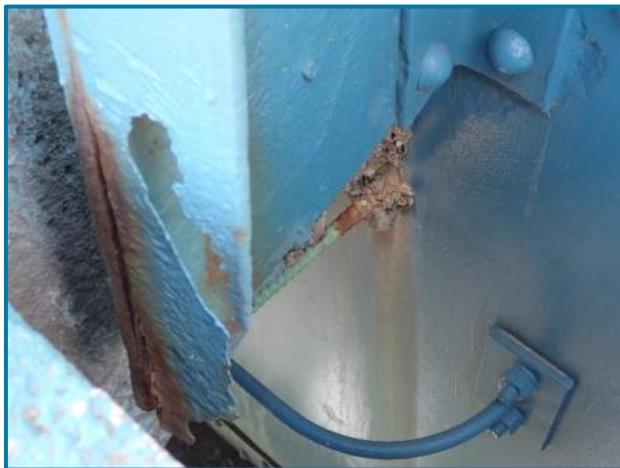
Photo 34 – Floorbeam 65 kneebrace at the deck interface at the Left Girder in East Suspension Span (looking northwest).

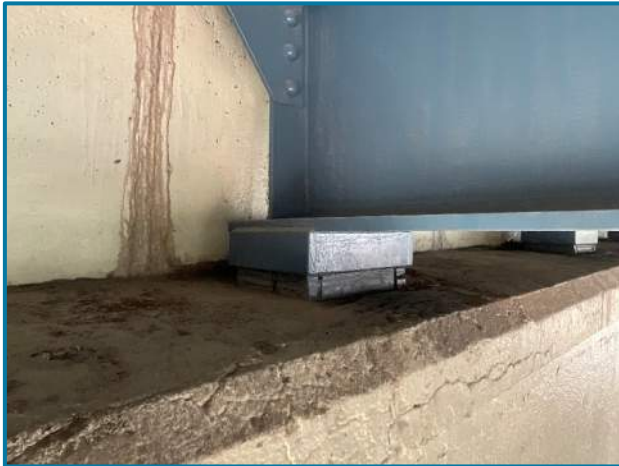
Photo 37 – Minor bulging of Beam 11 elastomeric bearing at Rear Abutment (looking northwest).

The elastomeric bearing devices are in satisfactory condition overall with isolated minor bulging, backed off anchor rod nuts or bent anchor rods. At the Rear Abutment, there is minor bulging of the elastomeric bearing pad under Beams 8, 11, 12, and 14 (see Photo 37). The northeast anchor bolt is bent with a loose nut under Stringer 11 at Pier 12E (see Photo 38). The elastomeric bearings at Piers 8E, 11E, 13E and 14E do not have anchor bolts due to retrofit (see Photo 39).

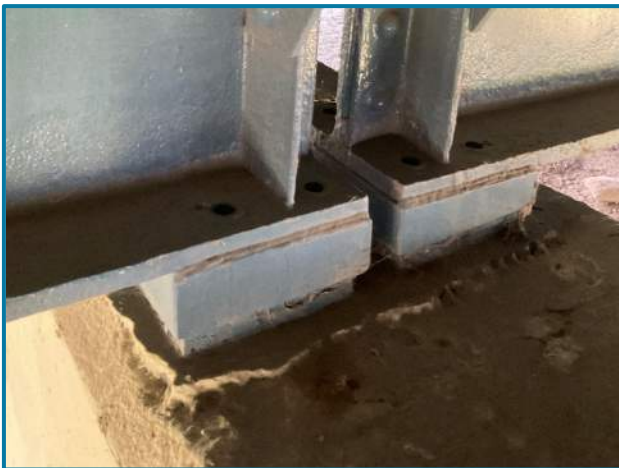
Photo 39 – Typical bearing retrofitted with an elastomeric bearing pad during a previous rehabilitation project (looking northeast)

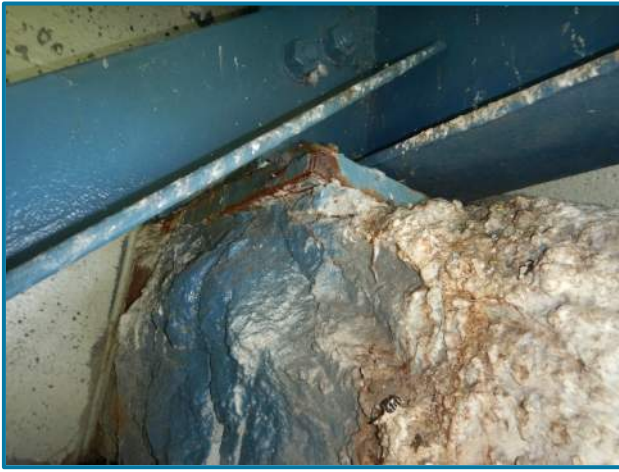
Photo 41 – Bearing seat spalled exposing up to a 1/2" wide by full length of the the masonry plate under Stringer 1 at Anchorage A (looking northwest).

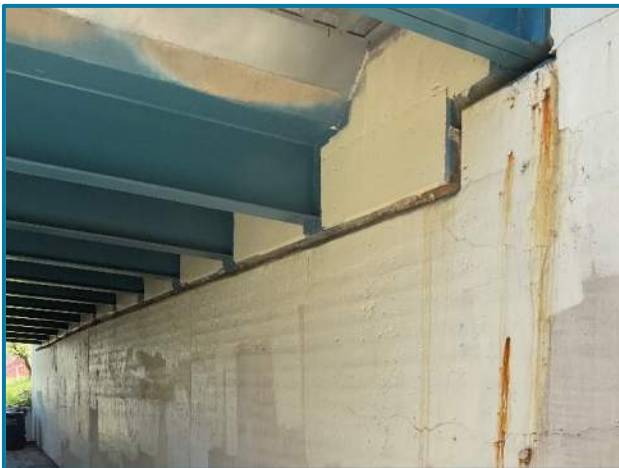
The concealed bearing devices at the semi-integral Forward Abutment are not visible for inspection and no alignment issues were noted in the deck or along the beams (see Photo 44).

Photo 44 – Concealed bearings at Forward Abutment (looking northeast).

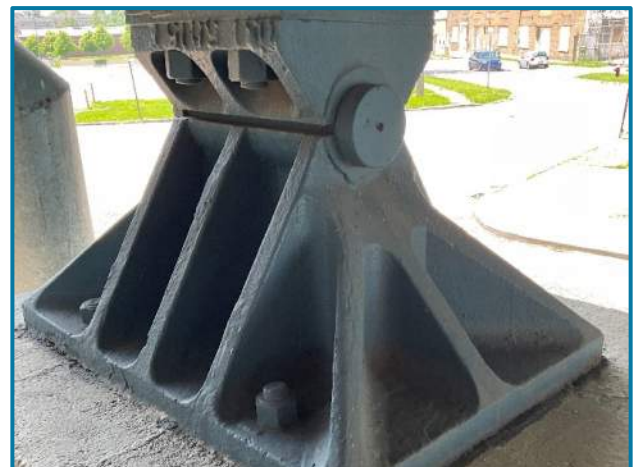
The fixed bearing devices are in good condition overall without any notable deficiencies (see Photo 45).

Photo 45 – Right Girder fixed bearing at Pier 7W (looking southwest).

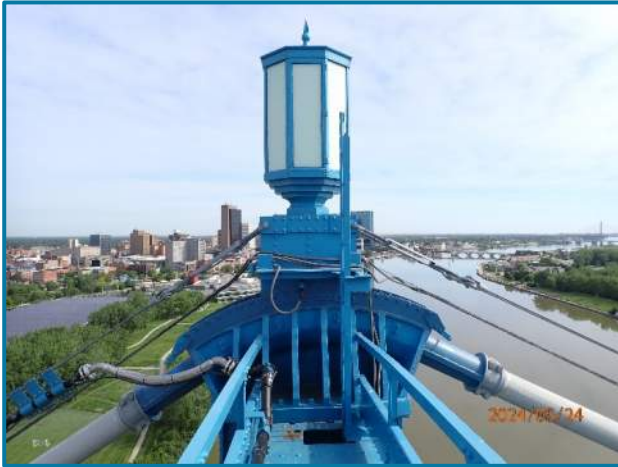
Photo 49 – North Cable saddle at Tower C (looking north).

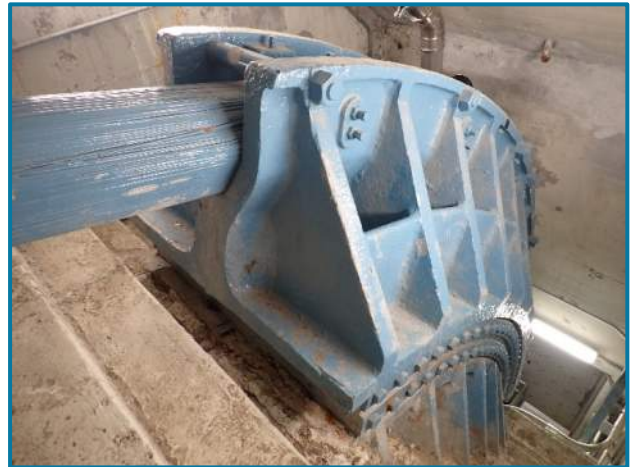
Photo 50 – North Cable saddle in Anchorage A (looking southwest).

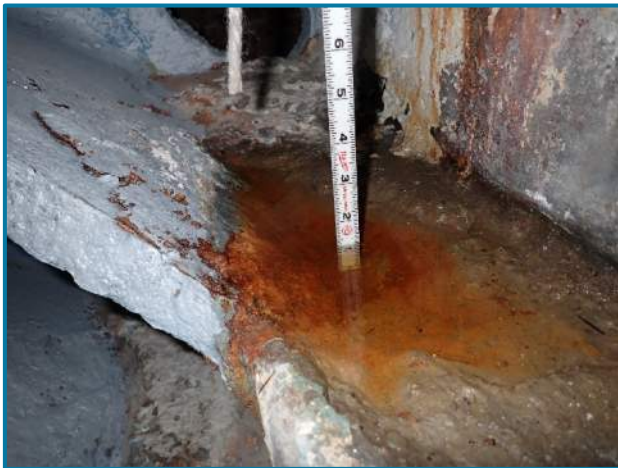
Photo 51 – Water ponding at South Cable saddle in Anchorage F (looking south).

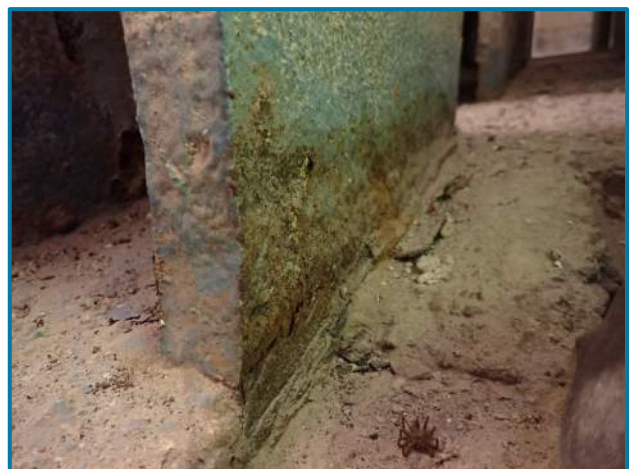
Photo 54 – Typical 1/8" to 3/16" deep pitting at base of the eyebars (looking northeast at the North Cable in Anchorage F).

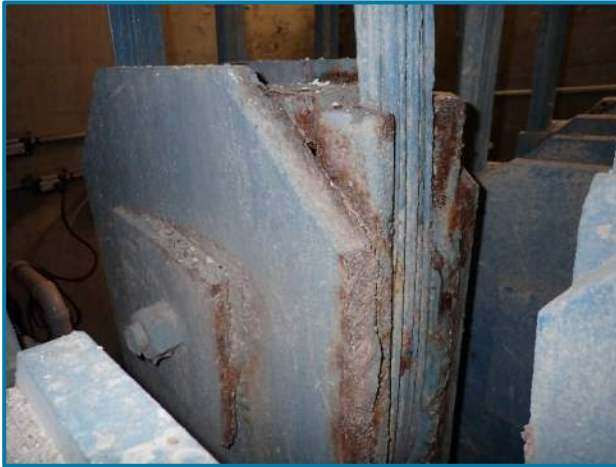
Photo 55 – Active pack rust between the eyebars and strand shoe (looking northwest, North Cable, Anchorage F).

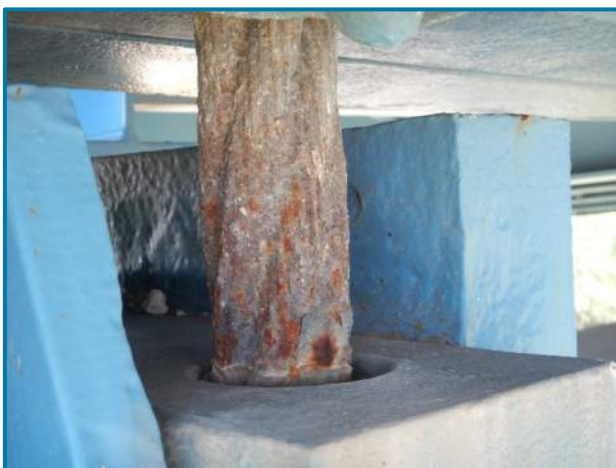
Photo 58 – Corrosion of strand at southwest suspender cable of North Suspender Cable 65 (looking southwest).

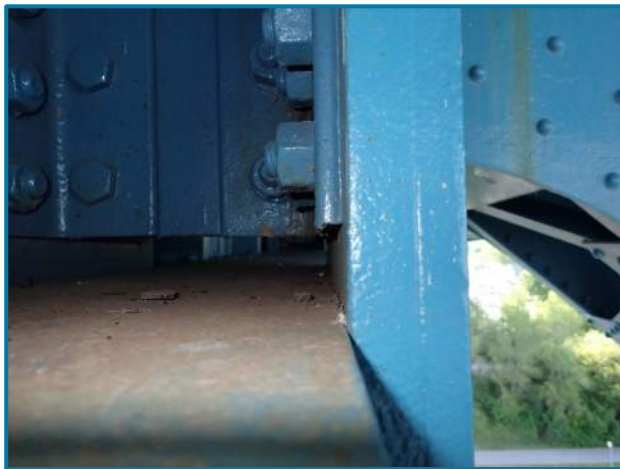
Photo 61 – Contact between link plates and tower pin tie beam at the lower west pin at the north leg of Tower D (looking east).

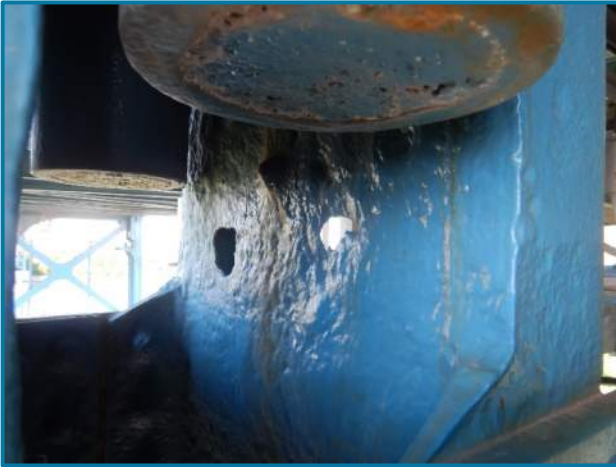
The steel hold-down columns at Pier B and Pier E are in satisfactory condition overall with widespread pitting and numerous corrosion holes. Three of the four columns exhibit perforations to the web of the interior channel under the secondary cable sockets. Most notably, the north channel of the south column at Pier E exhibits full-width 3/16" deep pitting with two perforations up to 2 1/2" in diameter (see Photo 64). Corrosion holes, severe section loss to rivet heads, and severed lattices are typical throughout the lateral and diagonal struts connecting the north and south columns (see Photo 65).

Photo 64 – 3/16" deep pitting with perforations up to 2 1/2" diameter through the north channel of the south column at Pier E (looking northwest).

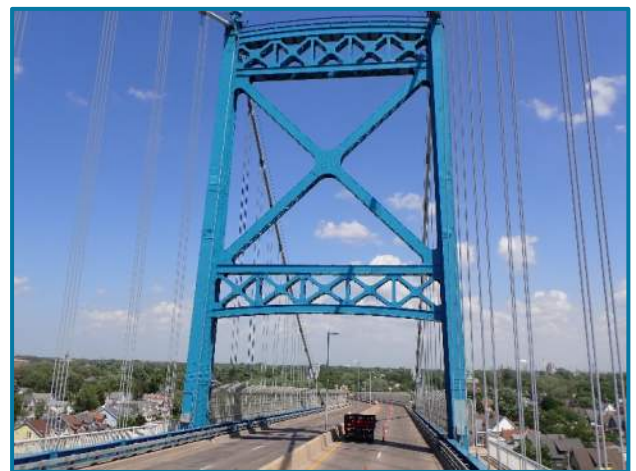
Photo 66 – Tower D, West Elevation (looking east).

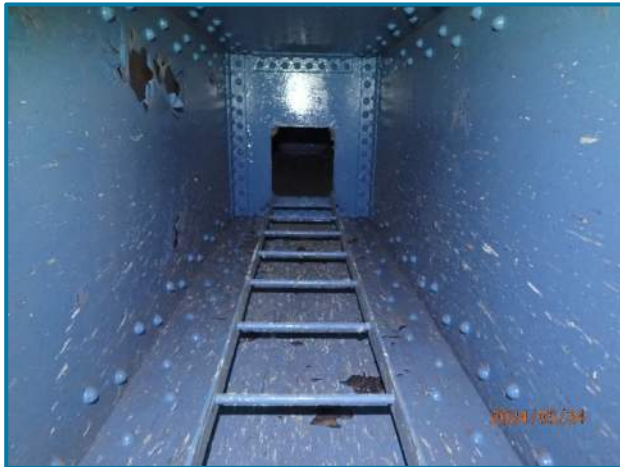
Photo 68 – Typical paint condition and paint flaking of the center cell of Tower D in the north leg (looking north).

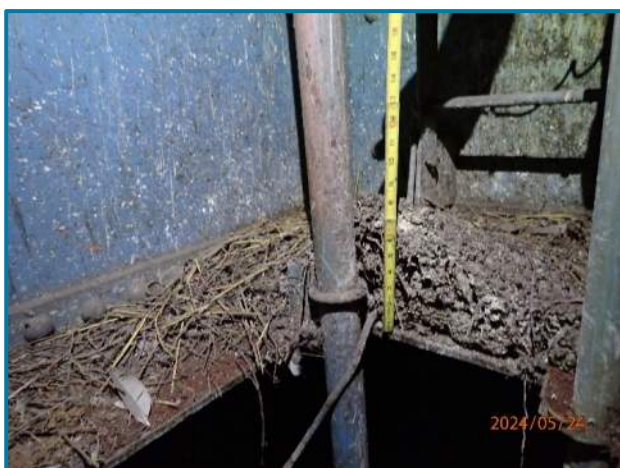
(see Photo 72). Debris accumulation and laminate corrosion up to 7" high by 1" thick is also typical of the center cell of each tower at its base (see Photo 73).

Photo 72 – Heavy accumulation of bird debris in the center cell of Tower D in the south leg, 2nd segment from the top (looking southeast).

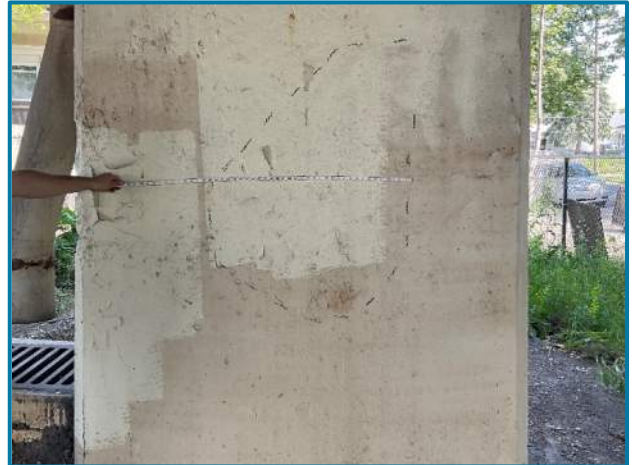
The reinforced concrete pier columns are in good condition. Typically, there are isolated minor spalls, rust stains, and hairline cracking throughout. An isolated 2' wide by 4' high delamination is present on Pier 6E, Column 1 on the south face about 4' above the ground level (see [Photo 74](#)). There is also a minor spall, 18" long by 2" high by 1/2" deep, below a sound patch at the south face of Column 1 at Pier 4W (see [Photo 75](#)).

Photo 74 – Isolated delamination on the south face of Column 1

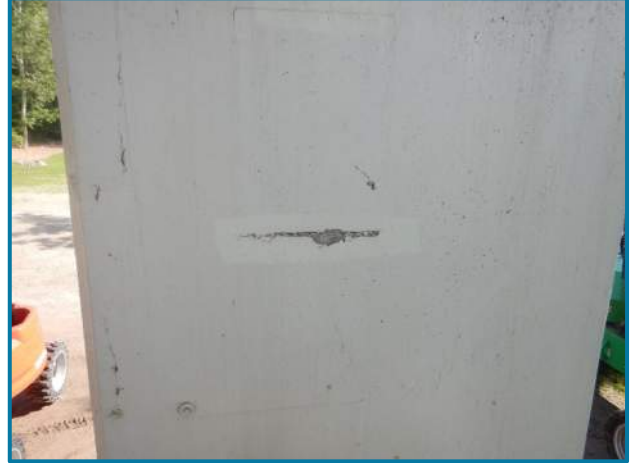
Photo 75 – Isolated spall on the south face of Column 1 at Pier 4W below an existing patched area (looking north).

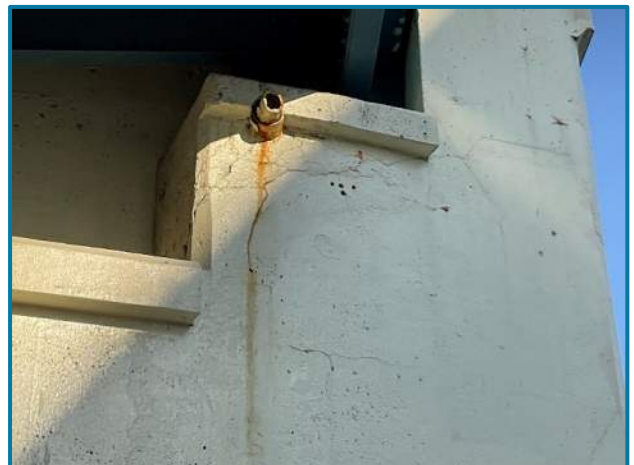
The reinforced concrete abutments are in good condition with minor spalls, isolated delaminations, and hairline cracking throughout. There is an isolated 2' wide delamination with moderate width cracking and rust staining under Beam 1 where a conduit protrudes through the Rear Abutment stem (see [Photo 76](#)) Both the Forward and Rear Abutments exhibit areas of moderate width horizontal and diagonal cracking with rust staining, which have been sealed over (see [Photo 77](#)).

Photo 76 – Isolated 2' wide delamination and rust staining from the existing conduit at the Rear Abutment under Beam 1 (looking west).

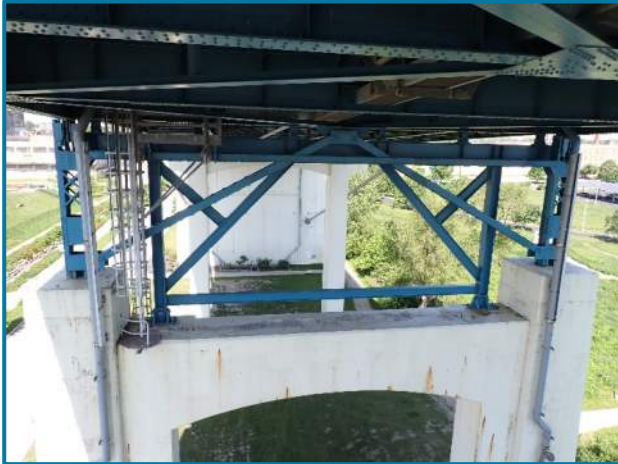
The steel pier caps are in very good condition overall without any notable deficiencies (see Photo 78). As previously noted, the bearing pins at Pier E remain unpainted, however, the bearing pin nuts have since been painted.

Photo 78 – Steel Pier Cap frame at Pier B (looking west).

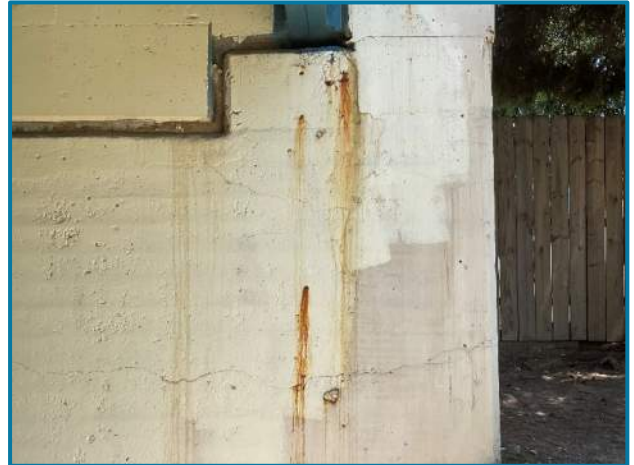
Photo 77 – Typical areas of moderate width horizontal and diagonal cracking with rust staining at the Forward Abutment under Stringer 13 (looking east).

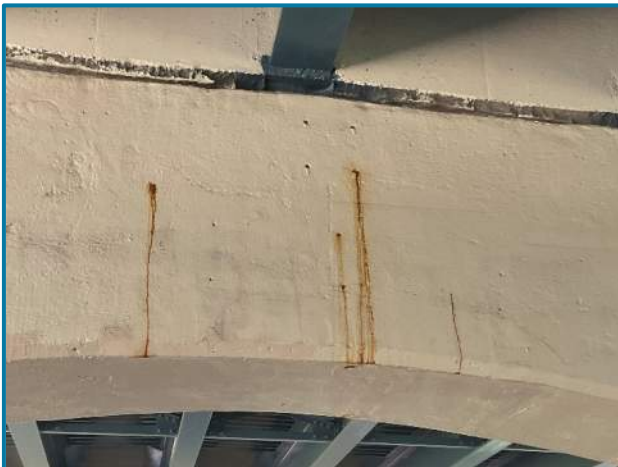
The reinforced concrete pier caps are in good condition with isolated spalls and hairline horizontal and vertical cracks throughout. Minor rust staining is typical of most pier caps (see Photo 79). There is a 2' wide by 6" high by 3" deep spall on the west face of the Pier 11E cap under Beam 11. The spall does not undermine the masonry plate or bearing area (see Photo 80). The east face of the Pier 13E cap under Stringer 2 exhibits a 3' long moderate width unsealed horizontal crack.

Photo 79 – Typical minor rust staining on the east face of the Pier 9E cap (looking west).

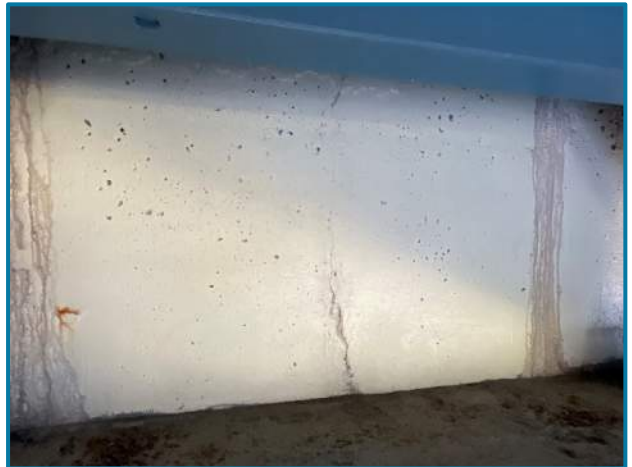
The abutment backwalls are in good condition with hairline cracking throughout. One previously noted 2' wide delamination is present between Beams 11 and 12 on the Rear Abutment backwall (see [Photo 81](#)).

Photo 81 – Hairline cracking and isolated 2' wide delamination on the Rear Abutment backwall between Beams 11 and 12 (looking west).

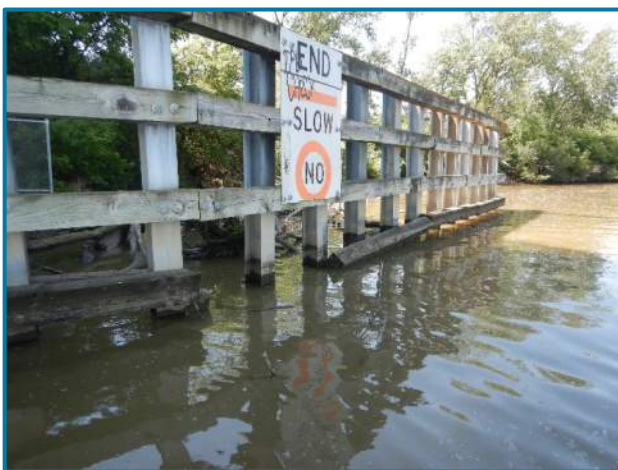
The pier protection is in satisfactory condition overall. Pier protection at Tower C is comprised of a system of steel piles and timber walers. Scattered checks and isolated dry rot of timbers is typical. Multiple walers have loose or missing fasteners, however, most remain intact, and one timber waler is missing (see [Photo 83](#)). The northernmost pile has poor-quality welds at the splice near the waterline (see [Photo 84](#)). Pier protection at Tower D is comprised of steel sheet piling in front of a concrete retaining wall. Sheet piling exhibits minor surface corrosion without section loss.

Photo 83 – Missing timber waler at Tower C pier and one waler with several missing fasteners (looking northwest).

8. Replace the missing timber waler and secure the loose timber walers to the piles.

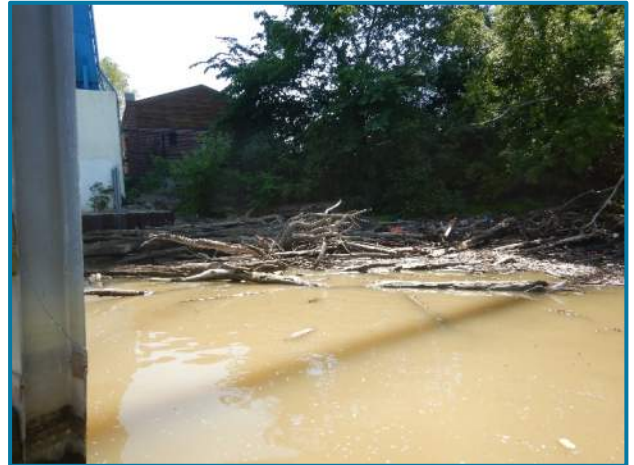
The channel is in GOOD CONDITION [7-NBIS] overall with no known obstructions, slumping or erosion noted through visual inspection. Minor debris has accumulated behind the north side of the pier protection at Tower C (see Photo 85). Typical channel views are shown in Photos 86 and 87.

Photo 85 – Debris accumulation behind the north end of pier protection at Tower C (looking west).

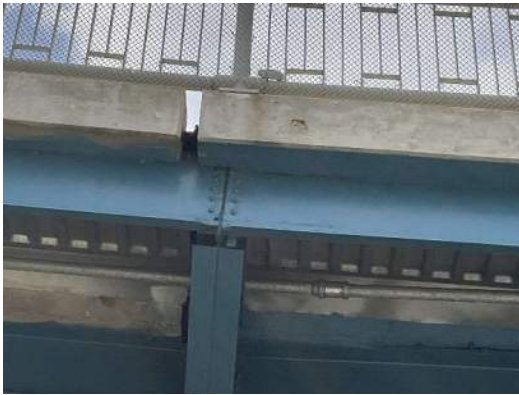
Photo 8W-001: Typical connection painted over section loss on north face of S1 at midspan sidewalk bracket, looking south

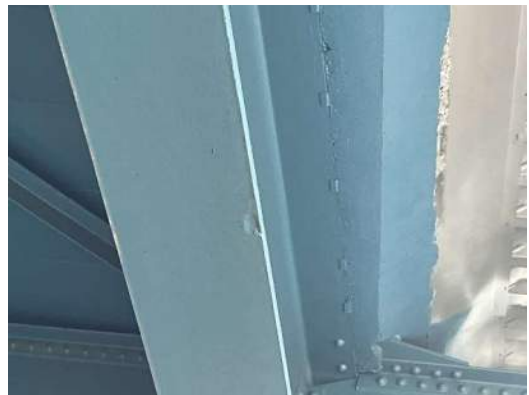
Photo 8W-002: Painted over gouge (3" long) on bottom flange of S13, between midspan sidewalk bracket and intermediate sidewalk bracket west of midspan

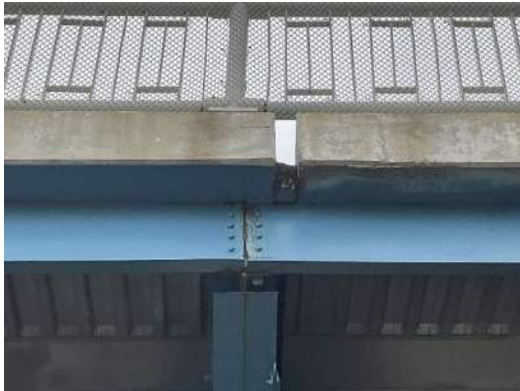
Photo 8W-003: Typical connection painted over section loss on south face of S14 at midspan sidewalk bracket, looking north

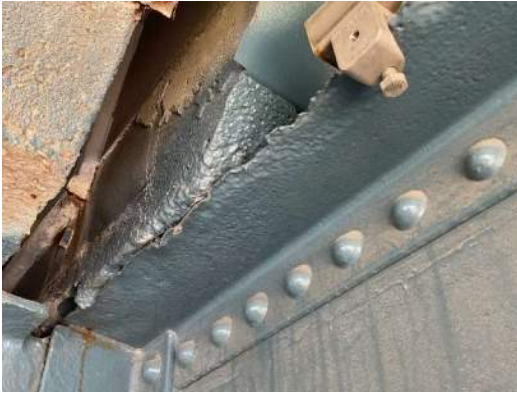
Photo 7W-001: Painted over 100% section loss on top flange of FB0 north overhang at LS2

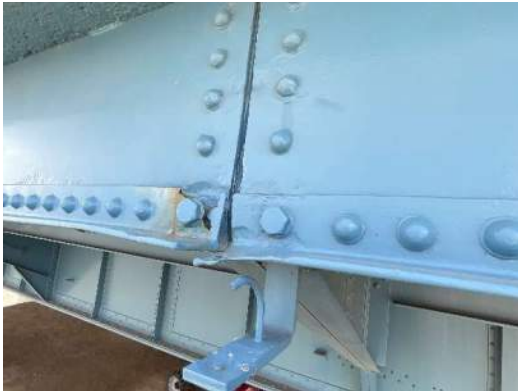
Photo 7W-003: Pack rust and painted over section loss at FB1 north overhang, at LS2, with minor active corrosion

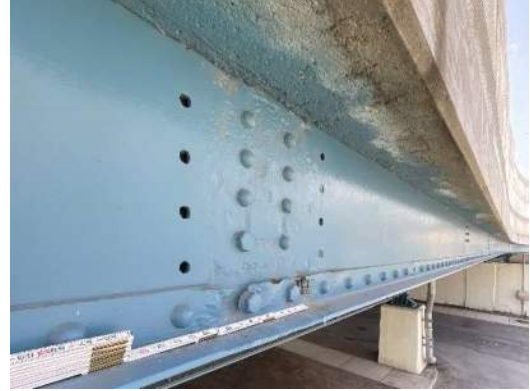
Photo 7W-004: Pack rust and painted over section loss on FB2 north overhang, at LS2, looking southwest

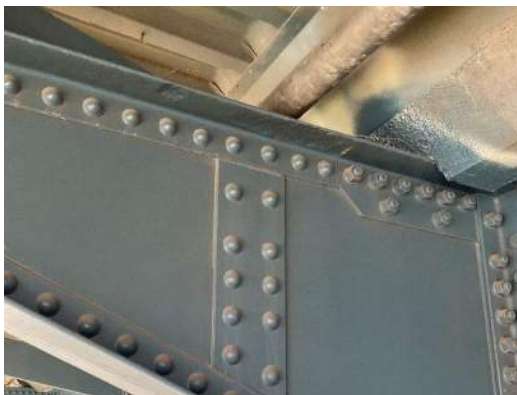
Photo 7W-005: Painted over pitting on top flange of FB2 north overhang, near LS1, looking west

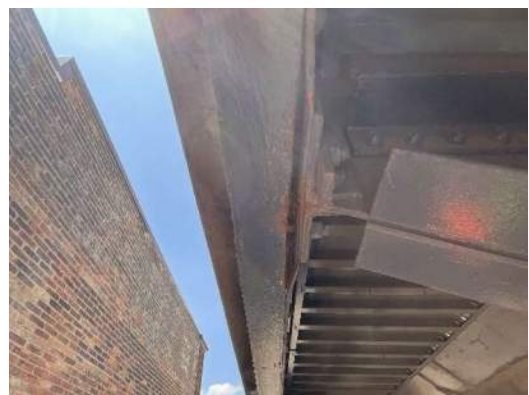
Photo 7W-006: Pack rust between bottom angle/web of stringer RS2 at FB2, looking west

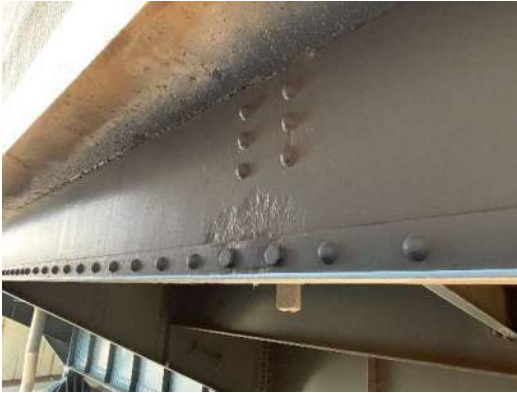
Photo 7W-007: Painted over pitting on south face of RS2, near FB2, looking northwest

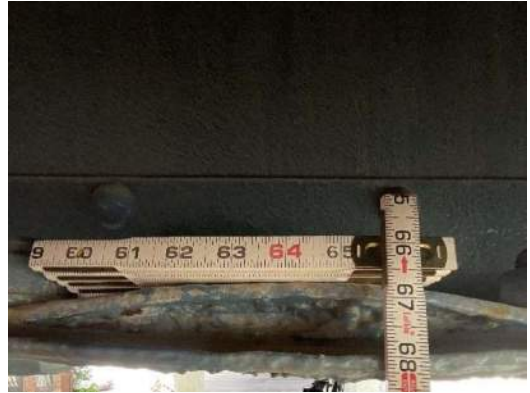
Photo 7W-008: Pack rust along the east face bottom flange of FB3 in multiple locations between S1 and S4, looking west

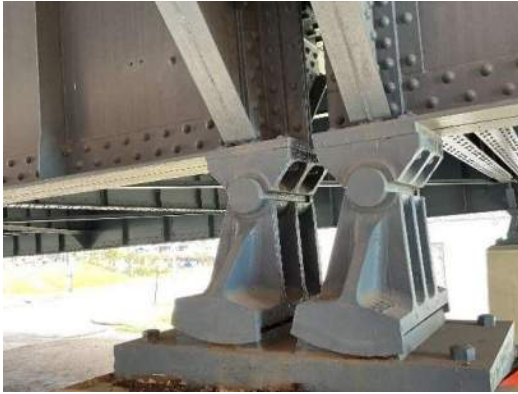
Photo 6W-001: Bearing tilted 10 degrees to the east at Pier 6W south bearing, looking north

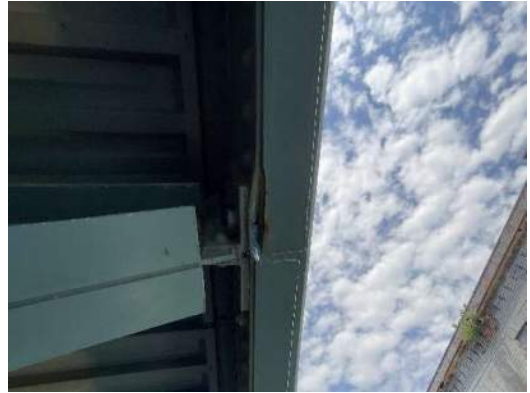
Photo 6W-002: Pack rust between bottom angle/web of stringer LS2 at FB1, looking west

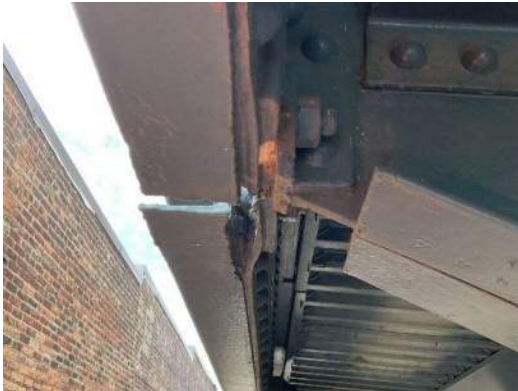
Photo 6W-003: Pack rust between bottom angle/web of stringer RS2 at FB1, looking west

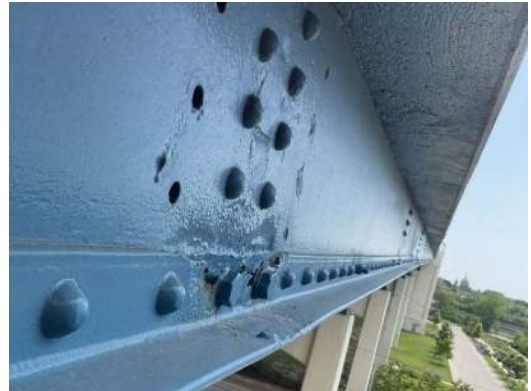
Photo 6W-004: Pack rust causing separation of bottom flange angle to web, with painted over 100% section loss, at FB2 south overhang, at RS2, looking east

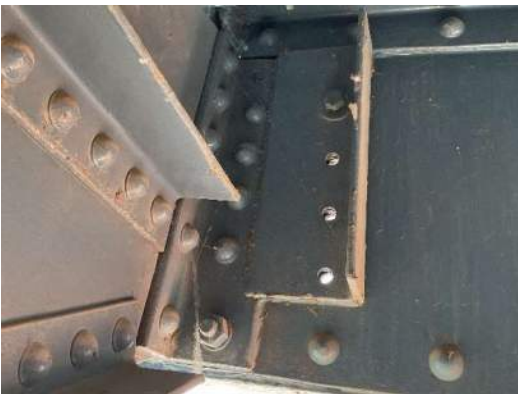
Photo 6W-005: Three missing bolts on stiffener angle on FB2 south overhang, at RS2

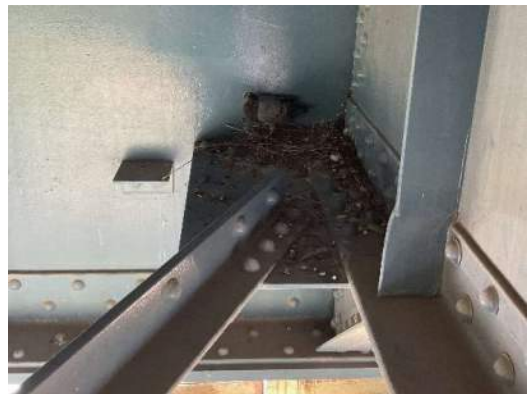
Photo 6W-006: Granular and bird debris on lateral bracing connection plate on east side of Right Girder at FB2, looking south

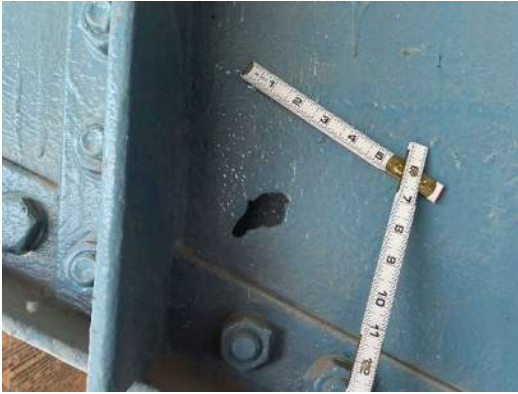
Photo 5W-001: 100% section loss and painted over pitting throughout east face web of FB0, between RS1 and RS2

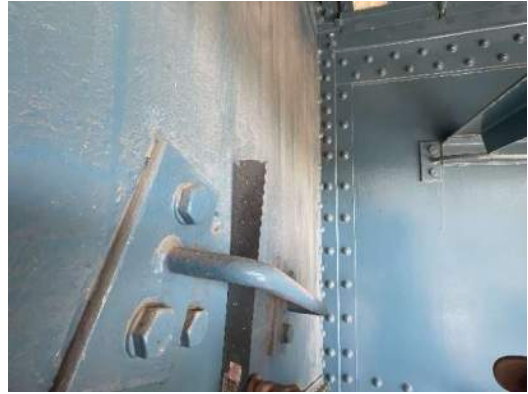
Photo 5W-002: Minor bowing to FB0, between RS1 and RS2

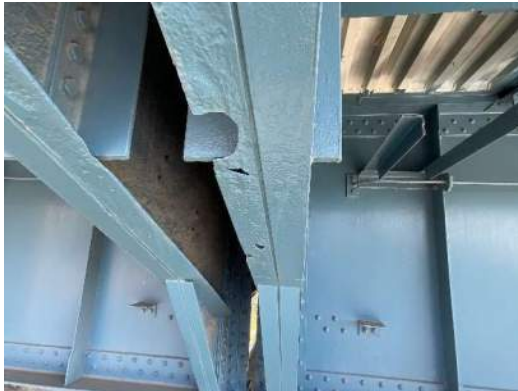
Photo 5W-003: 100% painted over section loss on bottom flange of FB0 south overhang, between RS1 and RS2

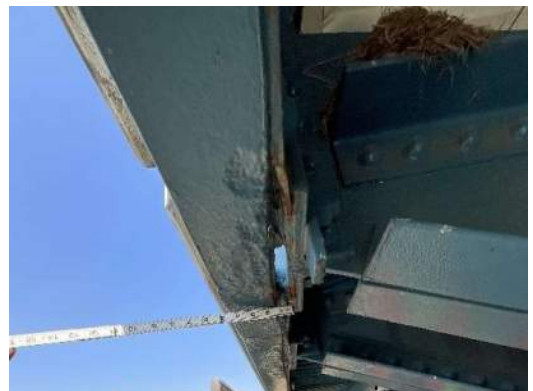
Photo 5W-004: 100% section loss on bottom flange angle of RS2 at FB0, with pack rust causing gap between stringer web and bottom flange

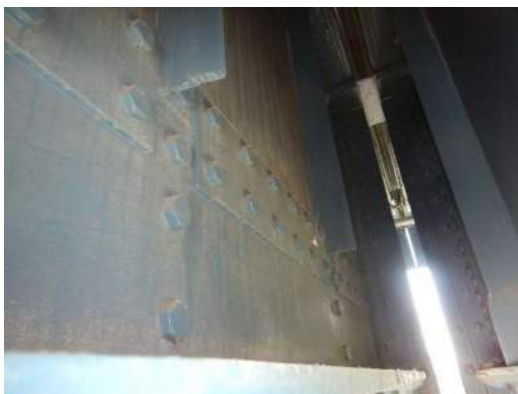
Photo 5W-005: 12" flame cut from bottom of stiffener on FB3 east face, at Left Girder, looking north

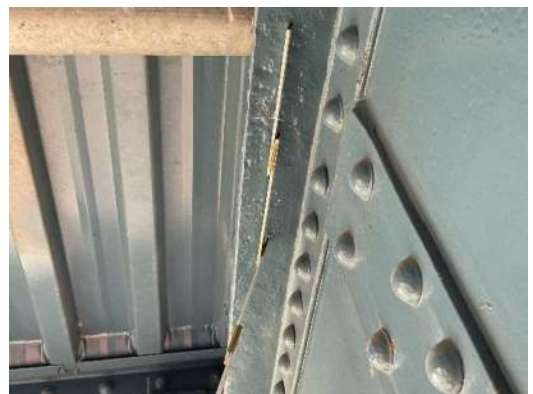
Photo 5W-006: Minor perforations in top flange of FB2 north overhang, near LS1, looking south

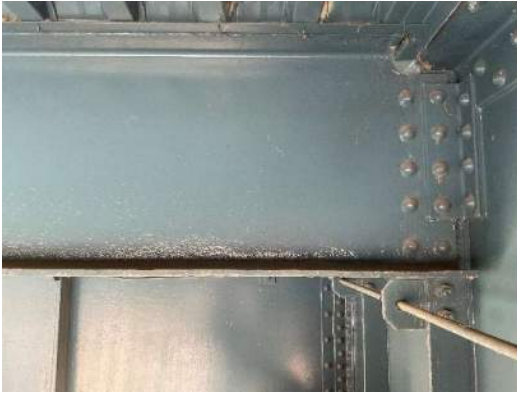
Photo 5W-007: Painted over pitting on south face web of S1, at FB2, looking north

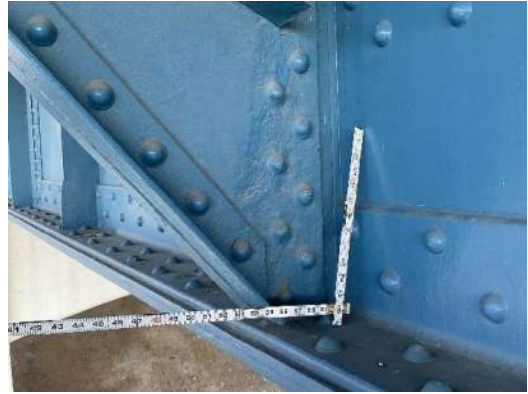
Photo 5W-008: Painted over pitting near FB2 and RS1 interface

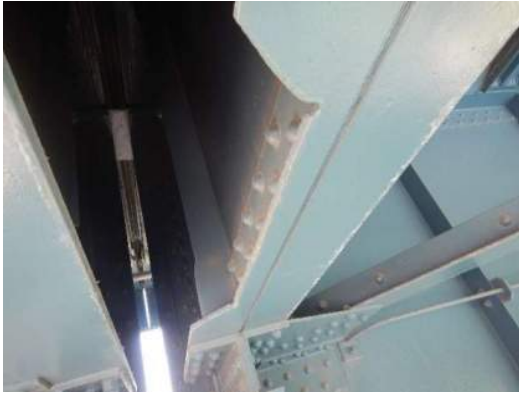
Photo 4W-001: Coped bottom flange (13" length) on FB0 near Left Girder, looking northwest

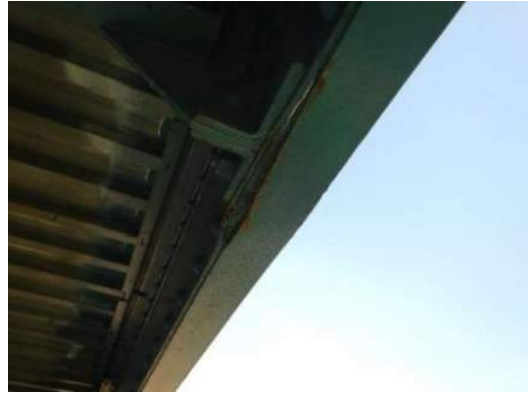
Photo 4W-002: 1/2" thick pack rust between sidewalk cantilever connection on LS2 between FB1 and FB2, looking northeast

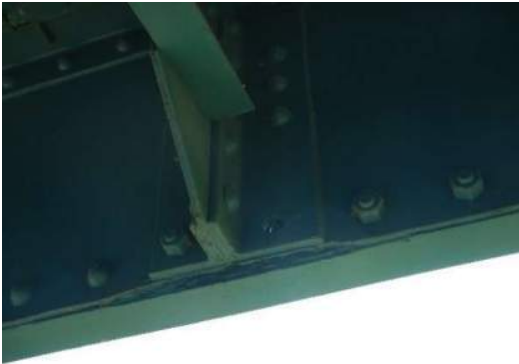
Photo 4W-003: Missing bolt at utility hanger connection on LS2 between FB3 and FB4, looking north

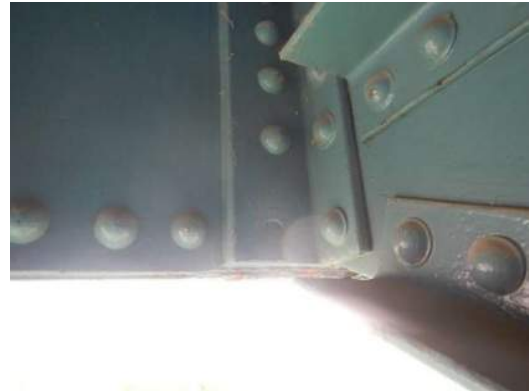
Photo 4W-004: Popped rivet head at the LS2 and FB4 connection, looking northwest

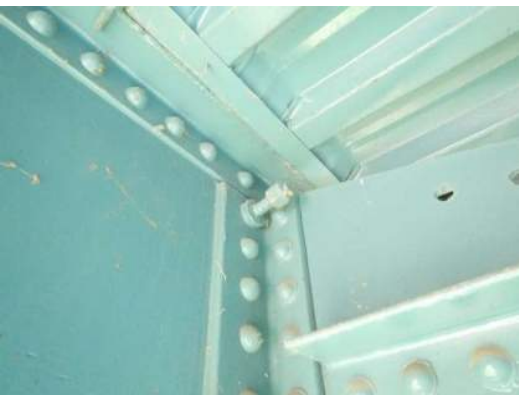
Photo 4W-005: Bolt backed off 2" at the LS2 and FB4 connection, looking northwest

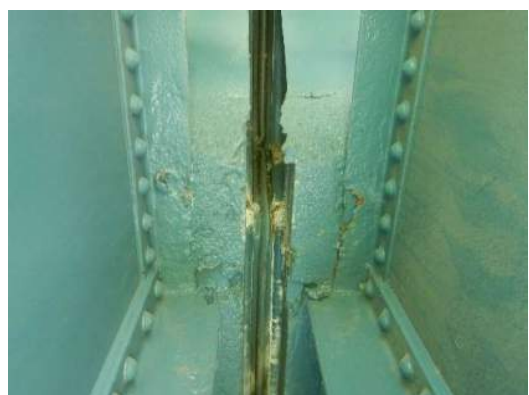
Photo 4W-006: Section loss up to 100% (2" long by 1" wide) on east side of FB4 top flange between LS1 and LS2, looking south

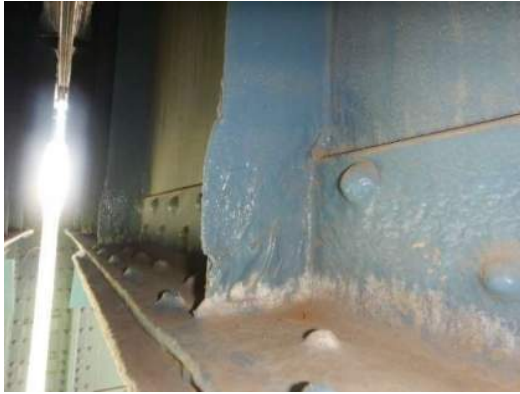
Photo 4W-007: Painted over section loss with caulking at stiffener base on east face of FB4 near S4, looking northwest

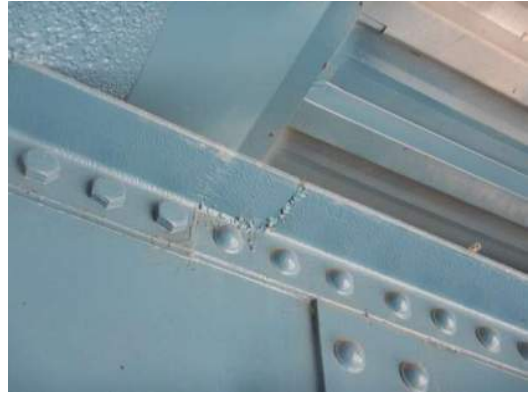
Photo 4W-008: Transverse weld in top flange of FB4 south cantilever between RS1 and RS2, looking southeast

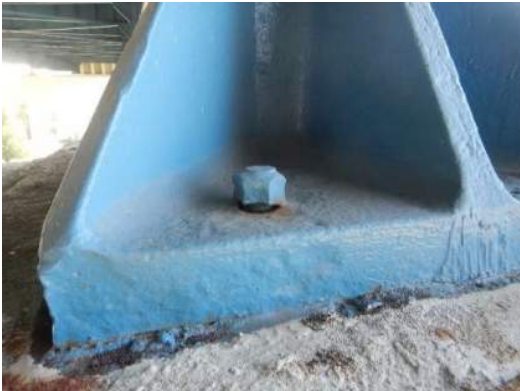
Photo 4W-009: Up to 50% section loss in northwest anchor rod of pier 3W Right Girder bearing, looking southeast

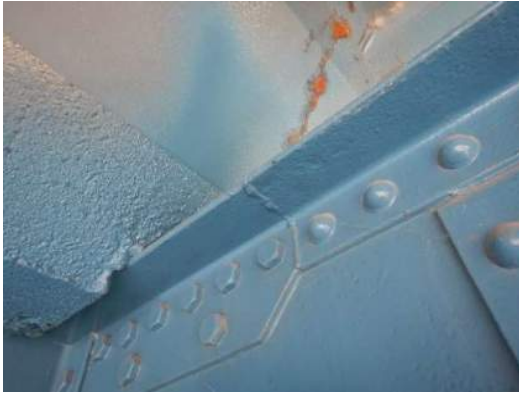
Photo 3W-001: Transverse weld in top flange of FB2 south cantilever between RS1 and RS2, looking east

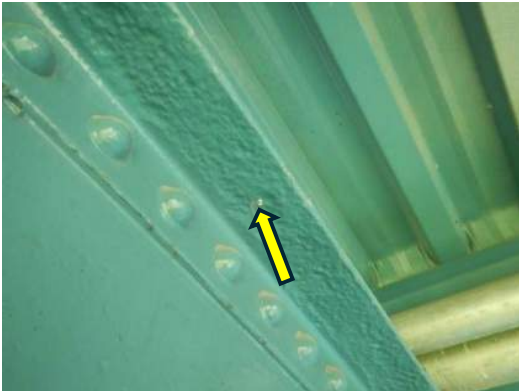
Photo 3W-003: 100% section loss (1/4" diameter) in top flange of FB3 east face between LS1 and LS2, looking northwest

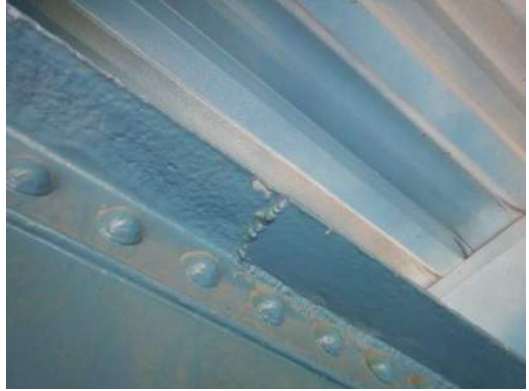
Photo 3W-004: Transverse weld in top flange of FB3 south cantilever between RS1 and RS2, looking west

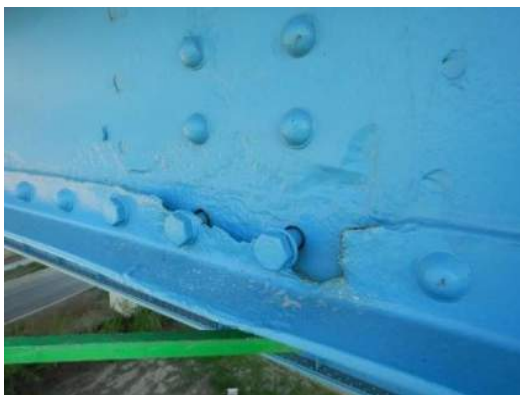
Photo 3W-005: 100% section loss by full height of vertical angle on exterior angle of RS2 near FB4, looking north
