PHYSICAL CONDITION REPORT
2024 ROUTINE ELEMENT LEVEL AND NSTM
INSPECTION

INSPECTION MAY 2024
REPORT AUGUST 2024

ANTHONY WAYNE BRIDGE
LUC-002-1862
SFN: 4800303

Ohio Department of Transportation, District 2
317 E Poe Rd
Bowling Green, OH 43402

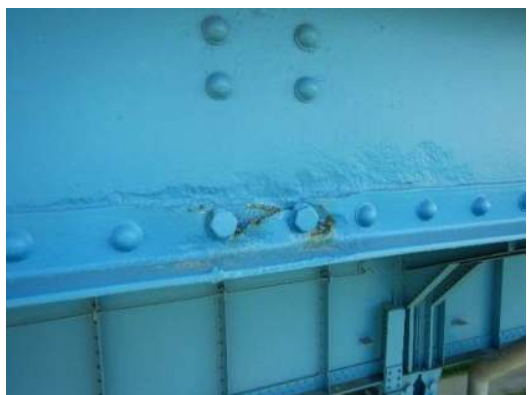
Photo 3W-006: 100% section loss by full height of vertical angle on exterior angle on RS2 between FB4 and FB5, looking north

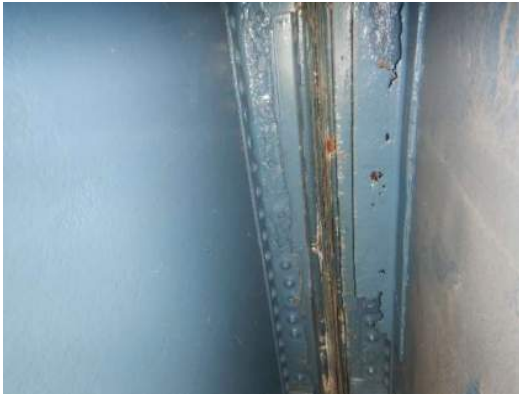
Photo 3W-007: 100% section loss throughout flanges and stiffeners on FB5 at north cantilever, looking up and south

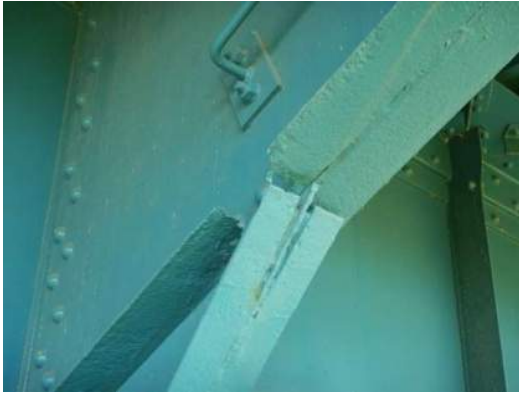
Photo 1W-001: 100% section loss on FB4 north cantilever bracket bottom flange, looking up and south

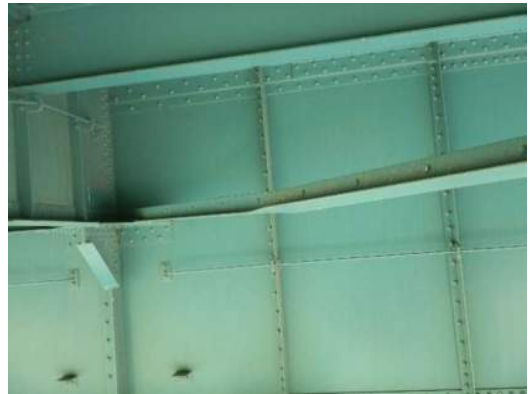
Photo 1W-002: Distorted and twisted up to 2' long on north lateral bracing between FB4 and FB5, looking north

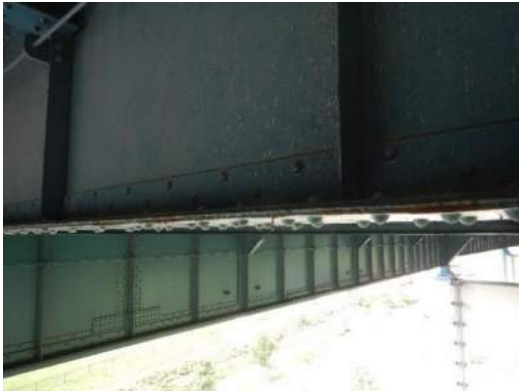
Photo 1W-003: Up to 1/2" thick pack rust between bottom flange and cover plate on FB4 at S3, looking southeast

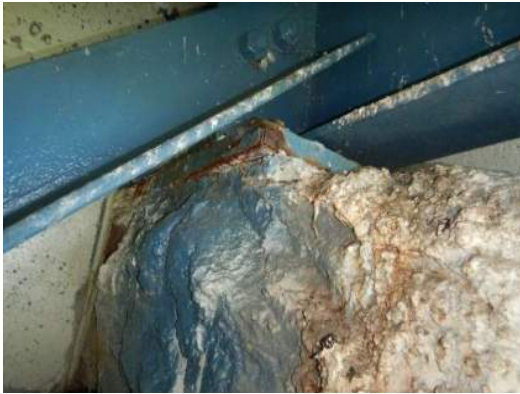
Photo RW-2-001: Spall undermining masonry plate (6" long by 1/2" deep) at anchorage A S1 bearing, looking northwest

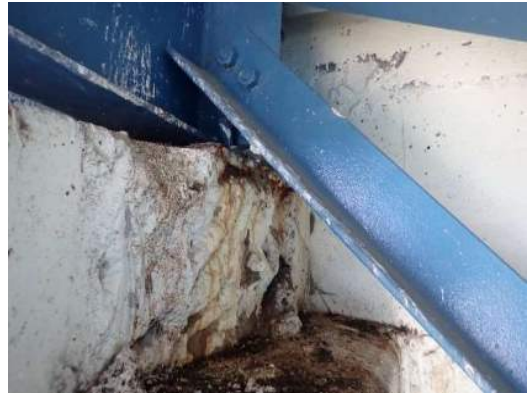
Photo RW-2-002: Beginning of undermining with slight section loss of bearing area (2' wide by 2' high by 2" deep) at anchorage A S2 bearing, looking southwest

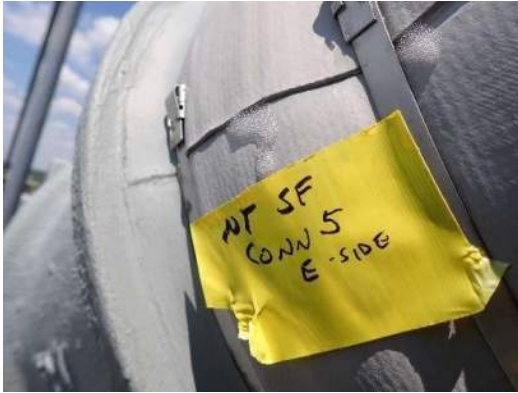
Photo NC-001: Main cable at suspender cable 5, leak, east end, south face

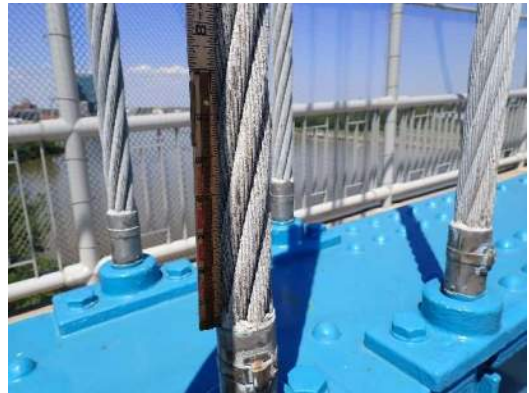
Photo NC-002: Suspender cable 8, coating failure

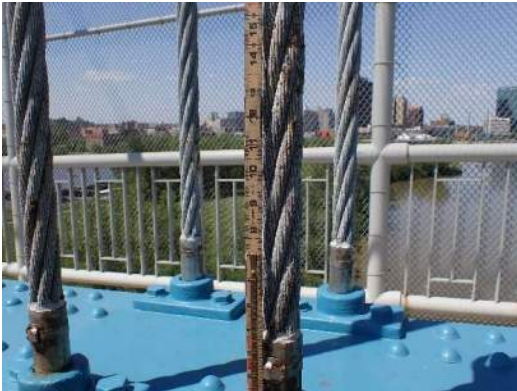
Photo NC-003: Suspender cable 10, areas of surface corrosion with active rust

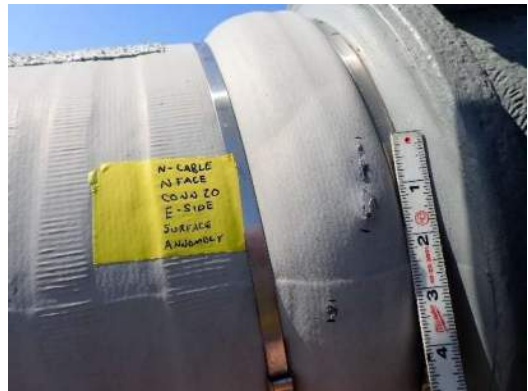
Photo NC-004: Main cable at suspender cable 20, surface defect, left and right side of connection, north face

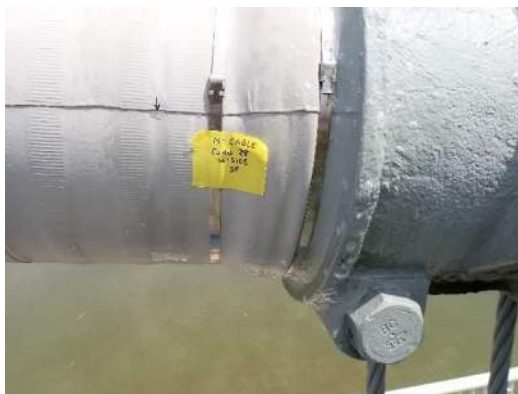
Photo NC-005: Main cable at suspender cable 28, two leaks, west end, south face

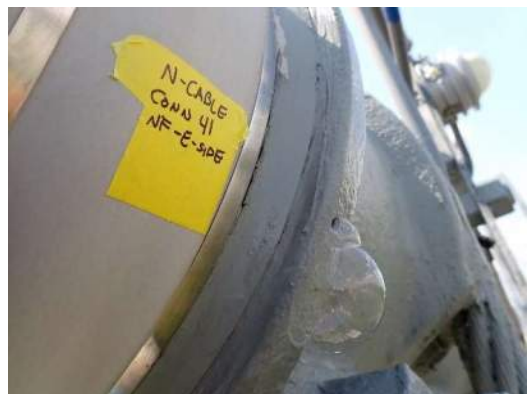
Photo NC-006: Main cable at suspender cable 41, connection leakage, east end, north face

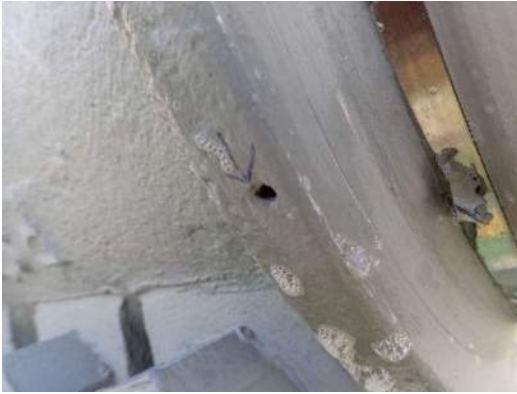
Photo SC-001: Main cable at suspender cable 2, leak, east end, north face

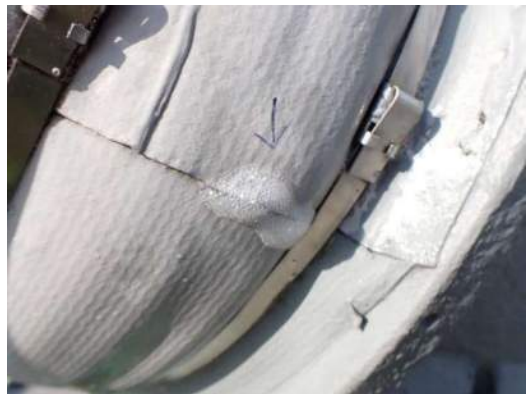
Photo SC-002: Main cable at suspender cable 5, slight leak at tape seam, east end, south face

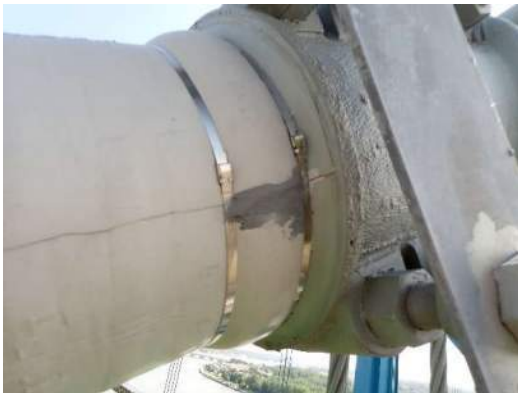
Photo SC-003: Main cable at suspender cable 9, slight leak at tape seam, west end, north face

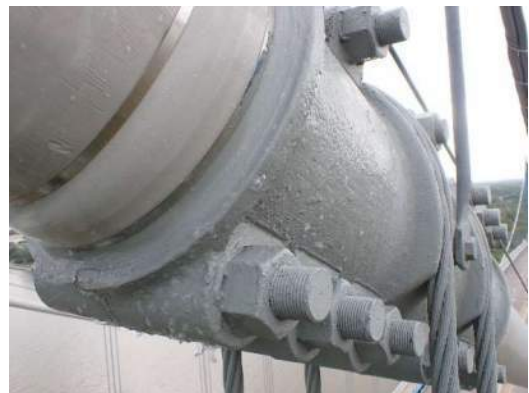
Photo SC-004: Main cable at suspender cable 15, leak, west end, south face

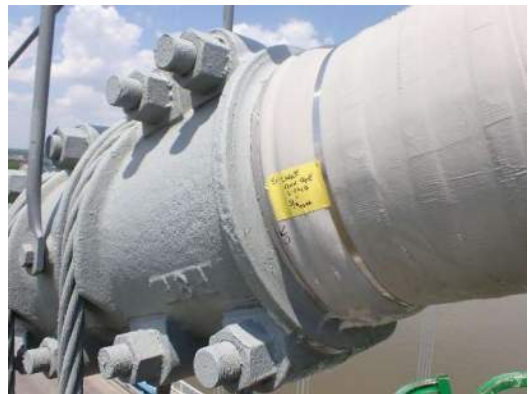
Photo SC-006: Main cable at suspender cable 46, leak in cable gouge, east end, south face

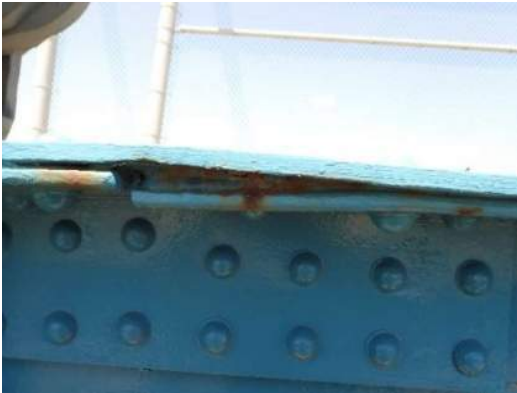
Photo WS-001: Pack rust between top flange plates of Left Girder at FB0, looking north

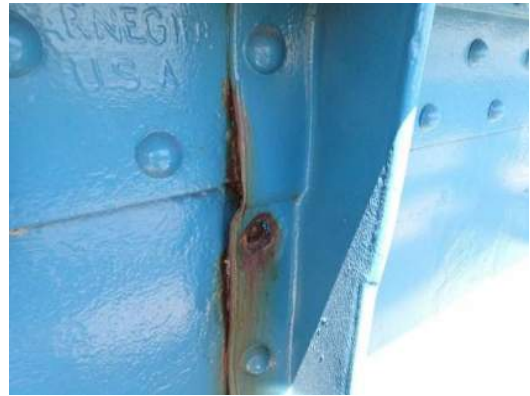
Photo WS-002: Punched hole with missing rivet at transverse stiffener on Left Girder south face east of FB0, looking northeast

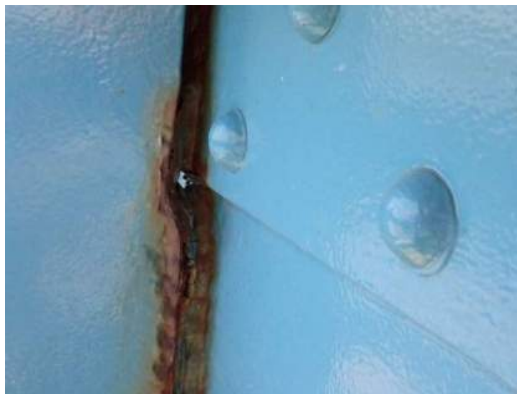
Photo WS-003: Kneebrace with 3/4" thick pack rust and up to 100% section loss on Left Girder south face at FB0, looking northwest

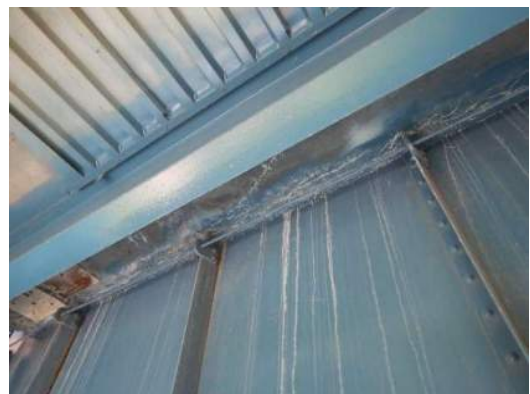
Photo WS-004: Typical efflorescence staining on Left Girder web, between FB0 and FB1

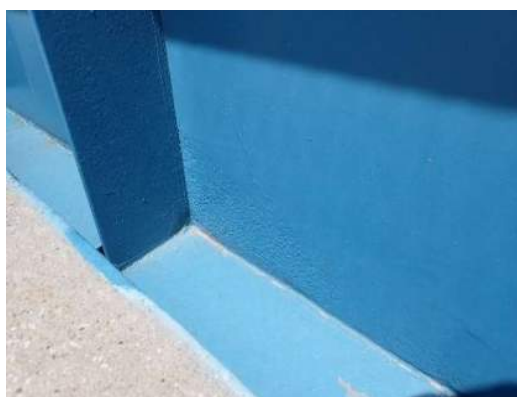
Photo WS-005: Pitting to the web of the Right Girder, near FB1

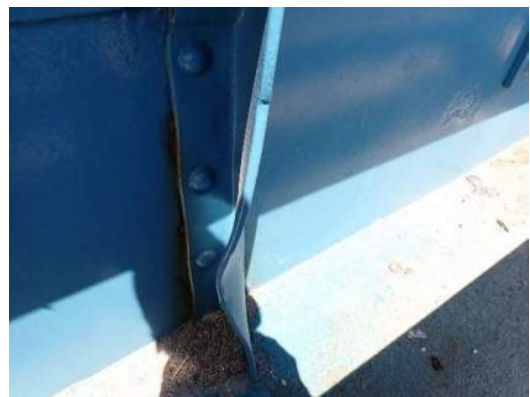
Photo WS-006: 2 1/4" impact damage to transverse stiffener outstanding leg on Left Girder south face east of FB1, looking north

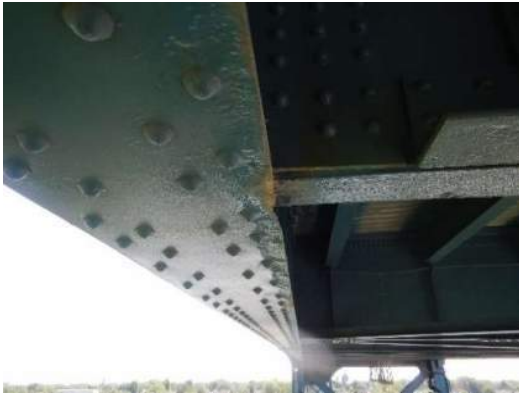
Photo WS-007: Section loss (20' long by 2" wide by 3/16" deep) on bottom flange of Left Girder near FB2, looking northeast

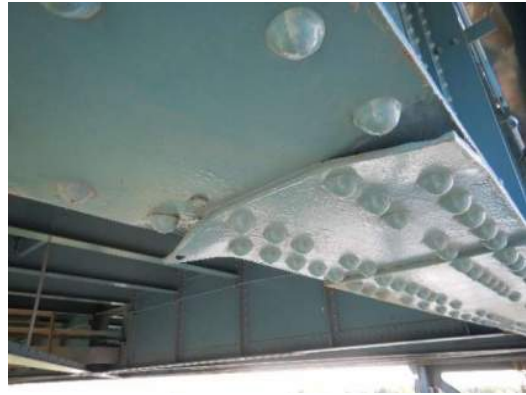
Photo WS-008: Section loss (3" wide by 1/4" deep) on bottom flange of Right Girder between FB3 and FB4

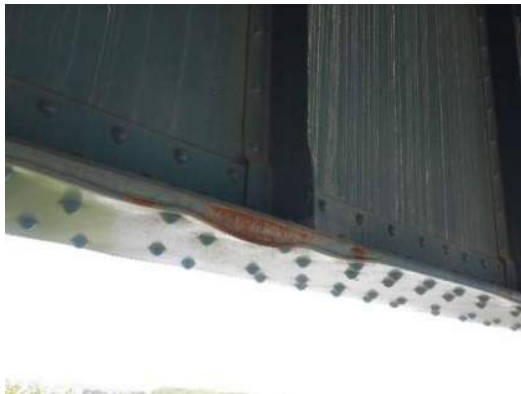
Photo WS-009: Pack rust between bottom flange plates on Left Girder between FB4 and FB5, looking northeast

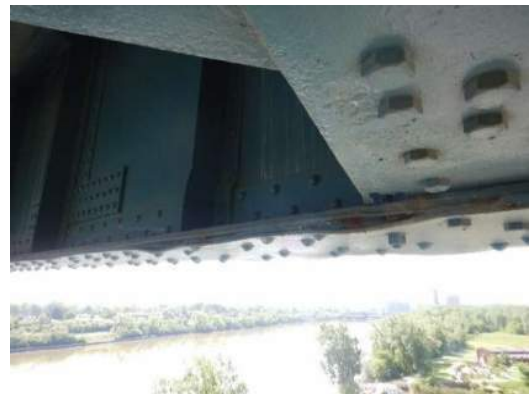
Photo WS-010: Pack rust between bottom flange plates on Right Girder between FB5 and FB6, looking southeast

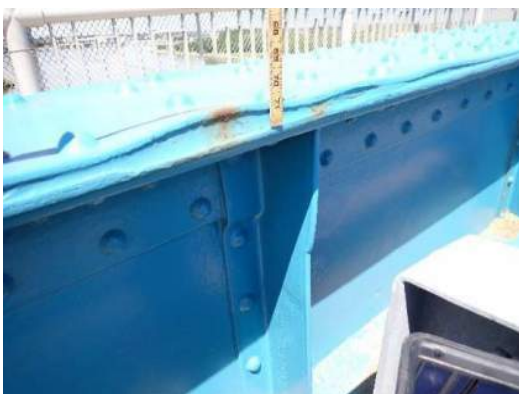
Photo WS-011: Pack rust between top flange plates on Left Girder between FB6 and FB7, looking northeast

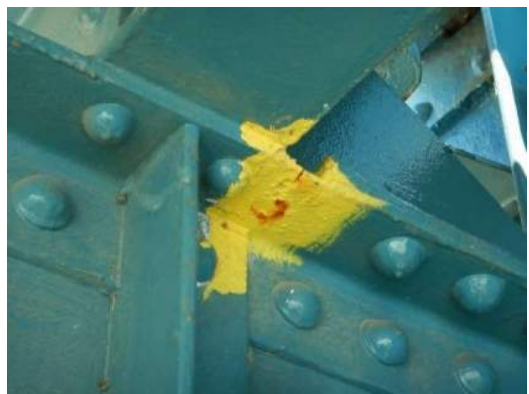
Photo WS-012: Top flange cracked on east side of FB10 south cantilever between Right Girder and RS1, looking northwest

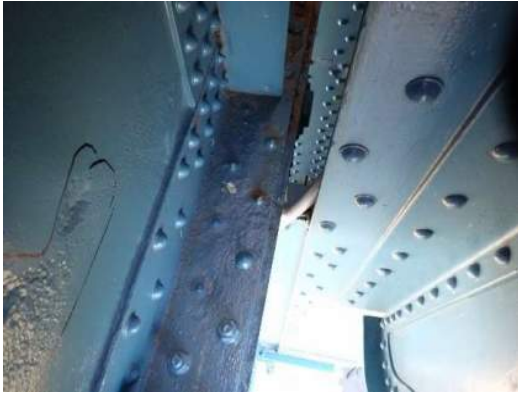
Photo MS-001: Rivet heads up to 100% section loss on north face of Left Girder bottom flange east of FB13, looking southwest

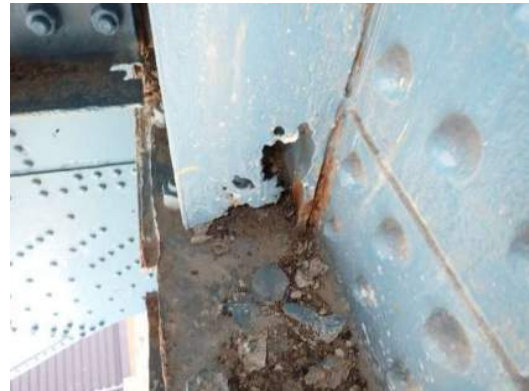
Photo MS-004: 100% section loss to transverse stiffener on Left Girder near FB13

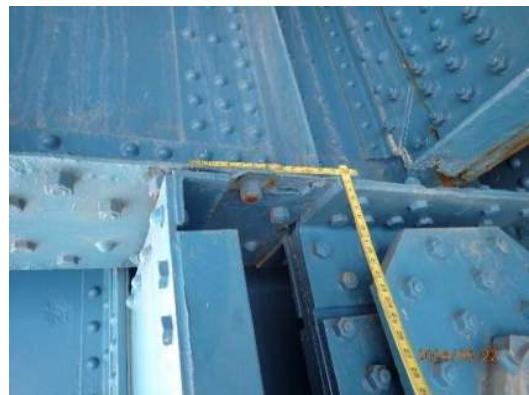
Photo MS-006: 1' long by 3" wide corrosion hole in Right Girder bottom flange north face at FB13, looking southwest

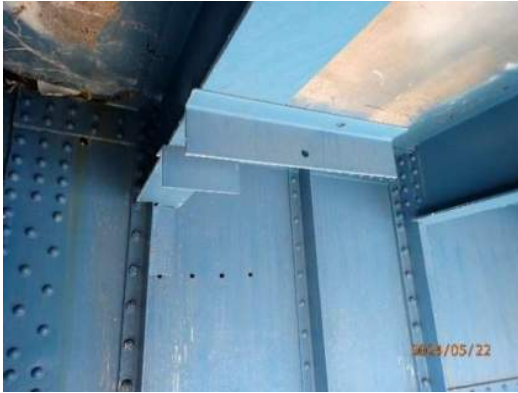
Photo MS-007: Stray angles welded longitudinally along S11 bottom flange on east side of FB13, looking northwest

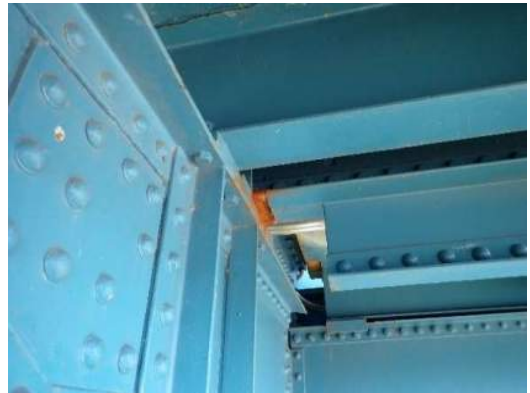
Photo MS-008: South sidewalk Stringer RS2 at FB13 with signs of expansion/contraction (2" on east side, 4" on west side), looking northwest

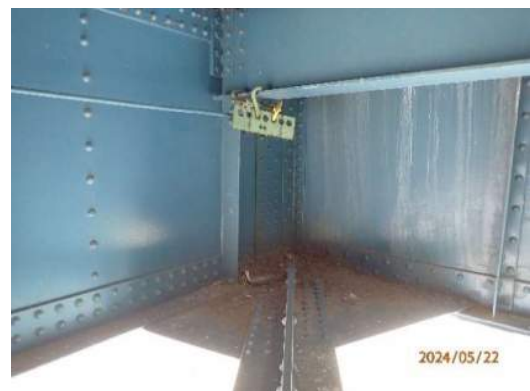
Photo MS-010: Abandoned rigging along bottom flange of S11 west of FB14, looking southeast

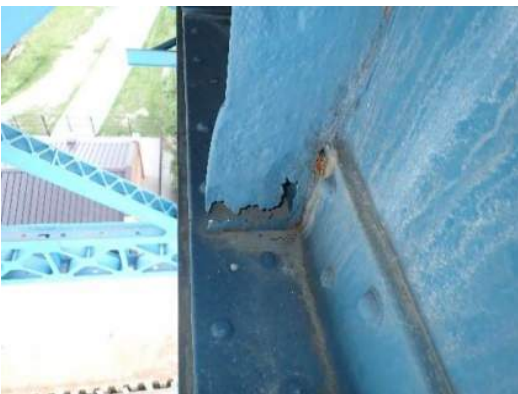
Photo MS-011: 100% section loss (3" high by full width) to transverse stiffener at bottom flange of Left Girder between FB14 and FB15, looking northwest

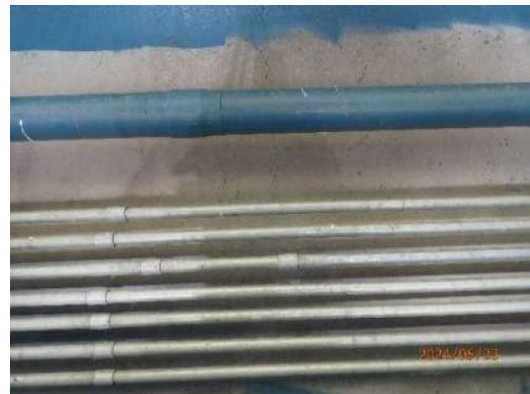
Photo MS-012: Area map cracking (3' long by full width) on underside of deck between LS1 - LS2 and FB16 - FB17, looking south

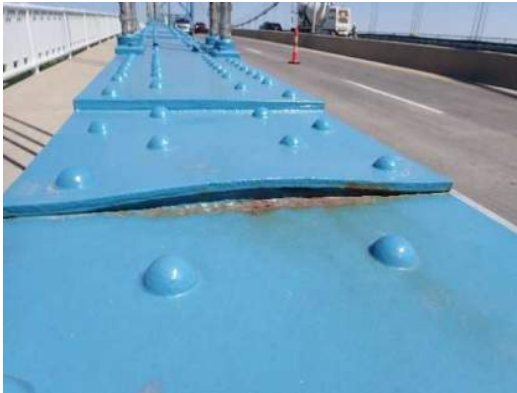
Photo MS-013: 12" wide by 3/4" thick pack rust between top flange and cover plate on Left Girder between FB16 and FB17, looking east

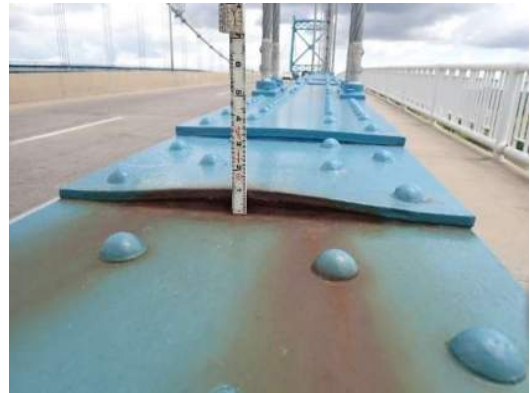
Photo MS-014: 3/4" thick pack rust between top flange plate and cover plate on Right Girder between FB17 and FB18

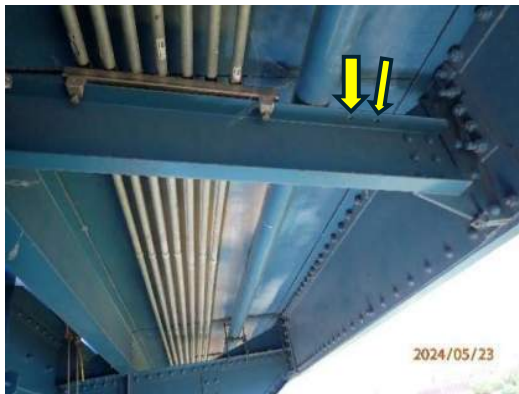
Photo MS-015: Two 3/4" diameter holes through top flange north overhang utility hanger between FB17 and FB18, looking west

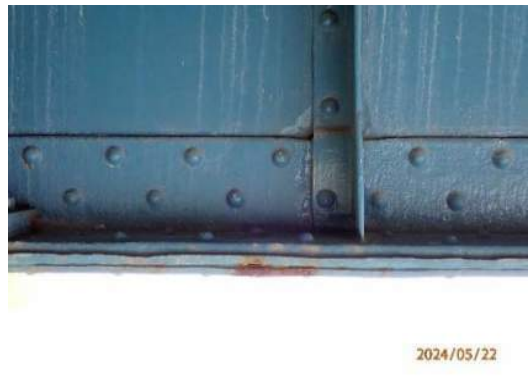
Photo MS-016: Pack rust between bottom flange plates of Left Girder south face between FB18 and FB19, looking north

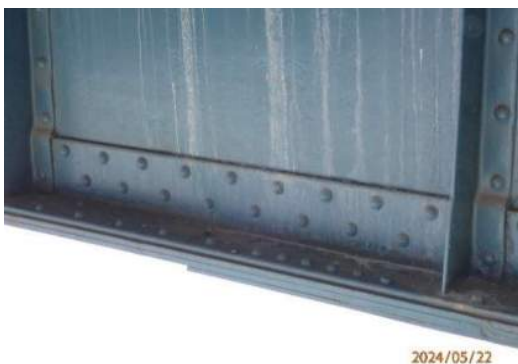
Photo MS-017: Rivets heads with 100% section loss and pitting on bottom flange of Right Girder north face between FB18 and FB19, looking south

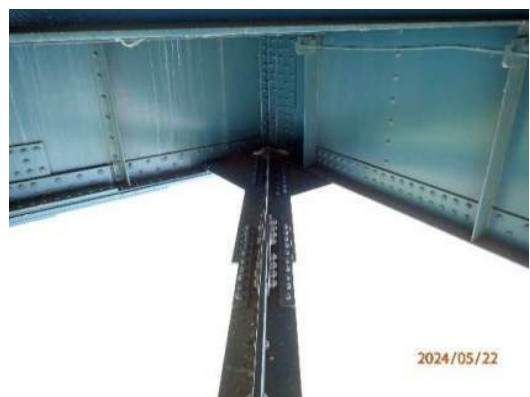
Photo MS-018: Bolted repair on lower lateral brace west of FB22 at Left Girder, looking northeast

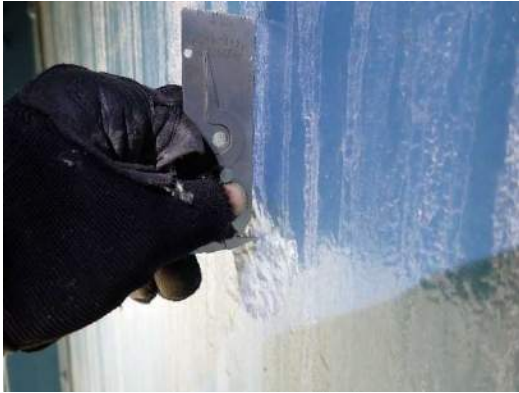
Photo MS-019: Pitting (3/16" deep by 3" diameter) on web of Right Girder between FB22 and FB23

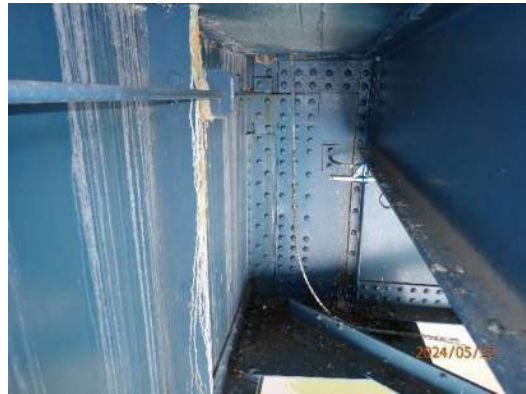
Photo MS-020: Typical efflorescence staining on east face of FB24 web, between S11 and Right Girder, looking west

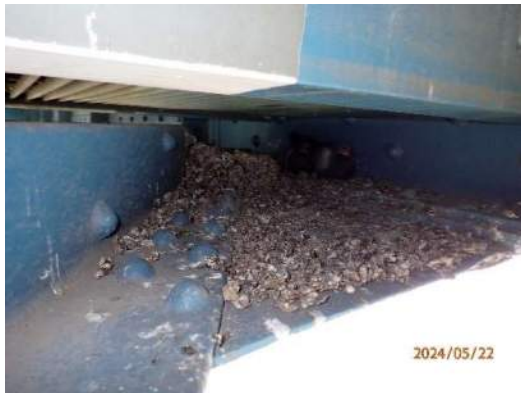
Photo MS-021: Typical granular and bird debris on lateral bracing connection plate, west side of FB25, between S6 and S7, looking east

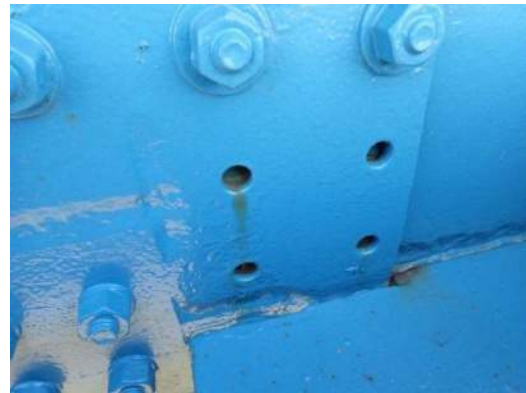
Photo MS-022: Eight bolt holes in repair plate, north web of Left Girder, east of FB25, looking south

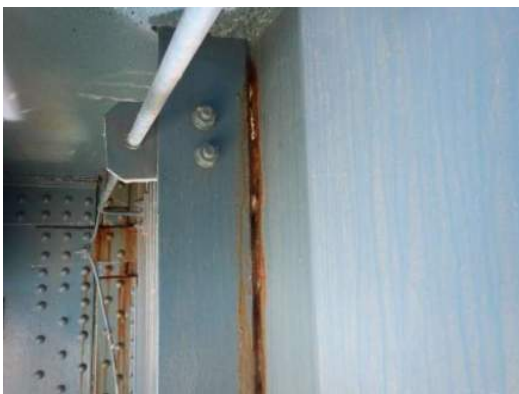
Photo MS-023: Pack rust (30" high by 3/4" thick) between transverse stiffener and Left Girder web, south face between FB26 and FB27, looking northwest

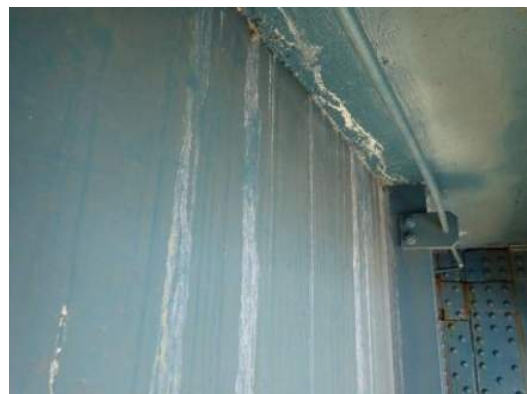
Photo MS-024: Typical efflorescence staining on north face of Right Girder, between FB26 and FB27, looking southwest

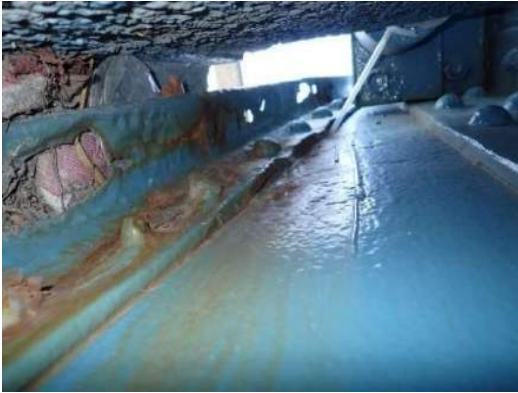
Photo MS-025: 100% section loss (up to 3" diameter) in multiple location on outstanding leg of Floorbeam Kneebrace, west face of FB27 at Right Girder, looking up and east

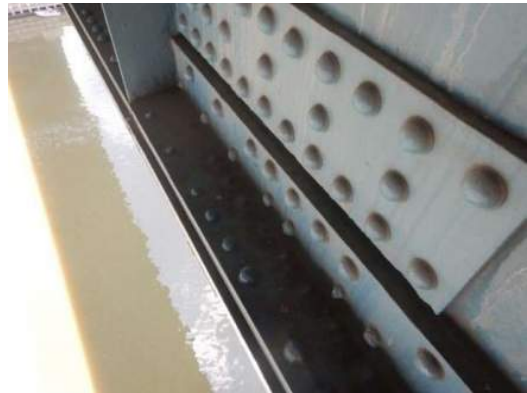
Photo MS-026: Rivet heads with up to 100% section loss on bottom flange of Left Girder, south face, between FB27 and FB28, looking northwest

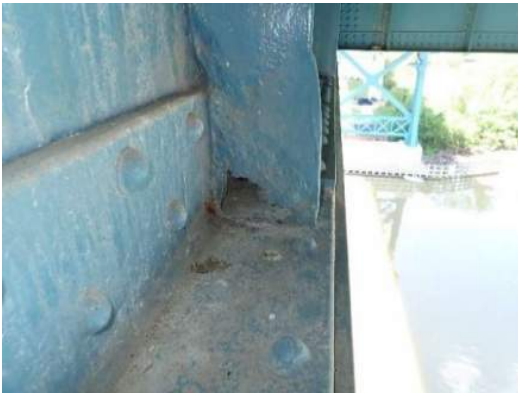
Photo MS-027: 100% section loss (4" wide x 3" high) to transverse stiffener on Right Girder north face, between FB27 and FB28, looking west

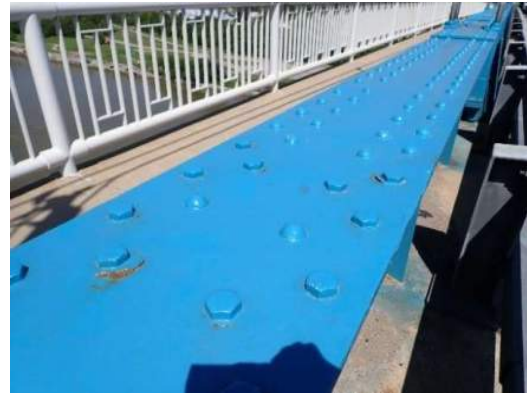
Photo MS-028: Isolated spots of peeling paint on top flange cover plate on Left Girder, between FB28 and FB29, looking northeast

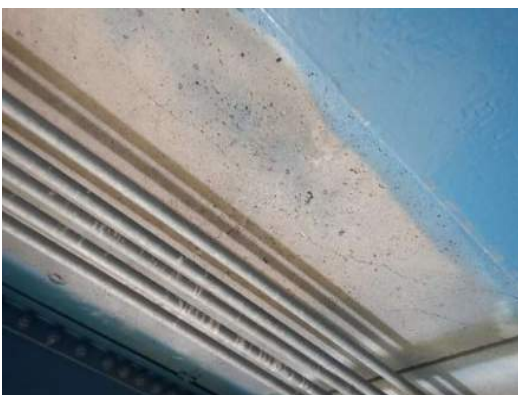
Photo MS-029: Hairline cracks (3' long by 5' wide) to underside of sidewalk, south overhang, east of FB28

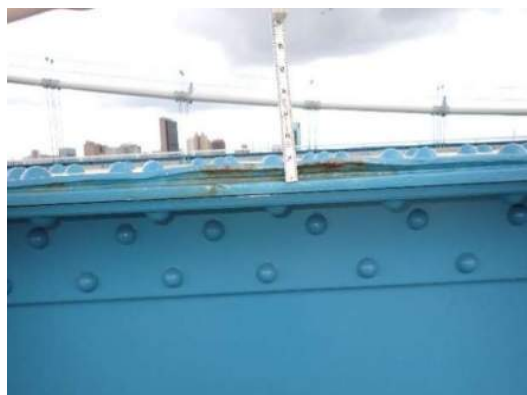
Photo MS-030: Pack rust (up to 3/4") between cover plate and top flange of Right Girder, between FB28 and FB29, looking north

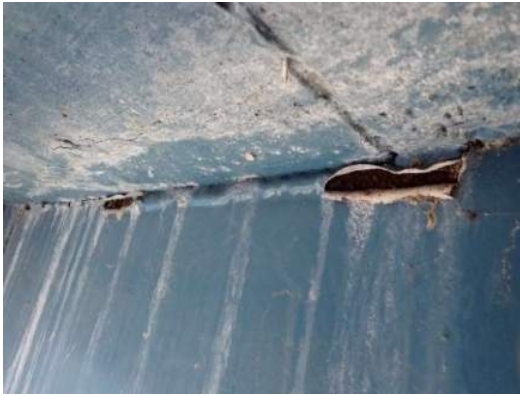
Photo MS-031: Peeling paint with laminate corrosion along edge deck and minor rust staining on north face of Right Girder, between FB28 and FB29, looking southeast

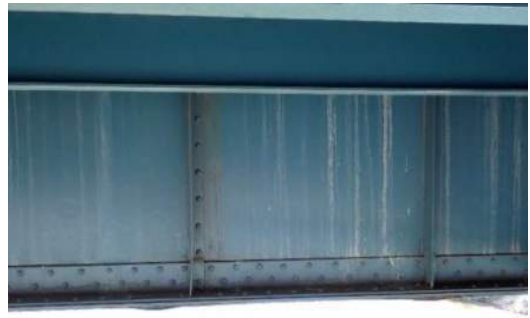
Photo MS-032: Pack rust (up to 3/4" thick) between north edge of bottom flange plates on Right Girder, between FB28 and FB29, looking south

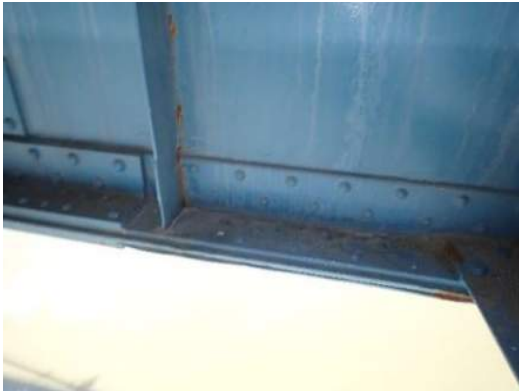
Photo MS-033: Pack rust between bottom flange and cover plate of Left Girder south face, between FB29 and FB30, section loss on transverse stiffener, looking north

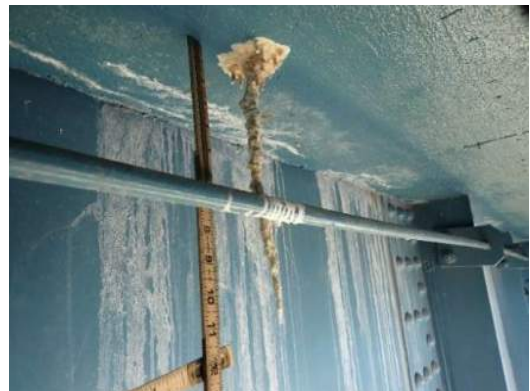
Photo MS-034: Efflorescence on underside of deck between FB29 and FB30, along Right Girder, looking southwest

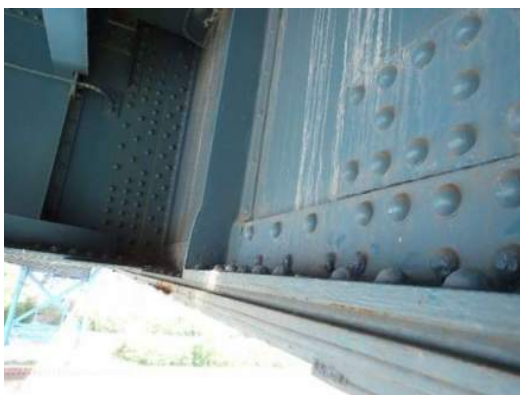
Photo MS-035: Pack rust between bottom flange plates on north edge of Right Girder, between FB29 and FB30, looking southeast

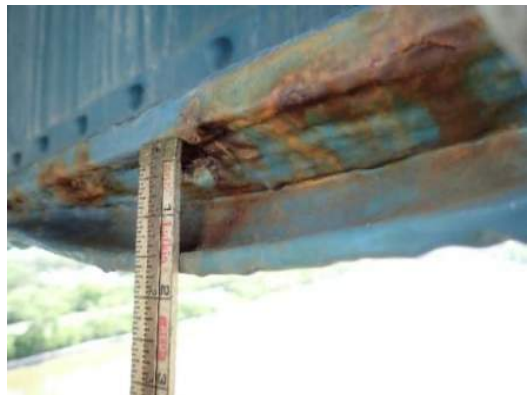
Photo MS-036: Pack rust (1 1/2" thick) between bottom flange plates with minor reactivated corrosion on north edge of Right Girder, east of FB30, looking southwest

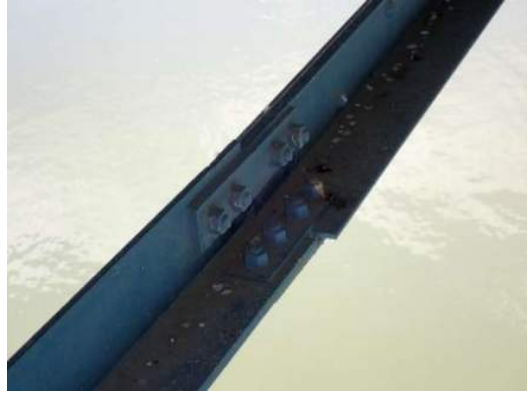
Photo MS-038: Bolted repair in lower lateral bracing near FB32 under S6

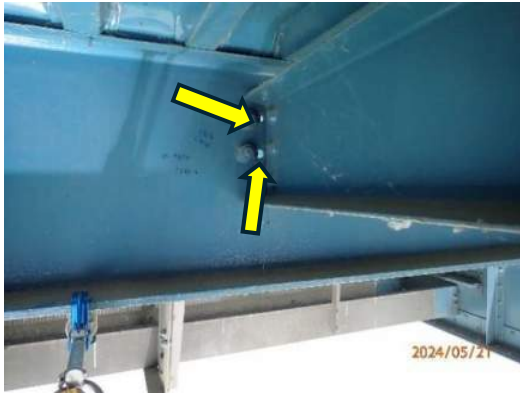
Photo MS-039: Two misdrilled holes in south face web of S8, between FB32 and FB33 at diaphragm, looking northeast

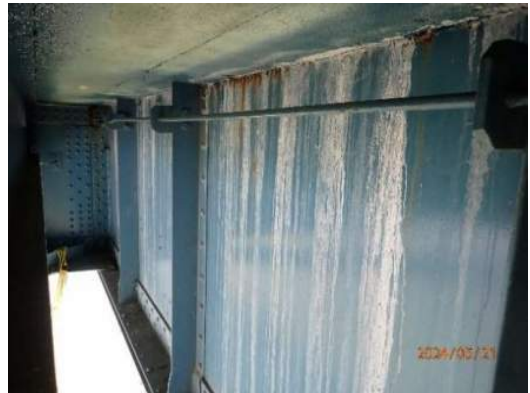
Photo MS-040: Efflorescence staining on north face web of Right Girder, between FB32 and FB33, looking southeast

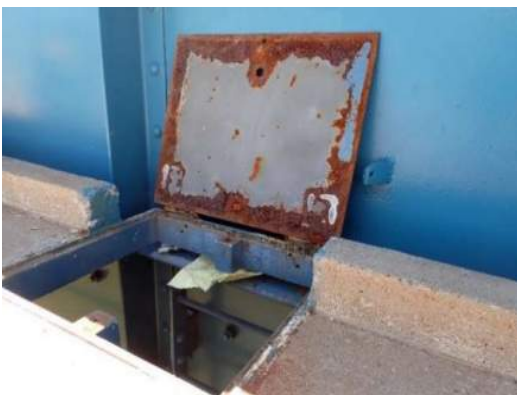
Photo MS-041: Broken hold down bolt in access hatch on LS1 between FB22 and FB23

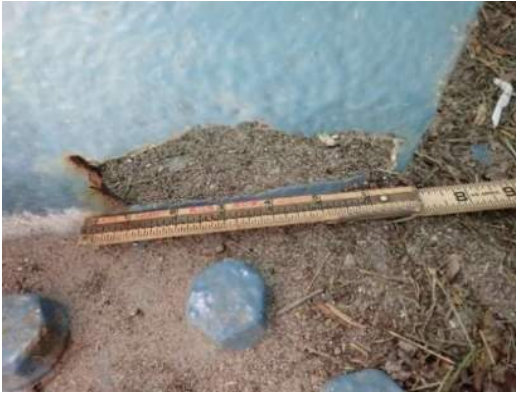
Photo MS-042: 100% section loss (7" long by 3.5" high) in lower lateral bracing web angle at FB33 near Left Girder, looking west

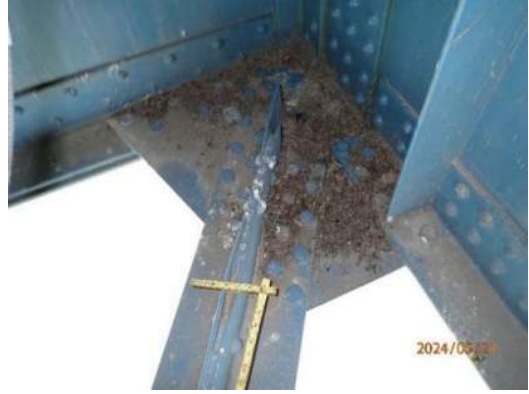
Photo MS-043: Pack rust (1" thick) between vertical flanges of lower lateral bracing, east side of FB33, at Right Girder, looking southwest

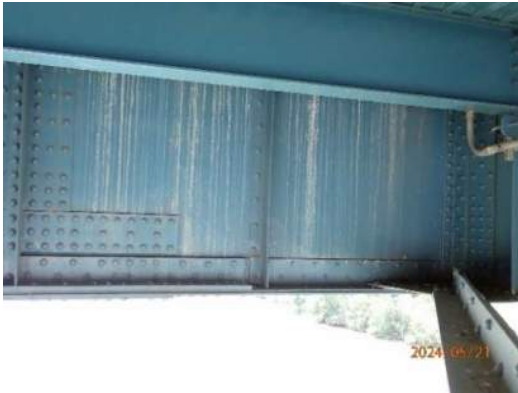
Photo MS-044: Pitting and efflorescence staining on north face web of Right Girder, between FB33 and FB34, looking south

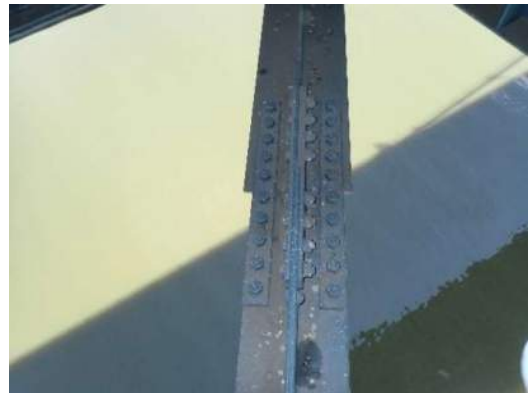
Photo MS-045: Bolted repair on lower lateral bracing at FB35 near Left Girder, looking northeast

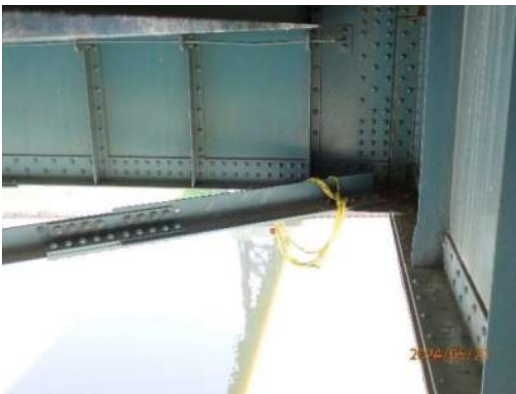
Photo MS-046: Bolted repair on lower lateral bracing on west side of FB35 at Right Girder, looking east

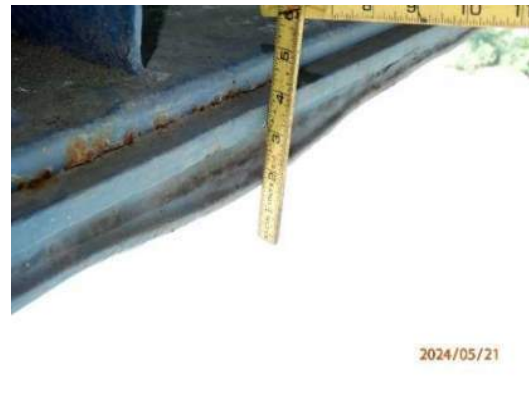
Photo MS-047: Pack rust (1 1/4" thick) between bottom flange plates on north face of Right Girder, between FB34 and FB35 at midspan, looking southwest

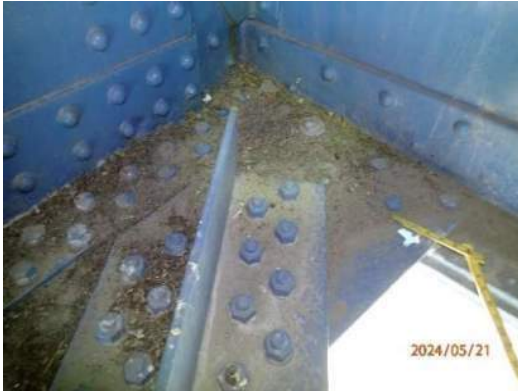
Photo MS-048: 100% section loss (1.75" diameter) in lateral bracing connection plate, west of FB35, at Right Girder, looking southeast

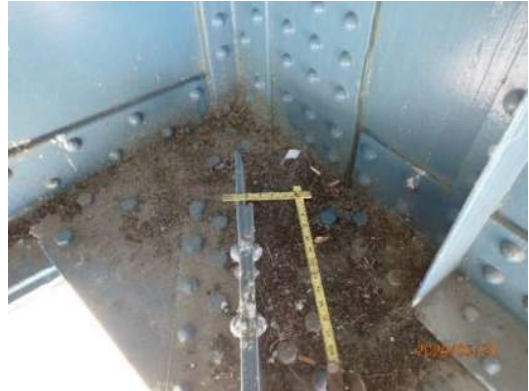
Photo MS-049: Pack rust (3/4" thick) between web angles of lower lateral bracing at connection plate, east of FB35, at Right Girder, looking southwest

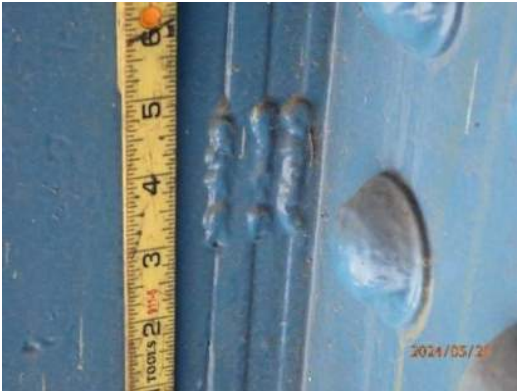
Photo MS-050: Tack weld between transverse stiffener angle and fill plate on north face of Right Girder, between FB35 and FB36, looking southeast

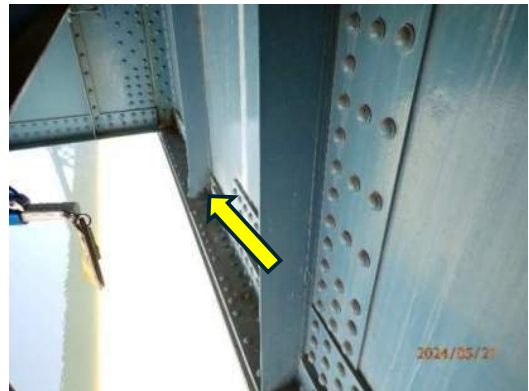
Photo MS-051: 100% section loss (4.5" high by full width) on transverse stiffener on north face of Right Girder, between FB35 and FB36, looking southeast

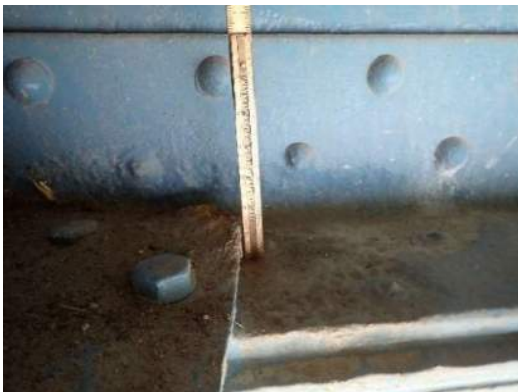
Photo MS-052: Pack rust (1" thick) between lower lateral brace connection plate and Left Girder, near FB35, looking north

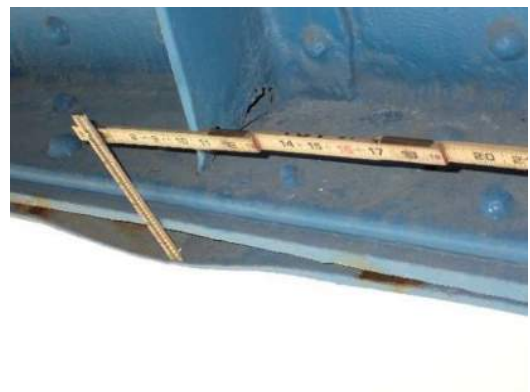
Photo MS-053: Pack rust (2" thick) between bottom flange plates of Left Girder, between FB36 and FB37

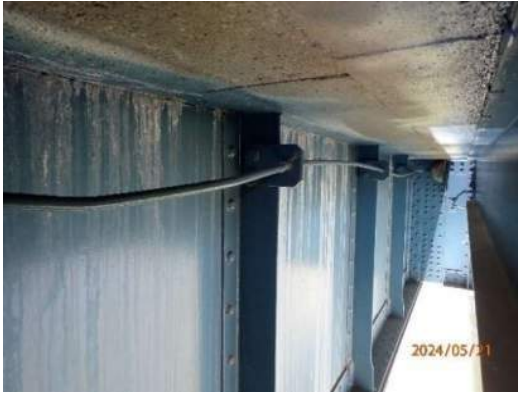
Photo MS-054: Offset handrail 2.5" high by full length, along Right Girder north face between FB36 and FB37, looking west

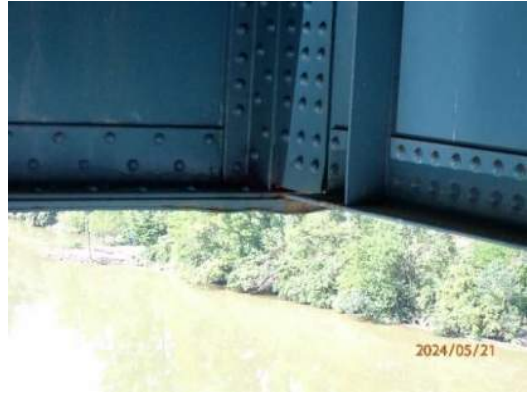
Photo MS-055: Pack rust (1" thick) between bottom flange plates on north face of Right Girder at FB36, looking south

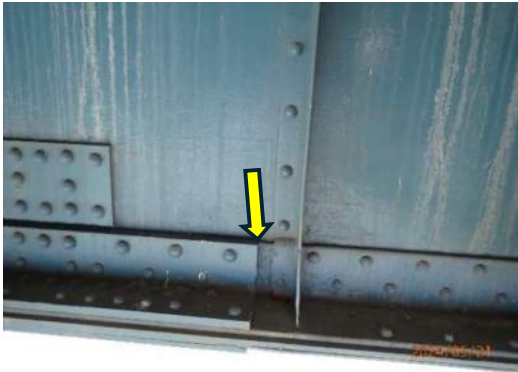
Photo MS-056: Pitting (3/8" deep by 2" wide by 8" high) on north face bottom flange of Right Girder, between FB37 and FB38, looking south

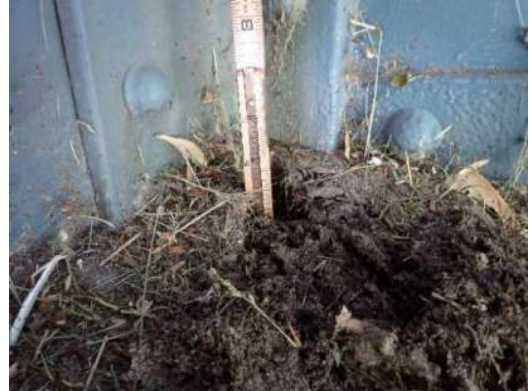
Photo MS-057: Typical granular and bird debris (4" high) on lower lateral brace connection plate to Left Girder, at FB37, looking north

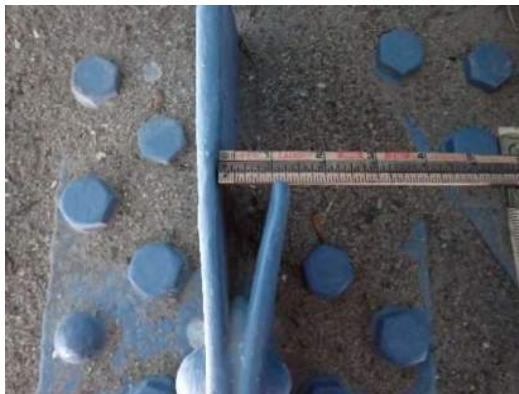
Photo MS-058: Pack rust between lower lateral brace angles, causing 1 1/8" deformation, at FB39 to Left Girder connection, looking north

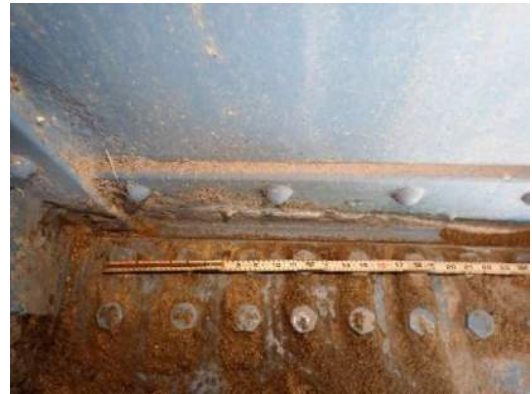
Photo MS-059: Pitting (up to 3/16" deep) and 100% section loss on rivets on Left Girder web angle, at FB39, looking north

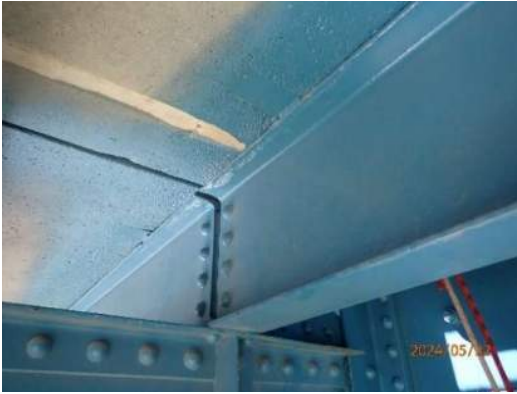
Photo MS-060: Pitting (2.5' long by 1.5" wide by up to 1/4" deep) on top flange north and south face of RS1, east and west of FB39, looking northwest

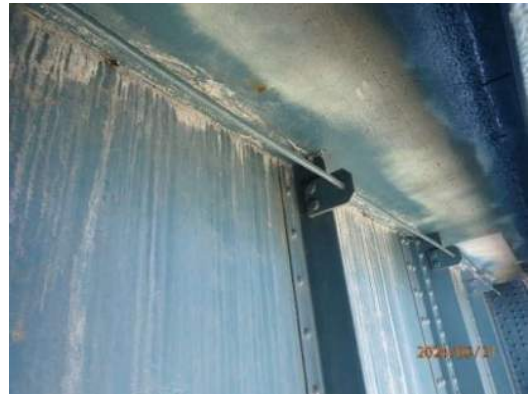
Photo MS-061: Efflorescence staining on north face web of Right Girder, between FB39 and FB40, looking southwest

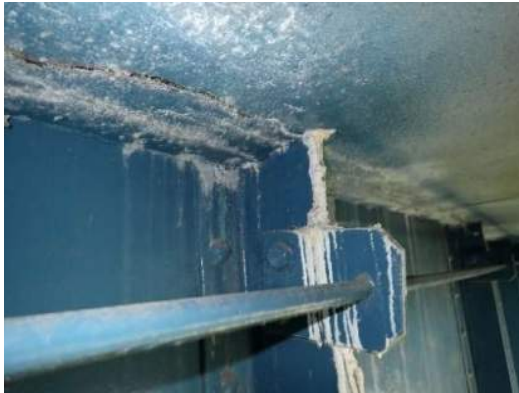
Photo MS-062: Efflorescence staining on north face of Right Girder, west of FB 41, looking southwest

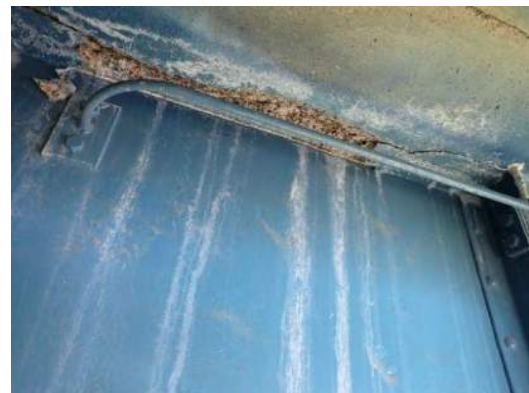
Photo MS-063: Spall (6" wide by 3' long) and delamination (6" wide by 16" long) on underside of deck along north face of Right Girder, west of FB41, looking southwest

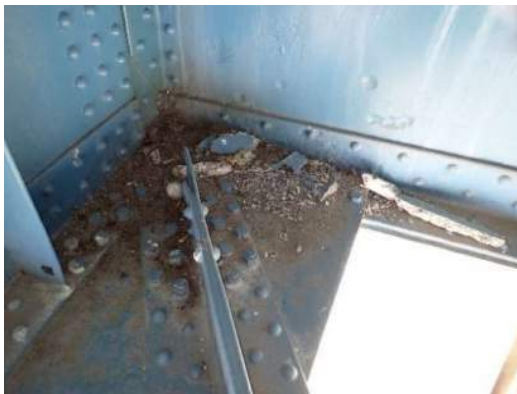
Photo MS-064: Granular and bird debris on lower lateral connection plate at Right Girder and west face of FB41, looking southeast

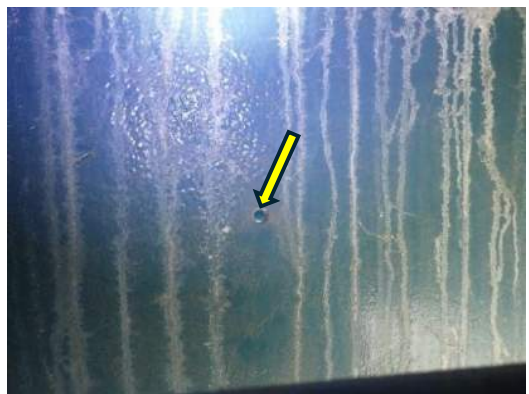
Photo MS-065: 3/8" drilled hole in Left Girder web, between FB42 and FB43, looking north. Fatigue category D detail

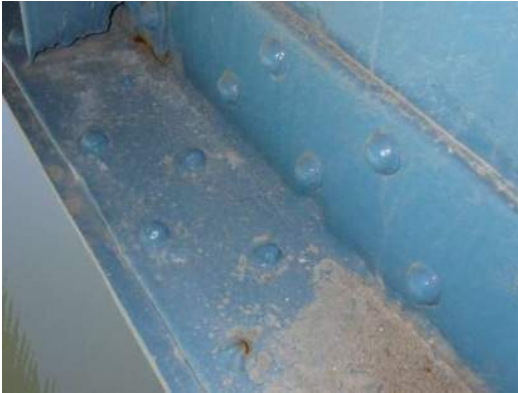
Photo MS-066: Up to 90% section loss on rivet heads on top of south face bottom flange of Left Girder between FB42 and FB43, looking northwest

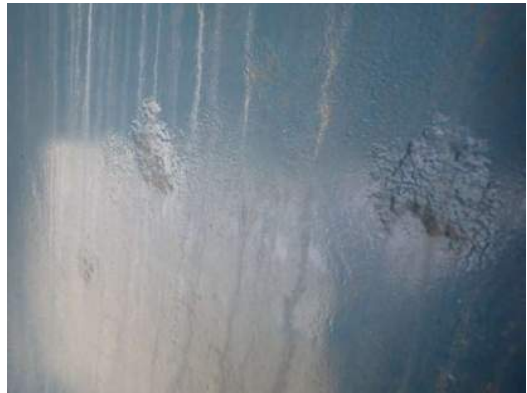
Photo MS-067: Pitting (1/16"-1/32" average depth) for 50% south web area on Left Girder between FB42 and FB43. Isolated locations up to 3/16" deep x 4" diameter, looking northwest

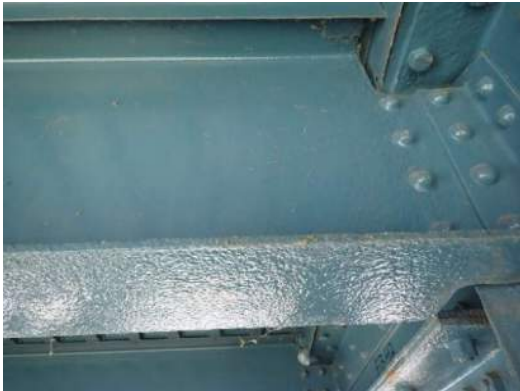
Photo MS-068: Pitting (1/16"-1/8" deep by full flange width by 36" long) on bottom flange of S6 east of FB42. Also pitting (full web height x 7" long) on web of S6. Looking southwest

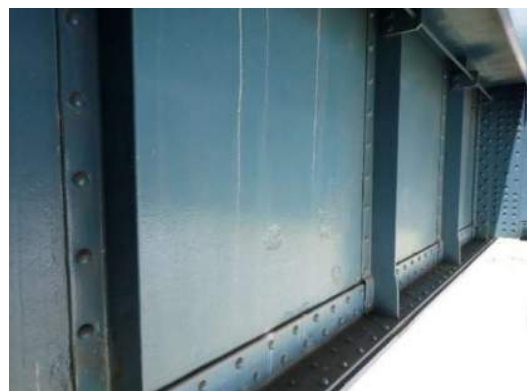
Photo MS-069: Pitting on north face web of Right Girder between FB42 and FB43, looking southwest

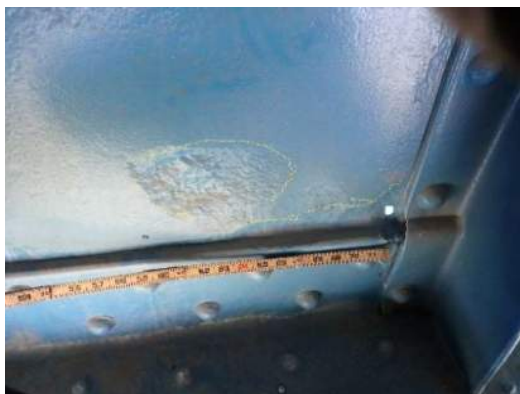
Photo MS-070: Hole (1/2" diameter) with advanced section loss (1/4" deep by 9" long by 4" high) on north face web of Right Girder between FB42 and FB43, looking south

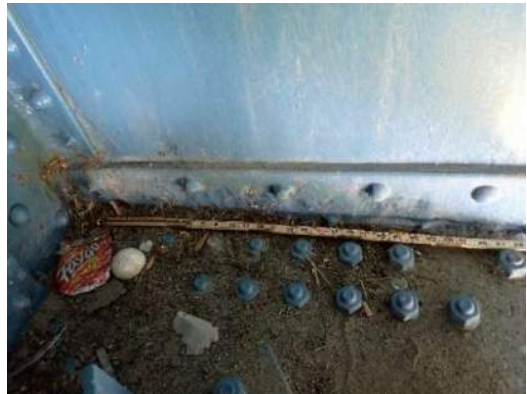
Photo MS-071: Pitting (up to 1/4" deep by full height) on vertical leg of bottom flange on north face of Right Girder at west face of FB43, looking south
