PHYSICAL CONDITION REPORT
2024 ROUTINE ELEMENT LEVEL AND NSTM
INSPECTION

INSPECTION MAY 2024
REPORT AUGUST 2024

ANTHONY WAYNE BRIDGE
LUC-002-1862
SFN: 4800303

Ohio Department of Transportation, District 2
317 E Poe Rd
Bowling Green, OH 43402

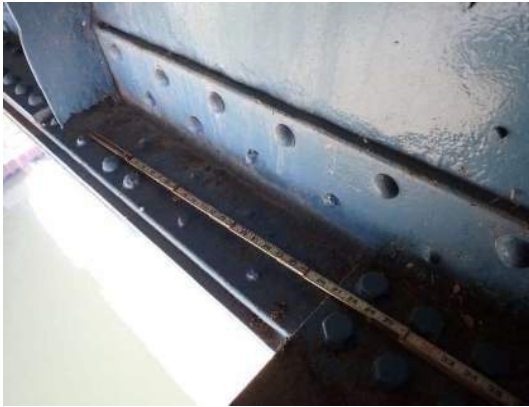
Photo MS-072: Up to 100% section loss on rivet heads on bottom flange on north face of Right Girder, east of FB43, looking southeast

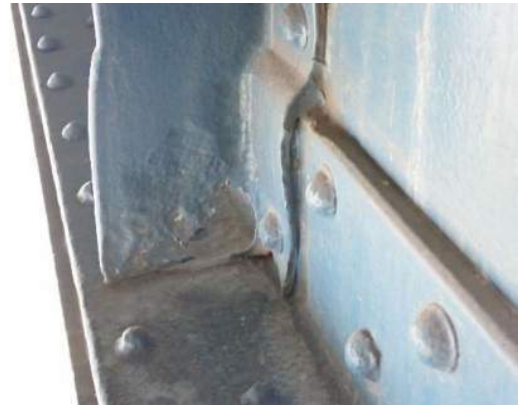
Photo MS-073: 100% section loss (3" high by full width) on transverse stiffener on south face of Left Girder, between FB44 and FB45, looking west

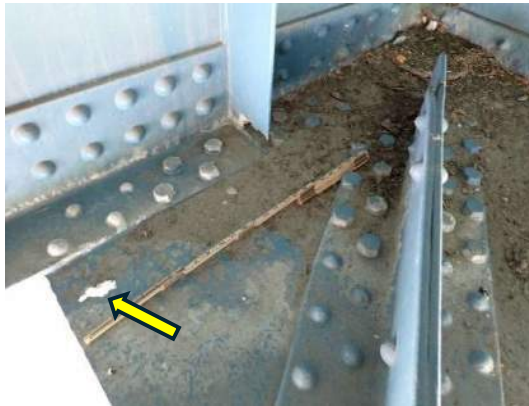
Photo MS-074: 100% section loss to lower lateral brace connection plate at Right Girder and FB45, looking southeast

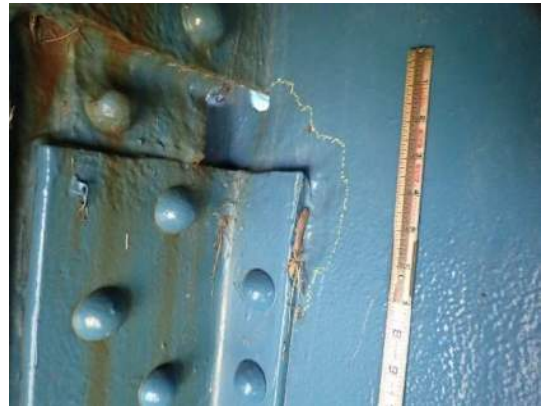
Photo MS-075: Pitting on web of Right Girder north face, west of FB45, looking southeast

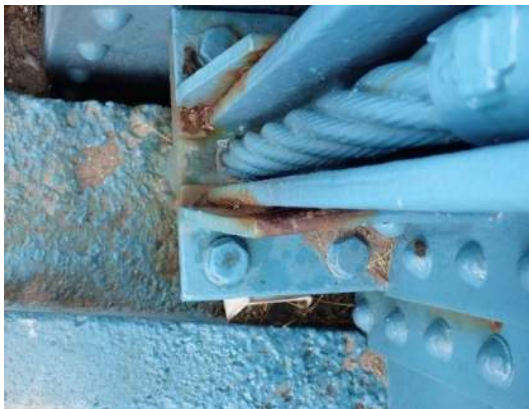
Photo MS-076: Pack rust between bearing and connection angles of Suspenders Cable 44 connection to Right Girder

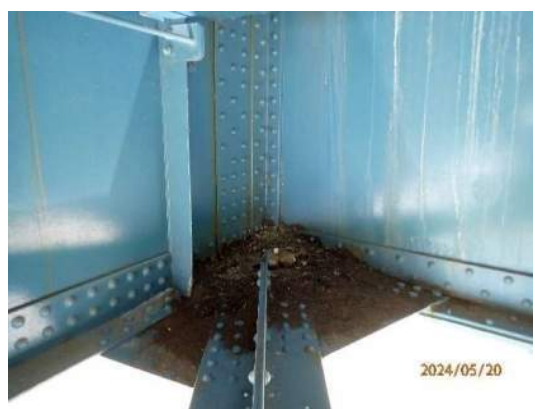
Photo MS-077: Dirt and debris on top of lateral bracing connection plate at Left Girder, east of FB47, looking northwest

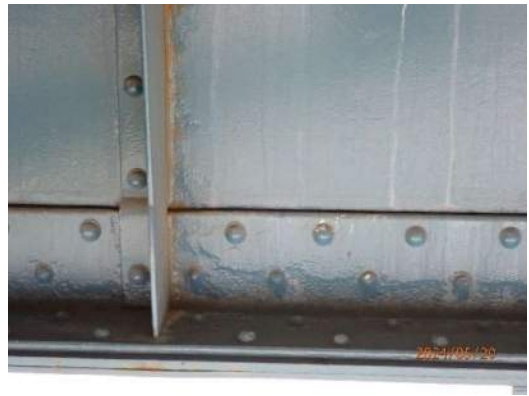
Photo MS-079: Pitting (1/8" deep) along bottom flange and stiffeners on Right Girder north face, between FB46 and FB46, looking south

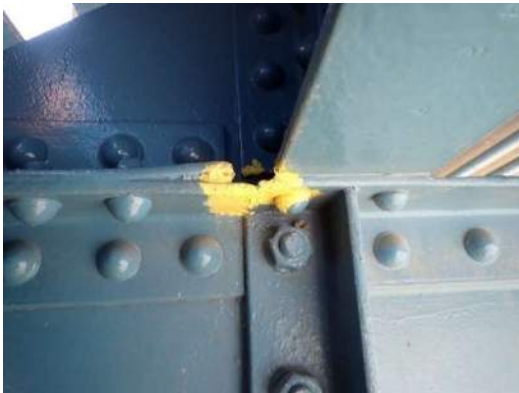
Photo MS-080: Crack highlighted with yellow paint in top flange of south sidewalk cantilever of FB47 west face, looking east

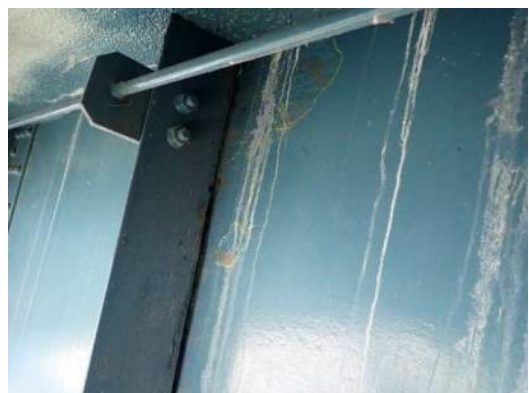
Photo MS-081: Pitting (3/16" deep by 6" high) to the web of Right Girder near top flange, north face, east of FB47, looking southeast

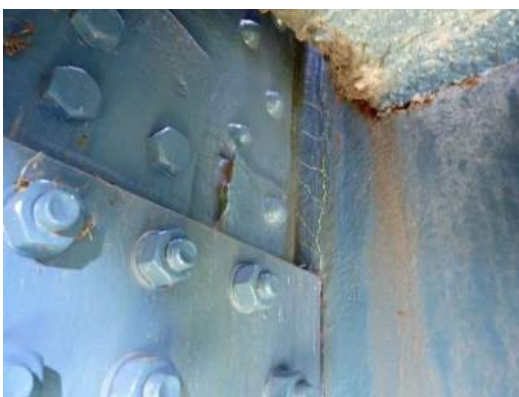
Photo MS-082: Pitting (3/16" deep by 2" wide by 24" high) in web of Right Girder west face of FB48, looking southeast and up

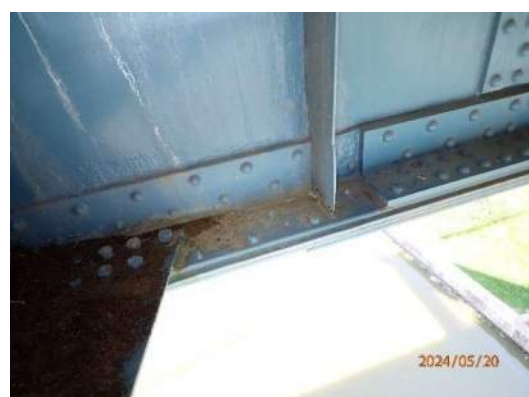
Photo MS-083: Section loss (25%-90%) of rivet heads on bottom flange of Left Girder, south face, between FB47 and FB48, looking northeast

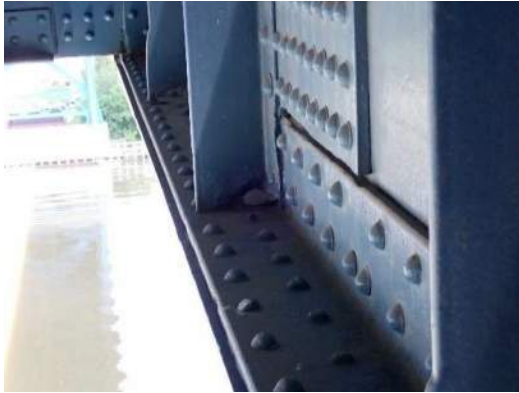
Photo MS-084: 100% section loss (up to 2.5" high by full width) on transverse stiffeners on Left Girder between FB48 and FB49, looking west

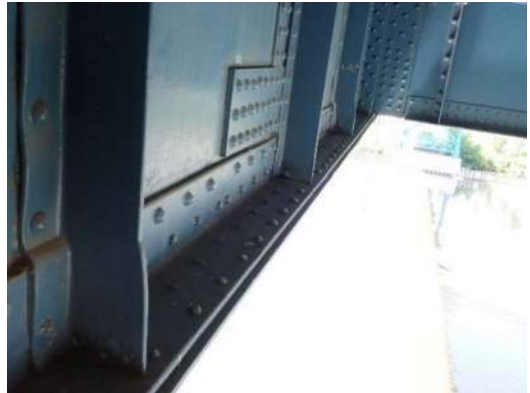
Photo MS-085: 100% section loss (up to 2" high and full width) on 3 transverse stiffeners on north face of Right Girder, between FB48 and FB49, looking west

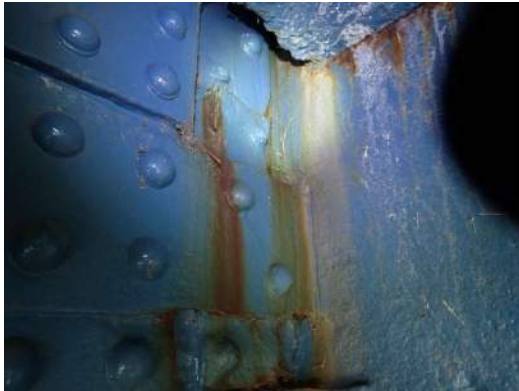
Photo MS-086: Pack rust (3/4" between FB49 plates on west face, with 1/16" deep pitting, looking east

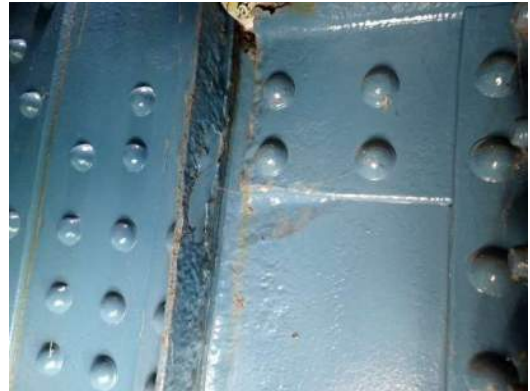
Photo MS-087: 100% section loss on outstanding leg of FB49 kneebrace, east face at Right Girder, looking southwest

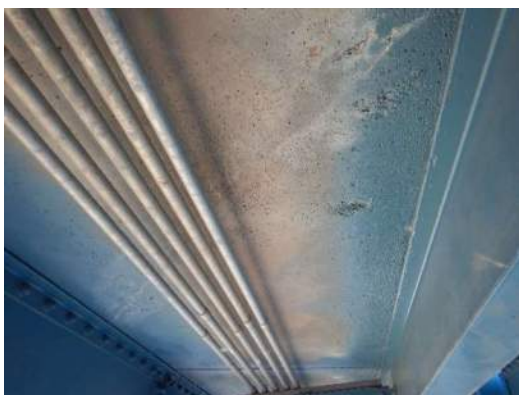
Photo MS-088: Hairline cracks between RS1 and RS2 and FB49 and FB50, with light efflorescence

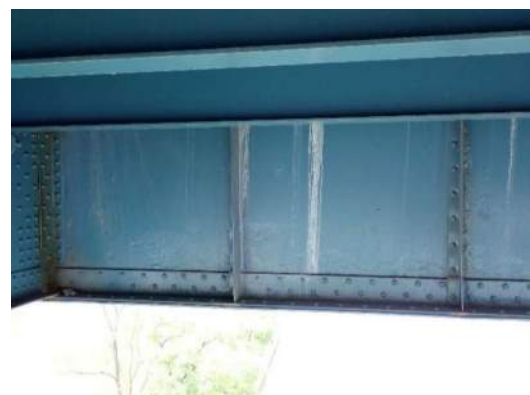
Photo MS-089: Pitting (1/8" deep) throughout web and flanges of Right Girder north face, west of FB50, looking south

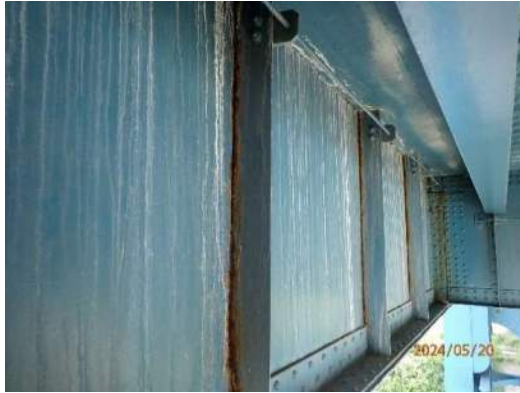
Photo MS-090: Efflorescence staining on southface of Left Girder, between FB49 and FB50, looking northeast

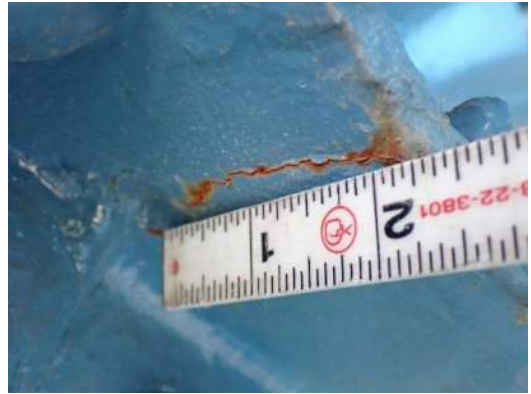
Photo MS-091: Crack (1 3/4" long) with light rust staining in top flange of north sidewalk cantilever on FB51

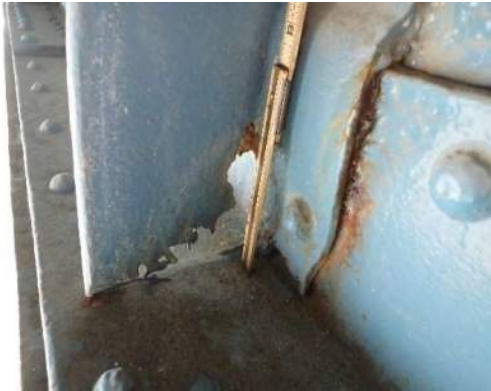
Photo MS-092: 100% section loss (up to 3" high by full width) in transverse stiffener on Left Girder near FB51, looking west

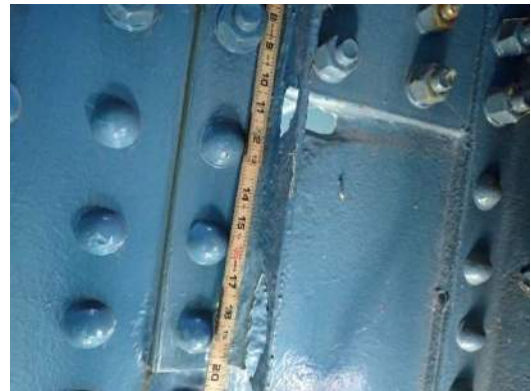
Photo MS-093: 100% section loss on outstanding leg of FB50 kneebrace, east face at Right Girder, looking northwest

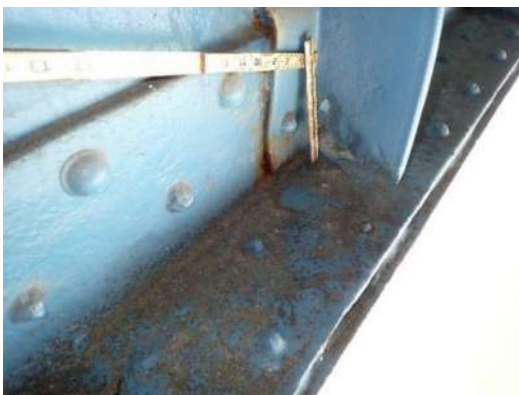
Photo MS-094: 100% section loss (4" high by full width) on transverse stiffener on Right Girder north face, west of FB51, looking west

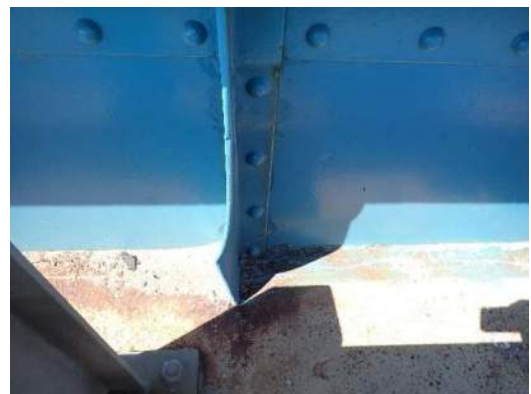
Photo MS-095: Impact damage on 3 stiffeners on Left Girder, between FB51 and FB52, looking north at center stiffener

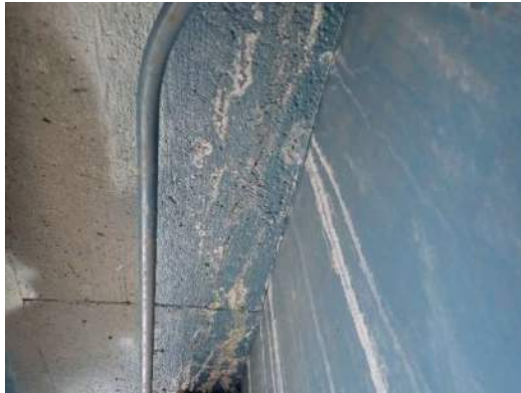
Photo MS-096: Efflorescence staining on south face of Left Girder web near FB51, looking west

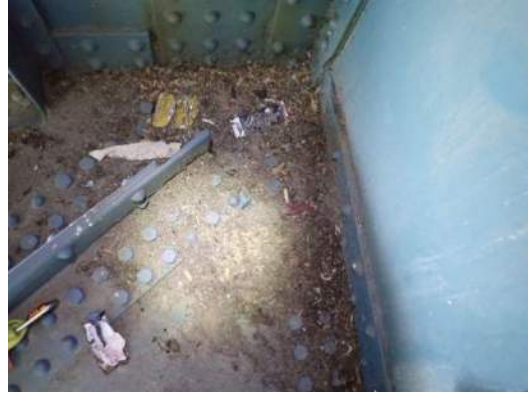
Photo MS-097: Dirt and debris accumulation on lateral bracing connection plate between FB51 and FB52, south face of Left Girder, looking northwest

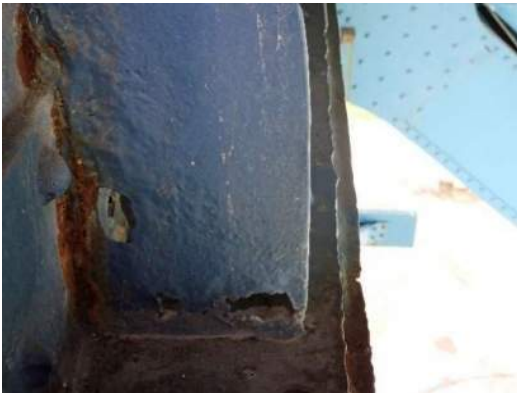
Photo MS-098: 100% section loss (up to 2" diameter) on transverse stiffener on south face of Left Girder, east of FB51, looking east

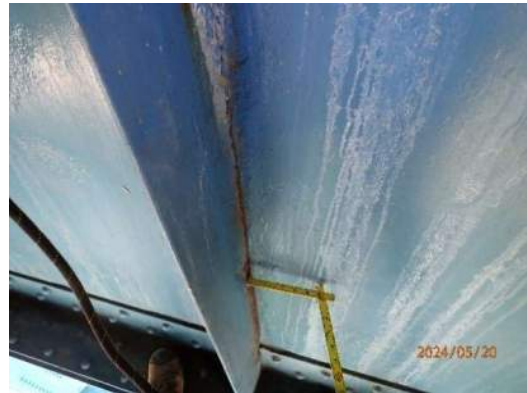
Photo MS-099: Pitting (1/16" deep by 2" wide by full height) on north face of Right Girder at stiffeners, between FB51 and FB52, looking south

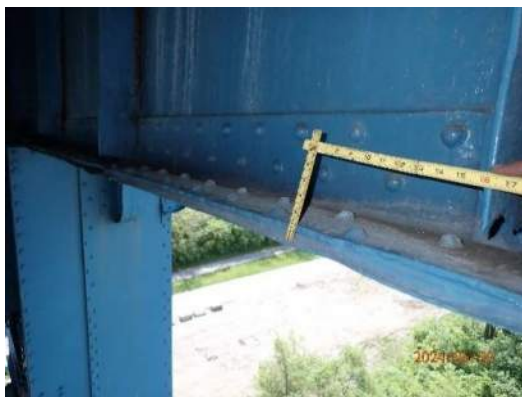
Photo MS-100: Pack rust (1/2" - 1" thick) between Right Girder bottom flange connection angle and bottom plate, between FB51 and FB52, looking southeast

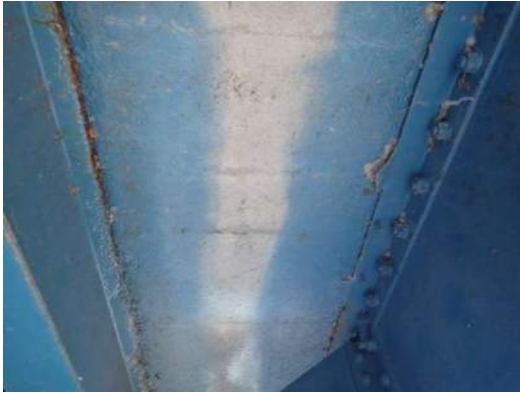
Photo ES-001: Hairline transverse cracks spaced 12" apart between LS1 and LS2, between FB53 and FB54

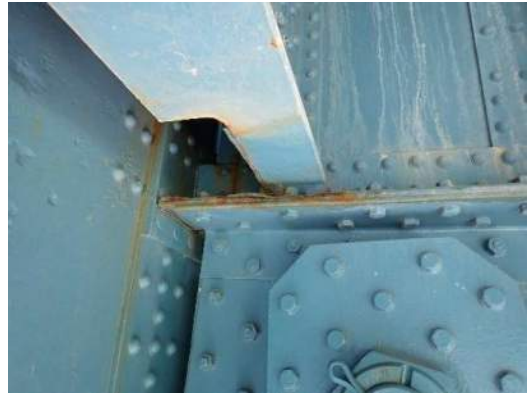
Photo ES-002: Pack rust (up to 1/2" thick) between bottom flange plates at Left Girder and FB53

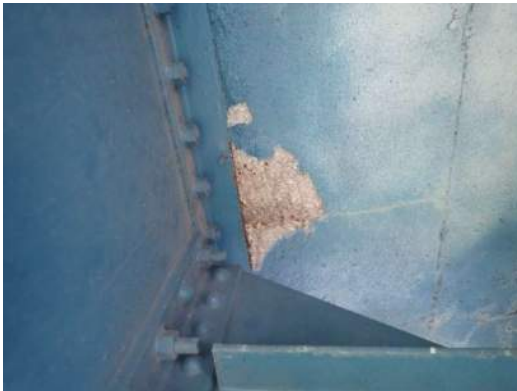
Photo ES-003: Spall (6" diameter by 1/2" deep) on underside deck south overhang, west of FB53

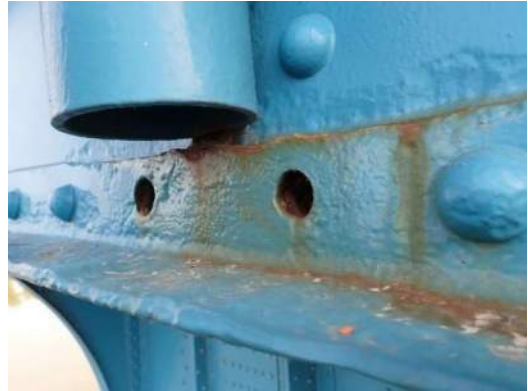
Photo ES-004: Two missing rivet heads at tower D, between south exterior stringer and sidewalk bracket, east most railing connection, looking north

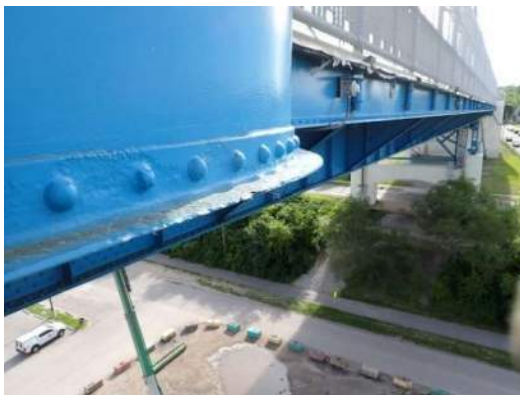
Photo ES-005: 100% section loss and knife edge on exterior bottom flange at tower D, south sidewalk exterior stringer, looking northeast

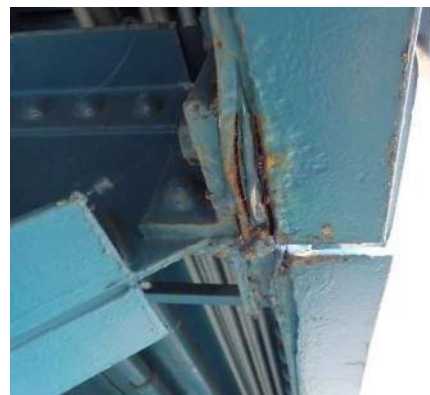
Photo ES-006: Pack rust (1" thick) and pitting (1/8" deep) at connection between LS2 and FB54

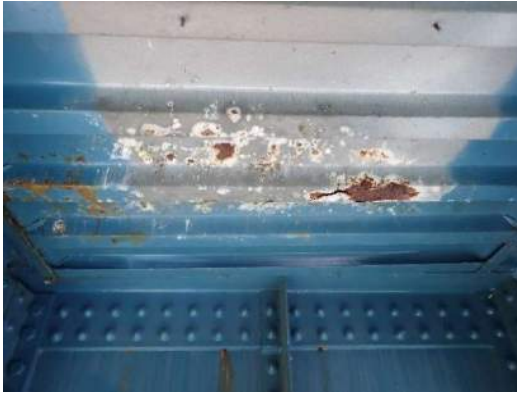
Photo ES-007: Laminate corrosion (3' wide by 1' long) on underside of pan between S1 and S2 and between FB54 and FB55

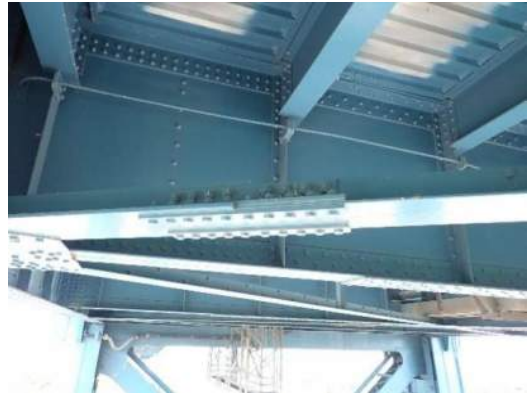
Photo ES-008: Bolted repair plates on lower lateral bracing between FB56 and FB57, near S11

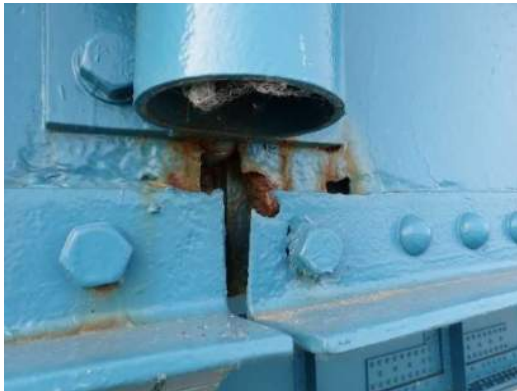
Photo ES-009: Pack rust (1" thick) and pitting (1/8" deep) with areas of 100% section loss at LS2 and FB58 connection

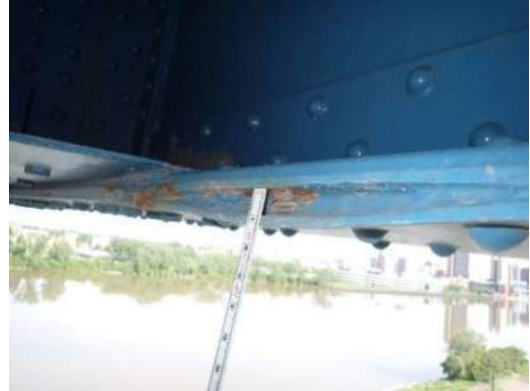
Photo ES-010: Pack rust between bottom flange plates on Left Girder, between FB58 and FB59

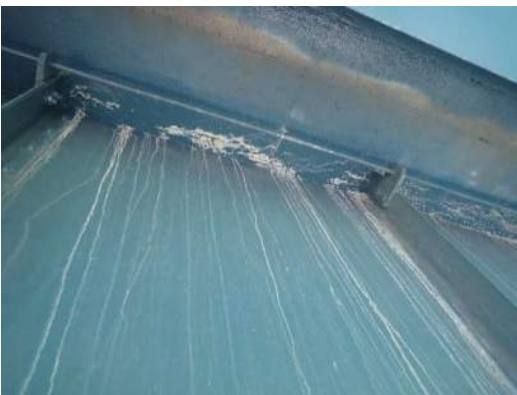
Photo ES-011: Efflorescence staining on Left Girder web, between FB58 and FB59

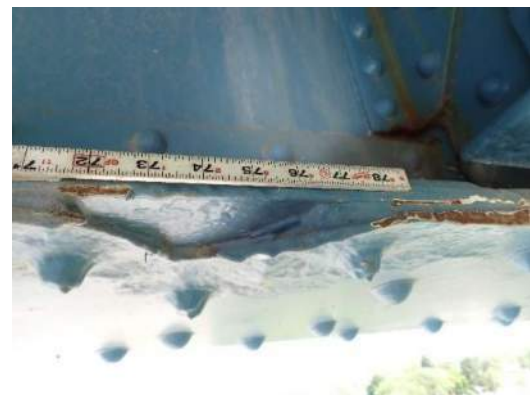
Photo ES-012: 100% section loss on rivet heads and pitting on bottom flange of Left Girder, between FB58 and FB59

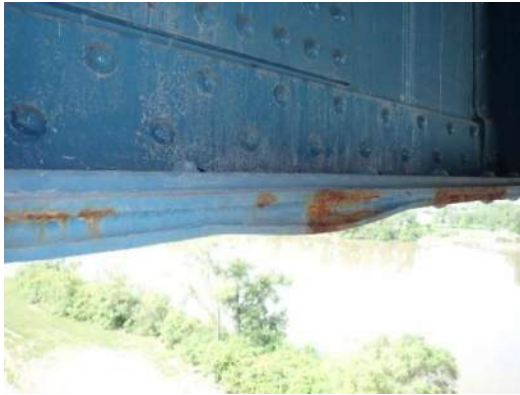
Photo ES-013: Pack rust between north face bottom flange plates of Right Girder, between FB59 and FB60

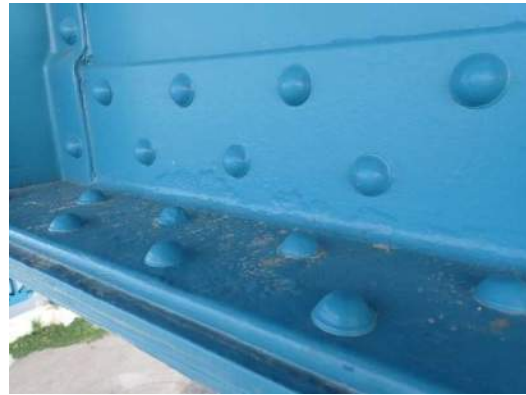
Photo ES-014: Pitting (1/16" - 1/8" deep) on bottom flange of Right Girder, between FB60 and FB61

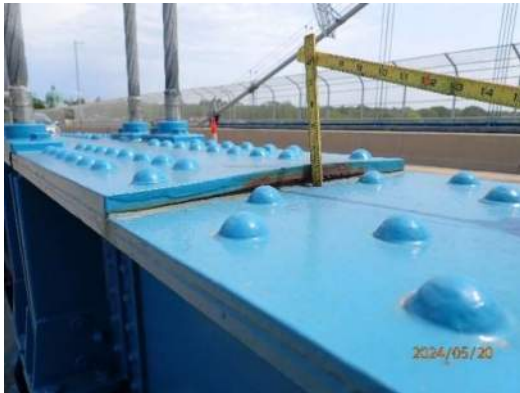
Photo ES-015: Pack rust (3/8" thick) on top of Left Girder between top flange plates, between FB60 and FB61, looking southeast

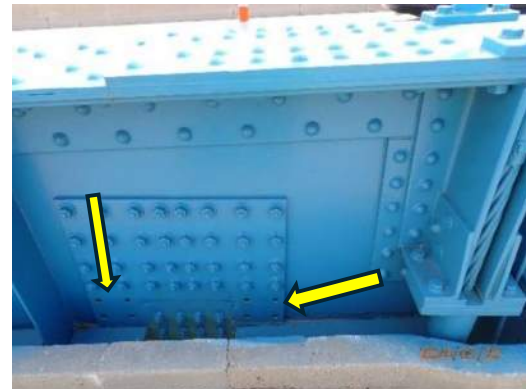
Photo ES-016: Eight open holes in north face repair plate on Left Girder, between FB61 and FB62, looking south

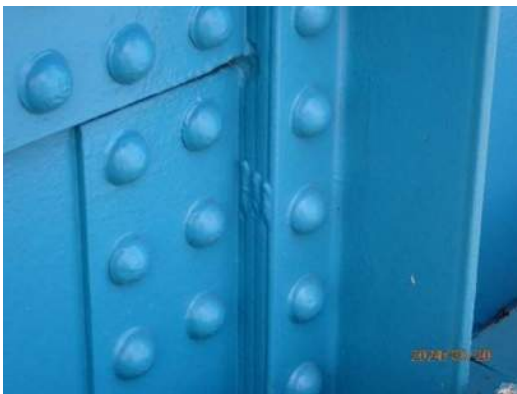
Photo ES-017: Tack welds on north face of Left Girder transverse stiffener, between FB61 and FB62, looking southwest

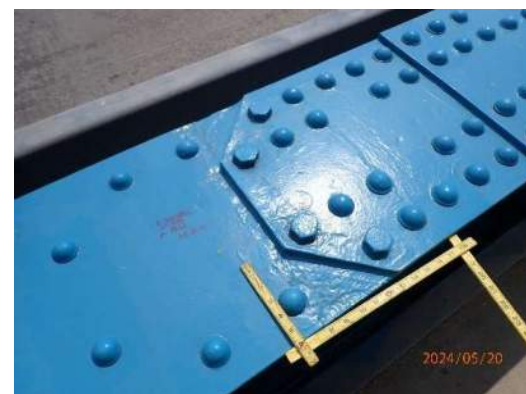
Photo ES-018: Section loss (1/8" deep by 5" wide by 6" long) top flange of Left Girder, between FB61 and FB62, looking southwest

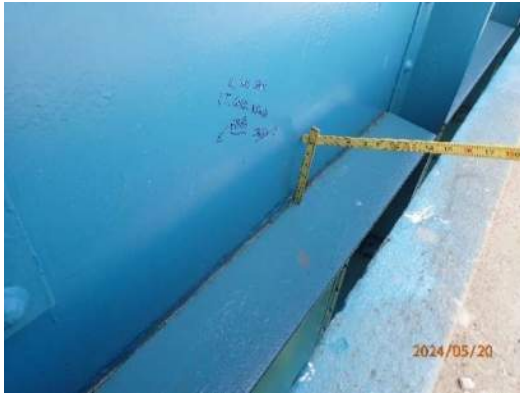
Photo ES-019: Pack rust (3/8" thick) and pitting (1/8" deep) on north face of Left Girder, between FB62 and FB63, looking southwest

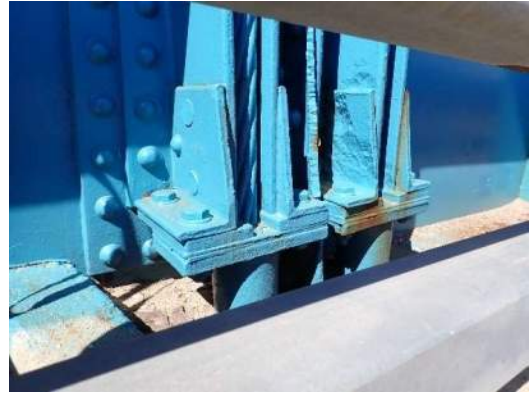
Photo ES-020: 6" wide portion of kneebrace removed above deck at Left Girder and FB63, looking northeast

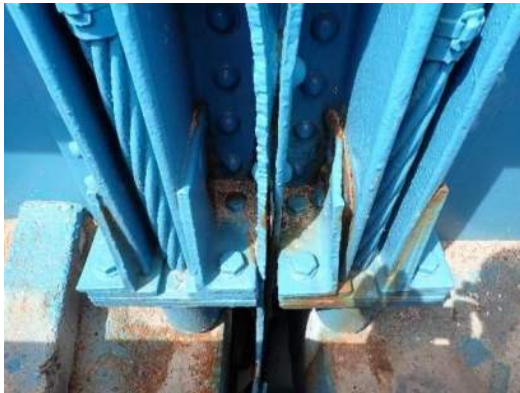
Photo ES-021: Pack rust between vertical cable plates and anchorage horizontal bearing plate at top of vertical legs of connection angle, at Left Girder south face, at FB63, looking north

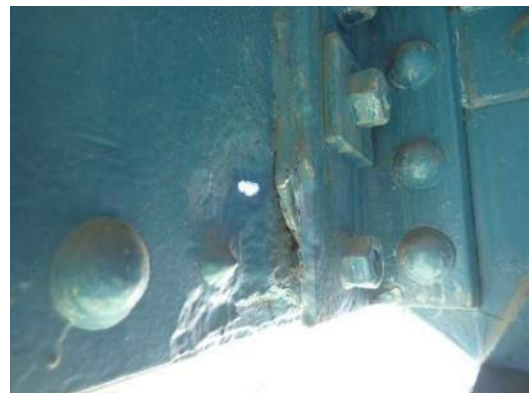
Photo ES-022: Pack rust (1" thick) and pitting (1/8" deep) with areas of 100% section loss at FB63 connection to RS2

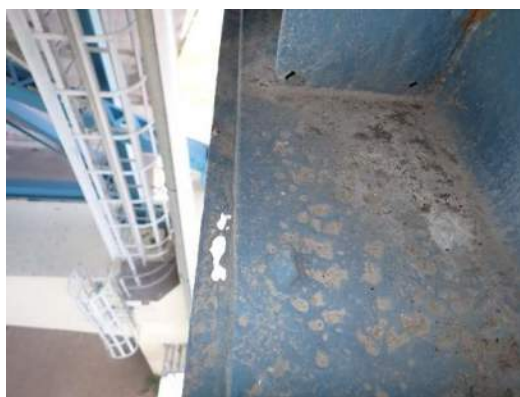
Photo ES-023: Pitting on top of bottom flange with up to 100% section loss on Right Girder, between FB64 and FB65

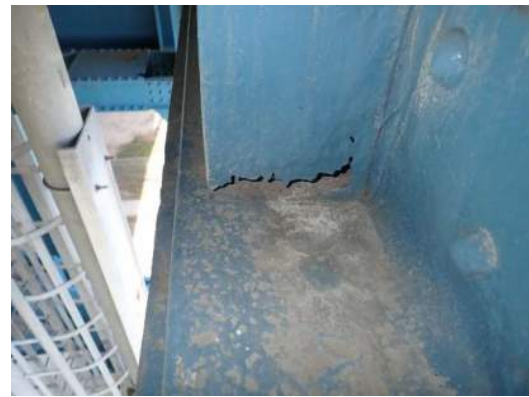
Photo ES-024: 100% section loss on transverse stiffeners on Right Girder, between FB64 and FB65

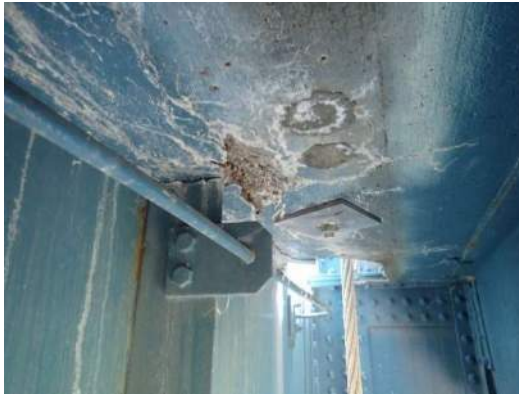
Photo ES-025: Spall on underside of deck, at Left Girder and FB64, looking northeast

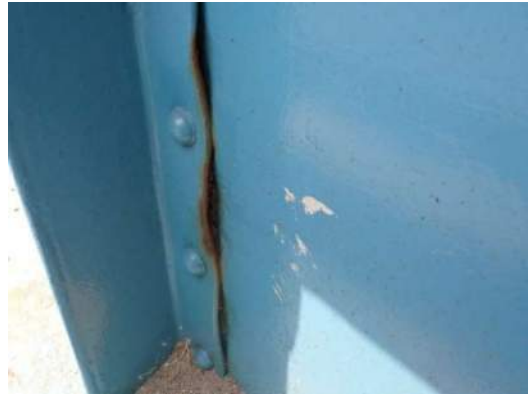
Photo ES-026: Pack rust (18" high by 1/2" thick) and pitting (8" high by 1/8" deep) between transverse stiffener and Left Girder web, between FB64 and FB65, looking northwest

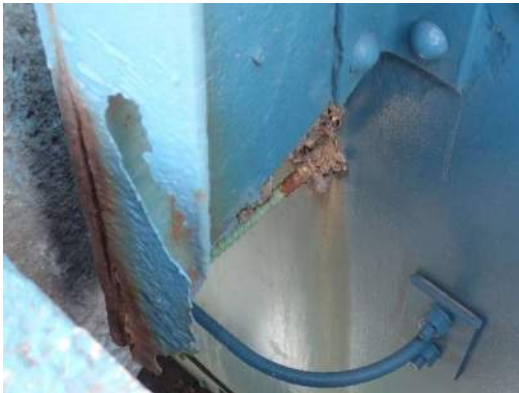
Photo ES-027: 100% section loss (11" high by 2" wide) on vertical gusset plate, south face connection angle leg, at Left Girder and FB65, looking northwest

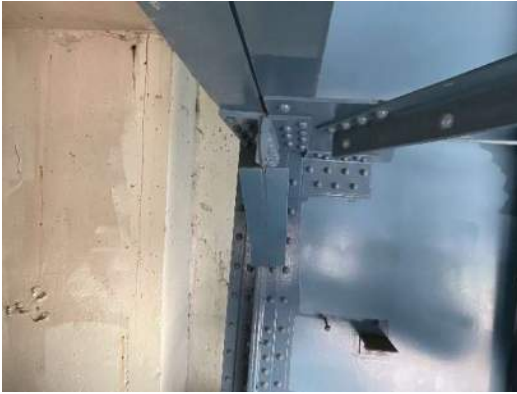
Photo 1E-001: Painted over pack rust and minor distortion to bottom angle of kneebrace under FB0 at Left Girder

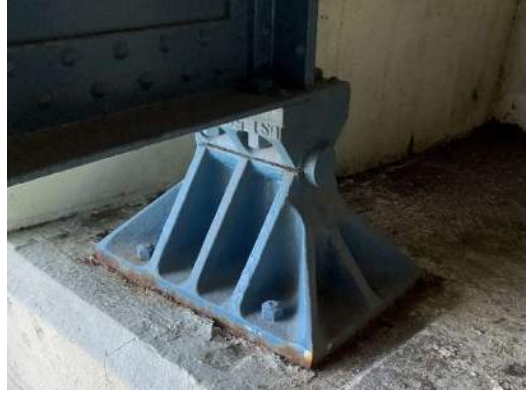
Photo 1E-002: Minor corrosion into masonry plate on Right Girder bearing at anchorage F

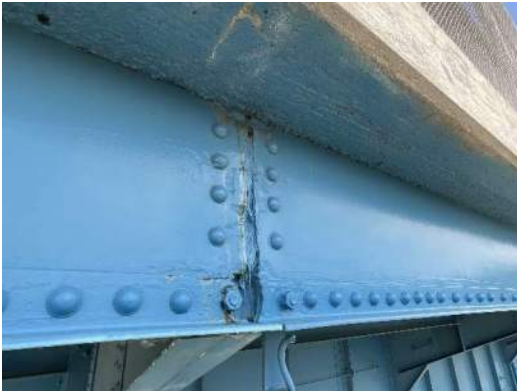
Photo 1E-003: Pack rust and painted over section loss of RS2 at FB1 overhang, looking northeast

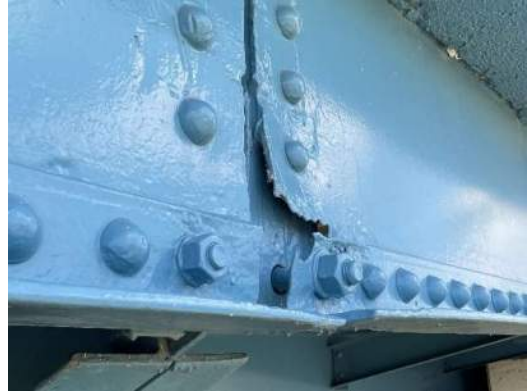
Photo 1E-004: Pack rust and painted over section loss of LS2 at FB1 overhang, looking west

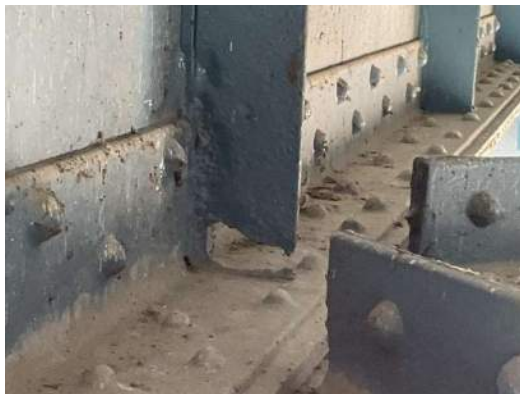
Photo 1E-005: 100% section loss to transverse stiffener below S4, west side of FB2, looking south

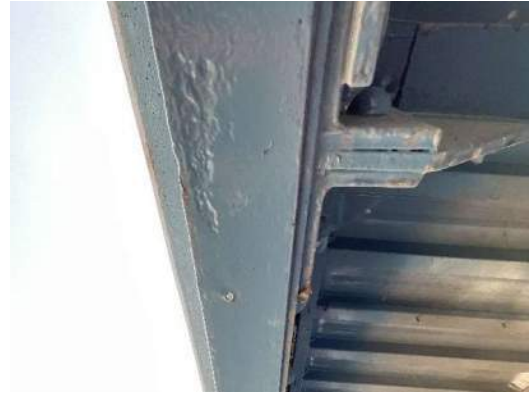
Photo 1E-006: Minor corrosion and painted over pitting of bottom flange angle of LS2 at intermediate channel bracket between FB2 and FB3, looking east

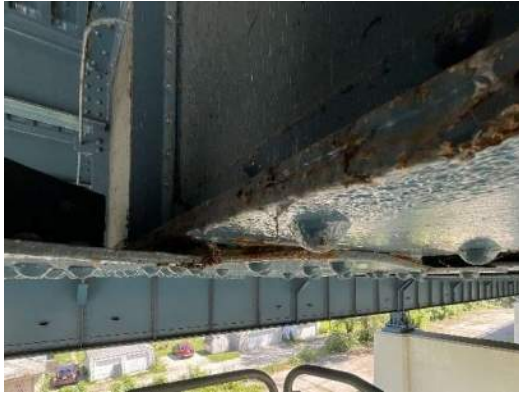
Photo 1E-007: Pack rust with minor deformations to lateral bracing connection plate, at S4 and FB2 interface

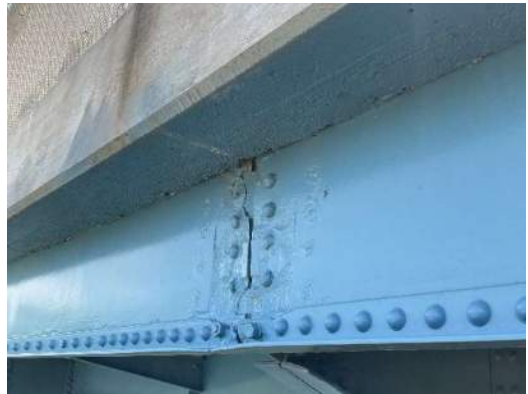
Photo 1E-008: Pack rust and painted over section loss of LS2 at FB3 overhang, looking southeast

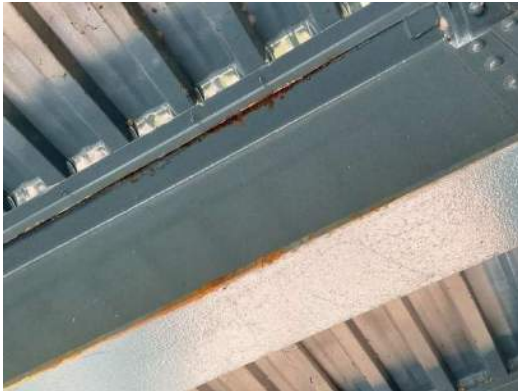
Photo 1E-009: Active corrosion (8' long) to top and bottom flange of S5, east of FB3

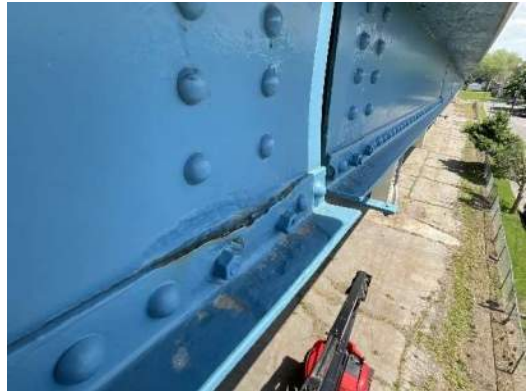
Photo 1E-010: Pack rust and painted over section loss of RS2 at FB4 overhang, looking east

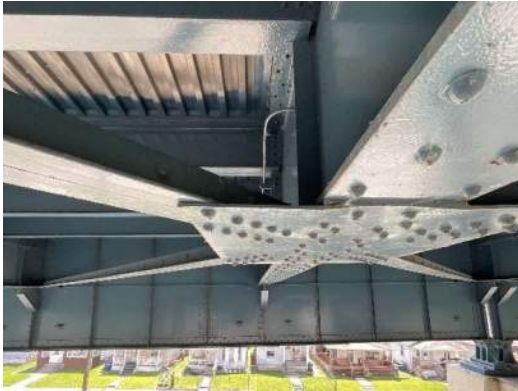
Photo 2E-001: Bowing on both sides of lateral bracing connection plate with painted over pack rust, at S4 and FB1 connection

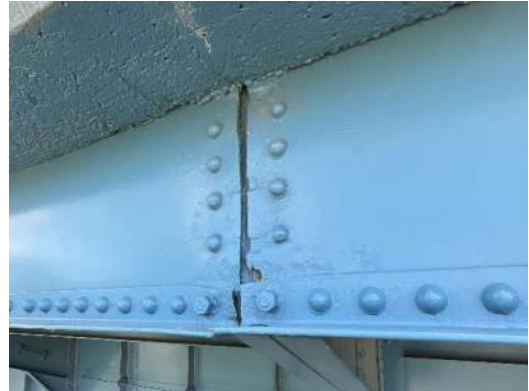
Photo 2E-002: Pack rust and painted over section loss of LS2 at FB2 overhang, looking southeast

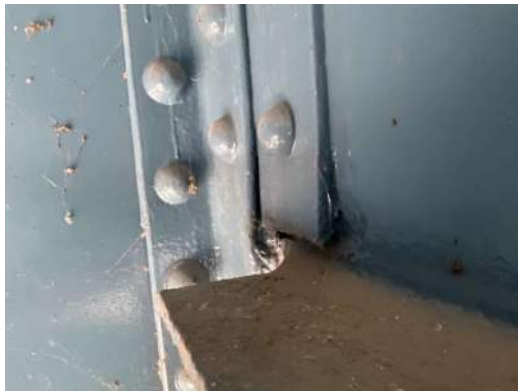
Photo 2E-003: Painted over pack rust between stringer web and angle connection, causing bowing, on S4 at connection to FB2, looking southeast

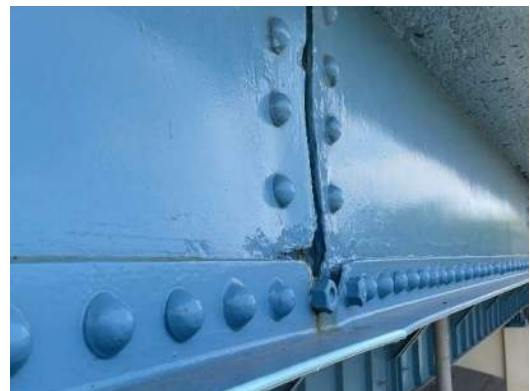
Photo 2E-004: Pack rust and painted over section loss of RS2 at FB2 overhang, looking northeast

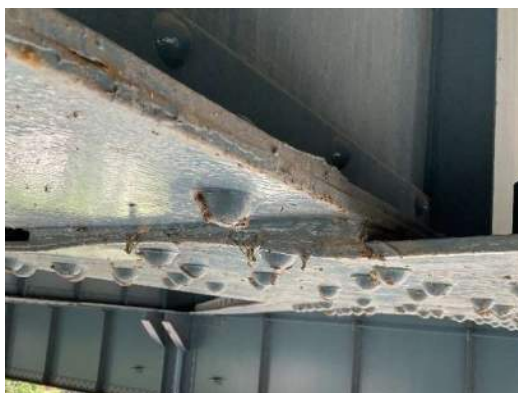
Photo 2E-005: Bowing on both sides of lateral bracing connection plate with painted over pack rust, at S4 and FB3 connection

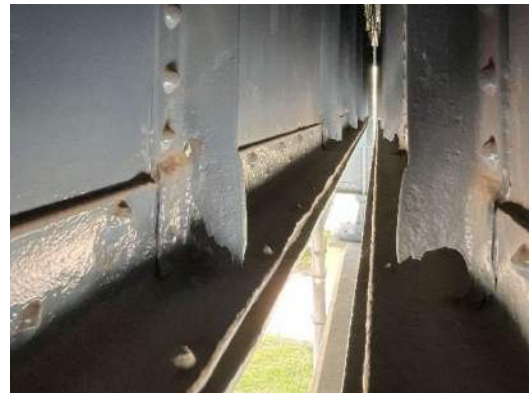
Photo 2E-006: 100% section loss in transverse stiffeners on east face of FB4

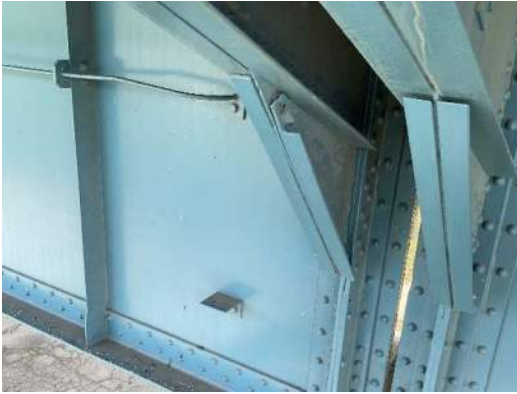
Photo 3E-001: 100% section loss and painted over corrosion to bottom angle of kneebrace on FB0 north overhang

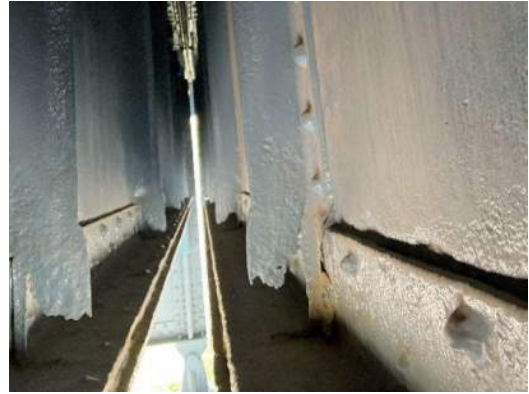
Photo 3E-002: 100% section loss on transverse stiffeners on west face of FB0, between S3 and S4

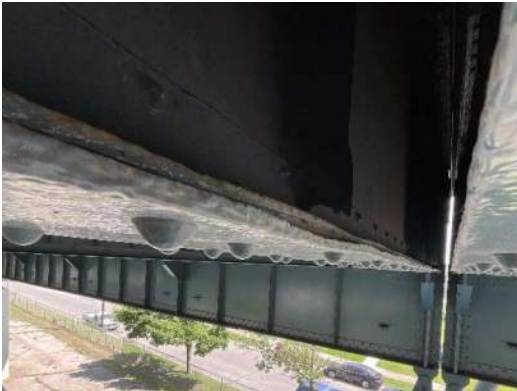
Photo 3E-003: Pack rust on bottom flange cover plate, causing waves on FB0 between S3 and S4

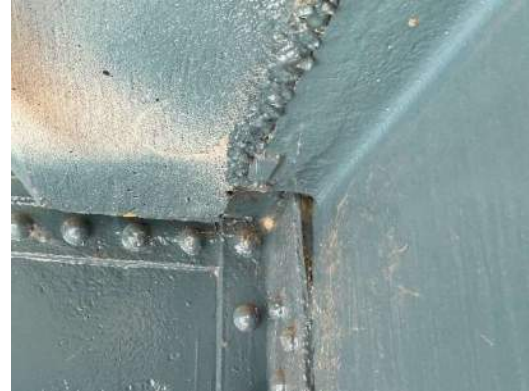
Photo 3E-004: Painted over pitting and pack rust on top of stringer RS2 at connection to FB2

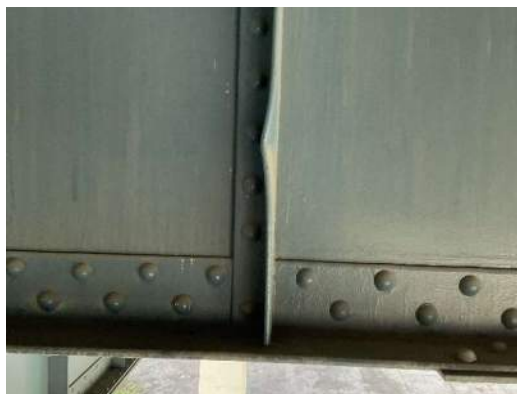
Photo 3E-005: Impact damage to transverse stiffener, painted over, on S2, west of FB1

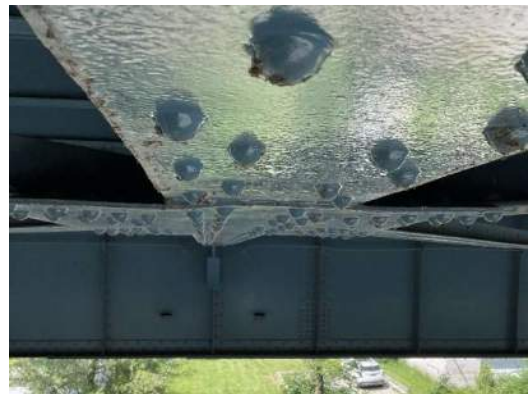
Photo 3E-006: Pack rust and minor bowing between bottom flange of FB1 and lower lateral connection plate at S4

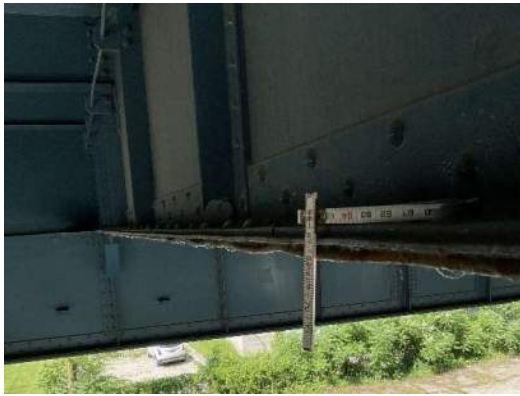
Photo 3E-007: 100% section loss on transverse stiffener on FB2 and pack rust along bottom flange of FB2, between S3 and S4

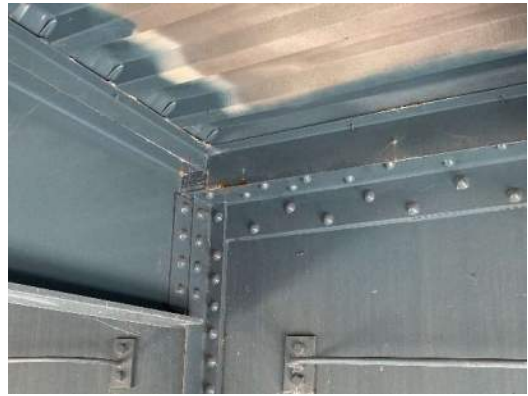
Photo 3E-008: Corrosion to deck pan flashing, along FB3, with efflorescence on north and south sides of S4

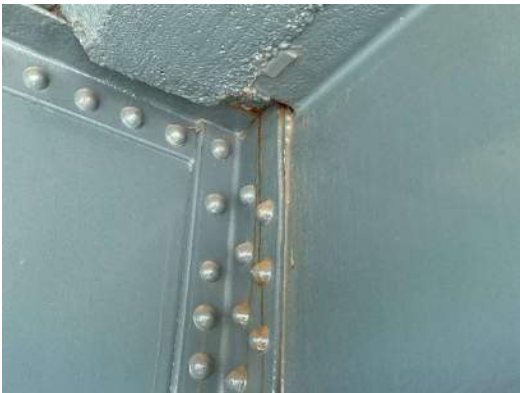
Photo 3E-009: Pack rust and bowing on RS1 at FB3 connection

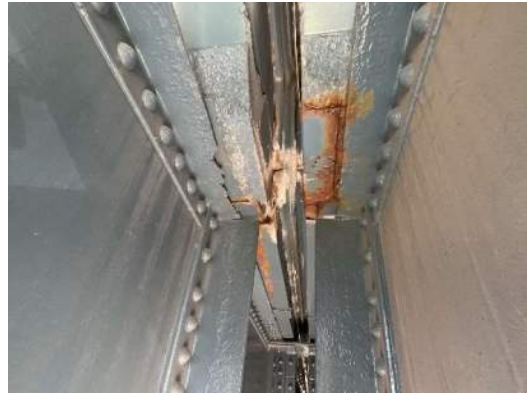
Photo 3E-010: Corrosion and efflorescence on joint above RS1 top flange and deck pan flashing on FB4 east face

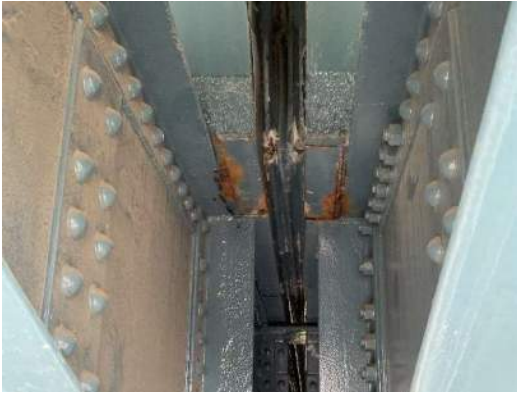
Photo 4E-001: Active corrosion to top flange of FB0 north overhang and deck pan flashing, looking south

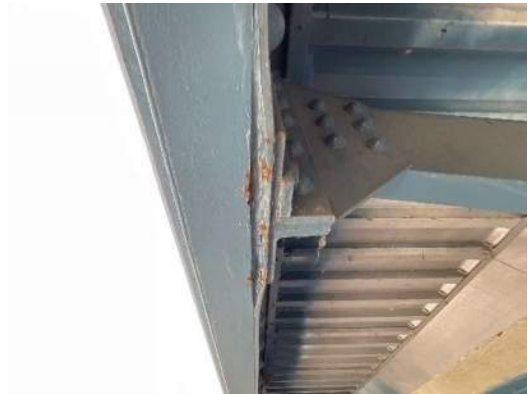
Photo 4E-002: Pack rust and painted over section loss to LS2 web, at intermediate bracket between FB0 and FB1, looking east

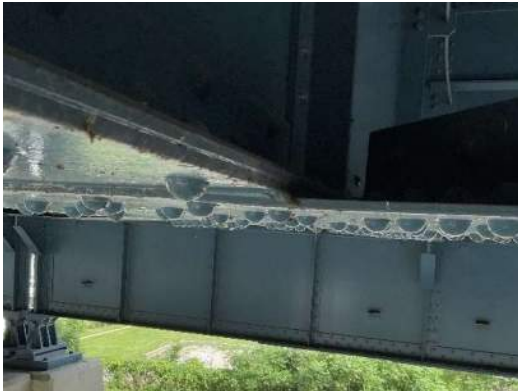
Photo 4E-003: Pack rust and bowing in lateral bracing connection plate at FB1 and S4

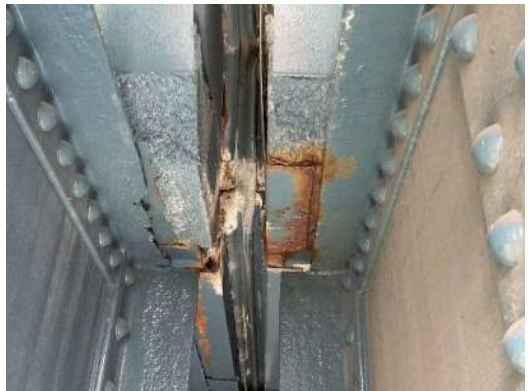
Photo 4E-004: Corrosion and efflorescence on top flange of RS1, top flange of FB0, and deck pan flashing, with rust staining, looking north

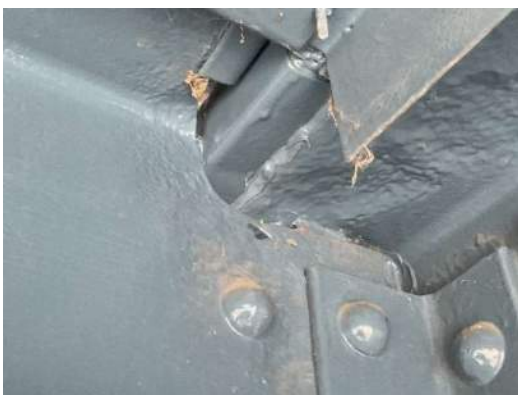
Photo 4E-005: 100% section loss on top of S1 web near at cope, at FB2

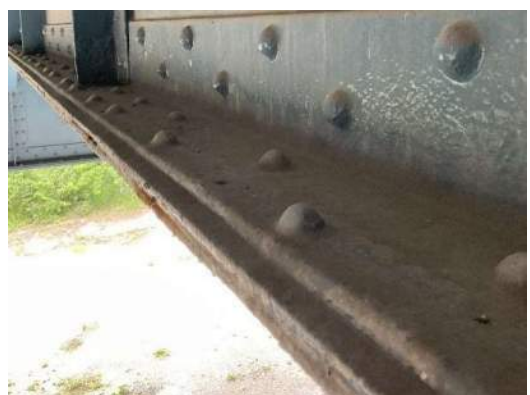
Photo 4E-006: Pack rust between bottom flange plates and pitting along top of bottom flange on FB2 west face

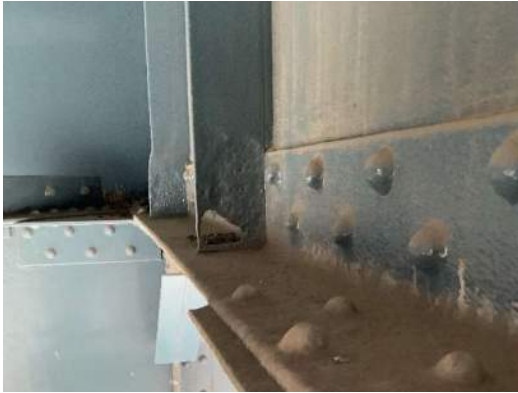
Photo 4E-007: 100% section loss in transverse stiffener on west face of FB2, between S3 and S4

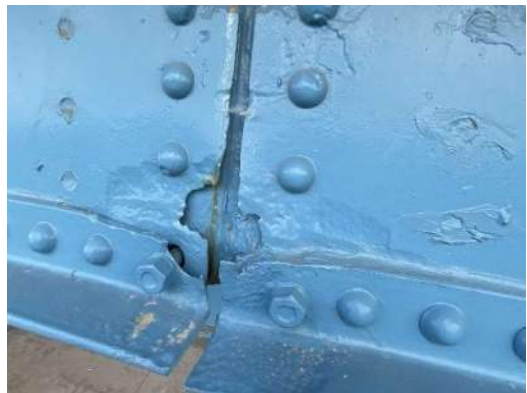
Photo 4E-008: Pack rust and painted over section loss of RS2 at FB2 south overhang, looking northwest

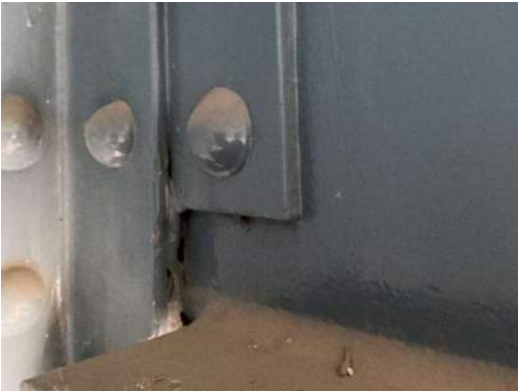
Photo 4E-009: Minor painted over pack rust between S1 web and vertical stiffener, at FB3

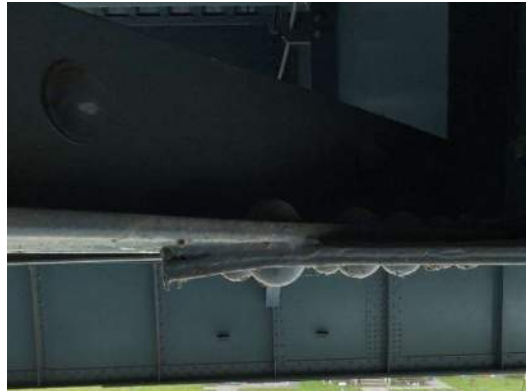
Photo 4E-010: Painted over pack rust and bowing of lateral bracing connection plate under lateral bracing angle and FB3 bottom flange, at S4

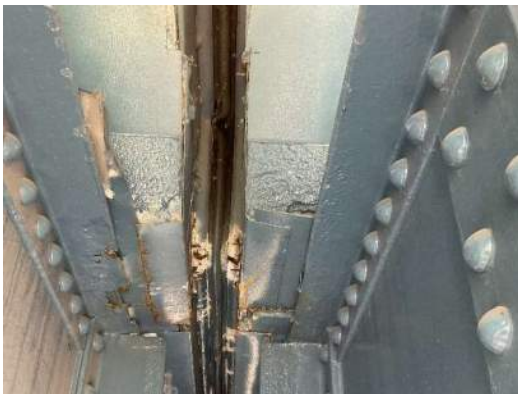
Photo 4E-011: Painted over corrosion on top flange of FB4 north overhang, with active corrosion and efflorescence on deck pan flashing above FB4, looking south

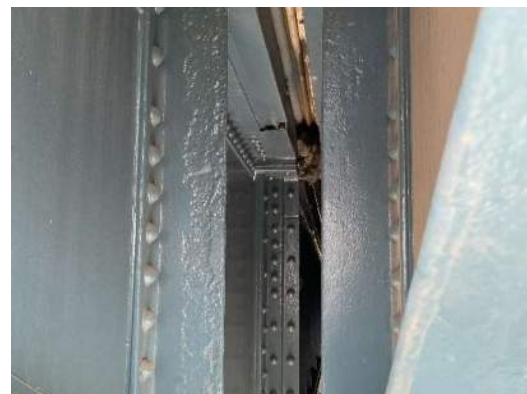
Photo 4E-012: Painted over pitting on transverse stiffener opposite of RS1 on east face of FB4, looking north

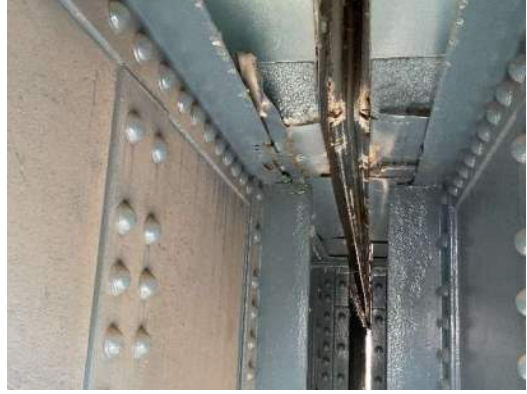
Photo 5E-002: Painted pitting on stiffeners and bottom flange of FB0 north overhang, active corrosion to top flange and deck pan flashing, with efflorescence, looking south

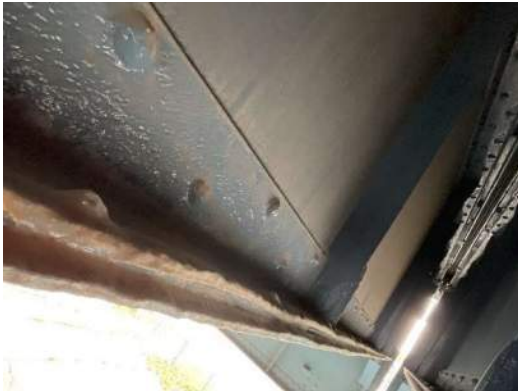
Photo 5E-003: Painted section loss on top and bottom flange of FB0 west face and bottom 4" of stiffeners, pack rust between bottom flange plates with wavy action, between S1 and S7

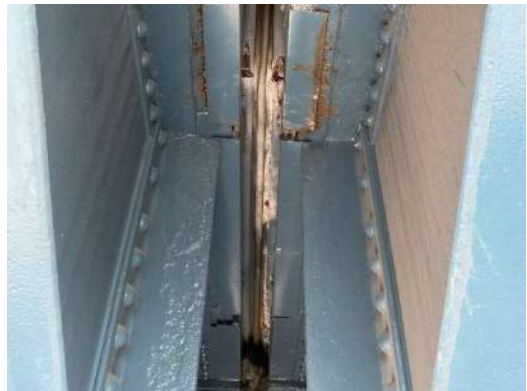
Photo 5E-004: Painted pitting on stiffeners and bottom flange of FB0 south overhang, active corrosion to top flange and deck pan flashing, with efflorescence, looking north
