PHYSICAL CONDITION REPORT
2024 ROUTINE ELEMENT LEVEL AND NSTM
INSPECTION

INSPECTION MAY 2024
REPORT AUGUST 2024

ANTHONY WAYNE BRIDGE
LUC-002-1862
SFN: 4800303

Ohio Department of Transportation, District 2
317 E Poe Rd
Bowling Green, OH 43402

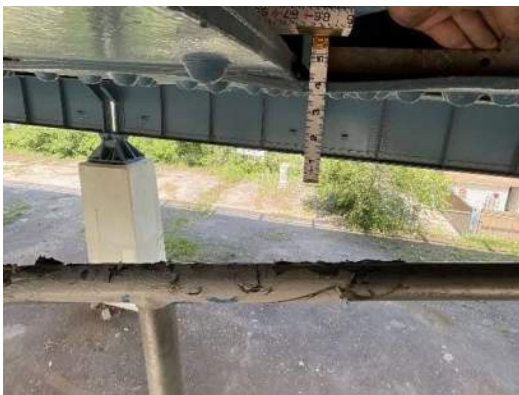
Photo 5E-005: Pack rust and bowing (up to 1/2") in connection plate for lateral bracing at bottom flange of FB1, at S4

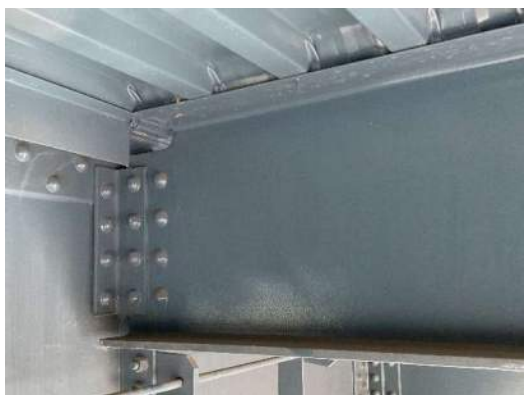
Photo 5E-006: Unpainted area (1 1/2' long by 4" high) with primer exposed on web of S7, west of FB2

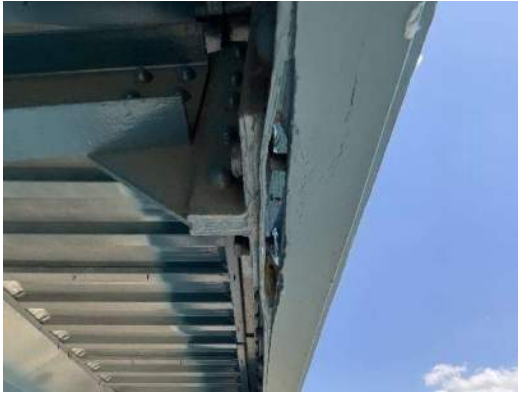
Photo 5E-007: Pack rust and painted over section loss on RS2 at intermediate overhang brace between FB1 and FB2, looking east

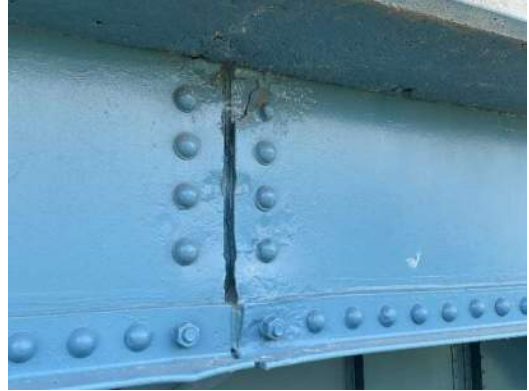
Photo 5E-008: Pack rust and painted over section loss on LS2 at FB2 overhang, looking southwest

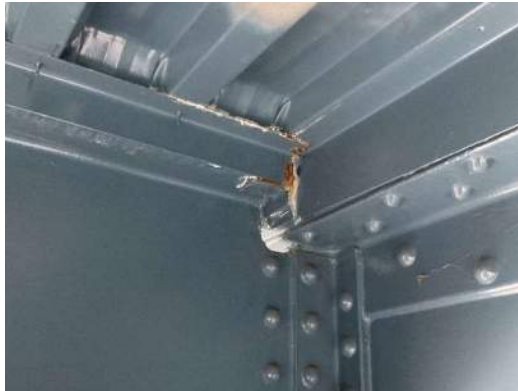
Photo 5E-009: Active corrosion and efflorescence at top flange of S4 and FB2

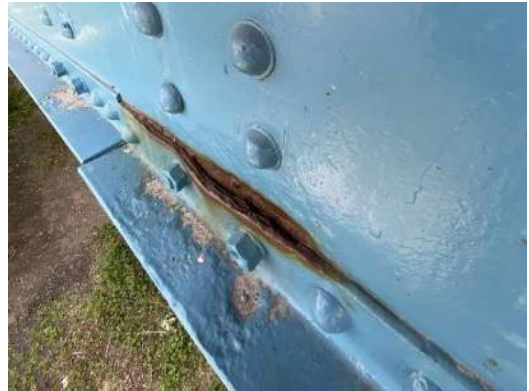
Photo 5E-010: Pack rust and painted over section loss on LS2 at FB4 overhang, looking southeast

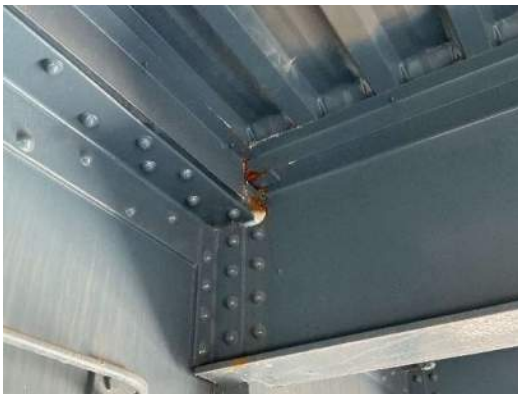
Photo 5E-011: Active corrosion to top flange of FB3 west face and top web of S4, dripping to bottom flange of S4, looking southeast

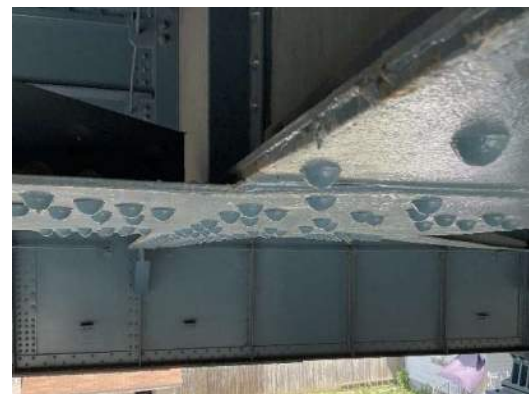
Photo 5E-012: Pack rust and bowing of lateral bracing connection plate and bottom flange of FB3, with sporadic, active corrosion to bottom flange cover plate FB3 west face

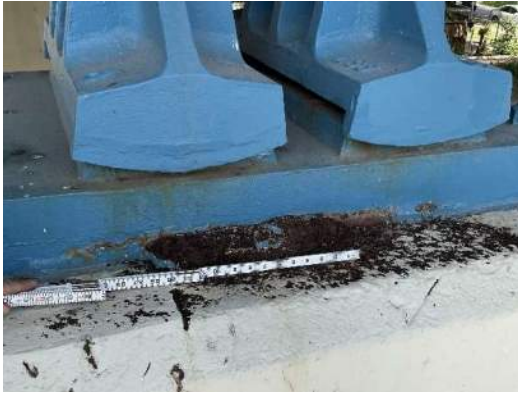
Photo 5E-013: Active area of minor corrosion on south side of masonry plate at south bearing on pier 5E, looking north

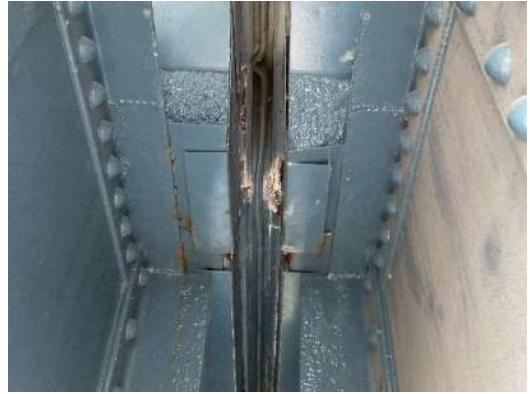
Photo 5E-014: Active corrosion to top flange of FB4 south overhang and deck pan flashing, with efflorescence, between RS1 and RS2

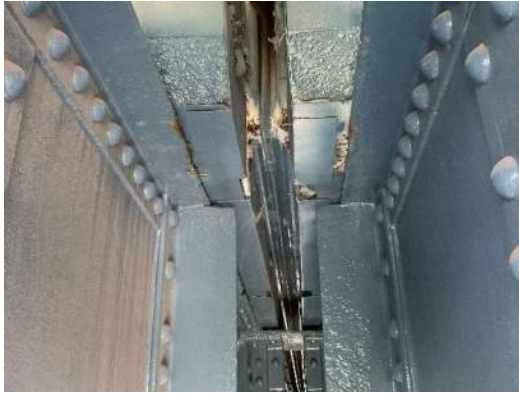
Photo 6E-001: Active corrosion and efflorescence through joint on east face FB0, with painted over section loss on top and bottom flange of FB0, north overhang

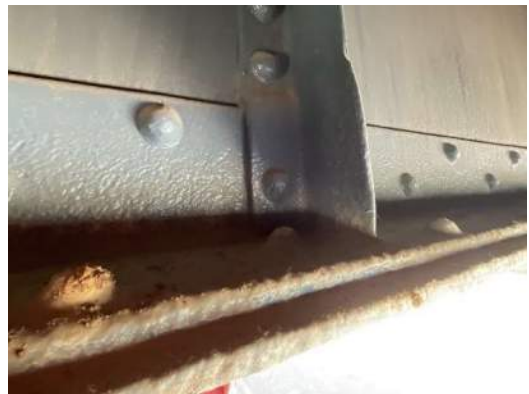
Photo 6E-002: Painted over section loss top and bottom flange, with active corrosion and painted pack rust intermittent along bottom flange of FB0, between S3 and S4

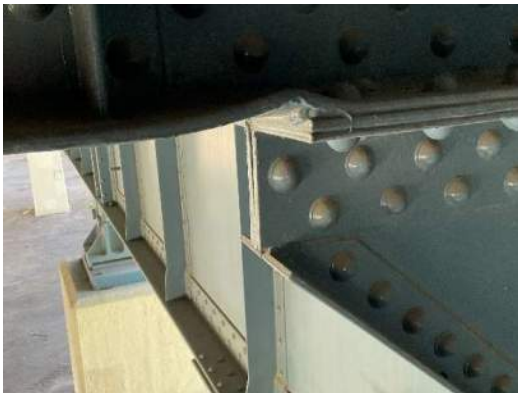
Photo 6E-003: Minor impact damage to bottom flange of FB1, south of Left Girder, looking northwest

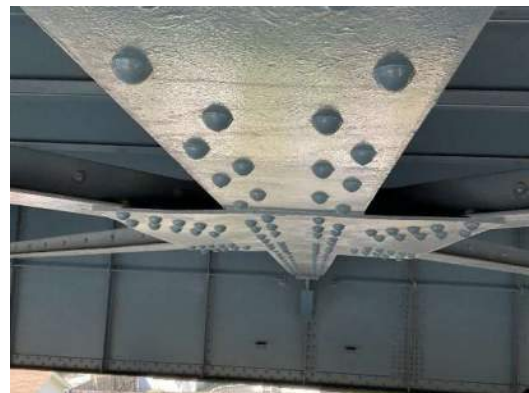
Photo 6E-004: Pack rust and bowing in lateral bracing connection plate on west side of FB1, at S4

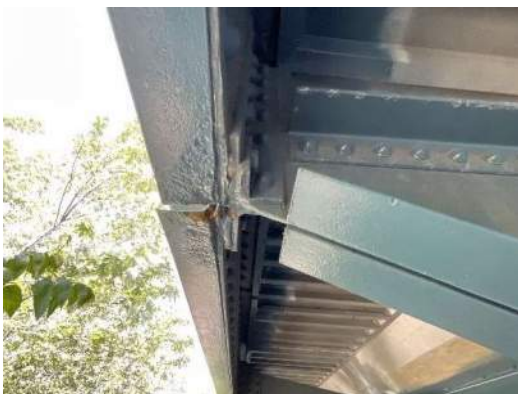
Photo 6E-005: Pack rust and painted over section loss of LS2, at FB2 north overhang, looking east

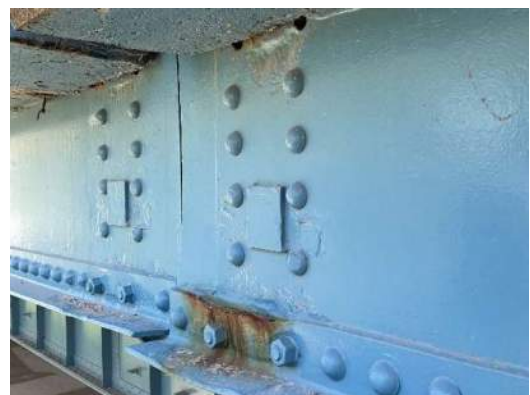
Photo 6E-006: Active corrosion and section loss on bottom flange angle and web of LS2, at FB4 north overhang, looking southeast

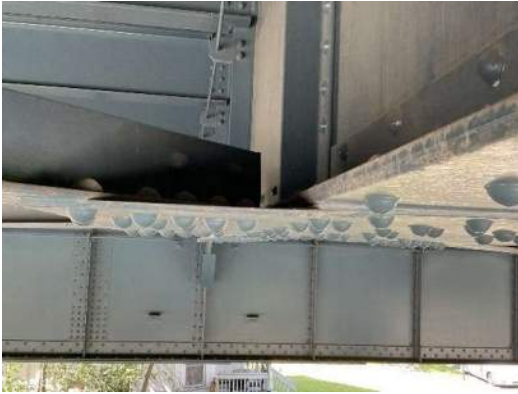
Photo 6E-007: Pack rust and bowing to lateral bracing connection plate, east and west of FB3, at S4

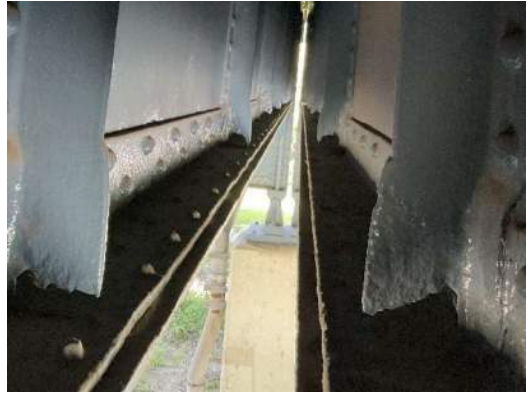
Photo 6E-008: 100% section loss on transverse stiffeners at bottom flange, FB4 east face, full length of FB4

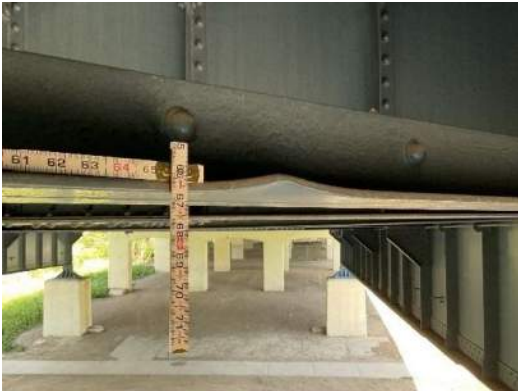
Photo 6E-009: Minor impact damage to angle of lateral bracing, near S7, between FB3 and FB4

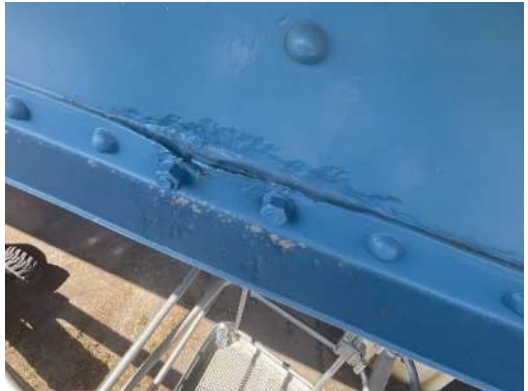
Photo 6E-010: Painted over corrosion and section loss on bottom flange angle and web of RS2, at intermediate bracket south overhang, between FB3 and FB4, looking north

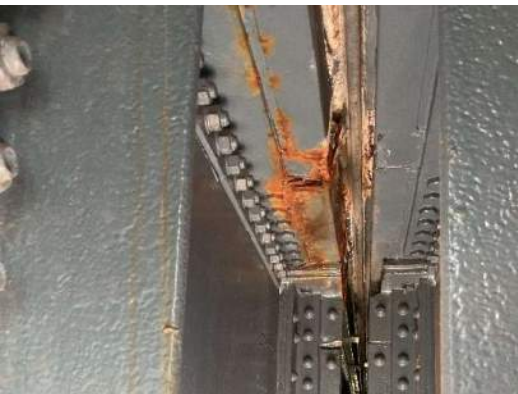
Photo 6E-011: Active corrosion and efflorescence at top flange FB4 and deck pan flashing, on south overhang

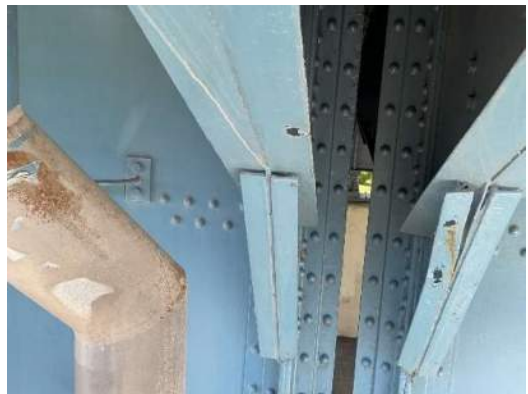
Photo 6E-012: 100% section loss in bottom flange of FB4 south overhang, near Right Girder, looking north

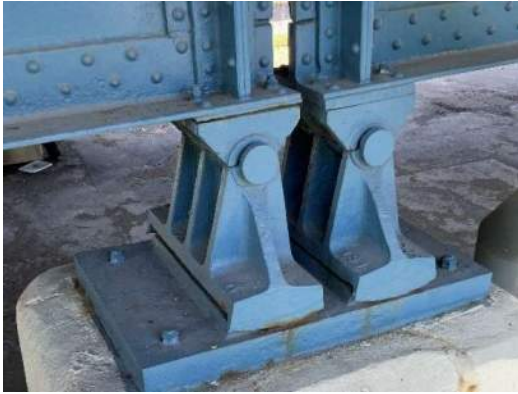
Photo 7E-001: Corrosion and pack rust between rocker assembly and masonry/sole plates at Pier 6E north bearing, looking southwest

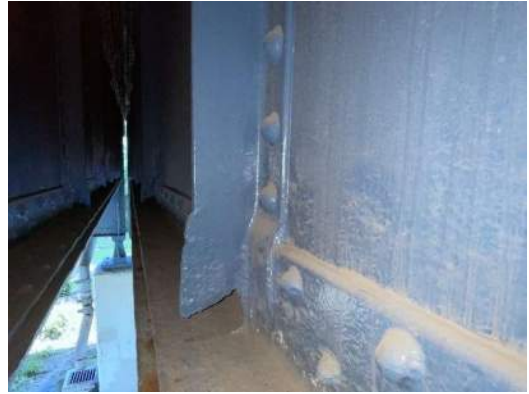
Photo 7E-002: 100% section loss to stiffeners 6 and 7 on west face of FB0, at bottom flange, between S4 and S5, looking north

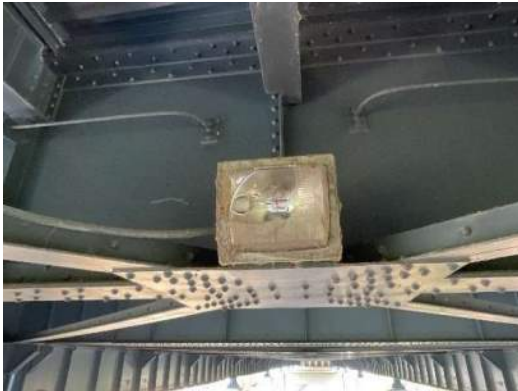
Photo 7E-003: Broken light under bridge at S4 and FB1 connection

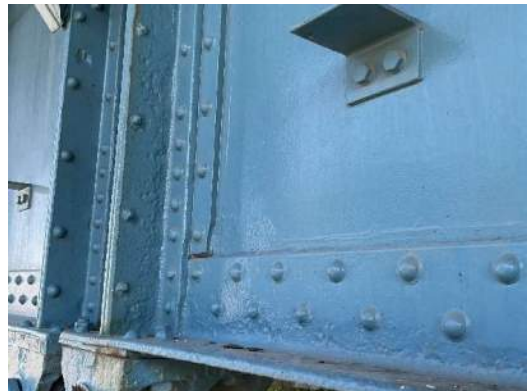
Photo 7E-004: Painted over pitting on FB0 angles, west face, near RS1, looking northeast

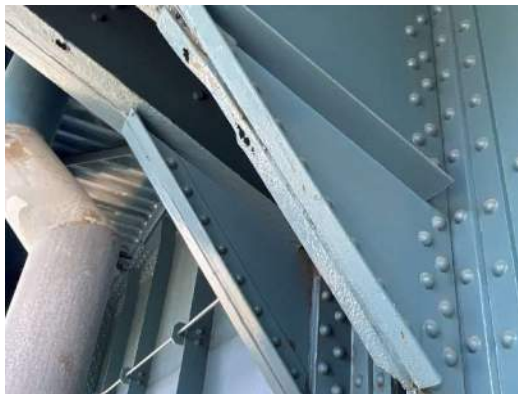
Photo 7E-005: Painted over pitting and 100% section loss in angle on FB0, between at RS2

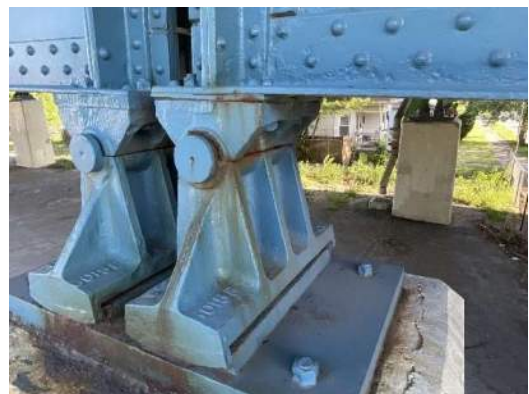
Photo 7E-006: Surface corrosion with pack rust on top of south bearing at pier 6E, looking northwest

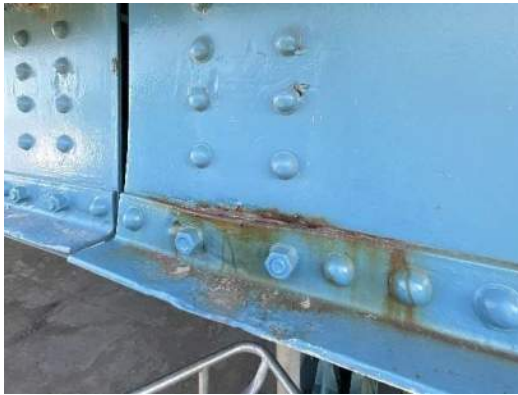
Photo 7E-007: Pack rust and painted over section loss to RS2 at FB0, looking northwest

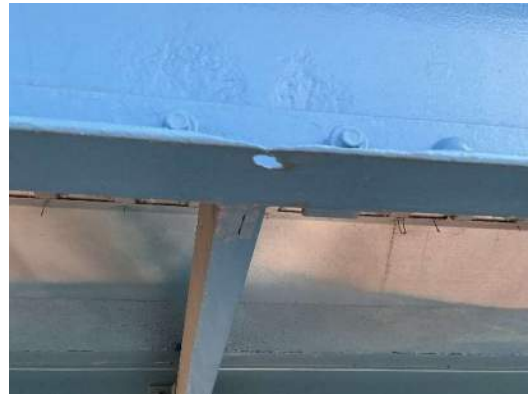
Photo 7E-008: 100% section loss in bottom flange angle of RS2 south face, between FB0 and FB1, looking north

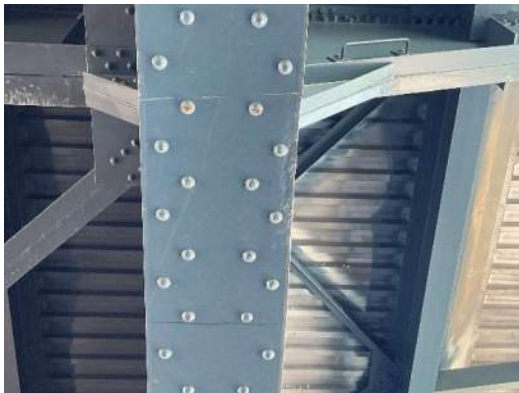
Photo 7E-009: Typical painted over section loss to bottom flange of Right Girder, intermittent for full length, shown at FB2

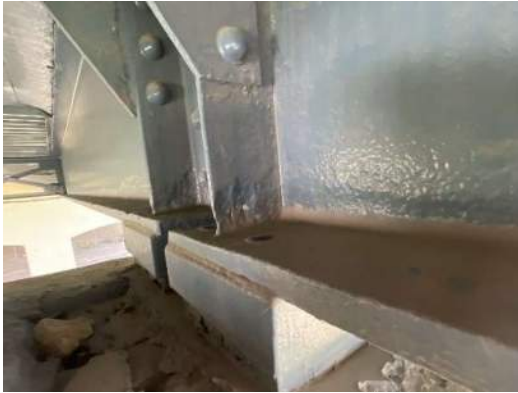
Photo 8E-001: Painted over pitting on throughout
S9 at pier 8E, looking southeast

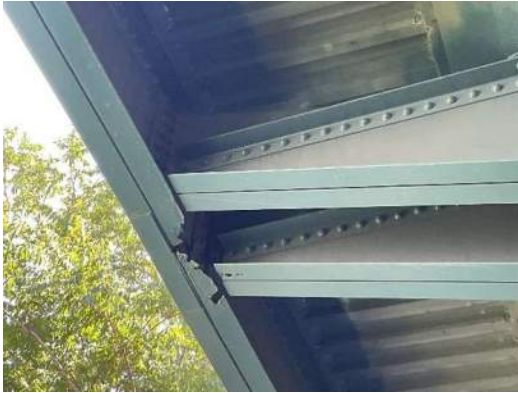
Photo 9E-001: Painted over corrosion and 100% section loss and pack rust between bottom angle/web of S1 at pier 9E

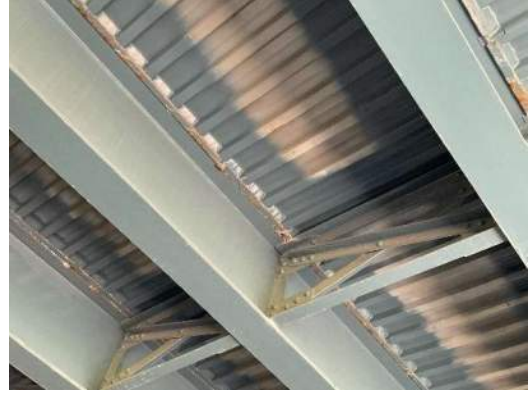
Photo 10E-002: Typical active corrosion along top flange for 50% length of stringers, shown along S9

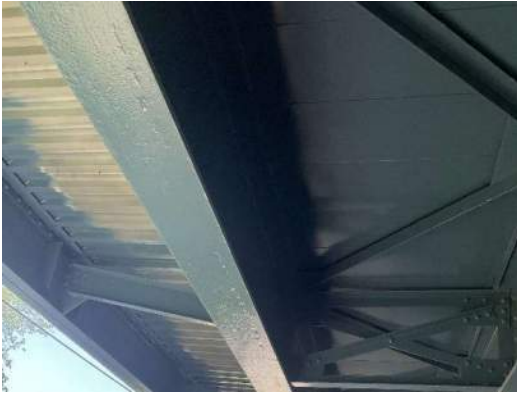
Photo 11E-001: Painted over section loss along
S12

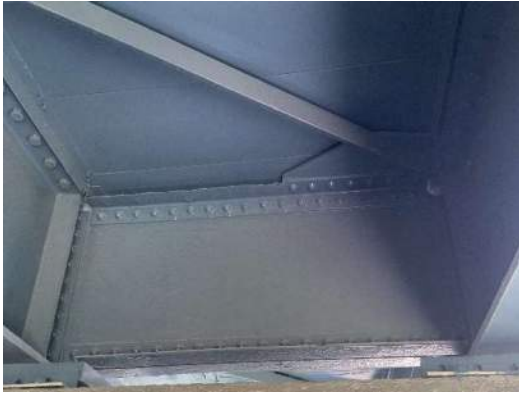
Photo 12E-001: Minor painted over pitting on cross frame, at pier 12E, between S11 and S12

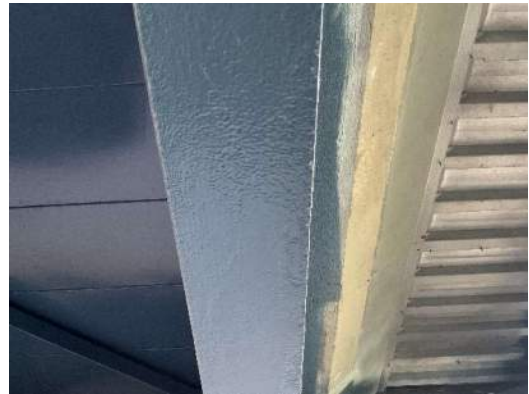
Photo 12E-002: Painted over section loss on bottom flange of S2, just east of pier 11E, looking north

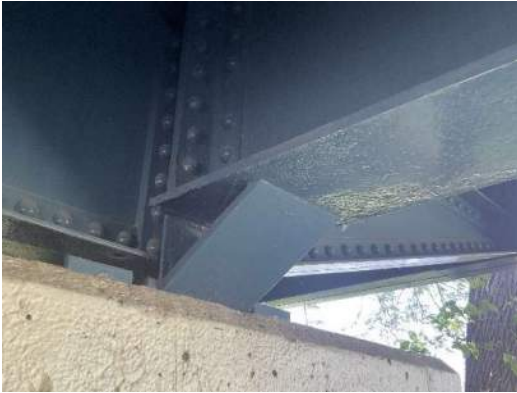
Photo 13E-001: Painted over section loss on S2, west end, looking northwest

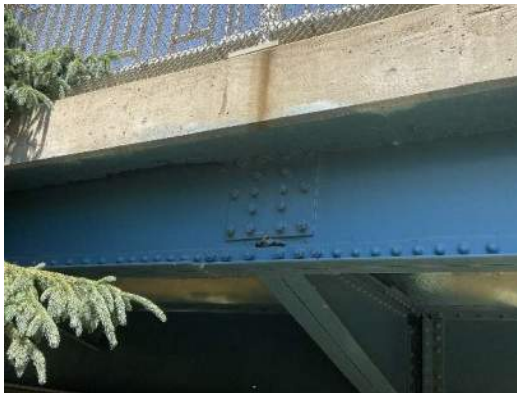
Photo 13E-003: Painted over corrosion with 100% section loss and pack rust between bottom angle/web of S13 at pier 12E, looking northeast

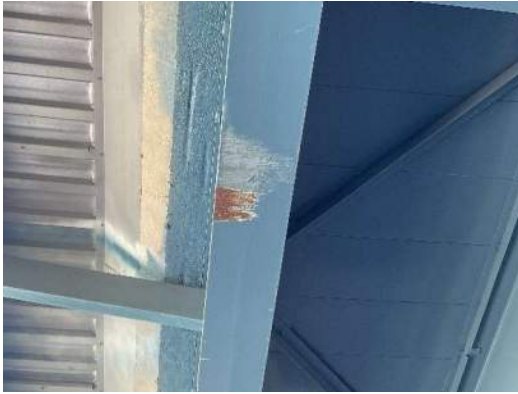
Photo 14E-001: Minor impact scrapes with active corrosion on the bottom flange of S2 midspan

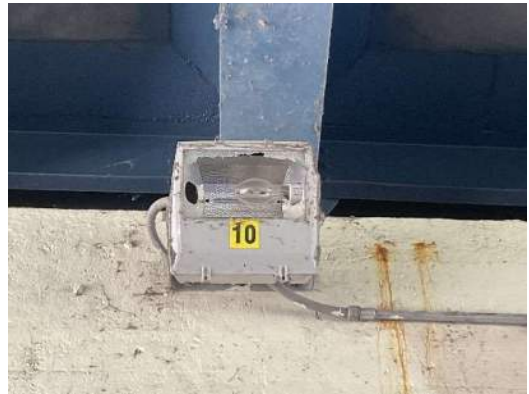
Photo 14E-002: Broken light cover below S7, at pier 13E, looking west

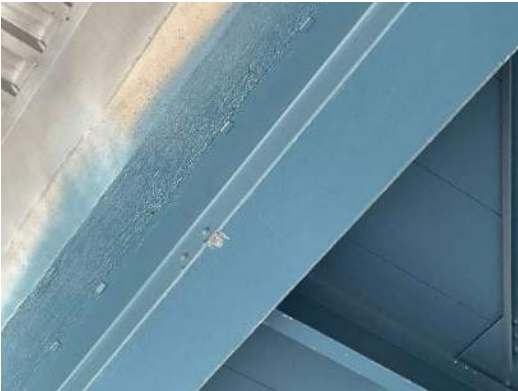
Photo 14E-003: Minor impact scrapes on bottom flange of S12 near midspan
