2022 PHYSICAL CONDITION INSPECTION REPORT

ERI-6-2893

State Route 6 over the Vermilion River

Ohio Department of Transportation

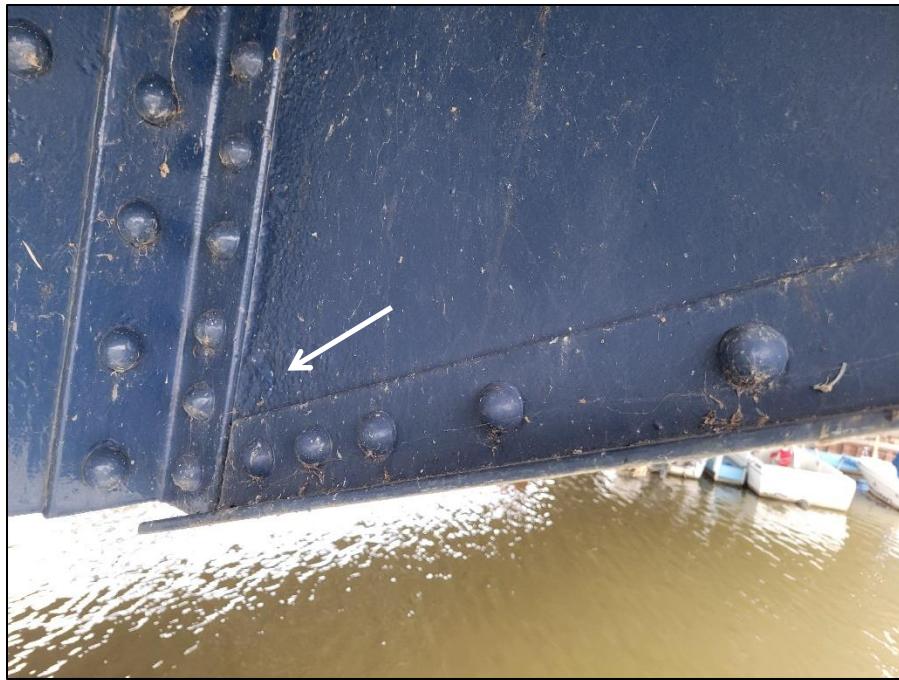
Sidewalk Cantilever Brackets - The sidewalk cantilever brackets are typically in good condition. There is some minor section loss in the webs at the connections to the trusses. The north cantilever bracket at L3 has a small hole in the web. The south cantilever bracket at L4 has three small holes in the web (see Picture 9). The south cantilever bracket at L5 has two small holes in the web. The south cantilever bracket at L6 has impact damage and a small hole in the web (see Picture 10). The sidewalk south cantilever at L9 has pack rust and minor active rust at the bottom of the connection angle at the bearing. Three of the sidewalk cantilever brackets have bent ends where boats have impacted the structure (see Picture 11).

Picture 10: Looking east at pinholes in web of south cantilever bracket at L4.

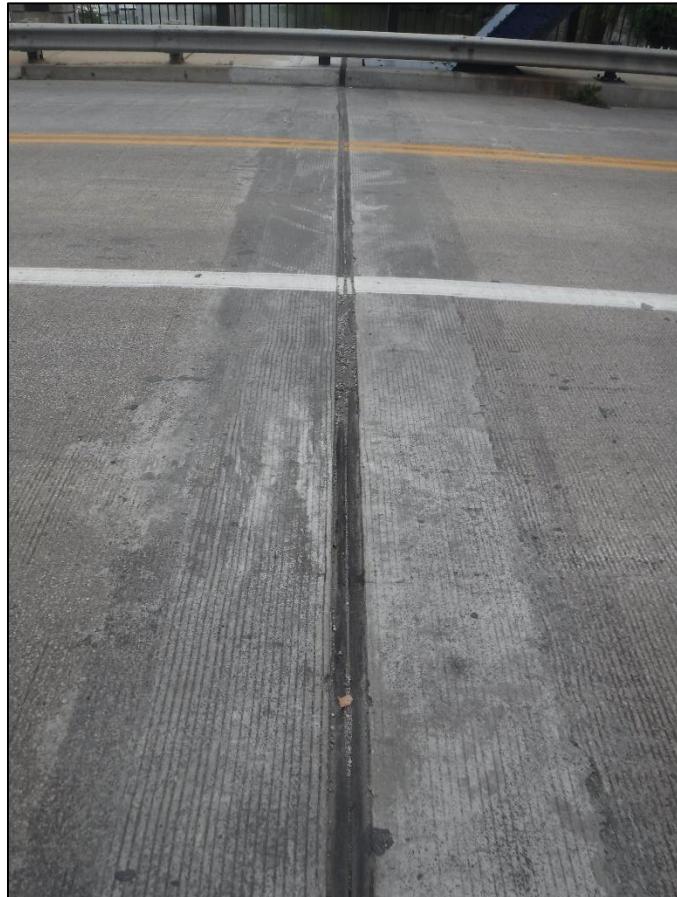
Compression Seals - A compression seal is located between the deck at forward abutment and the forward approach slab (see Picture 18).

Picture 18: Forward compression seal.

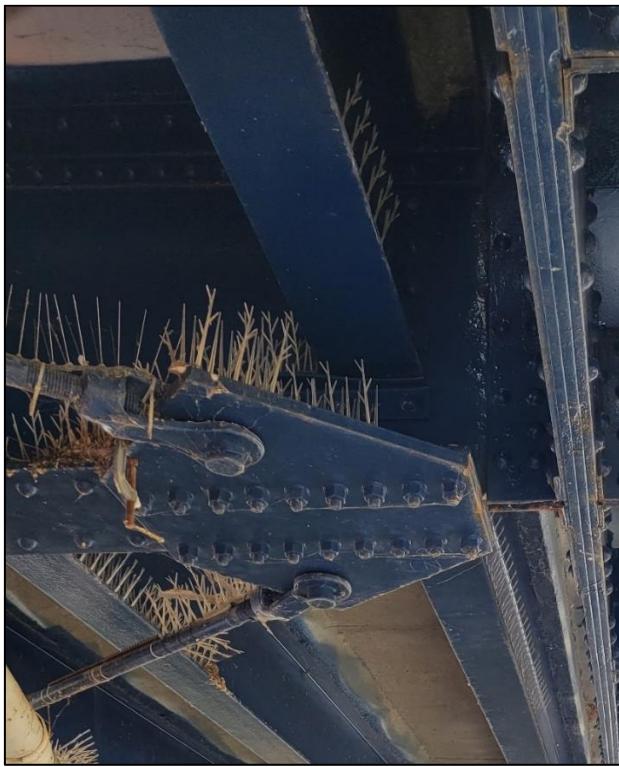
Approximately 23 stringers are not seated on the support angles. The stringer and floorbeam connections were rated in 2015, and found that the support angles are not needed to safely carry loads. The support angles were likely installed to temporarily support the stringers while the web connections were made. There are approximately 15 stringer support angles that are bent and have section loss (see Picture 21). There are pigeons and swallows nesting on the bridge. Pigeon spikes have been installed on the stringer bottom flanges (see Picture 22) over the boats docked at each side of the channel, but this has not fully deterred birds from nesting.

Picture 22: South lateral bracing connection angle of Floorbeam 7; note the pigeon spikes.

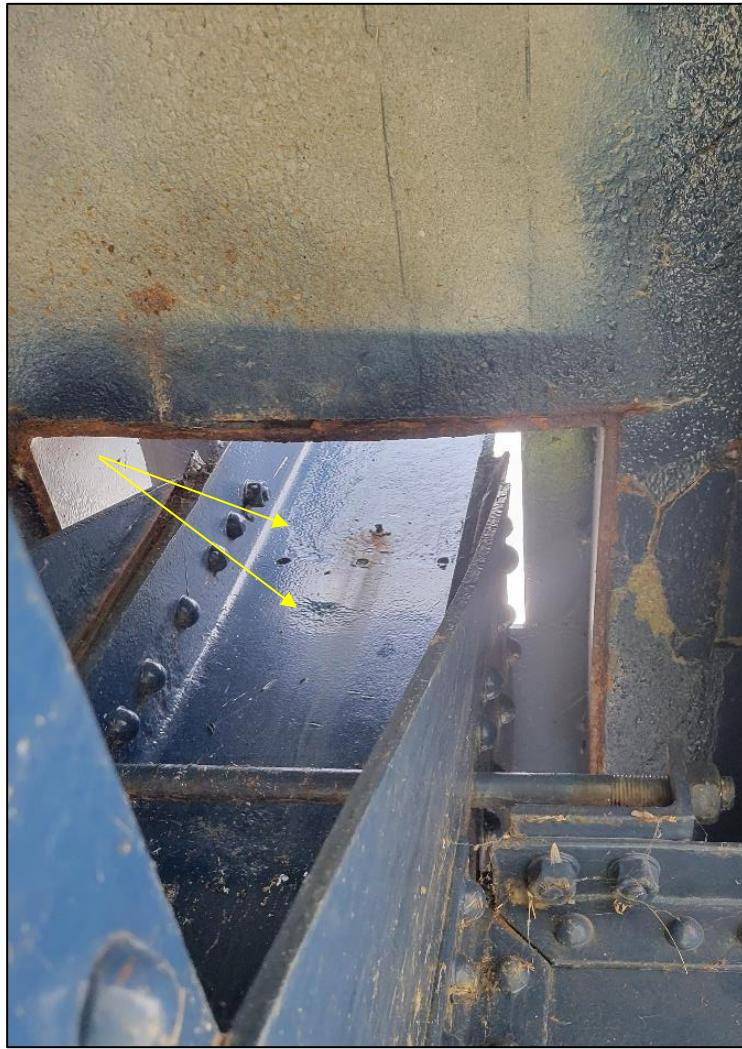
The verticals are rolled steel sections. The truss verticals are in **fair** condition having minor section loss (see Picture 24) and pitting in areas outside of the splash zone. There is pitting on the end verticals at the original end portal connection locations. The end portals were raised to increase vertical clearance in 1986. There is pitting at locations of the original pipe rail connections located above the deep beam guardrail. The truss verticals have pitting with section loss (approximately 10% of web area) in the splash zone (see Picture 25). Plates have been added to the bottom of the vertical webs at L2U2 of the south truss, L8U8 of the north truss, and L8U8 of the south truss. Vertical L6U6 on the north truss has a hole on the south side of the web in the splash zone. The vertical connections to floorbeams have minor section loss and pack rust.

Picture 25: L8U8 of the north truss typical pitting in splash zone.

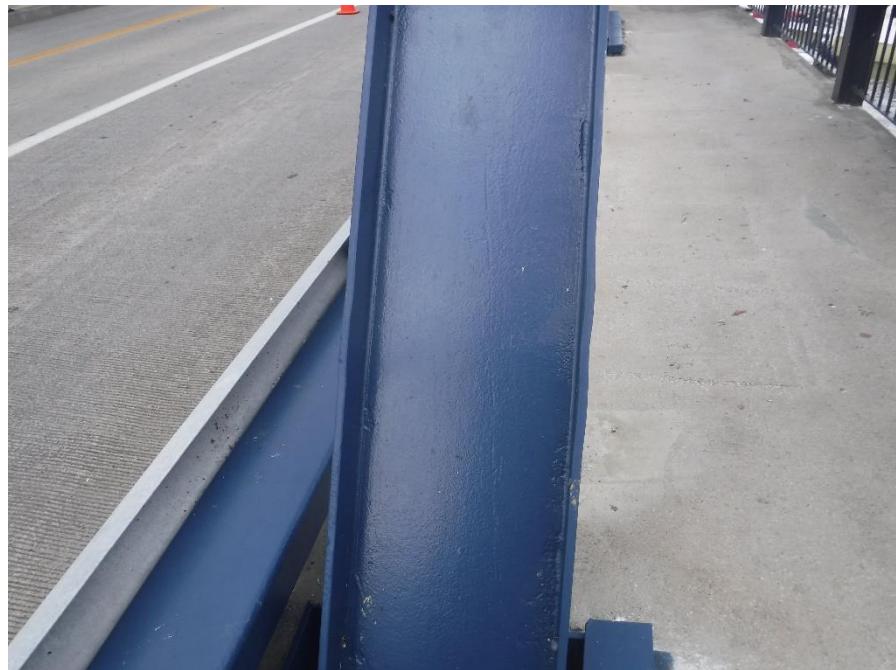
Truss Diagonals - The truss diagonals are in **fair** condition. The diagonals are rolled steel sections (see Picture 26). The truss diagonals and their connections have minor section loss and pitting in areas outside of the splash zone. There is pitting at locations of the original pipe rail connections located above the deep beam guardrail. The truss diagonals have pitting with section loss (approximately 10% of web area) in the splash zone (see Picture 27). There are holes and deep pitting in the webs of L3U4 of the south truss, L4U5 of the south truss, and L6U5 of the north truss. L6U7 of the south truss and L7U8 of the south truss have section loss and holes in the web at the bottom of the diagonal. Plates have been added to the bottom of the diagonal webs at L3U2 of the south truss, L5U4 of the south truss, and L6U5 of the south truss. The fill plates between the diagonals and the lower chord gusset plates have section loss with minor active rust, some of the fill plates are bent, and rivets are not engaged at some locations. U4L5 of the north truss has minor misalignment of flanges (see Picture 28).

Picture 28: Minor waviness of north flange of U4L5 of the north truss.

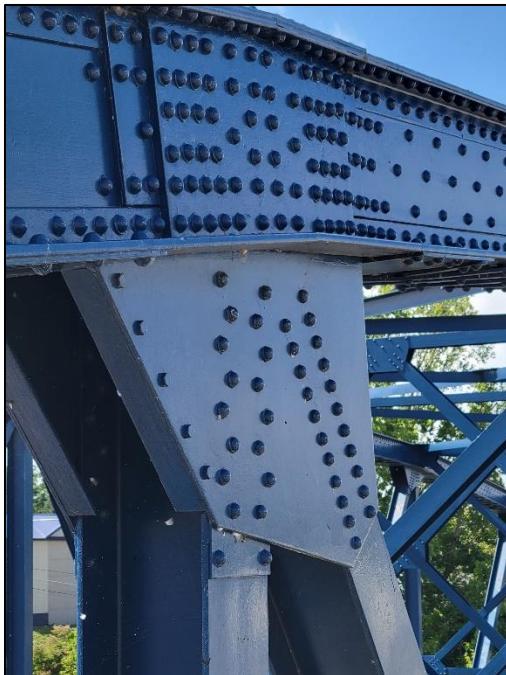
The truss gusset plates are in **poor** condition. The gusset plates were rated in 2009 by Wilbur Smith Associates based on field measured gusset plate thicknesses. The rating included section loss measured in the field and determined that the gusset plates have sufficient capacity. The section loss in the gusset plates has not increased since 2009. Bowing due to pack rust at the lower chord gusset plates governed the rating of the gusset plates on this bridge.

Picture 35: North face of gusset plate at U7.

- The addition of stiffening angles to the lower edge of U1 and U8.
- Blast and paint lower chord members and gusset plates to arrest active corrosion and pack rust.
- Reinforce sheet piling along river on west side and regrade back to abutment.

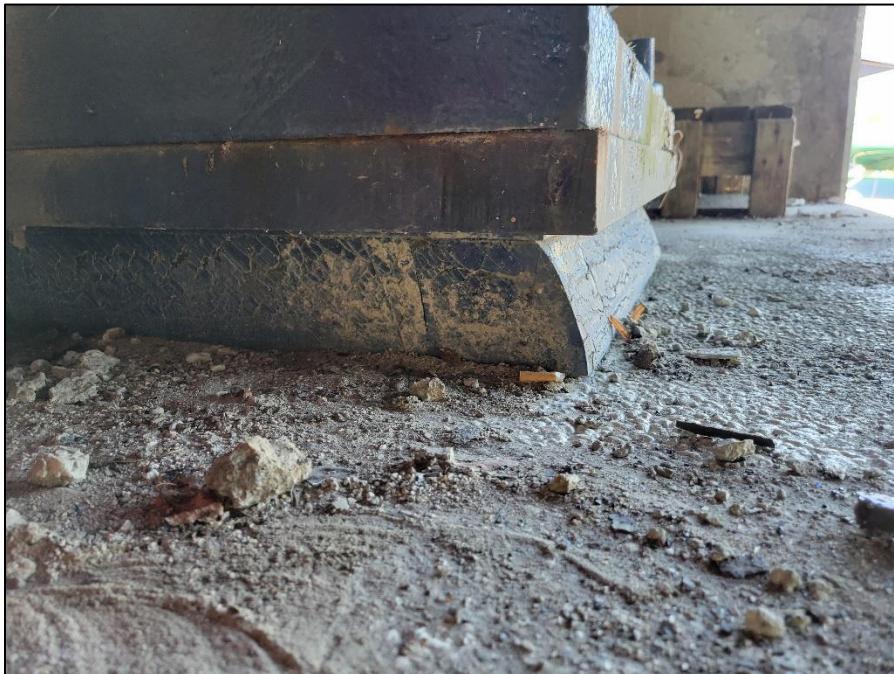
The movable bearings at the rear end of the structure are in **poor** condition and the fixed bearings at the forward end are in **fair** condition. The rear abutment bearings are elastomeric pads and rocker type (see Pictures 43 and 44). The forward abutment bearings are bolster type (see Picture 45). The north rocker bearing at the rear abutment has a 19.50-degree tilt towards the backwall at 80 degrees Fahrenheit (see Picture 43). The south rocker bearing at the rear abutment has a 17.00-degree tilt towards the backwall at 80 degrees Fahrenheit. The rear abutment elastomeric bearings have a horizontal deformation toward the backwall (see table below & Picture 43). The horizontal deformation difference is found by measuring the distance from front face of the rear abutment to the top and bottom of each edge of the elastomers.

L0 Elastomeric Bearings Top to Bottom Difference					
Truss	Edge	2014	2016	2020	2022
North	Outside	1 $\frac{1}{4}$ "	1 $\frac{5}{8}$ "	1 $\frac{3}{16}$ "	1 $\frac{3}{8}$ "
North	Inside	1 $\frac{1}{8}$ "	1 $\frac{3}{8}$ "		1 $\frac{1}{2}$ "
South	Inside	1 $\frac{3}{16}$ "	1 $\frac{5}{16}$ "	1 $\frac{5}{16}$ "	1 $\frac{5}{16}$ "
South	Outside	1 $\frac{3}{16}$ "	1 $\frac{1}{2}$ "		1 $\frac{5}{16}$ "

Picture 43: North elastomeric bearing on rear abutment.

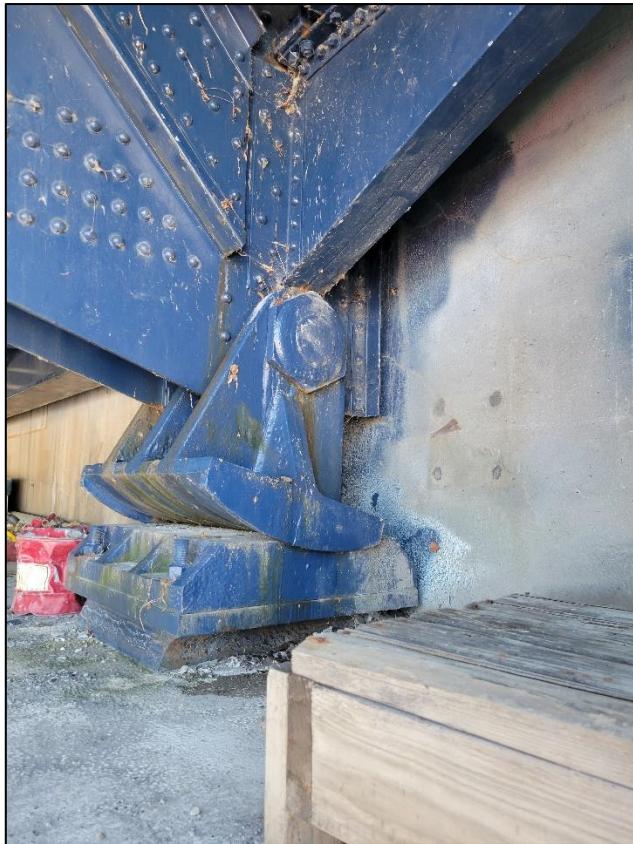
Picture 44: North side of north bearing at rear abutment.

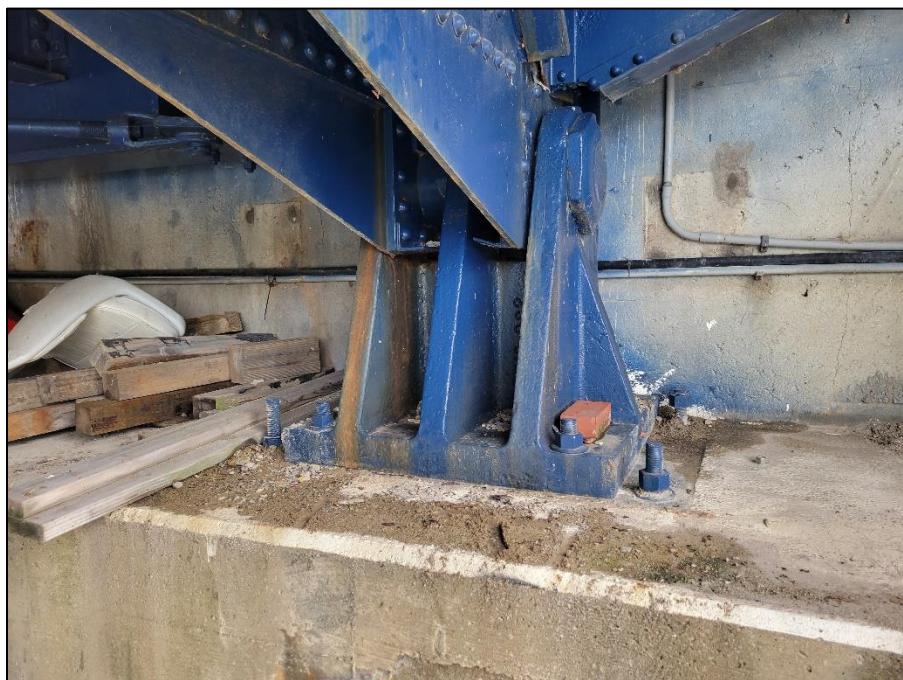
Picture 45: South bearing (bolster) on forward abutment.

There is minor active rust at the north bearing pin on the south nut on the forward abutment. There is minor pitting on the bearings where water and debris get through the curbs. There is a nut missing at the forward abutment south bearing on the northeast corner. There are loose bearing anchor nuts at several locations. See the following table for locations of loose bearing nuts:

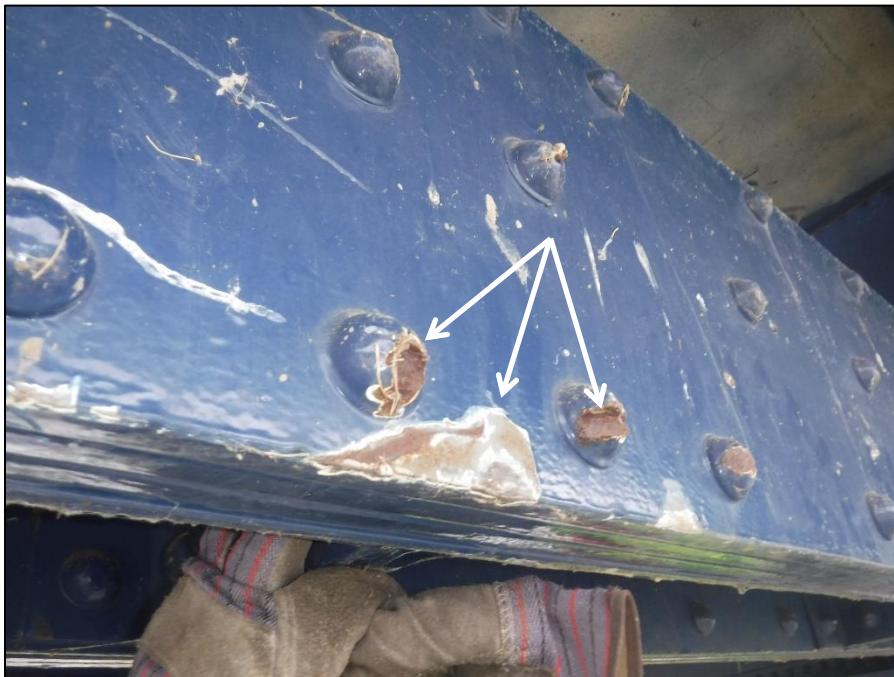
There is chipped paint or minor scrapes in the paint is typical on both the diagonals and verticals from roadway and sidewalk impacts, and on the lower chord due to minor impacts from boats (see Picture 47). There are chips and dings in the paint at L0U1 of the north truss, L6U7 of the north truss, L9U8 of the north truss, deep beam railing bolt in Panel 4, the pedestrian railing, the sway brace at Panel Point 2 and the lower gusset plate connection to the north truss.

Picture 47: Looking at south face of L5L6 of the south truss.

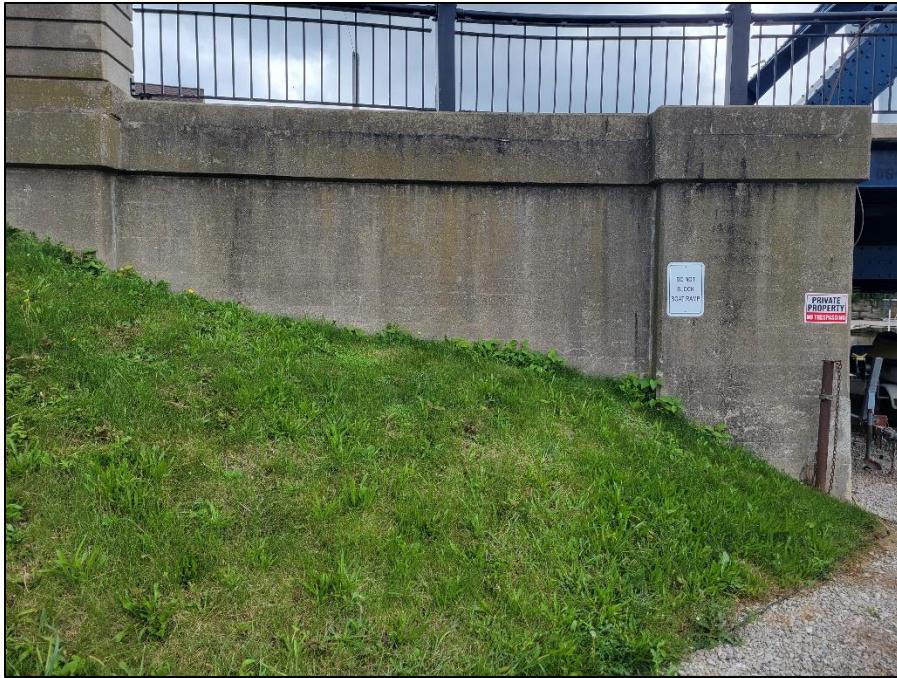
The wingwalls are in **fair** condition. The approach sidewalks at all corners have settled. This may be caused by the loss of fill from behind the wingwalls. There are a few spalls with exposed reinforcing on the backs of the southwest wingwall next to the seat. The southwest wingwall has 1.75 square feet of delamination. The southeast wingwall has a mural (See Picture 50). The southeast wingwall has map cracking, a few small delaminations and one long crack at the top. The seal in the joint between the southeast wingwall and the retaining wall to the east has deteriorated and is mostly gone. The northeast and northwest wingwalls have minor cracks (see Picture 51).

Picture 51: Northeast wingwall.

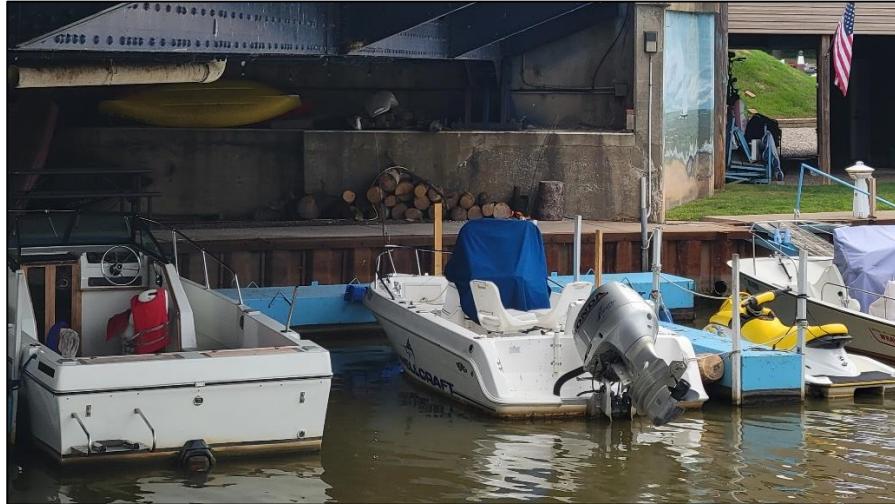
Slope protection for this bridge is in **good** condition. The rear abutment slope has crushed aggregate slope protection and vegetation. Sheet piling retains the soil in front of the rear abutment. There are several deep ruts leading to the sheet piling. The forward abutment slope has crushed aggregate slope protection and concrete sidewalks. Sheet piling retains the soil in front of the forward abutment all of the slope protection measures on the forward end of the structure is in good condition.

Picture 52: Looking east at forward abutment slope protection.

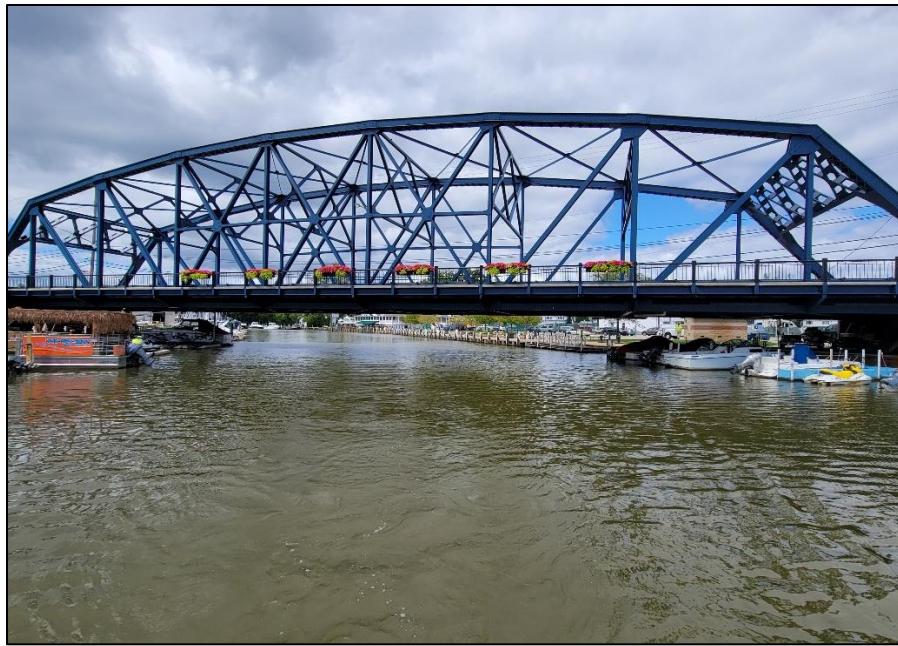
The alignment of the Vermilion River is **good**. No deficiencies are noted.

Picture 53: Looking downstream (north).

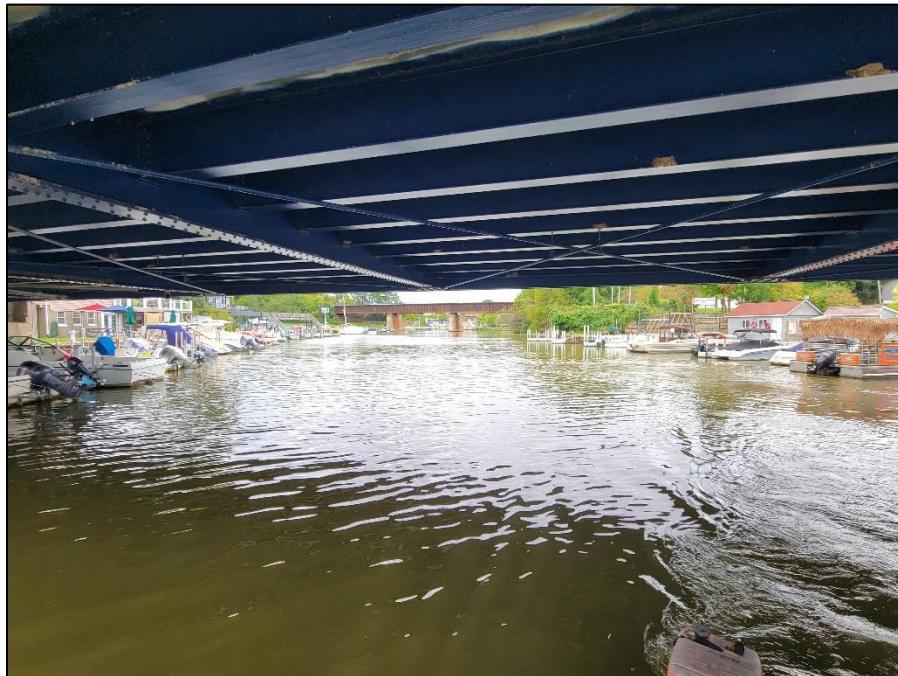
Picture 54: Looking upstream (south).

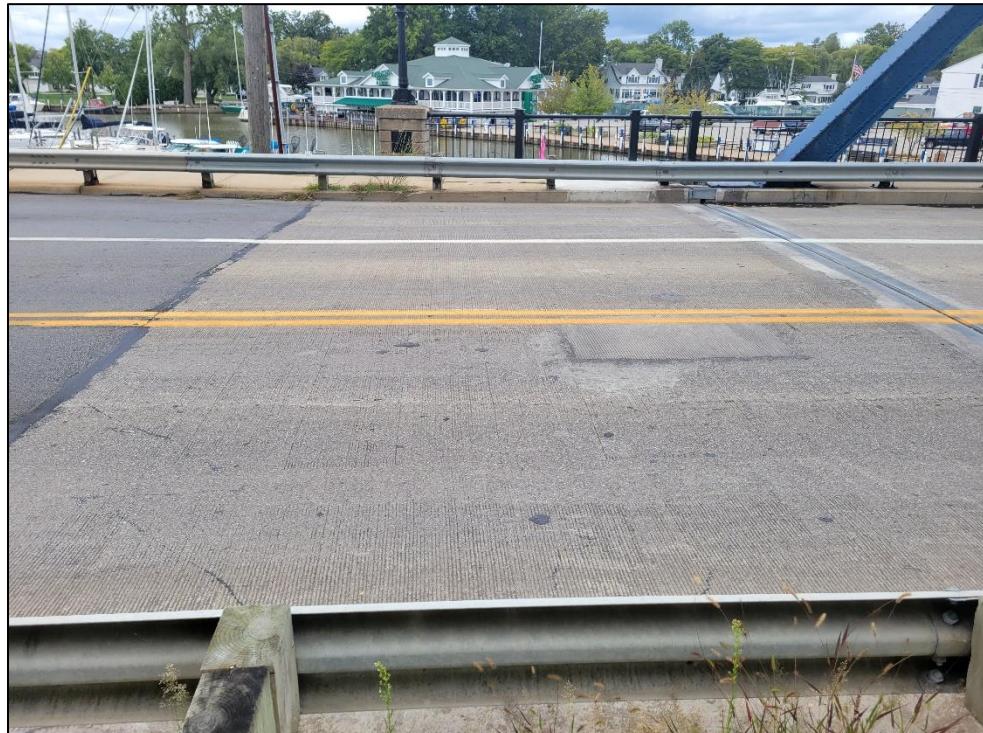
The reinforced concrete approach slabs are in **good** condition. The approach slabs are 20'-0" long, 13" thick reinforced concrete (see Picture 56). The approach slabs have a few small potholes, a 12 square foot patch was added in 2021 to repair a delamination in the eastbound lane on the west approach slab. A portion of the approach slab along both deck joints were replaced during the 2021 joint rehab to fix many small spalls along the joints.

Picture 56: Looking north at rear approach slab.

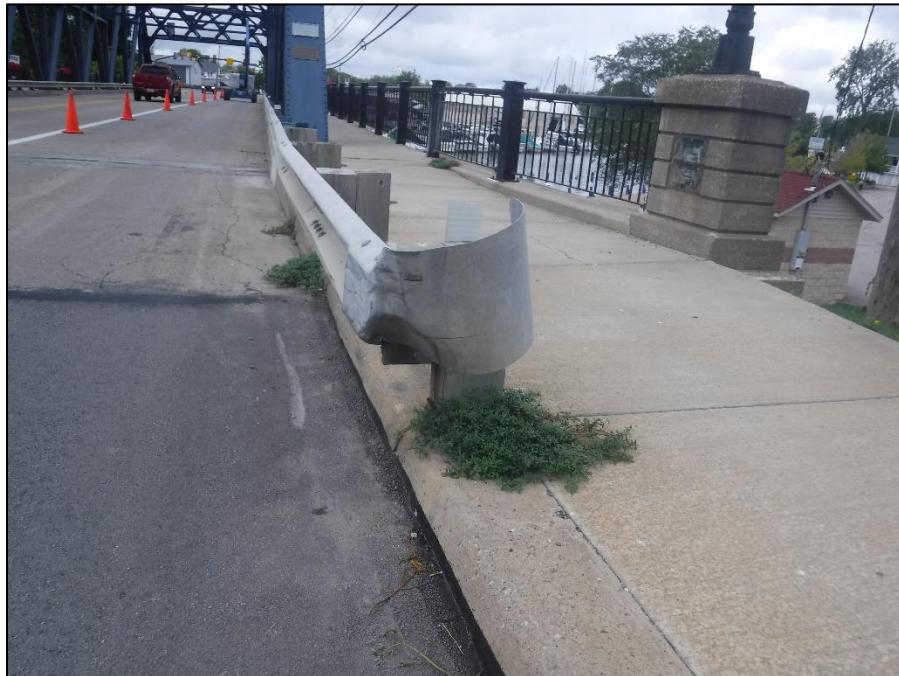
The approach guardrail is rated **fair**. The northeast (see Picture 60) and southwest end terminal assemblies have impact damage. The post connection bolts are loose at the first post off the northwest and southwest corners of the bridge. The end terminal assemblies at the northwest and southwest approaches have loose bearing plates and cables. The first timber post off the northeast approach has a loose timber block. There is minor paint transfer on the guardrail.

Picture 60: End terminal assembly at northeast corner.

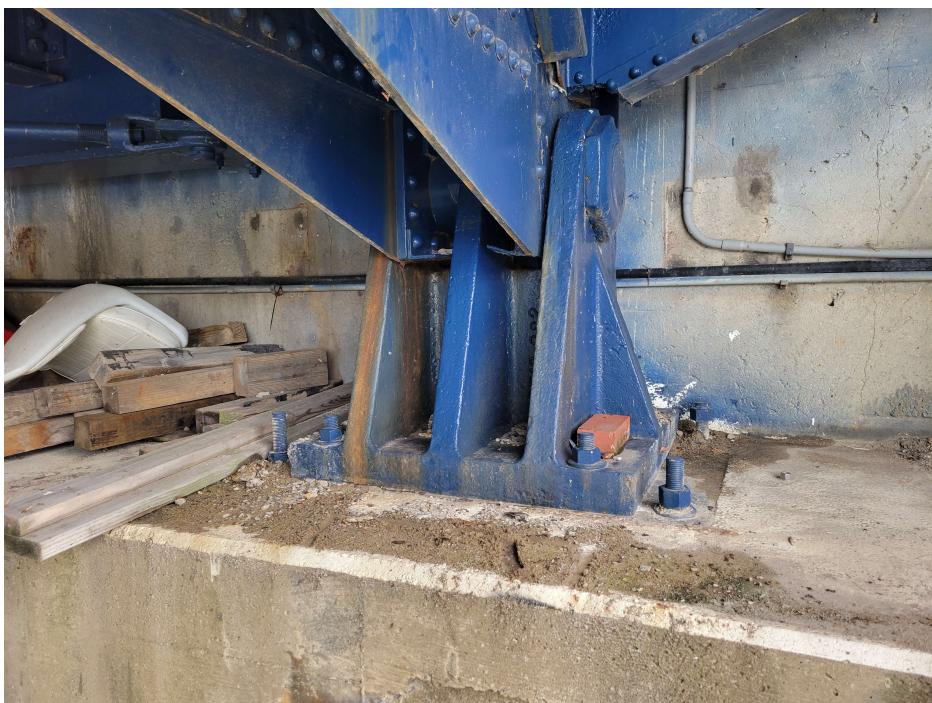
PHOTO 1

Description SE Bolster

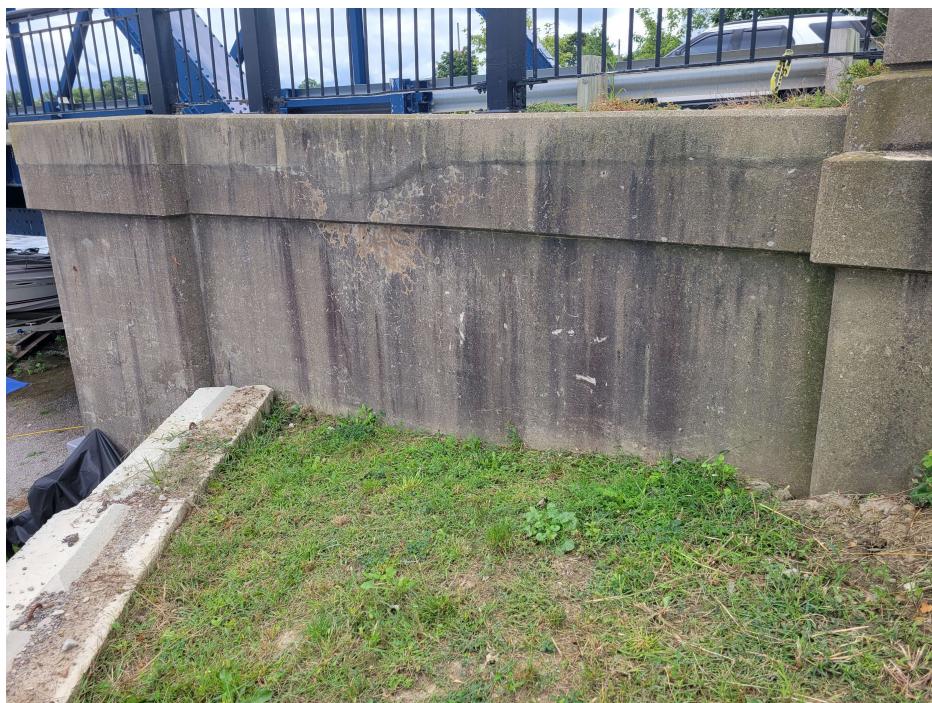
PHOTO 2

Description NW WW

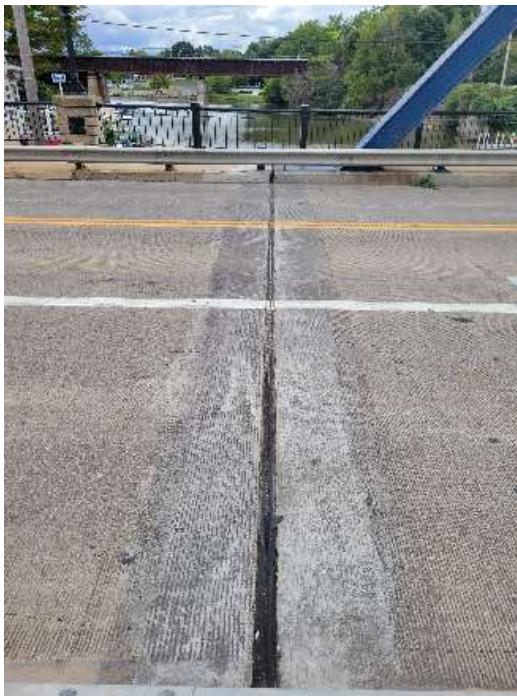
PHOTO 2

Description deflection joint at east end

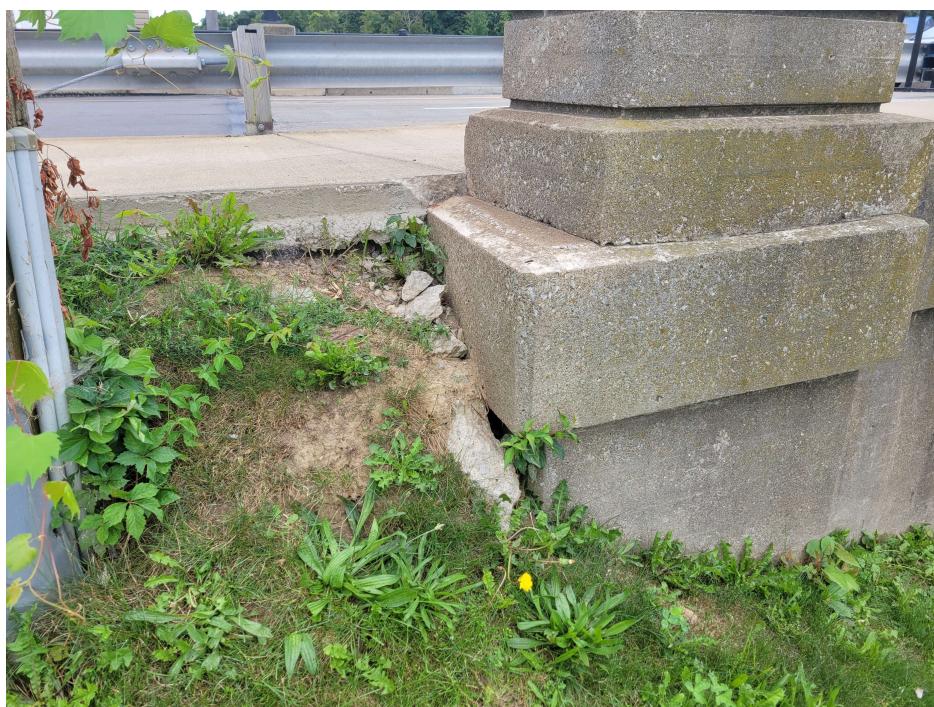
PHOTO 3

Description erosion at NE

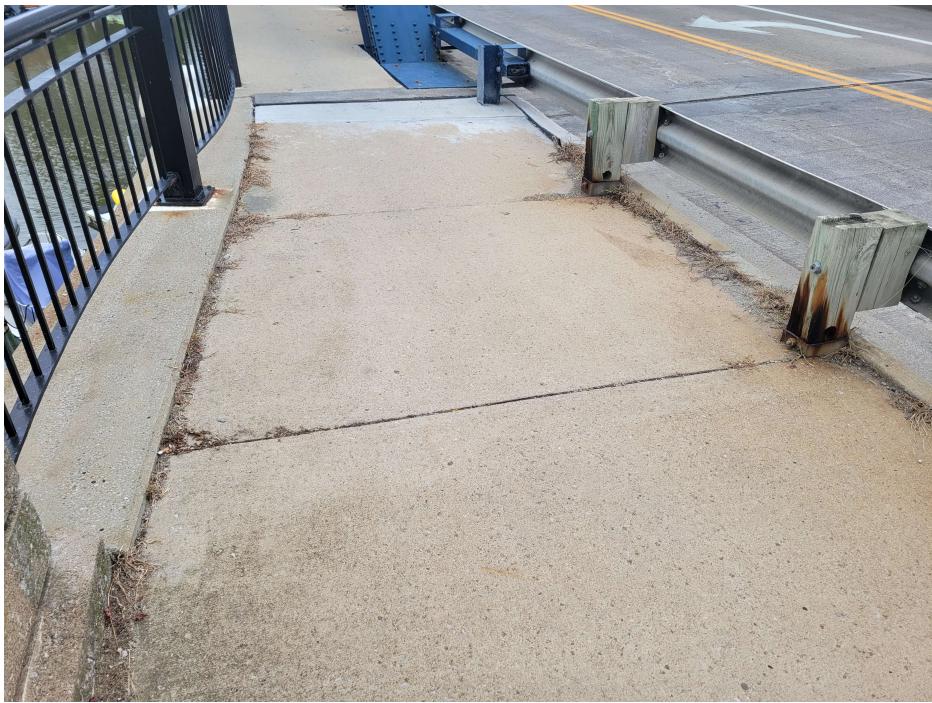
PHOTO 4

Description SE appr. Sidewalk

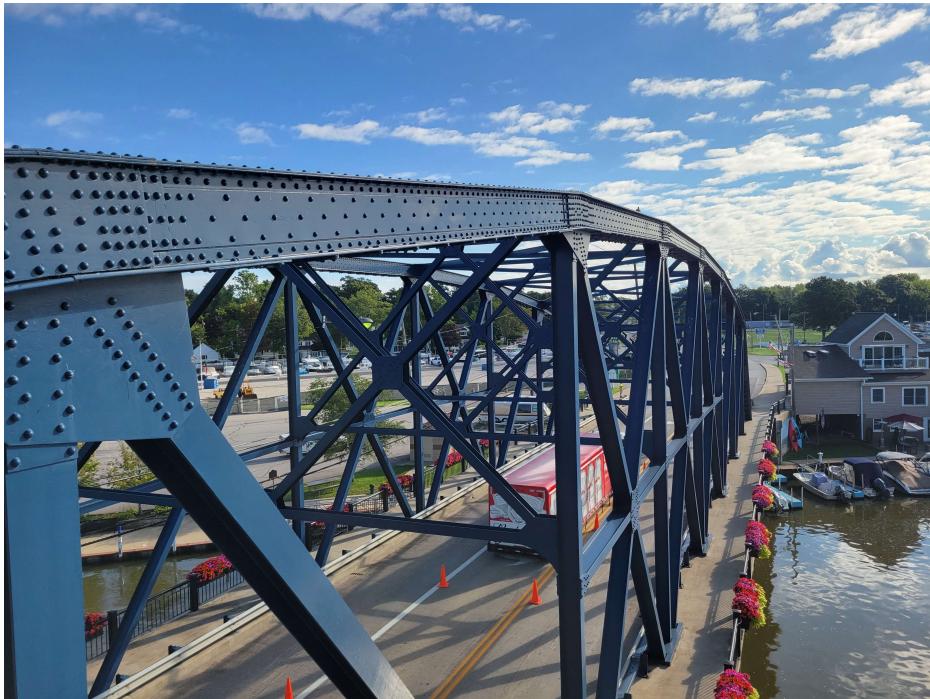
PHOTO 5

Description upper chord looking east

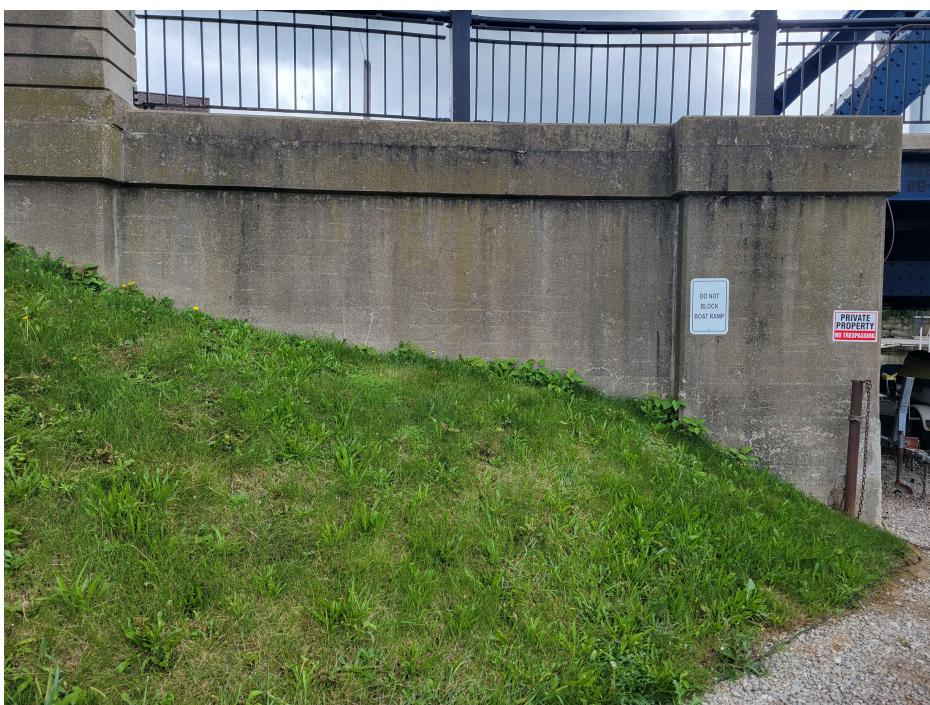
PHOTO 5

Description NE WW

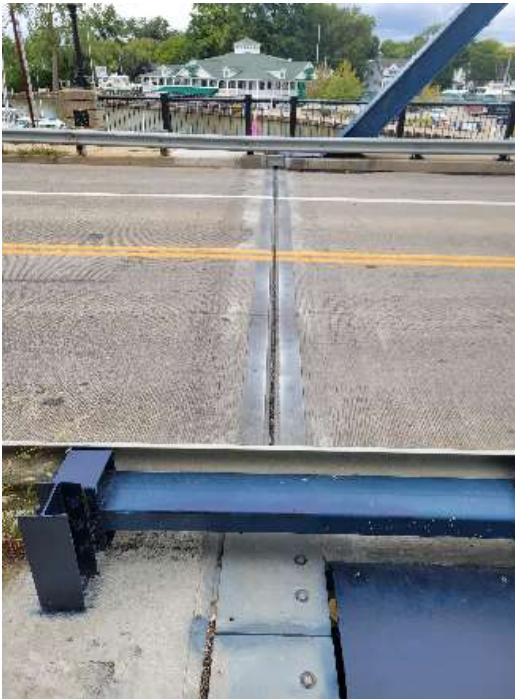
PHOTO 6

Description New Expansion joint (West end)

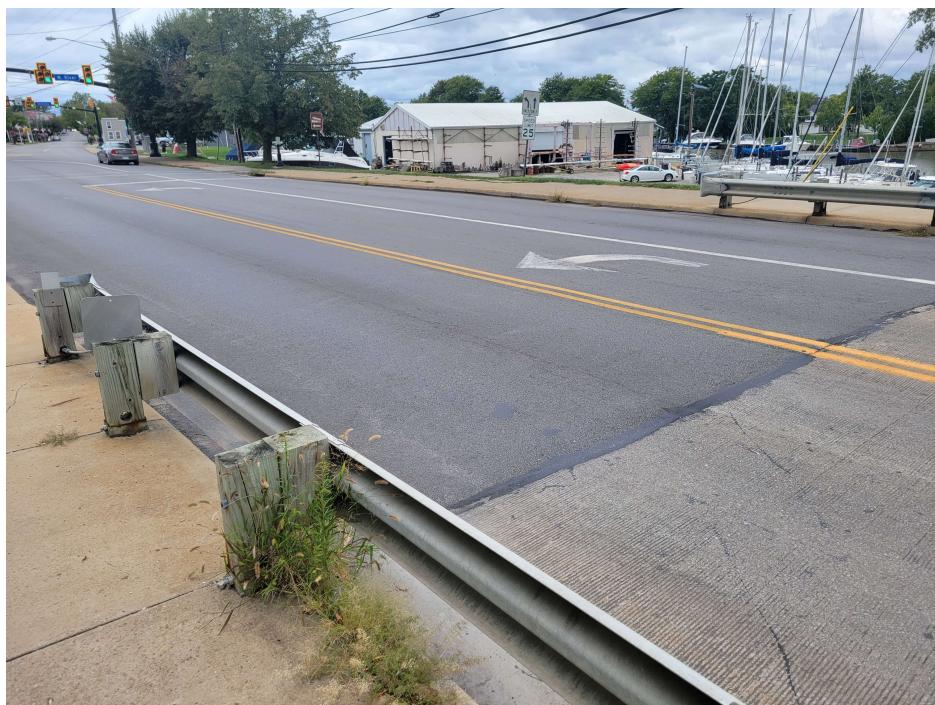
PHOTO 7

Description Rear Approach WS

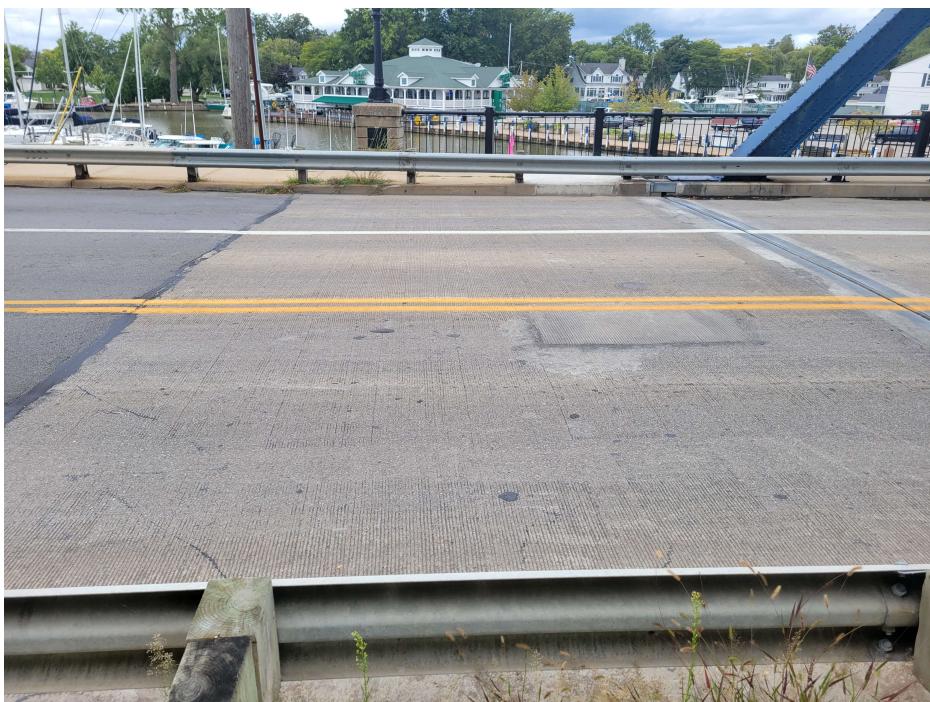
PHOTO 8

Description Rear Appr. Slab

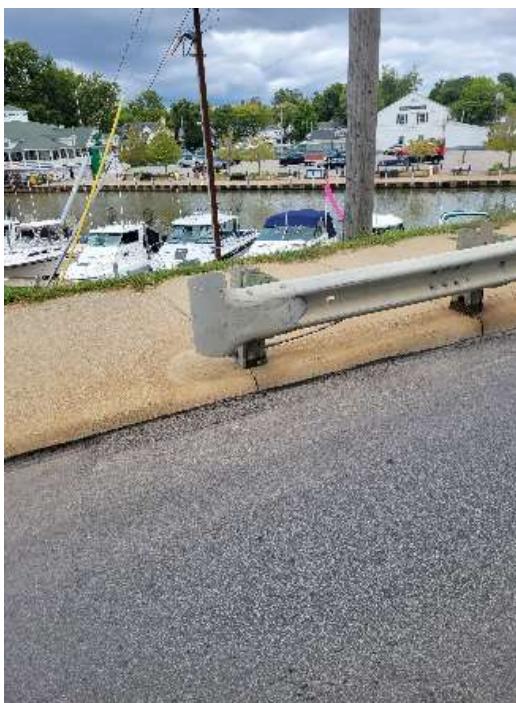
PHOTO 9

Description Damage at NW Terminal assembly

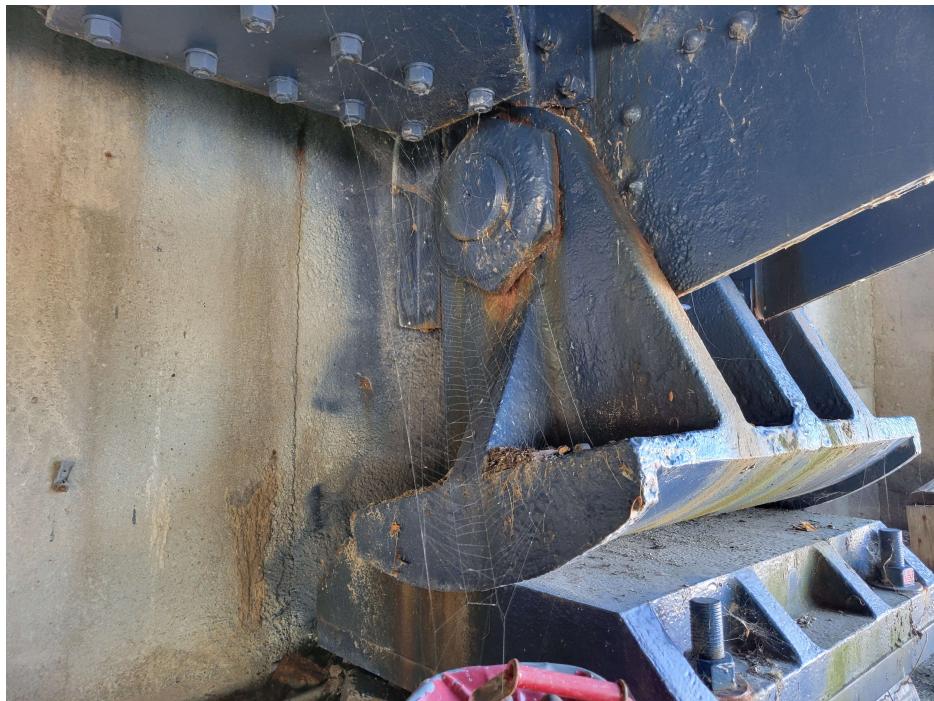
PHOTO 9

Description NW rocker

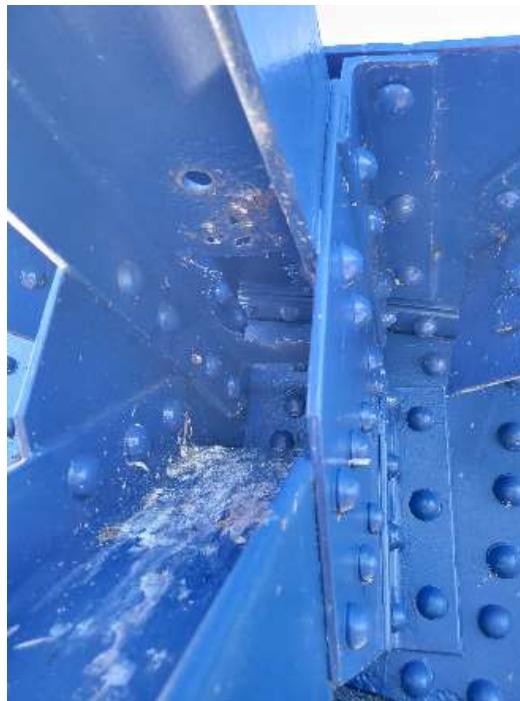
PHOTO 11

Description top of Sway brace U2 hole in webs

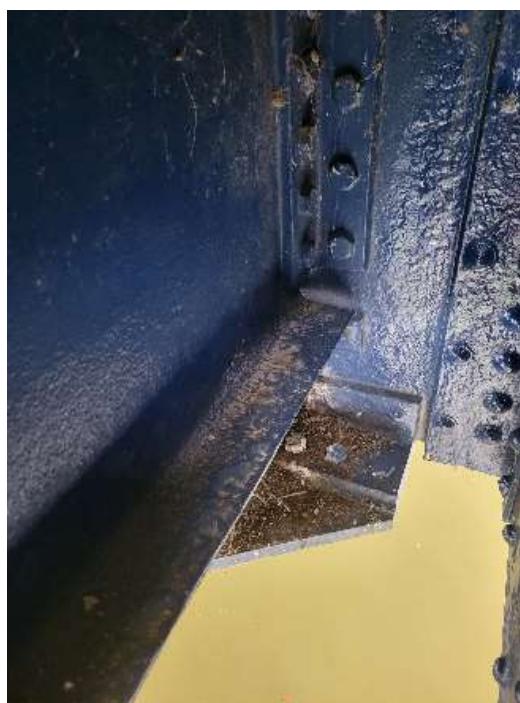
PHOTO 12

Description stringer 1 PP 7 holes in web and flange

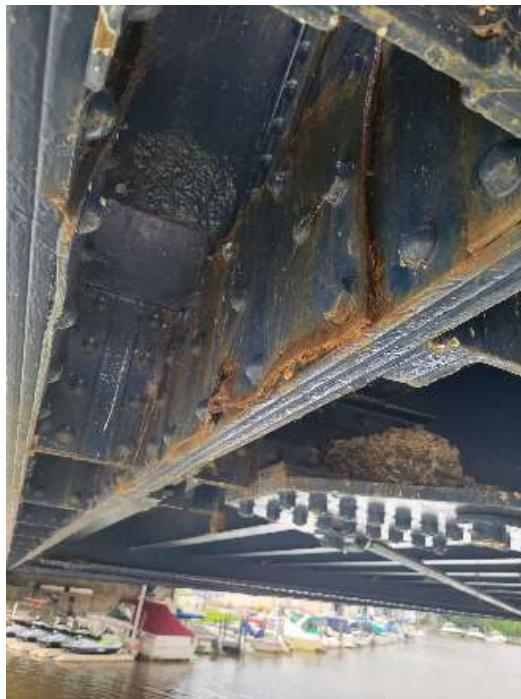
PHOTO 13

Description typical pack rust at bottom of gusset plate and lower chord.

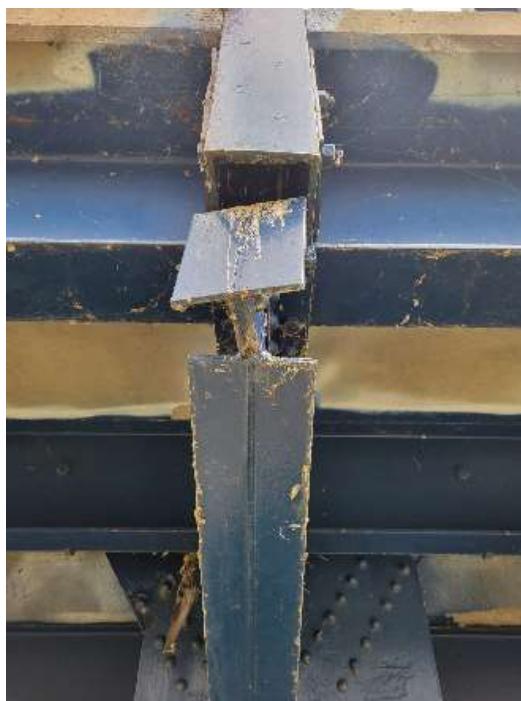
PHOTO 14

Description impact damage to sidewalk supports from boats fairly typical

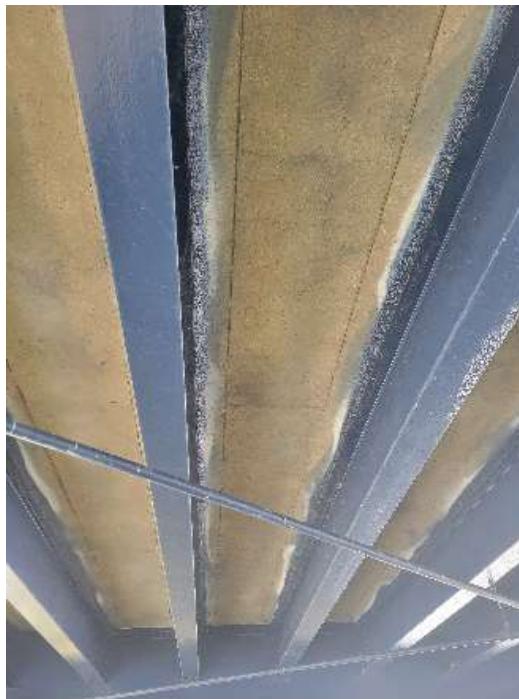
PHOTO 15

Description typical interior deck and stringer condition.

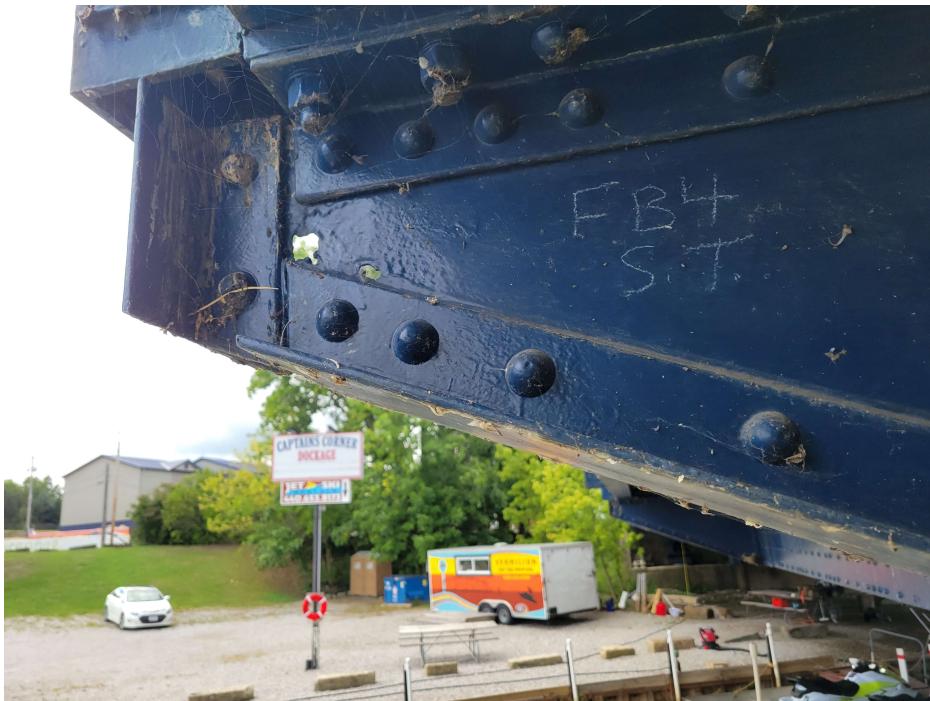
PHOTO 17

Description sidewalk support (FB4S
