2024 UPDATE TO THE
2022 PHYSICAL CONDITION INSPECTION REPORT

ERI-6-2893

U.S. Route 6 over the Vermilion River

Ohio Department of Transportation

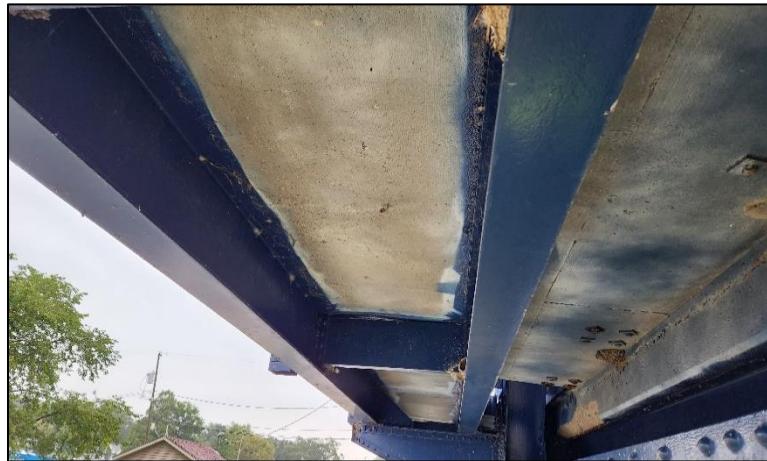
Sidewalk Stringers and Diaphragms - The sidewalk stringers are in good condition (see Picture 8) with minor section loss at the connections to the cantilever brackets. The fascia stringer of the north sidewalk at L6 has a small hole in the bottom flange. There are a few small localized areas with active rust at the ends of the fascia sidewalk stringers between the bearing and abutment backwall. There are holes in the end of the fascia sidewalk stringer web between the bearing and rear abutment backwall on south sidewalk. There is a hole in the end of the fascia sidewalk stringer web on south sidewalk in Panel 8 at L7. The diaphragms are in good condition.

Picture 8: Typical sidewalk stringer condition.

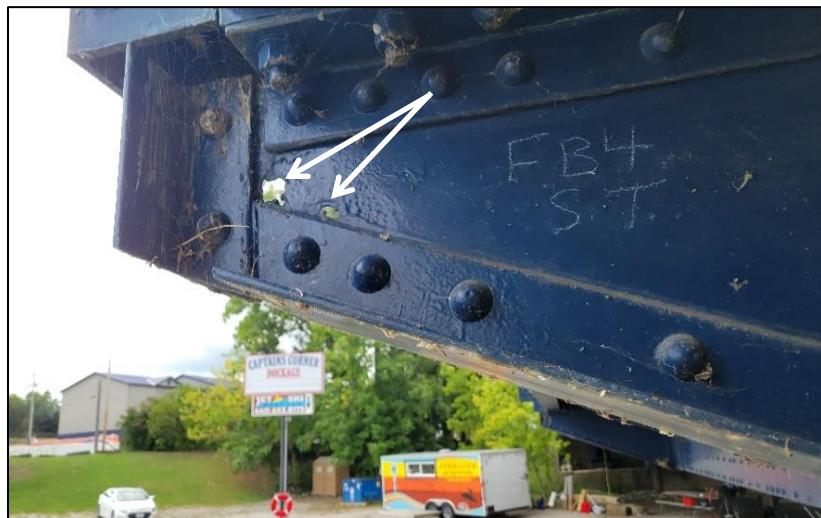
Sidewalk Cantilever Brackets - The sidewalk cantilever brackets are typically in good condition. There is some minor section loss in the webs at the connections to the trusses. The north cantilever bracket at L3 has a small hole in the web. The south cantilever bracket at L4 has three small holes in the web (see Picture 9). The south cantilever bracket at L5 has two small holes in the web. The south cantilever bracket at L6 has impact damage and a small hole in the web (see Picture 10). The sidewalk south cantilever at L9 has pack rust and minor active rust at the bottom of the connection angle at the bearing. Three of the sidewalk cantilever brackets have bent ends where boats have impacted the structure (see Picture 11).

Picture 9: Looking west at hole in web of south cantilever bracket at L4.

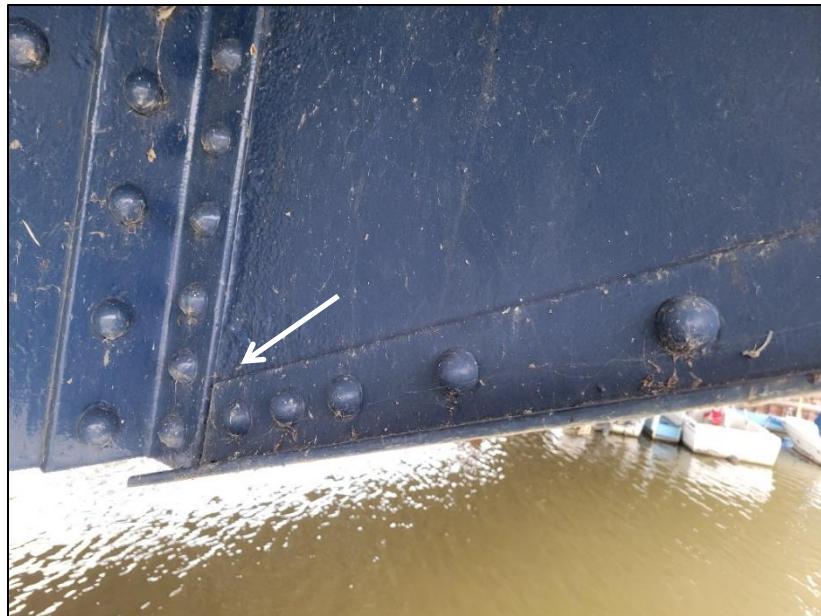
Picture 10: Looking east at pinholes in web of south cantilever bracket at L6.

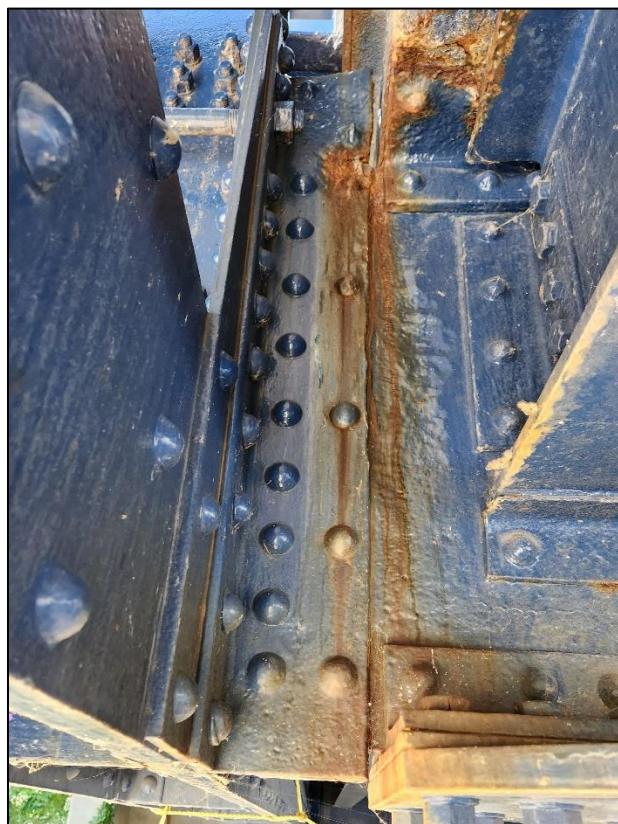
Picture 23: Floorbeam 1 south truss connection plate.

The paint system has good coverage with no major defects overall. Typical locations of minor corrosion include the guardrail post base plate anchor bolts, the tube of the deep beam railing, the stringer connections to the floorbeams, the floorbeam connections to the trusses (see Picture 23), the ends of the fascia sidewalk stringers at abutments, the end posts, the web plate U6U7 of the south truss with a small hole, the lower chord diaphragm connections, the lower chord gusset plate connections, the holes in the lower chord, and the bearing pin nuts.

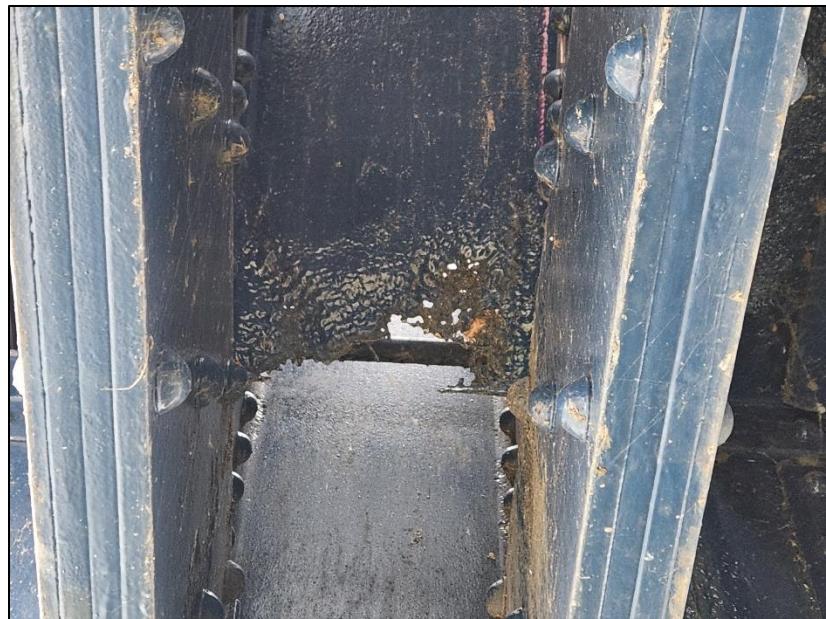
Picture 27: Reactivated pitting at the bottom of L7U8 of the south truss.

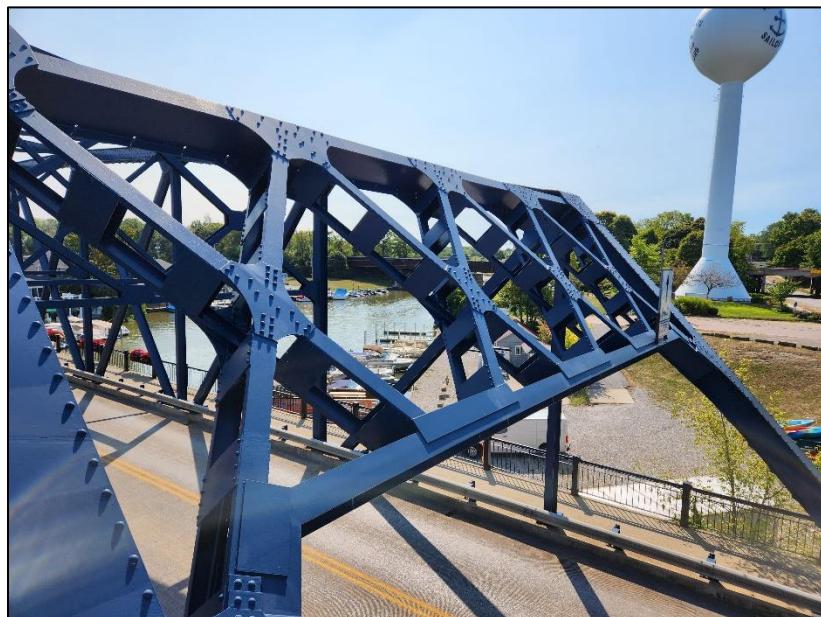
Picture 41: Portal at PP1.

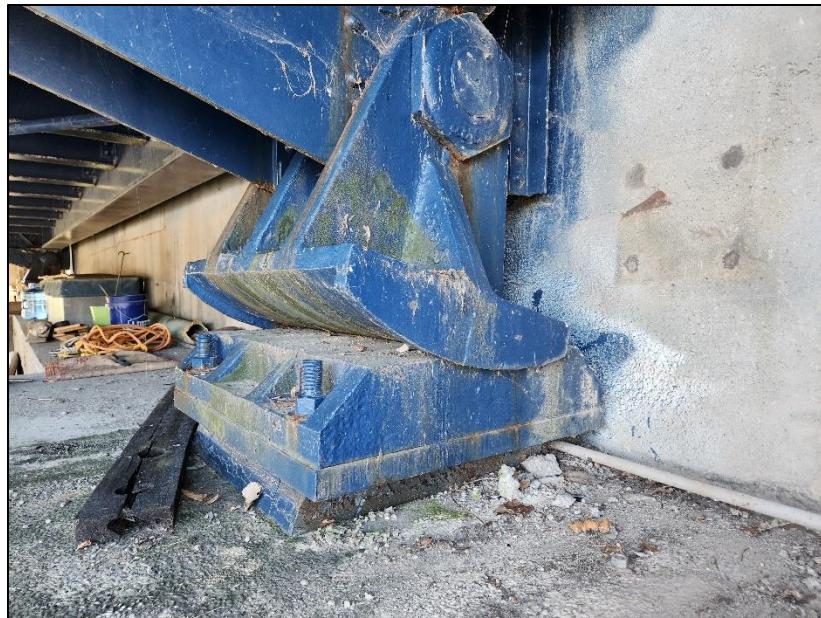
The movable bearings at the rear end of the structure are in **poor** condition and the fixed bearings at the forward end are in **fair** condition. The rear abutment bearings are elastomeric pads and rocker type (see Pictures 44 and 45). The forward abutment bearings are bolster type (see Picture 46). The north rocker bearing at the rear abutment has a 14.60-degree tilt towards the backwall at 72 degrees Fahrenheit (see Picture 45). The south rocker bearing at the rear abutment has a 13.30-degree tilt towards the backwall at 72 degrees Fahrenheit. The rear abutment elastomeric bearings have a horizontal deformation toward the backwall (see table below & Picture 44). The horizontal deformation difference is found by measuring the distance from front face of the rear abutment to the top and bottom of each edge of the elastomers.

Picture 45: North side of north bearing at rear abutment.

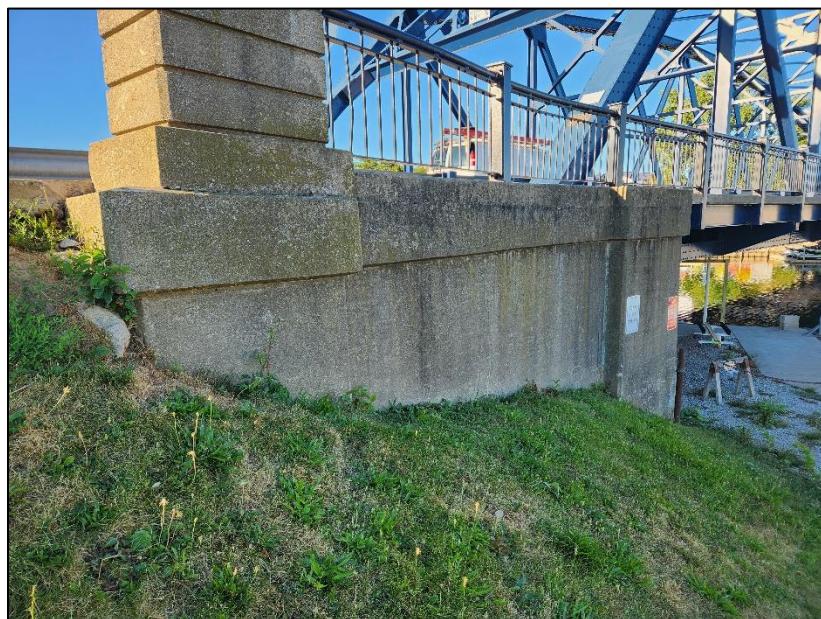
Picture 51: Northeast wingwall.

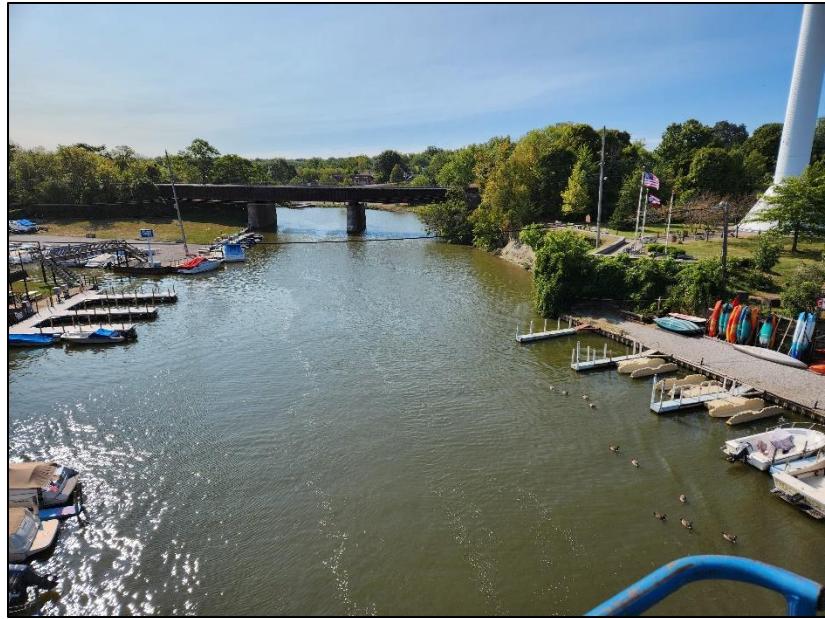
Picture 54: Looking upstream (south).

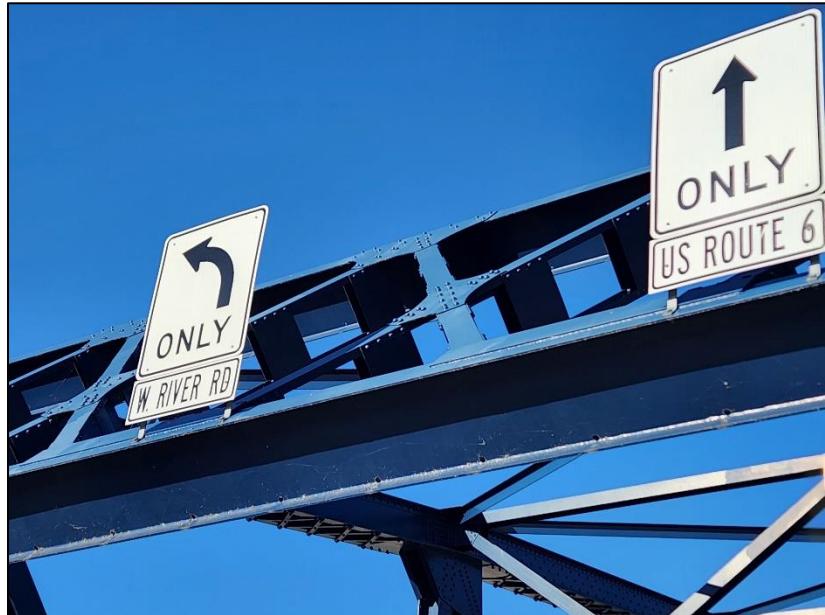
The warning signs are rated **good**. There are two signs attached to the east portal over the westbound lane and the turn lane (see Picture 61). There is one sign attached to the west portal over the eastbound lane.

Picture 61: Lane signs on east portal.

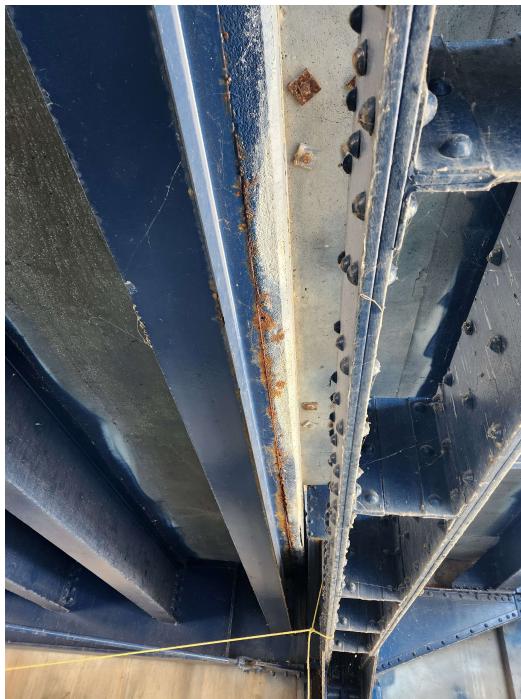
PHOTO 1

Description Stringer 10 Near FA rust on top flange

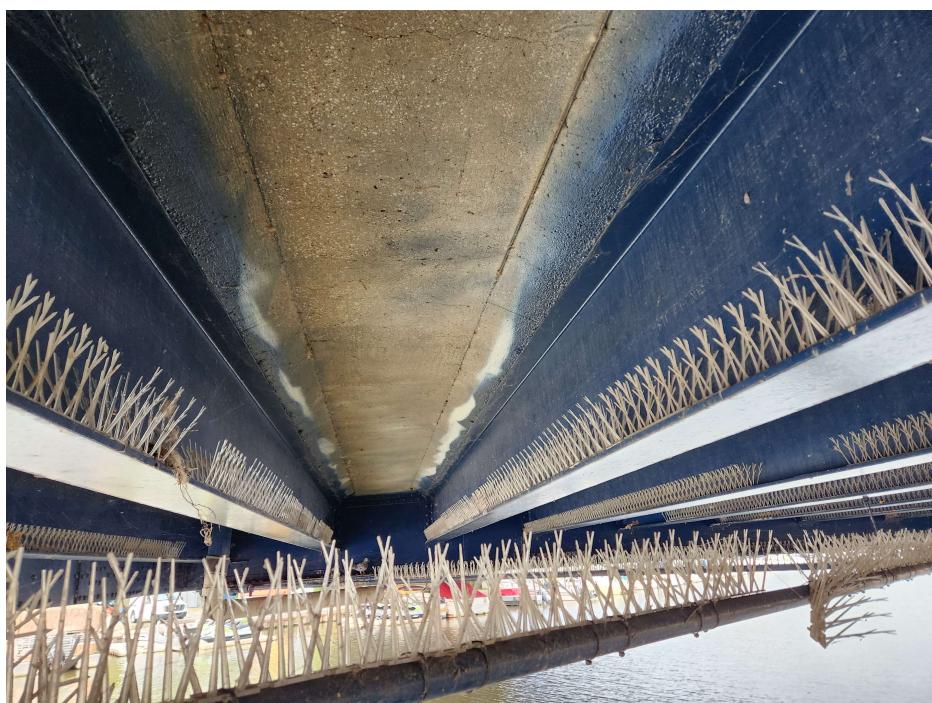
PHOTO 1

Description typical transverse Cracks in deck (bay 7 panel L7L8)

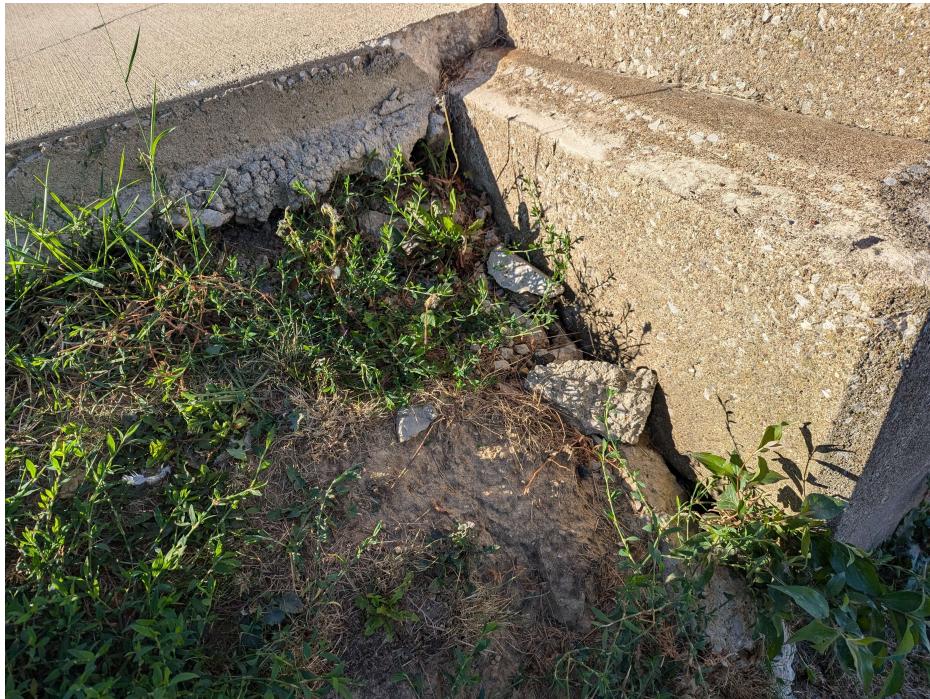
PHOTO 1

Description Undercutting of northeast sidewalk

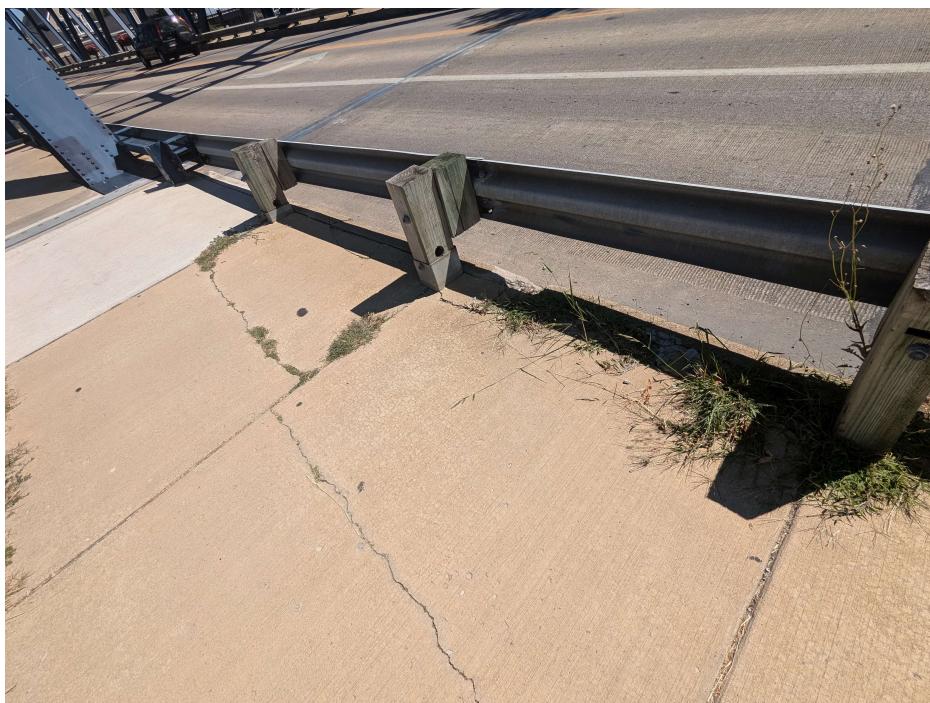
PHOTO 2

Description Cracks in northwest sidewalk

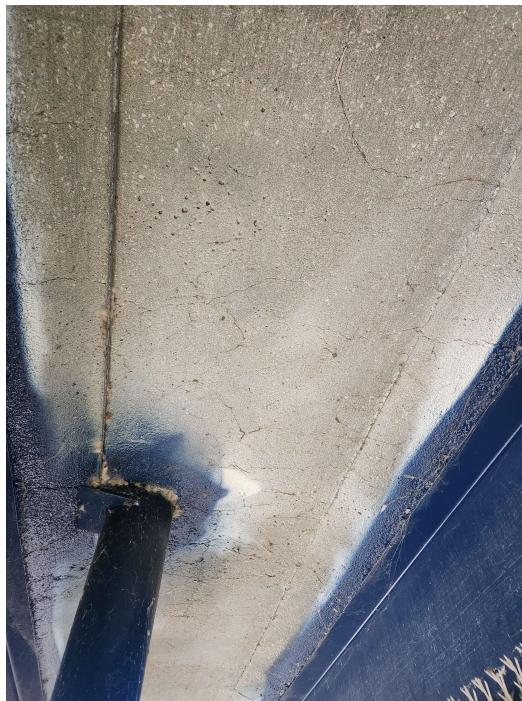
PHOTO 2

Description typical cracks bay 1 near PP 6

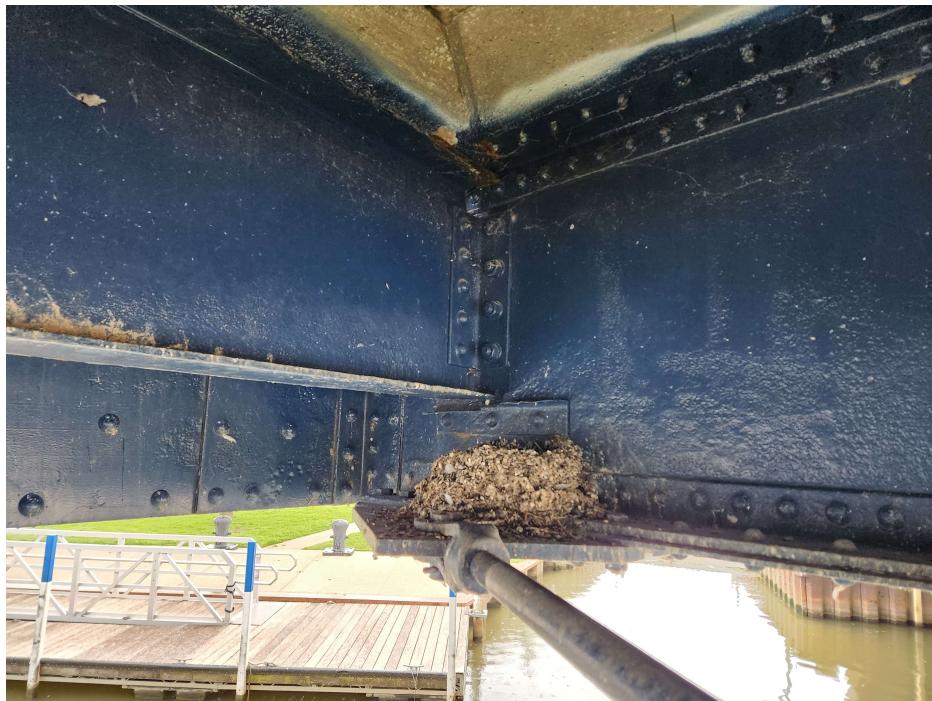
PHOTO 2

Description minor painted over pitting typical 5' from both truss lines. Nesting of pigeons on lower chord (L7 shown)

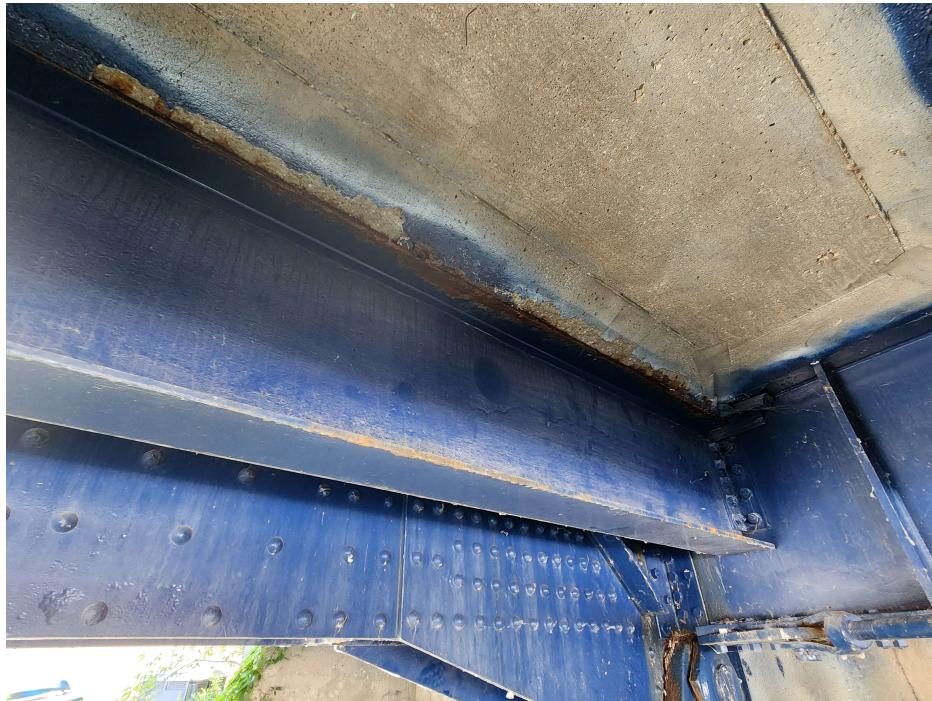
PHOTO 2

Description Stringer 1 Near FA rust on top flange

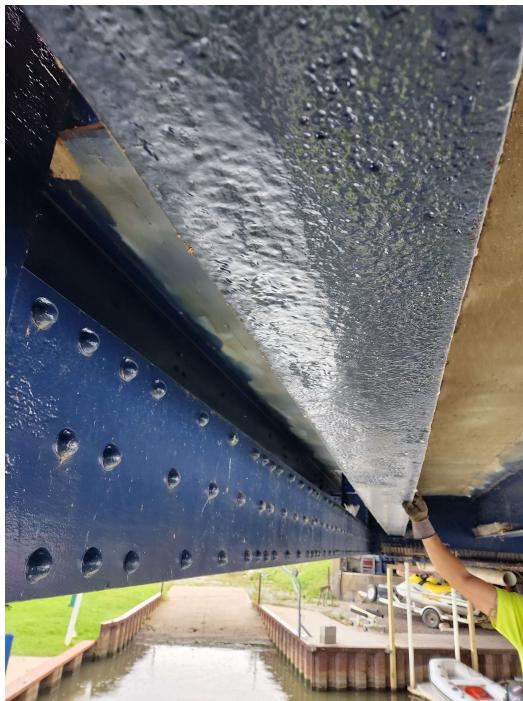
PHOTO 3

Description Piitting on bottom of stringer

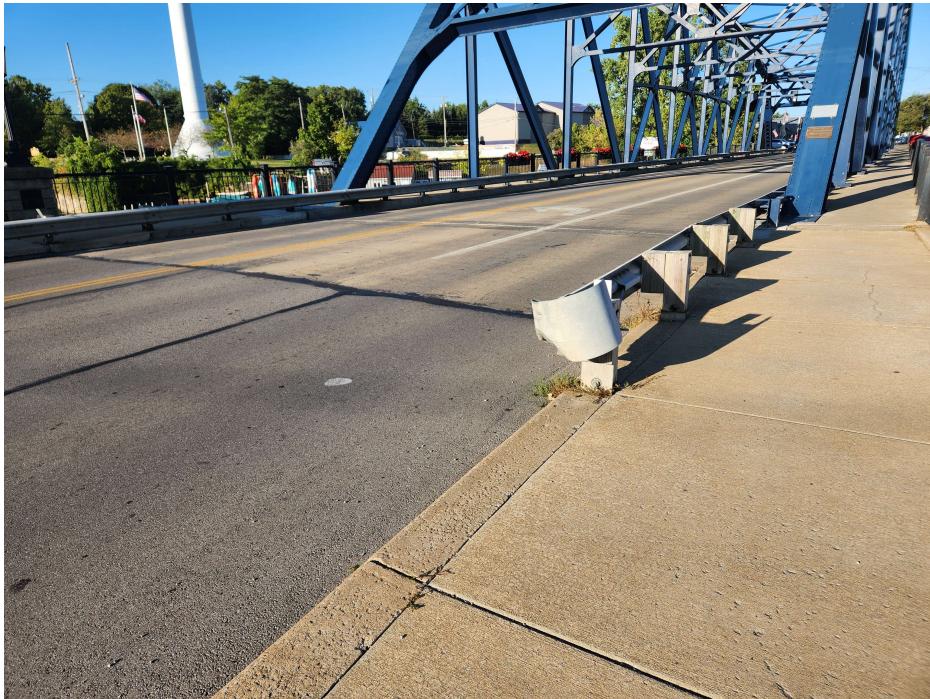
PHOTO 3

Description Impact Damage to northeast railing

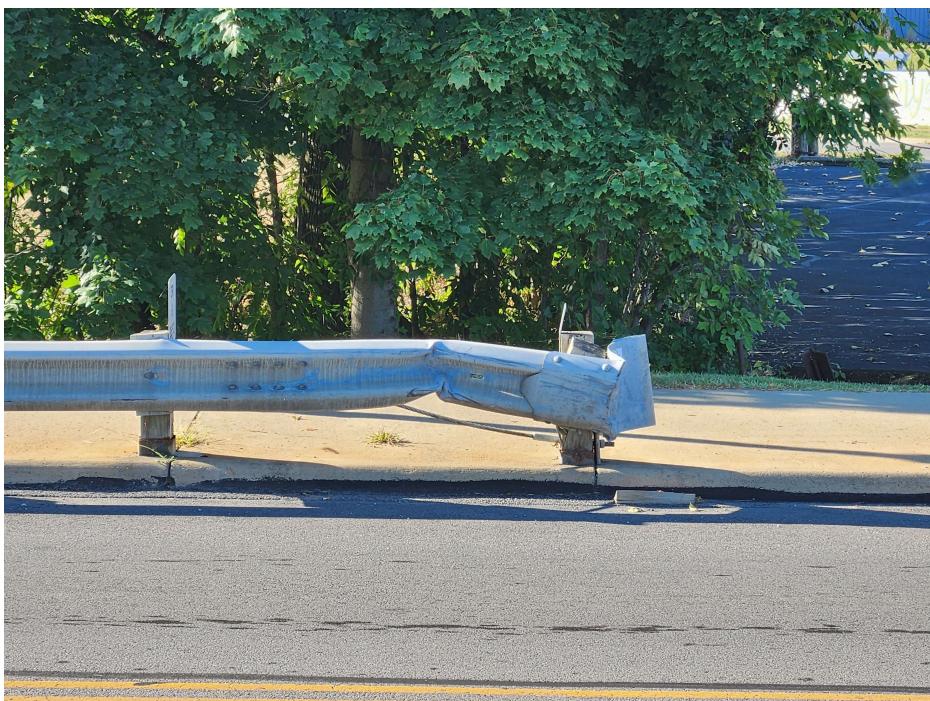
PHOTO 4

Description Impact damage to southwest railing

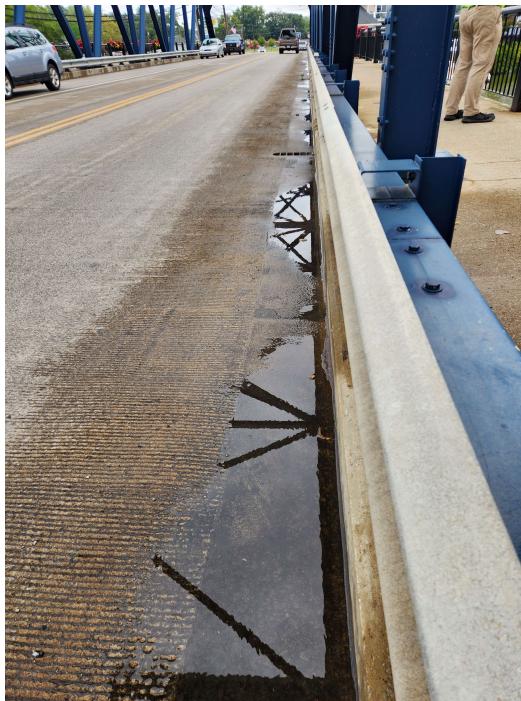
PHOTO 4

Description water ponding along south curb line

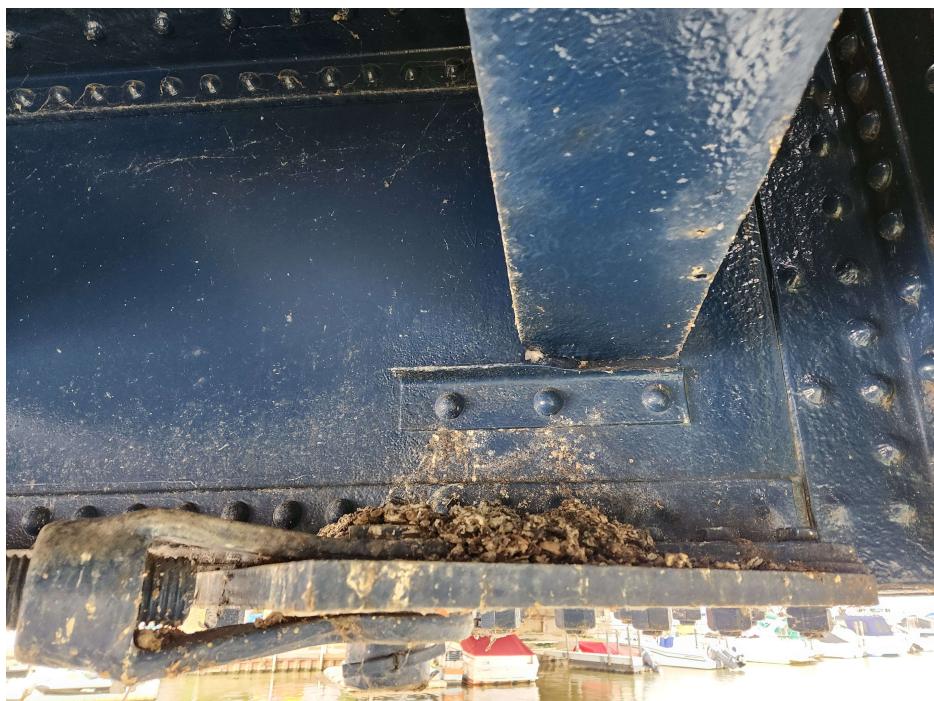
PHOTO 4

Description Holes in bottom of stringer 1

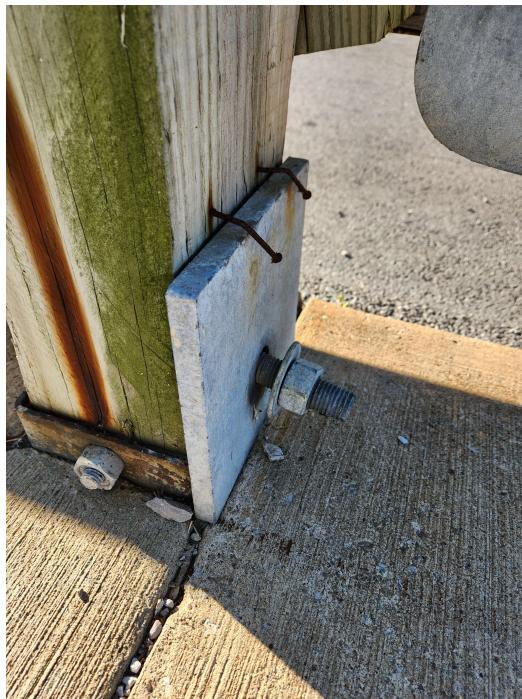
PHOTO 5

Description Loose terminal assembly at northwest

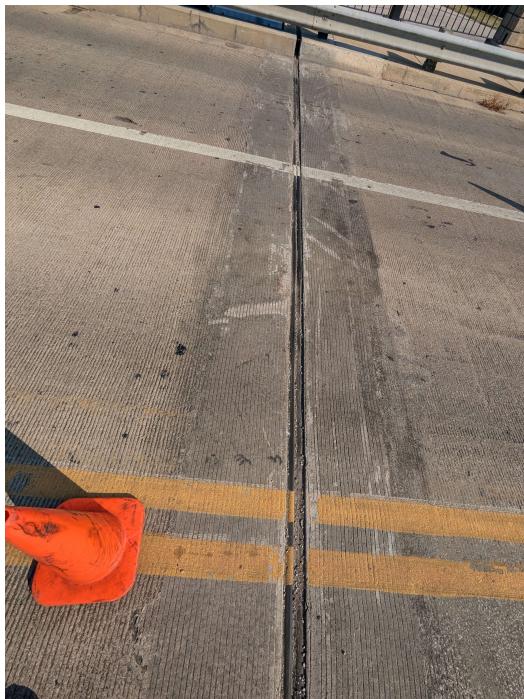
PHOTO 8

Description Forward Joint in Westbound and Turn Lanes

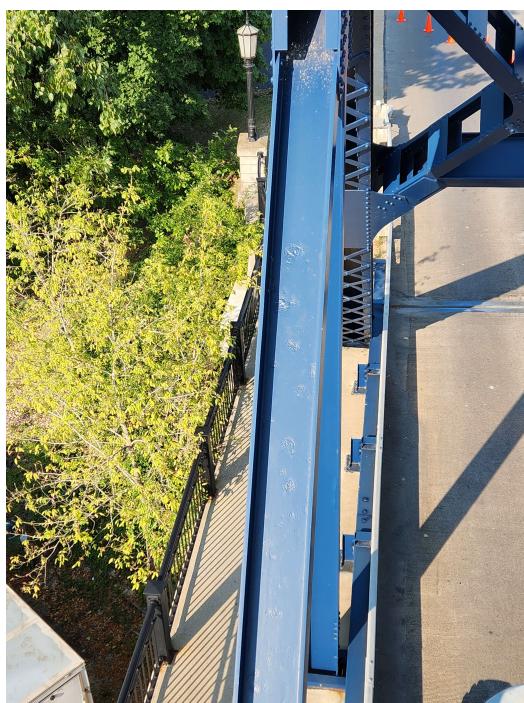
PHOTO 8

Description Typical painted over pitting on diagonals (U1-L2S)

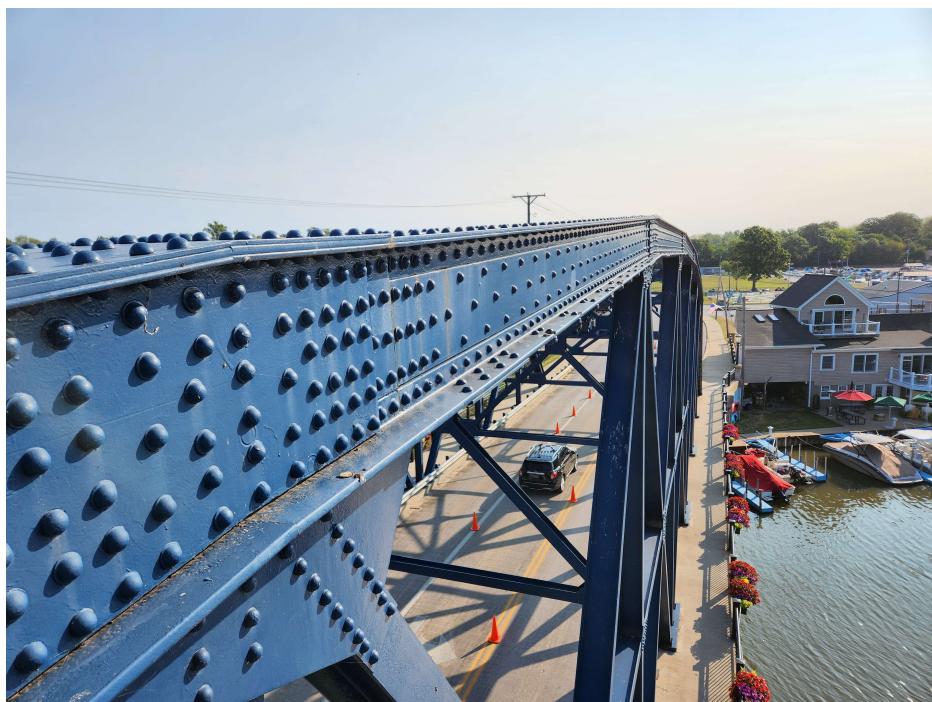
PHOTO 9

Description south truss

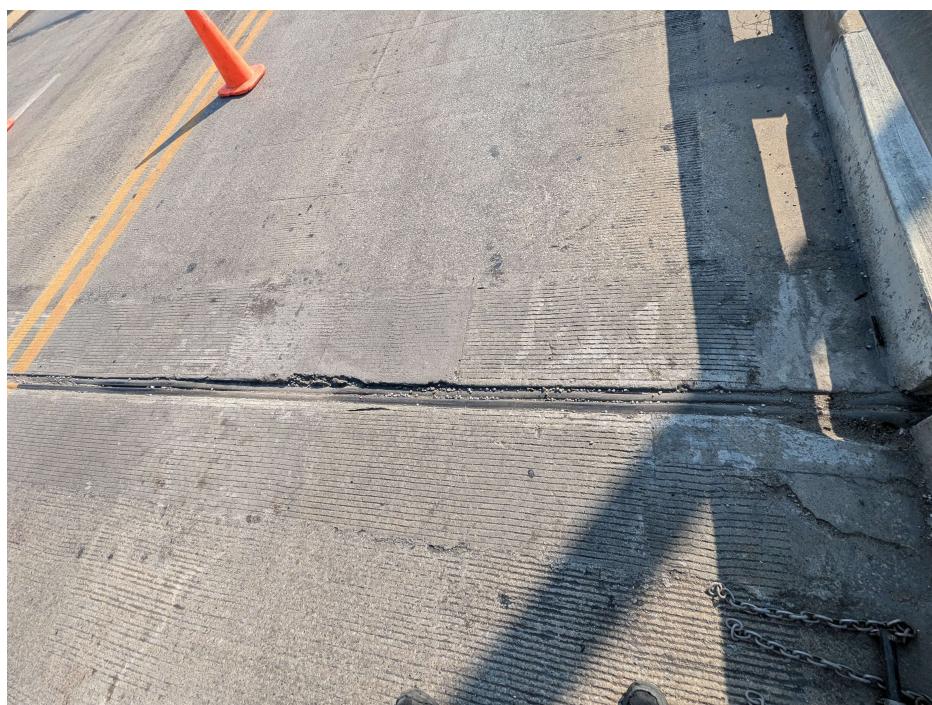
PHOTO 9

Description Forward Joint in Eastbound Lane

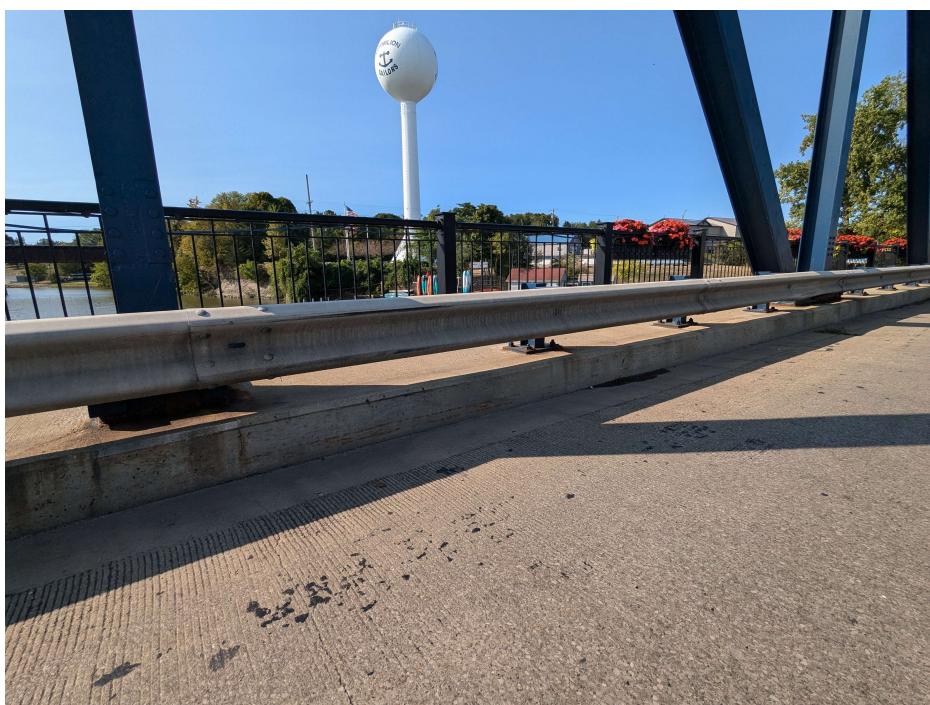
PHOTO 10

Description Impact Damage at L7S with rubmark to L8S

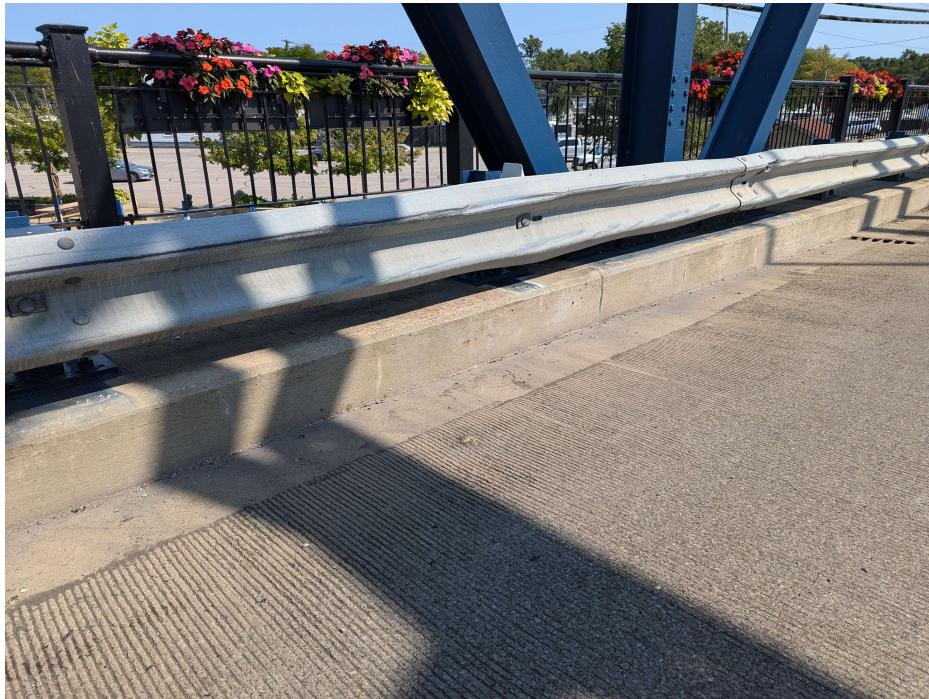
PHOTO 11

Description Impact Damage around L4N

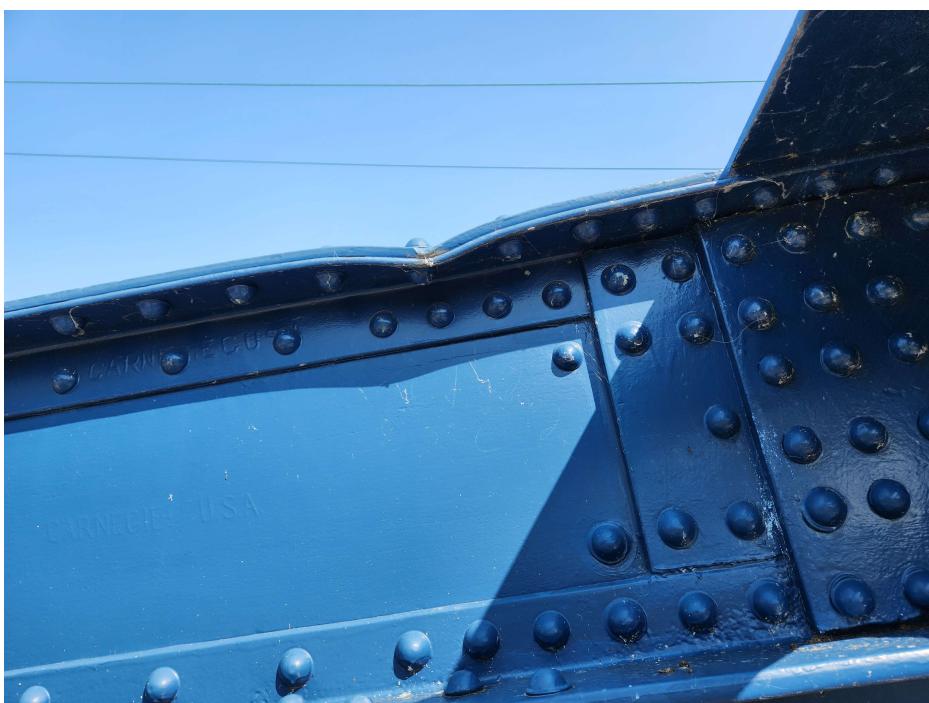
PHOTO 11

Description bend in upperchord near U2 N

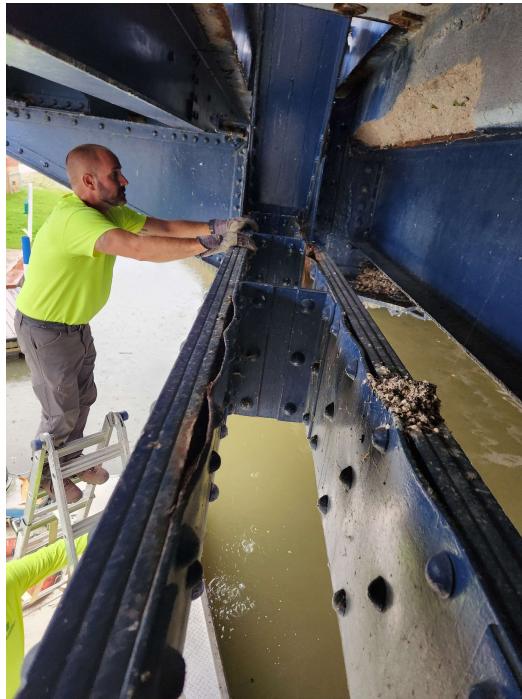
PHOTO 15

Description packrust between plates on bottom chord (L7N shown)

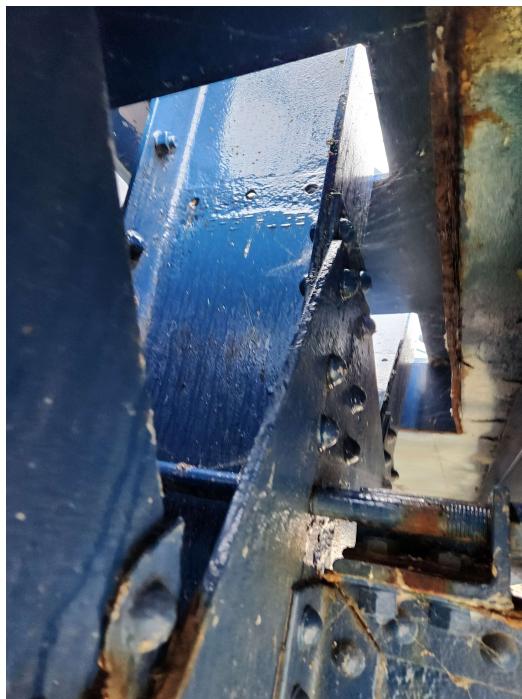
PHOTO 16

Description typical pitting on vertical at curb line

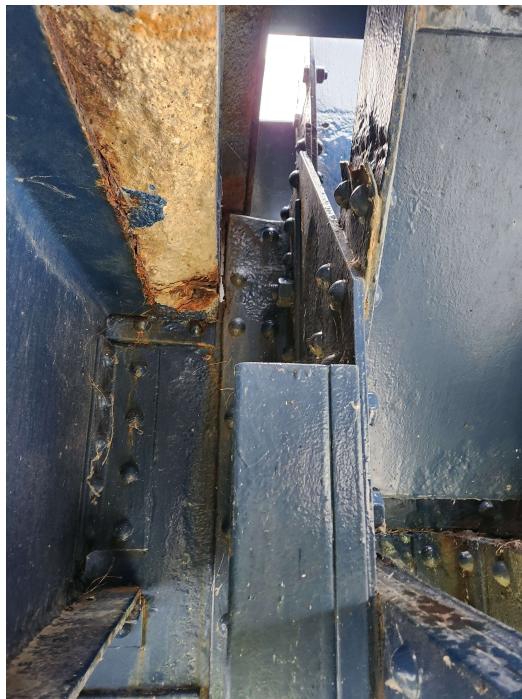
PHOTO 17

Description painted over pitting typical (L7N int)

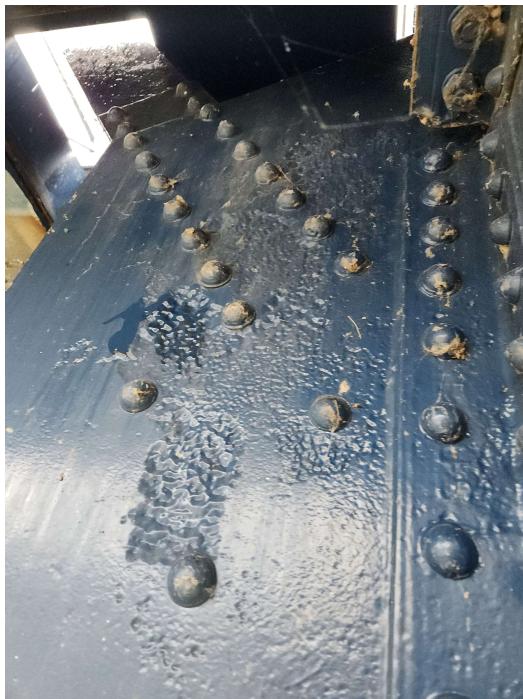
PHOTO 19

Description typical pitting on gusset lower chords

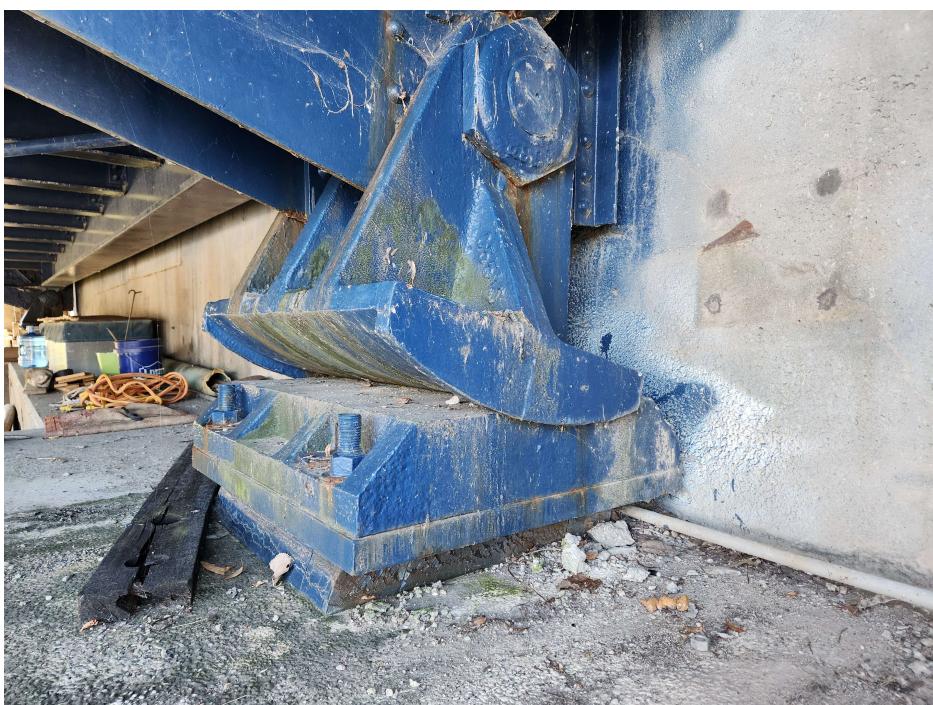
PHOTO 20

Description rocked back rocker typical (Rear N shown)

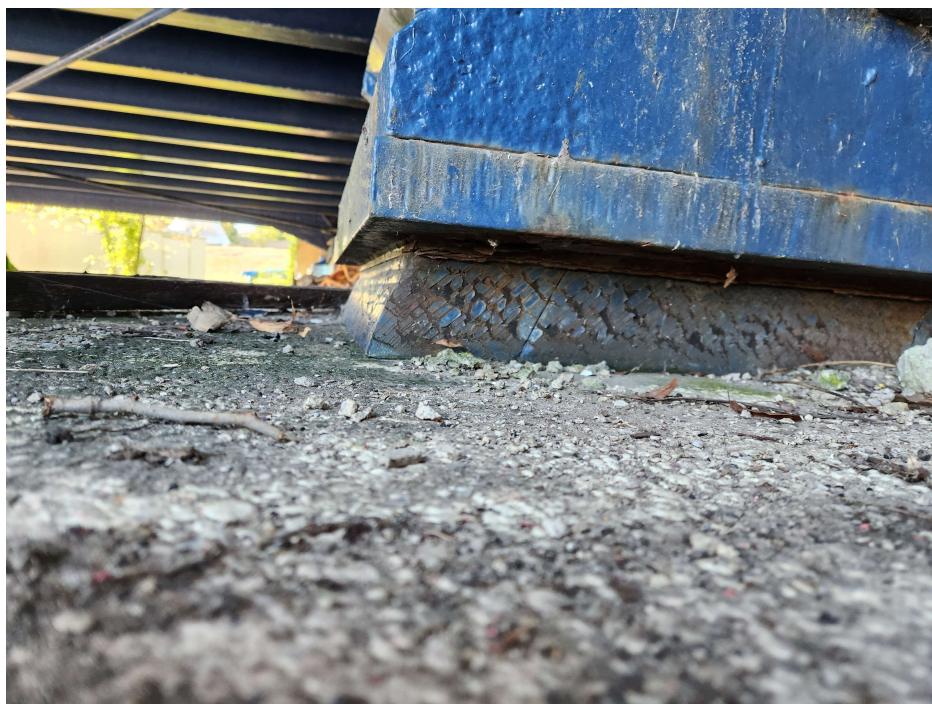
PHOTO 21

Description Expansion elastomer

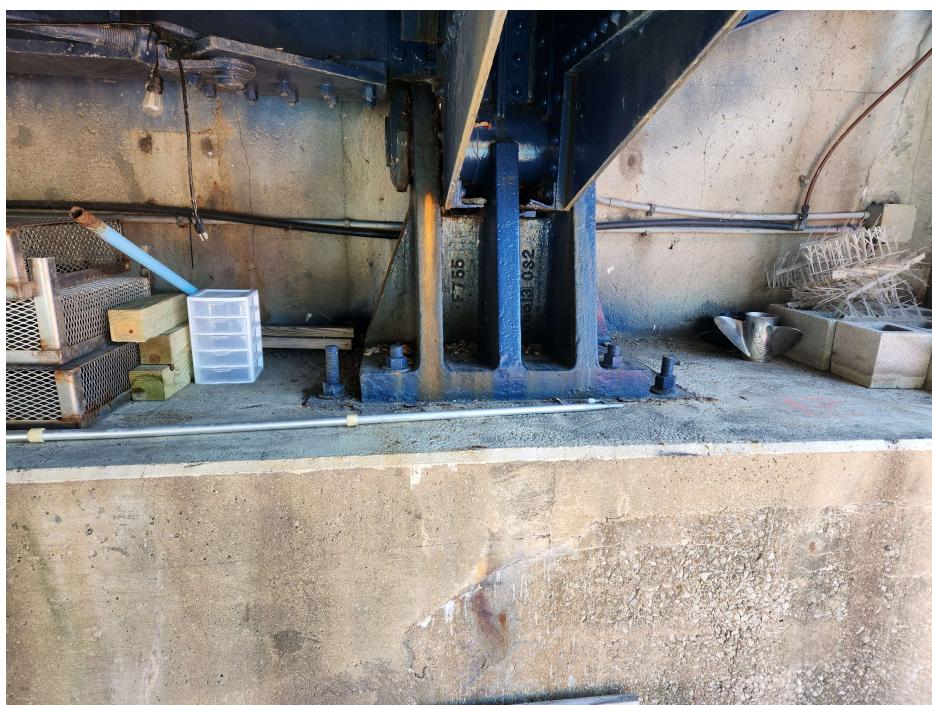
PHOTO 22

Description Fwd South bearing
