2020 IN-DEPTH & FRACTURE CRITICAL BRIDGE INSPECTION REPORT

ERI-6-2884

SFN: 2202344

Vermilion, Ohio

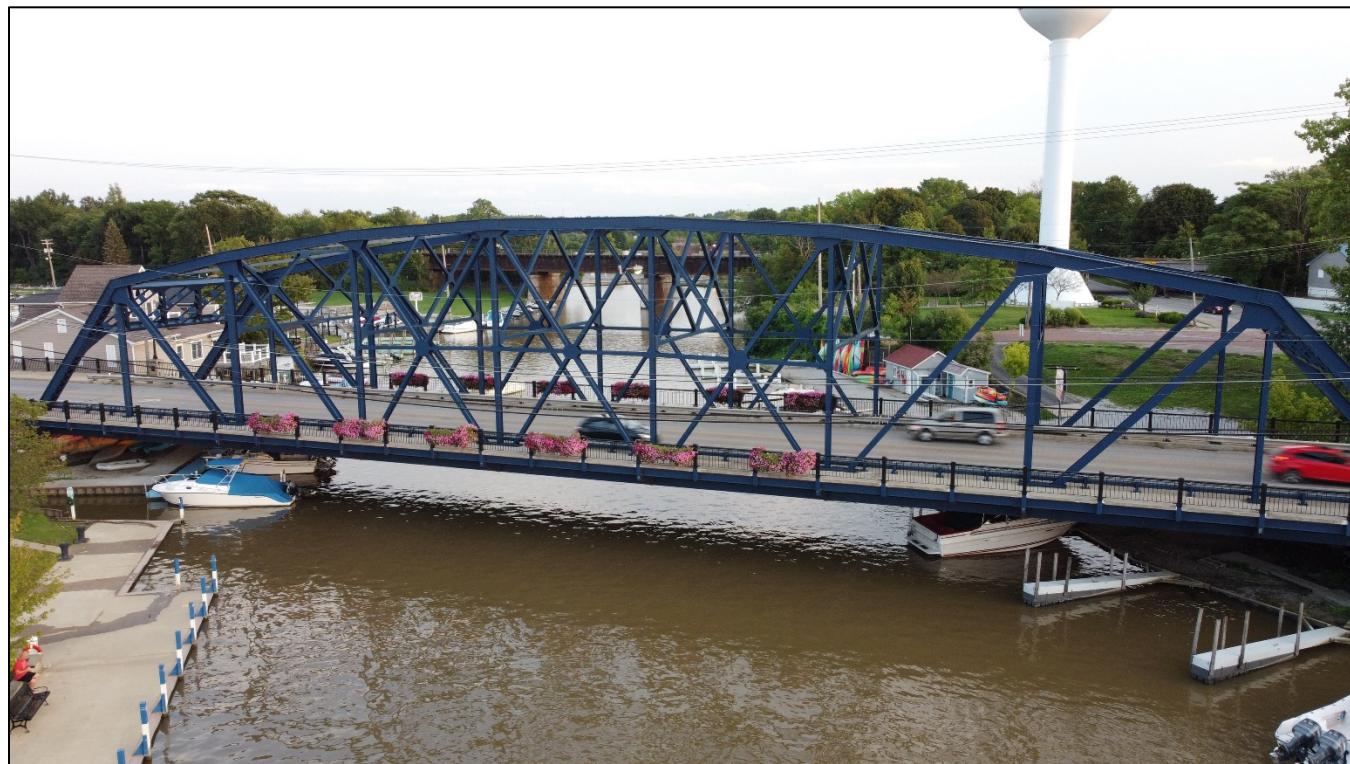
PHOTO 1 – ELEVATION LOOKING SOUTH

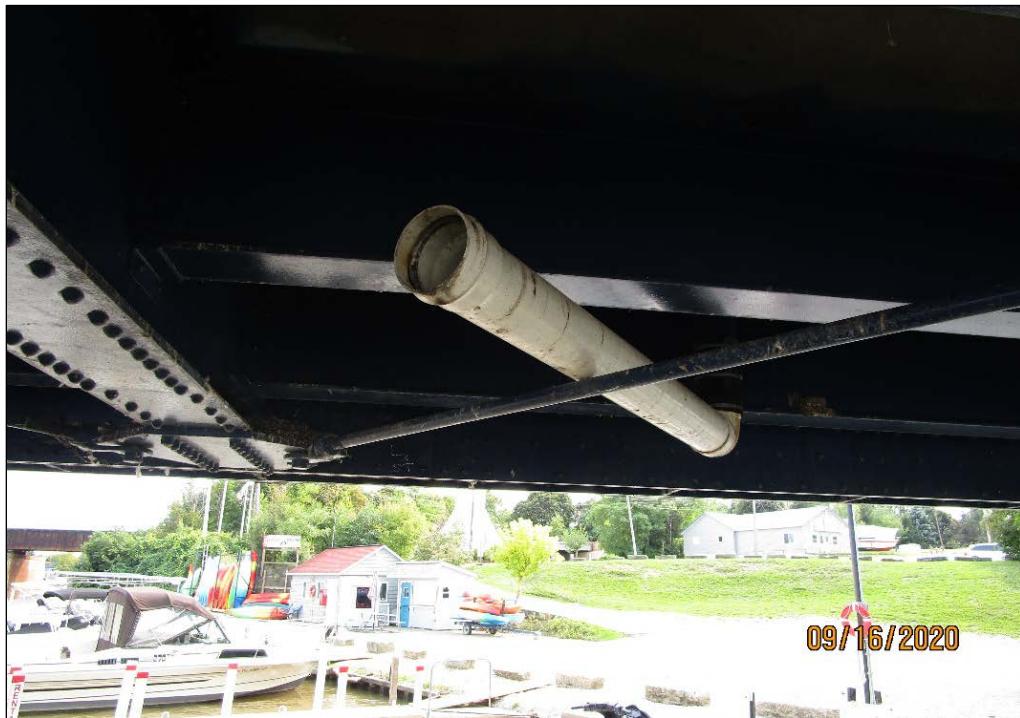
Drainage is in *GOOD* condition. Minor debris within and around the scupper was observed on the north curb (**Photo 15**). All drainpipe entrances are open and allow water to flow through. The plastic drainpipe at the northeast corner has been shortened since the 2018 inspection, it is possible that the cracked coupling broke and the pipe extension was removed since the previous inspection (**Photo 16**). Areas with minor ponding and debris are present along the south curb near the Rear Abutment (**Photos 13 & 17**).

PHOTO 16 – SHORTENED DRAINPIPE ON THE NORTHEAST CORNER

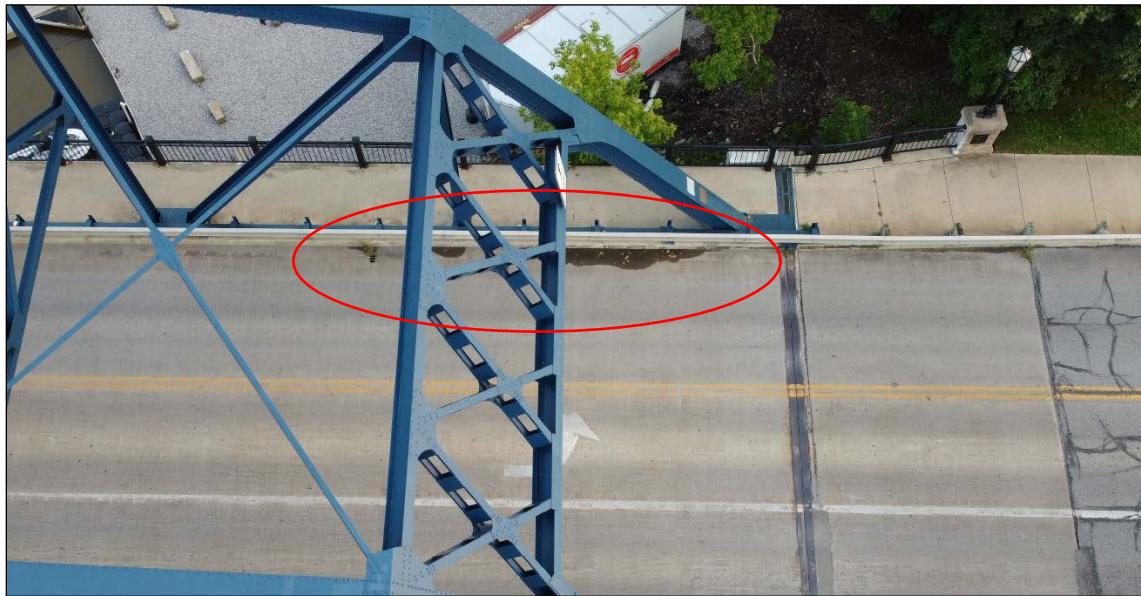
PHOTO 17 – MINOR PONDING ALONG THE SOUTH CURB NEAR THE REAR ABUTMENT

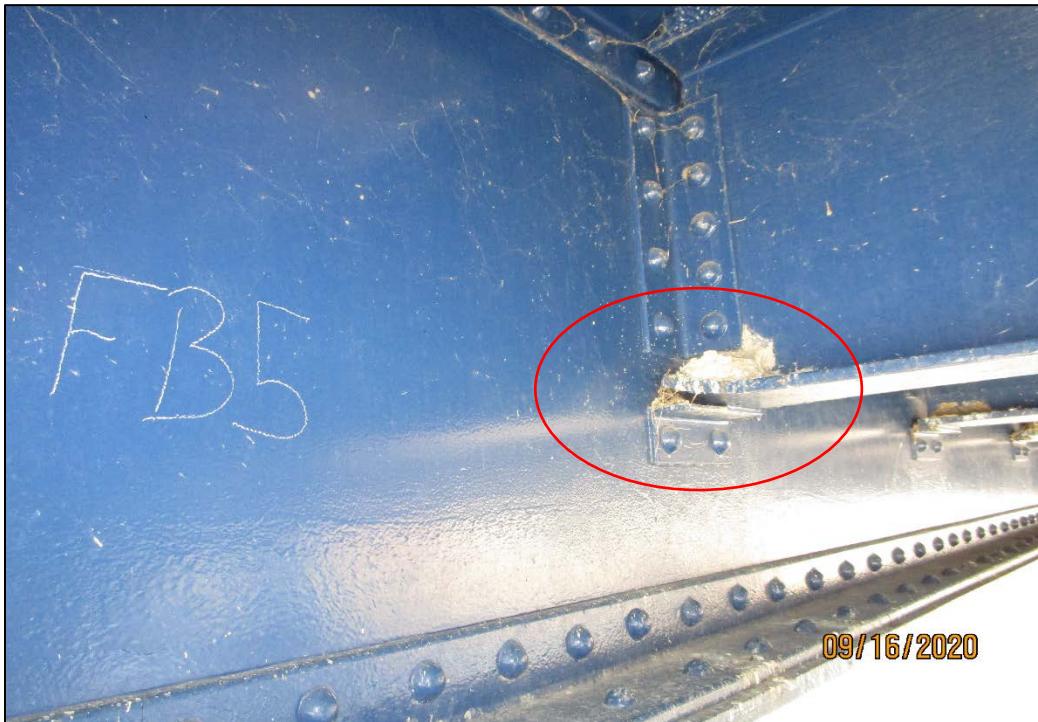
PHOTO 23 – BOTTOM FLANGE BENT AT FLOORBEAM CONNECTION, FLOORBEAM 5 AND STRINGER 6, PANEL 6

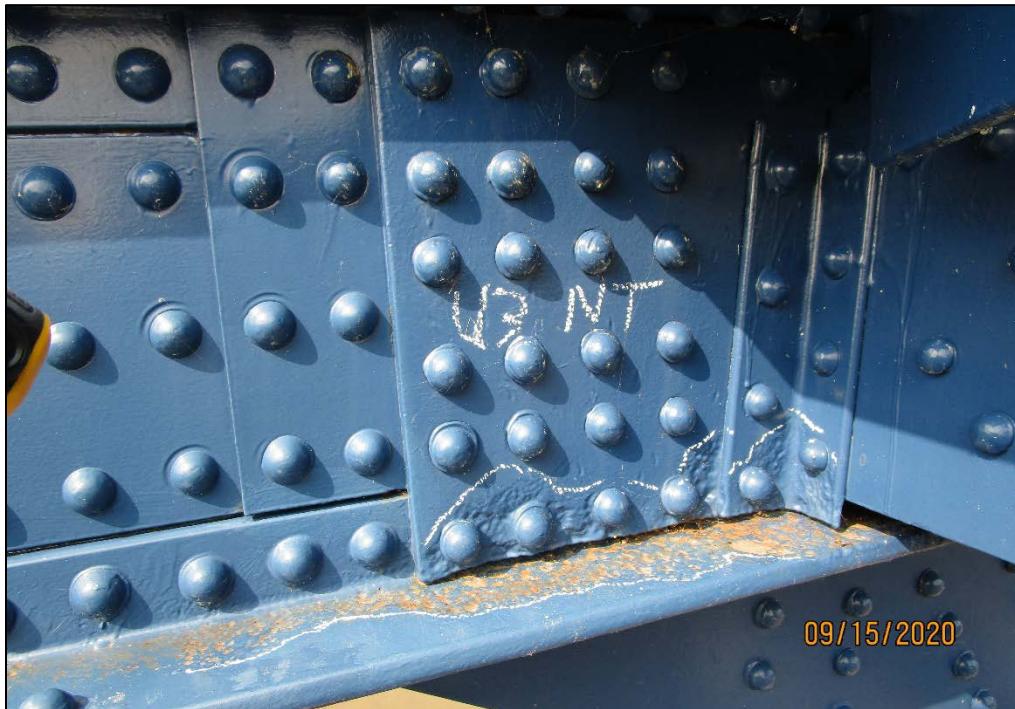
The Upper Chord exhibits typical painted over pitting on the bottom flange angles gussets (Photo 28). Minor arrested pitting is also present to the web plates in isolated areas. The top flange plate and angle are dented in isolated areas, likely due handling during transportation or erection (Photo 29). The top chord and end post diagonals have up to five pairs of bent lacing bars (Photo 30). See Table 3 for bent lacing bar summary. The end posts have minor pitting in the splash zone with some active corrosion (Photo 31).

PHOTO 28 – UPPER CHORD PAINTED OVER PITTING TO BOTTOM FLANGE, U3, NORTH TRUSS

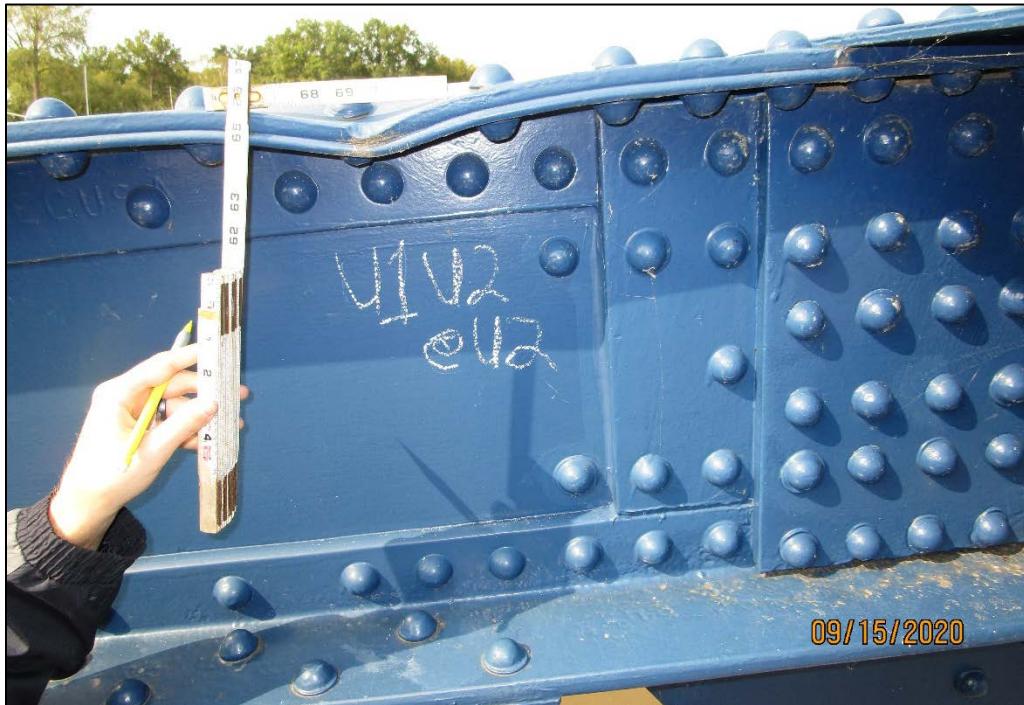
PHOTO 29 – BENT UPPER TOP FLANGE PLATE, U1U2 @ U2, NORTH TRUSS

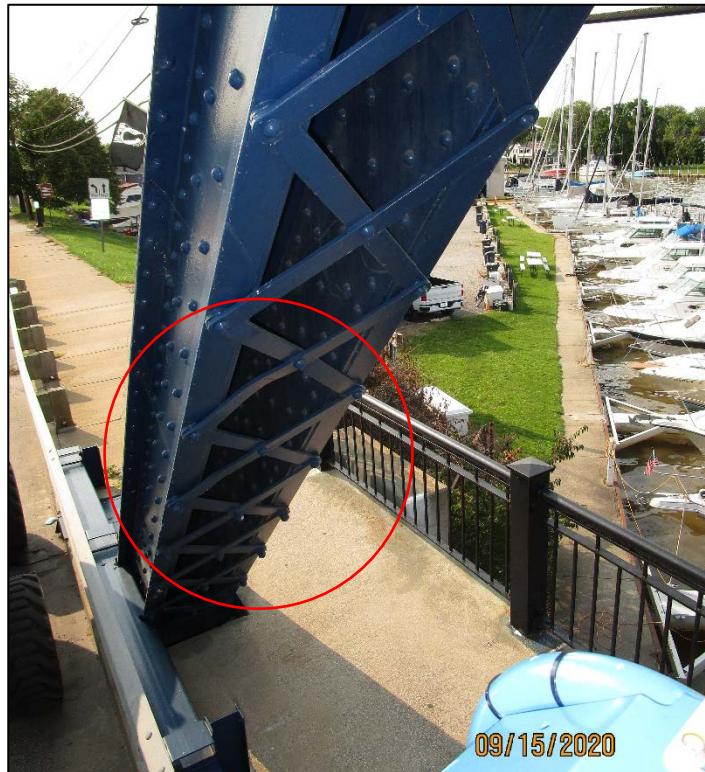
PHOTO 30 – TYPICAL BENT LACING BARS, LOU1, NORTH TRUSS

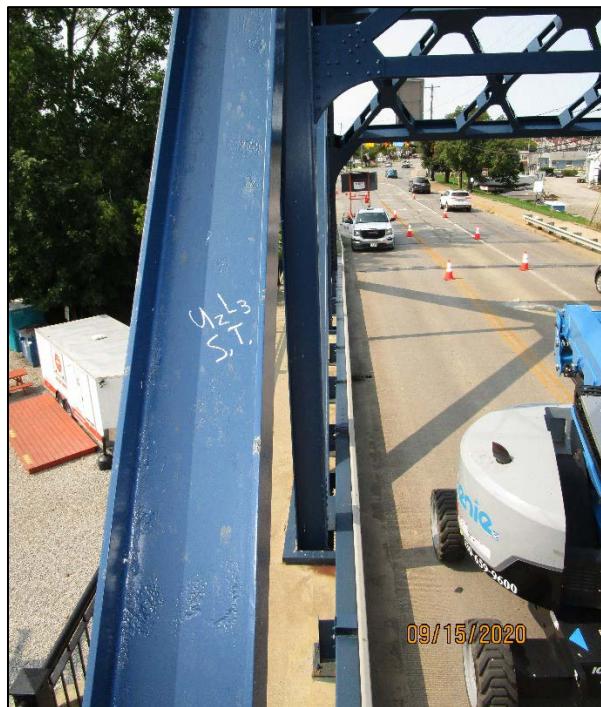
The diagonals exhibit typical painted over pitting and section loss, advanced in areas. This is most common at the web and flanges in the splash zone (Photos 32 & 33). Fill plates have section loss, up to 100% in areas, and pack rust between the flanges and the lower gussets. Some pack rust is reactivating. Various flanges are wavy for up to 12" (Photo 34). There is bird droppings and nest debris on various diagonals (Photo 35).

PHOTO 33 – PAINTED OVER PITTING, U2L3, SOUTH TRUSS

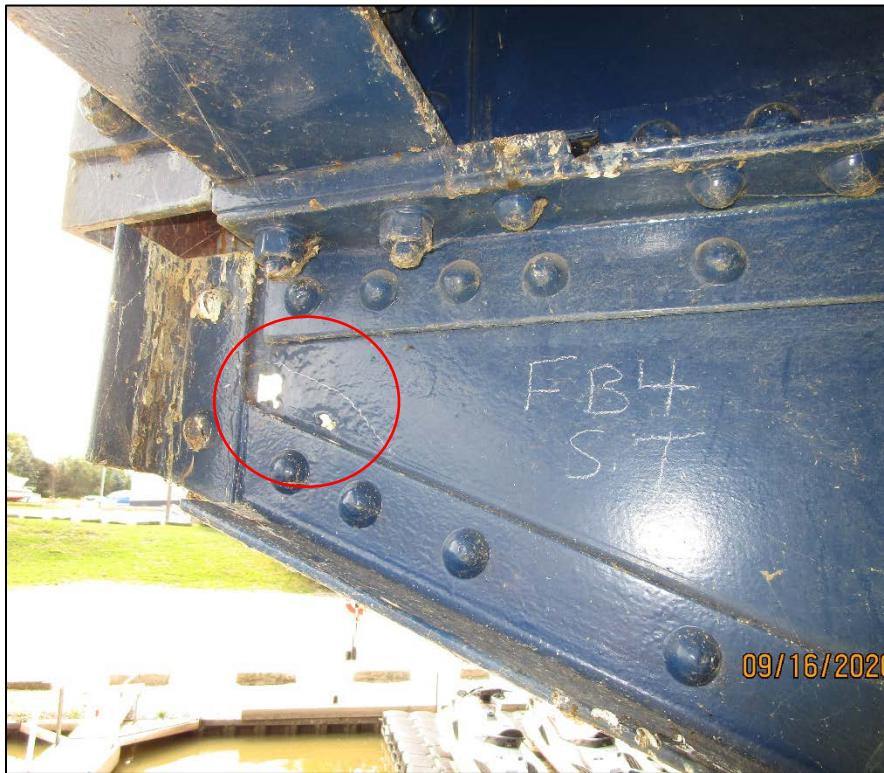
PHOTO 42 – PAINTED OVER PITTING WITH HOLE, FLOORBEAM 4 SIDEWALK CANTILEVER, SOUTH TRUSS

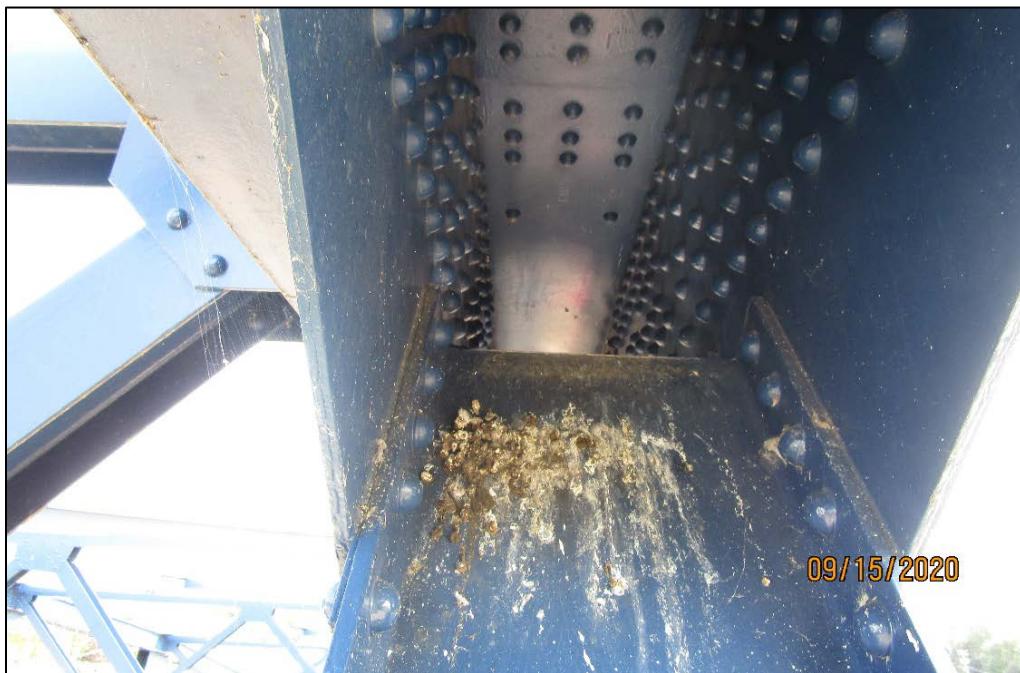
The paint system is in **Good** condition and is rated as a **7** on the modified protective coating rating system. Scattered areas of active corrosion exist throughout with isolated locations of re-activating pack rust, especially at the bearing gussets. Local protective coating failure is also present on the unpainted exterior deck stringer tops adjacent to edge spalls. Chipped paint is present on the truss end posts. Excessive pigeon droppings are present inside the upper chord, diagonals, and on the lower lateral bracing gussets (**Photos 50 & 51**).

PHOTO 51 – TYPICAL PIGEON DROPPINGS ON DIAGONALS NEAR UPPER CHORD

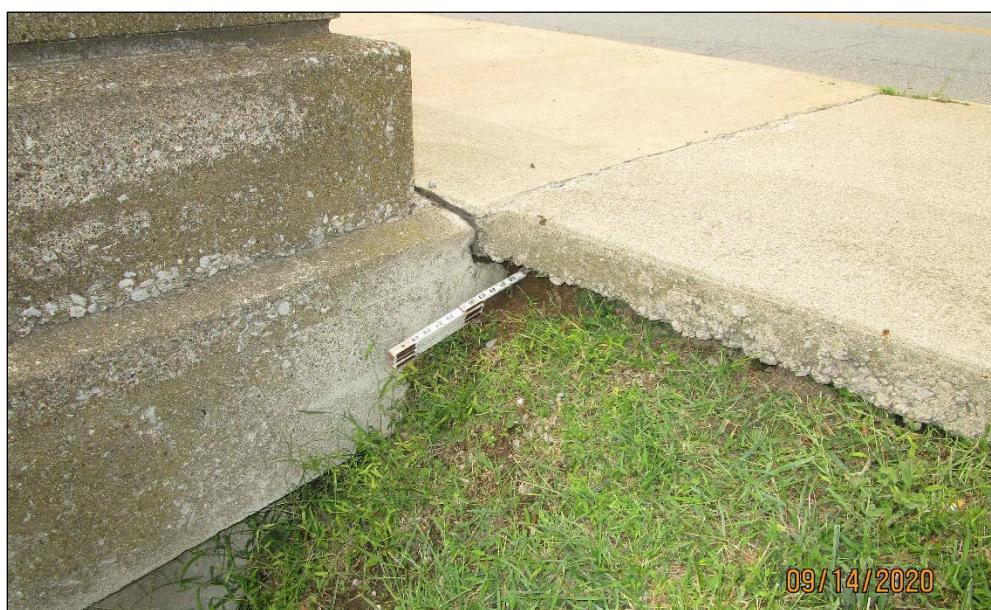
PHOTO 69 – EROSION OF SOUTHEAST EMBANKMENT UNDER SIDEWALK

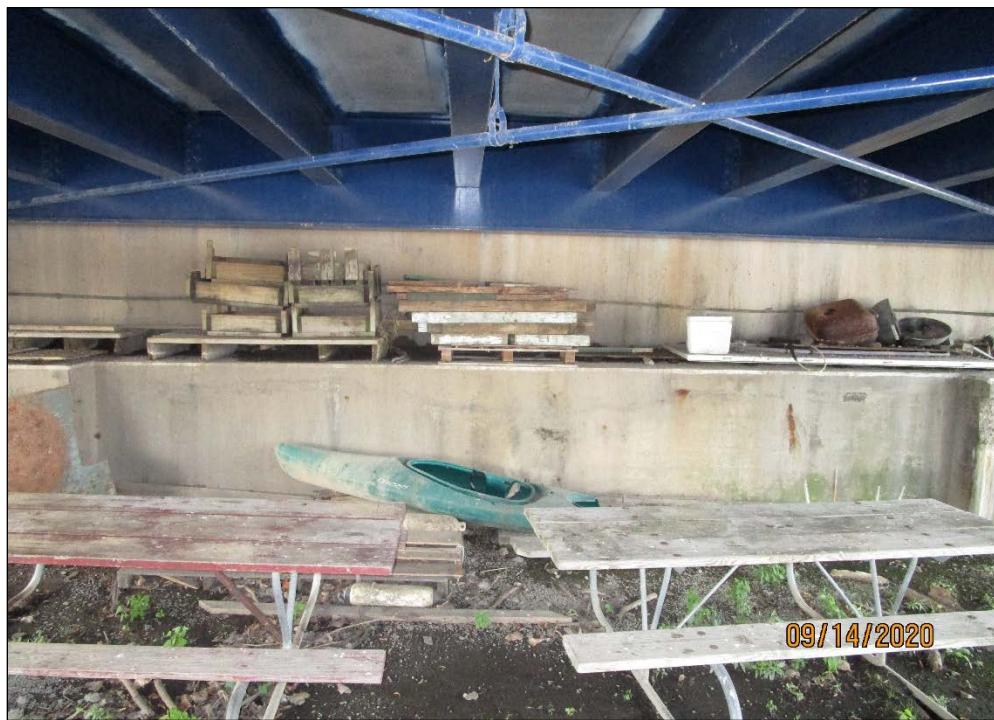
Private docks are below the structure along both shorelines of the Vermilion River. Small watercraft are being stored along both abutment barrels and on top of both abutment seats (**Photo 56**). At the Rear Abutment, random debris is being stored on the abutment seat (**Photo 70**).

PHOTO 70 – RANDOM DEBRIS ON REAR ABUTMENT SEAT
