2017 LUC-00280-0346 (SB/NB MAIN SPAN) ROUTINE  
INSPECTION REPORT  
BRIDGE INSPECTION REPORT

Inventory Bridge Number: LUC 00280 03.460

IR-280 over MAUMEE RIVER AND NSRR

Inspection Date: 09/15/2017

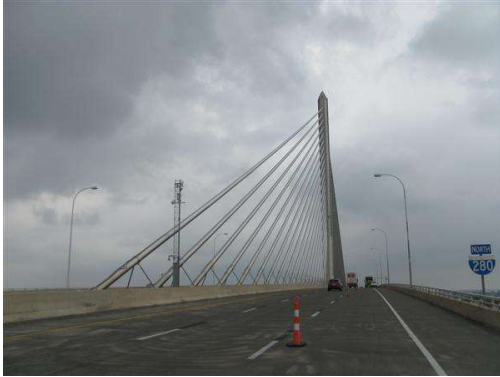
Photo 1

End view Main span Southbound looking  
North

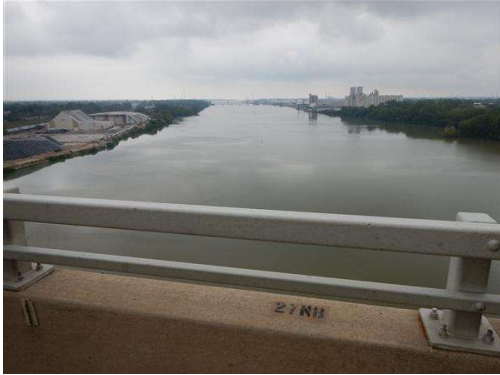
Photo 1

Maumee River flows West (left) to East (right) toward Lake Erie. No issues with the channel alignment were observed.

Channel alignment looking East

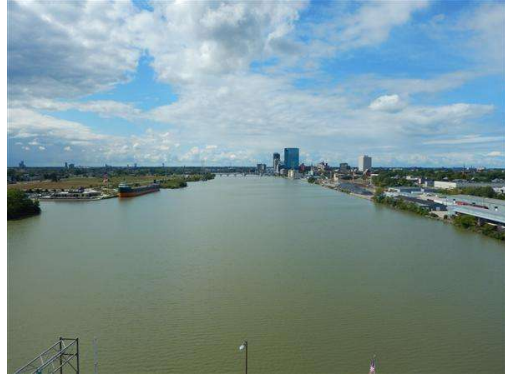
Photo 2

Channel alignment looking West
