2017 LUC-00280-0375\_R (NB NORTH APPROACH) ROUTINE  
INSPECTION REPORT  
BRIDGE INSPECTION REPORT

Structure File Number: 4806107

Inventory Bridge Number: LUC 00280 03.750 R

IR-280 over SUMMIT TO CHAMPLAIN, NSRR

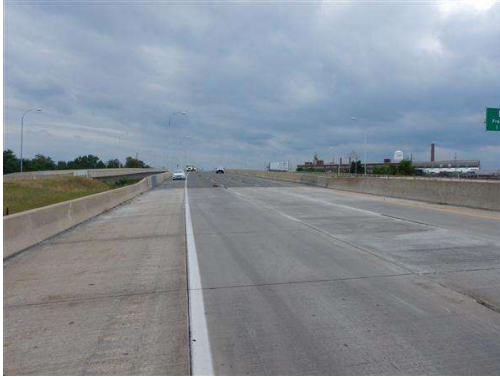
Photo 1

End view of the Northbound North approach looking South

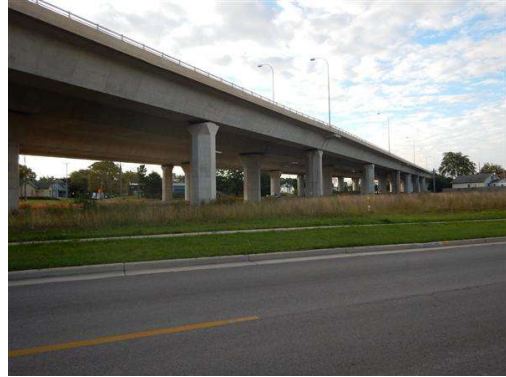
Photo 2

Northbound North Approach/Ramp D  
Elevation View looking Northwest

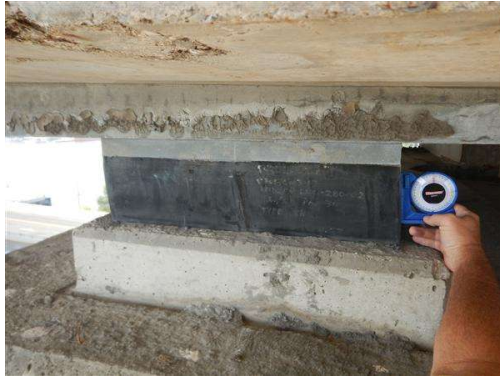
Photo 25

The plinths of Piers 32NB, 35NB, 37NB, 39NB, 46NB and 55NB exhibited areas of unsound, spalled or delaminated concrete with moderate to severe cracking in over 5% of the bearing area. See Photo 23. At the Pier 29NB West bearing, a gap between load plate and sole plate was observed. See Photo 24. The Pier 53NB West bearing was noted leaning 1 5/16" to South and the East bearing was leaning ¼" to the South. At Pier 34NB honeycombed concrete and cracks were observed in the pedestal. The Pier 30NB West bearing was rotated 3.5° to the East and the East bearing was rotated 5° to the South. See Photo 25.

East bearing at Pier 30NB leaning 3.5°  
South
