To: David E. Griffith, PE  
 From: Reneé Whittenberger, PE, RSP1 and Sela Jones, EIT  
 Date: January 30, 2025  
 Subject: Addendum to Report Recommendations

Upon providing a schematic plan of proposed countermeasures in the *TRU-SR 193-1.67 Roadway Segment Safety Improvement Study*, project team members met with stakeholders to gather feedback prior to the request of implementation funding. The following recommendations were provided in the report:

# TRU SR193 SAFETY STUDY

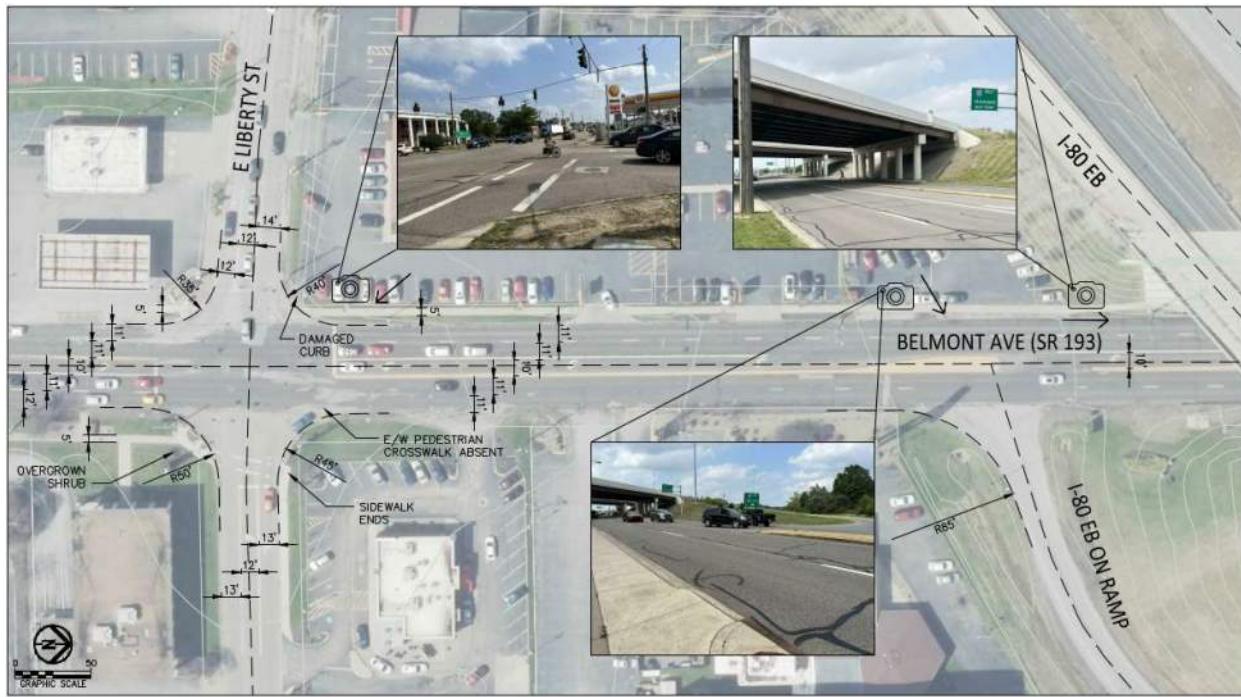
Figure 1. Existing site conditions, from Liberty Street to I-80.

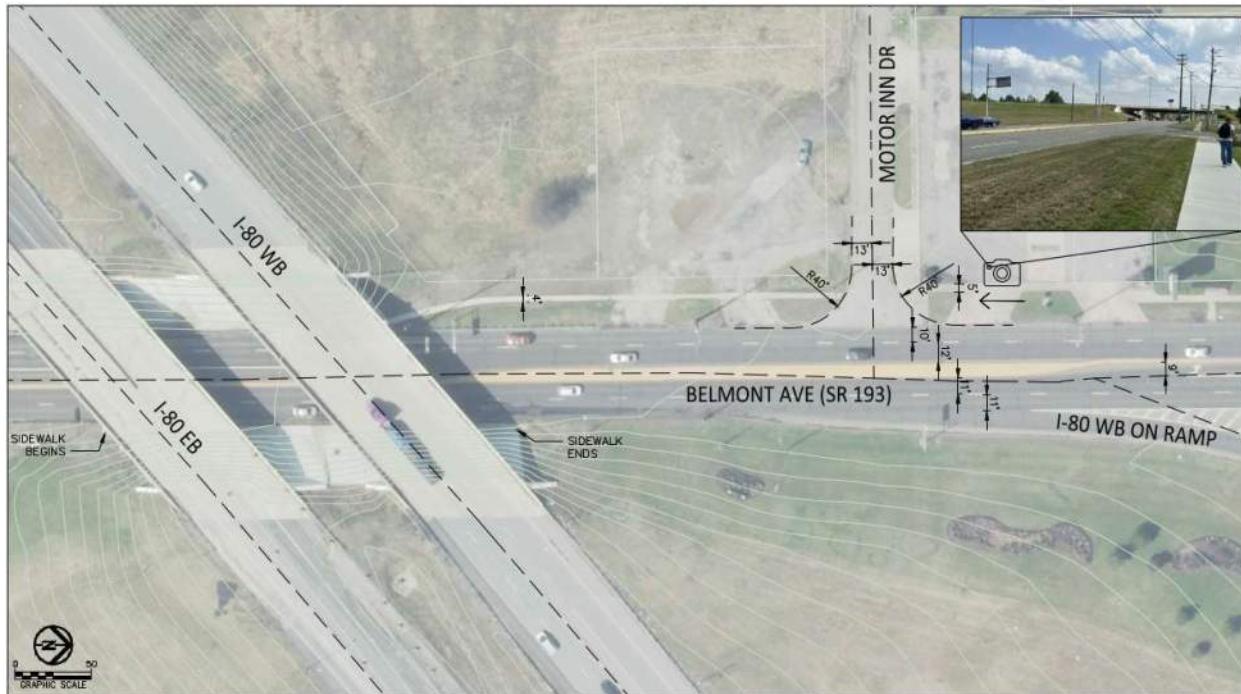
Figure 2. Existing site conditions, from I-80 to the I-80 westbound entrance ramp.

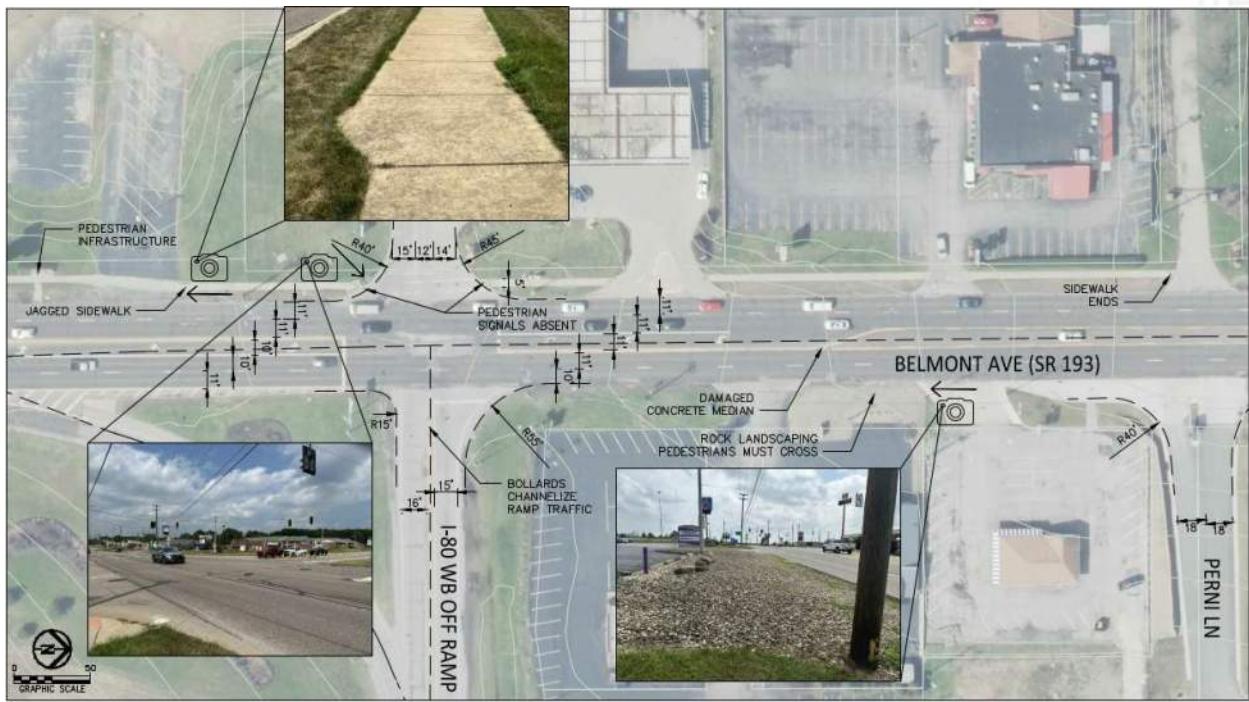
Figure 3. Existing site conditions, from the I-80 westbound entrance ramp to Perni Lane.

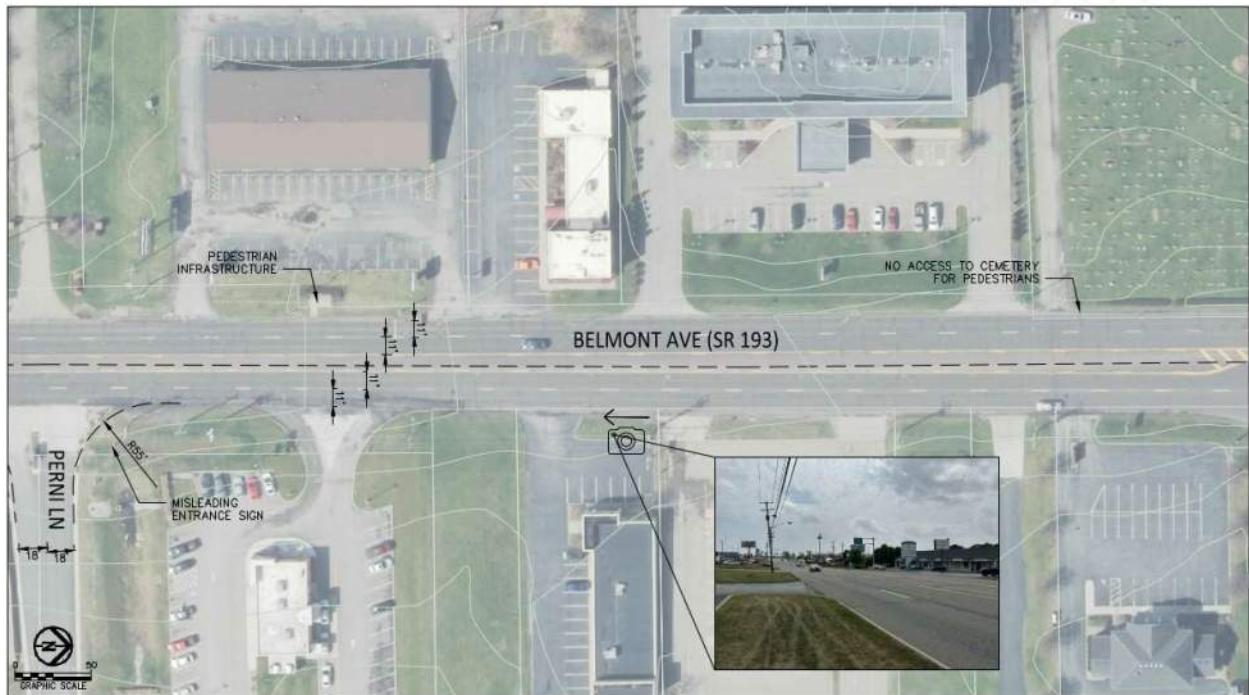
Figure 4. Existing site conditions, from Perni Lane to the cemetery.

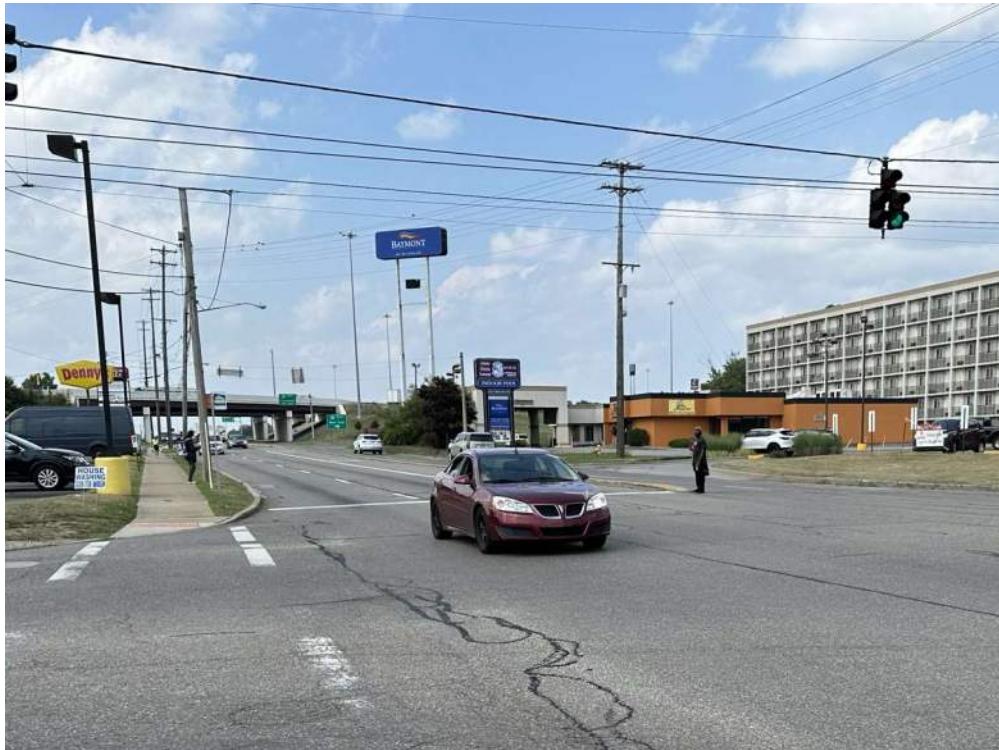
The intersection experiences all modes of highway traffic—passenger vehicles, motorcycles, trucks, transit, school buses, cyclists, and pedestrians. Most of the traffic witnessed at the site visit consisted of passenger vehicles. During the site visit, two pedestrians were observed at the intersection. One pedestrian was waiting for the WRTA bus at the northwest quadrant, and the other was trying to cross Belmont Avenue in front of Wendy's, where there is no crosswalk to accompany the pedestrian signals. These two pedestrians are pictured below in **Figure 15**. One cyclist was witnessed riding northbound on the west sidewalk. Another pedestrian was traveling northbound within the roadway and used the left turn lane to turn westbound onto Liberty Street. Upon turning onto Liberty Street,

Figure 15. At the Liberty Street intersection, one pedestrian waits for the WRTA bus and another crosses where no crosswalk is provided

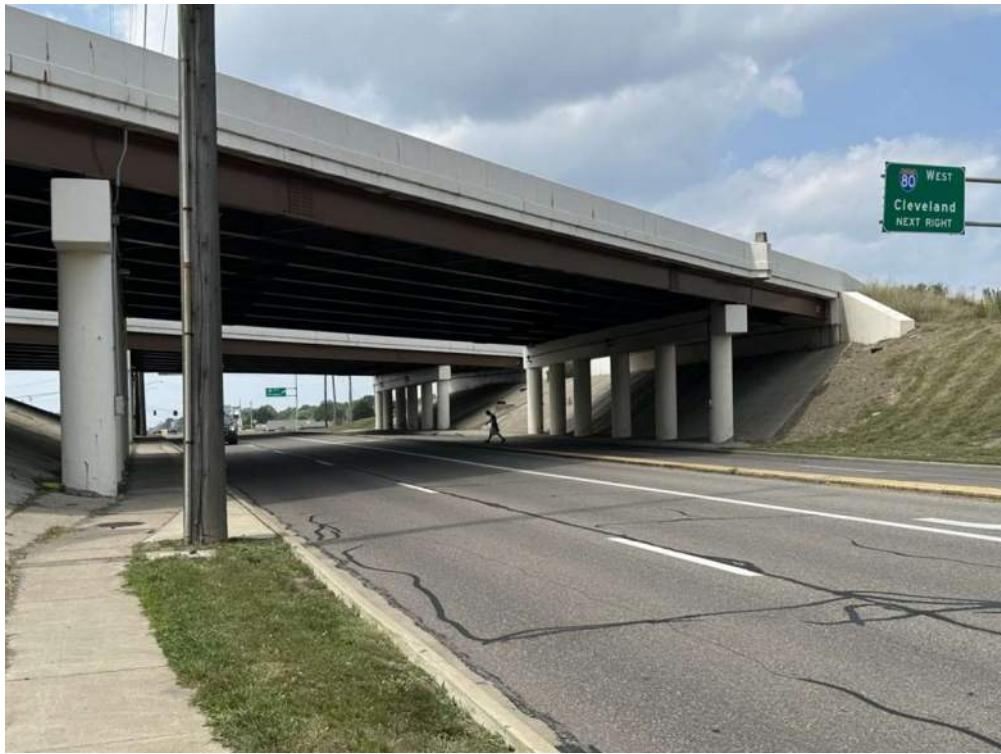
Figure 16. A pedestrian crosses Belmont Avenue under the I-80 overpass

If a pedestrian needs to reach the west side of the road from this bus stop, they will likely choose between the red and blue routes, as the green route does not lead to any marked crosswalks. The red route requires pedestrians to walk approximately 0.2 miles to the south prior to crossing. If their destination is north of the bus stop, this results in a detour almost half a mile long. Since many pedestrians may not be willing to travel this extra distance, either due to the extra time it takes or their own limited mobility, they often choose the blue route instead. During the site visit, multiple pedestrians were seen crossing mid-block. Recall **Figure 16** where a pedestrian was observed crossing Belmont Avenue under the dimly lit I-80 overpass.

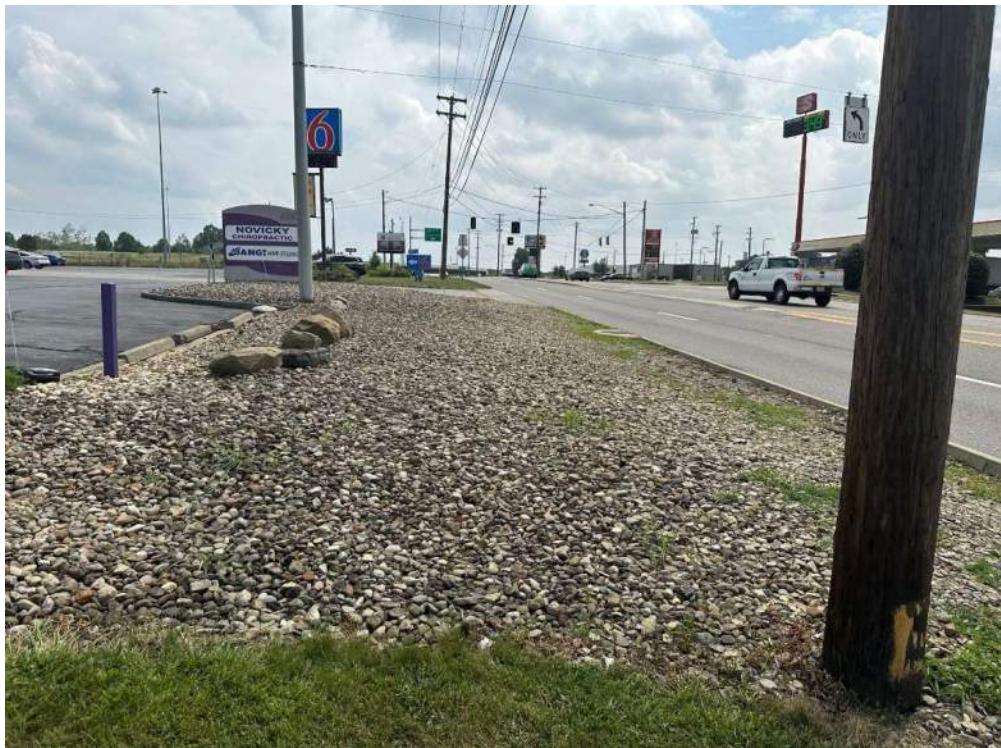
Figure 17. Rock landscaping on the east side of Belmont Avenue between the I-80 westbound ramps and Churchill Road

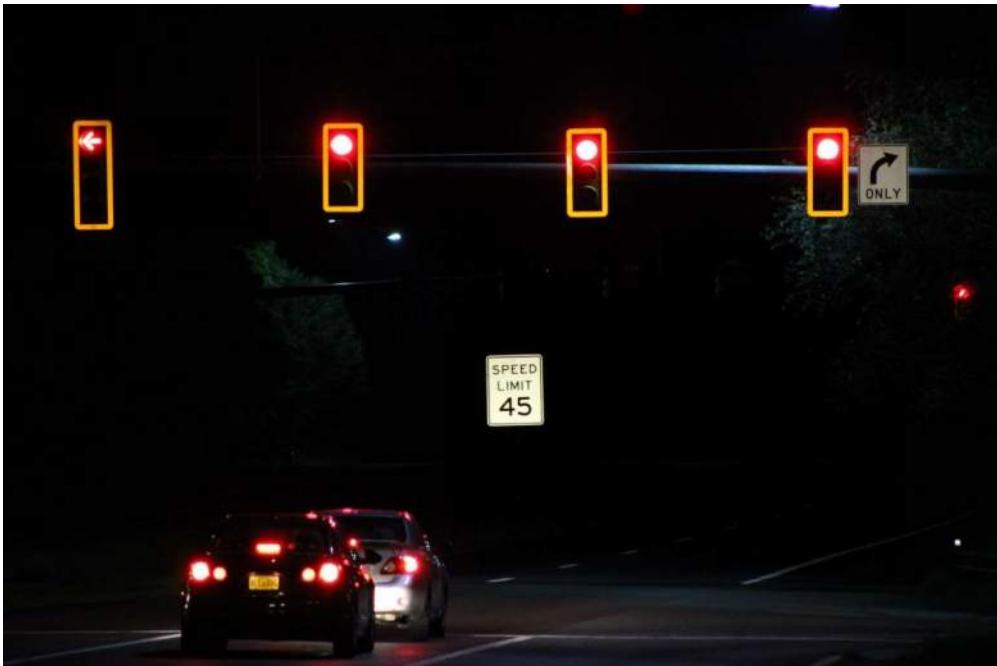
Figure 52. Reflective signal backplates increase signal visibility during dark hours

Signal visibility can be improved through the installation of new LED signals and reflective signal backplates, as shown in **Figure 52** below. This may improve awareness of and compliance with the signals, enhancing safety for all road users.
