2023 IN-DEPTH INSPECTION REPORT
BRIDGE NO: HAM-71-0000R, SFN 3105970
VAR-DISTRICT 8 Bridge Inspections
Brent Spence Approach Bridges

Cincinnati, Ohio

September 11th – September 19th, 2023

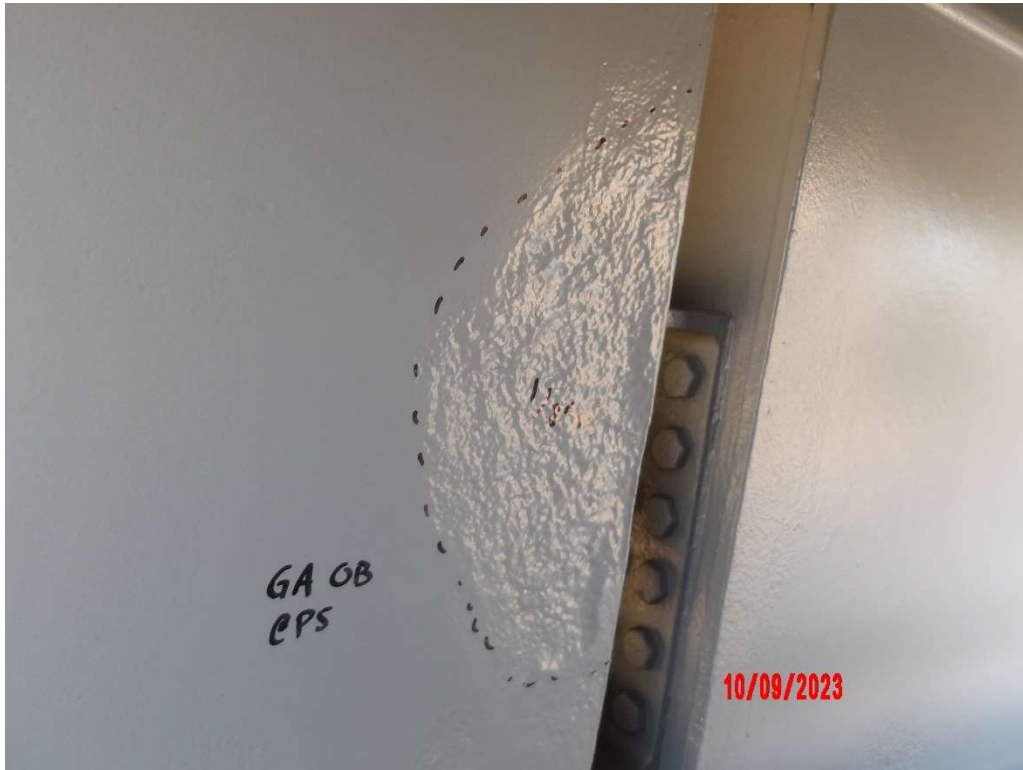
Photo 36- Girder A, Web at Pier 5, Section Loss 1/8" Web

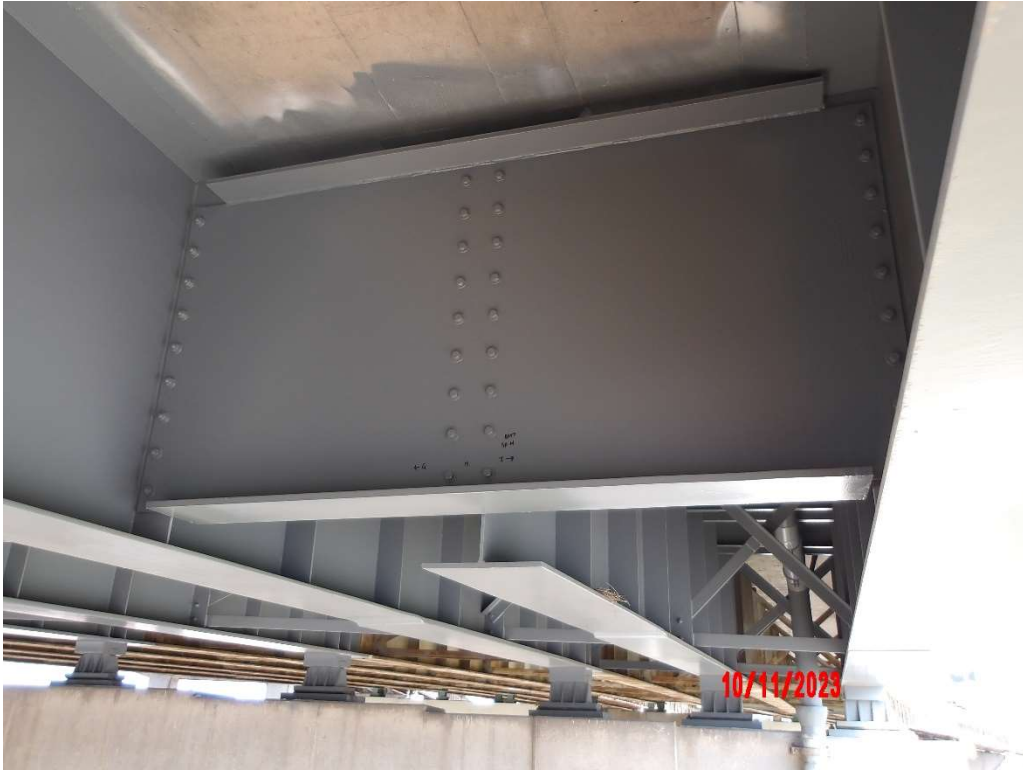
Photo 44- Girder H, Bay 7, Span 14, Additional Girder Detail

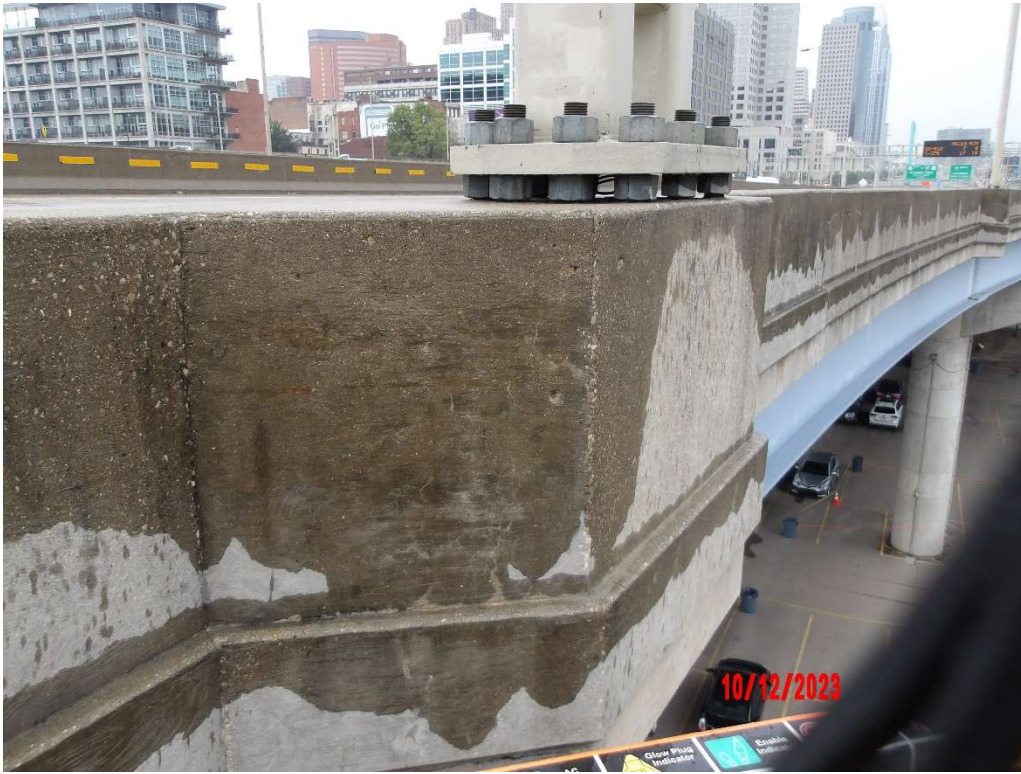
Photo 98- Sign Mount Bump Out
