2024 ROUTINE INSPECTION REPORT
BRIDGE NO: HAM-75-0022R, SFN 3108805
VAR-DISTRICT 8 Bridge Inspections
Brent Spence Approach Bridges

Cincinnati, Ohio

August 19th – September 11th, 2024

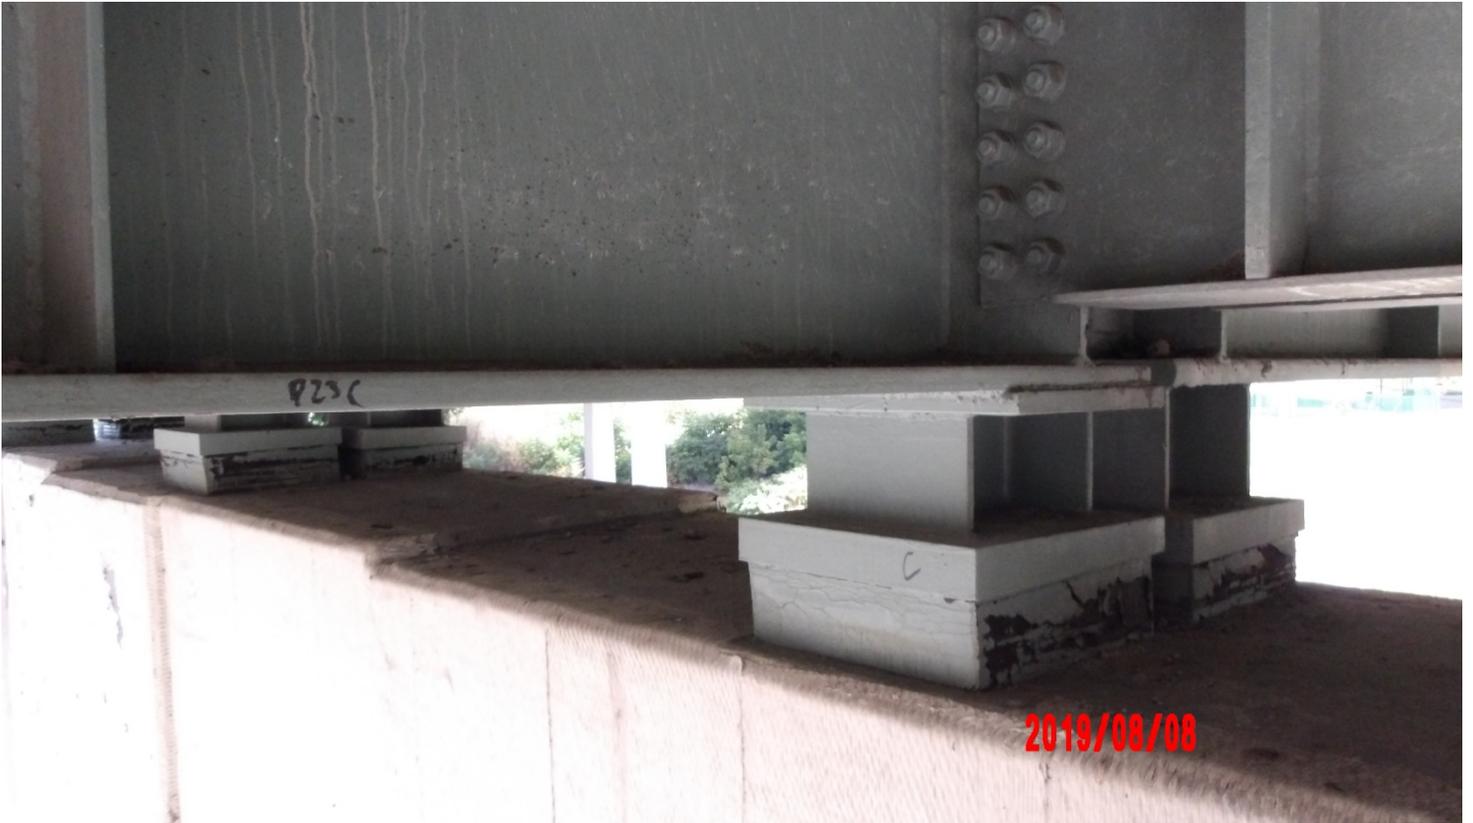
The elastomeric bearings are in GOOD CONDITION [7-NBIS] overall.

PHOTO 18. ELASTOMERIC BEARING C PIER 23C

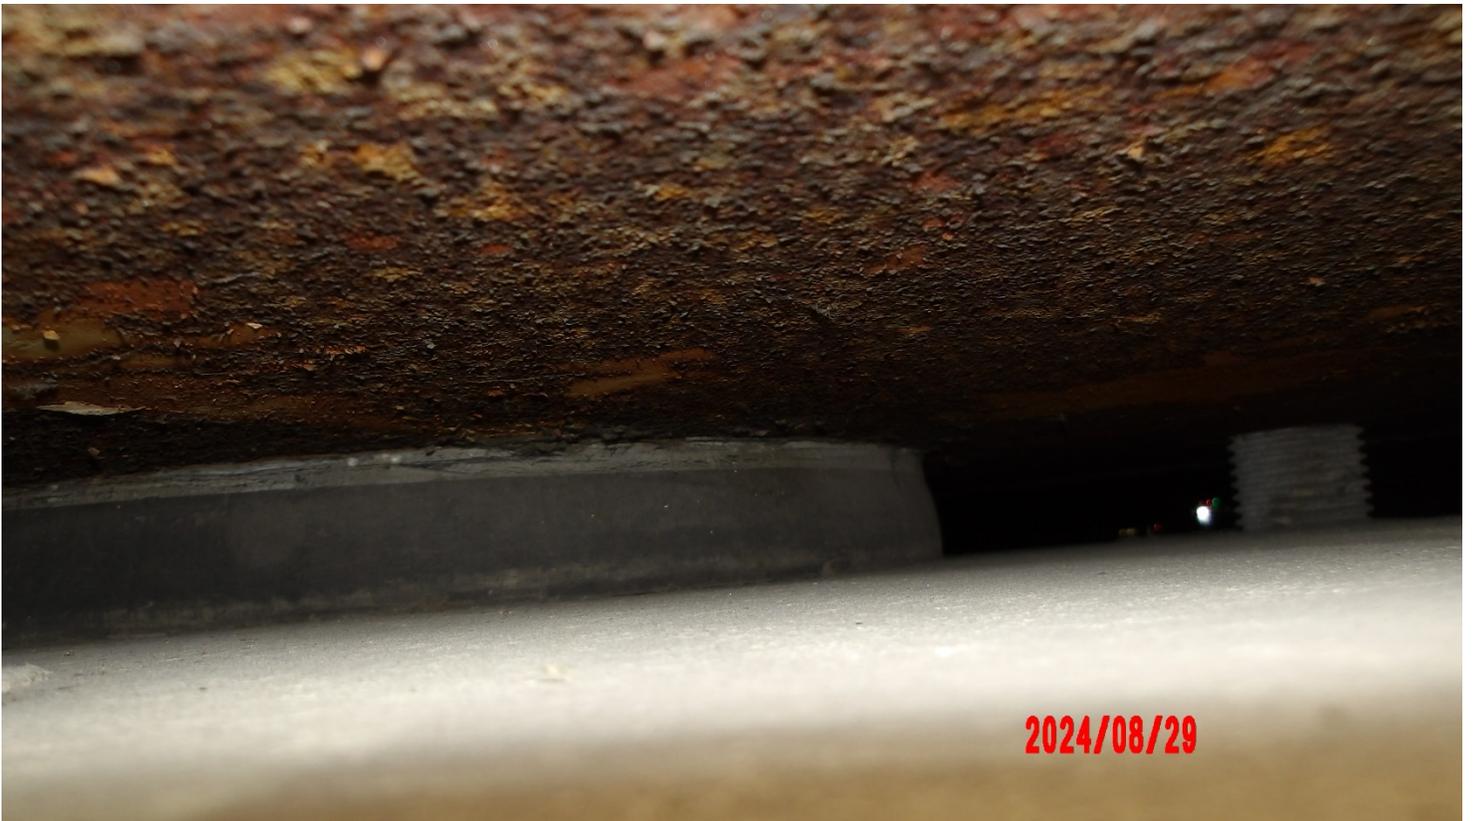
The 25C pier cap bearings consist of one elastomeric pad at each column and each pad is fixed with two anchor bolts connected with nuts on the pier cap interior. The bearings have no significant deficiencies observed on the pads or anchors. No issues were noted with the anchor rods.

PHOTO 19. ELASTOMERIC BEARING PIER 25J

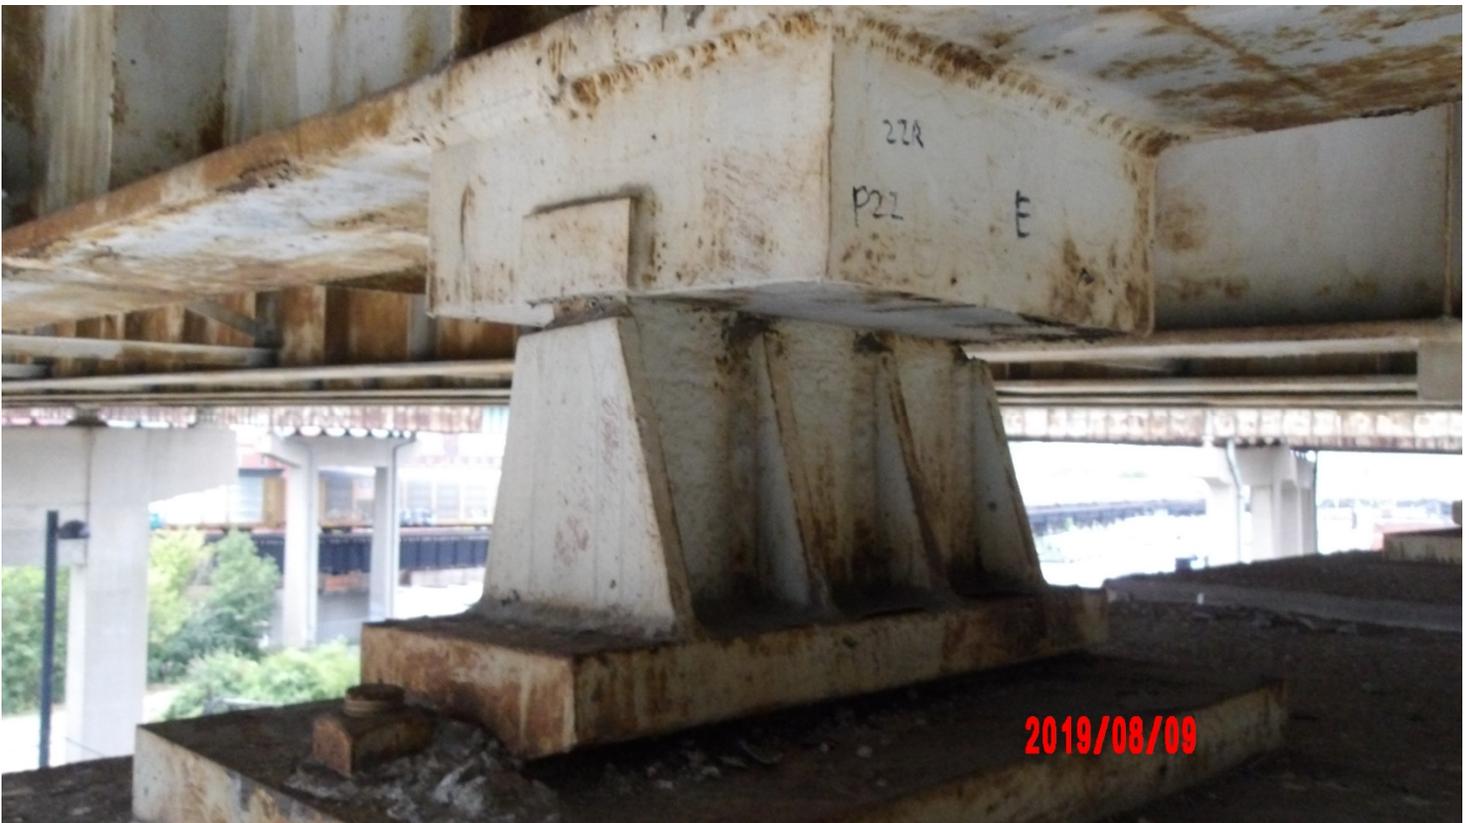
- The movable bearings typically exhibit surface corrosion with minor section loss, corrosion is more prominent on the fascia bearings.
- There is pack rust between the rocker and the masonry plate of Bearing A at Pier 17C, Bearing A and E at Pier 19C, Bearing E at Pier 21C, Bearings A and E at Pier 22C and Bearing E at Pier 25C with no indication of uplift
- The bearing at Abutment C, Bearing A has been covered with fill.

PHOTO 20. MOVABLE BEARING E PIER 22C

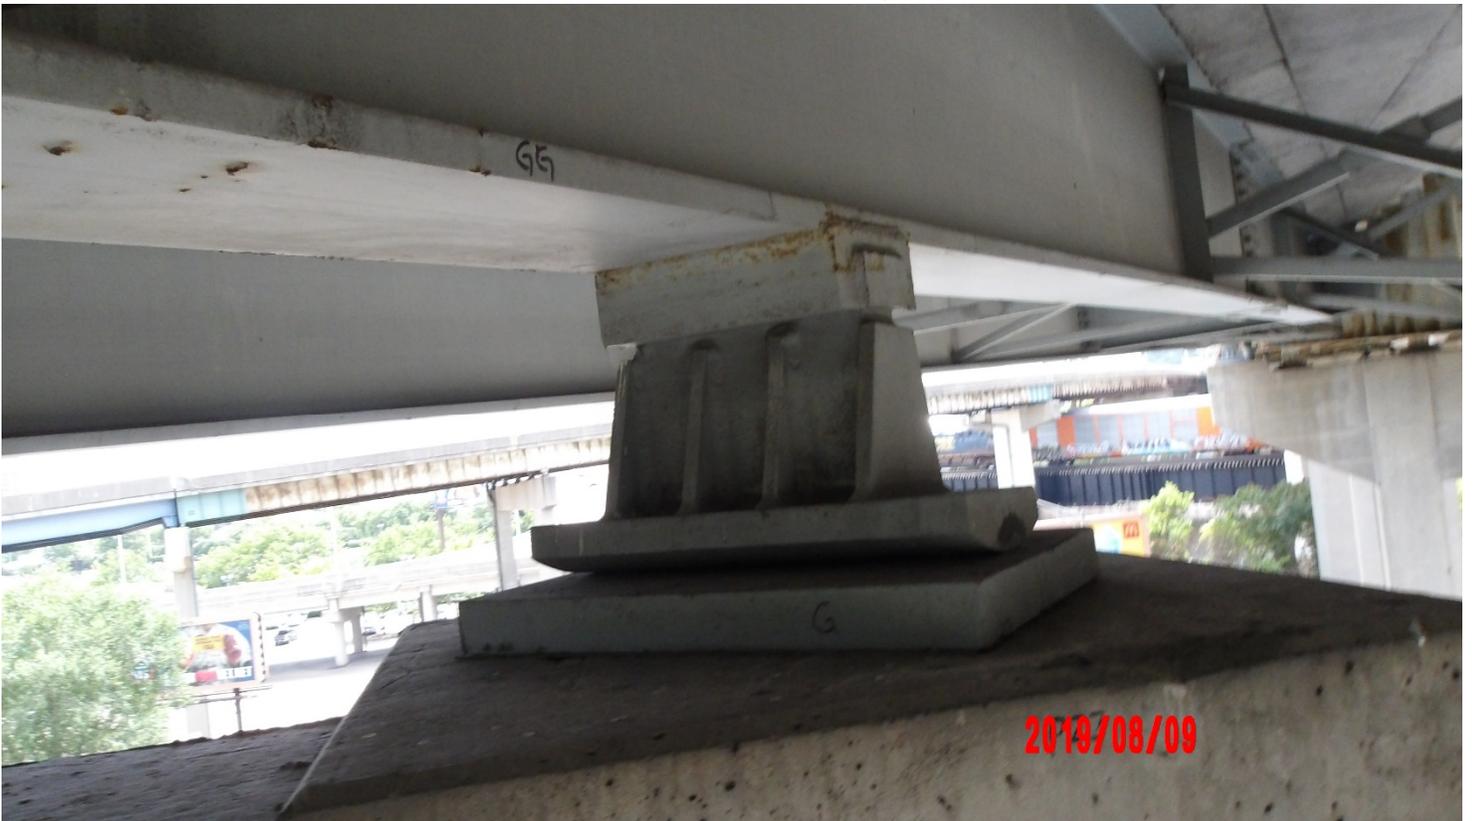
PHOTO 22. MOVABLE BEARING G PIER 23C

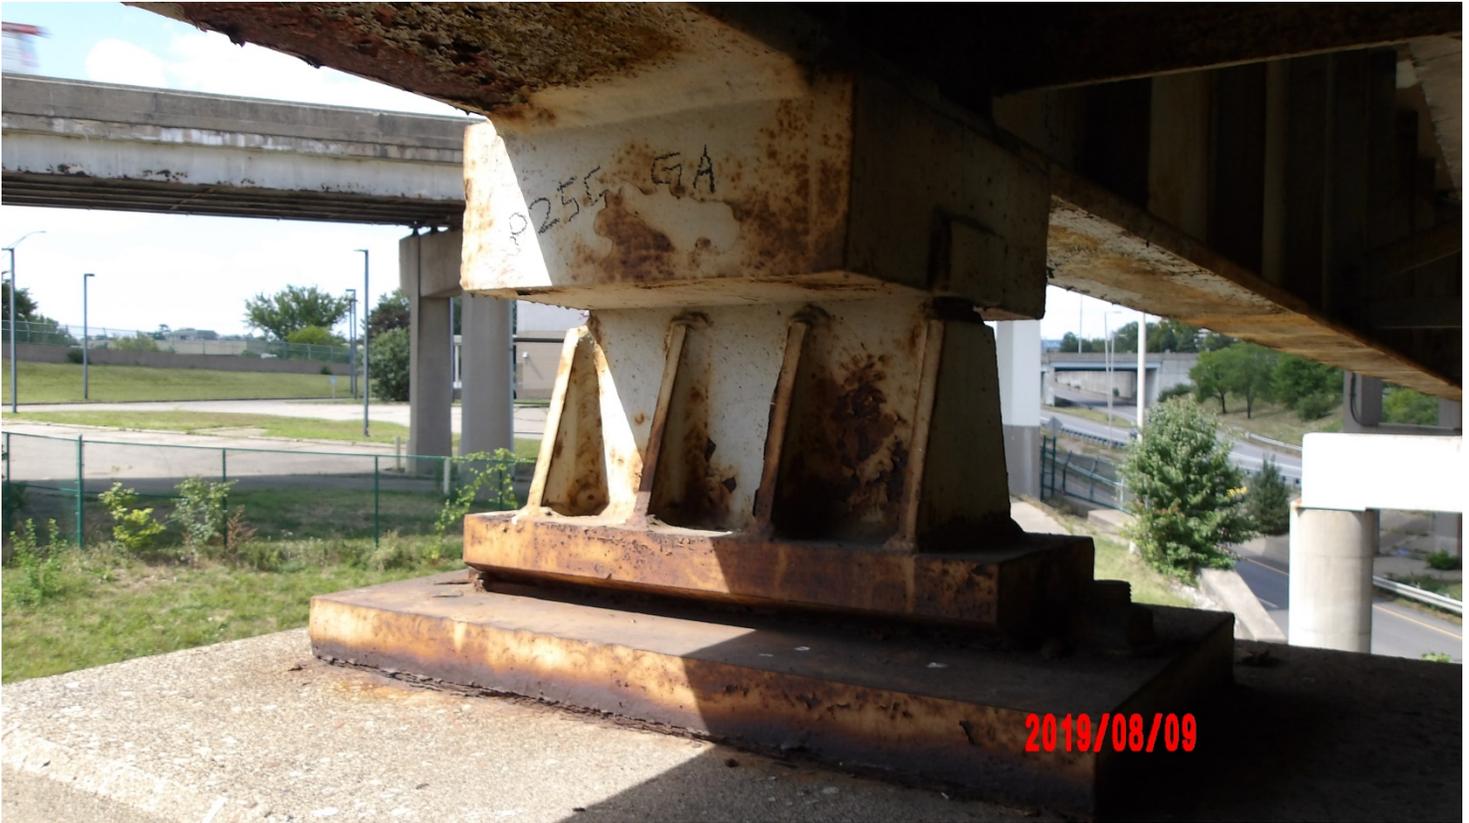
PHOTO 23. MOVABLE BEARING A PIER 25C

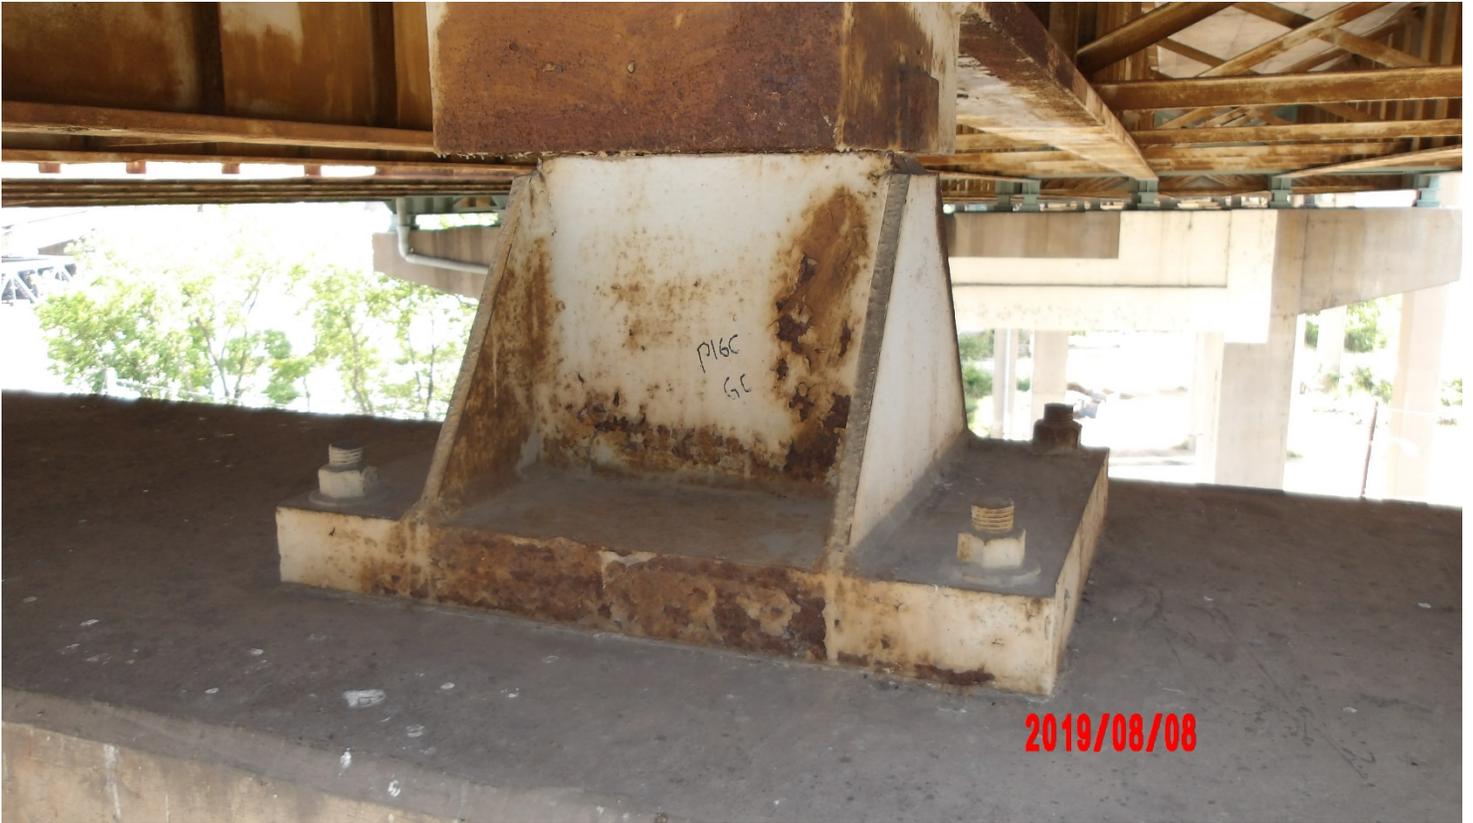
The fixed bearings are in SATISFACTORY CONDITION [6-NBIS] overall and exhibit surface corrosion with no measurable section loss, corrosion is more prominent on the fascia bearings.

PHOTO 24. FIXED BEARING C PIER 16C

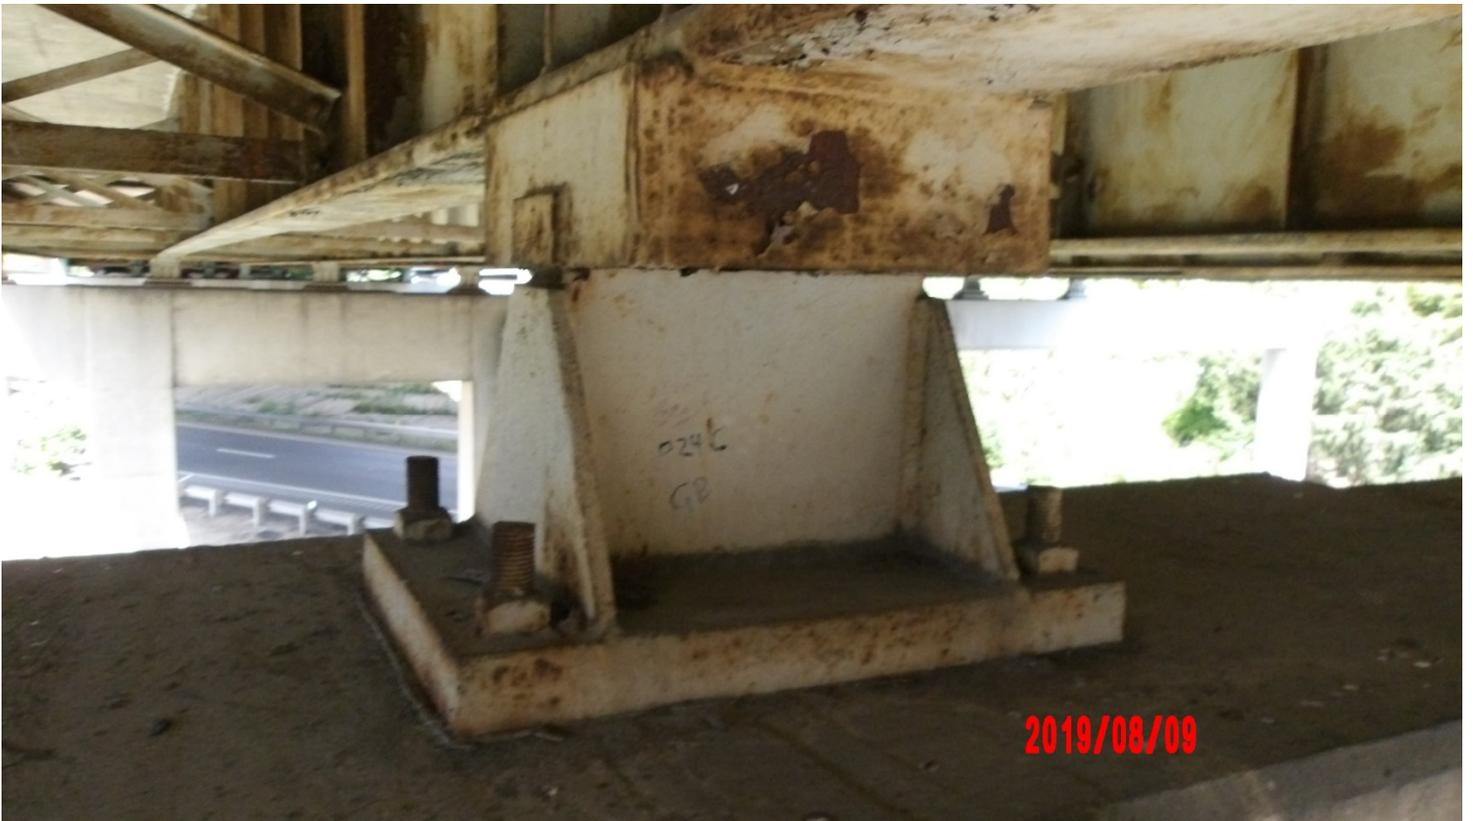
PHOTO 25. FIXED BEARING B PIER 24C

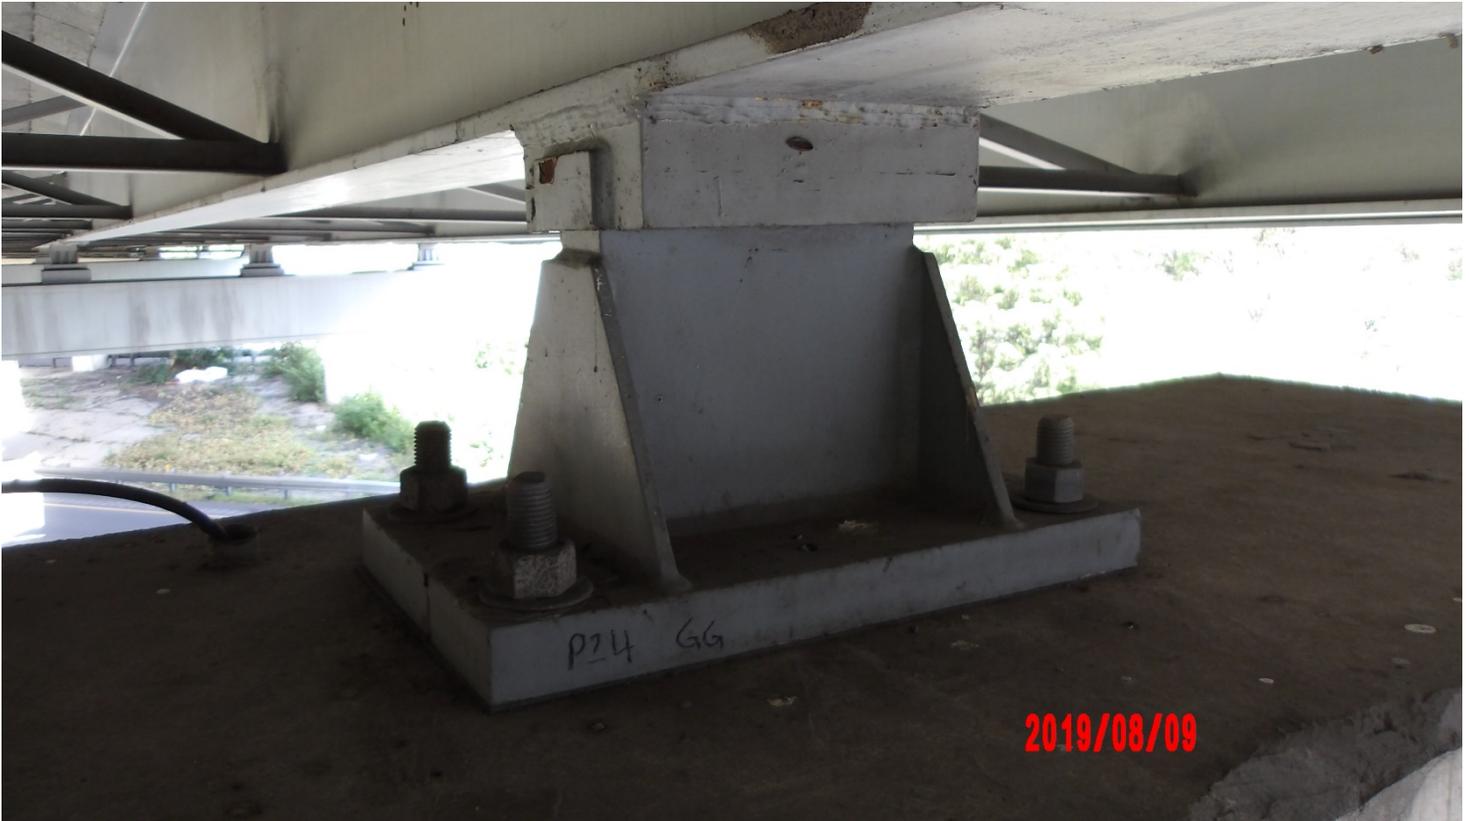
PHOTO 26. FIXED BEARING G PIER 24C

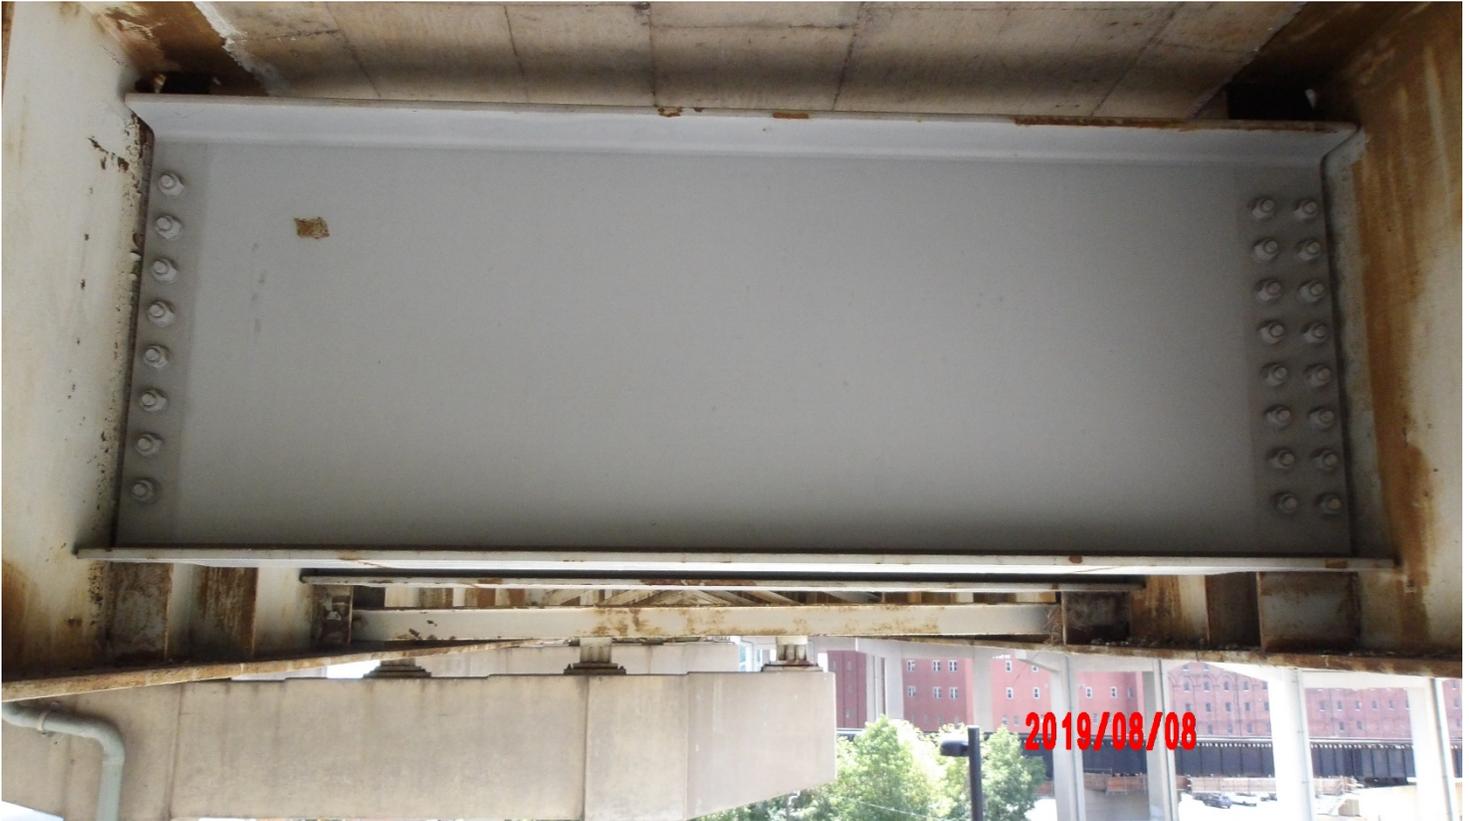
The diaphragms and cross frames are in good condition with minor surface corrosion and paint failure throughout the structure. Cross frame #6 in Span 19 is bent on the lower angle. Missing bolts is typical throughout the structure with welded retrofits at the connections.

PHOTO 27. DIAPHRAGM, RETROFIT DIAPHRAGM SPAN 24

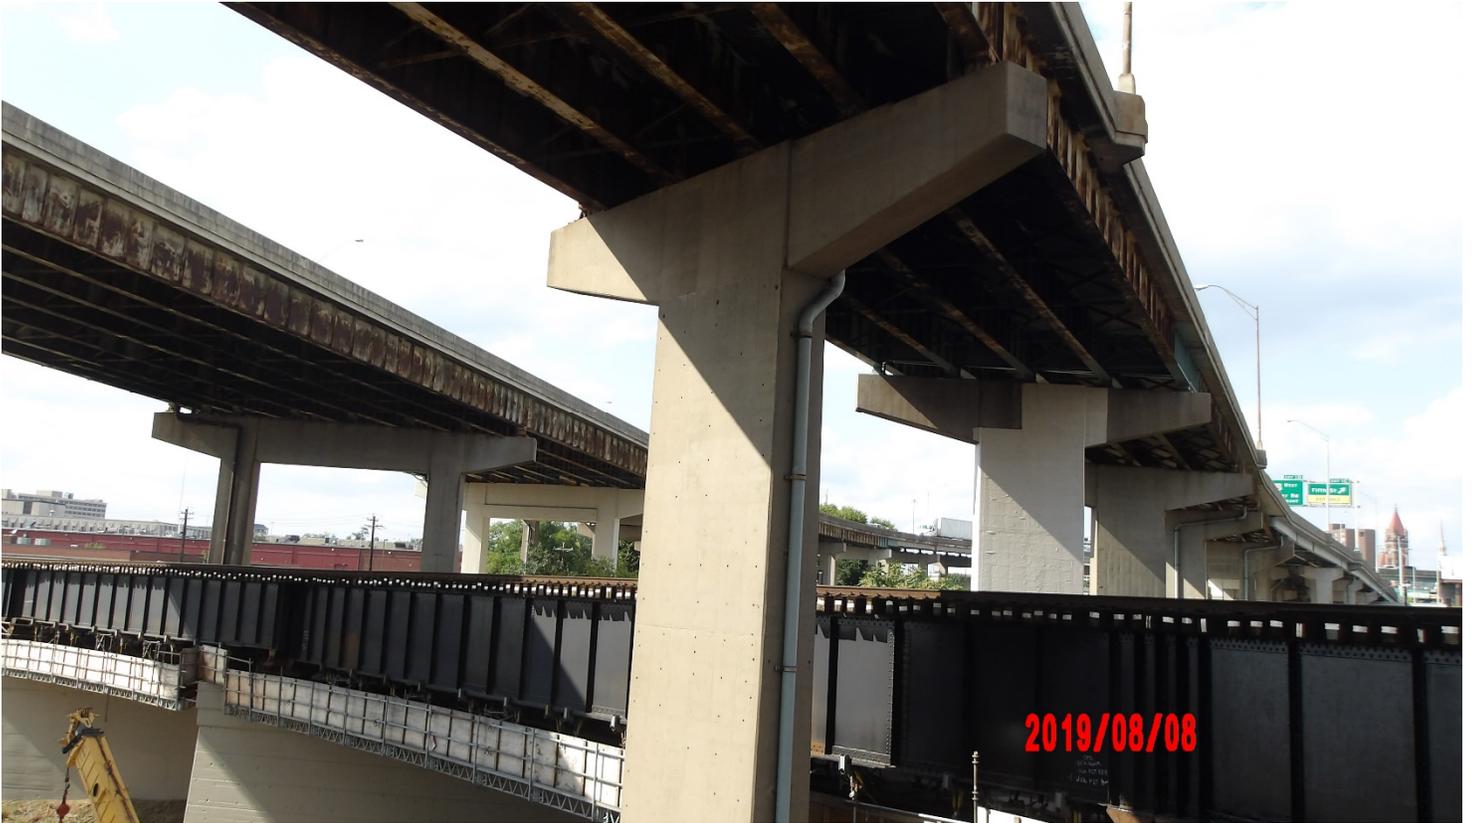
PHOTO 30. PIER 16C, FRONT FACE

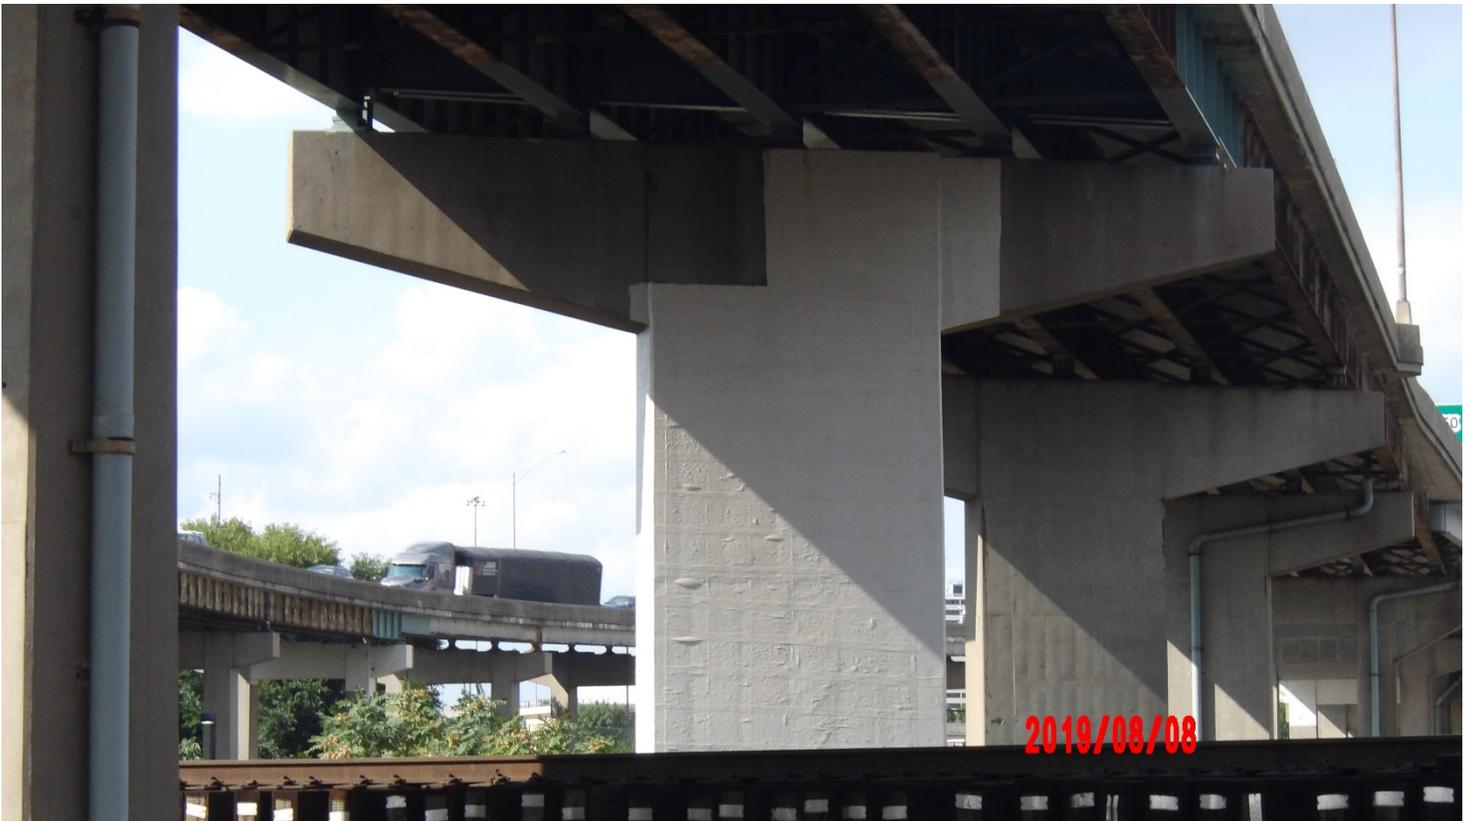
PHOTO 31. PIER 17C, FRONT FACE

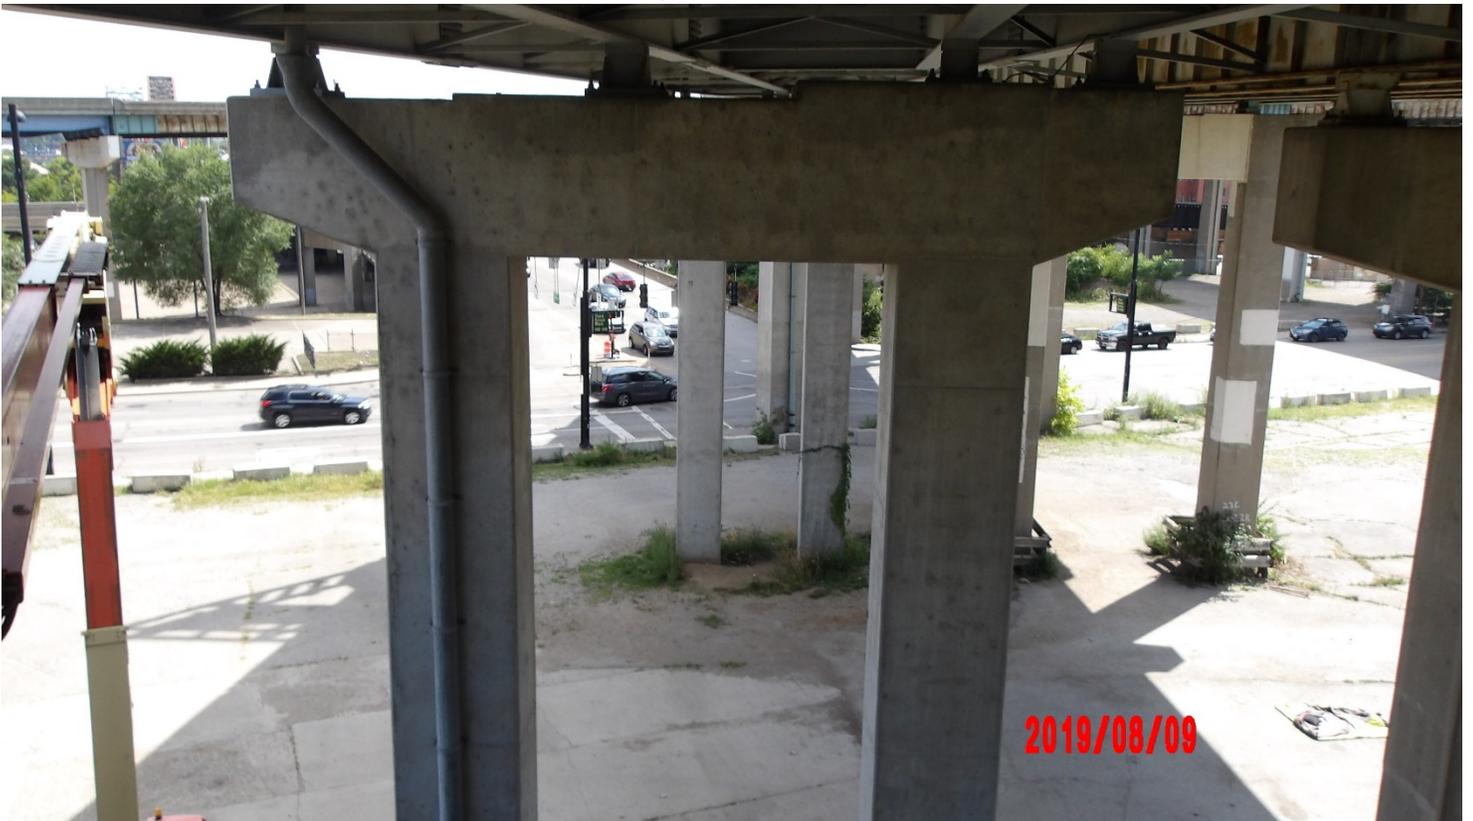
PHOTO 33. PIER 24C, FRONT FACE

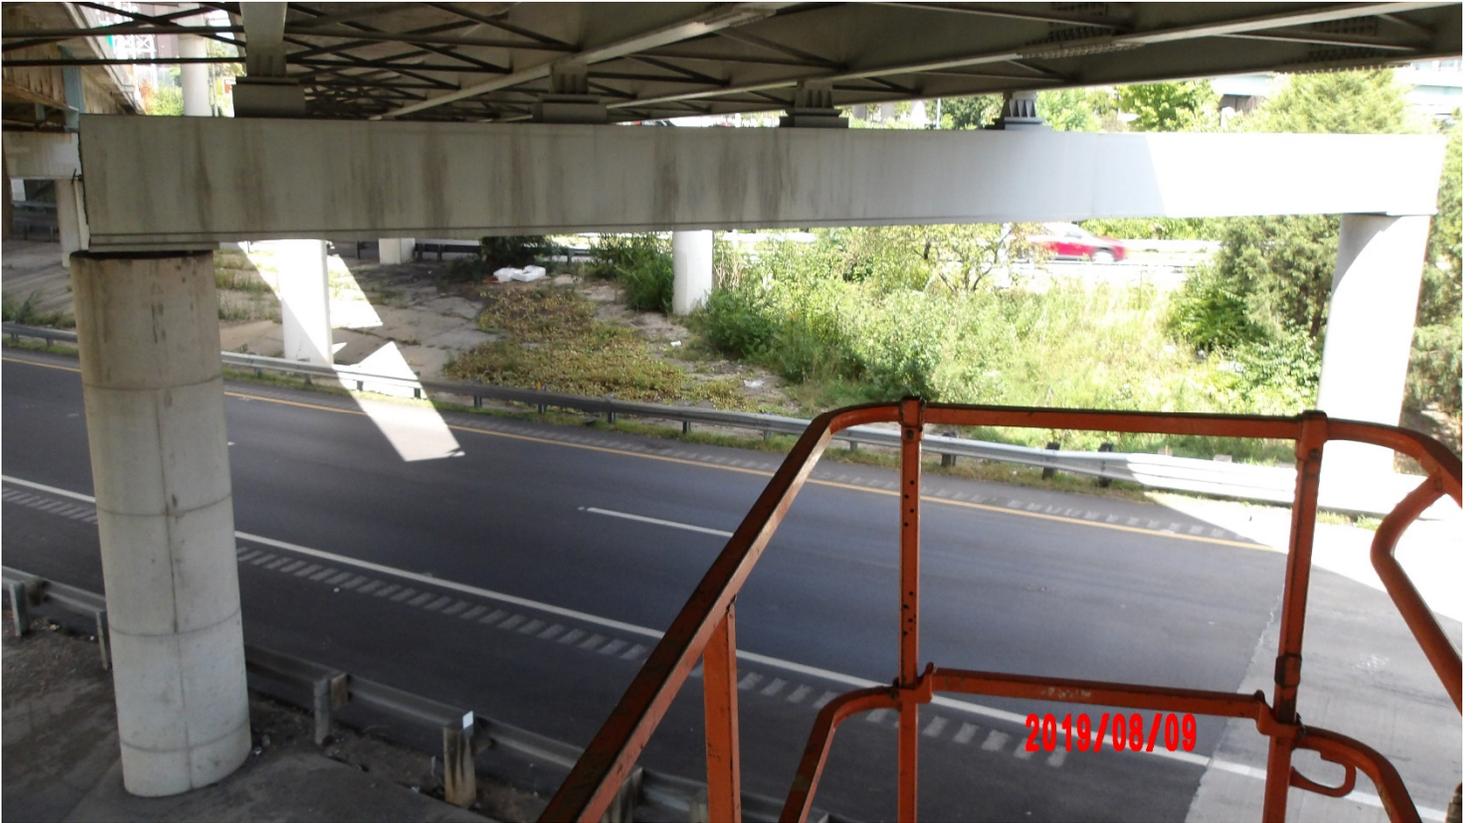
The interior of steel pier cap 25J is in GOOD CONDITION [7-NBIS]. Transverse diaphragms are numbered 1 to 7, from west to east. During the inspection, the interior of the pier cap was dry with no indications of moisture infiltration. There are minor deformations in the top flange backer bars on both webs. There is freckling and minor surface corrosion on Diaphragms 1, 2, and 7, and at both hatch openings.

PHOTO 34. PIER 25J, BACK FACE

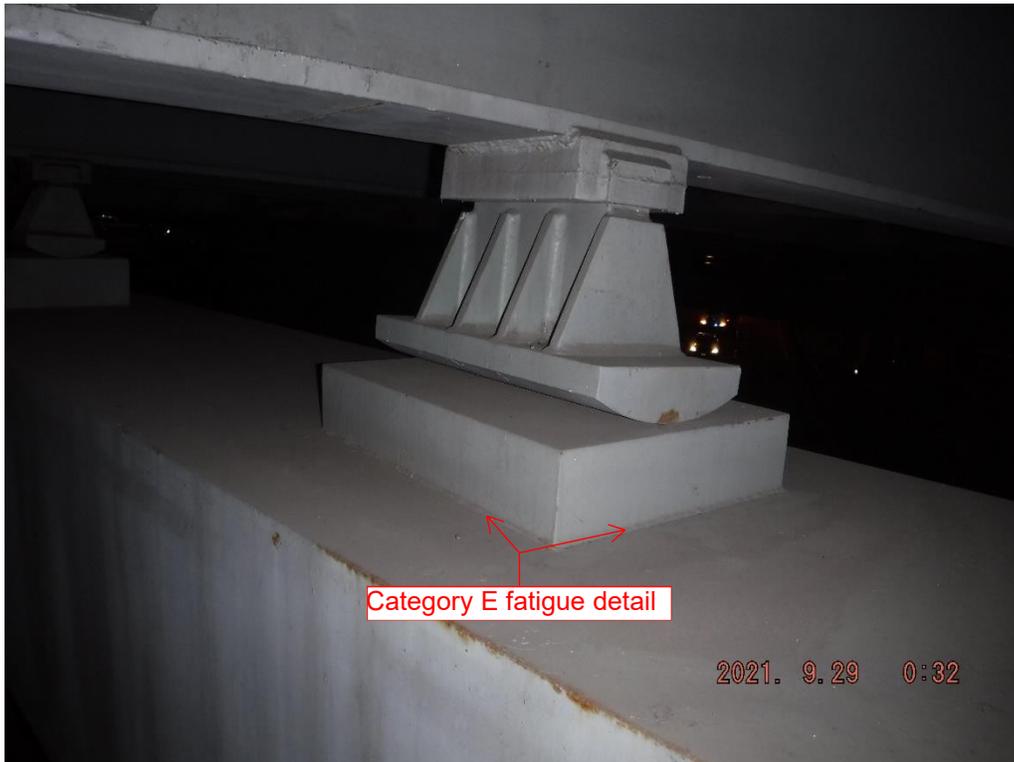
Category E: Steel bearing pedestal to top flange fillet weld connection with length $L > 4$ in. and a thickness $t \geq 1.0$ in. parallel or transverse to the direction of primary stress 4.

Photo 1 - Category E fatigue detail - Steel bearing pedestal welded to top flange

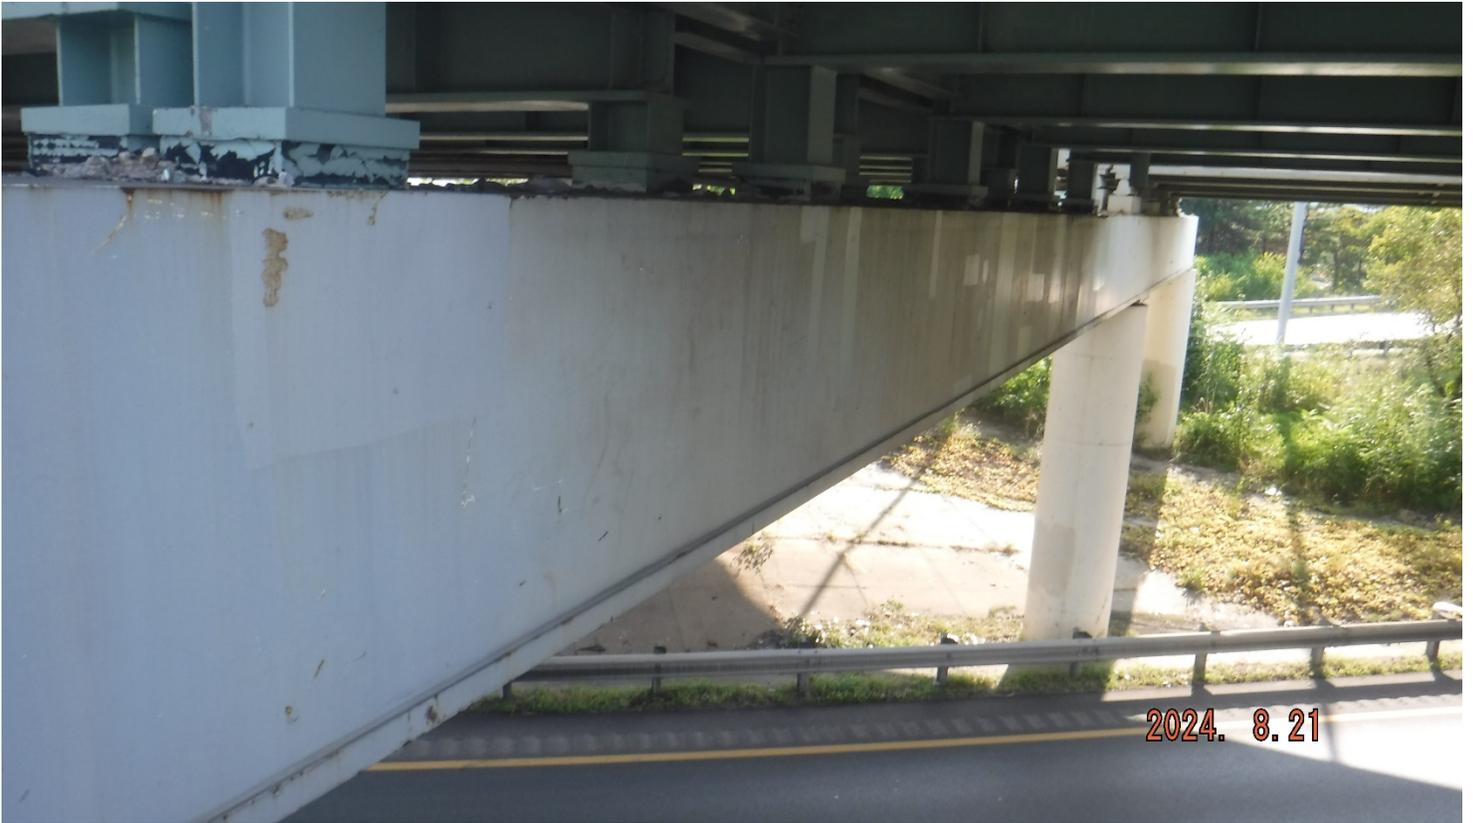
PHOTO 39. PIER 26C/J

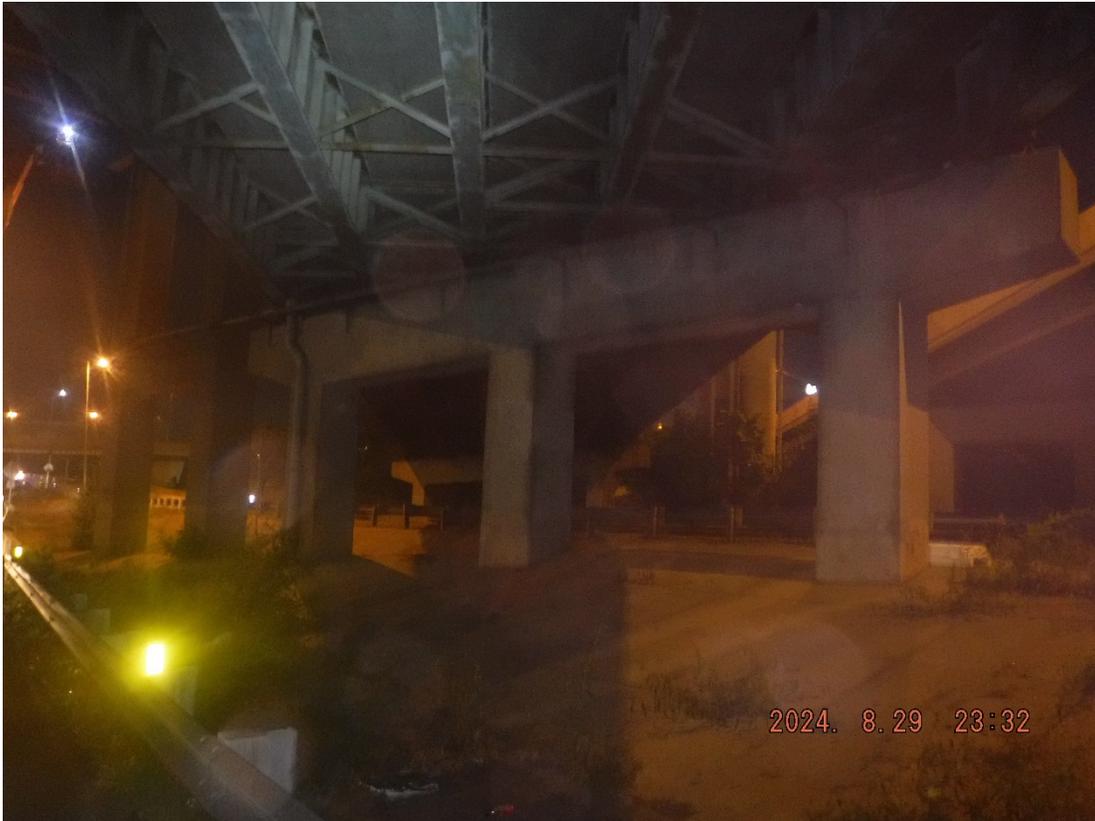
PHOTO 40. PIER 28C WEST FACE

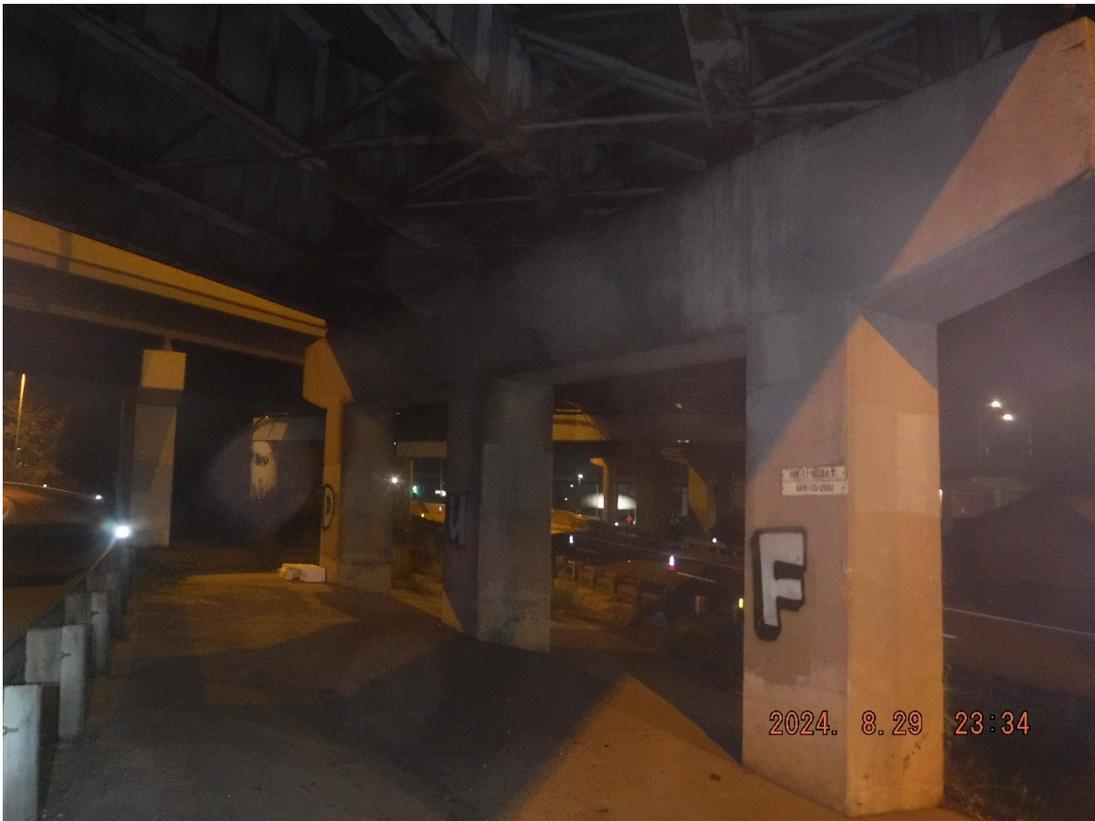
PHOTO 41. PIER 28C EAST FACE

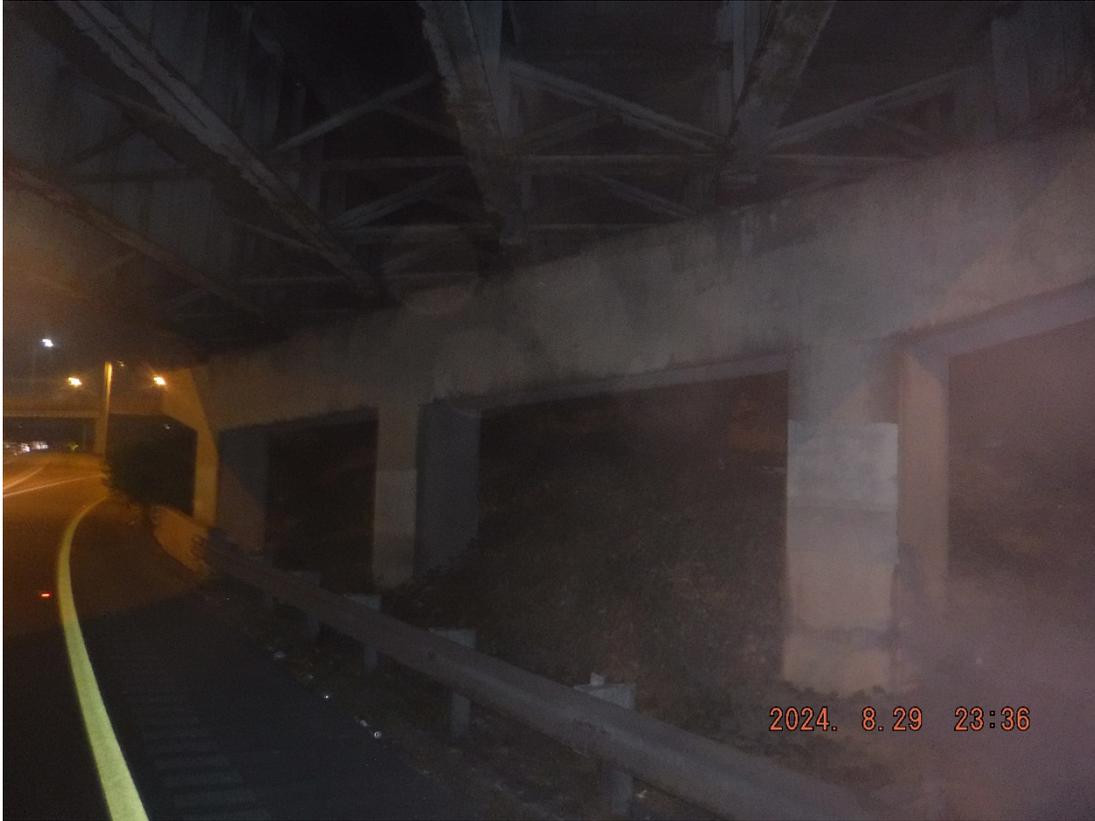
PHOTO 42. PIER 29C WEST FACE

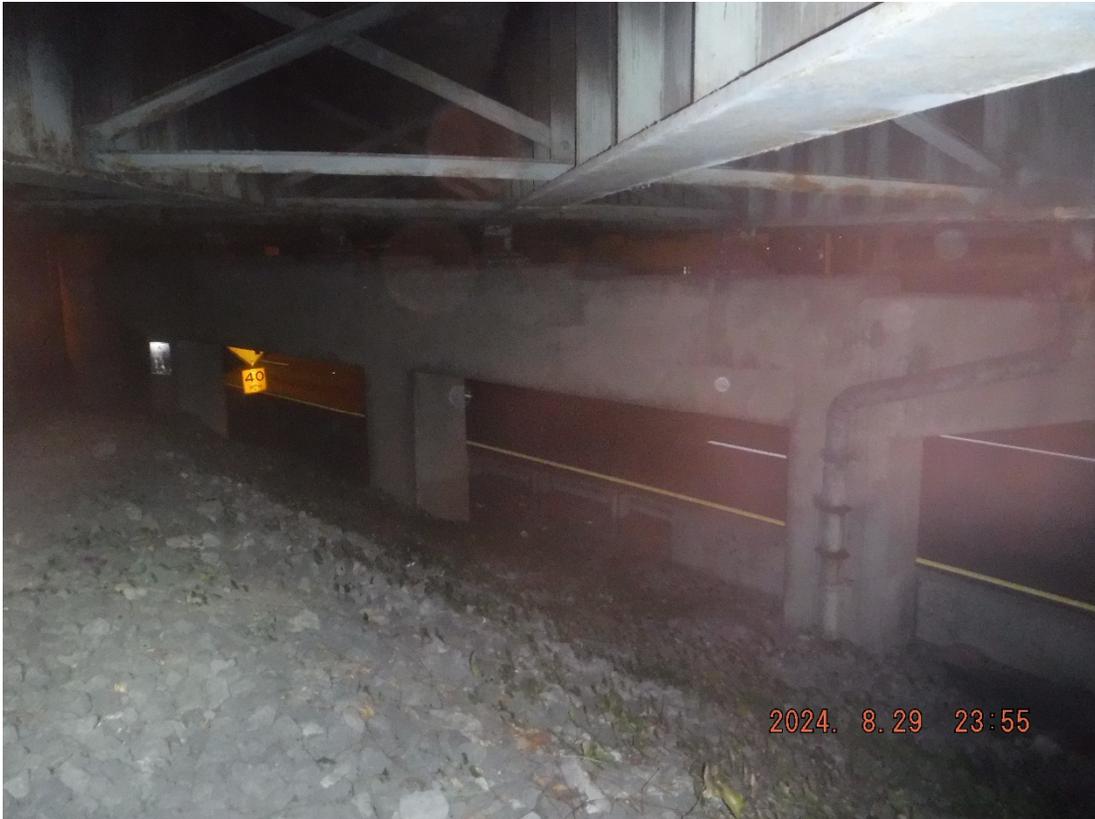
PHOTO 43. PIER 29C EAST FACE

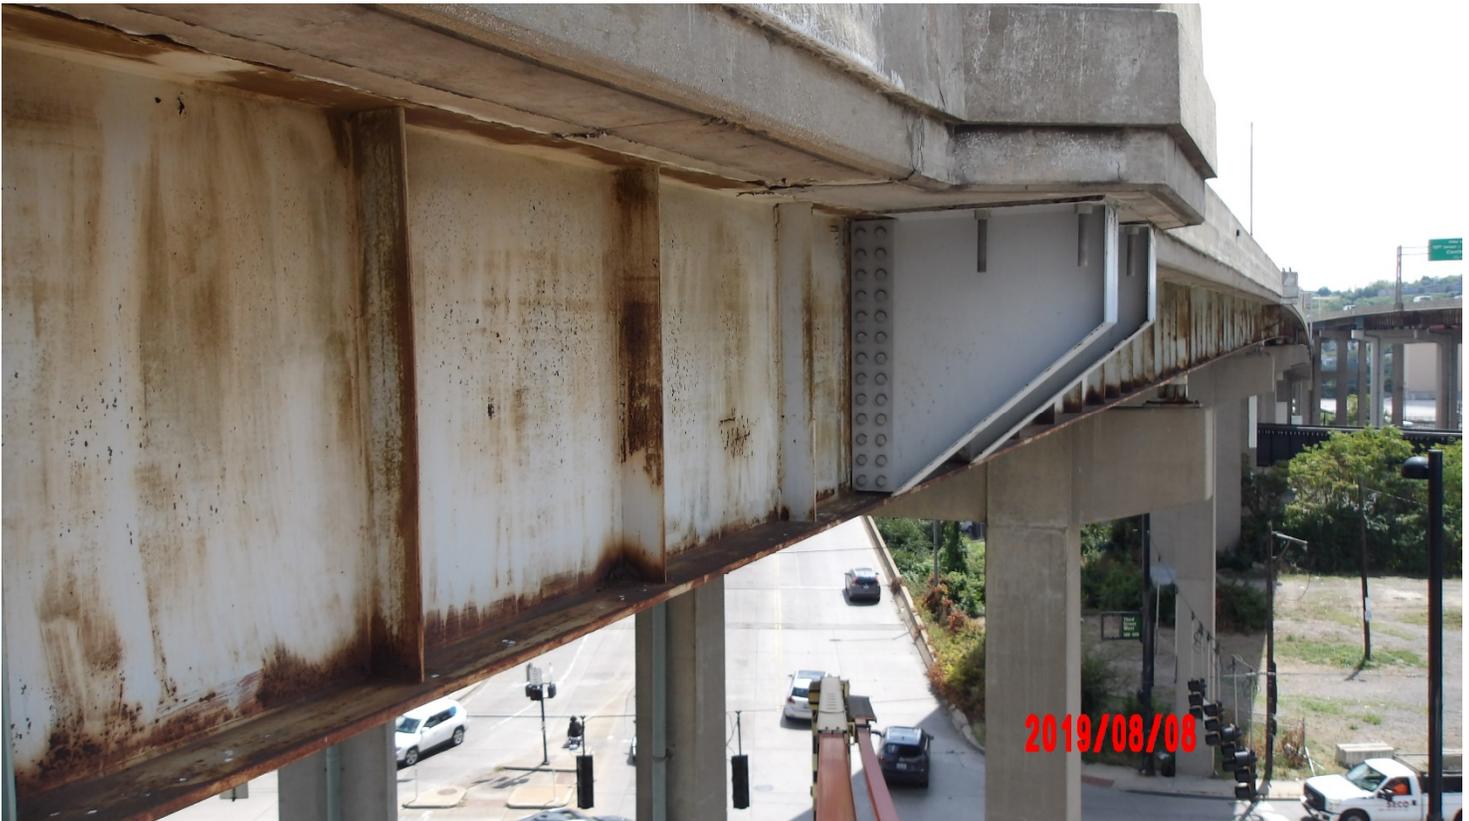
The structure-mounted sign supports are in satisfactory condition. There is one overhead sign support mounted to the railings near Pier 23C. There are no significant deficiencies noted for the support structure or the anchorage to the railings.

PHOTO 44. SIGNS, BUMPOUT OVERHANG FOR SIGN MOUNTS
