2024 ROUTINE INSPECTION REPORT
BRIDGE NO: HAM-75-0022R, SFN 3108805
VAR-DISTRICT 8 Bridge Inspections
Brent Spence Approach Bridges

Cincinnati, Ohio

August 19th – September 11th, 2024

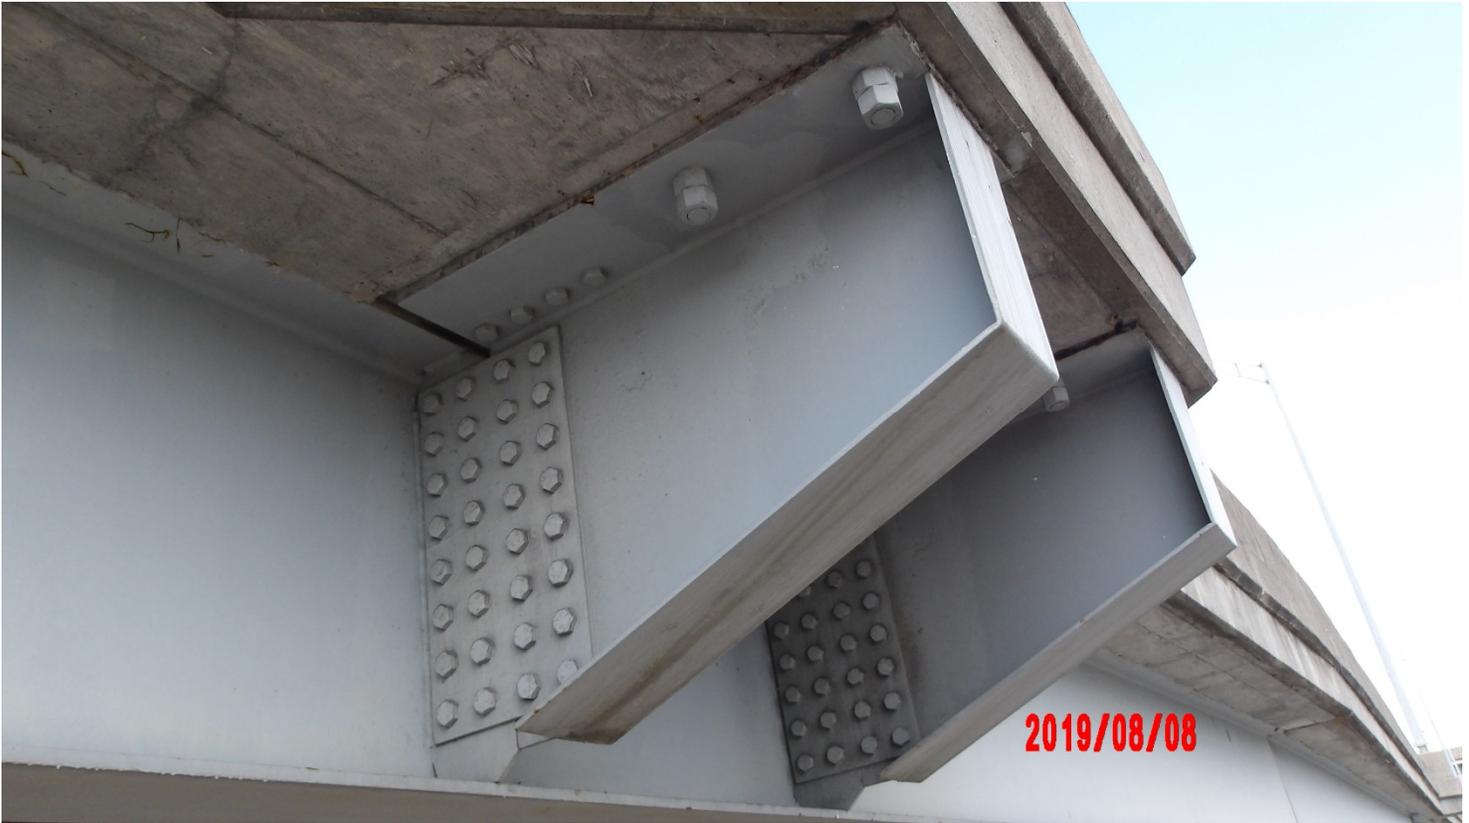
PHOTO 45. SIGNS, BUMPOUT OVERHANG FOR SIGN MOUNTS
