# Routine and NSTM Member Inspection Report

## HAM-42-0264R 2025 Routine and NSTM Member Inspection Report (VAR-District 8 Bridge Inspections for Steel Pier Caps)

SFN: 3101223, PID: 109781

August 23, 2025

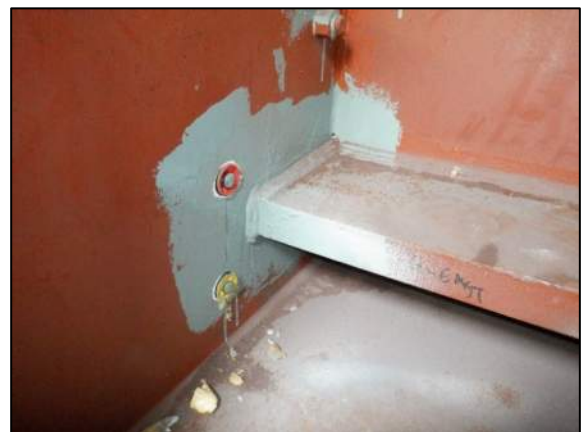
The pier cap is in overall FAIR condition [5] (Photo 1). The web plates have been retrofit with stress relief drilled holes connected by vertical saw-cuts adjacent to the welded connections of the girder bottom flange tie plates at all girders unless otherwise noted. Additional retrofits noted at the time of inspection were the drilling out of cracks and touch up paint of girder knee plate connections. Round cover plates are utilized to seal the drilled stress relief holes and are held in place by nuts and bolts (Photo 2).

*Photo 2: Typical Dog-Bone Retrofit*

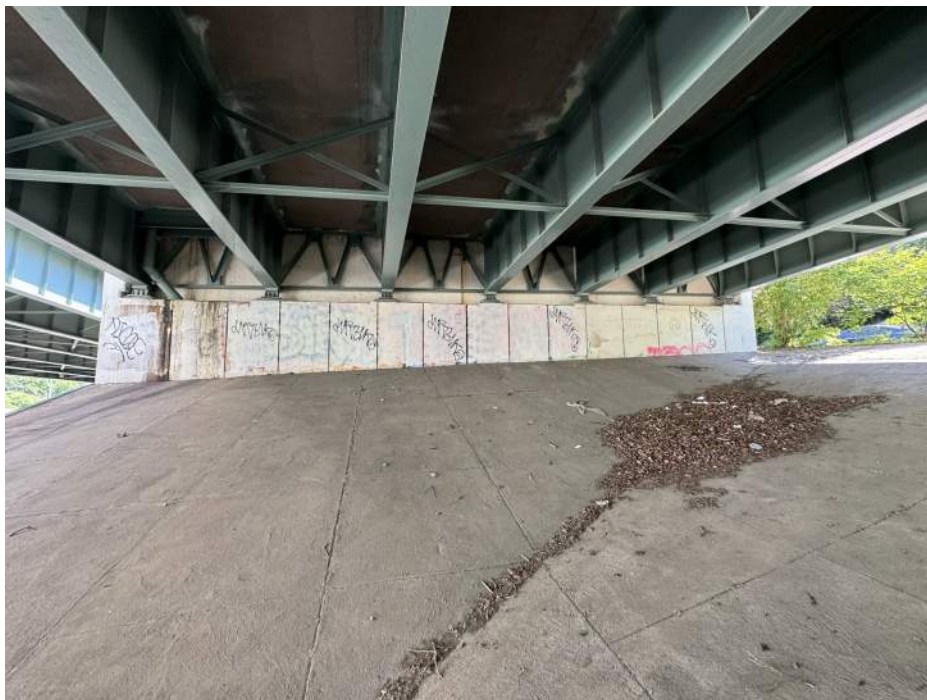
PHOTO 1

Description South abutment

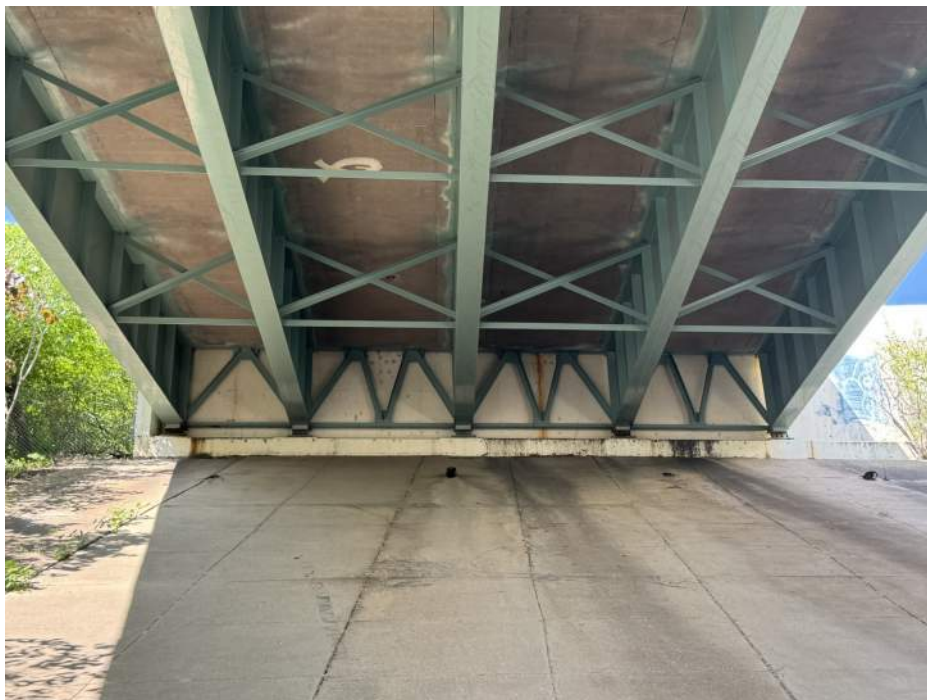
PHOTO 2

Description North abutment

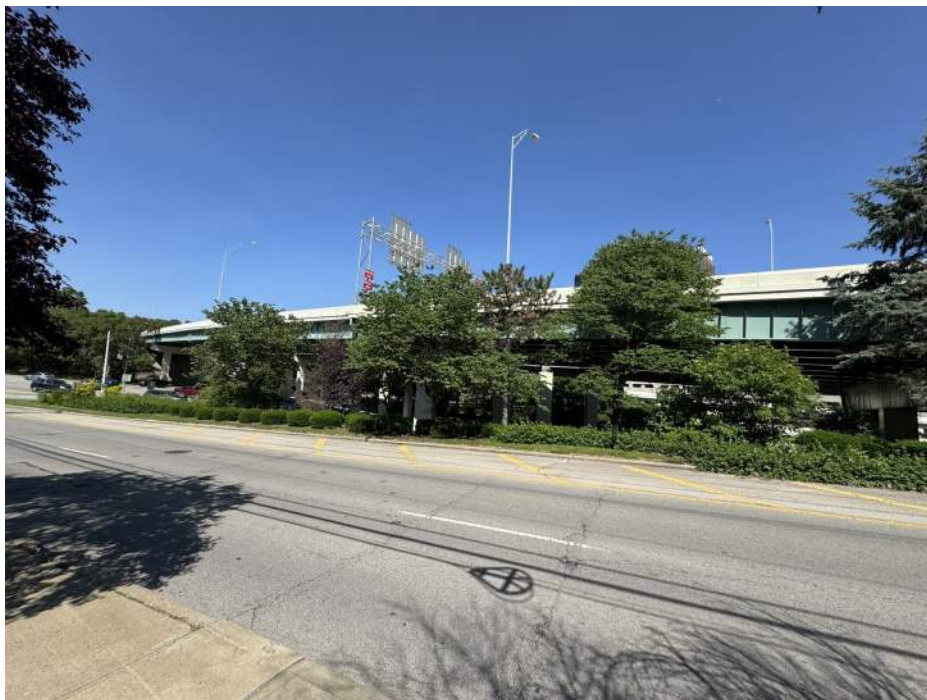
PHOTO 3

Description West bridge elevation

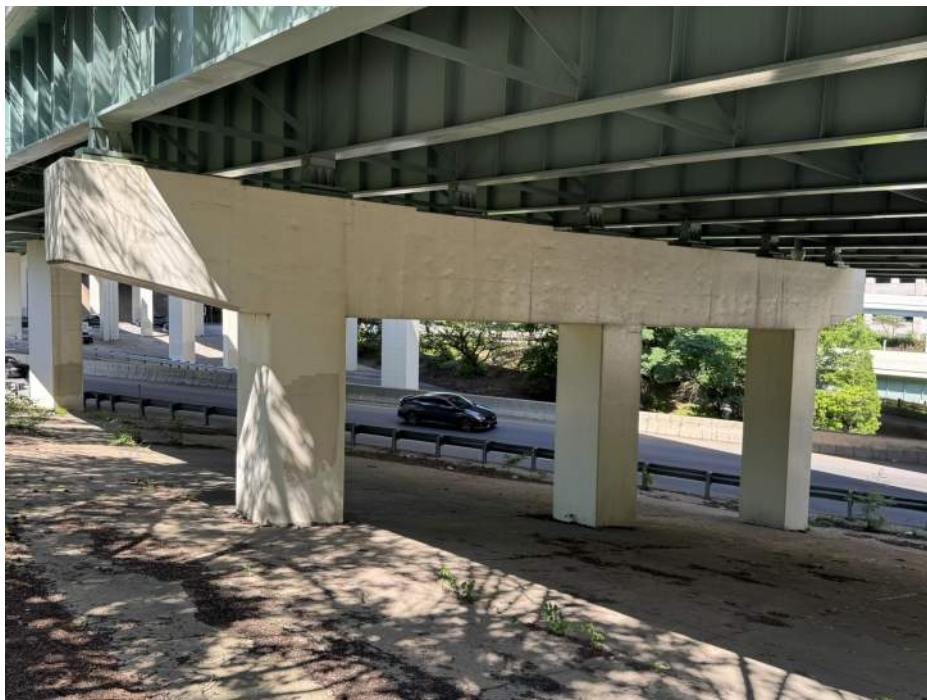
PHOTO 4

Description Typical pier 1

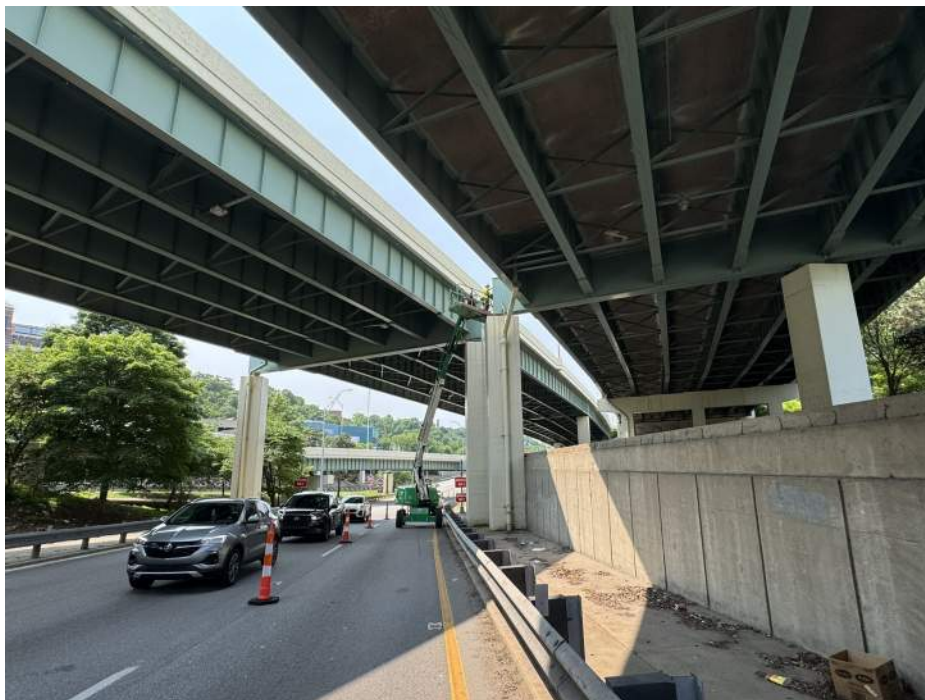
PHOTO 5

Description Pier 2 and typical superstructure

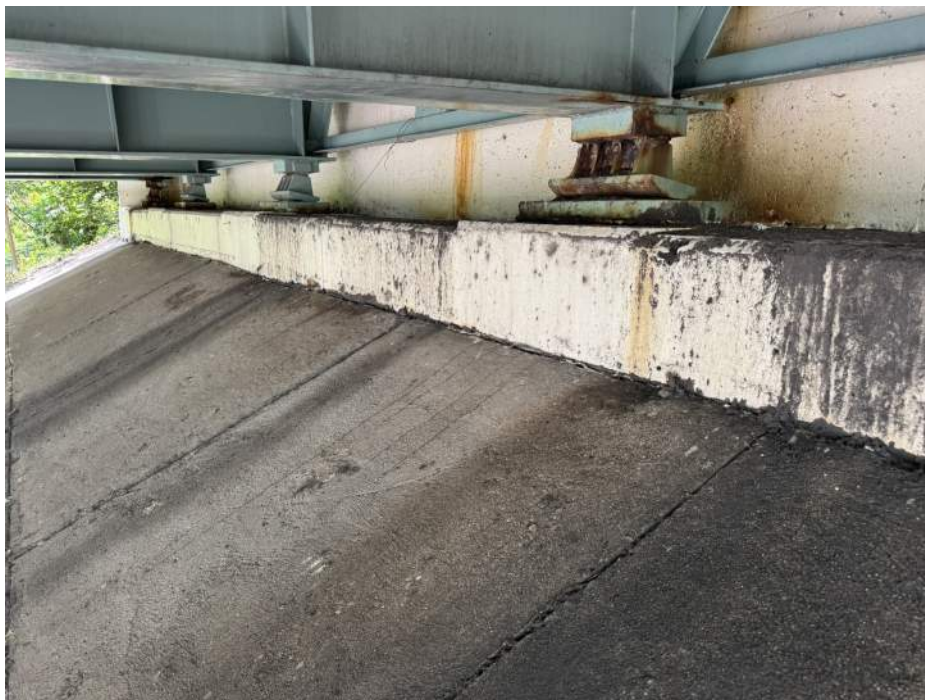
PHOTO 6

Description Typical condition of abutment bearings

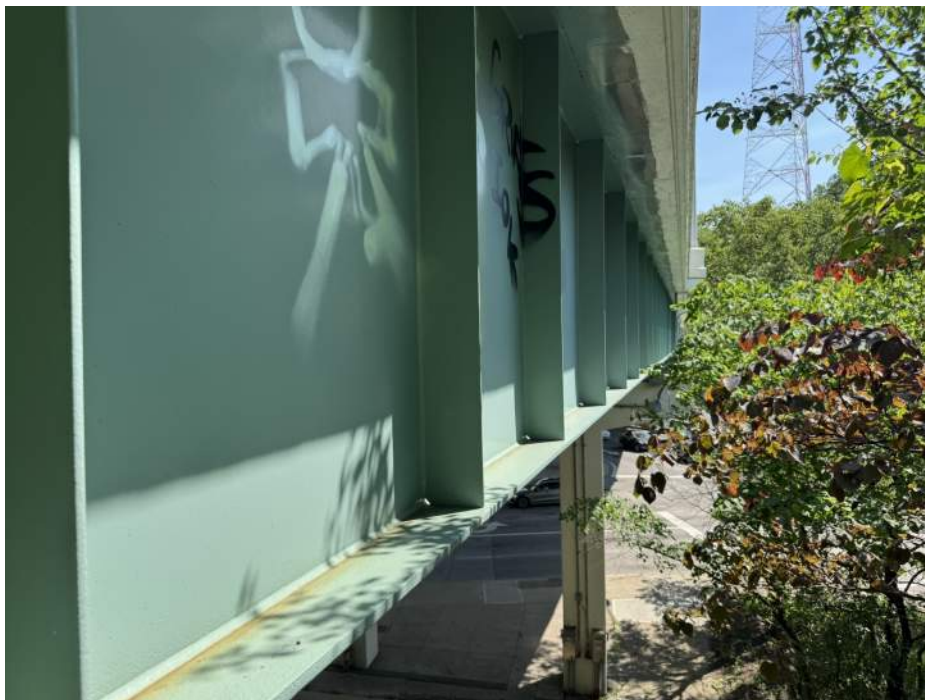
PHOTO 7

Description West fascia girder elevation

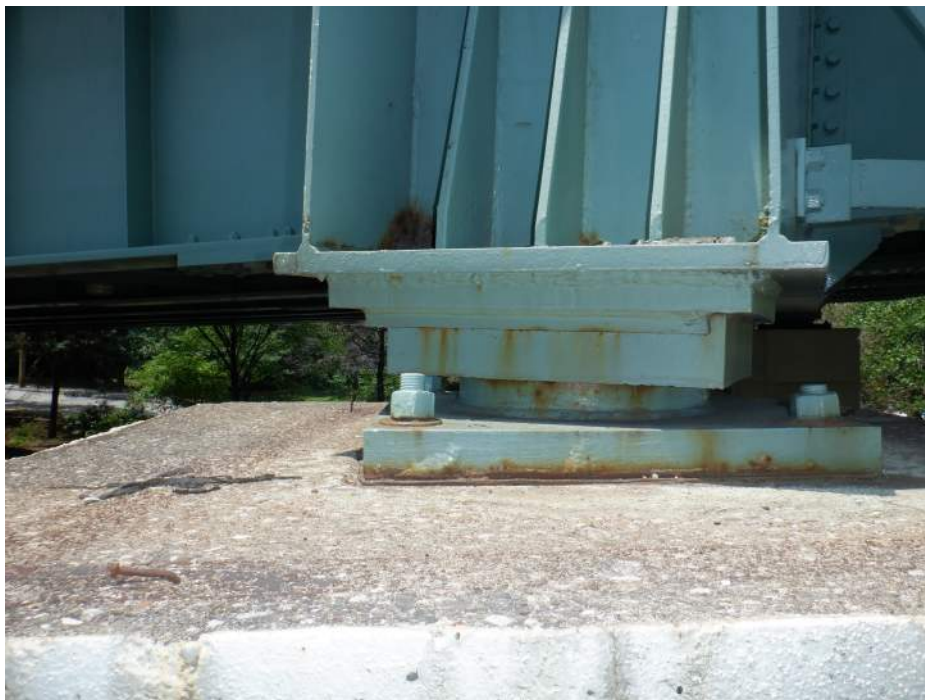
PHOTO 8

Description Typ. steel pier cap bearing

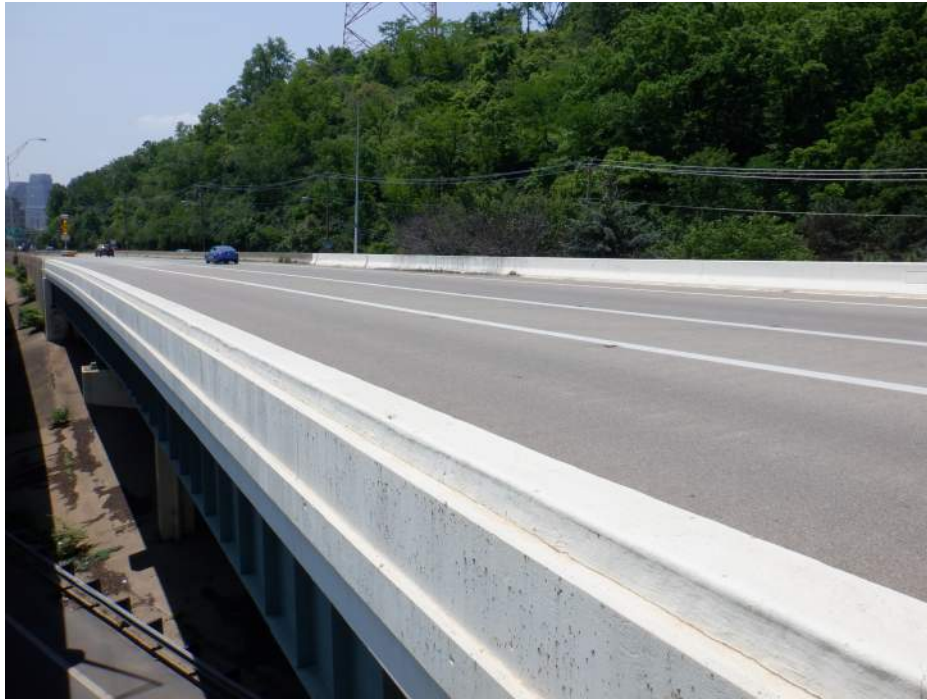
PHOTO 9

Description Typical deck

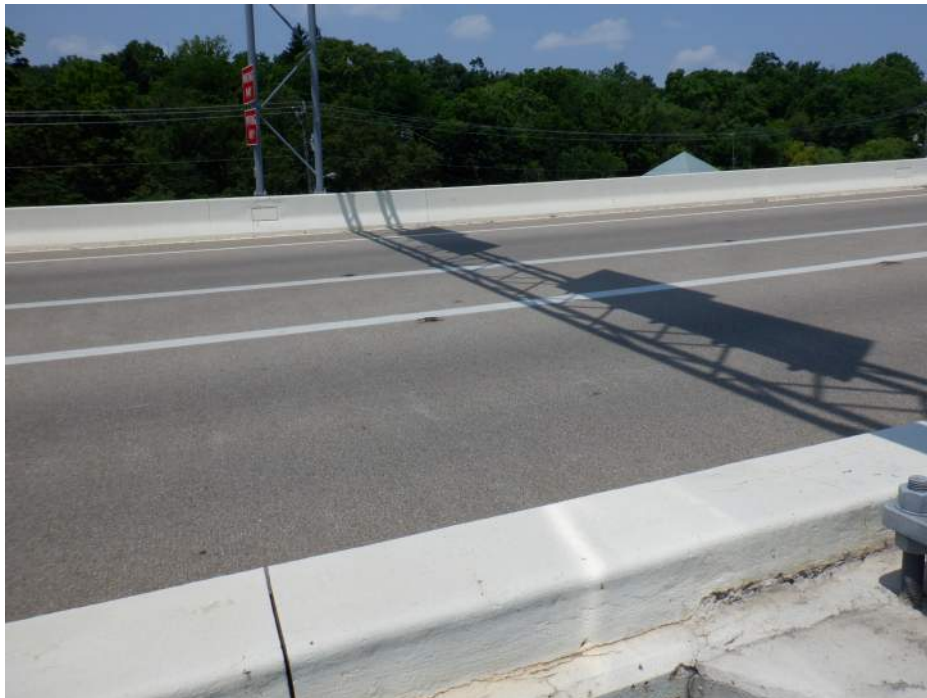
PHOTO 10

Description Typical deck
