# Routine and NSTM Member Inspection Report

## **HAM-71-0248L** **2025 Routine and NSTM Member Inspection** **Report** **(VAR-District 8 Bridge Inspections for Steel Pier** **Caps)**

**SFN: 3106780, PID: 109781**

August 23, 2025

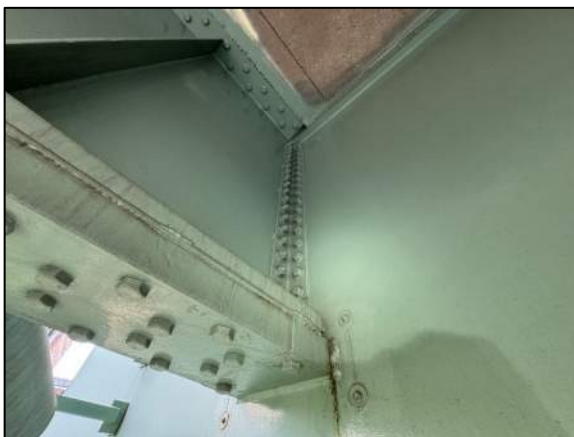
During previous rehabilitation, the web plates were retrofit with stress relief drilled holes connected by vertical saw cuts adjacent to the welded connections of the girder bottom flange tie plates (Photo 22).

*Photo 22: Typical Dog Bone Retrofit*

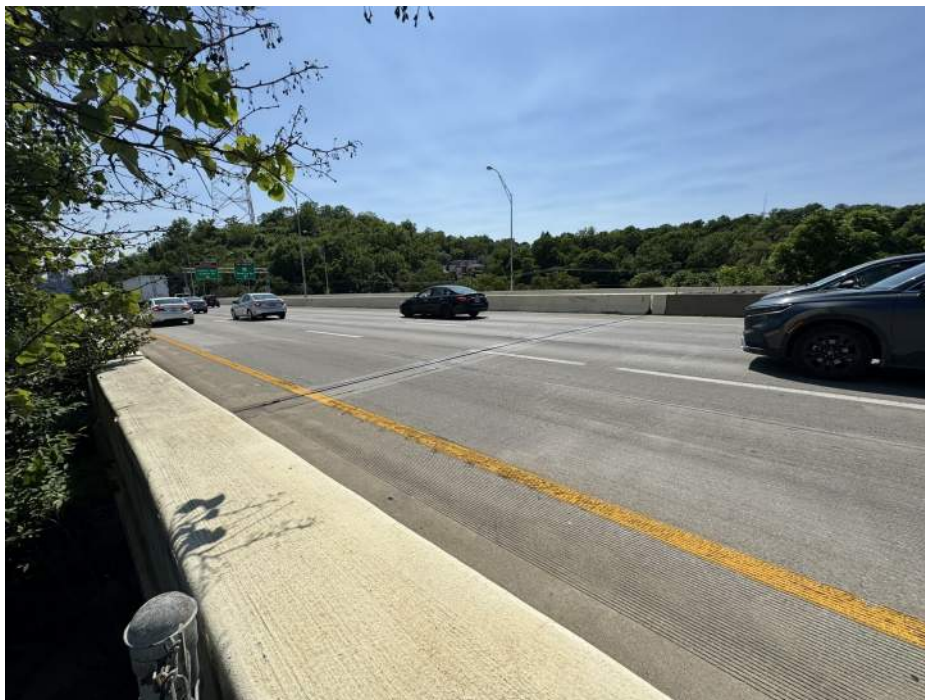
PHOTO 2

Description Typical deck and approach slab

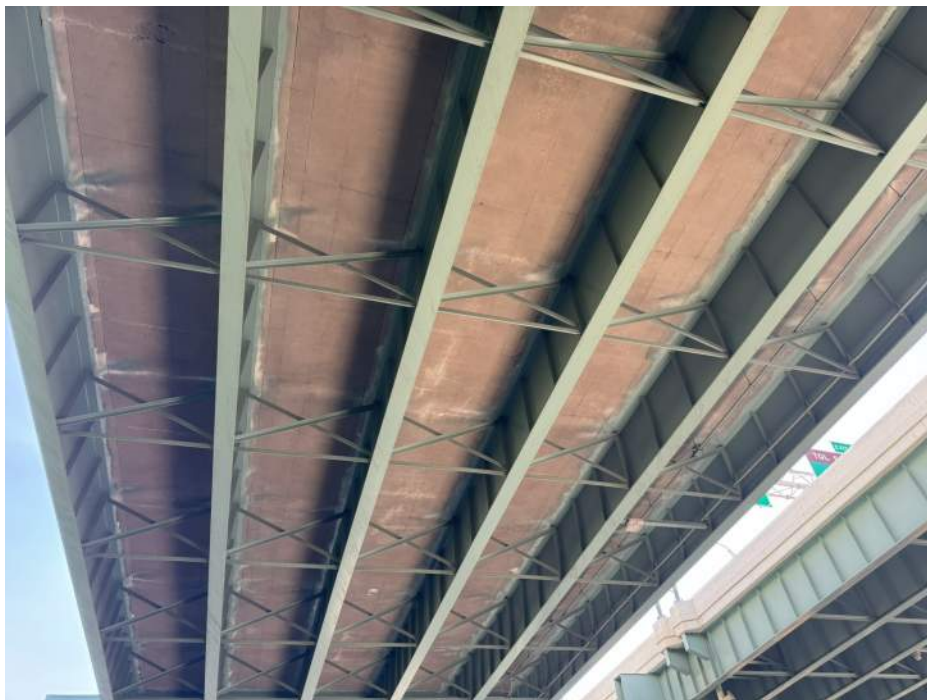
PHOTO 3

Description Typical superstructure and underside of deck

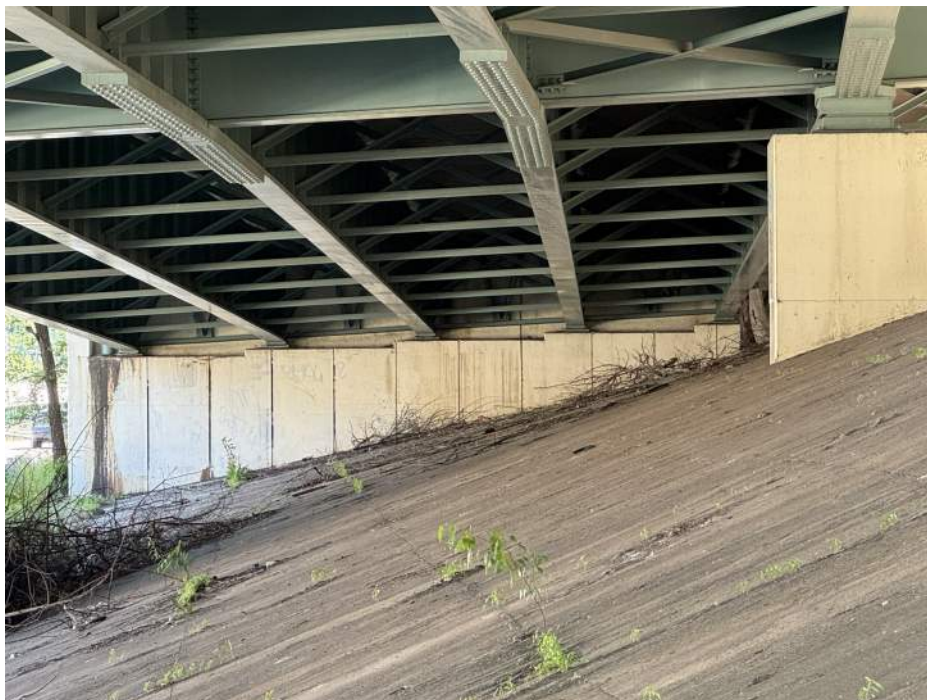
PHOTO 4

Description South abutment

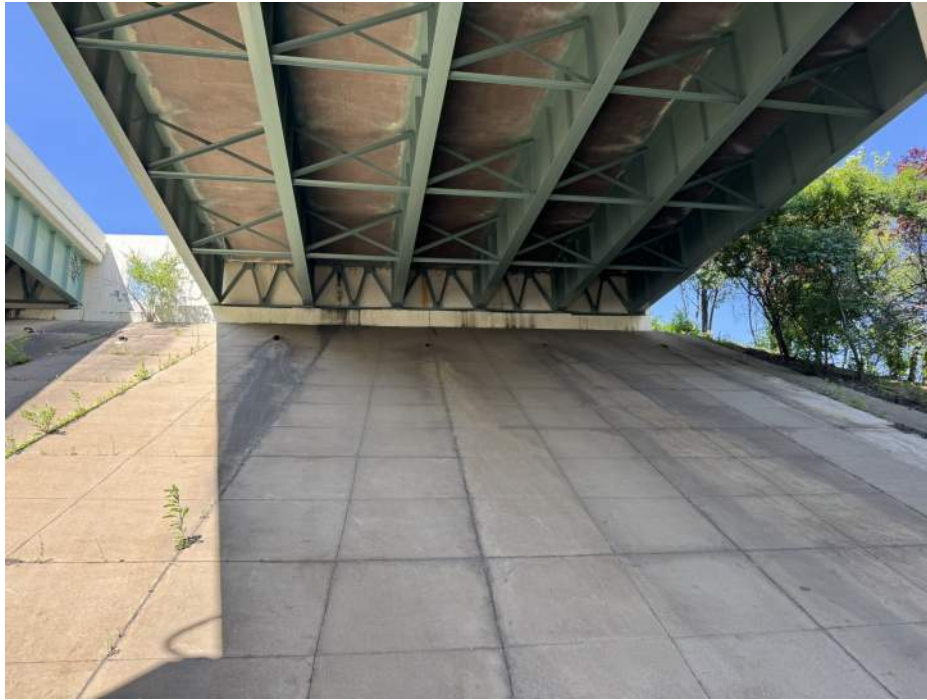
PHOTO 5

Description North abutment

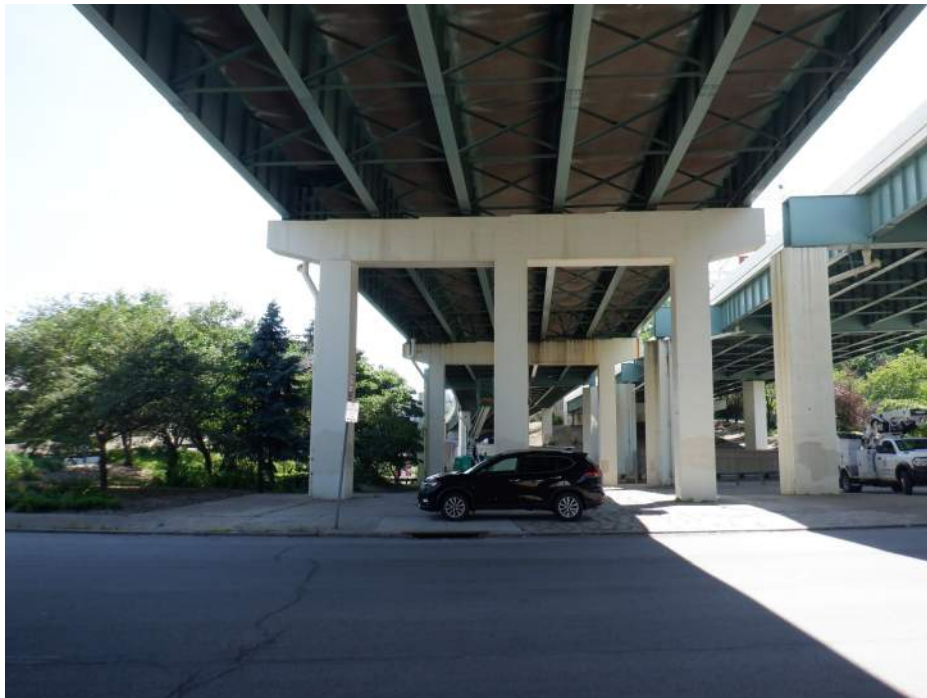
PHOTO 6

Description Typical Pier 5

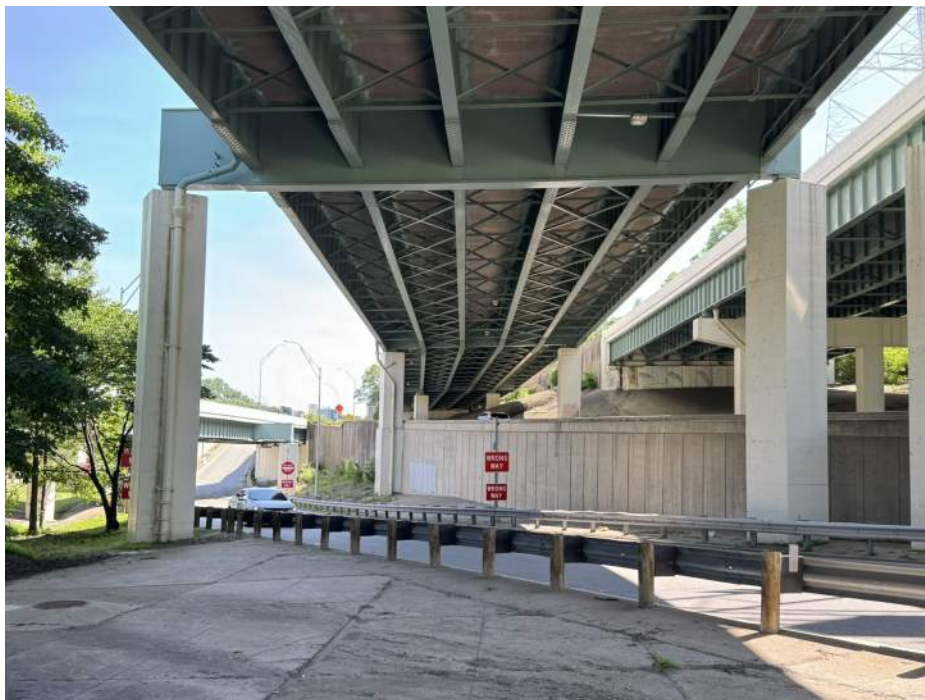
PHOTO 7

Description Typical steel pier cap, pier 3

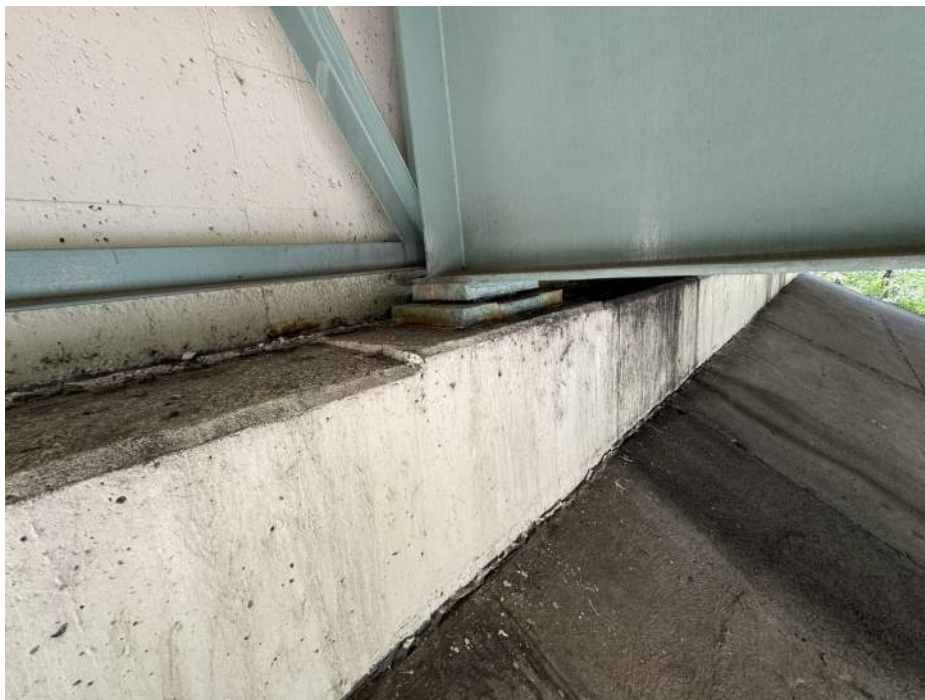
PHOTO 8

Description Typical abutment bearing

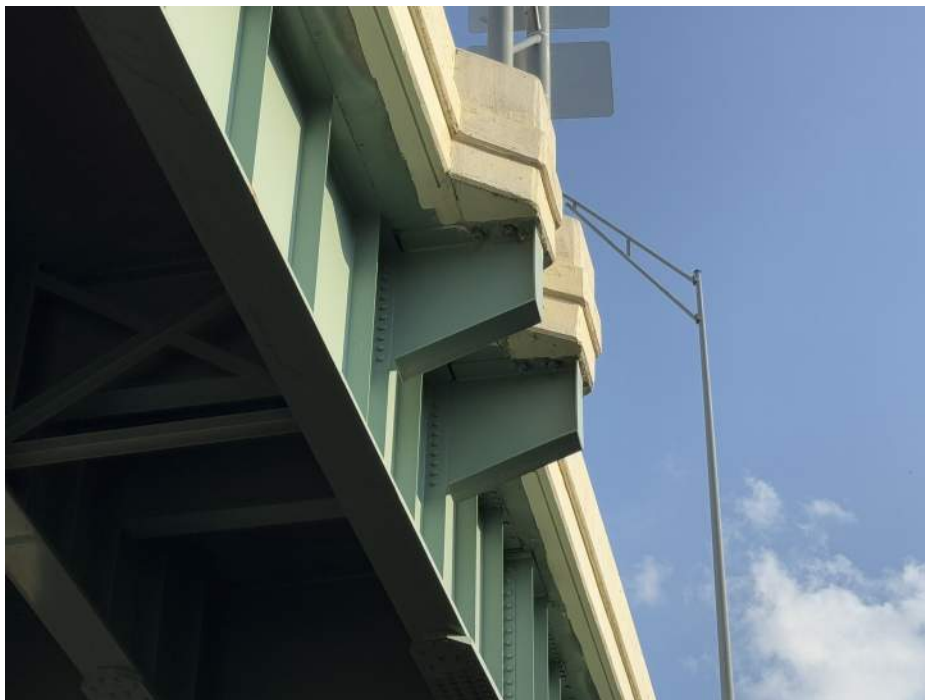
PHOTO 9

Description Typical sign support

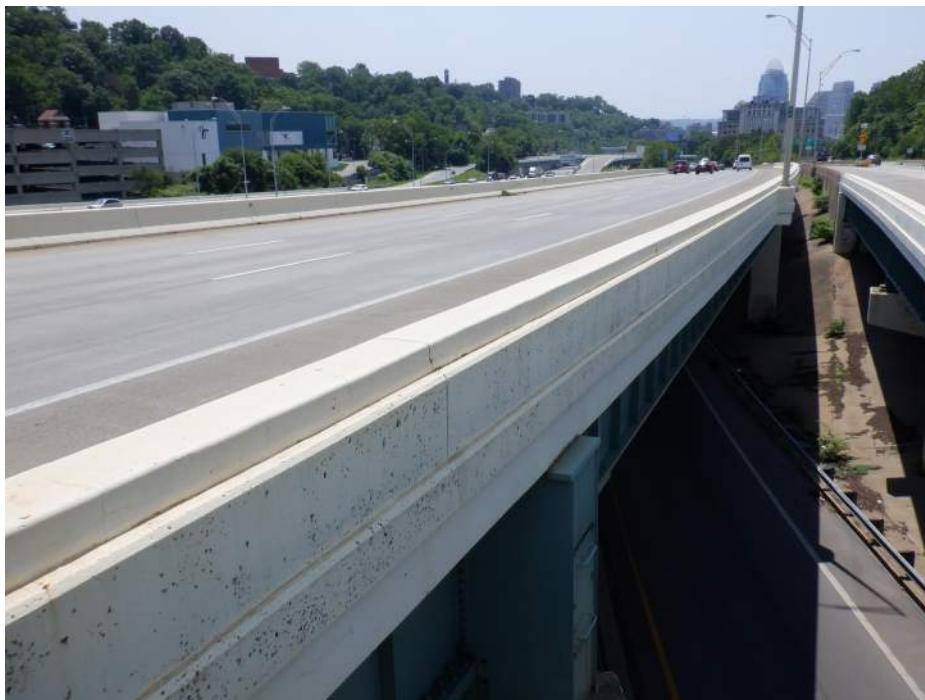
PHOTO 10

Description Bridge elevation, west fascia

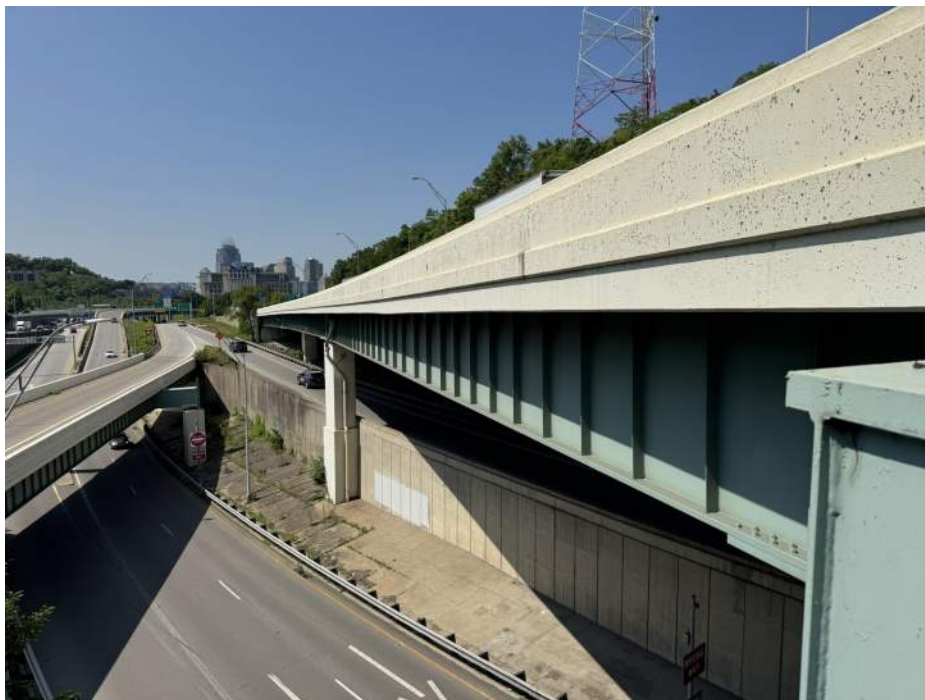
PHOTO 11

Description Bridge elevation, east fascia

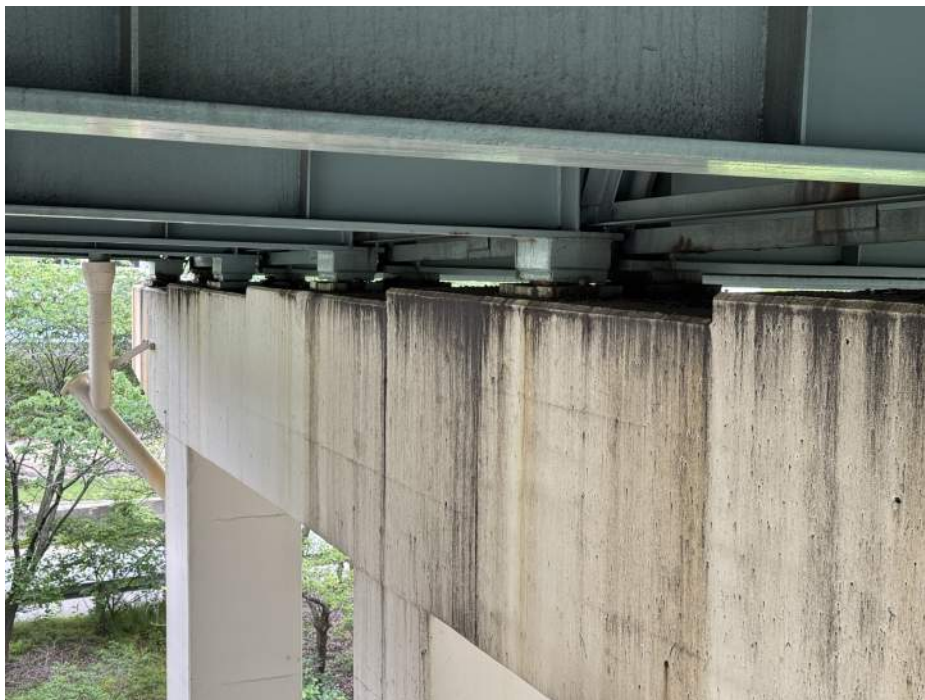
PHOTO 12

Description Pier 4 bearings under joint
