# NSTM Member Inspection Report

**HAM-71-0248R**

## 2025 NSTM Member Inspection Report (VAR-District 8 Bridge Inspections for Steel Pier Caps

**SFN: 3106802, PID: 109781**

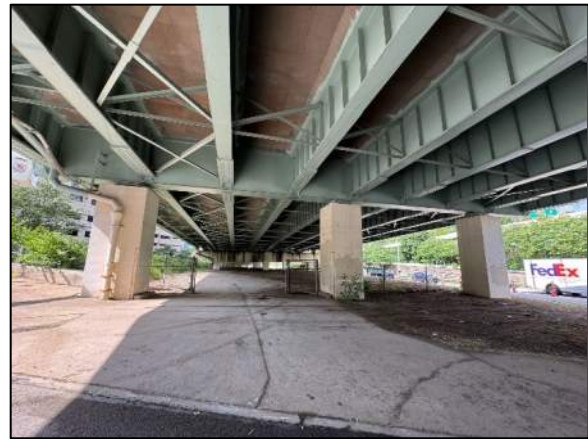
Pier Cap 9 is in GOOD CONDITION [7] overall (Photo 1). The condition rating has been raised in 2019 due to the designed repairs being constructed in 2017 returning the condition close to the original condition. Previously noted cracks were removed and dog bone crack arrest holes installed as specified in the repair plans in the appendix below. The interior of the cap was dry at the time of inspection. Moderate pitting of steel surfaces was found throughout the interior of the cap. The bottom flange in the interior end caps is heavily corroded.

*Photo 1: Pier Cap 9 Elevation*

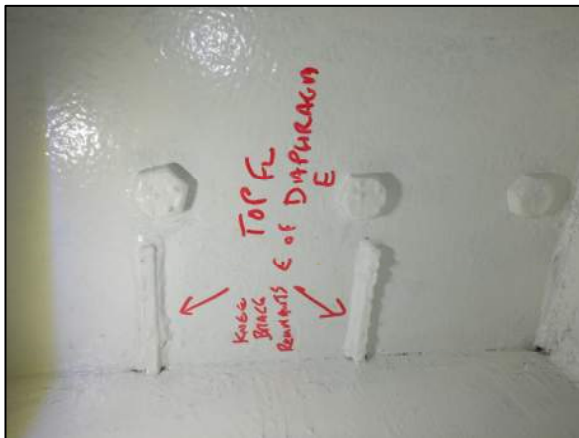
After the removal of the knee braces that were welded to the pier cap top flanges adjacent to each bearing, 5" L sections of the knee braces were left in place (Photo 9).

*Photo 9: East Face of Girder E Diaphragm and Top Flange; Knee Brace Remnants at The Top Flange*
