# NSTM Member Inspection Report

**HAM-562-0147**

## **2025 NSTM Member Inspection Report (VAR-District 8 Bridge Inspections for Steel Pier Caps)**

**SFN: 3113914, PID: 109781**

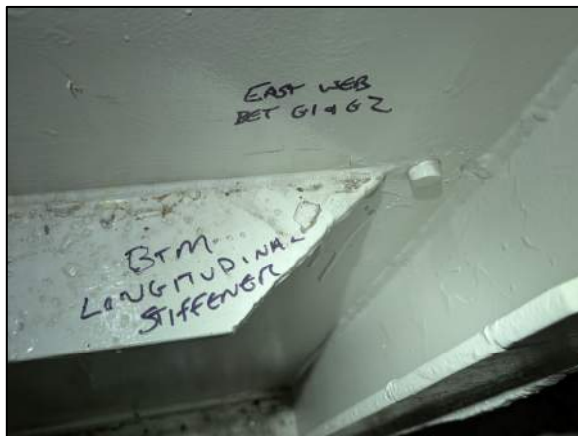
Photo 50: Typical longitudinal stiffener retrofit detail
